4th Atlas/NIST Workshop on Photovoltaic Materials Durability

Fragmentation test for crack propensity evaluation of PV backsheets

*Jae Hyun Kim, Yadong Lyu, Andrew Fairbrother,
Chen-An Wang, Xiaohong Gu*

NIST
Gaithersburg, Maryland

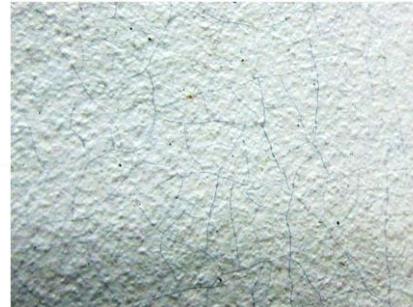
**Hairline cracks in polyamide backsheet (China, humid subtropical)

10 mm

- Various sizes in backsheets

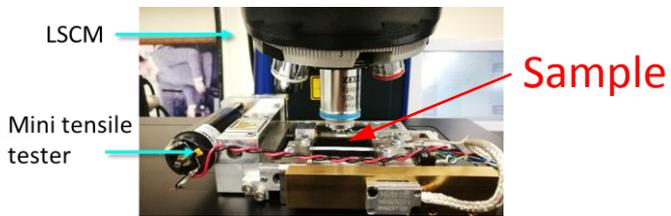
With mechanical stress **sequentially** (Fragmentation test)
