# **Micron Central New York Semiconductor Manufacturing Complex**

## **Fish Creek Stream and Wetland Mitigation Plan**

**Oswego County, NY**

May 2025

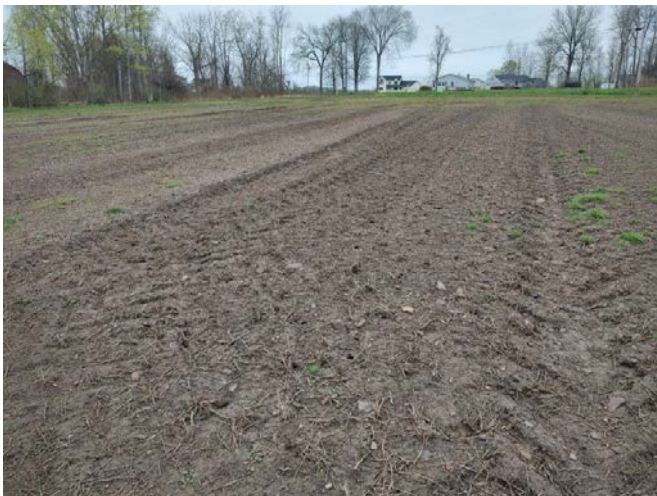
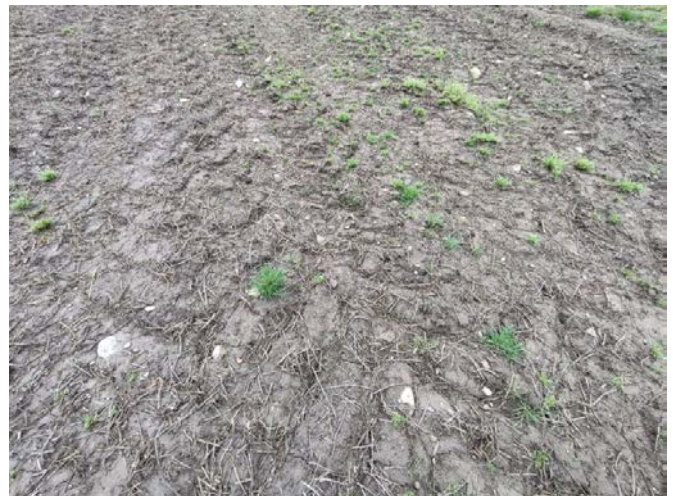
<b>Site Name: W-1 (Perry Road)</b>	<b>Date: 04-29-2024</b>
<b>Landowner: The Wetland Trust</b>	<b>Designer Name: Thomas R. Biebighauser</b>
<b>Individuals assisting with the design: Harrison Franz (The Wetland Trust)</b>	
<b>Objectives: Build a naturally appearing and functioning forested or shrub-scrub wetland for mitigation.</b>	<b>Site Description: An agricultural field that will be planted to soybeans.</b>
<b>Evidence of historic drainage or filling: Ditches along the edge of the field and the edge of the access road are removing surface water and lowering the elevation of groundwater. Buried drainage structures may be present in the field.</b>	
<b>Plant species: Soybeans</b>	<b>How the planned wetland is marked on the ground: Orange wire flags</b>
<b>Invasive species: none</b>	<b>Groundwater elevation in test hole? 11-inches below the surface.</b>
<b>Hydric soil present near the surface? No</b>	<b>Elevation-change from upper to lower edge of designed wetland: 3.0-feet</b>

<b>Soil test hole location: 43.294526°N 76.278344°W</b> <b>Soil texture: 0-11-inches = silt-loam topsoil, 11-inches – 48-inches mixed gravel and silt loam.</b>	
<b>Rock armoring is needed at the inlet and outlet due to high erosion potential.</b> <b>Inlet: 12-foot wide x 50-foot long x 1.0-foot deep = 600 feet<sup>3</sup>/27 feet<sup>3</sup>/yard<sup>3</sup> = 22 yards<sup>3</sup> x 1.5 tons/yard<sup>3</sup> = 33 tons</b> <b>Outlet: 12-foot wide x 75-foot long x 1.0-foot deep = 900 feet<sup>3</sup>/27 feet<sup>3</sup>/yard<sup>3</sup> = 33 yards<sup>3</sup> x 1.5 tons/yard<sup>3</sup> = 50 tons</b> <b>Total = 83 tons/24 tons/dump truck = 3.5 dump truck loads of rock needed</b>	
<b>Head-cuts located uphill or downhill of the planned wetland. No</b>	
<b>Woody debris source: Not available on site. Would need to be transported to the site.</b>	
<b>Construction notes: It should be possible to build a wetland on this site because the old field on the opposite site of the access road, which has the same soil texture and the same slope, supports a diversity of wetland plants. Fill the shallow and deep ditches bordering the field. Dig a core trench and build a groundwater dam around the lower 2/3 perimeter of the area. Build a low dam that is 1-foot high. Excavate a basin that is 6-inches deep in the center. Spread soil downhill. Create pits, mounds, and scrapes. Plant trees and shrubs on the mounds. Use rock to armor the inlet and outlet to prevent erosion.</b>

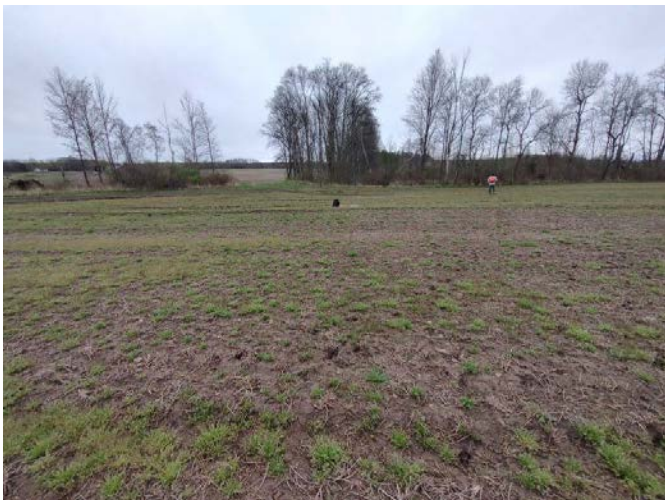
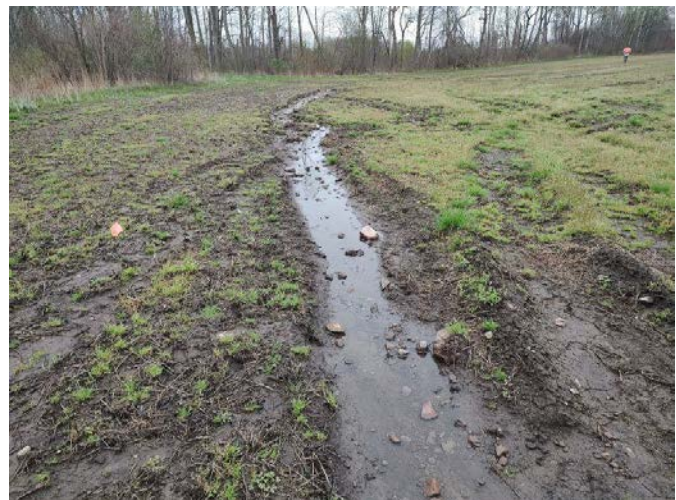
<b>Hydric soil present near the surface? No</b>	<b>Elevation-change from upper to lower edge of designed wetland: 3.0-feet</b>
<b>Soil test hole location: 43.295150°N 76.277983°W</b>	
<b>Soil texture: 0-11-inches = silt-loam topsoil, 11-inches – 48-inches mixed gravel and silt loam.</b>	
<b>Rock armoring is needed at the inlet and outlet:</b>	
<b>Inlet: 12-foot wide x 50-foot long x 1.0-foot deep = 600 feet<sup>3</sup>/27 feet<sup>3</sup>/yard<sup>3</sup> = 22 yards<sup>3</sup> x 1.5 tons/yard<sup>3</sup> = 33 tons</b>	
<b>Outlet: 12-foot wide x 75-foot long x 1.0-foot deep = 900 feet<sup>3</sup>/27 feet<sup>3</sup>/yard<sup>3</sup> = 33 yards<sup>3</sup> x 1.5 tons/yard<sup>3</sup> = 50 tons</b>	
<b>Total = 83 tons/24 tons/dump truck = 3.5 dump truck loads of rock needed</b>	
<b>Head-cuts located uphill or downhill of the planned wetland. No</b>	
<b>Woody debris source: Not available on site. Would need to be transported to the site.</b>

<b>Construction notes: It should be possible to build a wetland on this site because the old field on the opposite site of the access road, which has the same soil texture and the same slope, supports a diversity of wetland plants. Fill the shallow and deep ditches bordering the field. Dig a core trench and build a groundwater dam around the lower 2/3 perimeter of the area. Build a low dam that is 1-foot high. Excavate a basin that is 6-inches deep in the center. Spread soil downhill. Create pits, mounds, and scrapes. Plant trees and shrubs on the mounds. Use rock to armor the inlet and outlet to prevent erosion.</b>

W-2 (Ditch in center)

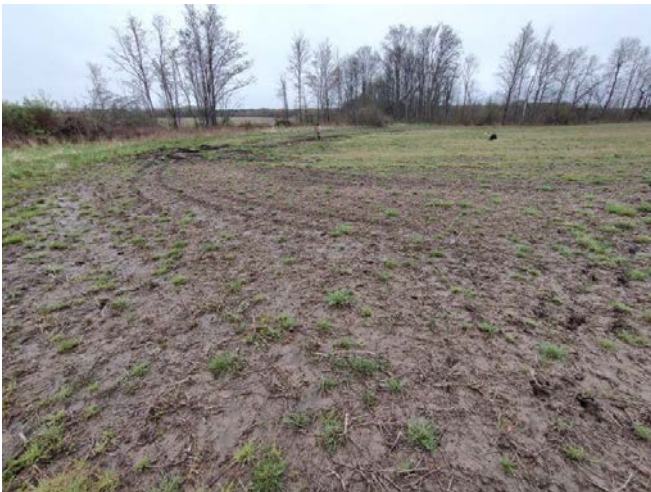
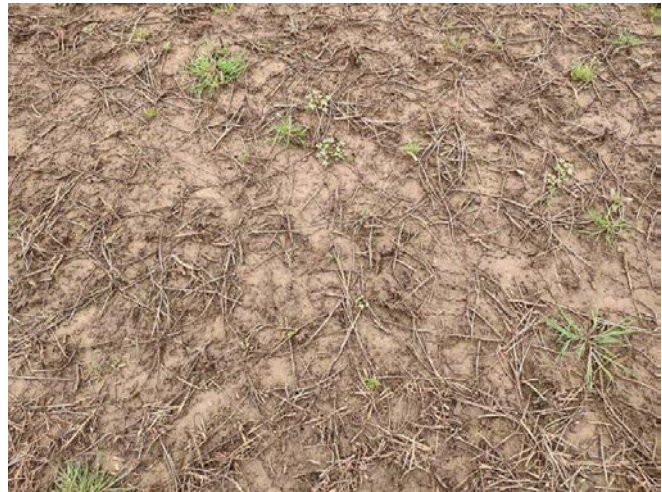
W-3

<b>Hydric soil present near the surface? No</b>	<b>Elevation-change from upper to lower edge of designed wetland: 3.0-feet</b>
<b>Soil test hole location: 43.295464°N 76.278301°W</b> <b>Soil texture: 0-14-inches = silt-loam topsoil, 14-inches – 48-inches mixed gravel and silt loam.</b>	
<b>Rock armoring is needed at the inlet and outlet:</b> <b>Inlet: 12-foot wide x 50-foot long x 1.0-foot deep = 600 feet<sup>3</sup>/27 feet<sup>3</sup>/yard<sup>3</sup> = 22 yards<sup>3</sup> x 1.5 tons/yard<sup>3</sup> = 33 tons</b> <b>Outlet: 12-foot wide x 75-foot long x 1.0-foot deep = 900 feet<sup>3</sup>/27 feet<sup>3</sup>/yard<sup>3</sup> = 33 yards<sup>3</sup> x 1.5 tons/yard<sup>3</sup> = 50 tons</b> <b>Total = 83 tons/24 tons/dump truck = 3.5 dump truck loads of rock needed</b>	
<b>Head-cuts located uphill or downhill of the planned wetland. No</b>	
<b>Woody debris source: Not available on site. Would need to be transported to the site.</b>

<b>Construction notes: It should be possible to build a wetland on this site because the old field on the opposite site of the access road, which has the same soil texture and the same slope, supports a diversity of wetland plants. Fill the shallow and deep ditches bordering the field. Dig a core trench around the lower 2/3 perimeter of the area. Excavate a basin that is 6-inches deep in the center. Spread soil uphill past W-1. Create pits, mounds, and scrapes. Plant trees and shrubs on the mounds. Use rock to armor the inlet and outlet to prevent erosion.</b>

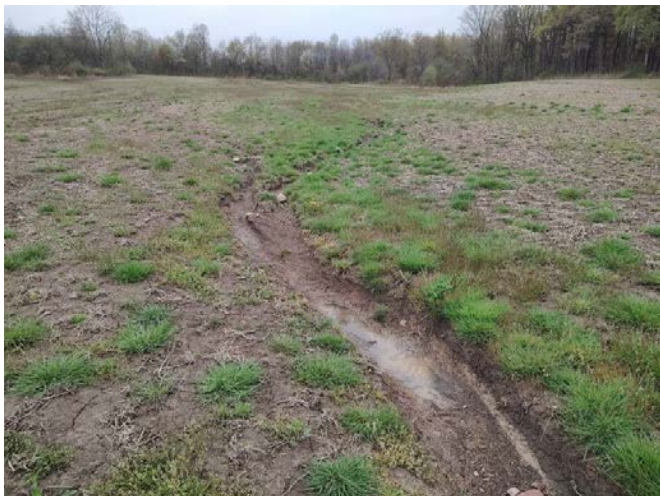
W-4

<b>Head-cuts located uphill or downhill of the planned wetland. Yes. A deep eroding ditch bisects the site.</b>	
<b>Woody debris source: Not available on site. Would need to be transported to the site.</b>	
<b>Construction notes: Fill the ditch draining the area. Dig a core trench and build a groundwater dam around the lower 2/3 perimeter of the area. Build a sinuous stream with a channel from 12-20-foot wide and banks no higher than 6-inches with restored forested and shrub-scrub wetlands on either side. Avoid building a dam because the restored stream must flow into and out from the wetland, and not look like an artificial spillway. Excavate a large and shallow basin that is 6-inches deep in the center. Spread the soil that is removed over the sides of the valley and not in the wetland being built. Create pits, mounds, and scrapes. Plant trees and shrubs on the mounds. Use rock to armor the stream inlet and outlet to prevent erosion.</b>

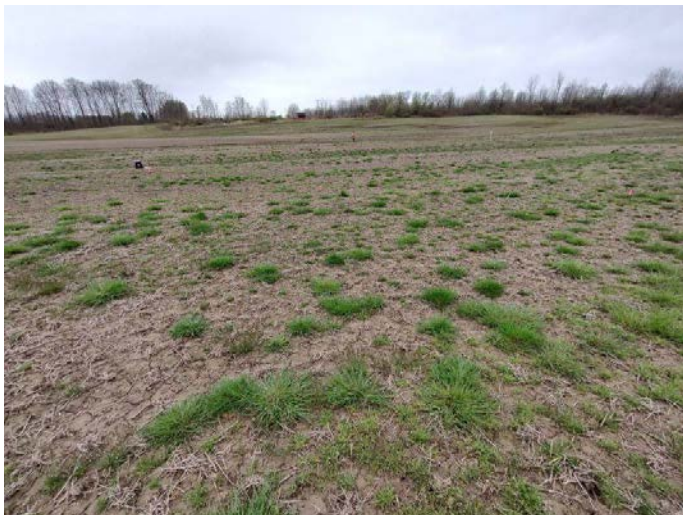
W-5

<b>Head-cuts located uphill or downhill of the planned wetland. Yes. A deep eroding ditch bisects the site.</b>	
<b>Woody debris source: Not available on site. Would need to be transported to the site.</b>	
<b>Construction notes: Fill the ditch draining the area. Dig a core trench and build a groundwater dam around the lower 2/3 perimeter of the area. Build a sinuous stream with a channel from 12-20-feet wide and banks no higher than 6-inches with restored forested and shrub-scrub wetlands on either side. Avoid building a dam because the restored stream must flow into and out from the wetland, and not look like an artificial spillway. Excavate a large and shallow basin that is 6-inches deep in the center. Spread the soil that is removed over the sides of the valley and not in the wetland being built. Create pits, mounds, and scrapes. Plant trees and shrubs on the mounds. Use rock to armor the stream inlet and outlet to prevent erosion.</b>

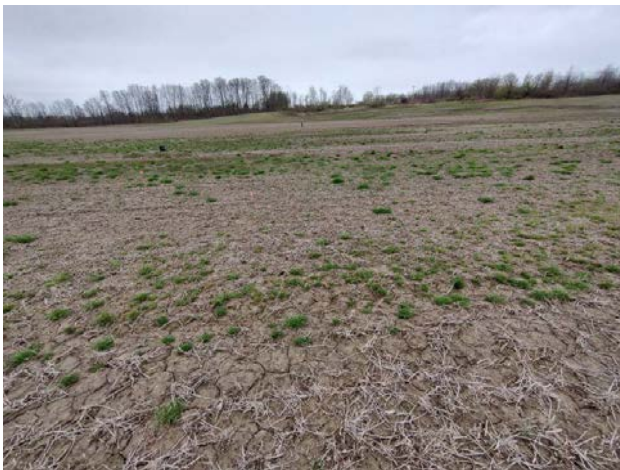
W-6

<b>Head-cuts located uphill or downhill of the planned wetland. Yes. A deep eroding ditch bisects the site.</b>	
<b>Woody debris source: Not available on site. Would need to be transported to the site.</b>	
<b>Construction notes: Fill the ditch draining the area. Dig a core trench and build a groundwater dam around the lower 2/3 perimeter of the area. Build a sinuous stream with a channel from 12-20-foot wide and banks no higher than 6-inches with restored forested and shrub-scrub wetlands on either side. Avoid building a dam because the restored stream must flow into and out from the wetland, and not look like an artificial spillway. Excavate a large and shallow basin that is 6-inches deep in the center. Spread the soil that is removed over the sides of the valley and not in the wetland being built. Create pits, mounds, and scrapes. Plant trees and shrubs on the mounds. Use rock to armor the stream inlet and outlet to prevent erosion.</b>

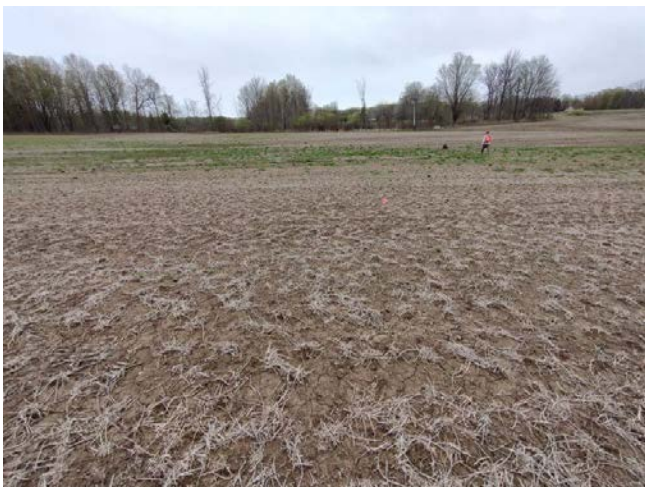
W-7

<b>Head-cuts located uphill or downhill of the planned wetland. Yes. A deep eroding ditch bisects the site.</b>	
<b>Woody debris source: Not available on site. Would need to be transported to the site.</b>	
<b>Construction notes: Fill the ditch draining the area. Dig a core trench and build a groundwater dam around the lower 2/3 perimeter of the area. Build a sinuous stream with a channel from 12-20-feet wide and banks no higher than 6-inches with restored forested and shrub-scrub wetlands on either side. Avoid building a dam because the restored stream must flow into and out from the wetland, and not look like an artificial spillway. Excavate a large and shallow basin that is 6-inches deep in the center. Spread the soil that is removed over the sides of the valley and not in the wetland being built. Create pits, mounds, and scrapes. Plant trees and shrubs on the mounds. Use rock to armor the stream inlet and outlet to prevent erosion.</b>

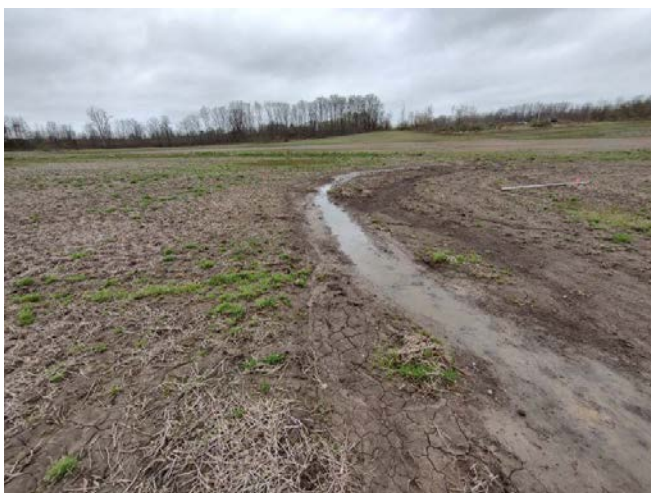
W-8

<b>Total = 288 tons/24 tons/dump truck = 12- dump truck loads of rock needed</b>	
<b>Head-cuts located uphill or downhill of the planned wetland. Yes. A deep eroding ditch bisects the site.</b>	
<b>Woody debris source: Not available on site. Would need to be transported to the site.</b>	
<b>Construction notes: Fill the ditch draining the area. Dig a core trench and build a groundwater dam around the lower 2/3 perimeter of the area. Build a sinuous stream with a channel from 18-26-feet wide and banks no higher than 6-inches with restored forested and shrub-scrub wetlands on either side. Avoid building a dam because the restored stream must flow into and out from the wetland, and not look like an artificial spillway. Excavate a large and shallow basin that is 6-inches deep in the center. Spread the soil that is removed over the sides of the valley and not in the wetland being built. Create pits, mounds, and scrapes. Plant trees and shrubs on the mounds. Use rock to armor the stream inlet and outlet to prevent erosion.</b>

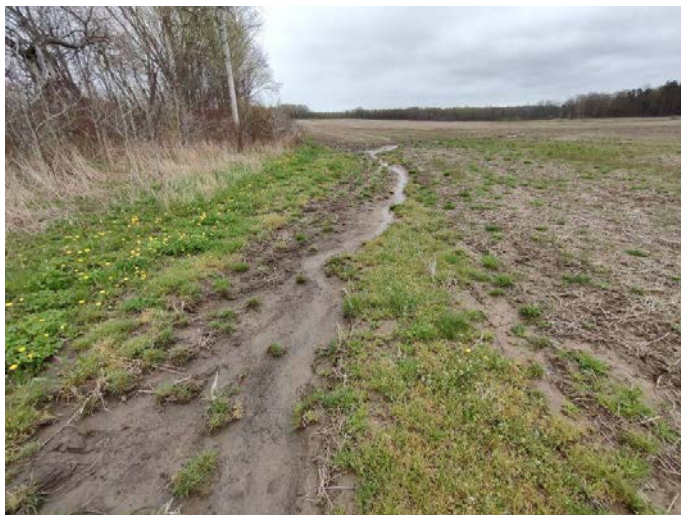
Site Name: W-9 (Perry Road)	Date: 04-29-2024
Landowner: The Wetland Trust	Designer Name: Thomas R. Biebighauser
Individuals assisting with the design: Harrison Franz (The Wetland Trust)	
Objectives: Build a naturally appearing forested/shrub-scrub wetland for mitigation.	Site Description: An agricultural field that will be planted with soybeans. The field is highly erodible due to the silt loam texture soil on the surface and steep slopes.
Evidence of historic drainage or filling: Ditches are removing surface water and lowering the elevation of groundwater. Diversion ditches are present along the edges of the fields with surface inlets that were installed to provide runoff with rapid entry into buried drainpipes. Lands with dead furrows are present.	
Plant species:	How the planned wetland is marked on the ground: Pink wire flags
Invasive species: none	Groundwater elevation in test hole? Not found

Hydric soil present (near the surface)? No	Elevation-change from upper to lower edge of designed wetland: 3.0-feet
Soil test hole location: 43.297052°N 76.275451°W Soil texture: 0-20-inches = silt-loam topsoil, 20-40-inches = sandy silt loam, 40-48-inches = clay.	
Rock armoring is needed at the inlet and outlet: Inlet: 12-foot wide x 50-foot long x 1.0-foot deep = 600 feet <sup>3</sup> /27 feet <sup>3</sup> /yard <sup>3</sup> = 22 yards <sup>3</sup> x 1.5 tons/yard <sup>3</sup> = 33 tons Outlet: 12-foot wide x 75-foot long x 1.0-foot deep = 900 feet <sup>3</sup> /27 feet <sup>3</sup> /yard <sup>3</sup> = 33 yards <sup>3</sup> x 1.5 tons/yard <sup>3</sup> = 50 tons Total = 83 tons/24 tons/dump truck = 3.5 dump truck loads of rock needed	
Head-cuts located uphill or downhill of the planned wetland. Yes. A deep eroding ditch bisects the site.	
Woody debris source: Not available on site. Would need to be transported to the site.

Construction notes: Fill the ditch draining the area with soil. Dig a core trench and build a groundwater dam around the lower 2/3 perimeter of the area. Excavate a large and shallow basin that is 6-inches deep in the center. Spread the soil that is removed over the sides of the valley and not in the wetland being built. Create pits, mounds, and scrapes. Plant trees and shrubs on the mounds. Use rock to armor the stream inlet and outlet to prevent erosion.

W-9 (showing ditch)

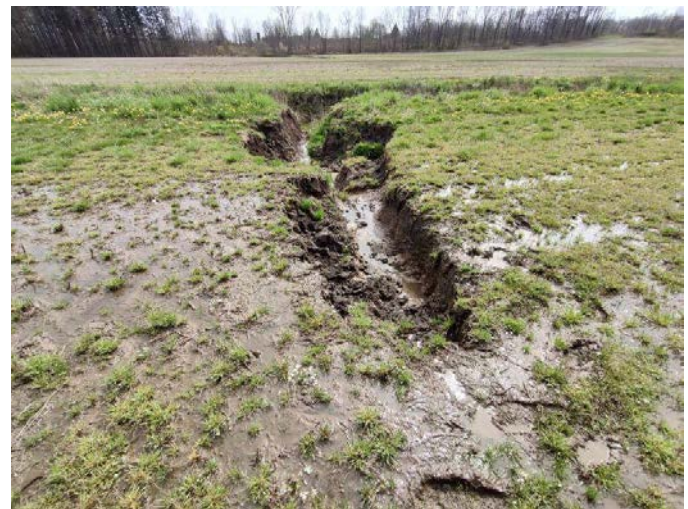
W-9 (Showing head-cut)

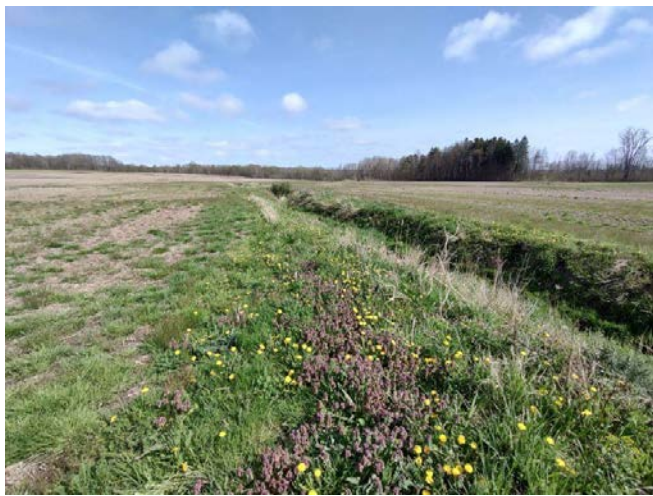
W-10

Woody debris source: Not available on site. Would need to be transported to the site.	
Construction notes: Fill the ditch draining the area with soil. Dig a core trench and build a groundwater dam around the lower 2/3 perimeter of the area. Build a sinuous stream with a channel from 18-26-feet wide and banks no higher than 6-inches with restored forested and shrub-scrub wetlands on either side. Avoid building a dam because the restored stream must flow into and out from the wetland, and not look like an artificial spillway. Excavate a large and shallow basin that is 6-inches deep in the center. Spread the soil that is removed over the sides of the valley and not in the wetland being built. Create pits, mounds, and scrapes. Plant trees and shrubs on the mounds. Use rock to armor the stream inlet and outlet to prevent erosion.

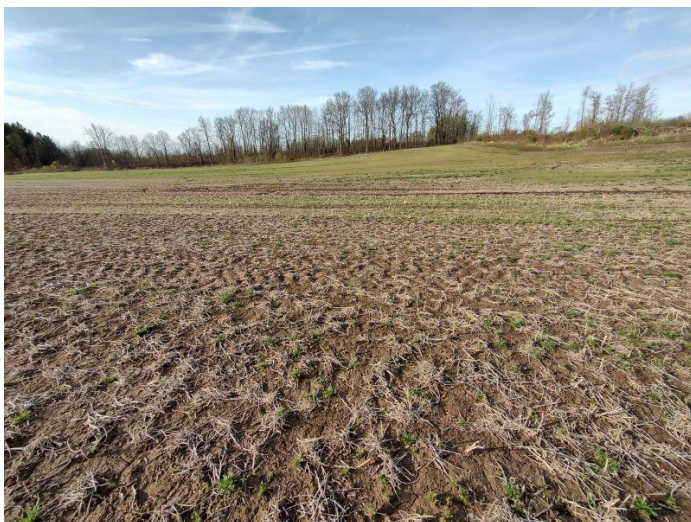
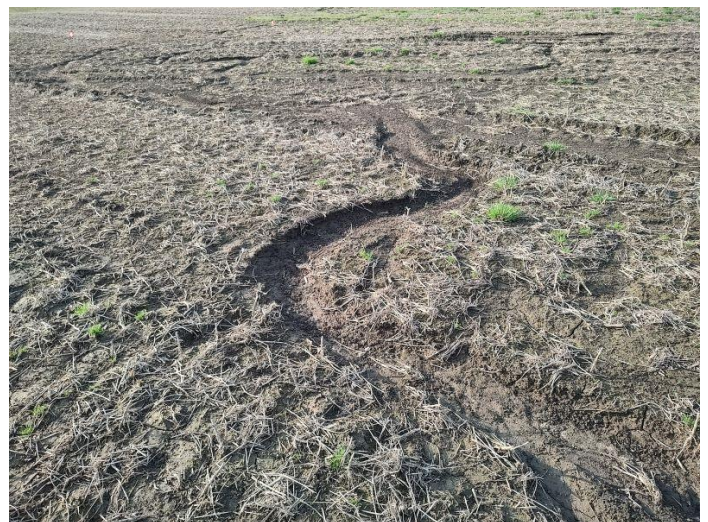
Site Name: W-11 (Perry Road)	Date: 04-30-2024
Landowner: The Wetland Trust	Designer Name: Thomas R. Biebighauser
Individuals assisting with the design: Dan Kwasnowski (The Wetland Trust), Harrison Franz (The Wetland Trust)	
Objectives: Build a naturally appearing forested/shrub-scrub wetland for mitigation.	Site Description: An agricultural field that will be planted with soybeans. The field is highly erodible due to the silt loam texture soil on the surface and steep slopes.
Evidence of historic drainage or filling: Ditches are removing surface water and lowering the elevation of groundwater. Diversion ditches are present along the edges of the fields with surface inlets that were installed to provide runoff with rapid entry into buried drainpipes. Lands with dead furrows are present.	
Plant species:	How the planned wetland is marked on the ground: Orange wire flags
Invasive species: none	Groundwater elevation in test hole? Not found

Hydric soil present near the surface? No	Elevation-change from upper to lower edge of designed wetland: 2.0-feet
Soil test hole location: 43.296209°N 76.276693°W Soil texture: 0-20-inches = silt-loam topsoil, 20-40-inches = sandy silt loam, 40-48-inches = clay.	
Rock armoring is needed at the inlet and outlet: Inlet: 12-foot wide x 50-foot long x 1.0-foot deep = 600 feet <sup>3</sup> /27 feet <sup>3</sup> /yard <sup>3</sup> = 22 yards <sup>3</sup> x 1.5 tons/yard <sup>3</sup> = 33 tons Outlet: 12-foot wide x 75-foot long x 1.0-foot deep = 900 feet <sup>3</sup> /27 feet <sup>3</sup> /yard <sup>3</sup> = 33 yards <sup>3</sup> x 1.5 tons/yard <sup>3</sup> = 50 tons Total = 83 tons/24 tons/dump truck = 3.5 dump truck loads of rock needed .	
Head-cuts located uphill or downhill of the planned wetland. Yes. An eroding ditch bisects the site.	
Woody debris source: Not available on site. Would need to be transported to the site.

Construction notes: Fill the ditch draining the area with soil. Dig a core trench and build a groundwater dam around the lower 2/3 perimeter of the area. Excavate a large and shallow basin that is 6-inches deep in the center. Spread the soil that is removed over the sides of the valley and not in the wetland being built. Create pits, mounds, and scrapes. Plant trees and shrubs on the mounds. Use rock to armor the stream inlet and outlet to prevent erosion.

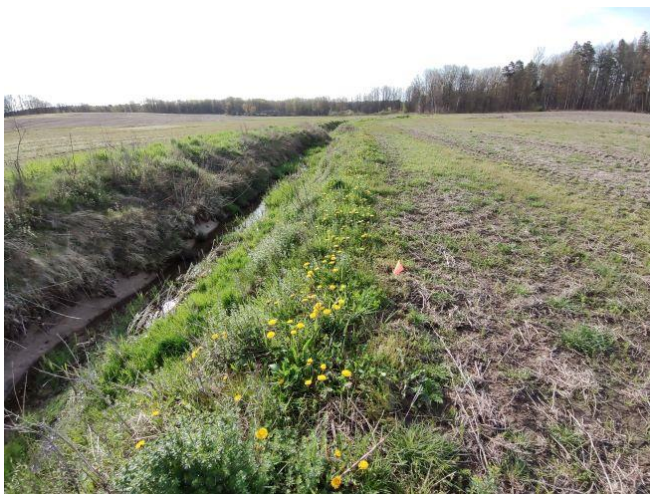
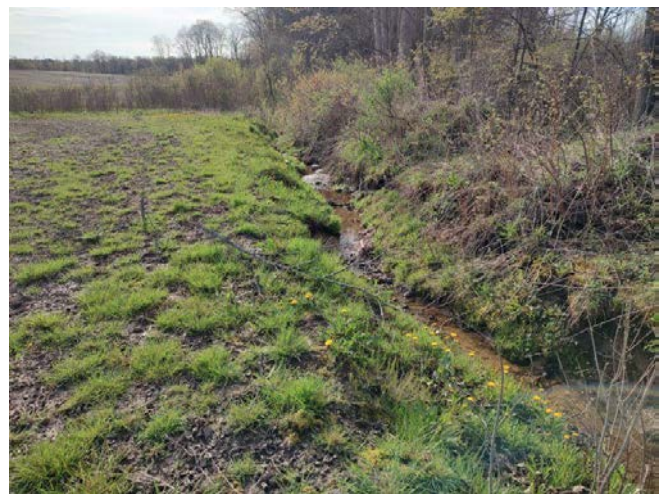
Invasive species: none	Groundwater elevation in test hole? Not found
Hydric soil present near the surface? No	Elevation-change from upper to lower edge of designed wetland: 2.0-feet
Soil test hole location: 43.295930°N 76.275289°W Soil texture: 0-20-inches = silt-loam topsoil, 20-40-inches = clay loam, 40-55-iches = clay.	
Rock armoring is needed at the inlet and outlet: Inlet: 26-feet wide x 100-feet long x 1.0-foot deep = 2,600 feet <sup>3</sup> /27 feet <sup>3</sup> /yard <sup>3</sup> = 96 yards <sup>3</sup> x 1.5 tons/yard <sup>3</sup> = 144 tons Outlet: 26-feet wide x 100-feet long x 1.0-foot deep = 2,600 feet <sup>3</sup> /27 feet <sup>3</sup> /yard <sup>3</sup> = 96 yards <sup>3</sup> x 1.5 tons/yard <sup>3</sup> = 144 tons Total = 288 tons/24 tons/dump truck = 12- dump truck loads of rock needed	
Head-cuts located uphill or downhill of the planned wetland. Yes. A deep eroding ditch bisects the site. Head-cuts are also located in the ditch along the south edge of the field.

Woody debris source: Not available on site. Would need to be transported to the site.	
Construction notes: Fill two ditches the area with soil. Dig a core trench and build a groundwater dam around the lower 2/3 perimeter of the area. Build a sinuous stream with a channel from 18-26-feet wide and banks no higher than 6-inches with restored forested and shrub-scrub wetlands on either side. Avoid building a dam because the restored stream must flow into and out from the wetland, and not look like an artificial spillway. Excavate a large and shallow basin that is 6-inches deep in the center. Spread the soil that is removed in the buffer area. Create pits, mounds, and scrapes. Plant trees and shrubs on the mounds. Use rock to armor the stream inlet and outlet to prevent erosion.

W-12 (Ditch to be filled)

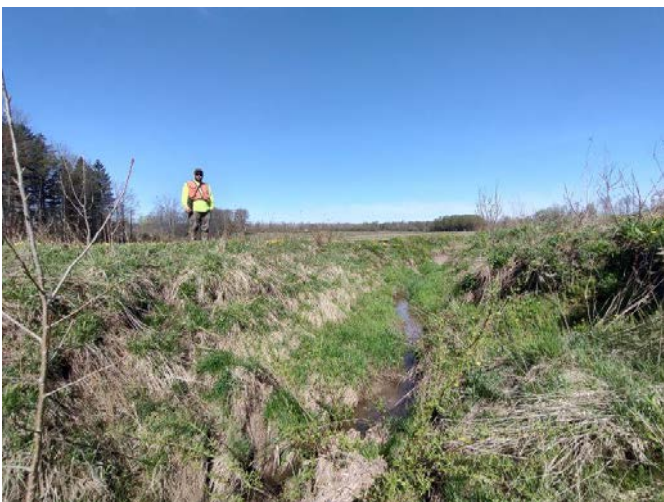
Invasive species: none	Groundwater elevation in test hole? 22-inches below the surface
Hydric soil present near the surface? No	Elevation-change from upper to lower edge: 2.0-feet
Soil test hole location: 43.294771°N 76.273865°W Soil texture: 0-19-inches = silt-loam, 19-60-inches = sand, 60-120-inches = clay.	
Rock armoring is needed at the inlet and outlet: Inlet: 26-foot wide x 80-foot long x 1.0-foot deep = 2,080 feet <sup>3</sup> /27 feet <sup>3</sup> /yard <sup>3</sup> = 77 yards <sup>3</sup> x 1.5 tons/yard <sup>3</sup> = 115 tons Buried vertical grade control at outlet: (70-foot wide x 80-foot long x 11-foot deep) x (0.5) = 30,800 feet <sup>3</sup> /27 feet <sup>3</sup> /yard <sup>3</sup> = 1,141 yards <sup>3</sup> x 1.5 tons/yard <sup>3</sup> = 1,140 tons Total = 1,255 tons/24 tons/dump truck = 52- dump truck loads of rock needed	
Head-cuts located uphill or downhill of the planned wetland. Yes. A deep eroding ditch bisects the site. Head-cuts are also located in the ditch along the south edge of the field.

Woody debris source: Not available on site. Would need to be transported to the site.	
Construction notes: Fill the ditch with soil. Dig a core trench and build a groundwater dam around the lower 2/3 perimeter of the area that blocks the sand layer. Build a sinuous stream with a channel from 18-26-foot wide and banks no higher than 6-inches with restored forested and shrub-scrub wetlands on either side. Install a buried vertical grade control structure made from rock where the restored stream meets the ditch. Avoid building a dam because the restored stream must flow into and out from the wetland, and not look like an artificial spillway. Excavate a large and shallow basin that is 6-inches deep in the center. Spread the soil that is removed in the buffer area. Create pits, mounds, and scrapes. Plant trees and shrubs on the mounds. Use rock to armor the stream inlet and outlet to prevent erosion.

W-13 (Ditch to be filled)

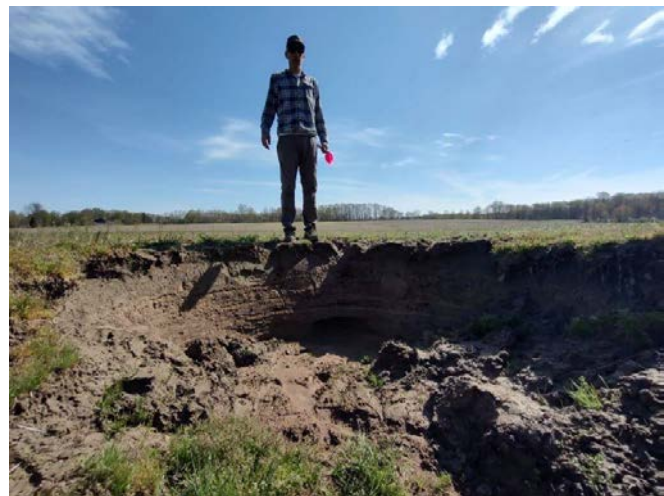
W-13 (Head-cut to control)

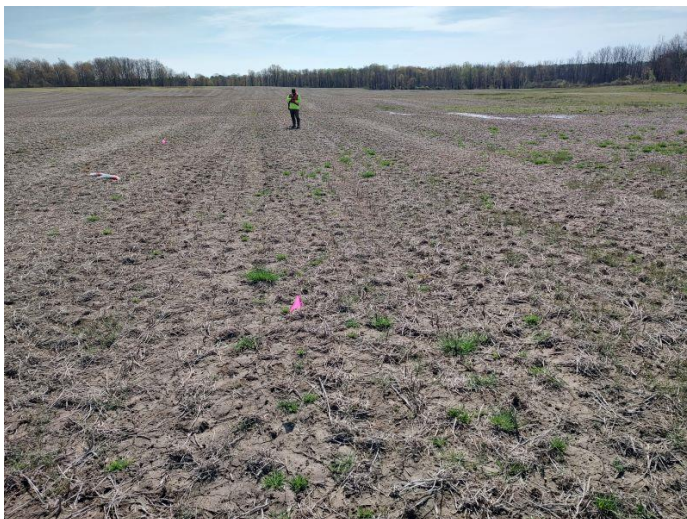
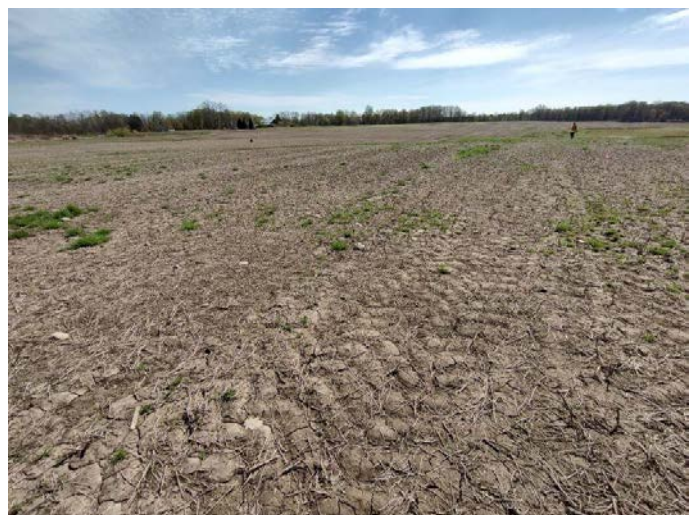
Site Name: W-14 (Perry Road)	Date: 04-30-2024
Landowner: The Wetland Trust	Designer Name: Thomas R. Biebighauser
Individuals assisting with the design: Dan Kwasnowski (The Wetland Trust), Harrison Franz (The Wetland Trust)	
Objectives: Build a naturally appearing forested/shrub-scrub wetland for mitigation.	Site Description: An agricultural field that will be planted with soybeans. The field is highly erodible due to the silt loam texture soil on the surface and steep slopes.
Evidence of historic drainage or filling: Ditches are removing surface water and lowering the elevation of groundwater. Diversion ditches are present along the edges of the fields with surface inlets that were installed to provide runoff with rapid entry into buried drainpipes. Lands with dead furrows are present.	
Plant species: Crabgrass and dandelions	How the planned wetland is marked on the ground: Pink wire flags
Invasive species: none	Groundwater elevation in test hole? Not found

Hydric soil present near the surface? No	Elevation-change from upper to lower edge of designed wetland: 2.0-feet
Soil test hole location: 43.296513°N 76.274603°W Soil texture: 0-40-inches = silt-loam, 40-48-inches = clay.	
Rock armoring is needed at the inlet and outlet. Yes Inlet: 12-feet wide x 50-feet long x 1.0-feet deep = 600 feet <sup>3</sup> /27 feet <sup>3</sup> /yard <sup>3</sup> = 22 yards <sup>3</sup> x 1.5 tons/yard <sup>3</sup> = 33 tons Outlet: 12-feet wide x 75-feet long x 1.0-feet deep = 900 feet <sup>3</sup> /27 feet <sup>3</sup> /yard <sup>3</sup> = 33 yards <sup>3</sup> x 1.5 tons/yard <sup>3</sup> = 50 tons Total = 83 tons/24 tons/dump truck = 3.5 dump truck loads of rock needed	
Head-cuts located uphill or downhill of the planned wetland. No	
Woody debris source: Not available on site. Would need to be transported to the site.	
Construction notes: Dig a core trench and build a groundwater dam around the lower 2/3 perimeter of the area. Excavate a large and shallow basin that is 6-inches deep in the center. Spread the soil that is removed over the sides of the valley and not in the wetland being built. Create pits, mounds, and scrapes. Plant trees and shrubs on the mounds. Use rock to armor the stream inlet and outlet to prevent erosion.

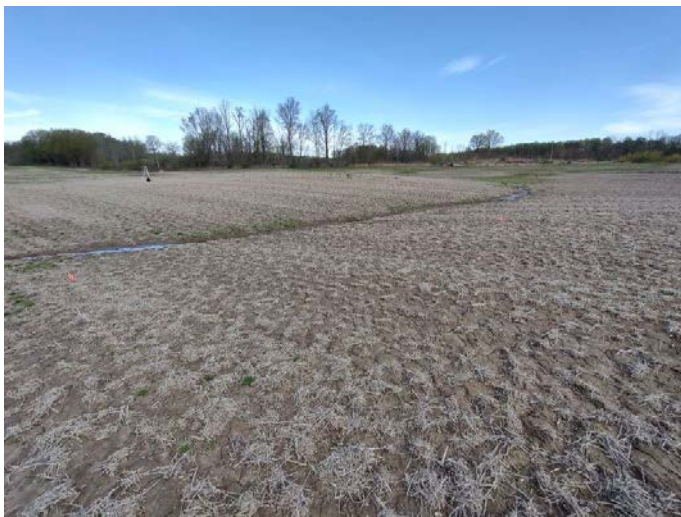
W-15

Construction notes: Dig a core trench and build a groundwater dam around the lower 2/3 perimeter of the area. Excavate a large and shallow basin that is 6-inches deep in the center. Fill the ditch with soil. Spread the soil that is removed downhill but not in W-10. Create pits, mounds, and scrapes. Plant trees and shrubs on the mounds. Use rock to armor the stream inlet and outlet to prevent erosion.

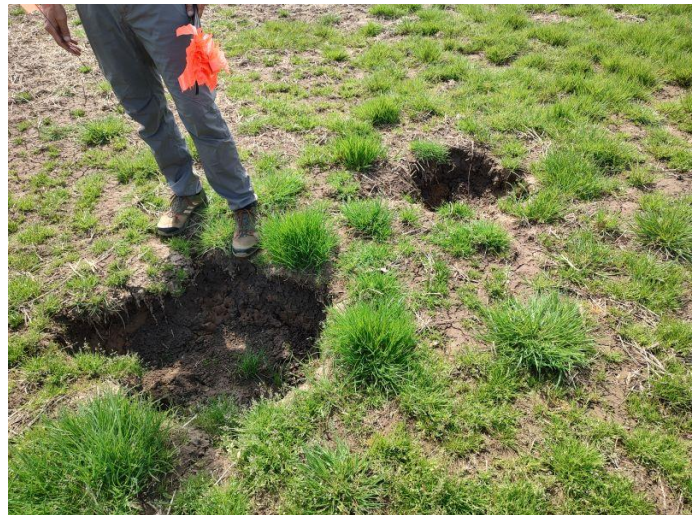
W-17 (Vertical holes show buried drainage structures are present.)

Hydric soil present near the surface? No	Elevation-change from upper to lower edge of designed wetland: 2.9-feet
Soil test hole location: 43.294770°N 76.272520°W Soil texture: 0-10-inches = silt-loam, 10-30-inches = sand, 30-48-inches = clay.	
Rock armoring is needed at the inlet and outlet: Inlet: 12-foot wide x 50-foot long x 1.0-foot deep $600 \text{ feet}^3 / 27 \text{ feet}^3/\text{yard}^3 = 22 \text{ yards}^3 \times 1.5 \text{ tons}/\text{yard}^3 = 33 \text{ tons}$ Outlet: 12-foot wide x 75-foot long x 1.0-foot deep $= 900 \text{ feet}^3 / 27 \text{ feet}^3/\text{yard}^3 = 33 \text{ yards}^3 \times 1.5 \text{ tons}/\text{yard}^3 = 50 \text{ tons}$ Total = 83 tons/24 tons/dump truck = 3.5 dump truck loads of rock needed	
Head-cuts located uphill or downhill of the planned wetland. A major head-cut is located at the low edge.	
Woody debris source: Not available on site. Would need to be transported to the site.

Construction notes: Dig a core trench and build a groundwater dam around the lower 2/3 perimeter of the area that blocks the sand layer. Excavate a large and shallow basin that is 6-inches deep in the center. Fill ditches with soil. Restore natural stream channel and floodplain wetlands. Spread the soil that is removed downhill but not in W-10. Create pits, mounds, and scrapes. Plant trees and shrubs on the mounds. Use rock to armor the inlet and outlet to prevent erosion.

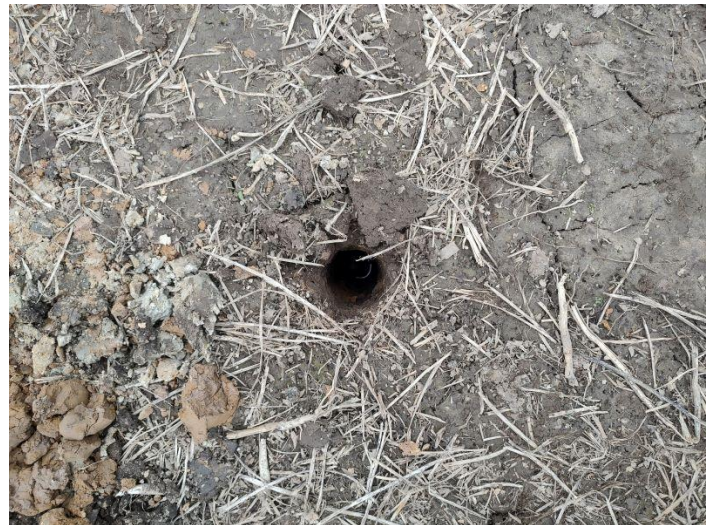
W-18 (Soil test hole)

Invasive species:	Groundwater elevation in test hole? 14-inches below the surface.
Hydric soil present near the surface? No	Elevation-change from upper to lower edge of designed wetland: 2.0-feet
Soil test hole location: 43.294527°N 76.271713°W Soil texture: 0-15-inches = silt-loam, 15-48-inches = clay.	
Rock armoring is needed at the inlet and outlet: Inlet: 12-foot wide x 50-foot long x 1.0-foot deep $600 \text{ feet}^3 / 27 \text{ feet}^3 / \text{yard}^3 = 22 \text{ yards}^3 \times 1.5 \text{ tons} / \text{yard}^3 = 33 \text{ tons}$ Outlet: 12-foot wide x 75-foot long x 1.0-foot deep $= 900 \text{ feet}^3 / 27 \text{ feet}^3 / \text{yard}^3 = 33 \text{ yards}^3 \times 1.5 \text{ tons} / \text{yard}^3 = 50 \text{ tons}$ Total = 83 tons / 24 tons/dump truck = 3.5 dump truck loads of rock needed	
Head-cuts located uphill or downhill of the planned wetland. A major head-cut is located at the low edge.

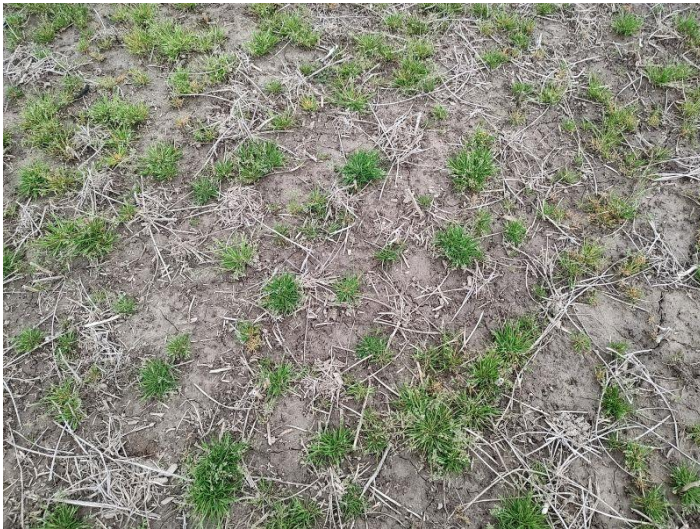
W-19

Hydric soil present near the surface? No	Elevation-change from upper to lower edge of designed wetland: 2.0-feet
Soil test hole location: 43.294181°N 76.270839°W Soil texture: 0-9-inches = silt-loam, 9-38-inches = sandy loam, 38-48-inches silt-loam.	
Is rock armoring needed at the inlet and outlet? Yes, see W-18.	
Head-cuts located uphill or downhill of the planned wetland. None	
Woody debris source: Not available on site. Would need to be transported to the site.	
Construction notes: Dig a core trench and build a groundwater dam around the lower 2/3 perimeter of the area. Replace the sand in the core trench with clay or silt-loam texture soil. Excavate a large and shallow basin that is 6-inches deep in the center. Fill ditches with soil. Spread the soil that is removed downhill. Create pits, mounds, and scrapes. Plant trees and shrubs on the mounds. Use rock to armor the inlet and outlet to prevent erosion.

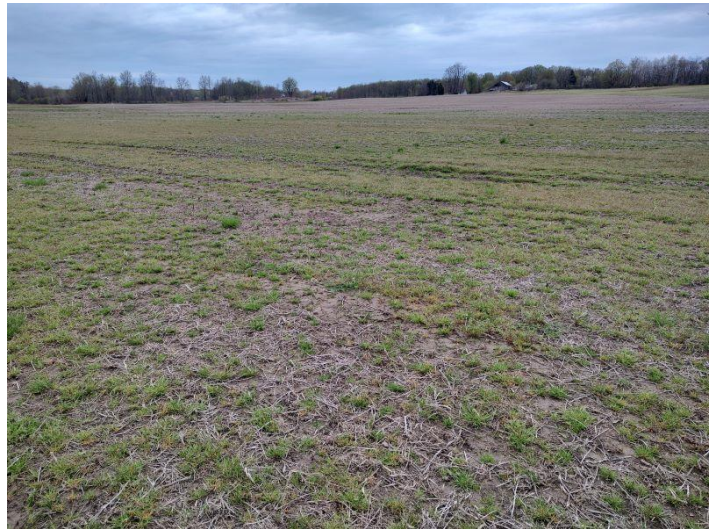
W-19 (Soil test hole)

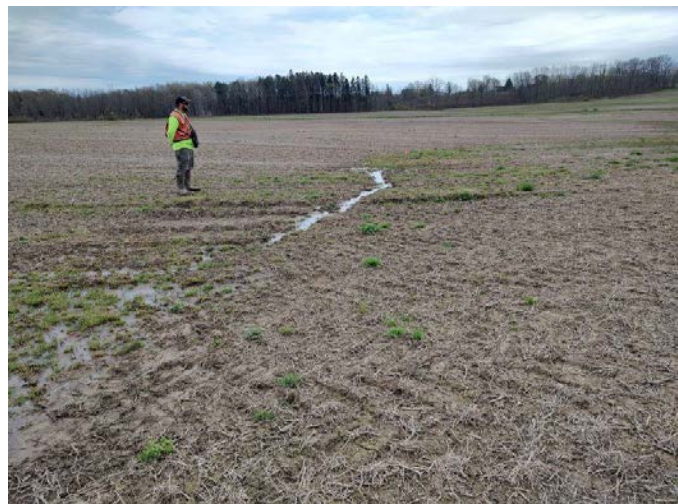
W-20 (Showing ditch that would be restored to a stream)

Hydric soil present near the surface? No	Elevation-change from upper to lower edge of designed wetland: 2.0-feet
Soil test hole location: 43.297618°N 76.272161°W Soil texture: 0-42-inches = silt-loam, 42-48-inches = clay.	
Rock armoring is needed at the inlet and outlet: Inlet: 12-foot wide x 50-foot long x 1.0-foot deep $600 \text{ feet}^3 / 27 \text{ feet}^3/\text{yard}^3 = 22 \text{ yards}^3 \times 1.5 \text{ tons}/\text{yard}^3 = 33 \text{ tons}$ Outlet: 12-foot wide x 75-foot long x 1.0-foot deep = $900 \text{ feet}^3 / 27 \text{ feet}^3/\text{yard}^3 = 33 \text{ yards}^3 \times 1.5 \text{ tons}/\text{yard}^3 = 50 \text{ tons}$ Total = 83 tons/24 tons/dump truck = 3.5 dump truck loads of rock needed	
Head-cuts located uphill or downhill of the planned wetland: Small head-cuts are in the ditch.	
Woody debris source: Not available on site. Would need to be transported to the site.	
Construction notes: Dig a core trench and build a groundwater dam around the lower 2/3 perimeter of the area. Excavate a large and shallow basin that is 6-inches deep in the center. Fill ditches with soil. Restore a natural stream channel and floodplain wetlands. Spread the soil that is removed downhill and over the side slopes. Create pits, mounds, and scrapes. Plant trees and shrubs on the mounds. Use rock to armor the inlet and outlet of the restored stream channel to prevent erosion.

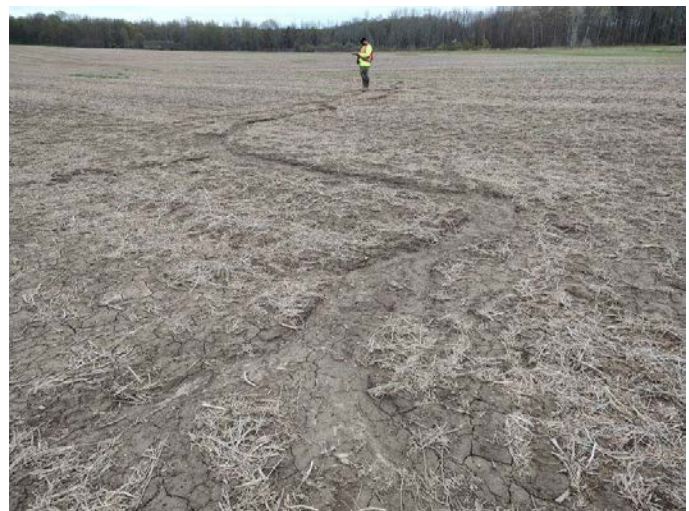
W-22 (Showing the ditch that would be restored to a stream)

Hydric soil present near the surface? No	Elevation-change from upper to lower edge of designed wetland: 2.0-feet
Soil test hole location: 43.296768°N 76.272821°W Soil texture: 0-42-inches = silt-loam, 42-48-inches = clay.	
Rock armoring is needed at the inlet and outlet: Inlet: 12-foot wide x 50-foot long x 1.0-foot deep $600 \text{ feet}^3 / 27 \text{ feet}^3/\text{yard}^3 = 22 \text{ yards}^3 \times 1.5 \text{ tons}/\text{yard}^3 = 33 \text{ tons}$ Outlet: 12-foot wide x 75-foot long x 1.0-foot deep $= 900 \text{ feet}^3 / 27 \text{ feet}^3/\text{yard}^3 = 33 \text{ yards}^3 \times 1.5 \text{ tons}/\text{yard}^3 = 50 \text{ tons}$ Total = 83 tons/24 tons/dump truck = 3.5 dump truck loads of rock needed	
Head-cuts located uphill or downhill of the planned wetland: Small head-cuts are in the ditch.	
Woody debris source: Not available on site. Would need to be transported to the site.	
Construction notes: Dig a core trench and build a groundwater dam around the lower 2/3 perimeter of the area. Excavate a large and shallow basin that is 6-inches deep in the center. Fill ditches with soil. Restore a natural stream channel and floodplain wetlands. Spread the soil that is removed downhill and over the side slopes. Create pits, mounds, and scrapes. Plant trees and shrubs on the mounds. Use rock to armor the inlet and outlet of the restored stream channel to prevent erosion.

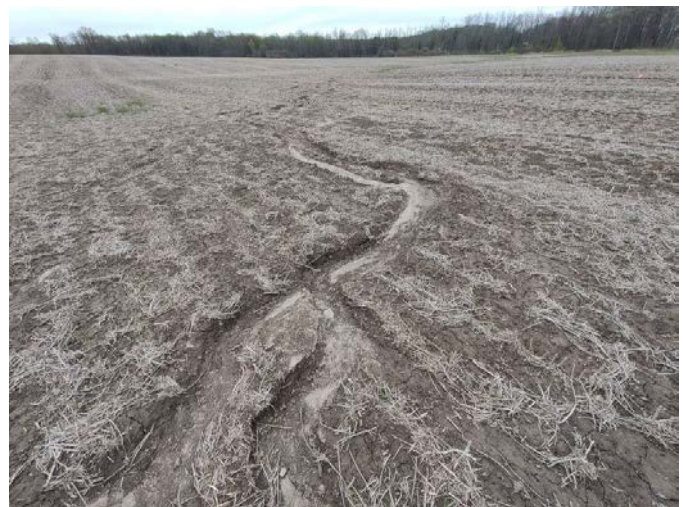
W-24 (Showing the ditch that would be restored to a stream)

Hydric soil present near the surface? No	Elevation-change from upper to lower edge of designed wetland: 2.0-feet
Soil test hole location: 43.296266°N 76.272328°W Soil texture: 0-42-inches = silt-loam, 42-48-inches = clay.	
Rock armoring is needed at the inlet and outlet: Inlet: 12-feet wide x 50-feet long x 1.0-feet deep $600 \text{ feet}^3 / 27 \text{ feet}^3/\text{yard}^3 = 22 \text{ yards}^3 \times 1.5 \text{ tons}/\text{yard}^3 = 33 \text{ tons}$ Outlet: 12-feet wide x 75-feet long x 1.0-feet deep = $900 \text{ feet}^3 / 27 \text{ feet}^3/\text{yard}^3 = 33 \text{ yards}^3 \times 1.5 \text{ tons}/\text{yard}^3 = 50 \text{ tons}$ Total = 83 tons/24 tons/dump truck = 3.5 dump truck loads of rock needed	
Head-cuts located uphill or downhill of the planned wetland: Small head-cuts are in the ditch.	
Woody debris source: Not available on site. Would need to be transported to the site.	
Construction notes: Dig a core trench and build a groundwater dam around the lower 2/3 perimeter of the area. Excavate a large and shallow basin that is 6-inches deep in the center. Fill ditches with soil. Restore a natural stream channel and floodplain wetlands. Spread the soil that is removed downhill and over the side slopes. Create pits, mounds, and scrapes. Plant trees and shrubs on the mounds. Use rock to armor the inlet and outlet of the restored stream channel to prevent erosion.

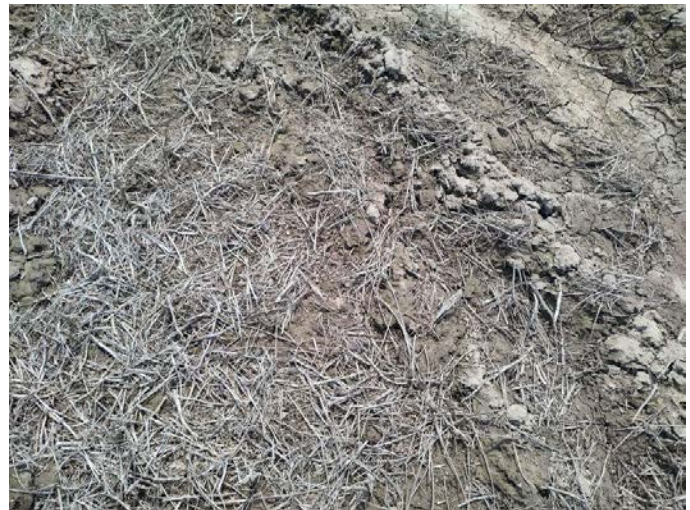
Wisner 5

<b>Invasive species:</b> Reed canary grass and purple loosestrife on neighboring private land.	<b>Groundwater elevation in test hole?</b> None
<b>Hydric soil present near the surface?</b> No	<b>Elevation-change upper to lower edge of designed wetland:</b> 2.0-feet
<b>Test Hole location:</b> 43.308189°N 76.218271°W <b>Soil texture:</b> 0-7-inches = topsoil, 7-48-inches = clay.	
<b>Rock armor the inlet and outlet for the wetland?</b> Yes Inlet: 12-feet wide x 50-feet long x 1.5-feet thick = 900 feet <sup>3</sup> /27 feet <sup>3</sup> /yard <sup>3</sup> = 33 yards <sup>3</sup> x 1.5 tons/yard <sup>3</sup> = 50 tons Outlet = 12-feet wide x 50-feet long x 1.5-feet thick = 900 feet <sup>3</sup> /27 feet <sup>3</sup> /yard <sup>3</sup> = 33 yards <sup>3</sup> x 1.5 tons/yard <sup>3</sup> = 50 tons Total = 100 tons	
<b>Head-cuts located uphill or downhill of the planned wetland.</b> Yes, in the ditch.

<b>Woody debris source:</b> Not available on site. Would need to be brought in by truck.	
<b>Construction notes:</b> Build a groundwater dam along the lower perimeter of the wetland being built. Fill ditch. Build an above ground dam that is no higher than 12-inches. Spread soil uphill to north. Shape and armor with rock an inlet and an outlet. Add pits, scrapes, and mounds and then plant with native trees and shrubs.

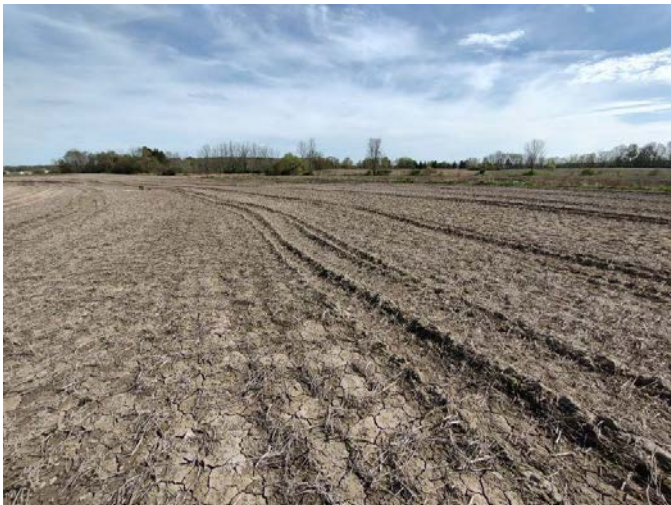
Wisner 7 (digging soil test hole)

<b>Site Name:</b> Wisner 8	<b>Date:</b> 05-04-2024
<b>Landowner:</b> The Wetland Trust	<b>Designer Name:</b> Thomas R. Biebighauser
<b>Individuals assisting with the design:</b> Michelle Herman (The Wetland Trust), Gabby Deyo (The Wetland Trust)	
<b>Objectives:</b> Build a naturally appearing and functioning wetland for mitigation.	<b>Site Description:</b> An agricultural field planted to soybeans. The wetland would cross and disable two ditches.
<b>Evidence of historic drainage or filling:</b> Ditches are present in each drainage and along the south edge of the property. The ditches may serve as outlets for buried drainage systems and drain historic natural wetland basins. Basins have been filled and land sloped so it will drain for farming.	
<b>Plant species:</b> Bare ground that is now planted to soybeans	<b>How the planned wetland is marked on the ground:</b> White wire flags
<b>Invasive species:</b>	<b>Groundwater elevation in test hole?</b> 39-inches below the surface

<b>Hydric soil present near the surface?</b> No	<b>Elevation-change upper to lower edge of designed wetland:</b> 2.0-feet
<b>Test Hole location:</b> 43.309175°N 76.218873°W <b>Soil texture:</b> 0-8-inches = topsoil, 8-39-inches = clay, 39-44-inches = sand, 44-48-inches = clay.	
<b>Rock armor the inlet and outlet for the wetland?</b> Yes <b>Inlet:</b> 12-foot wide x 50-foot long x 1.5-foot thick = 900 feet <sup>3</sup> /27 feet <sup>3</sup> /yard <sup>3</sup> = 33 yards <sup>3</sup> x 1.5 tons/yard <sup>3</sup> = 50 tons <b>Outlet =</b> 12-foot wide x 50-foot long x 1.5-foot thick = 900 feet <sup>3</sup> /27 feet <sup>3</sup> /yard <sup>3</sup> = 33 yards <sup>3</sup> x 1.5 tons/yard <sup>3</sup> = 50 tons <b>Total = 100 tons</b>	
<b>Head-cuts located uphill or downhill of the planned wetland.</b> None	
<b>Woody debris source:</b> Not available on site. Would need to be brought in by truck.	
<b>Construction notes:</b> Build a groundwater dam along the lower perimeter of the wetland being built. Fill ditch. Build an above ground dam that is no higher than 12-inches. Spread uphill to the southeast and east. Shape and armor with rock an inlet and an outlet. Add pits, scrapes, and mounds and then plant with native trees and shrubs.

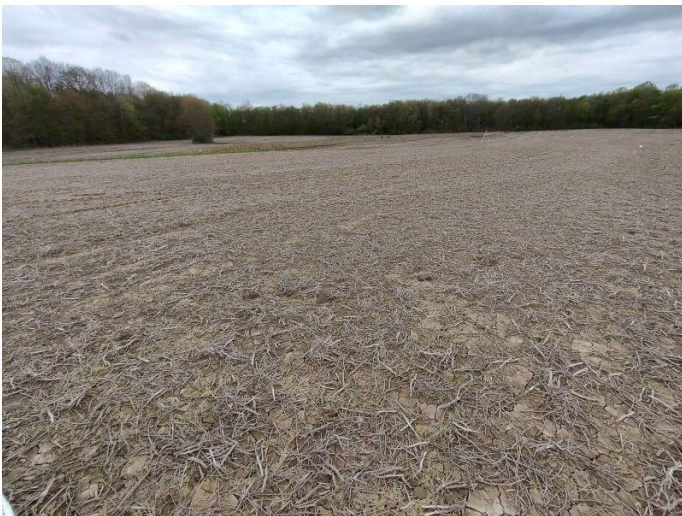
<b>Site Name:</b> Wisner 12	<b>Date:</b> 05-04-2024
<b>Landowner:</b> The Wetland Trust	<b>Designer Name:</b> Thomas R. Biebighauser
<b>Individuals assisting with the design:</b> Michelle Herman (The Wetland Trust), Gabby Deyo (The Wetland Trust)	
<b>Objectives:</b> Build a naturally appearing and functioning wetland for mitigation.	<b>Site Description:</b> An agricultural field planted to soybeans.
<b>Evidence of historic drainage or filling:</b> Ditches are present in each drainage and along the south edge of the property. The ditches may serve as outlets for buried drainage systems and drain historic natural wetland basins. Basins have been filled and land sloped so it will drain for farming.	
<b>Plant species:</b> Bare ground that is now planted to soybeans	<b>How the planned wetland is marked on the ground:</b> White wire flags
<b>Invasive species:</b>	<b>Groundwater elevation in test hole?</b> Not determined

<b>Hydric soil present near the surface?</b> No	<b>Elevation-change upper to lower edge of designed wetland:</b> 2.0-feet
<b>Test Hole location:</b> Not dug <b>Soil texture:</b> Like Wisner 11	
<b>Rock armor the inlet and outlet for the wetland?</b> Not needed.	
<b>Head-cuts located uphill or downhill of the planned wetland.</b> None	
<b>Woody debris source:</b> Not available on site. Would need to be brought in by truck.	
<b>Construction notes:</b> Build a groundwater dam along the lower perimeter of the wetland being built. Fill ditch. Build an above ground dam that is no higher than 12-inches. Spread soil to the Southwest. Add pits, scrapes, and mounds and then plant with native trees and shrubs.

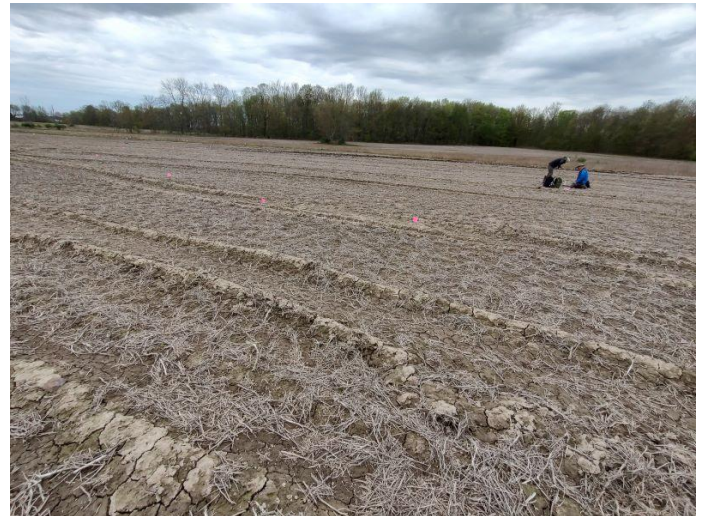
<b>Site Name:</b> Wisner 14	<b>Date:</b> 05-04-2024
<b>Landowner:</b> The Wetland Trust	<b>Designer Name:</b> Thomas R. Biebighauser
<b>Individuals assisting with the design:</b> Michelle Herman (The Wetland Trust), Gabby Deyo (The Wetland Trust)	
<b>Objectives:</b> Build a naturally appearing and functioning wetland for mitigation.	<b>Site Description:</b> An agricultural field planted to soybeans.
<b>Evidence of historic drainage or filling:</b> Ditches are present in each drainage and along the south edge of the property. The ditches may serve as outlets for buried drainage systems and drain historic natural wetland basins. Basins have been filled and land sloped so it will drain for farming.	
<b>Plant species:</b> Bare ground that is now planted to soybeans	<b>How the planned wetland is marked on the ground:</b> White wire flags
<b>Invasive species:</b>	<b>Groundwater elevation in test hole?</b> Not determined

<b>Hydric soil present near the surface?</b> No	<b>Elevation-change upper to lower edge of designed wetland:</b> 2.0-feet
<b>Test Hole location:</b> Not dug <b>Soil texture:</b> Like Wisner 13	
<b>Rock armor the inlet and outlet for the wetland?</b> Not needed.	
<b>Head-cuts located uphill or downhill of the planned wetland.</b> None	
<b>Woody debris source:</b> Not available on site. Would need to be brought in by truck.	
<b>Construction notes:</b> Build a groundwater dam along the lower perimeter of the wetland being built. Fill ditch. Build an above ground dam that is no higher than 12-inches. Spread soil downhill to the south. Add pits, scrapes, and mounds and then plant with native trees and shrubs.
