# **Micron Central New York Semiconductor Manufacturing Complex**

## **Fish Creek Stream and Wetland Mitigation Plan**

**Oswego County, NY**

May 2025

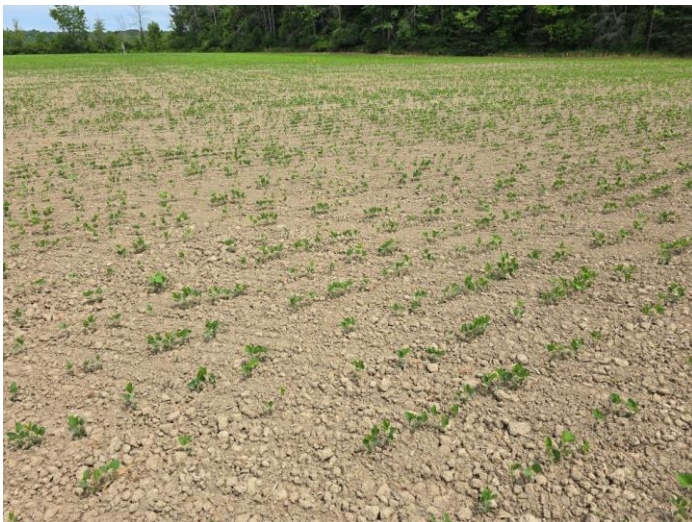
Meyers 1 Overview

<b>Site Name:</b> Meyers 1	<b>Date:</b> 06-25-2024
<b>Landowner:</b> The Wetland Trust	<b>Designer Name:</b> Thomas R. Biebighauser
<b>Individuals assisting with the design:</b> Dylan Johnson-Jordan (The Wetland Trust), Kendall Hastings (The Wetland Trust)	
<b>Objectives:</b> Build a naturally appearing and functioning Forested Wetland for mitigation.	<b>Site Description:</b> An agricultural field planted to soybeans.
<b>Evidence of historic drainage or filling:</b> Ditches are located along the side of County Route 37 and the south edge of the property. It is very possible that buried drainage structures are present.	
<b>Plant species:</b> Soybeans	<b>How the planned wetland is marked on the ground:</b> Orange wire
<b>Invasive species:</b> Chufa	<b>Groundwater elevation in test hole?</b> 20-inches (the test hole was left open overnight)
<b>Hydric soil present near the surface?</b> No	<b>Elevation-change from upper to lower edge of designed wetland:</b> 1.7-feet

<b>Test Hole location:</b> 43.265022°N 76.190454°W	
<b>Soil texture:</b> 0-7-inches = topsoil, 7-126-inches = clay. Loose layers of clay are transporting water below the surface.	
<b>Rock armoring or vertical grade control needed at the inlet or outlet.</b> Not needed	
<b>Head-cuts located uphill or downhill of the planned wetland.</b> A head-cut located along Youngs Creek will be controlled as part of this project.	
<b>Woody debris source:</b> Not available on site. Would need to be brought in by truck.	
<b>Construction notes:</b> Avoid building a dam or raising elevations that could flood the neighbor's home or County Route 37. Build a groundwater dam along the lower 2/3-edge of the marked perimeter. Be careful not to block the ditch along County Route 37, or the culvert under County Route 37. Level the surface of the ground, add scrapes, pits and mounds (10-foot spacing). Spread the soil that is removed in buffers where possible and away from Highway 37 to make natural ridges in the field higher. Leave gaps between areas of spread soil so water will drain and not back up onto neighbors' land. Plant native trees on the mounds and higher ground.

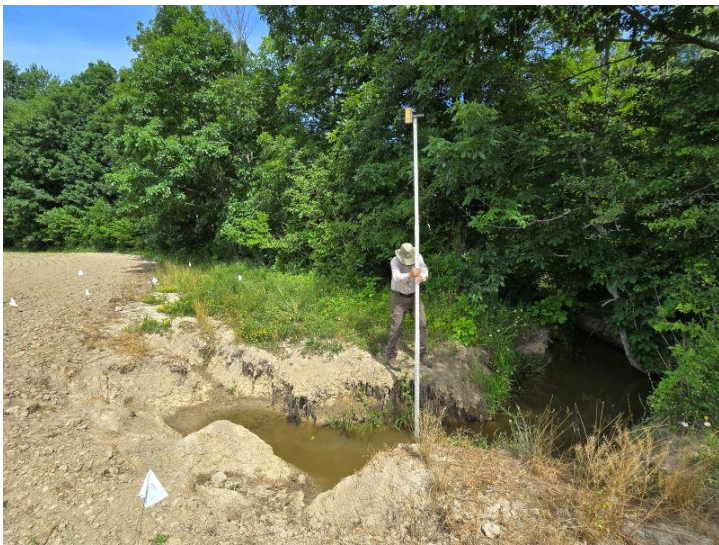
The white wire flags show where rock would be buried to control the head-cut

<b>Site Name:</b> 8-Meyers Head-cut Control	<b>Date:</b> 06-26-2024
<b>Landowner:</b> The Wetland Trust	<b>Designer Name:</b> Thomas R. Biebighauser
<b>Individuals assisting with the design:</b> Dylan Johnson Jordan (The Wetland Trust), Kendall Hastings (The Wetland Trust)	
<b>Objectives:</b> Protect the wetlands being built by controlling a major head-cut.	<b>Site Description:</b> A head-cut located in the main drainage for the Meyers Field will be controlled.
<b>Evidence of historic drainage or filling:</b> The site is an outlet ditch for a buried drainage system that is eroding. Head-cuts will advance into the field and constructed wetlands unless they are controlled.	
<b>Plant species:</b> Soybeans	<b>How the planned is marked on the ground:</b> White wire flags
<b>Invasive species:</b>	<b>Groundwater elevation in test hole?</b> At stream level.
<b>Hydric soil present near the surface?</b> No	<b>Elevation-change in head-cut =</b> 3.2-feet vertical.

<b>Location:</b> 43.267545°N 76.190763°W <b>Soil texture:</b> Silt loam overlaying clay.	
<b>This project involves controlling a major head-cut located in the primary drainage ditch for the property. See the drawing prepared for building buried vertical grade control structures.</b>	
<b>Woody debris source:</b> n/a	
<b>Construction notes:</b> Rock needed for buried vertical grade control structure = 12-foot wide x 70-foot long x 6.2-foot deep = 5,208feet <sup>3</sup> /27feet <sup>3</sup> /yard <sup>3</sup> = 193yards <sup>3</sup> x 1.5-tons/yard <sup>3</sup> = 289 tons.

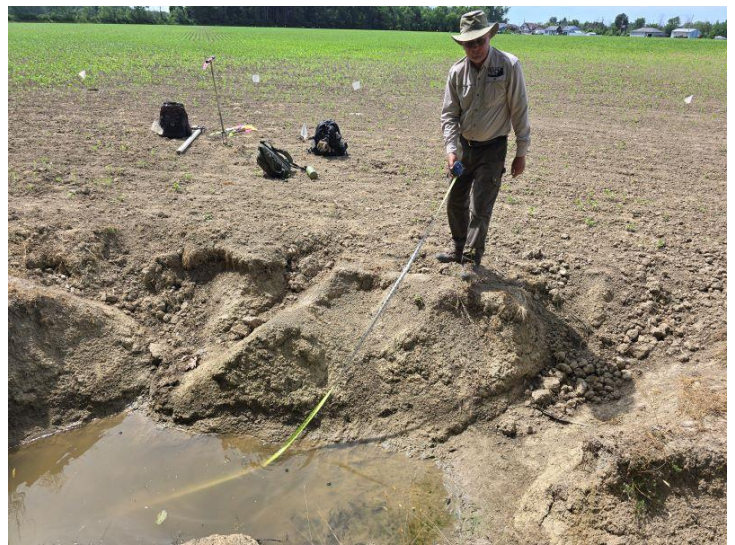
The head-cut will destroy the planned wetlands unless it is controlled.

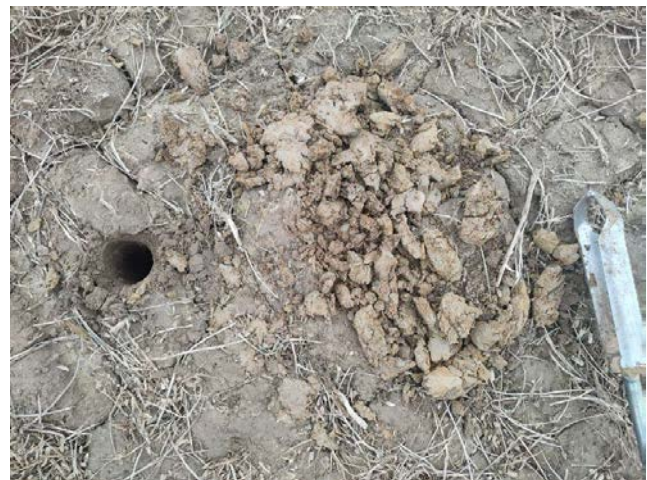
R-2 (with soil test hole)

<b>Site Name:</b> R-2 (Bruce Rio Farm)	<b>Date:</b> 05-01-2024
<b>Landowner:</b> The Wetland Trust	<b>Designer Name:</b> Thomas R. Biebighauser
<b>Individuals assisting with the design:</b> Harrison Franz (The Wetland Trust), Kirsten Gerhart (The Wetland Trust), Michelle Herman (The Wetland Trust)	
<b>Objectives:</b> Build a naturally appearing and functioning wetland for mitigation.	<b>Site Description:</b> An agricultural field that will be planted to soybeans.
<b>Evidence of historic drainage or filling:</b> Deep ditches in the fields drain water into Youngs Creek along the Northern edge of the property. Buried drainage structures carry water into these ditches. Deep ruts in the field are not holding water, indicating that buried drainage structures are present.	
<b>Plant species:</b> Soybeans	<b>How the planned wetland is marked on the ground:</b> Pink wire flags
<b>Invasive species:</b> none	<b>Groundwater elevation in test hole?</b> Not found.

<b>Hydric soil present near the surface?</b> Yes, but not during the growing season.	<b>Elevation-change from upper to lower edge of designed wetland:</b> 1.3-feet
<b>Soil test hole location:</b> 43.266021°N 76.188117°W <b>Soil texture:</b> 0-8-inches = topsoil, 8-48-inches-clay (7-inch-long thin ribbon formed)	
<b>Rock armoring or vertical grade control needed at the inlet or outlet.</b> Not needed	
<b>Head-cuts located uphill or downhill of the planned wetland.</b> No	
<b>Woody debris source:</b> Not available on site. Would need to be transported to the site.	
<b>Construction notes:</b> Access the area from the Meyers site to avoid damaging Bruce Rio's driveway. Apply gravel to the access road bordering the west edge of the property. Build a groundwater dam along the lower 2/3-edge of the marked perimeter. There is very little room for spreading soil so it will be necessary to level the area and keep most soil within the marked perimeter. Level the surface of the ground, add scrapes, pits and mounds (10-foot spacing). Plant native trees on the mounds and higher ground.

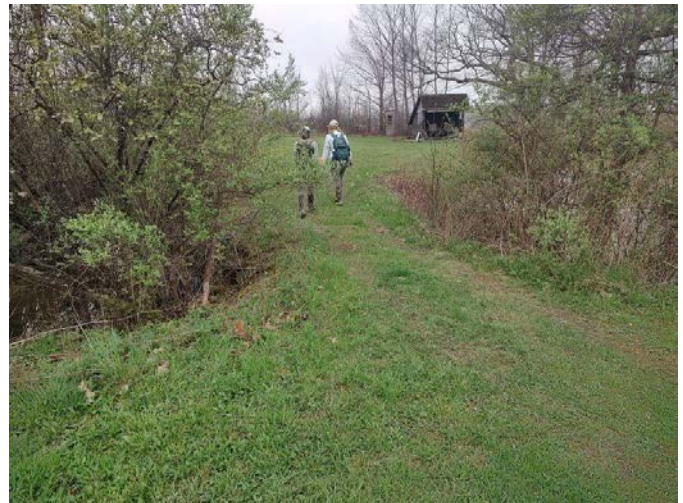
R-3 (showing the culvert to remove and ditch to fill)

<b>Site Name:</b> R-3 (Bruce Rio Farm)	<b>Date:</b> 05-01-2024
<b>Landowner:</b> The Wetland Trust	<b>Designer Name:</b> Thomas R. Biebighauser
<b>Individuals assisting with the design:</b> Harrison Franz (The Wetland Trust), Kirsten Gerhart (The Wetland Trust), Michelle Herman (The Wetland Trust)	
<b>Objectives:</b> Build a naturally appearing and functioning wetland for mitigation.	<b>Site Description:</b> An agricultural field that will be planted to soybeans.
<b>Evidence of historic drainage or filling:</b> A ditch bisects the designed wetland and drains water into Youngs Creek along the Northern edge of the property. Buried drainage structures carry water into this ditch. Deep ruts in the field are not holding water, indicating that buried drainage structures are present.	
<b>Plant species:</b> Soybeans	<b>How the planned wetland is marked on the ground:</b> Orange wire flags
<b>Invasive species:</b> none	<b>Groundwater elevation in test hole?</b> Not found.

<b>Hydric soil present near the surface?</b> No	<b>Elevation-change from upper to lower edge =</b> 2.0-feet
<b>Soil test hole location:</b> 43.267148°N 76.187908°W <b>Soil texture:</b> 0-8-inches = topsoil, 8-48-inches-clay (7-inch-long thin ribbon formed)	
<b>Rock armoring or vertical grade control needed at the inlet or outlet.</b> Yes.	
<b>Head-cuts located uphill or downhill of the planned wetland.</b> No	
<b>Woody debris source:</b> Not available on site. Would need to be transported to the site.	
<b>Construction notes:</b> Access the area from the Meyers site to avoid damaging Bruce Rio's driveway. Apply gravel to the access road bordering the west edge of the property. Build a groundwater dam along the lower 2/3-edge of the marked perimeter. Remove culvert and build a low dam to fill a section of the ditch with soil. There is very little room for spreading soil so it will be necessary to level the area and keep most soil within the marked perimeter. Some soil may be spread along the Northern edge of the area. Add scrapes, pits and mounds (10-foot spacing). Plant native trees on the mounds and higher ground. A wide spillway that is armored with rock should be built as spillway will serve as the outlet for most of the runoff from the field. Rock needed for spillway = 16-foot wide x 100-foot long x 1.5-foot deep = 2,400 feet <sup>3</sup> /27feet <sup>3</sup> /yard <sup>3</sup> = 88 yards <sup>3</sup> x 1.5-tons/yard <sup>3</sup> = 132 tons.

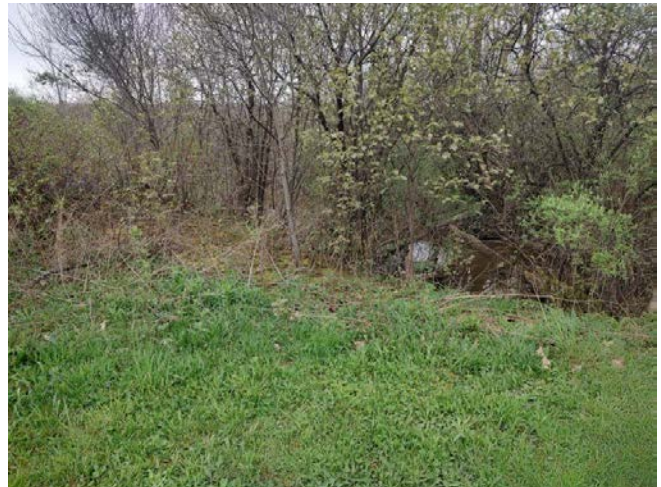
R-4 (showing the ditch to fill)

<b>Site Name:</b> R-4 (Bruce Rio Farm)	<b>Date:</b> 05-01 & 02,-2024
<b>Landowner:</b> The Wetland Trust	<b>Designer Name:</b> Thomas R. Biebighauser
<b>Individuals assisting with the design:</b> Harrison Franz (The Wetland Trust), Kirsten Gerhart (The Wetland Trust), Michelle Herman (The Wetland Trust)	
<b>Objectives:</b> Build a naturally appearing and functioning wetland for mitigation.	<b>Site Description:</b> An agricultural field that will be planted to soybeans.
<b>Evidence of historic drainage or filling:</b> A ditch bisects the designed wetland and drains water into Youngs Creek along the Northern edge of the property. Buried drainage structures carry water into this ditch. Deep ruts in the field are not holding water, indicating that buried drainage structures are present.	
<b>Plant species:</b> Soybeans	<b>How the planned wetland is marked on the ground:</b> Orange wire flags
<b>Invasive species:</b> none	<b>Groundwater elevation in test hole?</b> Not found.

<b>Hydric soil present near the surface?</b> No	<b>Elevation-change from upper to lower edge =</b> 2.0-feet
<b>Soil test hole location:</b> 43.268915°N 76.186527°W	
<b>Soil texture:</b> 0-8-inches = topsoil, 8-48-inches-clay (7-inch-long thin ribbon formed)	
<b>Rock armoring or vertical grade control needed at the inlet or outlet.</b> Yes.	
<b>Head-cuts located uphill or downhill of the planned wetland.</b> No	
<b>Woody debris source:</b> Obtain by removing the planted Norway Spruce trees growing next to the planned wetland.	
<b>Construction notes:</b> Build a groundwater dam along the lower 2/3-edge of the marked perimeter, staying 50-feet away from the streambank. Build a low dam to fill a section of the ditch with soil. Add scrapes, pits and mounds (10-foot spacing). Plant native trees on the mounds and higher ground. A wide spillway that is armored with rock should be built. Rock needed for spillway = 16-feet wide x 75-feet long x 1.5-feet deep = 1,200 feet <sup>3</sup> /27feet <sup>3</sup> /yard <sup>3</sup> = 44 yards <sup>3</sup> x 1.5-tons/yard <sup>3</sup> = 66 tons.

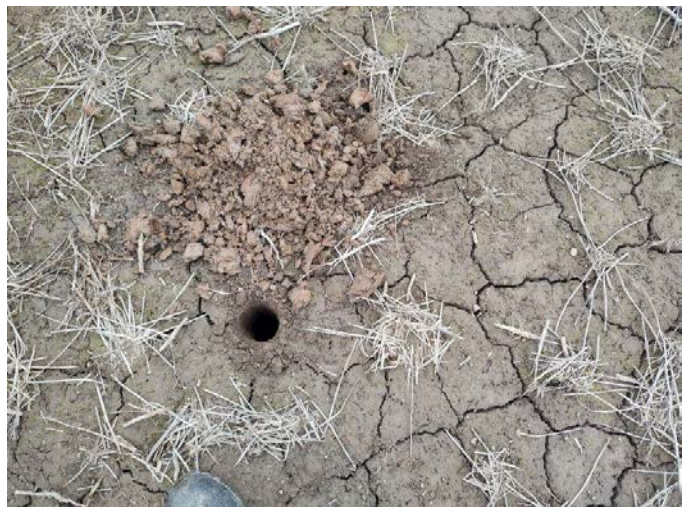
R-5 (showing the soil test hole)

<b>Site Name: R-5 (Bruce Rio Farm)</b>	<b>Date: 05-01-2024</b>
<b>Landowner: The Wetland Trust</b>	<b>Designer Name: Thomas R. Biebighauser</b>
<b>Individuals assisting with the design: Kirsten Gerhart (The Wetland Trust), Michelle Herman (The Wetland Trust)</b>	
<b>Objectives: Build a naturally appearing and functioning wetland for mitigation.</b>	<b>Site Description: An agricultural field to be planted to soybeans. Located on a level area of ground in front of Bruce Rio's home.</b>
<b>Evidence of historic drainage or filling: Deep ruts in the field are not holding water, indicating that buried drainage structures are present.</b>	
<b>Plant species: Soybeans</b>	<b>How the planned wetland is marked on the ground: Orange wire flags</b>
<b>Invasive species: none</b>	<b>Groundwater elevation in test hole? Not found.</b>
<b>Hydric soil present near the surface? No</b>	<b>Elevation-change from upper to lower edge = 1.5-feet</b>

<b>Soil test hole location: 43.262848°N 76.186518°W</b>	
<b>Soil texture: 0-10-inches = topsoil, 10-48-inches-clay (4-inch-long thin ribbon formed)</b>	
<b>Rock armoring or vertical grade control needed at the inlet or outlet. No</b>	
<b>Head-cuts located uphill or downhill of the planned wetland. No</b>	
<b>Woody debris source: Not available on site. Would need to be transported to the site.</b>	
<b>Construction notes: Build a groundwater dam along the lower 2/3-edge of the marked perimeter. Spread soil that is removed north on the downhill slope. Leave gaps in the soil to avoid flooding the home. Plant native trees on the mounds and higher ground.</b>

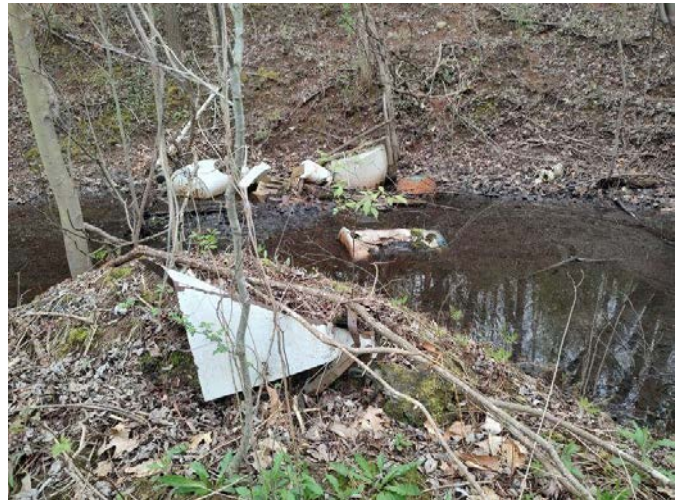
R-7 (showing the dump that would be cleaned and the ditch that would be expanded into a wetland)

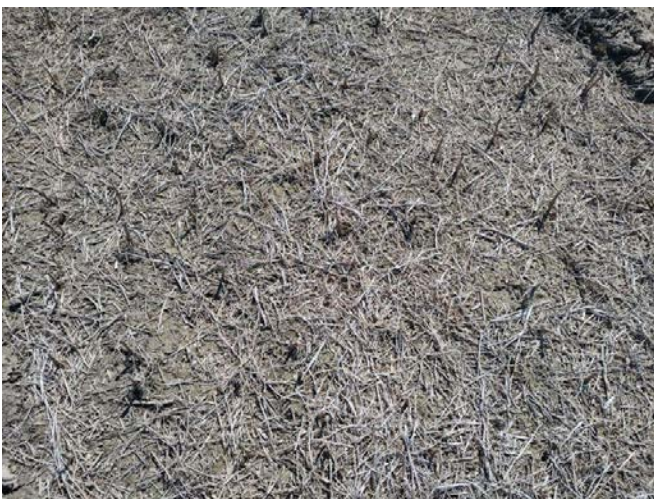
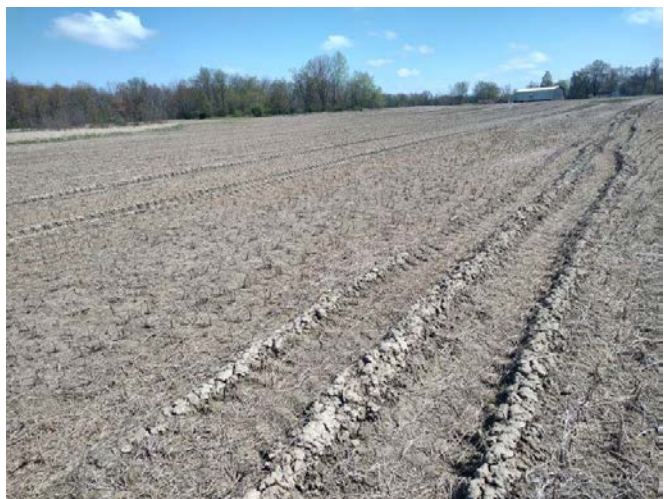
<b>Site Name:</b> R-8 (Bruce Rio Farm)	<b>Date:</b> 05-01-2024
<b>Landowner:</b> The Wetland Trust	<b>Designer Name:</b> Thomas R. Biebighauser
<b>Individuals assisting with the design:</b> Kirsten Gerhart (The Wetland Trust), Michelle Herman (The Wetland Trust)	
<b>Objectives:</b> Build a naturally appearing and functioning Emergent wetland for mitigation.	<b>Site Description:</b> An agricultural field to be planted to soybeans.
<b>Evidence of historic drainage or filling:</b> A drainage ditch is located along the lower edge of the designed wetland. This ditch would not be filled by the project.	
<b>Plant species:</b> Soybeans	<b>How the planned wetland is marked on the ground:</b> Pink wire flags
<b>Invasive species:</b> none	<b>Groundwater elevation in test hole?</b> Not found.
<b>Hydric soil present near the surface?</b> No	<b>Elevation-change from upper to lower edge =</b> 1.5-feet
<b>Soil test hole location:</b> 43.263536°N 76.186280°W <b>Soil texture:</b> 0-10-inches = topsoil, 10-48-inches-clay

<b>Rock armoring or vertical grade control needed at the inlet or outlet.</b> No	
<b>Head-cuts located uphill or downhill of the planned wetland.</b> No	
<b>Woody debris source:</b> Not available on the property. Would need to be transported to the site.	
<b>Construction notes:</b> Build a low above ground dam and a groundwater dam along the lower 2/3-edge of the marked perimeter. Spread soil that is removed downhill. Plant native trees on the mounds and higher ground.

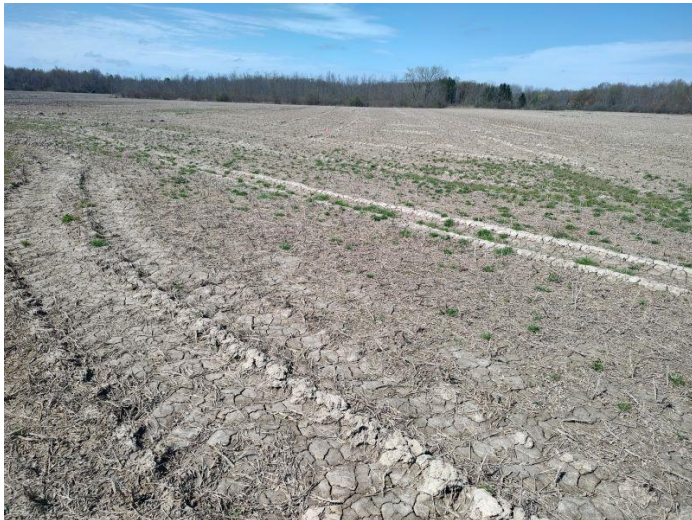
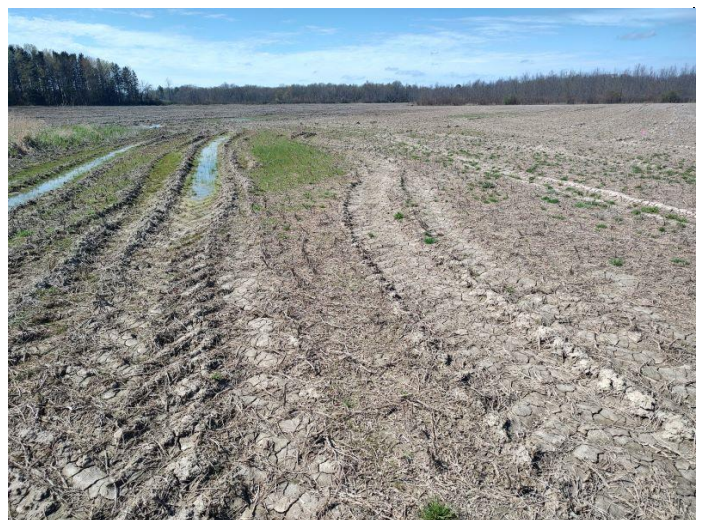
<b>Site Name: R-9 (Bruce Rio Farm)</b>	<b>Date: 05-01-2024</b>
<b>Landowner: The Wetland Trust</b>	<b>Designer Name: Thomas R. Biebighauser</b>
<b>Individuals assisting with the design: Kirsten Gerhart (The Wetland Trust), Michelle Herman (The Wetland Trust)</b>	
<b>Objectives: Build a naturally appearing and functioning Emergent wetland for mitigation.</b>	<b>Site Description: An agricultural field to be planted to soybeans. Contains deep tire ruts filled with water.</b>
<b>Evidence of historic drainage or filling: The primary drainage ditch for the large field is located within this designed wetland. The ditch should be blocked at the south edge where water enters the wetland, and again at the north or outlet end where water leaves the wetland. Blocking the ditch in both places will restore the historic elevation of groundwater in the field.</b>	
<b>Plant species: Soybeans</b>	<b>How the planned wetland is marked on the ground: Pink wire flags</b>

<b>Invasive species: none</b>	<b>Groundwater elevation in test hole? Not found.</b>
<b>Hydric soil present near the surface? No</b>	<b>Elevation-change from upper to lower edge = 2.0-feet</b>
<b>Soil test hole location: 43.265017°N 76.186358°W Soil texture: 0-10-inches = topsoil, 10-48-inches-clay</b>	
<b>Rock armoring or vertical grade control needed at the inlet or outlet. No</b>	
<b>Head-cuts located uphill or downhill of the planned wetland. No</b>	
<b>Woody debris source: Not available on the property. Would need to be transported to the site.</b>	
<b>Construction notes: Build a low above ground dam and a groundwater dam along the lower 2/3-edge of the marked perimeter. Spread soil that is removed uphill. Plant native trees on the mounds and higher ground.</b>

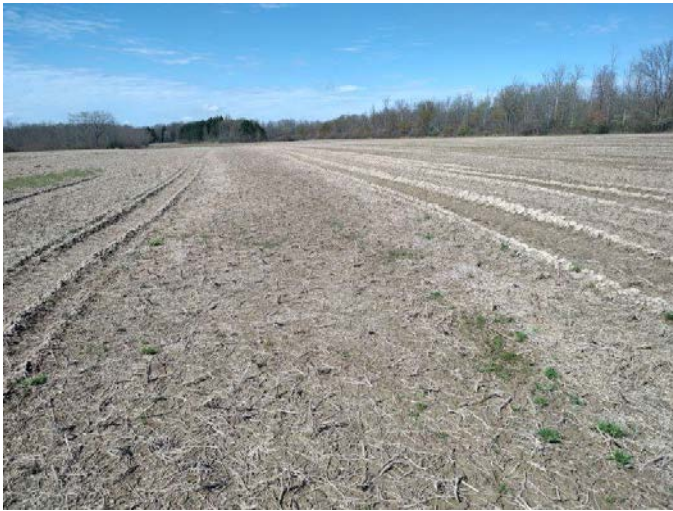
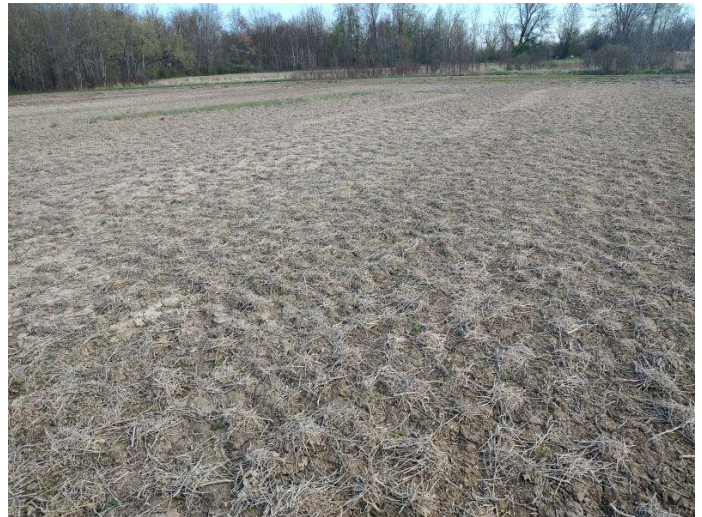
<b>Site Name: R-10 (Bruce Rio Farm)</b>	<b>Date: 05-01-2024</b>
<b>Landowner: The Wetland Trust</b>	<b>Designer Name: Thomas R. Biebighauser</b>
<b>Individuals assisting with the design: Kirsten Gerhart (The Wetland Trust), Michelle Herman (The Wetland Trust)</b>	
<b>Objectives: Build a naturally appearing and functioning Emergent wetland for mitigation.</b>	<b>Site Description: An agricultural field to be planted to soybeans. Adjacent to an old farm pond.</b>
<b>Evidence of historic drainage or filling: A shallow drainage ditch is located along the uphill edge of the designed wetland along the edge of the woods. This ditch would not be filled because it may affect neighboring property.</b>	
<b>Plant species: Soybeans</b>	<b>How the planned wetland is marked on the ground: Orange wire flags</b>
<b>Invasive species: none</b>	<b>Groundwater elevation in test hole? Not found.</b>
<b>Hydric soil present near the surface? No</b>	<b>Elevation-change from upper to lower edge = 2.0-feet</b>

<b>Soil test hole location: 43.263937°N 76.185066°W Soil texture: 0-9-inches = topsoil, 9-48-inches-clay</b>	
<b>Rock armoring or vertical grade control needed at the inlet or outlet. No</b>	
<b>Head-cuts located uphill or downhill of the planned wetland. No</b>	
<b>Woody debris source: Not available on the property. Would need to be transported to the site.</b>	
<b>Construction notes: Build a groundwater dam along the lower 2/3-edge of the marked perimeter. Spread soil that is removed in the buffer to the east. Plant native trees and shrubs on the mounds and higher ground.</b>

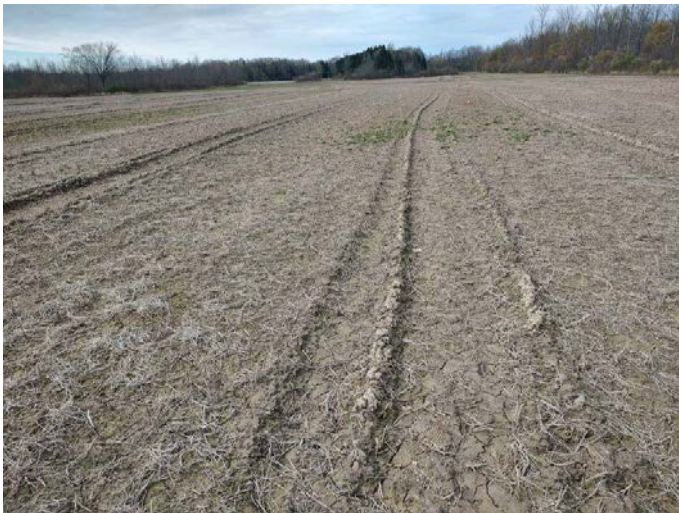
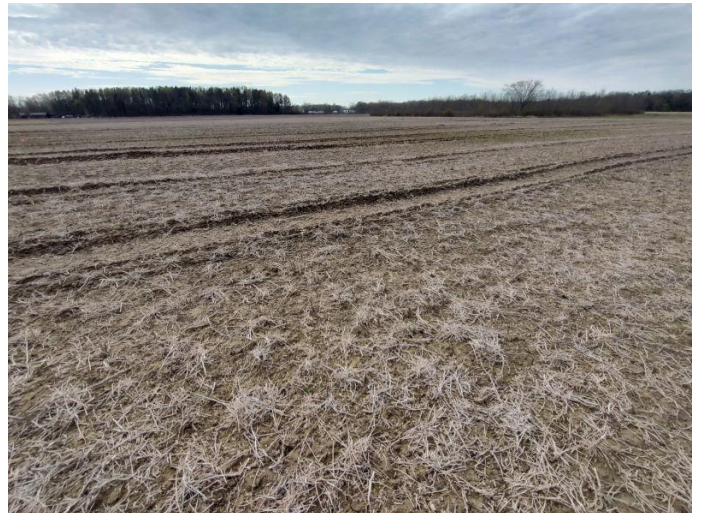
<b>Site Name: R-11 (Bruce Rio Farm)</b>	<b>Date: 05-01-2024</b>
<b>Landowner: The Wetland Trust</b>	<b>Designer Name: Thomas R. Biebighauser</b>
<b>Individuals assisting with the design: Kirsten Gerhart (The Wetland Trust), Michelle Herman (The Wetland Trust)</b>	
<b>Objectives: Build a naturally appearing and functioning wetland for mitigation.</b>	<b>Site Description: An agricultural field to be planted to soybeans.</b>
<b>Evidence of historic drainage or filling: A shallow drainage ditch is located along the uphill edge of the designed wetland along the edge of the woods. This ditch would not be filled because it may affect neighboring property.</b>	
<b>Plant species: Soybeans</b>	<b>How the planned wetland is marked on the ground: Orange wire flags</b>
<b>Invasive species: none</b>	<b>Groundwater elevation in test hole? Not found.</b>
<b>Hydric soil present near the surface? No</b>	<b>Elevation-change from upper to lower edge = 2.0-feet</b>

<b>Soil test hole location: 43.264564°N 76.184768°W Soil texture: 0-9-inches = topsoil, 9-48-inches-clay</b>	
<b>Rock armoring or vertical grade control needed at the inlet or outlet. No</b>	
<b>Head-cuts located uphill or downhill of the planned wetland. No</b>	
<b>Woody debris source: Not available on the property. Would need to be transported to the site.</b>	
<b>Construction notes: Build a groundwater dam along the lower 2/3-edge of the marked perimeter. Spread soil that is removed in the buffer to the east. Plant native trees and shrubs on the mounds and higher ground.</b>

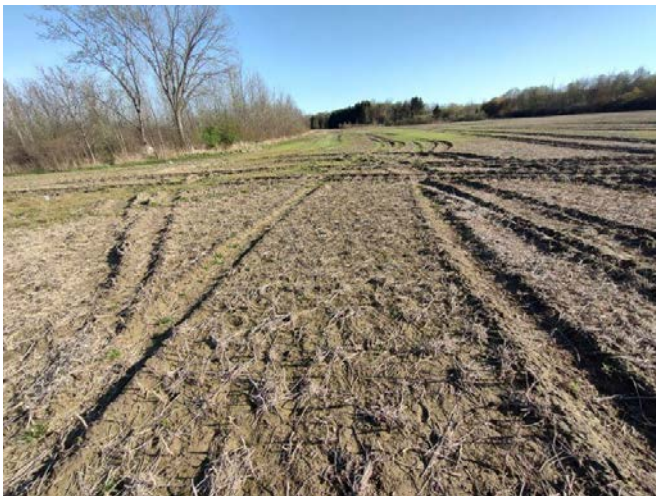
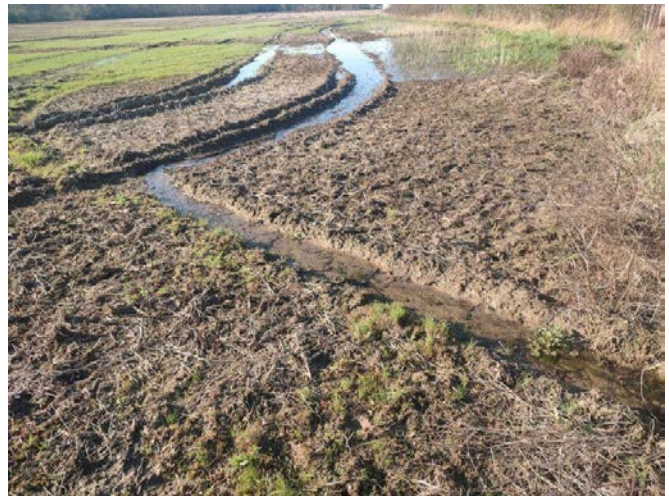
<b>Site Name: R-13 (Bruce Rio Farm)</b>	<b>Date: 05-02-2024</b>
<b>Landowner: The Wetland Trust</b>	<b>Designer Name: Thomas R. Biebighauser</b>
<b>Individuals assisting with the design: Kirsten Gerhart (The Wetland Trust), Michelle Herman (The Wetland Trust)</b>	
<b>Objectives: Build a naturally appearing and functioning wetland for mitigation.</b>	<b>Site Description: An agricultural field to be planted to soybeans.</b>
<b>Evidence of historic drainage or filling: A ditch bisects the area. This ditch will be filled and blocked by the project.</b>	
<b>Plant species: Soybeans</b>	<b>How the planned wetland is marked on the ground: Orange wire flags</b>
<b>Invasive species: none</b>	<b>Groundwater elevation in test hole? Not found.</b>
<b>Hydric soil present near the surface? No</b>	<b>Elevation-change from upper to lower edge = 1.0-feet</b>
<b>Soil test hole location: 43.264564°N 76.184768°W Soil texture: 0-9-inches = topsoil, 9-48-inches-clay</b>

<b>Rock armoring or vertical grade control needed at the inlet or outlet. No</b>	
<b>Head-cuts located uphill or downhill of the planned wetland. No</b>	
<b>Woody debris source: Not available on the property. Would need to be transported to the site.</b>	
<b>Construction notes: Build a groundwater dam across the floodplain of the ditch draining the area. Level the area and shape scrapes, pits, and mounds. Do not build a dam. Plant native trees and shrubs on the mounds and higher ground.</b>

R-13 Showing ditch in the Spring.

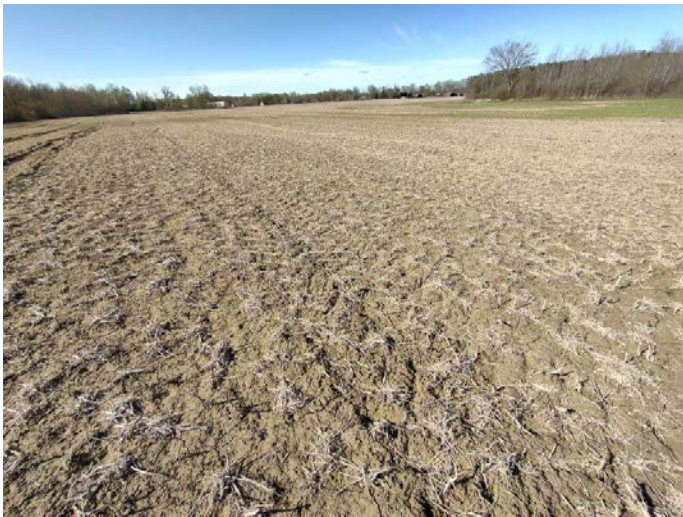
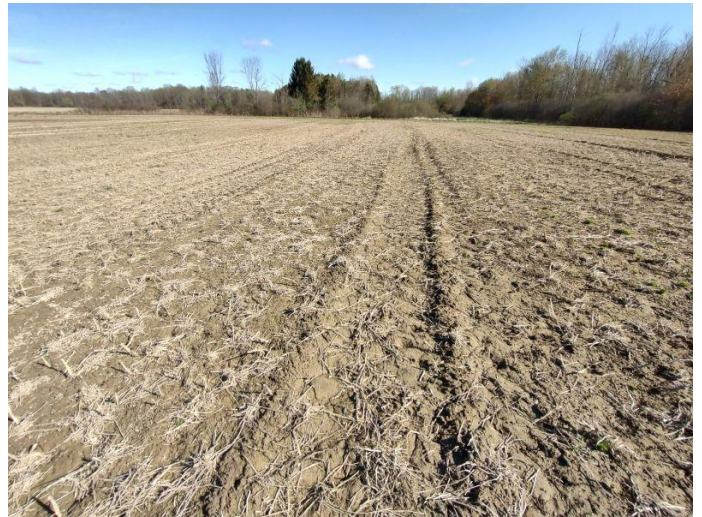
<b>Site Name: R-14 (Bruce Rio Farm)</b>	<b>Date: 05-02-2024</b>
<b>Landowner: The Wetland Trust</b>	<b>Designer Name: Thomas R. Biebighauser</b>
<b>Individuals assisting with the design: Kirsten Gerhart (The Wetland Trust), Michelle Herman (The Wetland Trust)</b>	
<b>Objectives: Build a naturally appearing and functioning wetland for mitigation.</b>	<b>Site Description: An agricultural field to be planted to soybeans.</b>
<b>Evidence of historic drainage or filling: Ditches have been dug to drain the field. Buried drainage structures may be present.</b>	
<b>Plant species: Soybeans</b>	<b>How the planned wetland is marked on the ground: Orange wire flags</b>
<b>Invasive species: none</b>	<b>Groundwater elevation in test hole? Not found.</b>
<b>Hydric soil present near the surface? No</b>	<b>Elevation-change from upper to lower edge = 2.0-feet</b>
<b>Soil test hole location: 43.265363°N 76.184511°W</b>

<b>Soil texture: 0-8-inches = topsoil, 8-13-inches = Silt Loam, 13-48-inches = Clay</b>	
<b>Rock armoring or vertical grade control needed at the inlet or outlet. No</b>	
<b>Head-cuts located uphill or downhill of the planned wetland. No</b>	
<b>Woody debris source: Not available on the property. Would need to be transported to the site.</b>	
<b>Construction notes: Build a groundwater around the lower 2/3 perimeter of the area Level the area and shape scrapes, pits, and mounds. Do not build a dam. Spread soil that is removed over the buffer along the east edge of the area. Plant native trees and shrubs on the mounds and higher ground.</b>

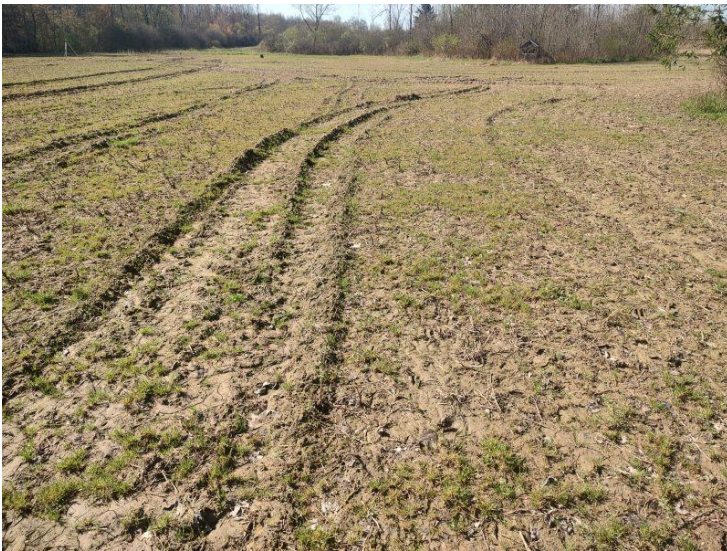
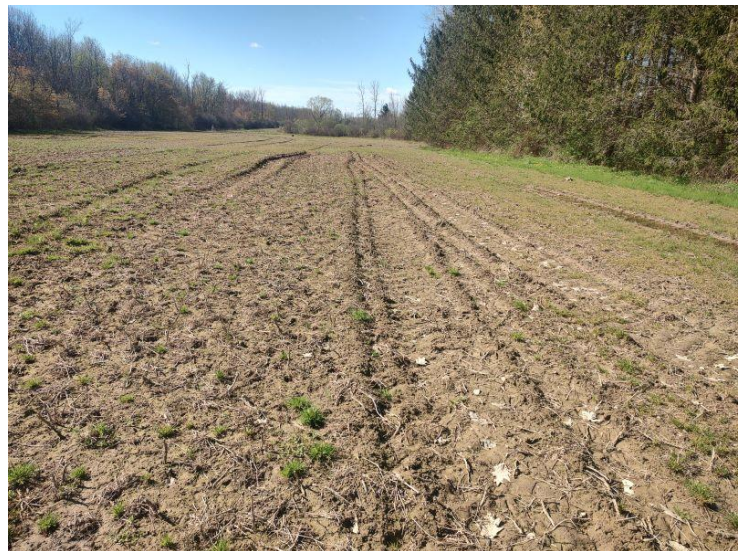
<b>Site Name: R-15 (Bruce Rio Farm)</b>	<b>Date: 05-02-2024</b>
<b>Landowner: The Wetland Trust</b>	<b>Designer Name: Thomas R. Biebighauser</b>
<b>Individuals assisting with the design: Kirsten Gerhart (The Wetland Trust), Harrison Franz (The Wetland Trust)</b>	
<b>Objectives: Build a naturally appearing and functioning wetland for mitigation.</b>	<b>Site Description: An agricultural field to be planted to soybeans.</b>
<b>Evidence of historic drainage or filling: Ditches have been dug to drain the field. Buried drainage structures may be present. The surface of the ground has been sloped so it will drain. Shallow ditches are located along the edge of the field.</b>	
<b>Plant species: Soybeans</b>	<b>How the planned wetland is marked on the ground: Orange wire flags</b>
<b>Invasive species: none</b>	<b>Groundwater elevation in test hole? Not found.</b>
<b>Hydric soil present near the surface? No</b>	<b>Elevation-change from upper to lower edge = 2.0-feet</b>

<b>Soil test hole location: 43.267859°N 76.184456°W Soil texture: 0-8-inches = topsoil, 8-48-inches = Clay</b>	
<b>Rock armoring or vertical grade control needed at the inlet or outlet. No</b>	
<b>Head-cuts located uphill or downhill of the planned wetland. No</b>	
<b>Woody debris source: Woody debris source: Obtain by removing the planted Norway Spruce trees growing next to the planned wetland.</b>	
<b>Construction notes: Do not build a groundwater dam or an above ground dam. Level the area and excavate shallow scrapes up to 6-inches deep with pits and mounds. Spread soil that is removed over the buffer along the east edge of the area. Plant native trees and shrubs on the mounds and higher ground.</b>

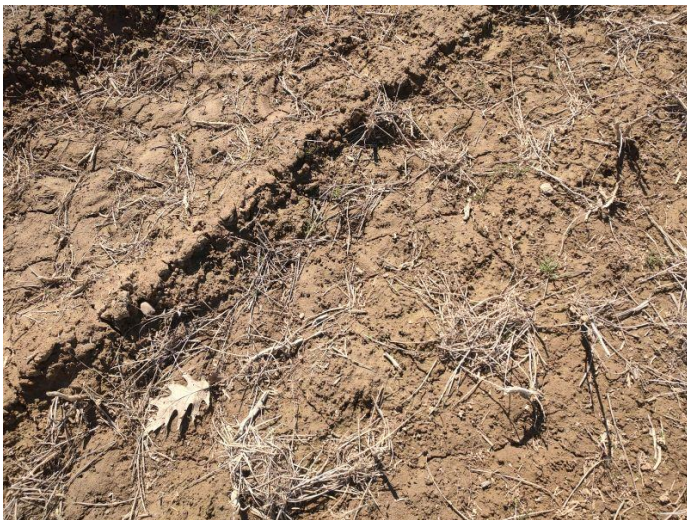
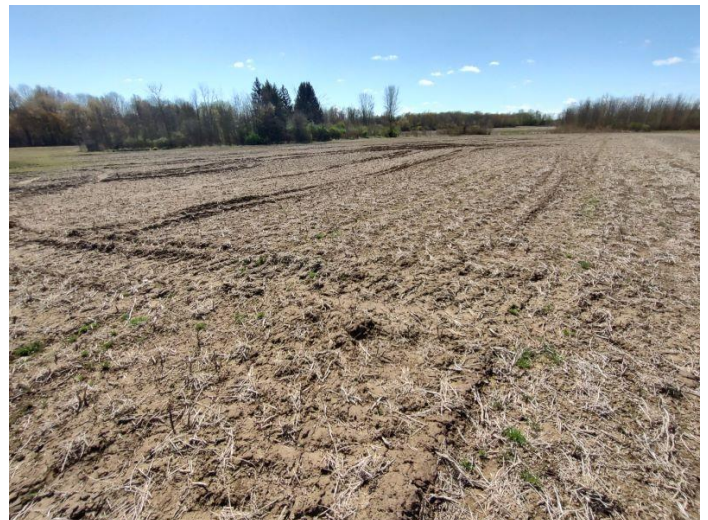
<b>Site Name: R-16 (Bruce Rio Farm)</b>	<b>Date: 05-02-2024</b>
<b>Landowner: The Wetland Trust</b>	<b>Designer Name: Thomas R. Biebighauser</b>
<b>Individuals assisting with the design: Kirsten Gerhart (The Wetland Trust), Harrison Frantz (The Wetland Trust)</b>	
<b>Objectives: Build a naturally appearing and functioning wetland for mitigation.</b>	<b>Site Description: An agricultural field to be planted to soybeans.</b>
<b>Evidence of historic drainage or filling: Ditches have been dug to drain the field. Buried drainage structures may be present. The surface of the ground has been sloped so it will drain. Shallow ditches are located along the edge of the field.</b>	
<b>Plant species: Soybeans</b>	<b>How the planned wetland is marked on the ground: Pink wire flags</b>
<b>Invasive species: none</b>	<b>Groundwater elevation in test hole? Not found.</b>
<b>Hydric soil present near the surface? No</b>	<b>Elevation-change from upper to lower edge = 3.0-feet</b>

<b>Soil test hole location: 43.267327°N 76.185515°W Soil texture: 0-8-inches = topsoil, 8-48-inches = Clay</b>	
<b>Rock armoring or vertical grade control needed at the inlet or outlet. No</b>	
<b>Head-cuts located uphill or downhill of the planned wetland. No</b>	
<b>Woody debris source: Woody debris source: Obtain by removing the planted Norway Spruce trees growing next to the planned wetland.</b>	
<b>Construction notes: Build a groundwater dam that will cross the ditch adjacent to the Norway Spruce Plantation. Level the area and excavate shallow scrapes up to 6-inches deep with pits and mounds. Spread soil that is removed downhill along the western edge of the area. Plant native trees and shrubs on the mounds and higher ground.</b>

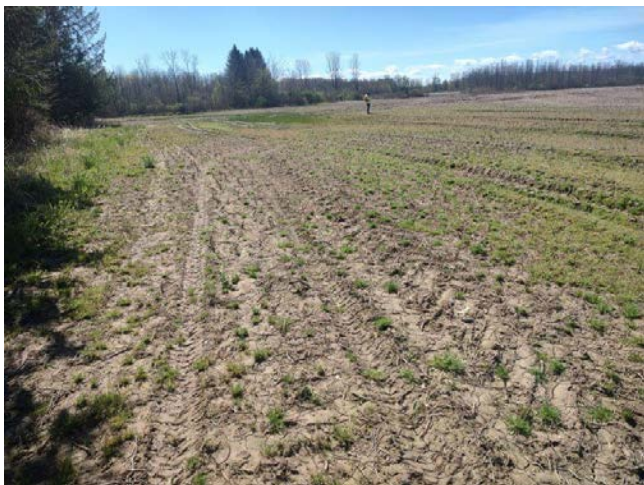
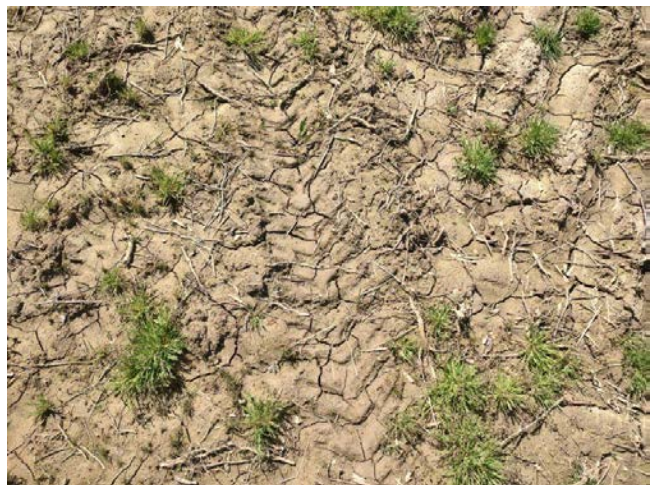
<b>Site Name:</b> R-17 (Bruce Rio Farm)	<b>Date:</b> 05-02-2024
<b>Landowner:</b> The Wetland Trust	<b>Designer Name:</b> Thomas R. Biebighauser
<b>Individuals assisting with the design:</b> Kirsten Gerhart (The Wetland Trust), Harrison Frantz (The Wetland Trust)	
<b>Objectives:</b> Build a naturally appearing and functioning wetland for mitigation.	<b>Site Description:</b> An agricultural field to be planted to soybeans.
<b>Evidence of historic drainage or filling:</b> Ditches have been dug to drain the field. Buried drainage structures may be present. The surface of the ground has been sloped so it will drain. Shallow ditches are located along the edge of the field.	
<b>Plant species:</b> Soybeans	<b>How the planned wetland is marked on the ground:</b> White wire flags
<b>Invasive species:</b> none	<b>Groundwater elevation in test hole?</b> 1-inch below surface
<b>Hydric soil present near the surface?</b> No	<b>Elevation-change from upper to lower edge =</b> 3.0-feet

<b>Soil test hole location:</b> 43.268248°N 76.185647°W <b>Soil texture:</b> 0-6-inches = topsoil, 6-23-inches = Silt Loam, 23-48-inches = clay	
<b>Rock armoring or vertical grade control needed at the inlet or outlet.</b> No	
<b>Head-cuts located uphill or downhill of the planned wetland.</b> No	
<b>Woody debris source:</b> Woody debris source: Obtain by removing the planted Norway Spruce trees growing next to the planned wetland.	
<b>Construction notes:</b> Build a groundwater dam around the lower 2/3 perimeter of the area. Build an above ground dam no higher than 1.5-feet. Level the area and excavate shallow scrapes up to 6-inches deep with pits and mounds. Spread soil that is removed downhill along the eastern edge of the area. Plant native trees and shrubs on the mounds and higher ground. Also excavate scrapes between R-3 and R-17.

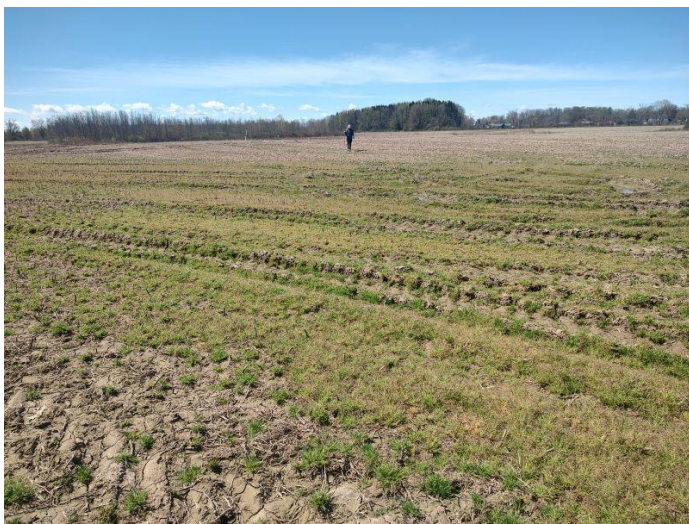
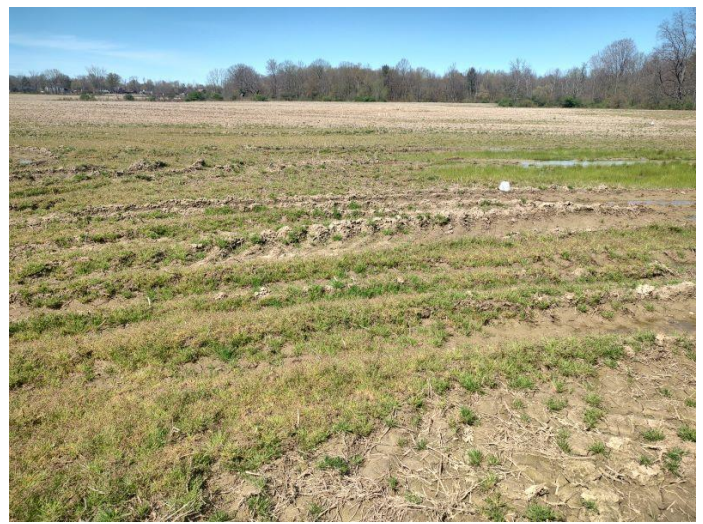
<b>Site Name: R-18 (Bruce Rio Farm)</b>	<b>Date: 05-02-2024</b>
<b>Landowner: The Wetland Trust</b>	<b>Designer Name: Thomas R. Biebighauser</b>
<b>Individuals assisting with the design: Kirsten Gerhart (The Wetland Trust), Harrison Frantz (The Wetland Trust)</b>	
<b>Objectives: Build a naturally appearing and functioning wetland for mitigation.</b>	<b>Site Description: An agricultural field to be planted to soybeans.</b>
<b>Evidence of historic drainage or filling: Ditches have been dug to drain the field. Buried drainage structures may be present. The surface of the ground has been sloped so it will drain. Shallow ditches are located along the edge of the field.</b>	
<b>Plant species: Soybeans</b>	<b>How the planned wetland is marked on the ground: White wire flags</b>
<b>Invasive species: none</b>	<b>Groundwater elevation in test hole? 1-inch below surface</b>
<b>Hydric soil present near the surface? No</b>	<b>Elevation-change from upper to lower edge = 3.0-feet</b>

<b>Soil test hole location: 43.269413°N 76.185691°W Soil texture: 0-9-inches = topsoil, 9-48-inches = clay</b>	
<b>Rock armoring or vertical grade control needed at the inlet or outlet. No</b>	
<b>Head-cuts located uphill or downhill of the planned wetland. No</b>	
<b>Woody debris source: Woody debris source: Obtain by removing the planted Norway Spruce trees growing next to the planned wetland.</b>	
<b>Construction notes: Build a groundwater dam around the lower 2/3 perimeter of the area. Build an above ground dam no higher than 1.0-feet. Level the area and excavate shallow scrapes up to 6-inches deep with pits and mounds. Spread soil that is removed downhill along the Northern edge of the area. Plant native trees and shrubs on the mounds and higher ground.</b>
