# **Micron Central New York Semiconductor Manufacturing Complex**

## **Oneida River Wetland Mitigation Plan**

**Oswego County, NY**

May 2025

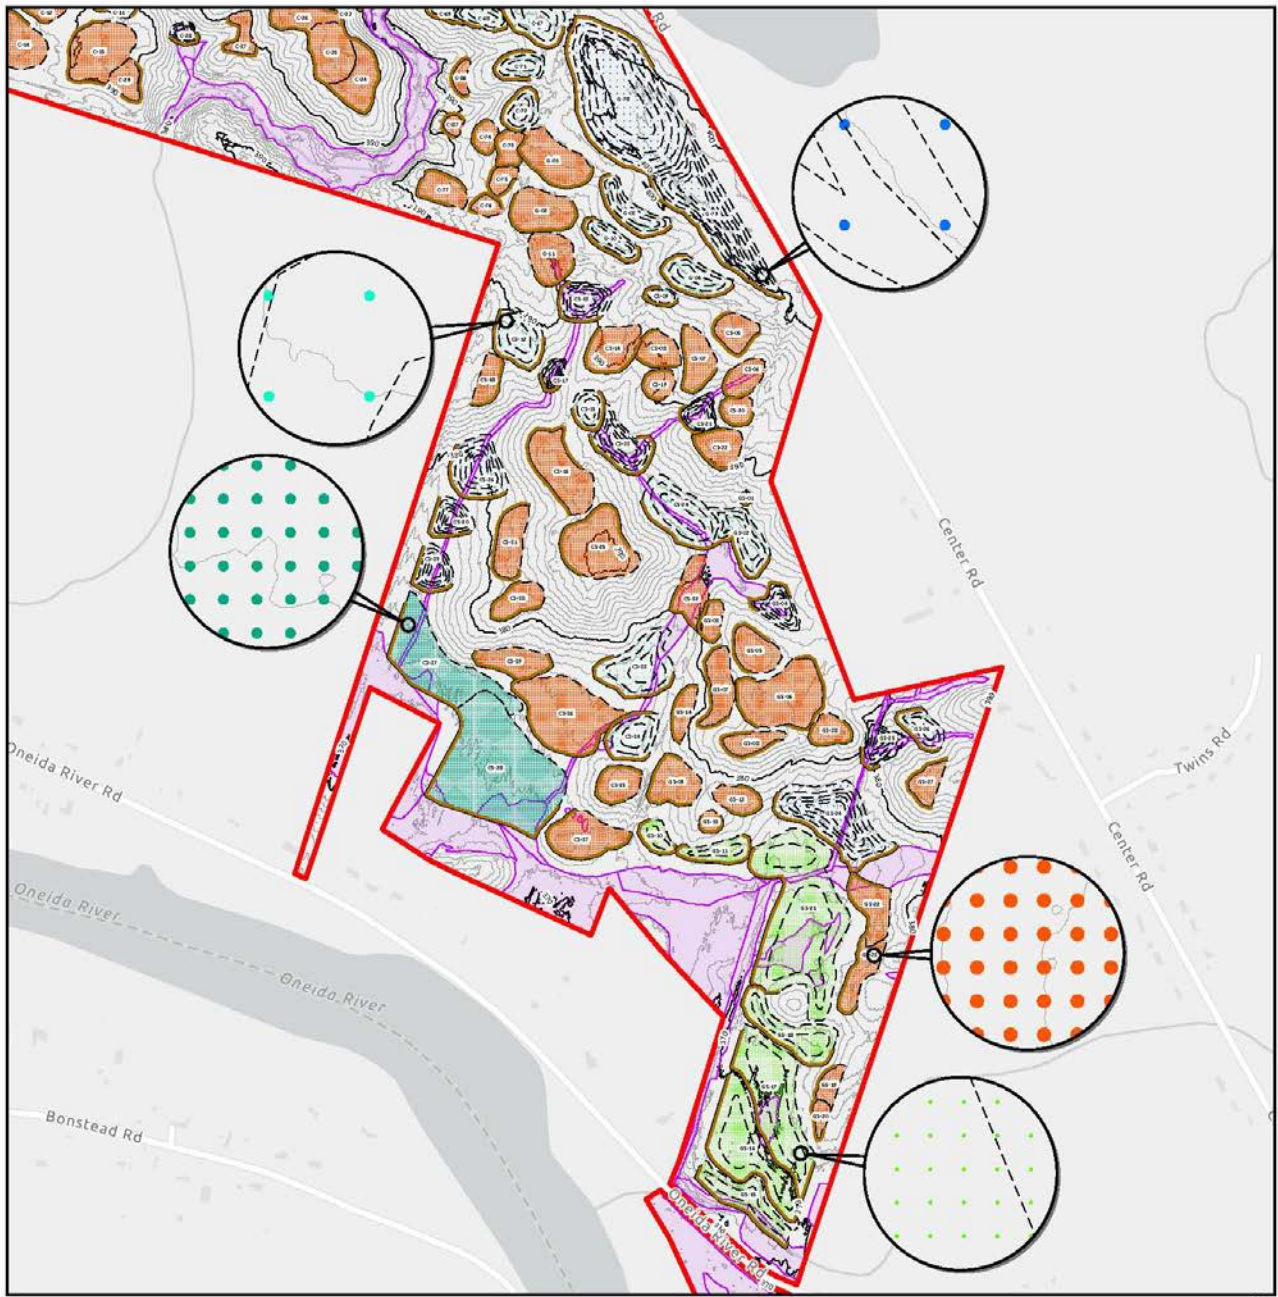
**Figure 5-5. Wetland Grading Plan- Southeast**

**Wetland Grading Plan - Southeast**  
 Oneida River  
 Town of Schroepfel,  
 Oswego County, NY

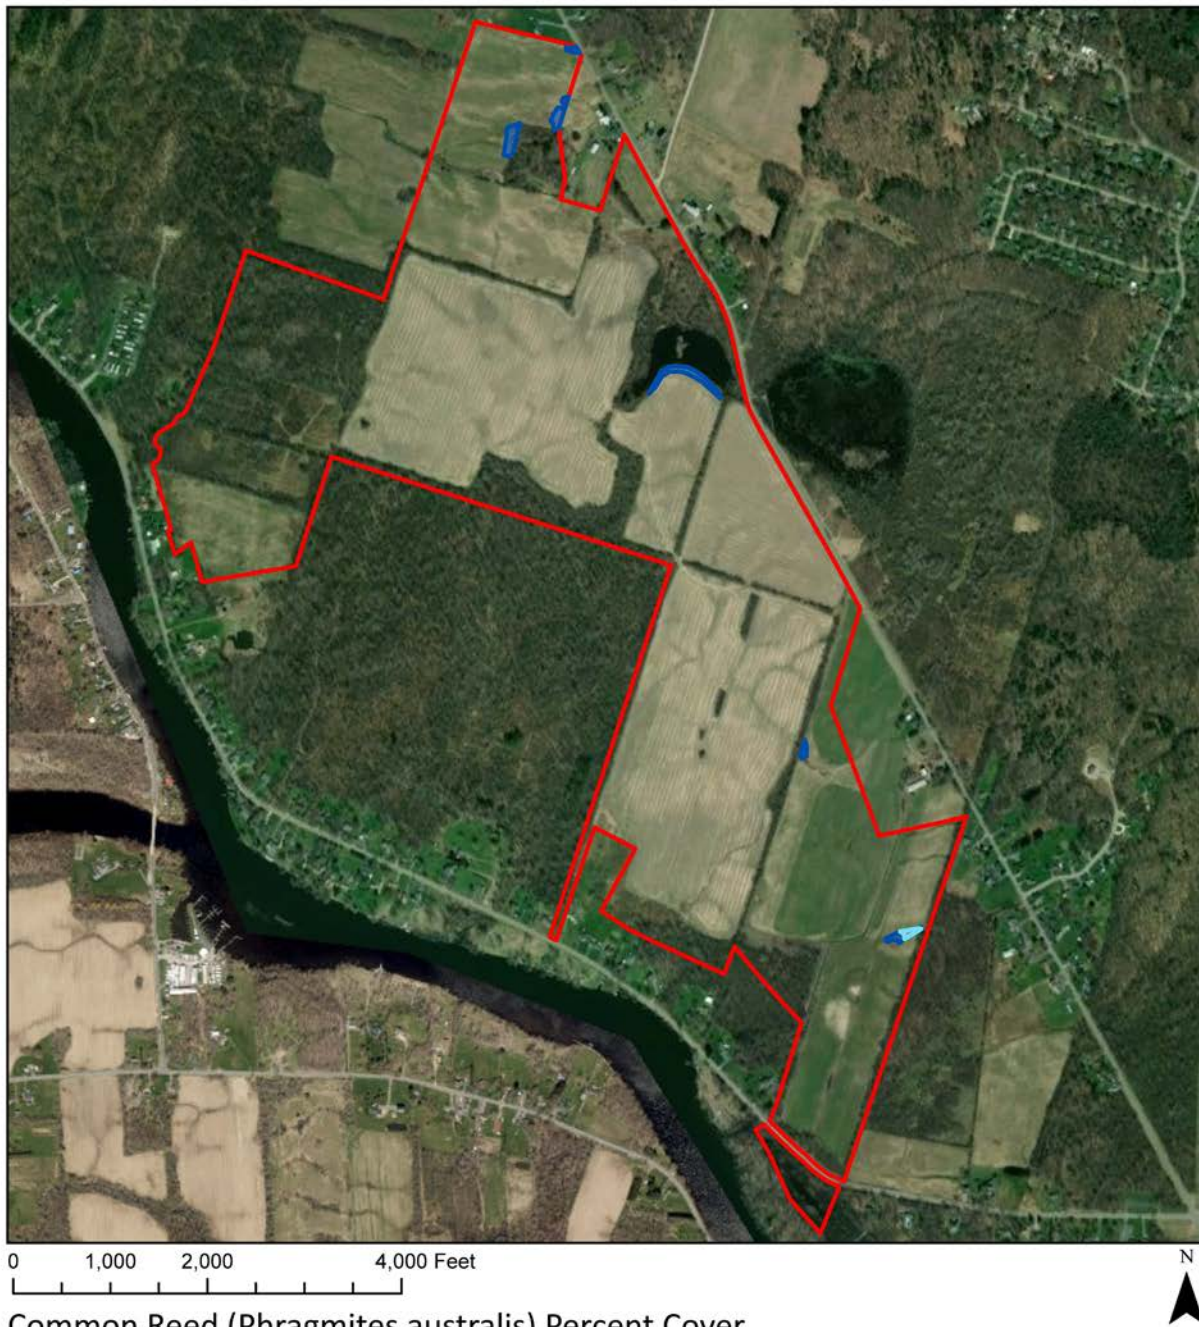
Figure 8-3. Phragmites Percent Cover

Common Reed (*Phragmites australis*) Percent Cover

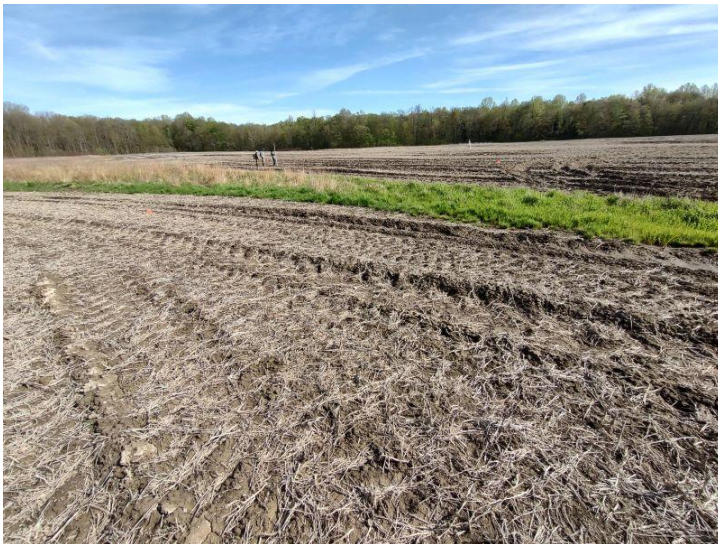
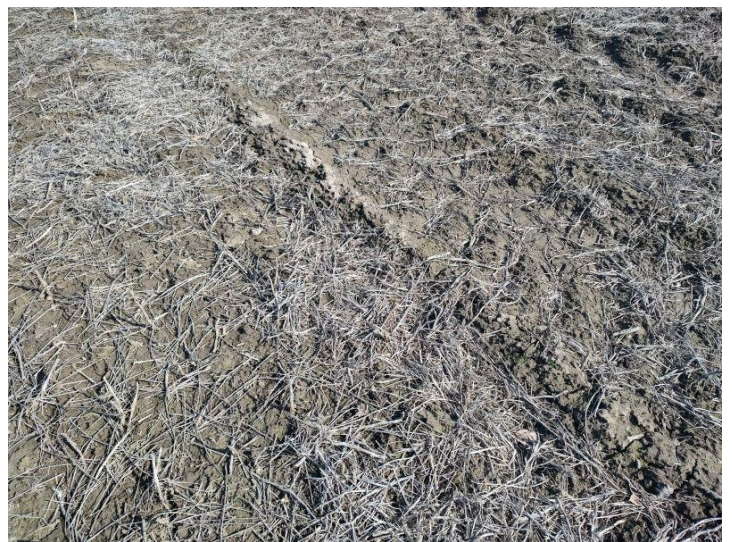
Wisner 1

<b>Construction notes:</b> Build a groundwater dam along the lower perimeter of the wetland being built. Fill ditch. Build an above ground dam that is no higher than 12-inches. Spread soil to the south. Shape and armor with rock an inlet and an outlet. Add pits, scrapes, and mounds and then plant with native trees and shrubs.

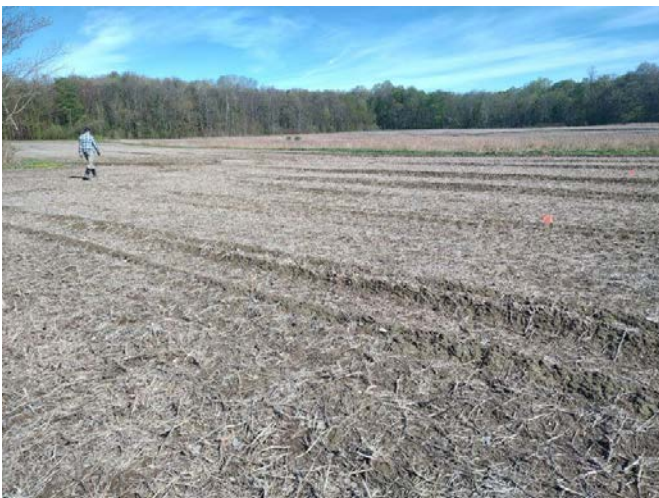
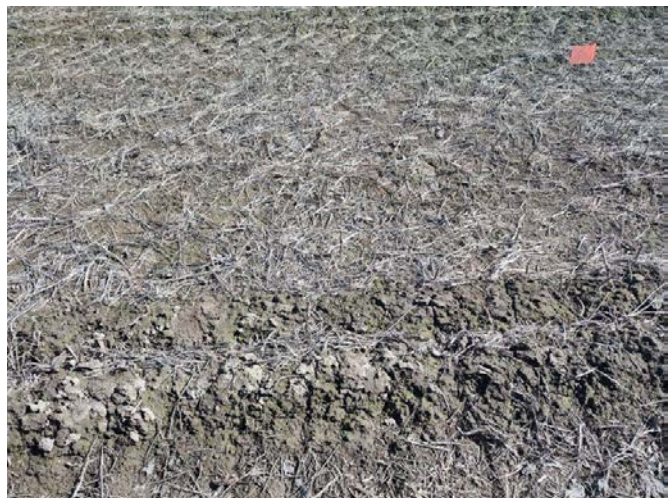
Wisner 2

<b>Hydric soil present near the surface?</b> No	<b>Elevation-change upper to lower edge of designed wetland:</b> 2.0-feet
<b>Test Hole location:</b> 43.308288°N 76.221014°W (Same as for Wisner 1) <b>Soil texture:</b> 0-12-inches = topsoil, 12-29-inches = clay, 29-32-inches = sand, 32-34-inches = silt loam.	
<b>Rock armor the inlet and outlet for the wetland?</b> No	
<b>Head-cuts located uphill or downhill of the planned wetland.</b> None	
<b>Woody debris source:</b> Not available on site. Would need to be brought in by truck.	
<b>Construction notes:</b> Build a groundwater dam along the lower perimeter of the wetland being built. Build an above ground dam that is no higher than 12-inches. Spread soil to the south into buffer. Add pits, scrapes, and mounds and then plant with native trees and shrubs.

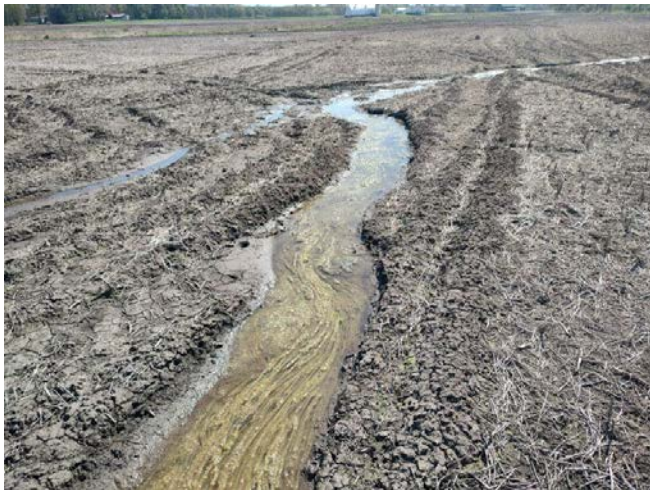
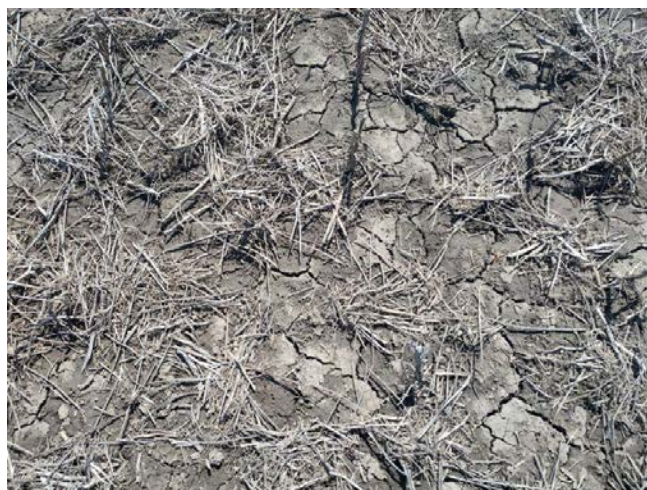
Wisner 3

<b>Construction notes:</b> Build a groundwater dam along the lower perimeter of the wetland being built. Fill ditch. Build an above ground dam that is no higher than 12-inches. Shape and armor with rock an inlet and an outlet. Spread soil to the south into buffer. Add pits, scrapes, and mounds and then plant with native trees and shrubs.

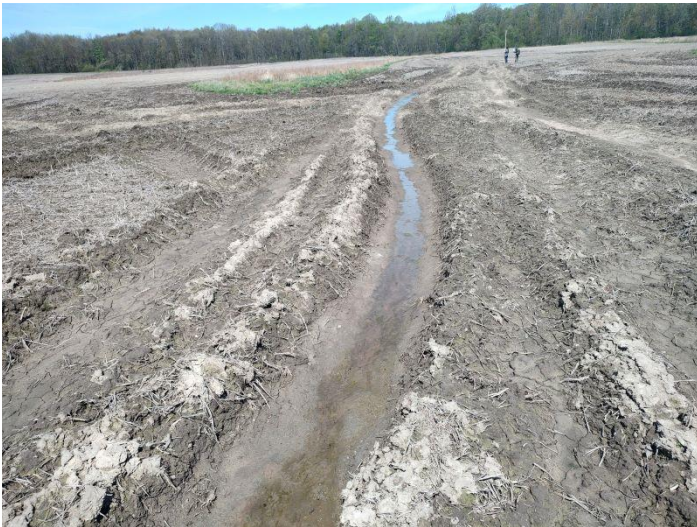
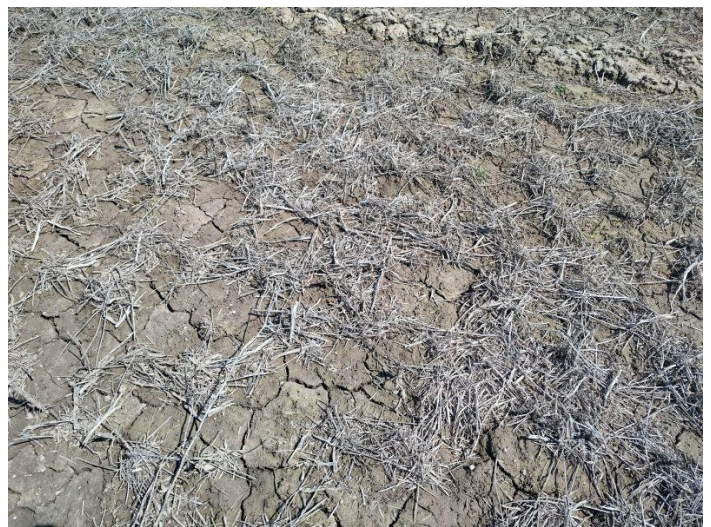
Wisner 4

<b>Construction notes:</b> Build a groundwater dam along the lower perimeter of the wetland being built. Fill ditch. Build an above ground dam that is no higher than 10-inches. Spread soil to the south. Shape and armor with rock an inlet and an outlet. Add pits, scrapes, and mounds and then plant with native trees and shrubs.

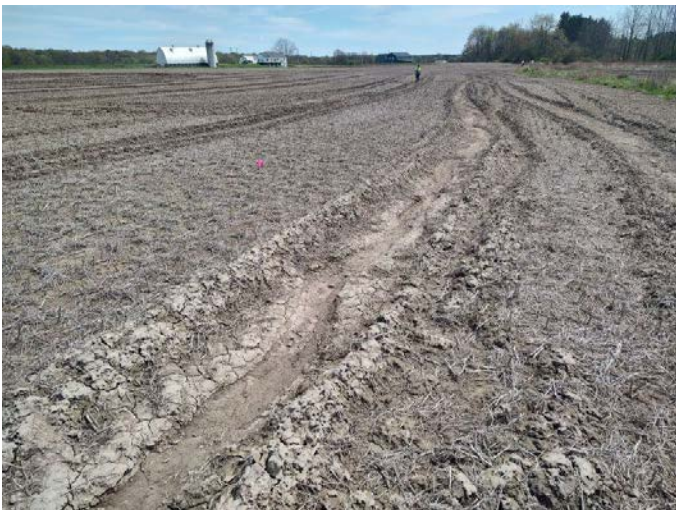
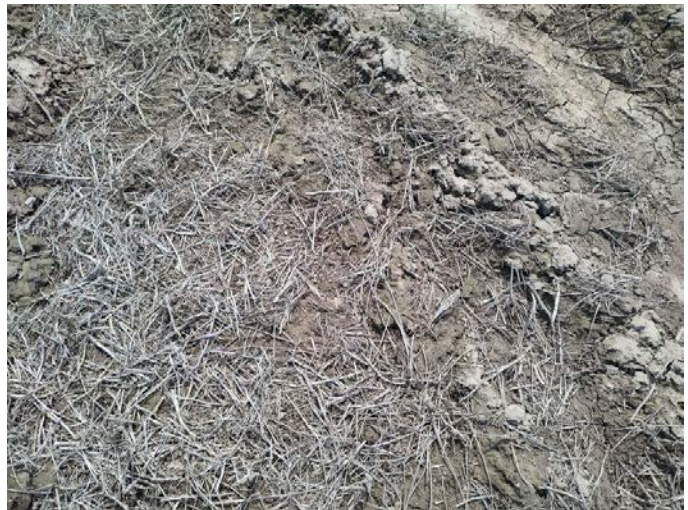
Wisner 5

<b>Hydric soil present near the surface?</b> No	<b>Elevation-change upper to lower edge of designed wetland:</b> 1.5-feet
<b>Test Hole location:</b> 43.307020°N 76.216876°W <b>Soil texture:</b> 0-14-inches = topsoil, 14-22-inches sand & clay, 22-48-inches = clay.	
<b>Rock armor the inlet and outlet for the wetland?</b> Yes <b>Inlet:</b> 12-feet wide x 50-feet long x 1.5-feet thick = 900 feet <sup>3</sup> /27 feet <sup>3</sup> /yard <sup>3</sup> = 33 yards <sup>3</sup> x 1.5 tons/yard <sup>3</sup> = 50 tons <b>Outlet =</b> 12-feet wide x 50-feet long x 1.5-feet thick = 900 feet <sup>3</sup> /27 feet <sup>3</sup> /yard <sup>3</sup> = 33 yards <sup>3</sup> x 1.5 tons/yard <sup>3</sup> = 50 tons <b>Total = 100 tons</b>	
<b>Head-cuts located uphill or downhill of the planned wetland.</b> Yes, in the ditch.	
<b>Woody debris source:</b> Not available on site. Would need to be brought in by truck.	
<b>Construction notes:</b> Build a groundwater dam along the lower perimeter of the wetland being built. Fill ditch. Build an above ground dam that is no higher than 10-inches. Spread soil to the south into the buffer. Shape and armor with rock an inlet and an outlet. Add pits, scrapes, and mounds and then plant with native trees and shrubs.

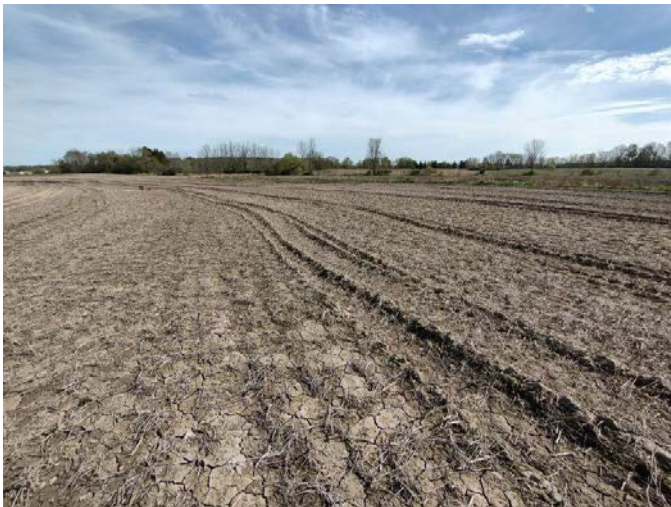
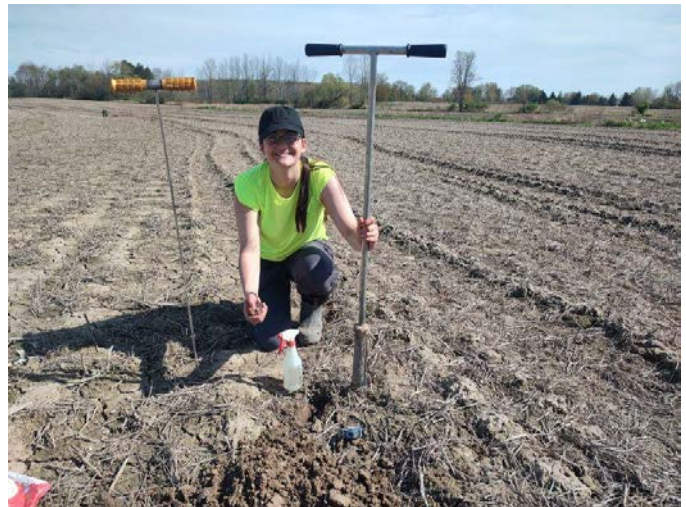
<b>Woody debris source:</b> Not available on site. Would need to be brought in by truck.	
<b>Construction notes:</b> Build a groundwater dam along the lower perimeter of the wetland being built. Fill ditch. Build an above ground dam that is no higher than 12-inches. Spread soil uphill to north. Shape and armor with rock an inlet and an outlet. Add pits, scrapes, and mounds and then plant with native trees and shrubs.

Wisner 7 (digging soil test hole)

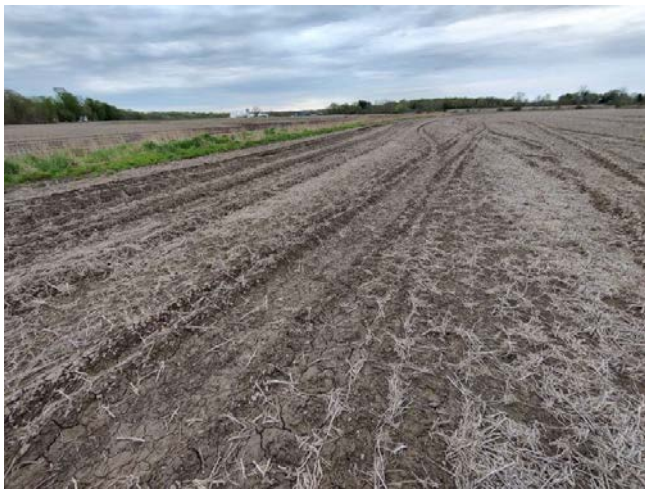
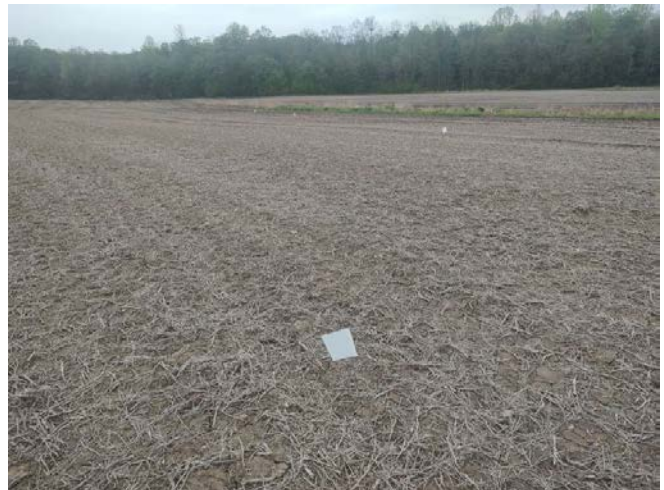
Wisner 8

<b>Hydric soil present near the surface?</b> No	<b>Elevation-change upper to lower edge of designed wetland:</b> 2.0-feet
<b>Test Hole location:</b> 43.309175°N 76.218873°W <b>Soil texture:</b> 0-8-inches = topsoil, 8-39-inches = clay, 39-44-inches = sand, 44-48-inches = clay.	
<b>Rock armor the inlet and outlet for the wetland?</b> Yes <b>Inlet:</b> 12-foot wide x 50-foot long x 1.5-foot thick = 900 feet <sup>3</sup> /27 feet <sup>3</sup> /yard <sup>3</sup> = 33 yards <sup>3</sup> x 1.5 tons/yard <sup>3</sup> = 50 tons <b>Outlet =</b> 12-foot wide x 50-foot long x 1.5-foot thick = 900 feet <sup>3</sup> /27 feet <sup>3</sup> /yard <sup>3</sup> = 33 yards <sup>3</sup> x 1.5 tons/yard <sup>3</sup> = 50 tons <b>Total = 100 tons</b>	
<b>Head-cuts located uphill or downhill of the planned wetland.</b> None	
<b>Woody debris source:</b> Not available on site. Would need to be brought in by truck.	
<b>Construction notes:</b> Build a groundwater dam along the lower perimeter of the wetland being built. Fill ditch. Build an above ground dam that is no higher than 12-inches. Spread uphill to the southeast and east. Shape and armor with rock an inlet and an outlet. Add pits, scrapes, and mounds and then plant with native trees and shrubs.

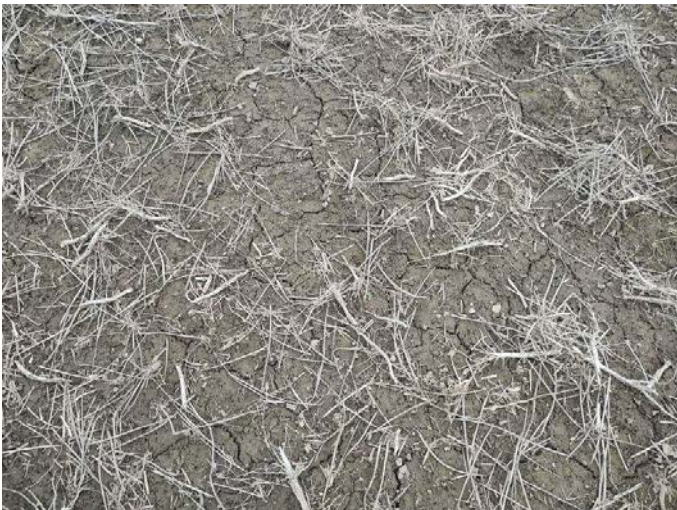
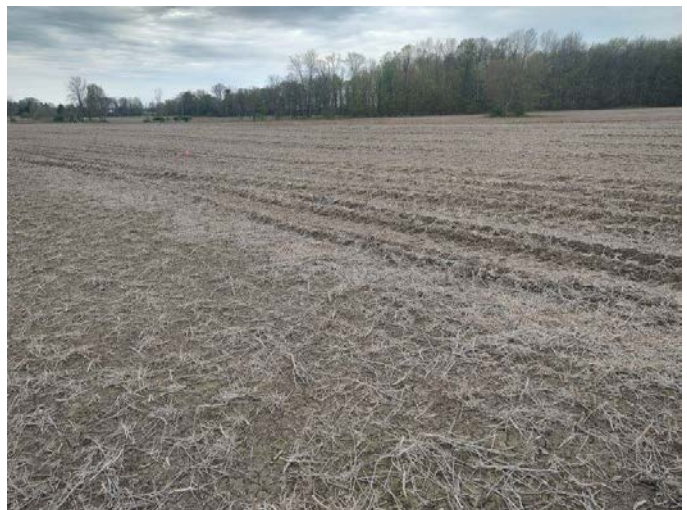
Wisner 9

<b>Construction notes:</b> Build a groundwater dam along the lower perimeter of the wetland being built. Fill ditch. Build an above ground dam that is no higher than 10-inches. Spread soil uphill to the north. Shape and armor with rock an inlet and an outlet. Add pits, scrapes, and mounds and then plant with native trees and shrubs.

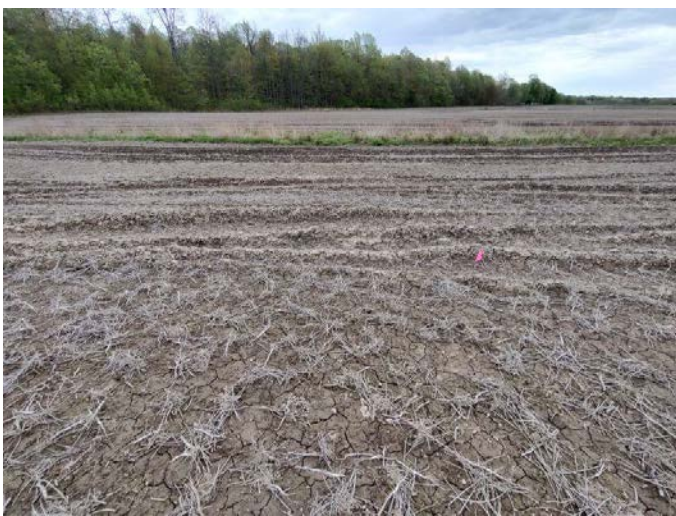
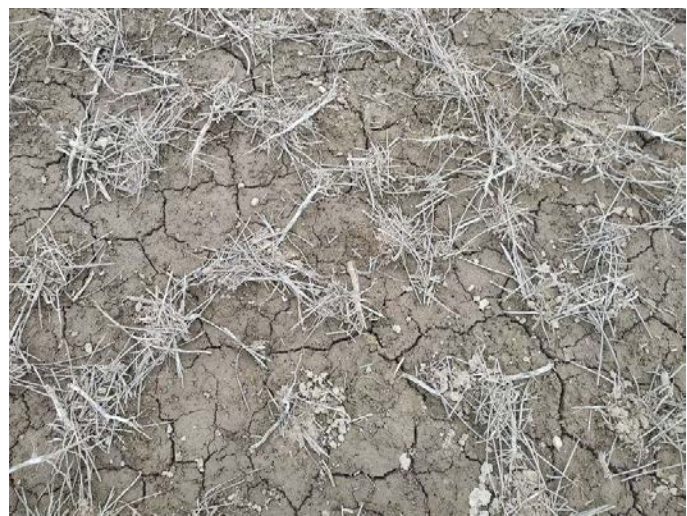
Wisner 10

<b>Hydric soil present near the surface?</b> No	<b>Elevation-change upper to lower edge of designed wetland:</b> 2.0-feet
<b>Test Hole location:</b> Not dug <b>Soil texture:</b> Like Wisner 9	
<b>Rock armor the inlet and outlet for the wetland?</b> Yes Inlet: 12-feet wide x 50-feet long x 1.5-feet thick = $900 \text{ feet}^3 / 27 \text{ feet}^3/\text{yard}^3 = 33 \text{ yards}^3 \times 1.5 \text{ tons}/\text{yard}^3 = 50 \text{ tons}$ Outlet = 12-feet wide x 50-feet long x 1.5-feet thick = $900 \text{ feet}^3 / 27 \text{ feet}^3/\text{yard}^3 = 33 \text{ yards}^3 \times 1.5 \text{ tons}/\text{yard}^3 = 50 \text{ tons}$ Total = 100 tons	
<b>Head-cuts located uphill or downhill of the planned wetland.</b> None	
<b>Woody debris source:</b> Not available on site. Would need to be brought in by truck.	
<b>Construction notes:</b> Build a groundwater dam along the lower perimeter of the wetland being built. Fill ditch. Build an above ground dam that is no higher than 12-inches. Spread soil east or west uphill. Shape and armor with rock an inlet and an outlet. Add pits, scrapes, and mounds and then plant with native trees and shrubs.

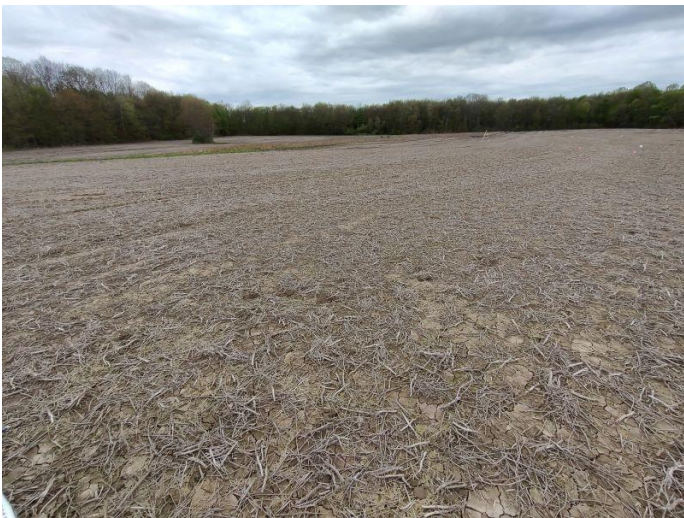
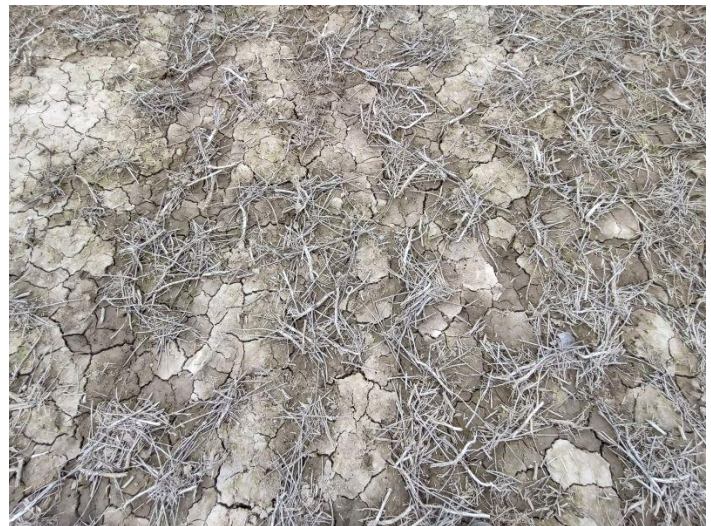
Wisner 11

<b>Hydric soil present near the surface?</b> No	<b>Elevation-change upper to lower edge of designed wetland:</b> 2.0-feet
<b>Test Hole location:</b> 43.308454°N 76.220184°W <b>Soil texture:</b> 0-9-inches = topsoil, 9-39-inches = clay, 39-41-inches – sand, 41-48-inches = clay	
<b>Rock armor the inlet and outlet for the wetland?</b> Not needed.	
<b>Head-cuts located uphill or downhill of the planned wetland.</b> None	
<b>Woody debris source:</b> Not available on site. Would need to be brought in by truck.	
<b>Construction notes:</b> Build a groundwater dam along the lower perimeter of the wetland being built. Fill ditch. Build an above ground dam that is no higher than 12-inches. Spread soil to the Southwest. Add pits, scrapes, and mounds and then plant with native trees and shrubs.

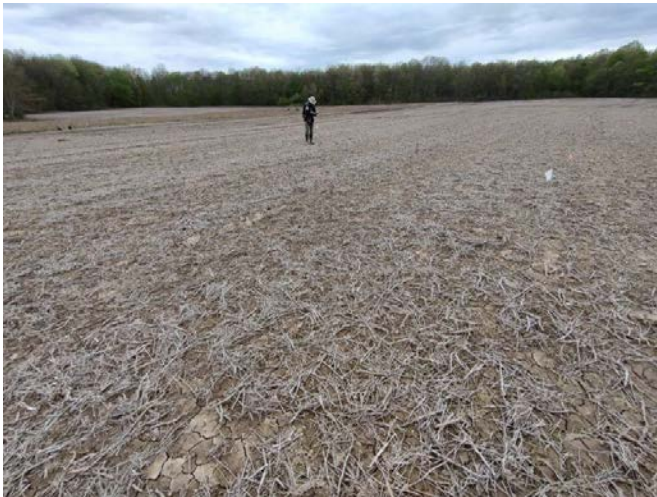
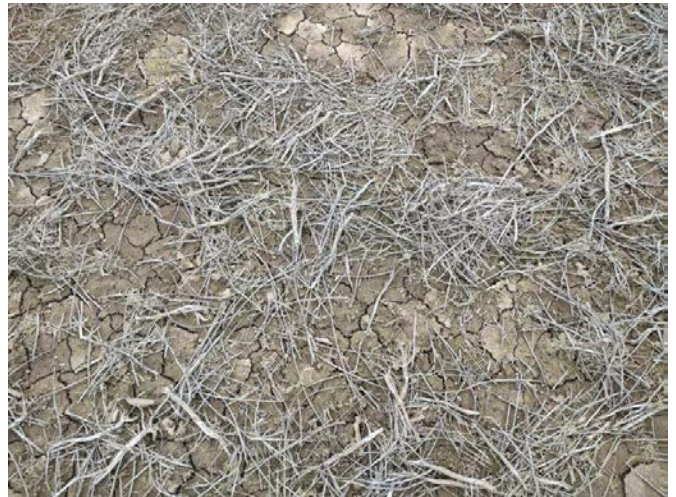
Wisner 12

<b>Hydric soil present near the surface?</b> No	<b>Elevation-change upper to lower edge of designed wetland:</b> 2.0-feet
<b>Test Hole location:</b> Not dug <b>Soil texture:</b> Like Wisner 11	
<b>Rock armor the inlet and outlet for the wetland?</b> Not needed.	
<b>Head-cuts located uphill or downhill of the planned wetland.</b> None	
<b>Woody debris source:</b> Not available on site. Would need to be brought in by truck.	
<b>Construction notes:</b> Build a groundwater dam along the lower perimeter of the wetland being built. Fill ditch. Build an above ground dam that is no higher than 12-inches. Spread soil to the Southwest. Add pits, scrapes, and mounds and then plant with native trees and shrubs.

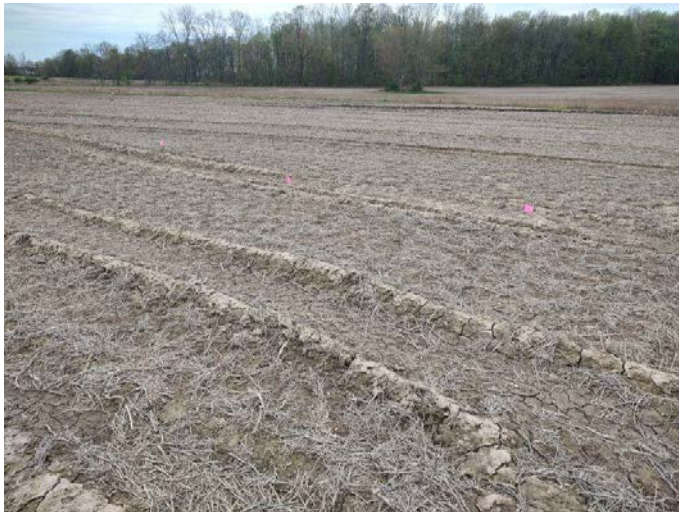
Wisner 13

<b>Hydric soil present near the surface? No</b>	<b>Elevation-change upper to lower edge of designed wetland: 2.0-feet</b>
<b>Test Hole location: 43.309410°N 76.221220°W</b>	
<b>Soil texture: 0-8-inches = topsoil, 8-29-inches clay, 29-30-inches = sand, 30-inches bedrock.</b>	
<b>Rock armor the inlet and outlet for the wetland? Not needed.</b>	
<b>Head-cuts located uphill or downhill of the planned wetland. None</b>	
<b>Woody debris source: Not available on site. Would need to be brought in by truck.</b>	
<b>Construction notes: Build a groundwater dam along the lower perimeter of the wetland being built. Fill ditch. Build an above ground dam that is no higher than 12-inches. Spread soil to the South. Add pits, scrapes, and mounds and then plant with native trees and shrubs.</b>

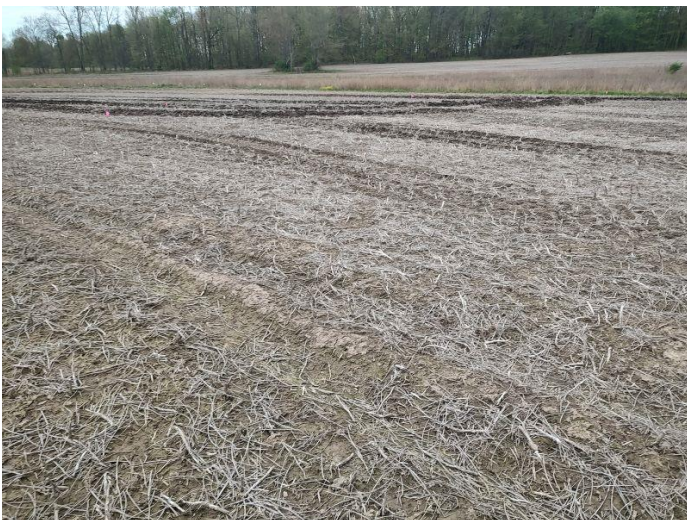
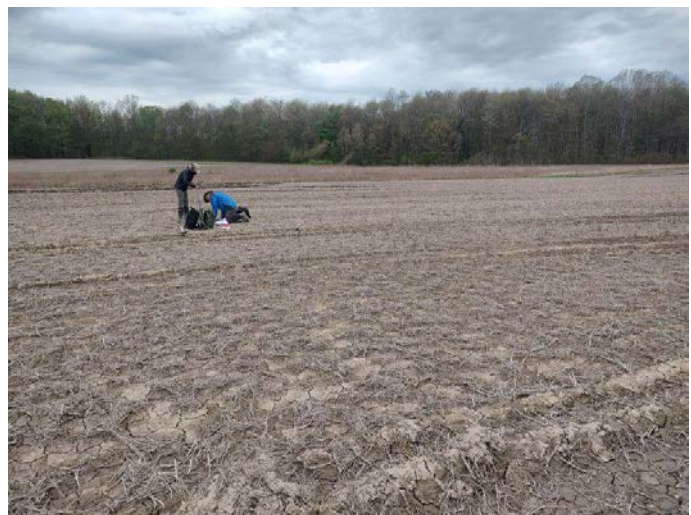
<b>Site Name:</b> Wisner 14	<b>Date:</b> 05-04-2024
<b>Landowner:</b> The Wetland Trust	<b>Designer Name:</b> Thomas R. Biebighauser
<b>Individuals assisting with the design:</b> Michelle Herman (The Wetland Trust), Gabby Deyo (The Wetland Trust)	
<b>Objectives:</b> Build a naturally appearing and functioning wetland for mitigation.	<b>Site Description:</b> An agricultural field planted to soybeans.
<b>Evidence of historic drainage or filling:</b> Ditches are present in each drainage and along the south edge of the property. The ditches may serve as outlets for buried drainage systems and drain historic natural wetland basins. Basins have been filled and land sloped so it will drain for farming.	
<b>Plant species:</b> Bare ground that is now planted to soybeans	<b>How the planned wetland is marked on the ground:</b> White wire flags
<b>Invasive species:</b>	<b>Groundwater elevation in test hole?</b> Not determined

<b>Hydric soil present near the surface?</b> No	<b>Elevation-change upper to lower edge of designed wetland:</b> 2.0-feet
<b>Test Hole location:</b> Not dug <b>Soil texture:</b> Like Wisner 13	
<b>Rock armor the inlet and outlet for the wetland?</b> Not needed.	
<b>Head-cuts located uphill or downhill of the planned wetland.</b> None	
<b>Woody debris source:</b> Not available on site. Would need to be brought in by truck.	
<b>Construction notes:</b> Build a groundwater dam along the lower perimeter of the wetland being built. Fill ditch. Build an above ground dam that is no higher than 12-inches. Spread soil downhill to the south. Add pits, scrapes, and mounds and then plant with native trees and shrubs.

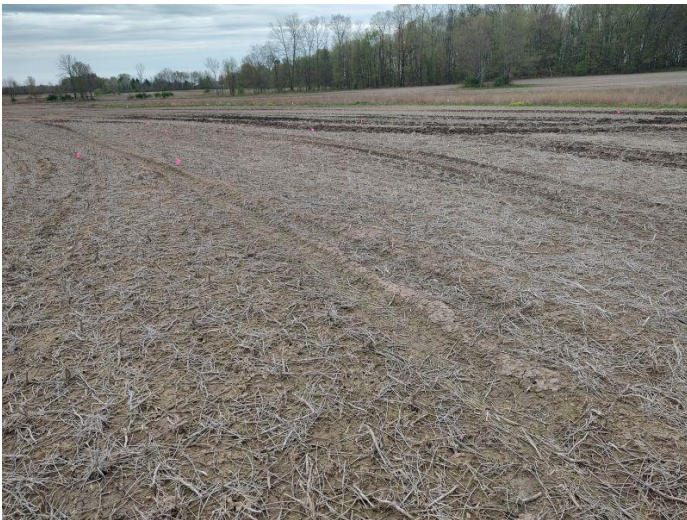
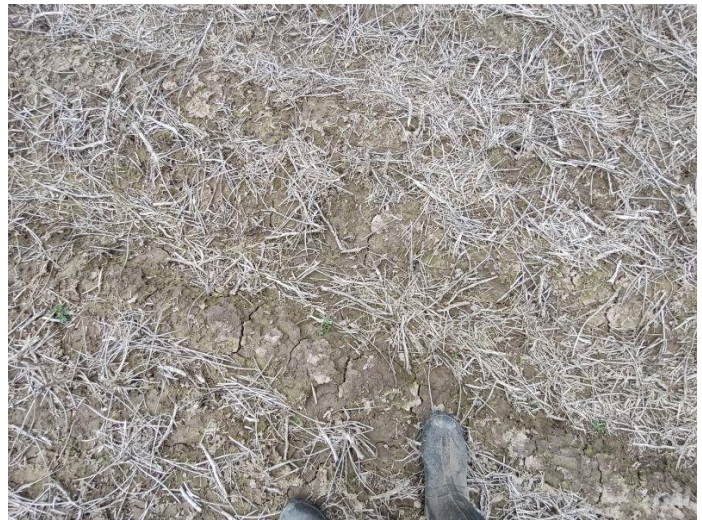
<b>Site Name:</b> Wisner 15	<b>Date:</b> 05-04-2024
<b>Landowner:</b> The Wetland Trust	<b>Designer Name:</b> Thomas R. Biebighauser
<b>Individuals assisting with the design:</b> Michelle Herman (The Wetland Trust), Gabby Deyo (The Wetland Trust)	
<b>Objectives:</b> Build a naturally appearing and functioning wetland for mitigation.	<b>Site Description:</b> An agricultural field planted to soybeans.
<b>Evidence of historic drainage or filling:</b> Ditches are present in each drainage and along the south edge of the property. The ditches may serve as outlets for buried drainage systems and drain historic natural wetland basins. Basins have been filled and land sloped so it will drain for farming.	
<b>Plant species:</b> Bare ground that is now planted to soybeans	<b>How the planned wetland is marked on the ground:</b> Pink wire flags
<b>Invasive species:</b>	<b>Groundwater elevation in test hole?</b> Not determined

<b>Hydric soil present near the surface?</b> No	<b>Elevation-change upper to lower edge of designed wetland:</b> 2.0-feet
<b>Test Hole location:</b> Not dug <b>Soil texture:</b> Like Wisner 13 & 14	
<b>Rock armor the inlet and outlet for the wetland?</b> Not needed.	
<b>Head-cuts located uphill or downhill of the planned wetland.</b> None	
<b>Woody debris source:</b> Not available on site. Would need to be brought in by truck.	
<b>Construction notes:</b> Build a groundwater dam along the lower perimeter of the wetland being built. Fill ditch. Build an above ground dam that is no higher than 12-inches. Spread soil downhill to the south. Add pits, scrapes, and mounds and then plant with native trees and shrubs.
