Micron Central New York Semiconductor Manufacturing Complex

Buxton Creek Stream and Wetland Mitigation Plan

Oswego County, NY

The Wetland Trust, Inc.

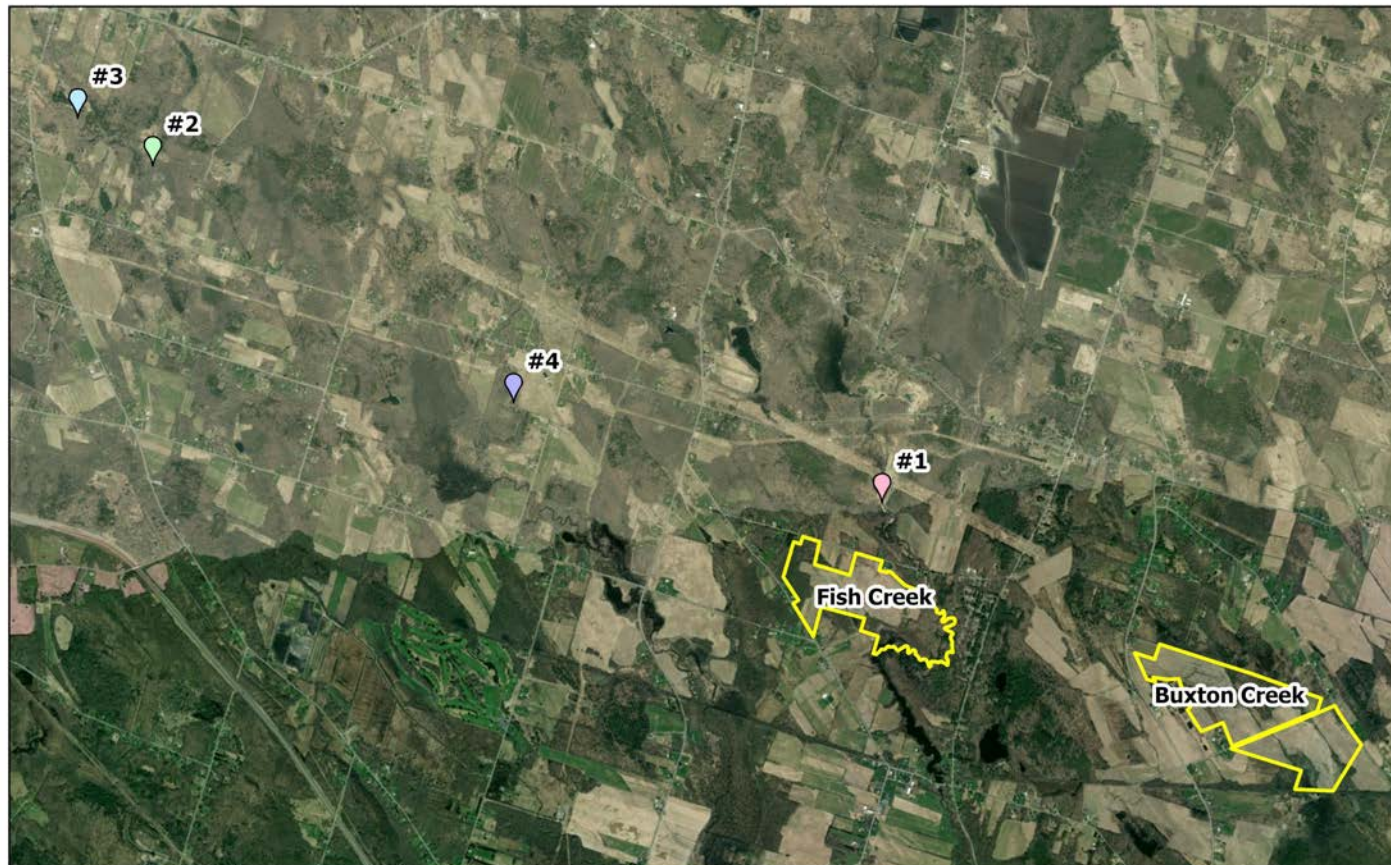
Figure 8-1a. Reference Stream Reaches

Reference Stream Reaches
Towns of Hastings, Palermo, and Schroepfel
Oswego County, NY

Local streams that have not been relocated, channelized, placed underground, affected by head cuts, or otherwise heavily altered were used to inform the design of the mitigation streams. Key reference streams were portions of Fish Creek, Bell Creek, and Sixmile Creek as shown in **Figures 8-1a-e**. Reference reach #1 (**Figure 8-1b**) is most proximate to the Buxton Creek property to the northwest. The imagery shows a stream that is braided with a complex of wetlands on nearly level ground. Bell Creek and Sixmile Creek references reaches #2-4 (**Figures 8-1c-e**) exemplify the sinuosity and presence of wetlands on the floodplain of natural streams in the area.

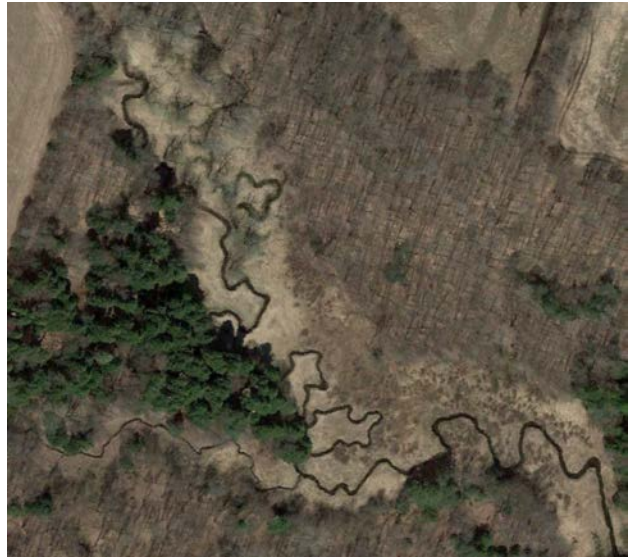
Figure 8-1d. Reference Reach #3 Bell Creek

Imagery: 2017, Location: 43.334094 -76.356244

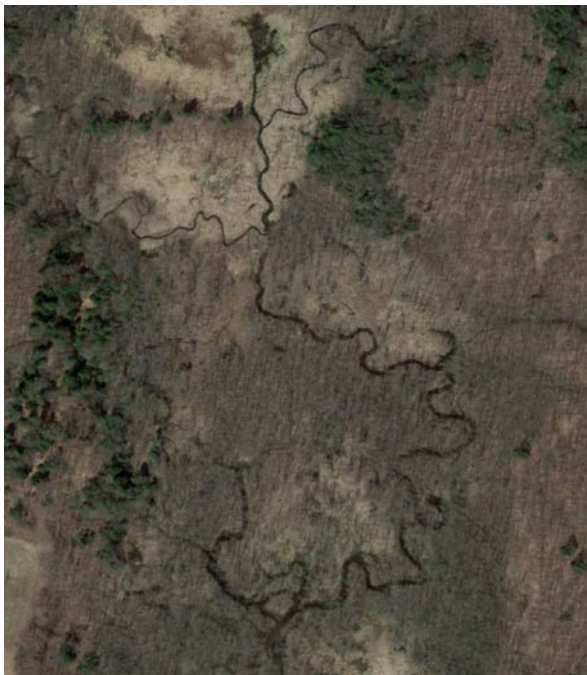
Figure 8-1c. Reference Reach #2 Bell Creek

Imagery: 2017, Location: 43.330381, -76.348298

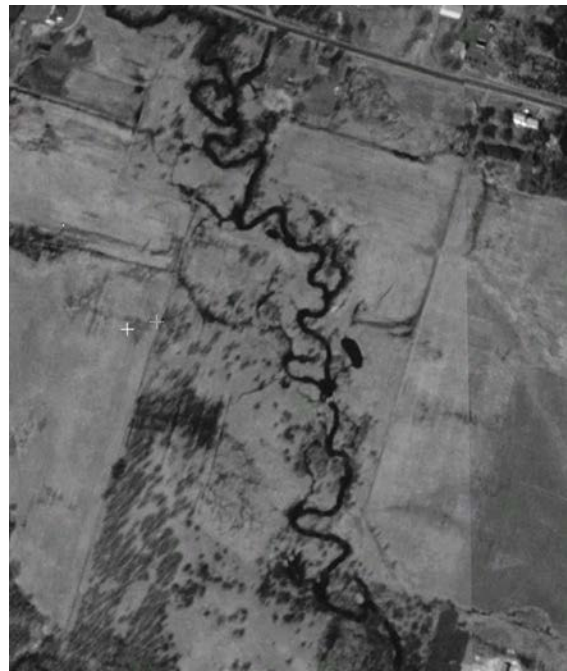
Figure 8-1e. Reference Reach #4 Sixmile Creek

Imagery: 1994, Location: 43.311918, -76.310130

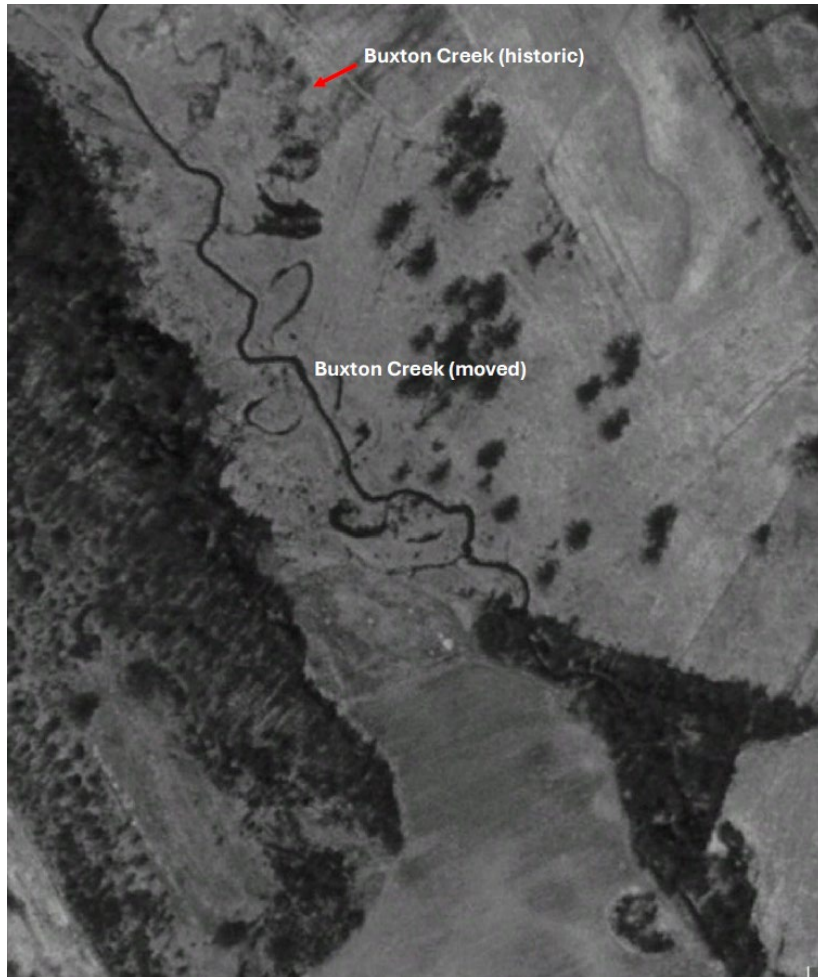
Figure 8-2a. Buxton Creek North of Bell Road

material placed in it. See **Figures 8-2a** and **8-2b** for 1994 aerial imagery where the historic channels are visible.

Stream restoration at the Buxton Creek site involves the main channel and a tributary to the main channel. The existing stream channels are ditches measuring approximately 8 feet wide by three feet deep. The channels have been straightened and designed to carry water around and away from the agriculture fields. The channels are deeper than historic channels, flowing in a thick clay layer. The floodplain of the streams is regularly cleared using heavy machinery. The streams have artificially high banks to contain flows in the stream with sporadic cuts in the bank to allow sheet flow from fields to discharge into the ditch. Former channels can be found adjacent to the excavated channel, and are considerably higher, more shallow and wider in comparison to the ditch. On the north side of Bell Road, Buxton Creek restored reaches 1.2-1.4 are historic natural channels of Buxton Creek where the flows will be returned. The southern reaches of the existing channel south of Bell Road show sinuosity, but this is not a historic channel. This sinuosity is where the stream was left to find its own course after being tilled over, and it cut through the fine

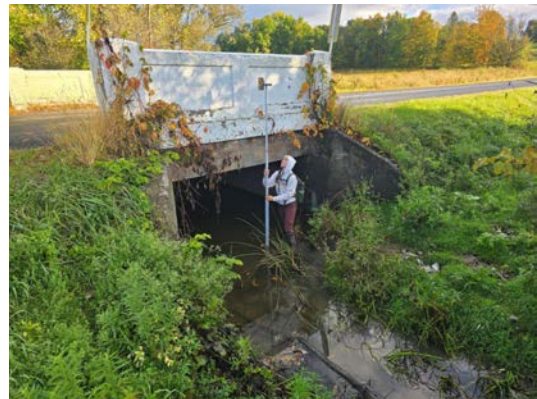
Buxton Creek flows under Bell Road through a small concrete bridge with an opening measuring approximately 4 feet 4 inches high by 10 feet wide (see right). This design has taken every precaution to ensure that the Bell Road bridge over Buxton Creek will continue to perform as well if not better than current conditions. This will be accomplished by ensuring that streambed elevations below the bridge are lower than the streambed flowing under the bridge so water will not back up under the bridge. Similarly, the restored channels to the north of the Bell Road bridge largely use existing historic channels that will slow and calm the flow approaching the bridge. Further, high flows north of the bridge will be able to spread into established wetlands in the adjacent field. And there are no changes proposed for the straight reach approaching the bridge.

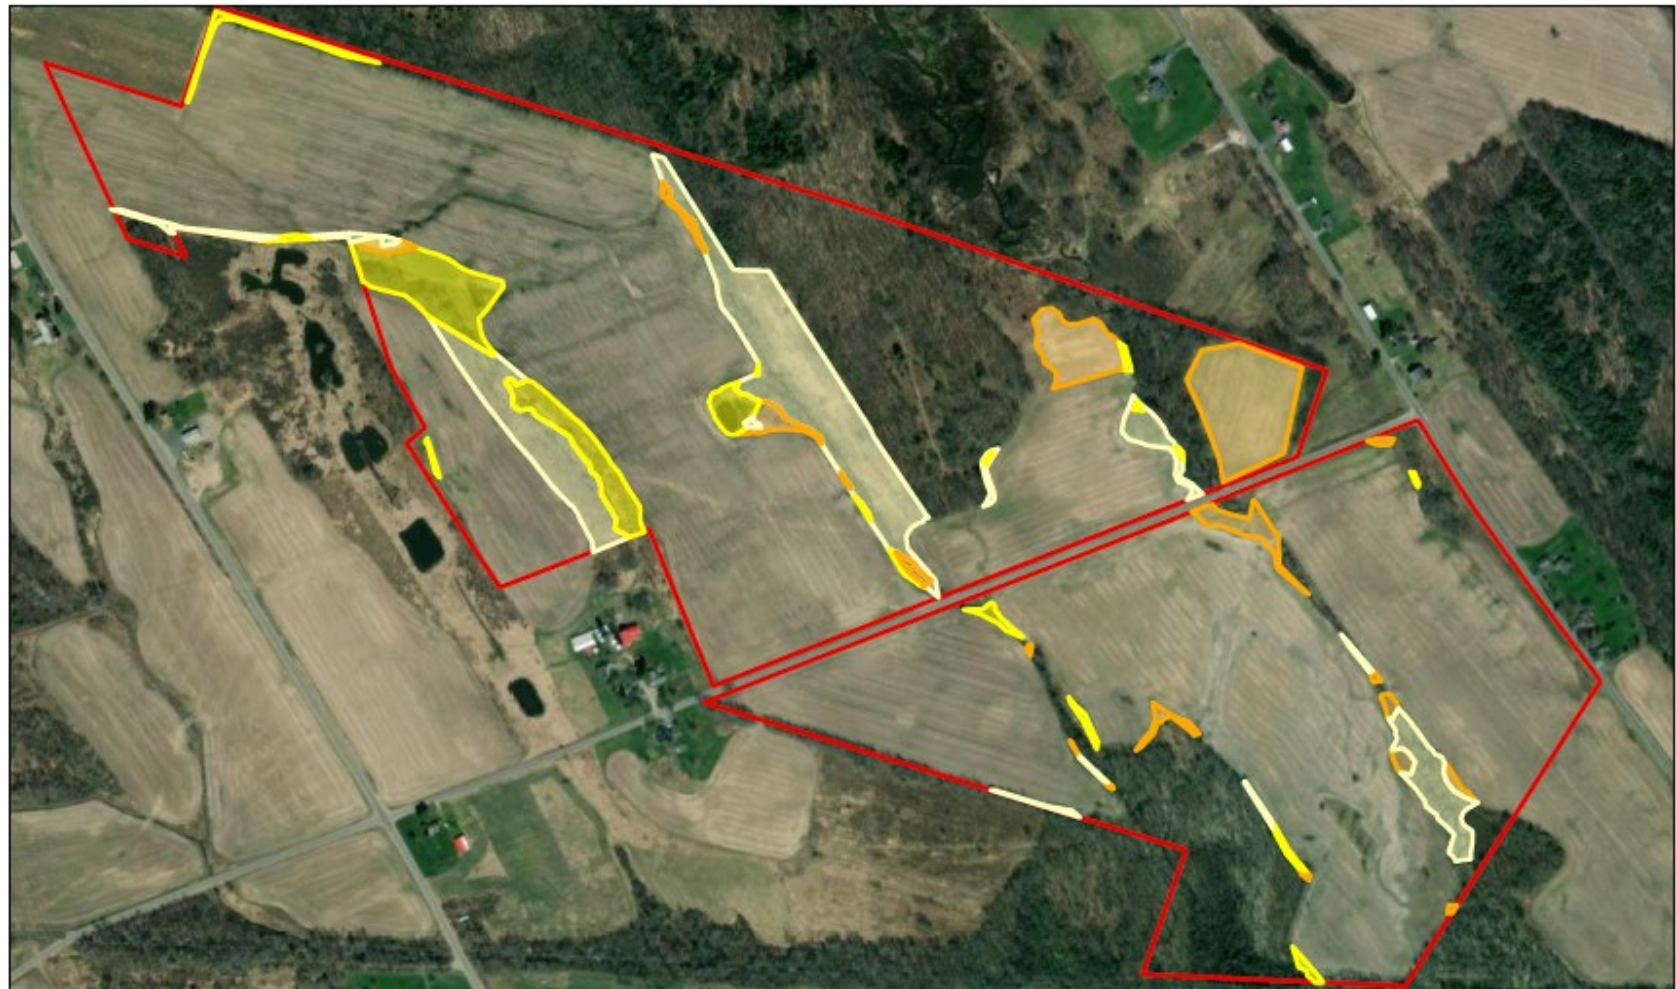
Figure 8-2 Baseline Reed Canary Grass Percent Cover (2024)

Reed Canary (*Phalaris arundinacea*) Percent Cover
Buxton Creek
Town of Schroepfel,
Oswego County, NY

>25% (3.04 acres Covered)

Baseline data collection will identify existing invasive species communities within the mitigation site. This process will involve field surveys using GIS mapping, orthoimagery using drones, and photographic documentation to establish the extent and density of invasive species populations. Baseline surveys will include mapping of invasive species distribution with percentage cover estimates. The data collected will be used to inform the site preparation and treatment strategies outlined in later sections of this ISMP. See **Figures 8-1 through 8-4** in **Section 8** for baseline invasive species maps.

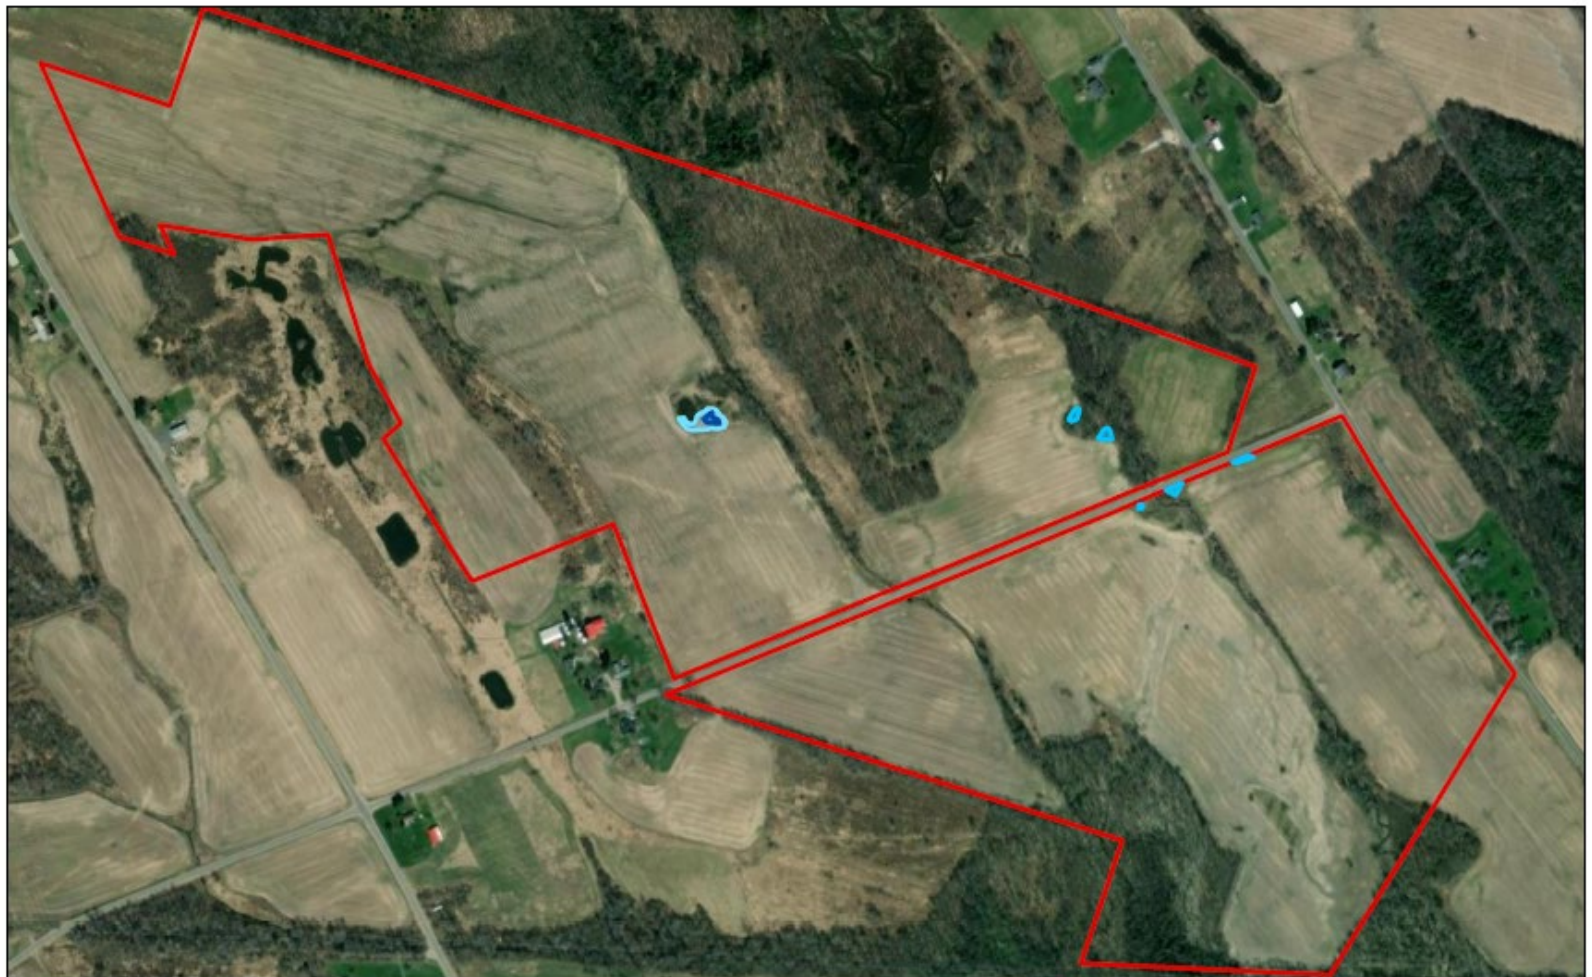
Figure 8-3 Baseline Phragmites Percent Cover (2024)

Reed Grass (*Phragmites australis*) Percent Cover
Buxton Creek
Town of Schroepfel,
Oswego County, NY

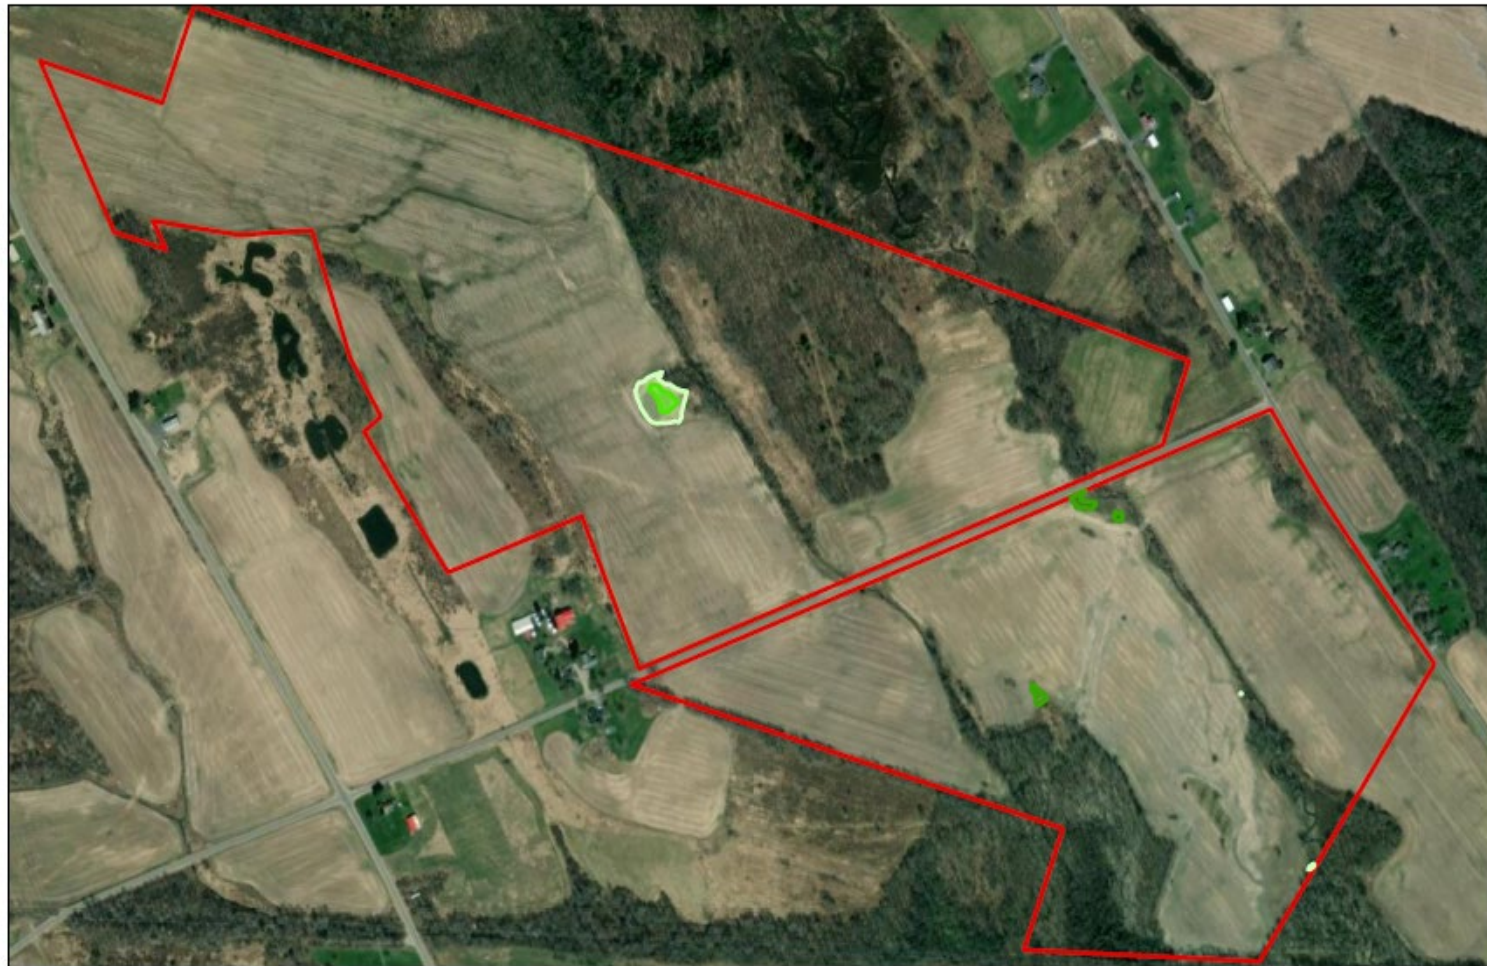
Figure 8-4 Baseline Cattail Percent Cover (2024)

Cattail (*Typha* sp.) Percent Cover

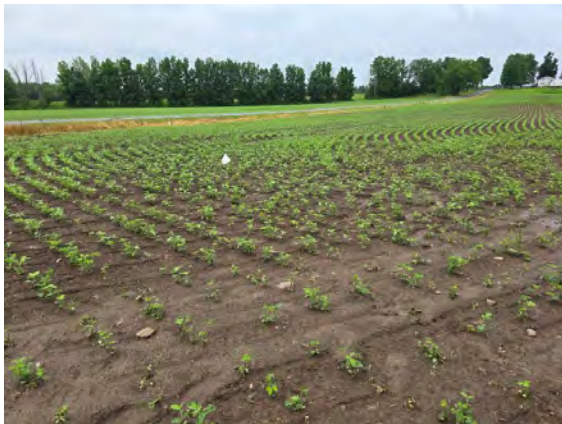
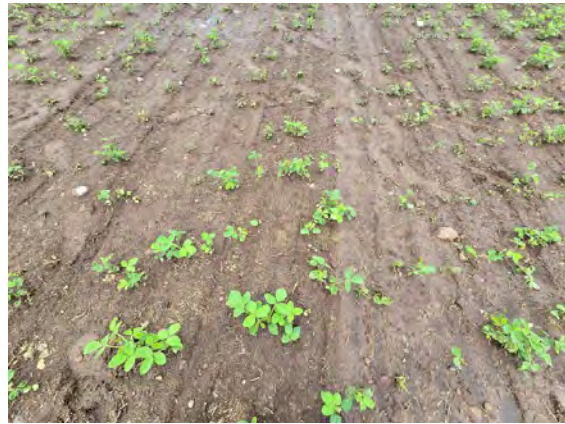
W-1

| Construction notes: Fill the ditch draining the area and restore wetlands on the floodplain of the stream to be restored. Dig a core trench and build a groundwater dam around the lower 2/3 perimeter of the area. Build a sinuous stream with a channel from 20-26-foot wide and banks no higher than 6-inches with restored wetlands on either side. Avoid building a dam because the restored stream must flow into and out from the wetland, and not look like an artificial spillway. Excavate a large and shallow basin that is deepest in the center. Most of the soil will be used to build groundwater dams for the other wetlands being built. Spread excess soil in the buffer along the Bell Road and north of the area. Create pits, mounds, and scrapes. Plant trees and shrubs on the mounds. Use rock to armor the outlet to prevent erosion. | |

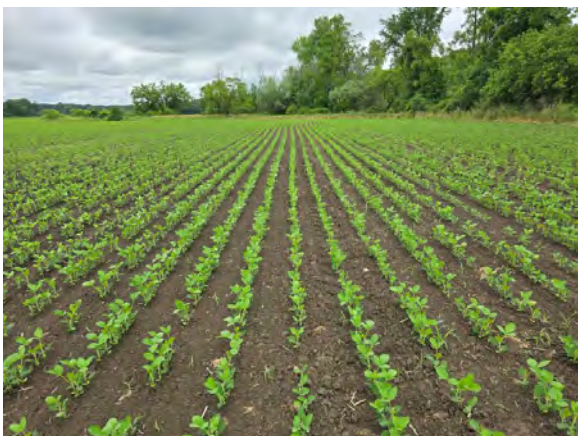
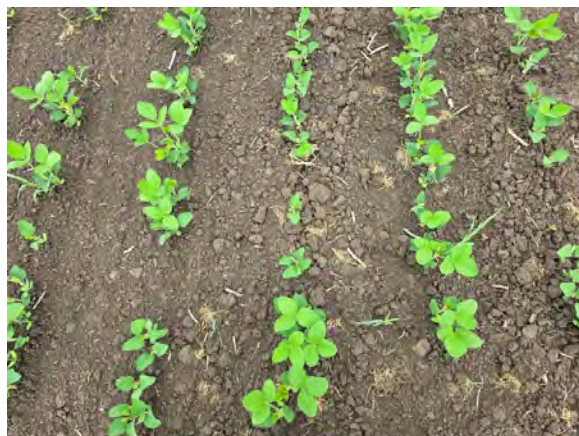
W-2

| Construction notes: Fill the ditch draining the area and restore wetlands on the floodplain of the stream to be restored. Dig a core trench and build a groundwater dam around the lower 2/3 perimeter of the area. Build a sinuous stream with a channel from 20-26-feet wide and banks no higher than 6-inches with restored wetlands on either side. Avoid building a dam because the restored stream must flow into and out from the wetland, and not look like an artificial spillway. Excavate a large and shallow basin that is deepest in the center. Most of the soil will be used to build groundwater dams for the other wetlands being built. Spread excess soil in the buffer along the west of the area. Create pits, mounds, and scrapes. Plant trees and shrubs on the mounds. Use rock to armor the outlet to prevent erosion. | |

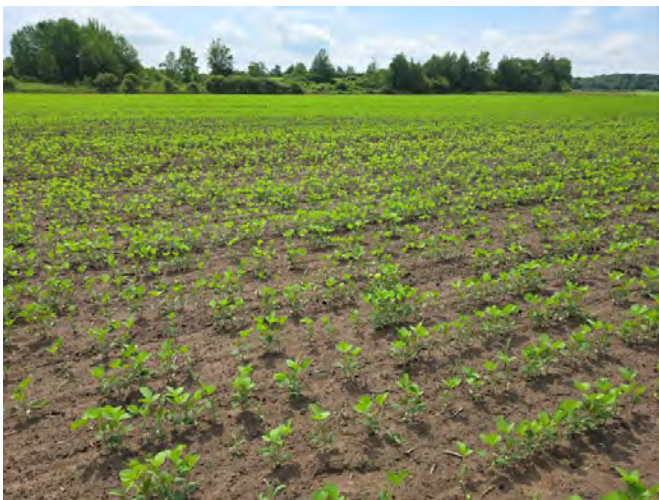
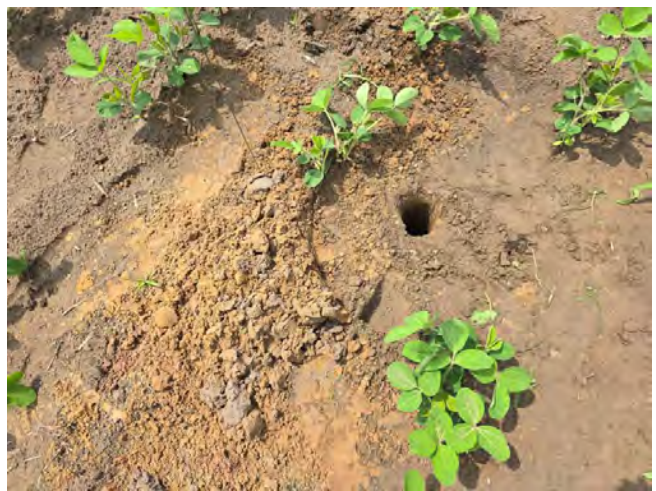
| Construction notes: Dig a core trench and build a groundwater dam around the lower 2/3 perimeter of the area. Excavate a large and shallow basin that is deepest in the center. May need to transport clay from another area to fill the core trench. Spread excess soil in the buffer along the uphill and west edge of the area. Create pits, mounds, and scrapes. Plant trees and shrubs on the mounds. | |

W-3 (showing test hole)

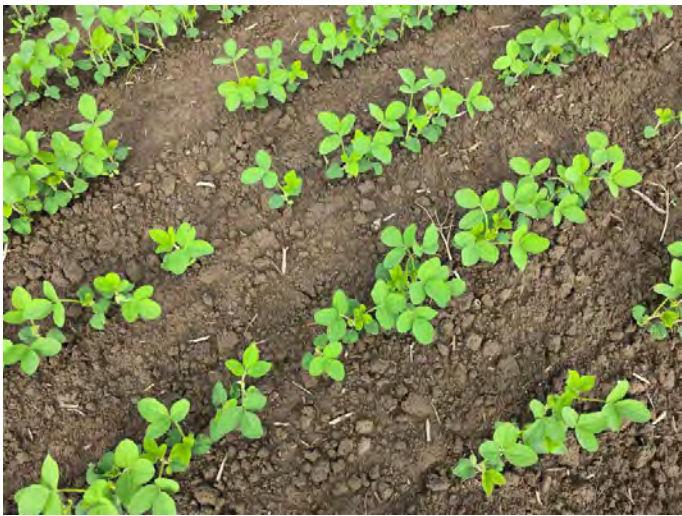
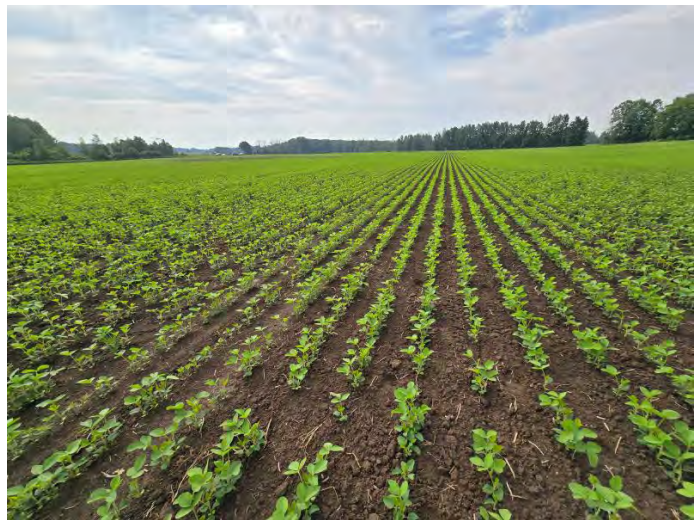
W-4

| Construction notes: Dig a core trench and build a groundwater dam around the lower 2/3 perimeter of the area. Excavate a large and shallow basin that is deepest in the center. Transport clay from another area to fill the core trench. Spread excess soil in the buffer along the west edge of the area. Create pits, mounds, and scrapes. Plant trees and shrubs on the mounds. | |

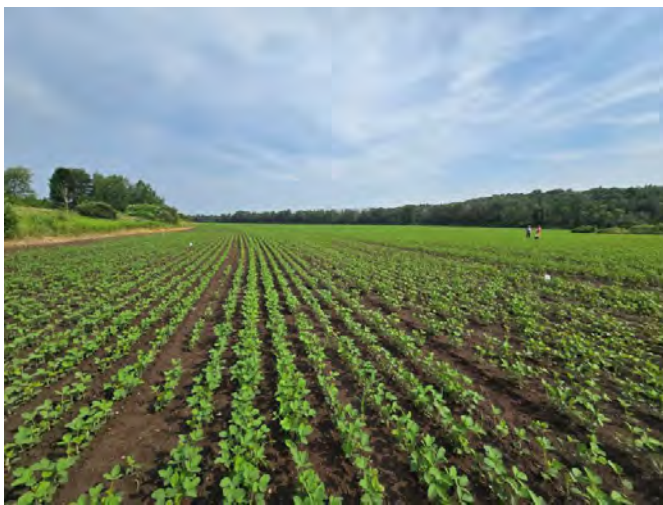
W-5

| Construction notes: Block diversion ditch along the west side of the field. Dig a core trench and build a groundwater dam around the lower 2/3 perimeter of the area. Excavate a large and shallow basin that is deepest in the center. Transport clay from another area to fill the core trench. Spread excess soil in the buffer along the Southwest edge of the area. Create pits, mounds, and scrapes. Loosen compacted soil and plant trees and shrubs on the mounds. | |

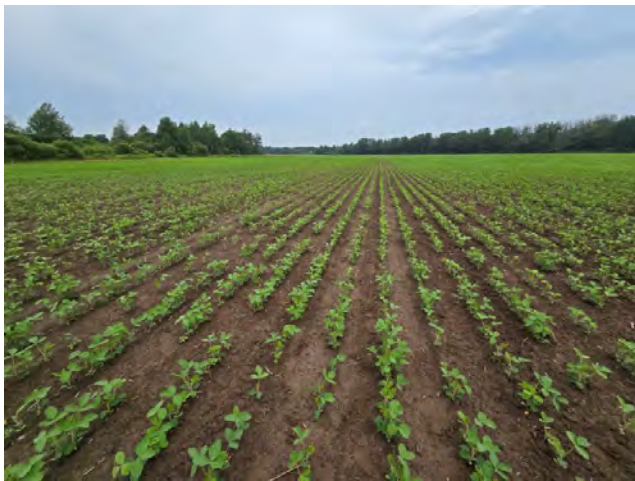
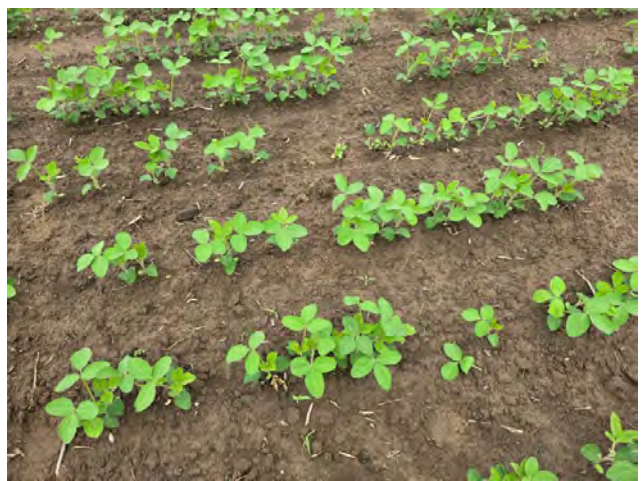
W-6

| Construction notes: Block diversion ditch along the west side of the field. Dig a core trench and build a groundwater dam around the lower 2/3 perimeter of the area. Excavate a large and shallow basin that is deepest in the center. Transport clay from another area to fill the core trench. Spread excess soil west of the area. Create pits, mounds, and scrapes. Loosen compacted soil and plant trees and shrubs on the mounds. | |

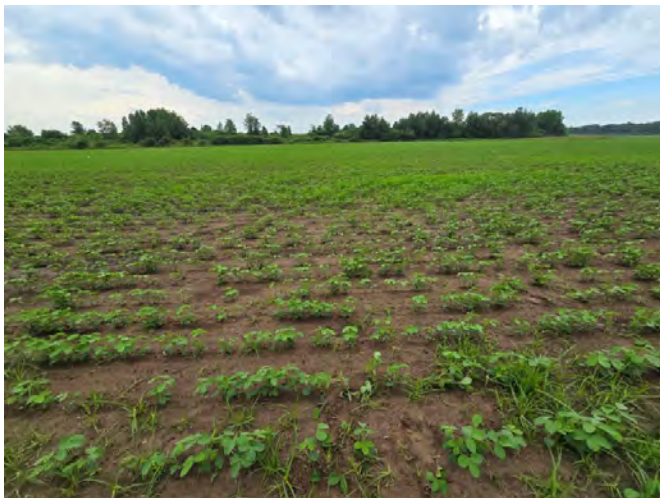
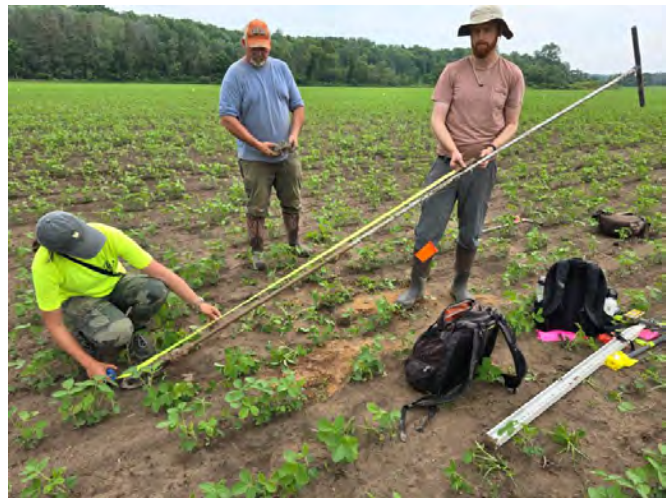
| Construction notes: Block diversion ditch along the west side of the field. Dig a core trench and build a groundwater dam around the lower 2/3 perimeter of the area. Excavate a large and shallow basin that is deepest in the center. Transport clay from another area to fill the core trench. Spread excess soil west of the area. Create pits, mounds, and scrapes. Loosen compacted soil and plant trees and shrubs on the mounds. | |

W-7 (using a 10.5-foot soil auger to dig the test hole)

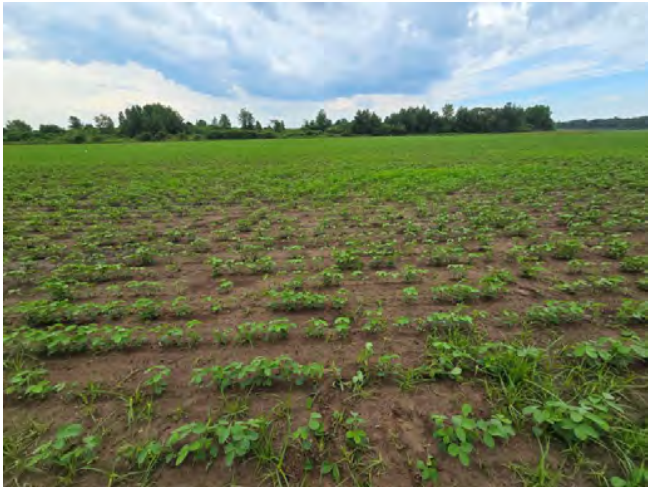
W-8

| Construction notes: Dig a core trench and build a groundwater dam around the lower 2/3 perimeter of the area. Excavate a large and shallow basin that is deepest in the center. Transport clay from another area to fill the core trench. Spread excess soil downhill and south of the area. Create pits, mounds, and scrapes. Loosen compacted soil and plant trees and shrubs on the mounds. | |

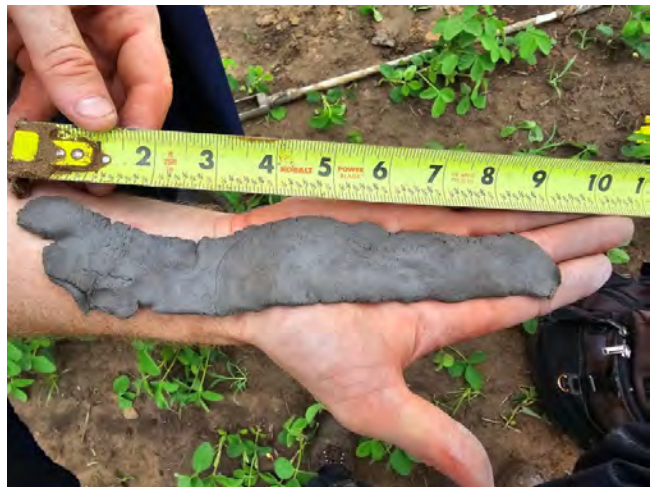
W-8 (showing clay that is present 35-inches below the surface)

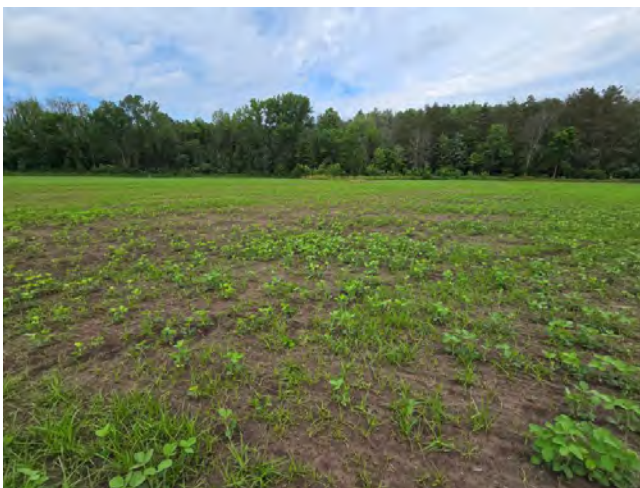
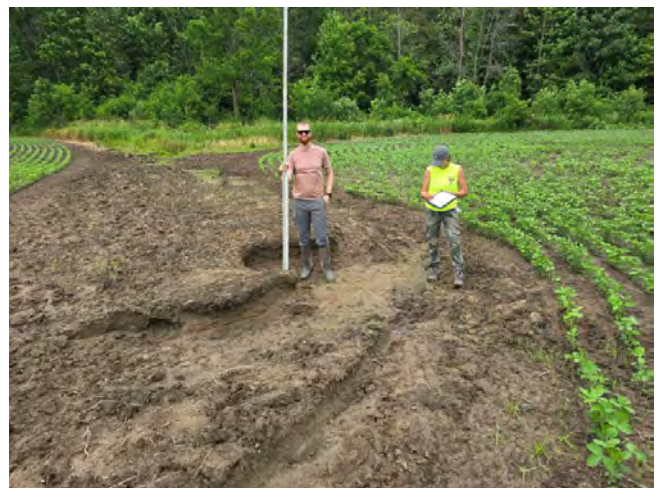
| Construction notes: Dig a core trench and build a groundwater dam around the lower 2/3 perimeter of the area. Excavate a large and shallow basin that is deepest in the center. Transport clay from another area to fill the core trench if needed. Spread excess soil to the south of the area. Create pits, mounds, and scrapes. Loosen compacted soil and plant trees and shrubs on the mounds. Build a naturally appearing stream and floodplain in the area. Fill a section of the ditch along the east side of the field. | |

W-9 (Showing one of the head-cuts that would be controlled)

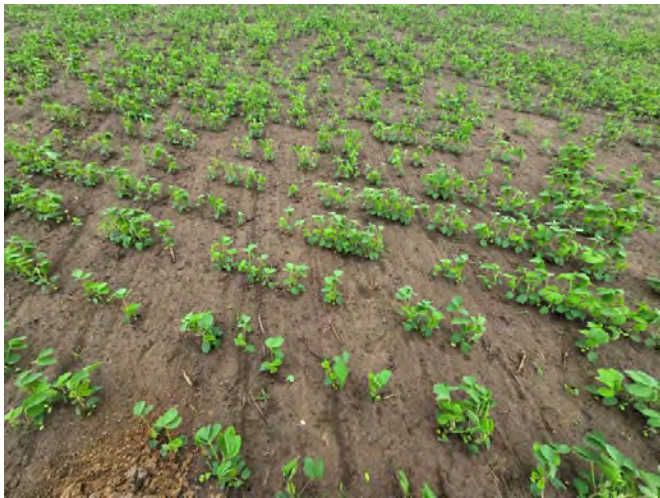
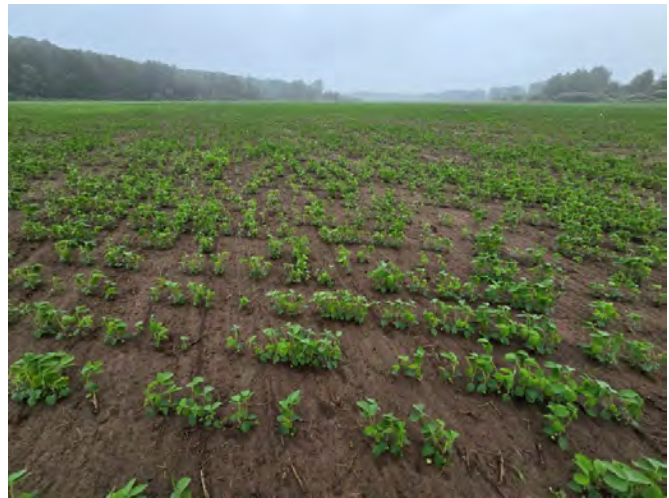
W-10

| Construction notes: Dig a core trench and build a groundwater dam around the lower 2/3 perimeter of the area. Excavate a large and shallow basin that is deepest in the center. Transport clay from another area to fill the core trench, replacing the sandy loam that is removed with clay. Spread excess soil southwest of the area. Create pits, mounds, and scrapes. Loosen compacted soil and plant trees and shrubs on the mounds. | |

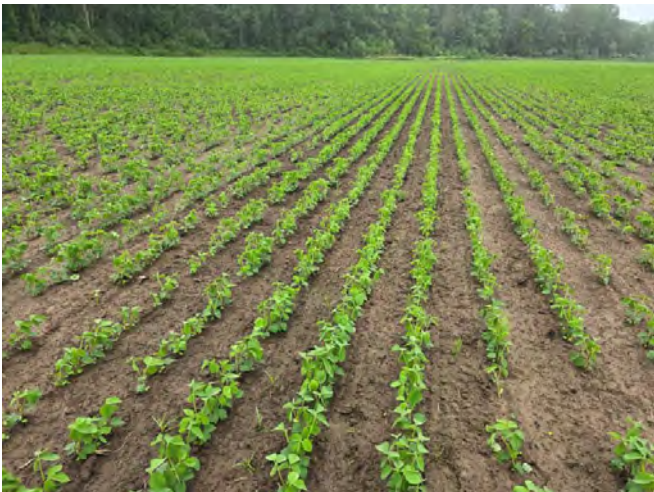
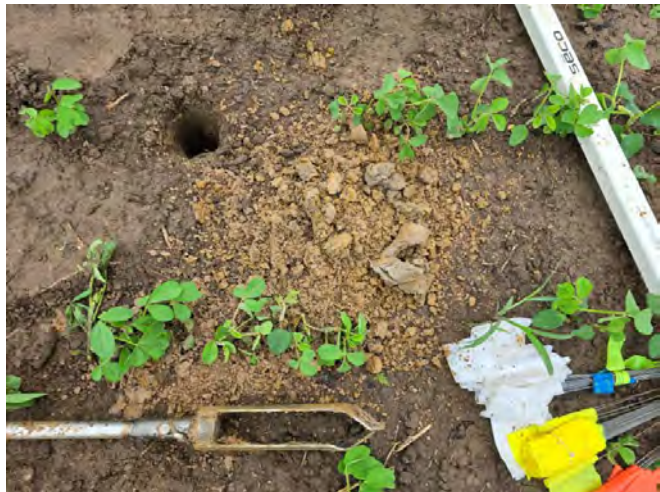
| Construction notes: Dig a core trench and build a groundwater dam around the lower 2/3 perimeter of the area. Excavate a large and shallow basin that is deepest in the center. Transport clay from another area to fill the core trench, replacing the sandy loam that is removed with clay. Spread excess soil north into the buffer. Create pits, mounds, and scrapes. Loosen compacted soil and plant trees and shrubs on the mounds. | |

W-11 (Showing soil test hole)

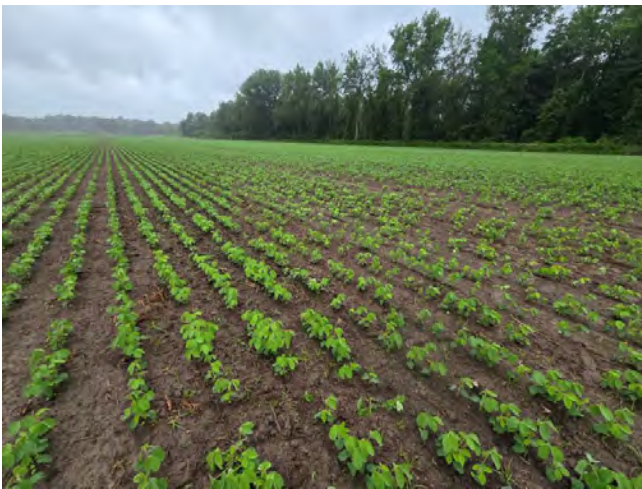
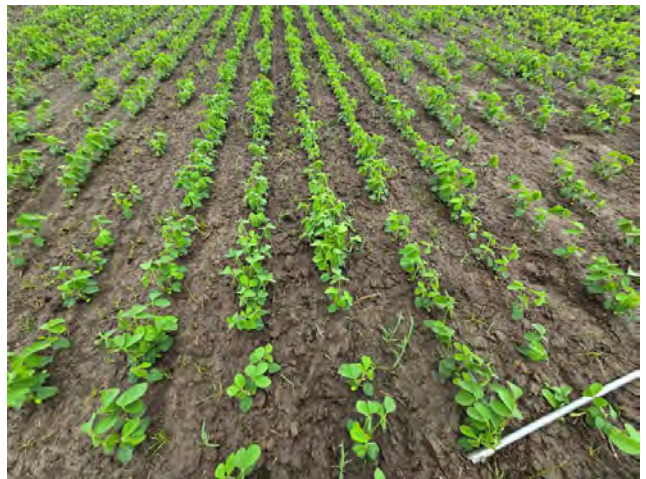
W-12

| Construction notes: Dig a core trench and build a groundwater dam around the lower 2/3 perimeter of the area. Excavate a large and shallow basin that is deepest in the center. Transport clay from another area to fill the core trench, replacing the sandy loam that is removed with clay. Spread excess soil north into the buffer. Create pits, mounds, and scrapes. Loosen compacted soil and plant trees and shrubs on the mounds. | |

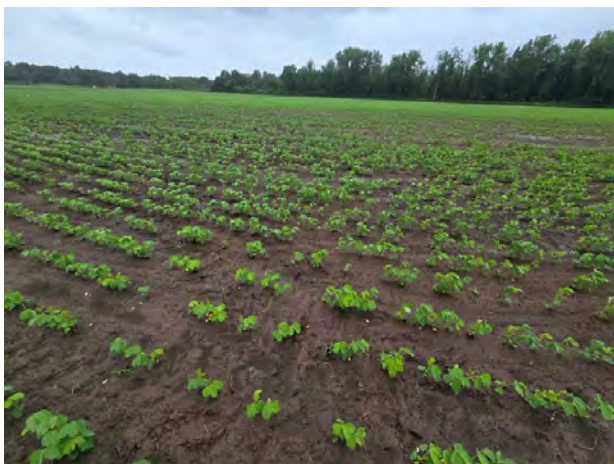
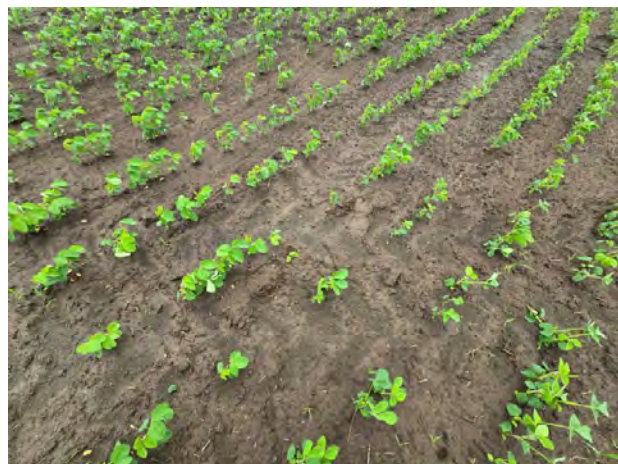
W-13

| Construction notes: Dig a core trench and build a groundwater dam around the lower 2/3 perimeter of the area. Excavate a large and shallow basin that is deepest in the center. Transport clay from another area to fill the core trench, replacing the sandy loam with clay. Spread excess soil south uphill into the buffer. Armor with rock the inlet and outlet. Create pits, mounds, and scrapes. Loosen compacted soil and plant trees and shrubs on the mounds. | |

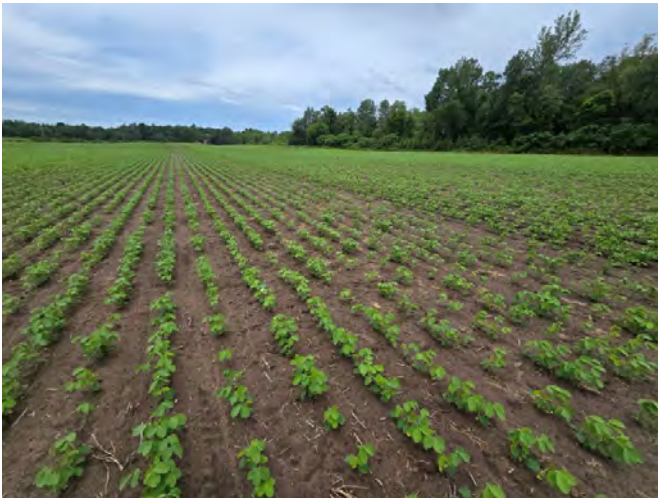
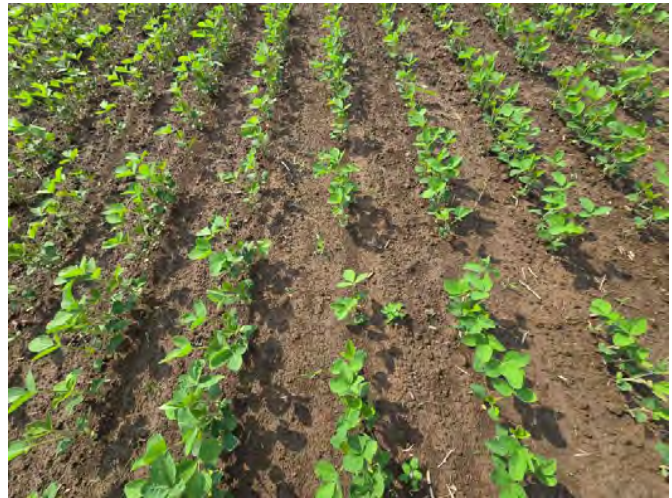
W-15

| Construction notes: Dig a core trench and build a groundwater dam around the lower 2/3 perimeter of the area. Excavate a large and shallow basin that is deepest in the center. Transport clay from another area to fill the core trench, replacing the sandy loam with clay. Spread excess soil north into the buffer. Create pits, mounds, and scrapes. Loosen compacted soil and plant trees and shrubs on the mounds. | |

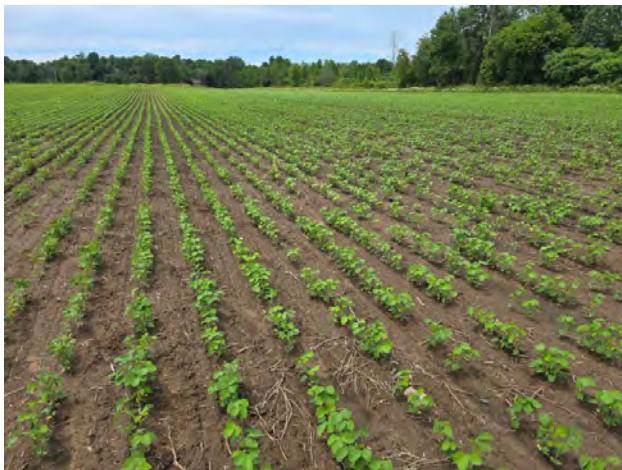
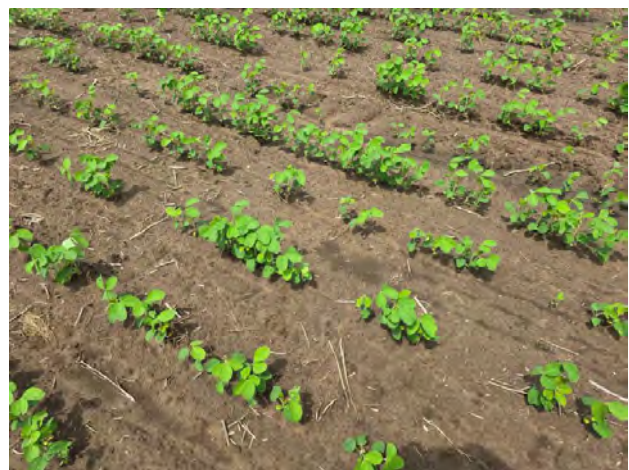
W-16

| Construction notes: Dig a core trench and build a groundwater dam around the lower 2/3 perimeter of the area. Excavate a large and shallow basin that is deepest in the center. Transport clay from another area to fill the core trench, replacing the sandy loam with clay. Spread excess soil south. Create pits, mounds, and scrapes. Loosen compacted soil and plant trees and shrubs on the mounds. | |

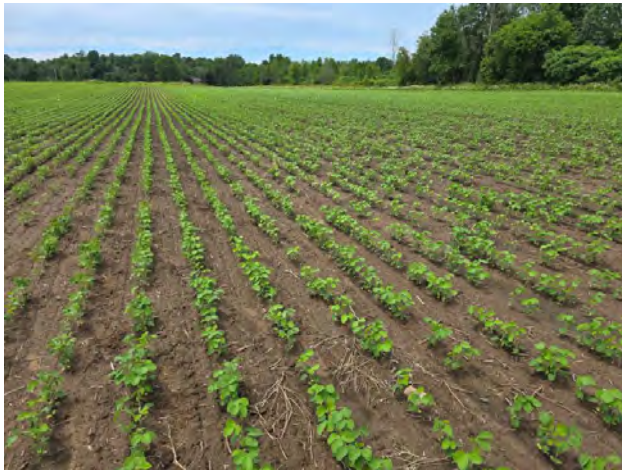
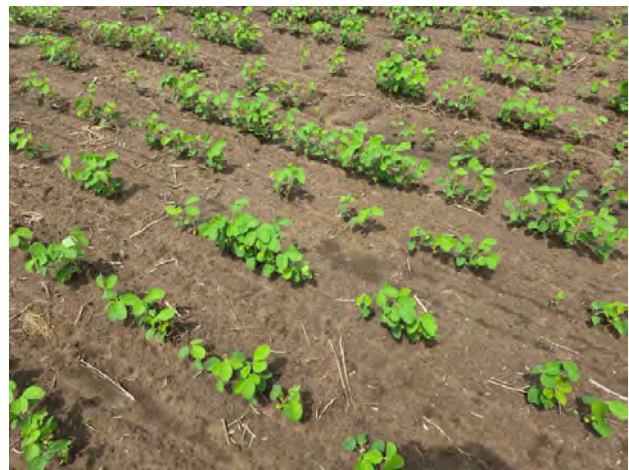
W-17

| Construction notes: Dig a core trench and build a groundwater dam around the lower 2/3 perimeter of the area. Excavate a large and shallow basin that is deepest in the center. Save and use all silt loam to place in the core trench. Transport clay from another area to fill the core trench, replacing the sandy loam with clay. Spread excess soil south or west. Create pits, mounds, and scrapes. Loosen compacted soil and plant trees and shrubs on the mounds. | |

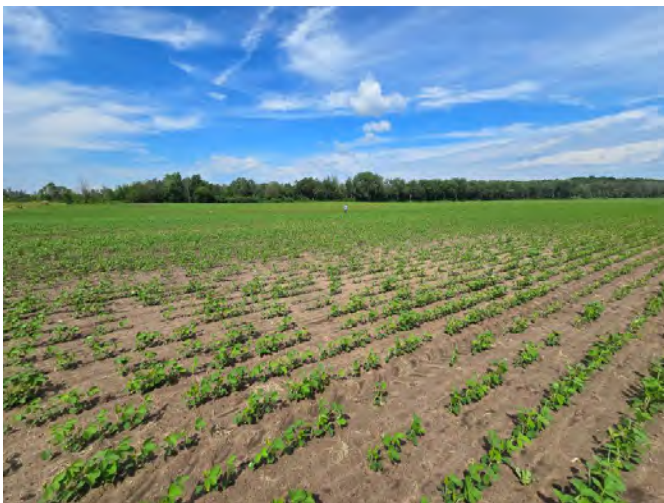
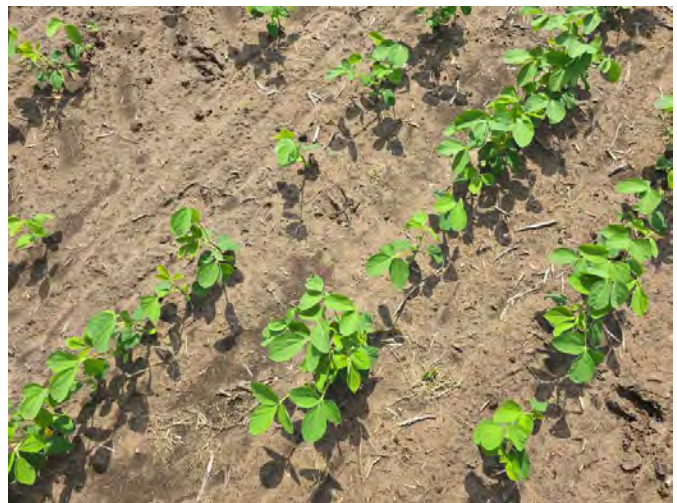
W-18

| <i>This wetland may be a primary source of silt loam and clay for building the groundwater dams for wetlands sites that have a thick layer of sand on the surface. Dig all the silt loam and clay soil possible from this area, including within the buffer, and replace with sand if needed.</i> | |
| Construction notes: Dig a core trench and build a groundwater dam around the lower 2/3 perimeter of the area. Excavate a large and shallow basin that is deepest in the center. Transport clay from another area to fill the core trench, replacing the sandy loam with clay. Spread excess soil north or west. Create pits, mounds, and scrapes. Loosen compacted soil and plant trees and shrubs on the mounds. | |

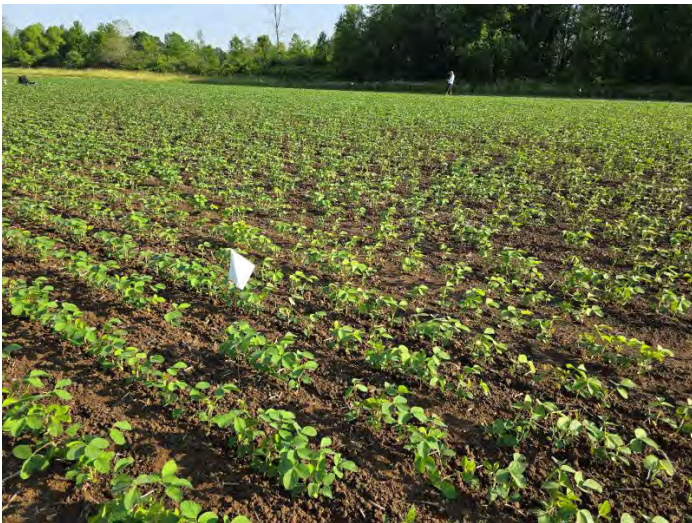
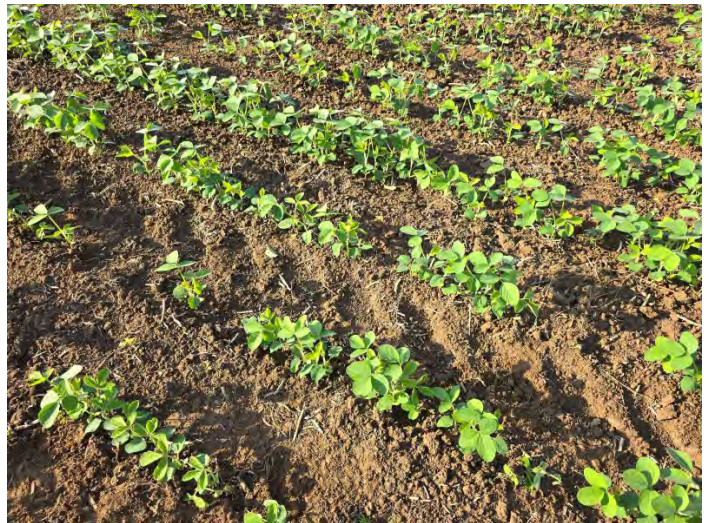
W-19

| Construction notes: Dig a core trench and build a groundwater dam around the lower 2/3 perimeter of the area. Excavate a large and shallow basin that is deepest in the center. Transport clay from another area to fill the core trench, replacing the sandy loam with clay. Spread excess soil north. Create pits, mounds, and scrapes. Loosen compacted soil and plant trees and shrubs on the mounds. | |
