Micron Central New York Semiconductor Manufacturing Complex

Buxton Creek Stream and Wetland Mitigation Plan

Oswego County, NY

The Wetland Trust, Inc.

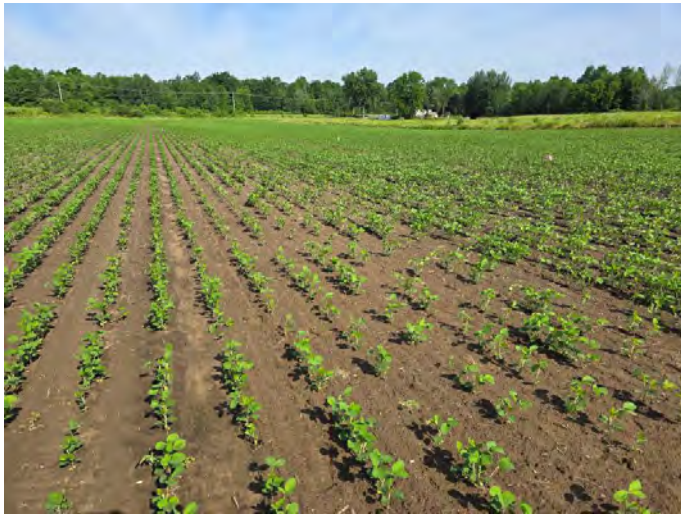
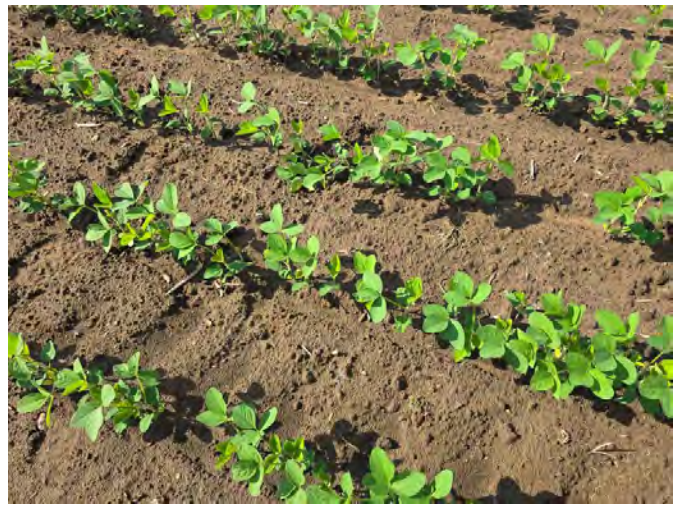
W-20

| Construction notes: Dig a core trench and build a groundwater dam around the lower 2/3 perimeter of the area. Excavate a large and shallow basin that is deepest in the center. Transport clay from another area to fill the core trench, replacing the sandy loam with clay. Spread excess soil north or west. Create pits, mounds, and scrapes. Loosen compacted soil and plant trees and shrubs on the mounds. | |

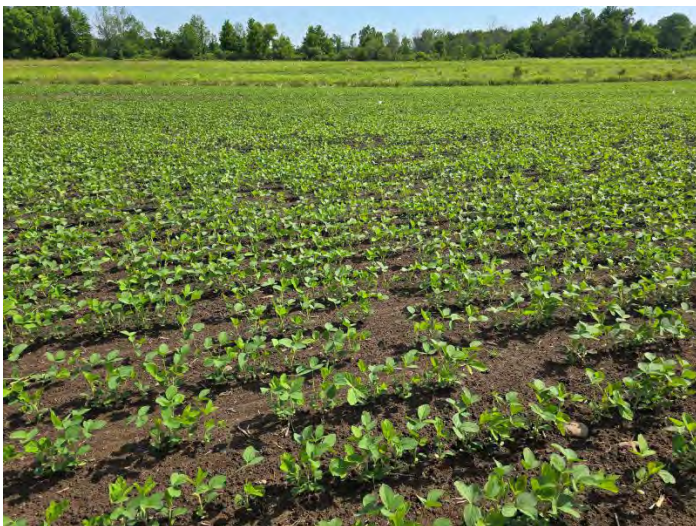
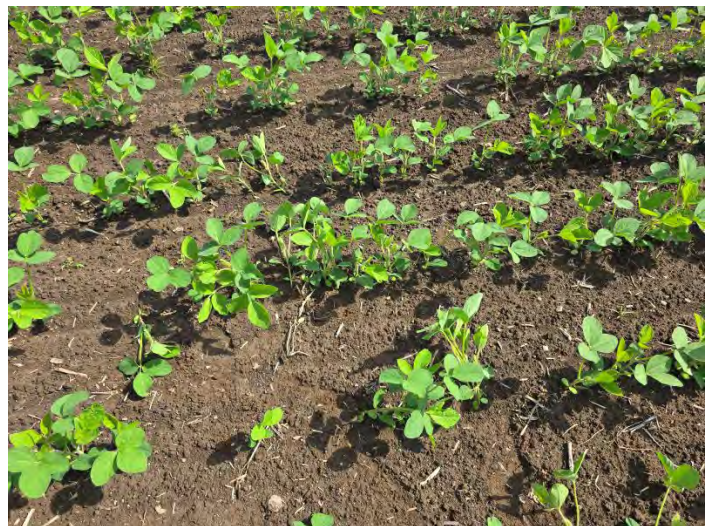
W-21

| Construction notes: Build a groundwater dam along the lower perimeter of the wetland being built. Build an above ground dam that is no higher than 12-inches. Spread soil downhill to the south. Add pits, scrapes, and mounds and then plant with native trees and shrubs. | |

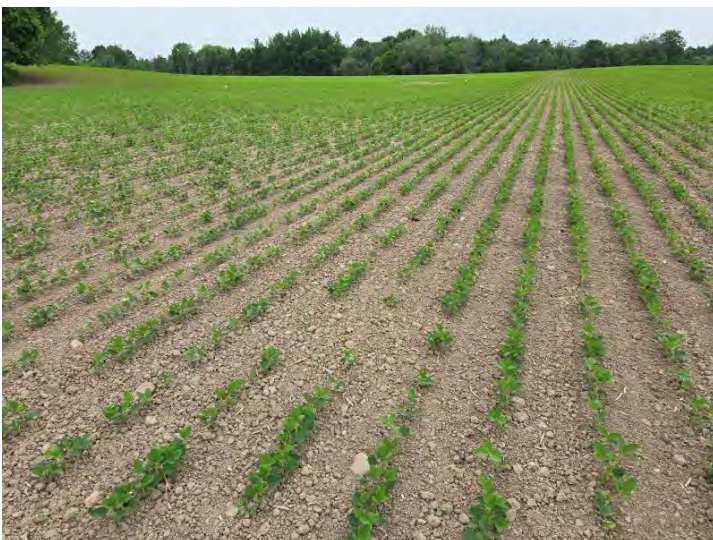
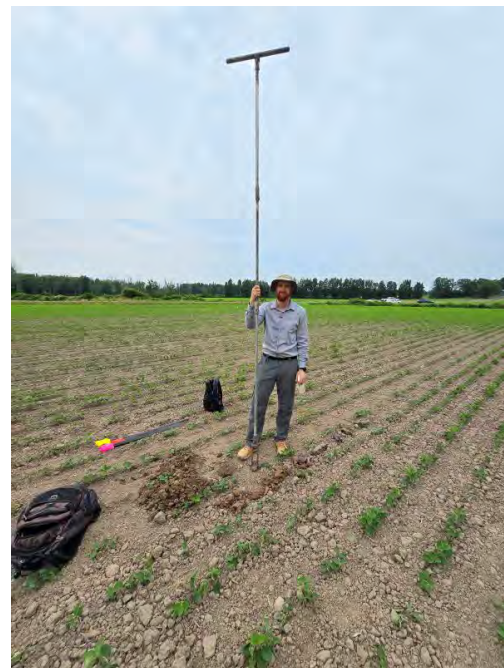
Reed 1 (digging a deep test hole using a 10.5-foot-long soil auger)

| Construction notes: Build a groundwater dam along the lower perimeter of the wetland being built. Build an above ground dam that is no higher than 12-inches. Spread soil downhill. Add pits, scrapes, and mounds and then plant with native trees and shrubs. | |

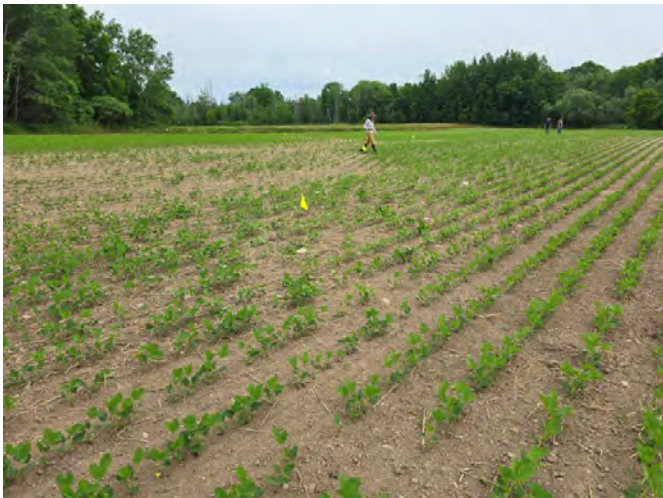
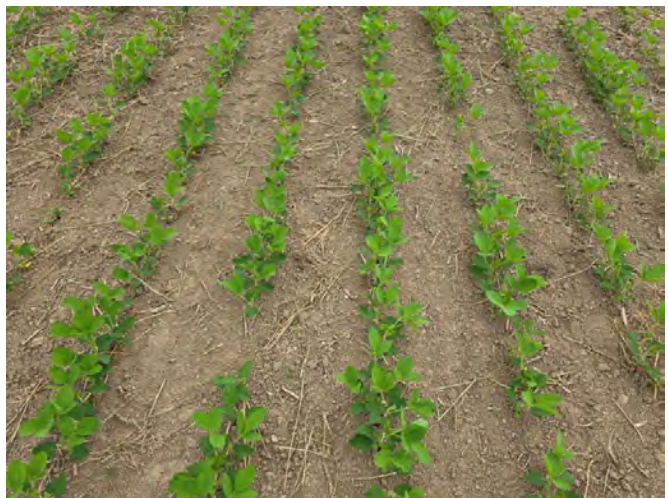
Reed 2

| Construction notes: Build a groundwater dam along the lower perimeter of the wetland being built. Build an above ground dam that is no higher than 12-inches. Spread soil downhill. Add pits, scrapes, and mounds and then plant with native trees and shrubs. | |

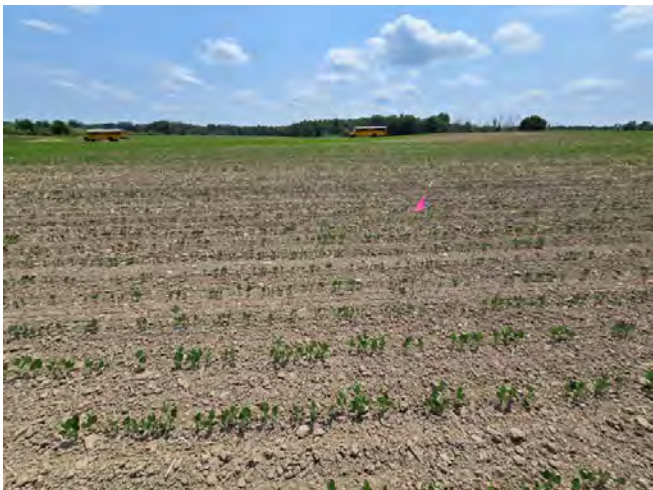
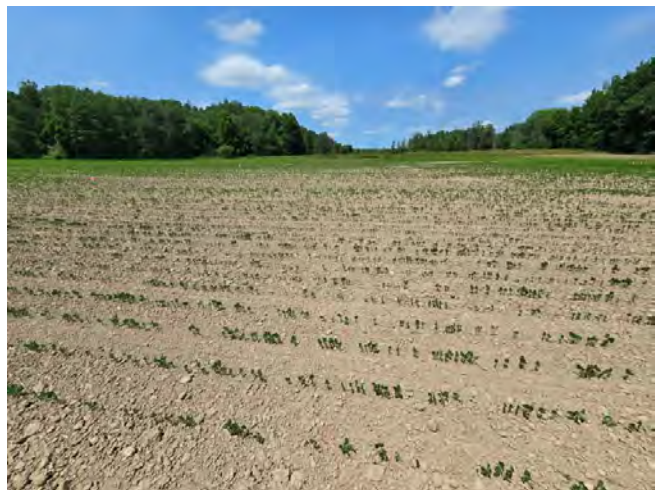
Reed 3

| Construction notes: Build a groundwater dam along the lower perimeter of the wetland being built. Build an above ground dam that is no higher than 12-inches. Spread soil downhill and into buffer along the Bell Road. Add pits, scrapes, and mounds and then plant with native trees and shrubs. Place sandy loam soil for turtle nesting habitat. | |

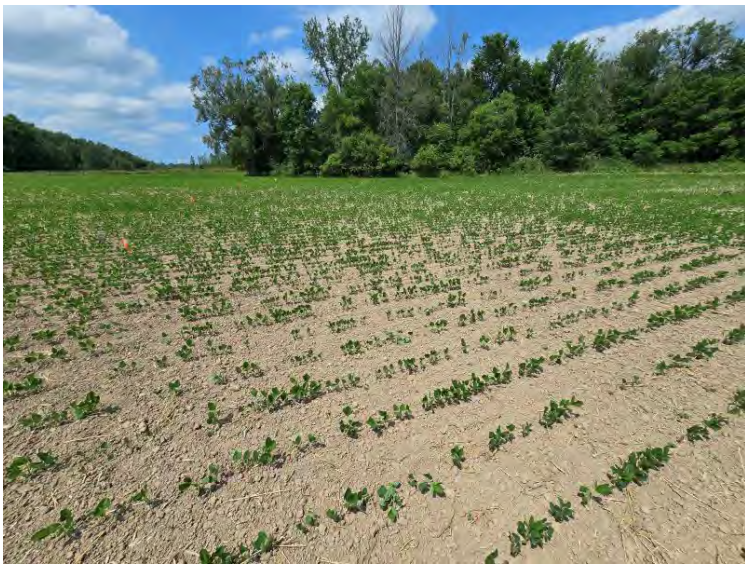
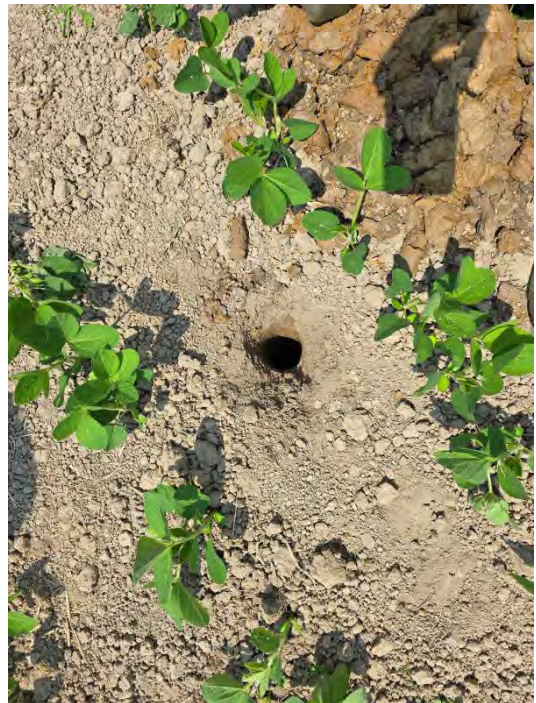
Reed 4 (showing soil test hole)

| Construction notes: Build a groundwater dam along the lower perimeter of the wetland being built. Build an above ground dam that is no higher than 16-inches. Spread soil downhill. Add pits, scrapes, and mounds and then plant with native trees and shrubs. | |

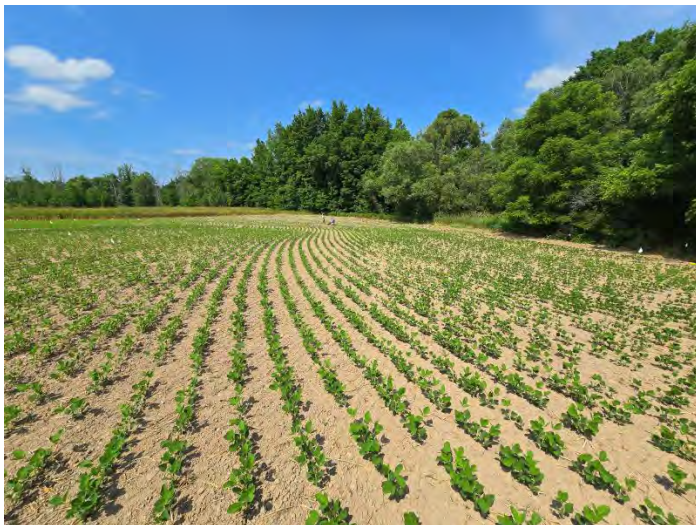
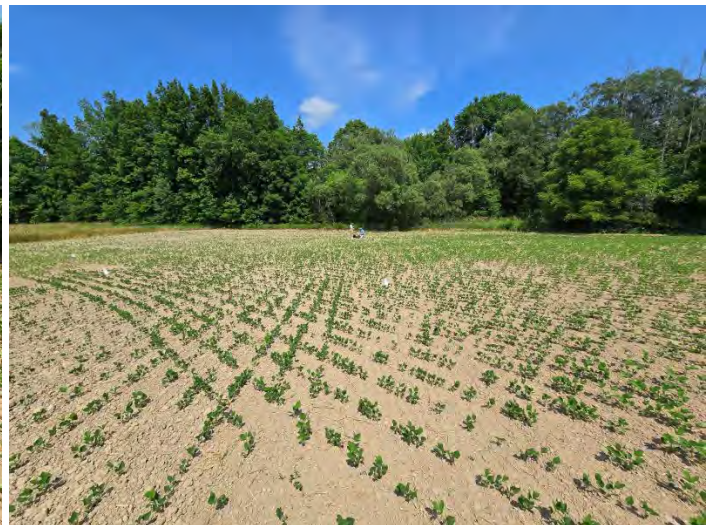
Reed 5

| Construction notes: Build a groundwater dam along the lower perimeter of the wetland being built. Build an above ground dam that is no higher than 12-inches. Spread soil downhill. Add pits, scrapes, and mounds and then plant with native trees and shrubs. | |

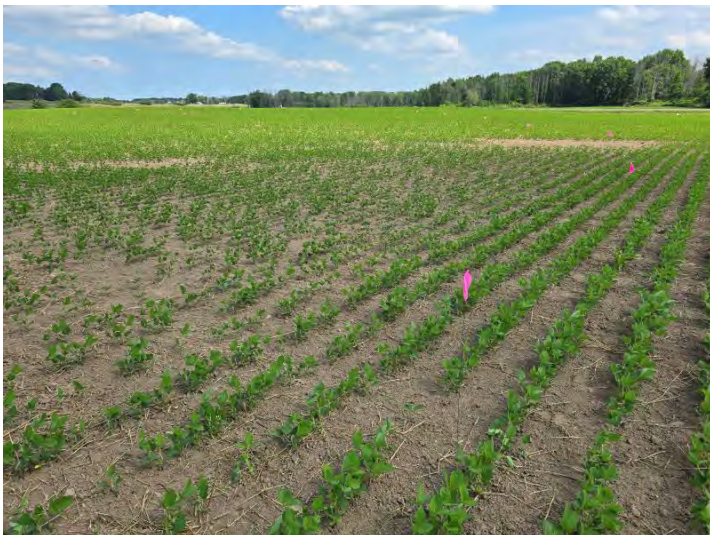
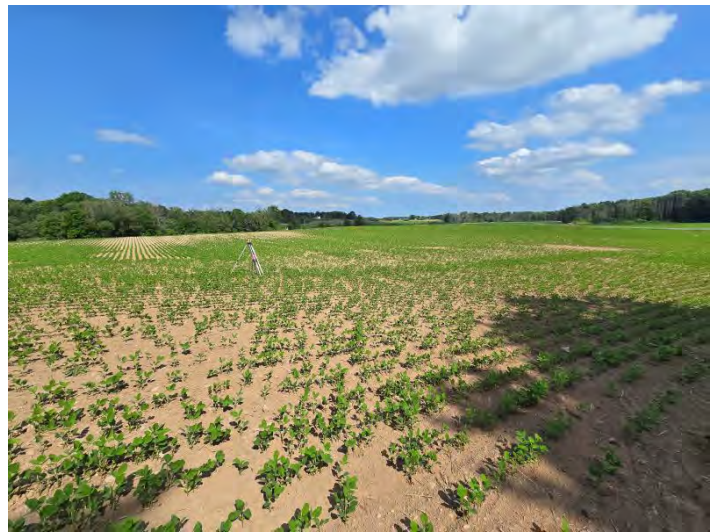
Reed 6

| Construction notes: Build a groundwater dam along the lower perimeter of the wetland being built. Build an above ground dam that is no higher than 12-inches. Spread soil downhill. Add pits, scrapes, and mounds and then plant with native trees and shrubs. | |
