Micron Central New York Semiconductor Manufacturing Complex

Oneida River Wetland Mitigation Plan

Oswego County, NY

May 2025

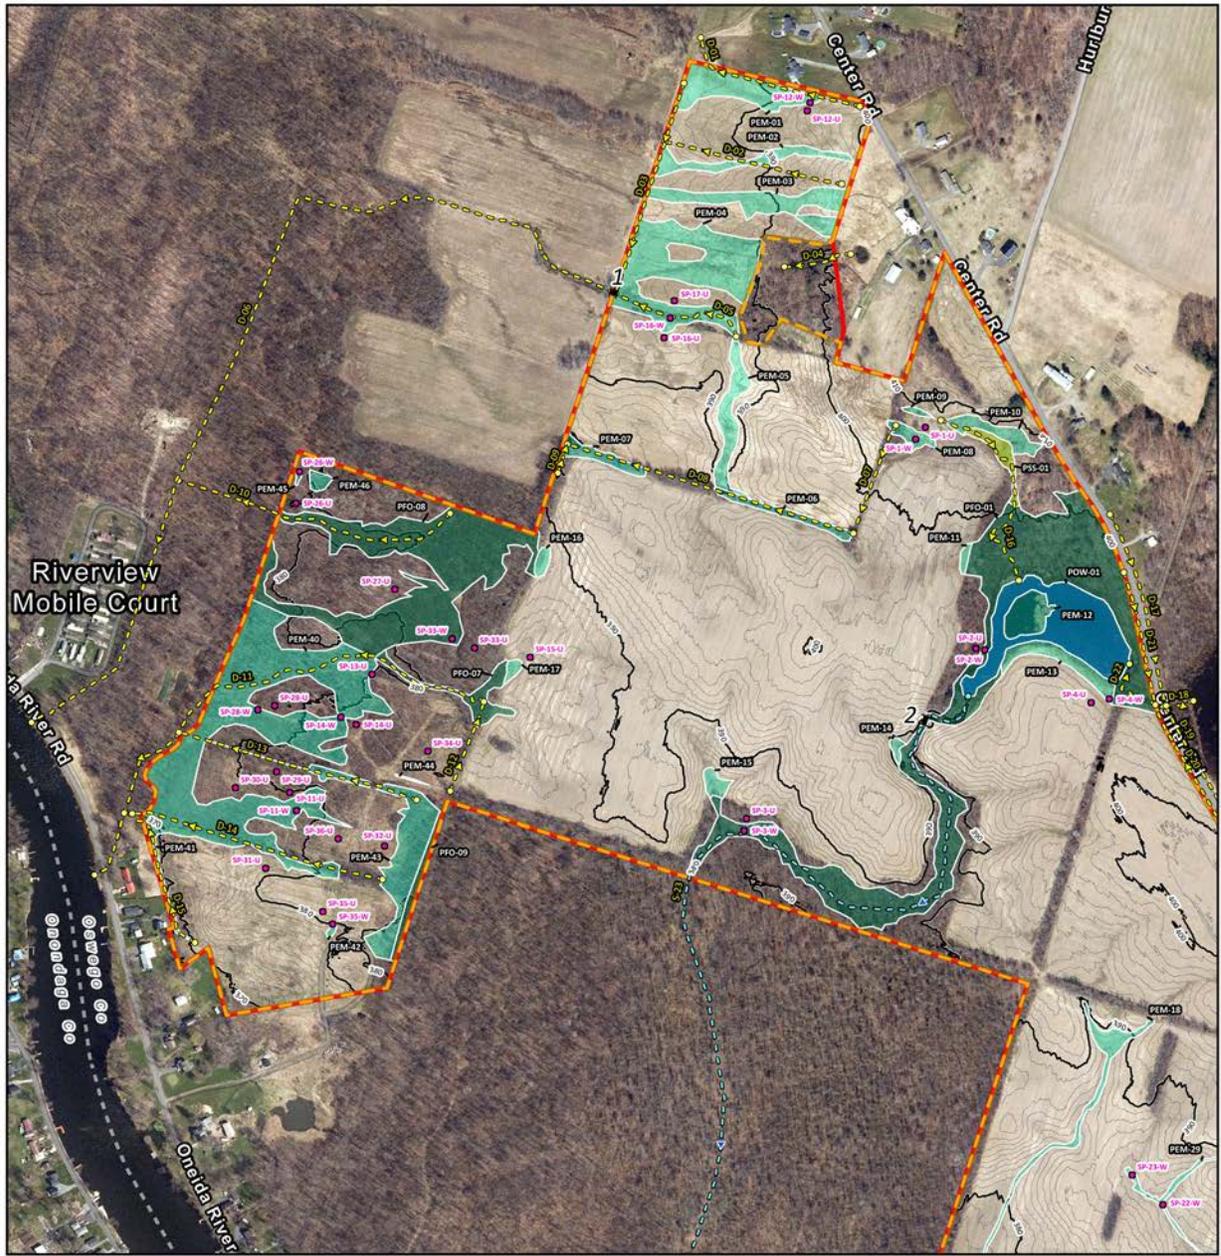
Figure 3-3. Delineated Wetlands and Drainage Features- Northwest

Delineated Wetlands and Drainage Features
 Oneida River - Northwest
 Town of Schroepfel,
 Oswego County, NY

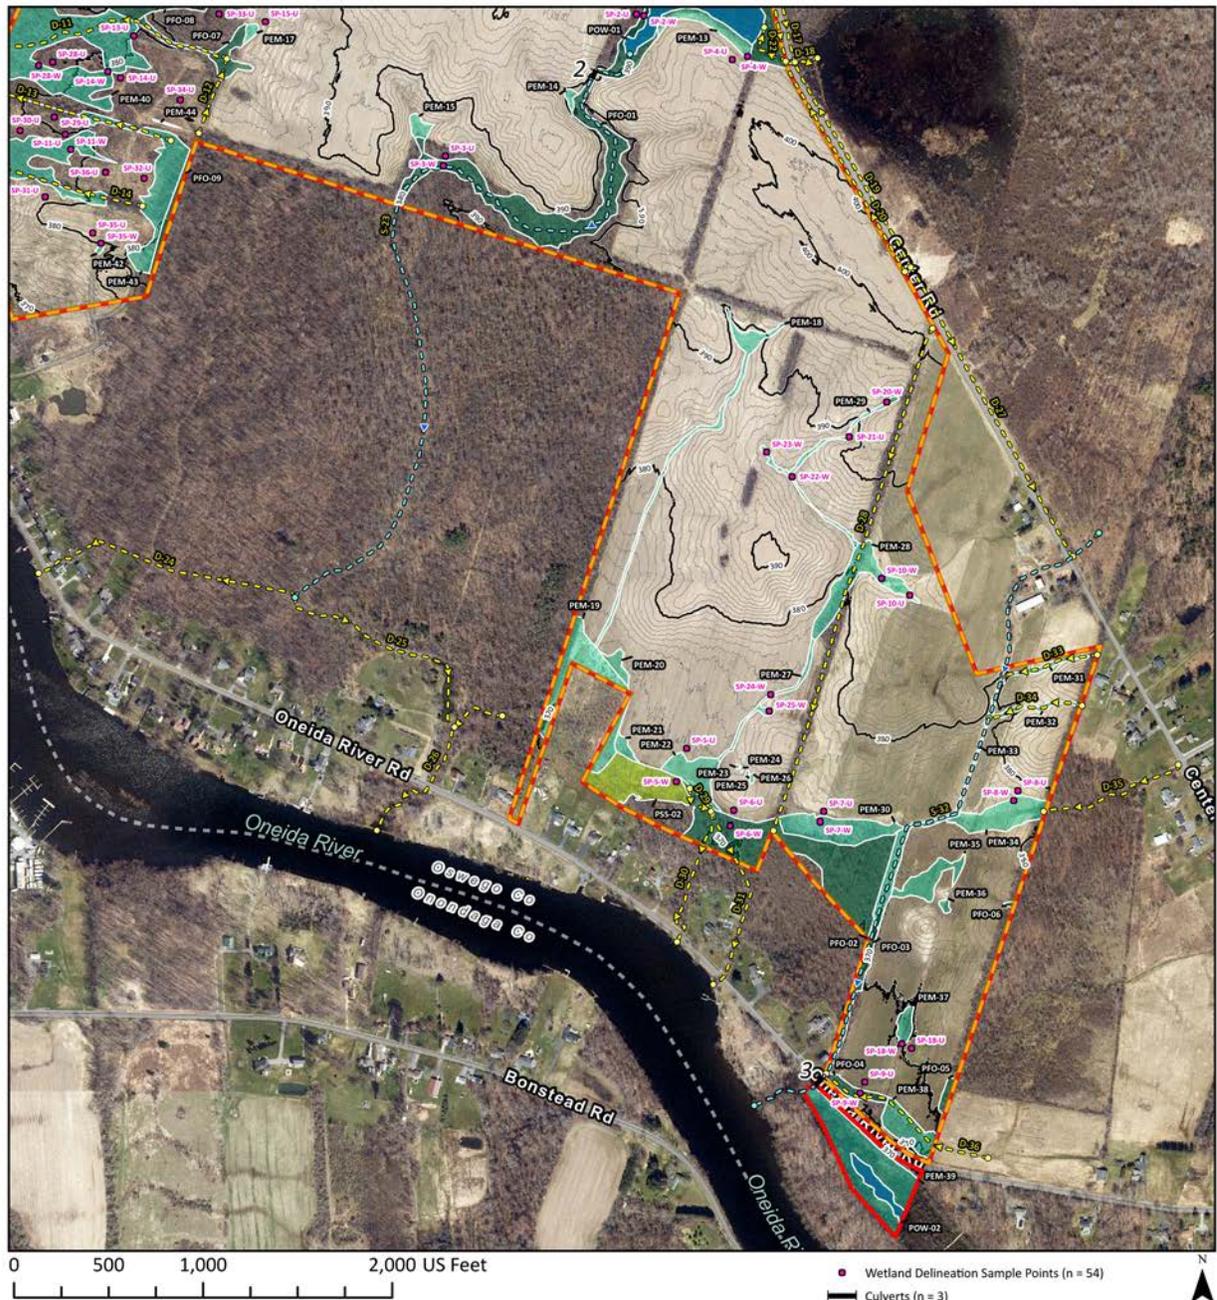
Figure 3-4. Delineated Wetlands and Drainage Features- Southeast

Delineated Wetlands and Drainage Features

Oneida River - Southeast
 Town of Schroepel,
 Oswego County, NY

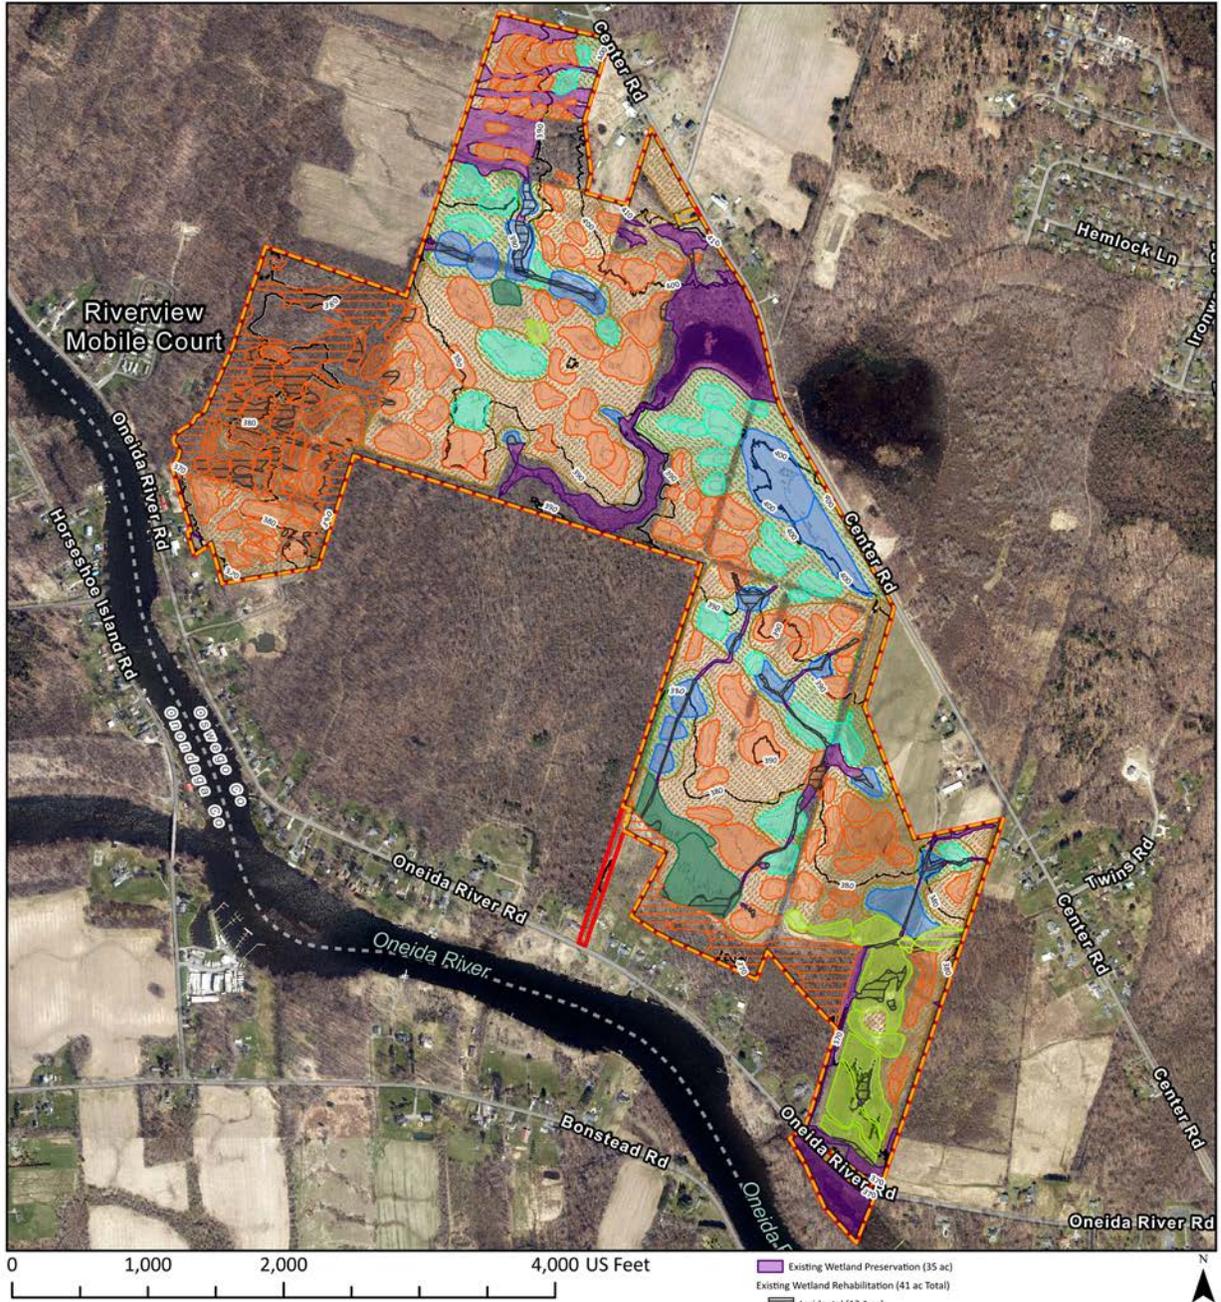
Figure 5-1. Oneida River Site Plan

Site Plan
 Oneida River
 Town of Schroeppel,
 Oswego County, NY

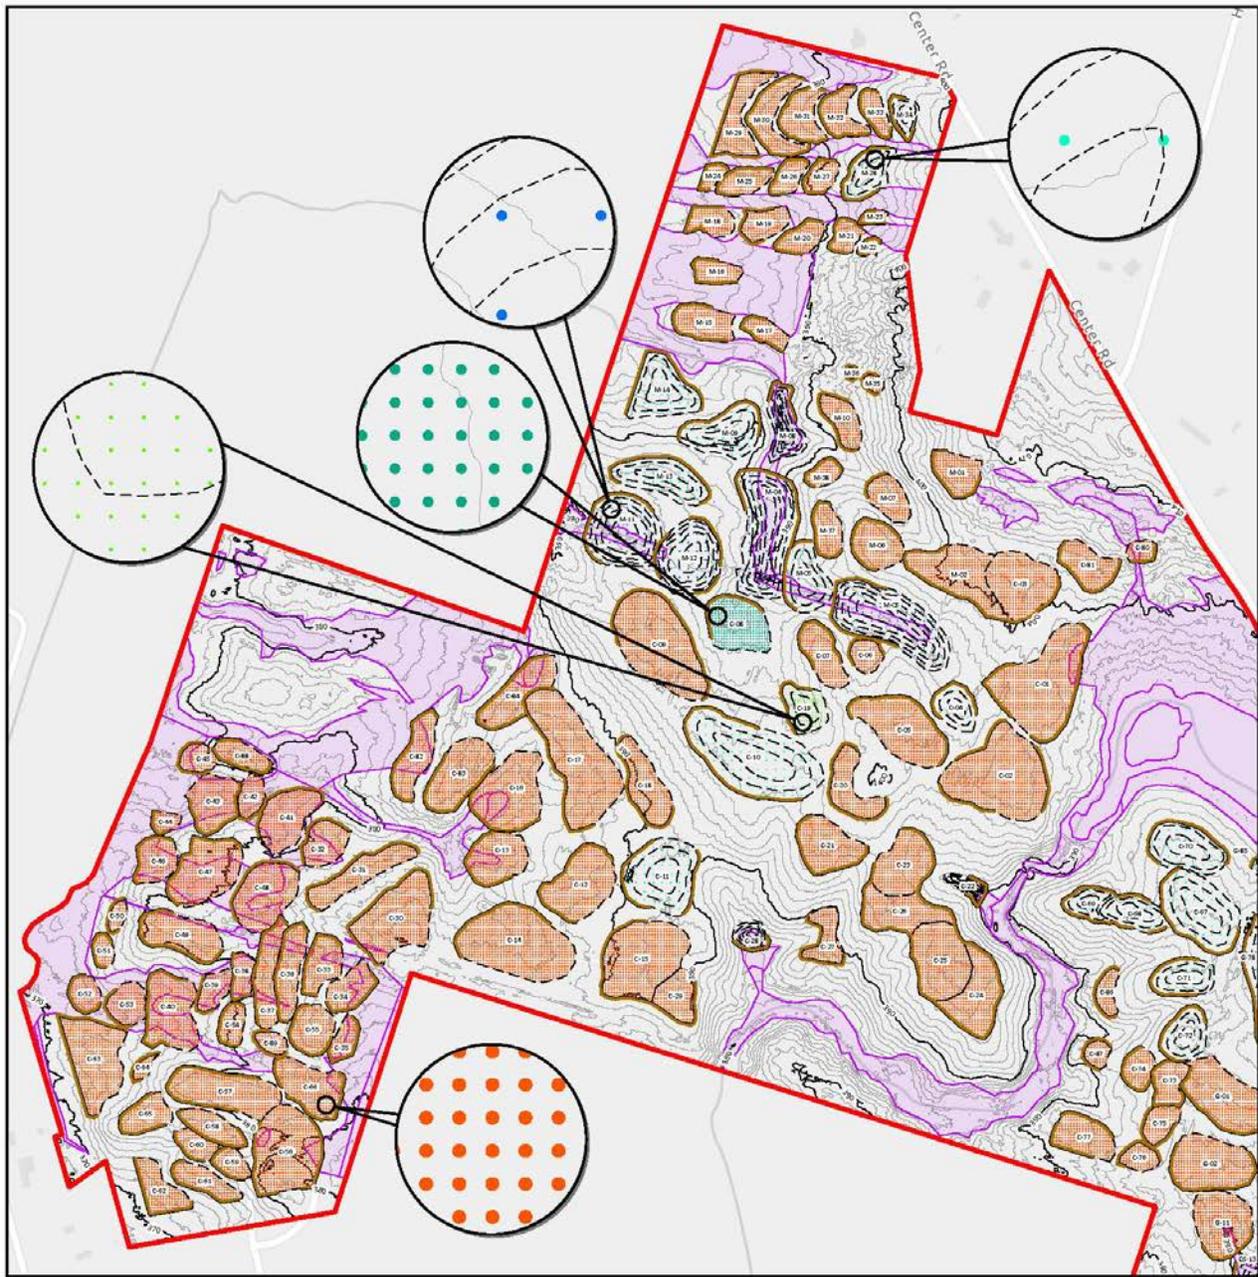
Figure 5-4. Wetland Grading Plan- Northwest

Wetland Grading Plan - Northwest
 Oneida River
 Town of Schroepfel,
 Oswego County, NY

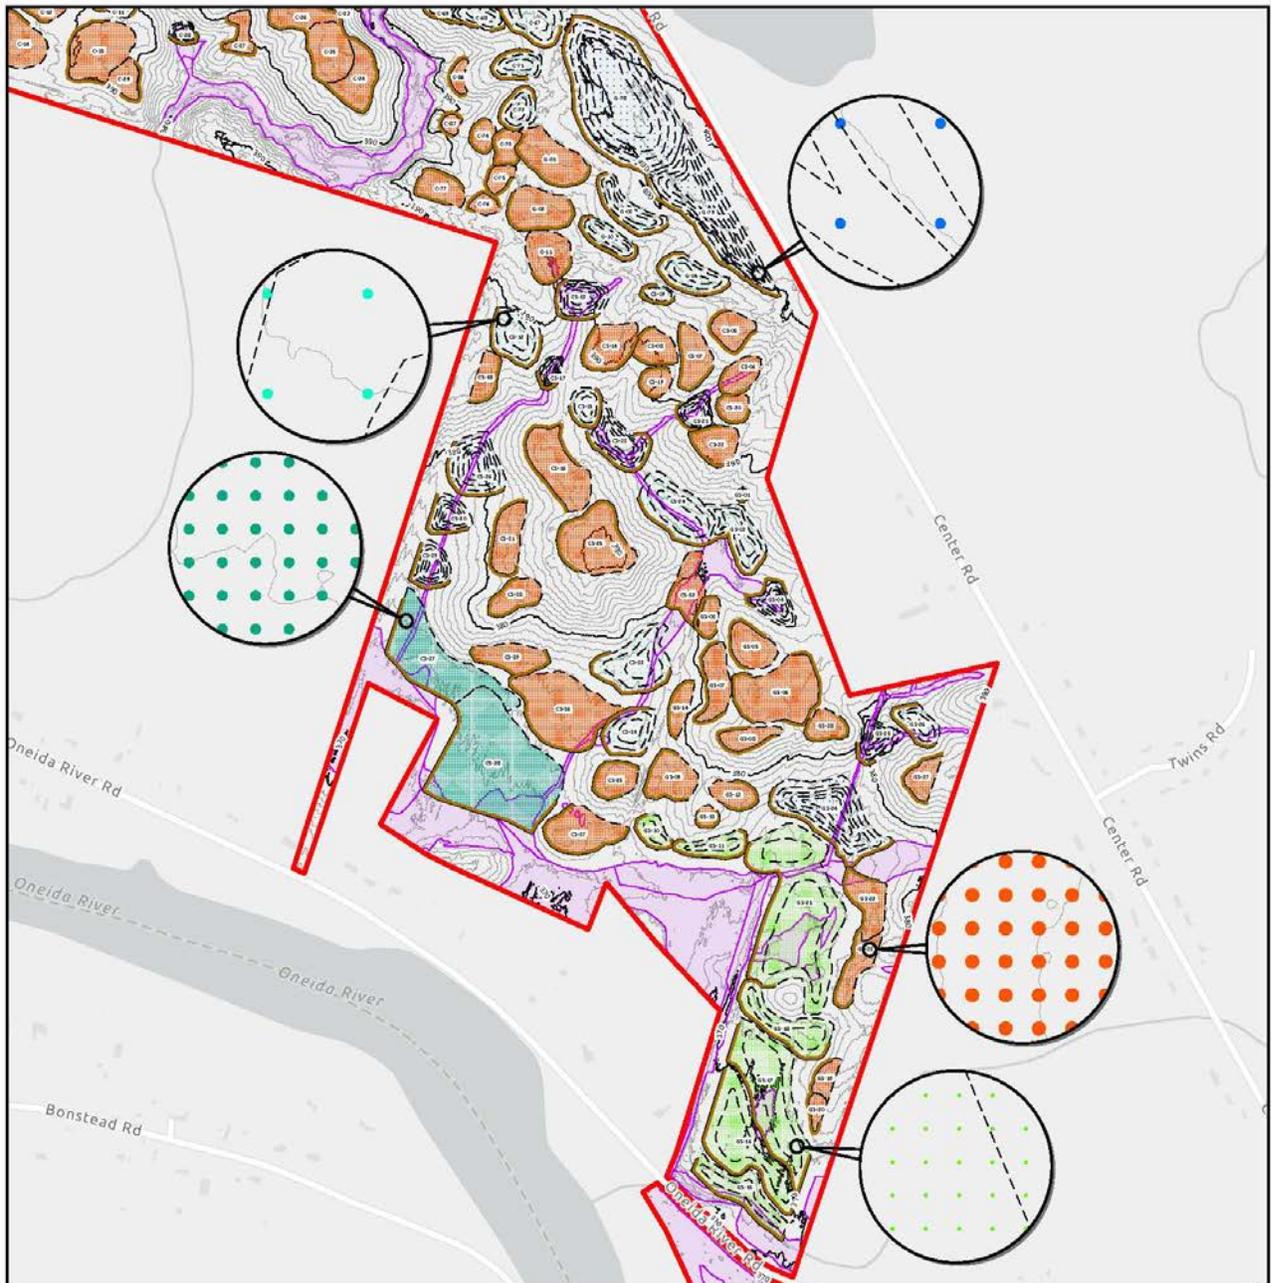
Figure 5-5. Wetland Grading Plan- Southeast

Wetland Grading Plan - Southeast
 Oneida River
 Town of Schroepel,
 Oswego County, NY

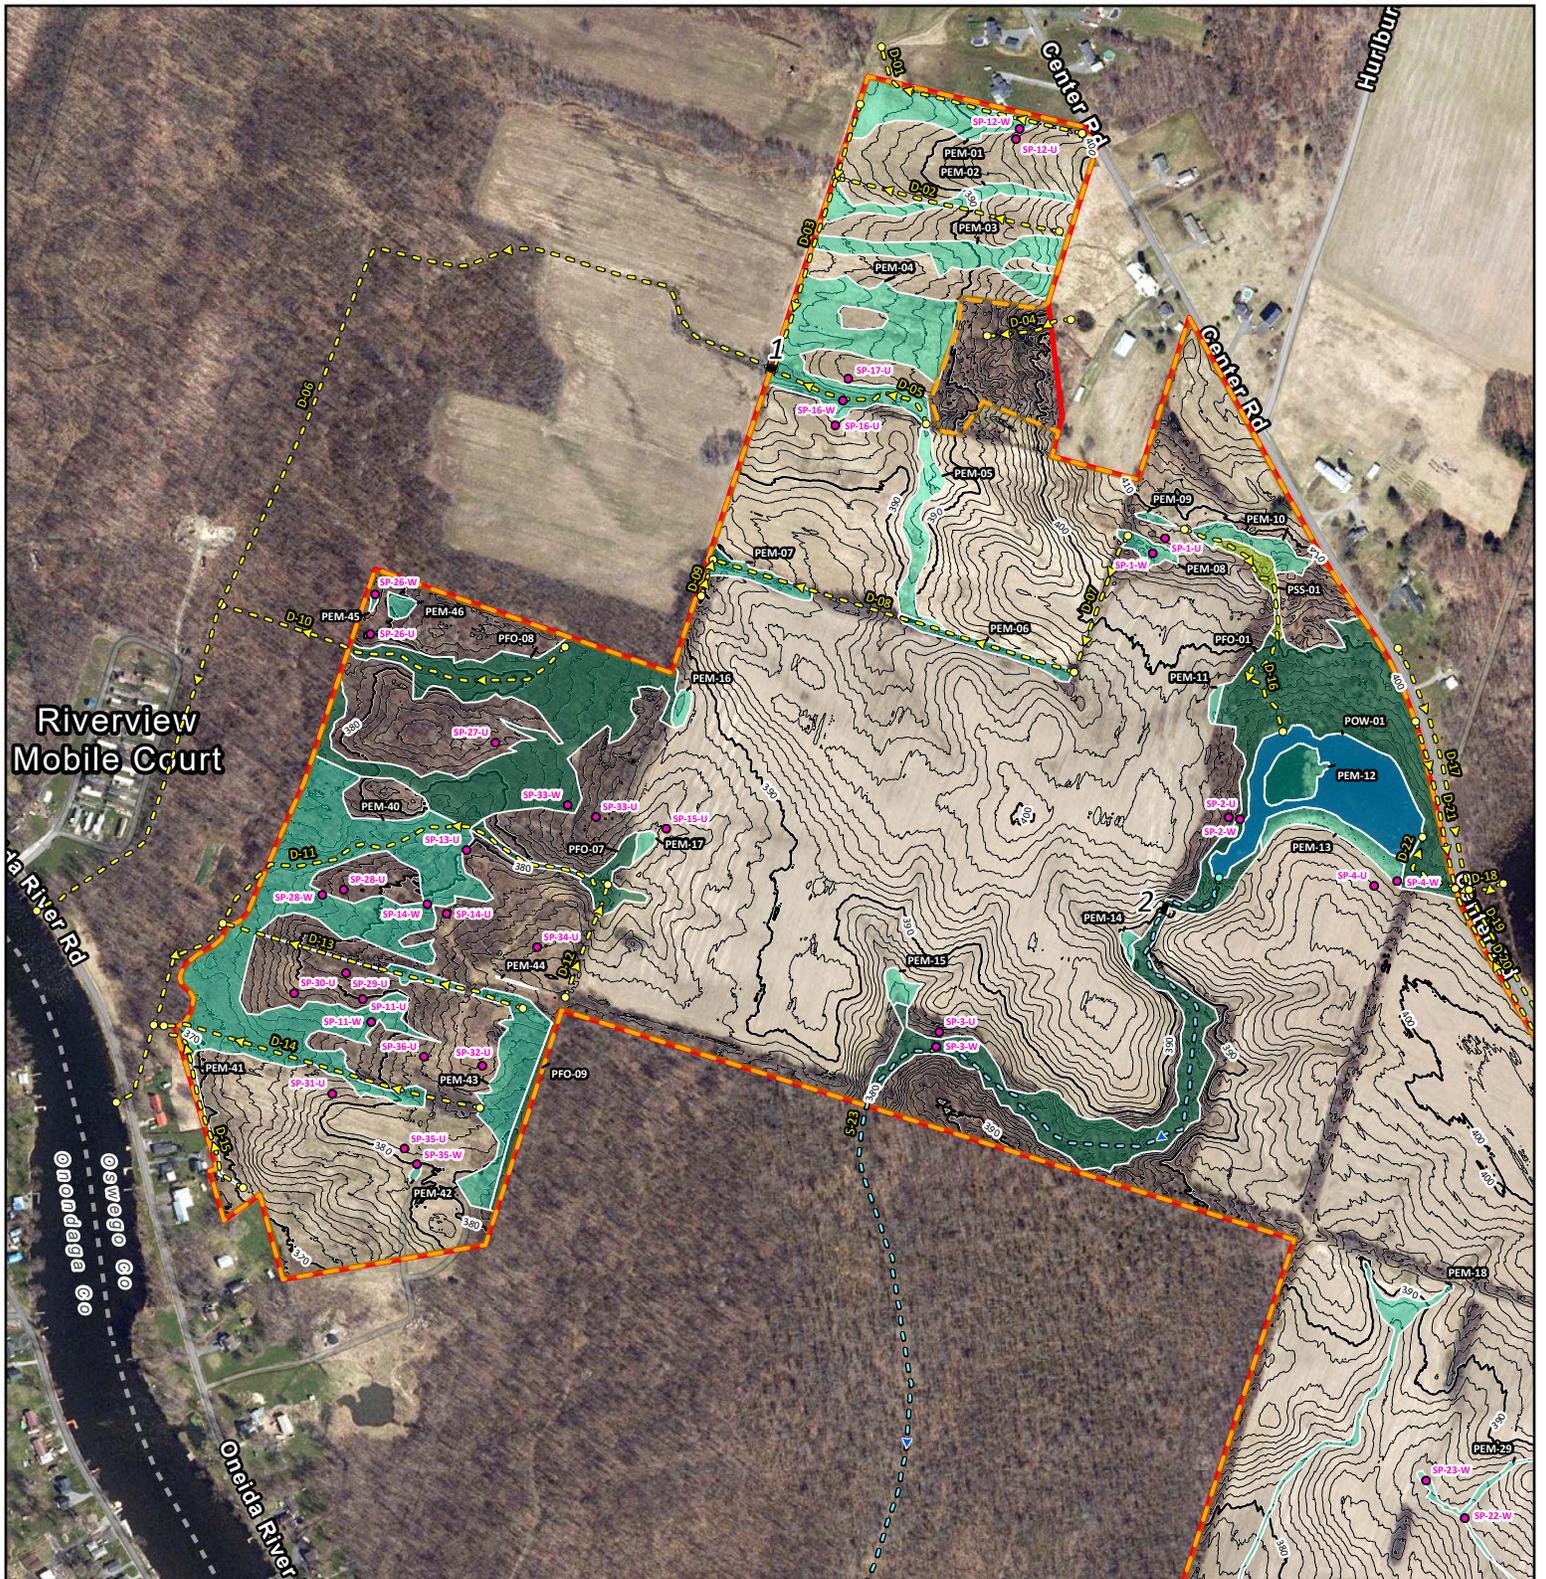
Delineated Wetlands and Drainage Features

- Wetland Delineation Sample Points (n = 54)
- Culverts (n = 3)
- Drainage Features**
- Ditch
- Stream
- Delineated Wetlands (76.9 ac Total)**
- Open Water - Pond (4 ac)
- PEM (43.2 ac)
- PSS (2.5 ac)
- PFO (27.2 ac)
- Contour Line (1 ft)
- Delineation Concurrence Request Boundary (399.5 ac)
- TWT Property Boundary (407 ac)

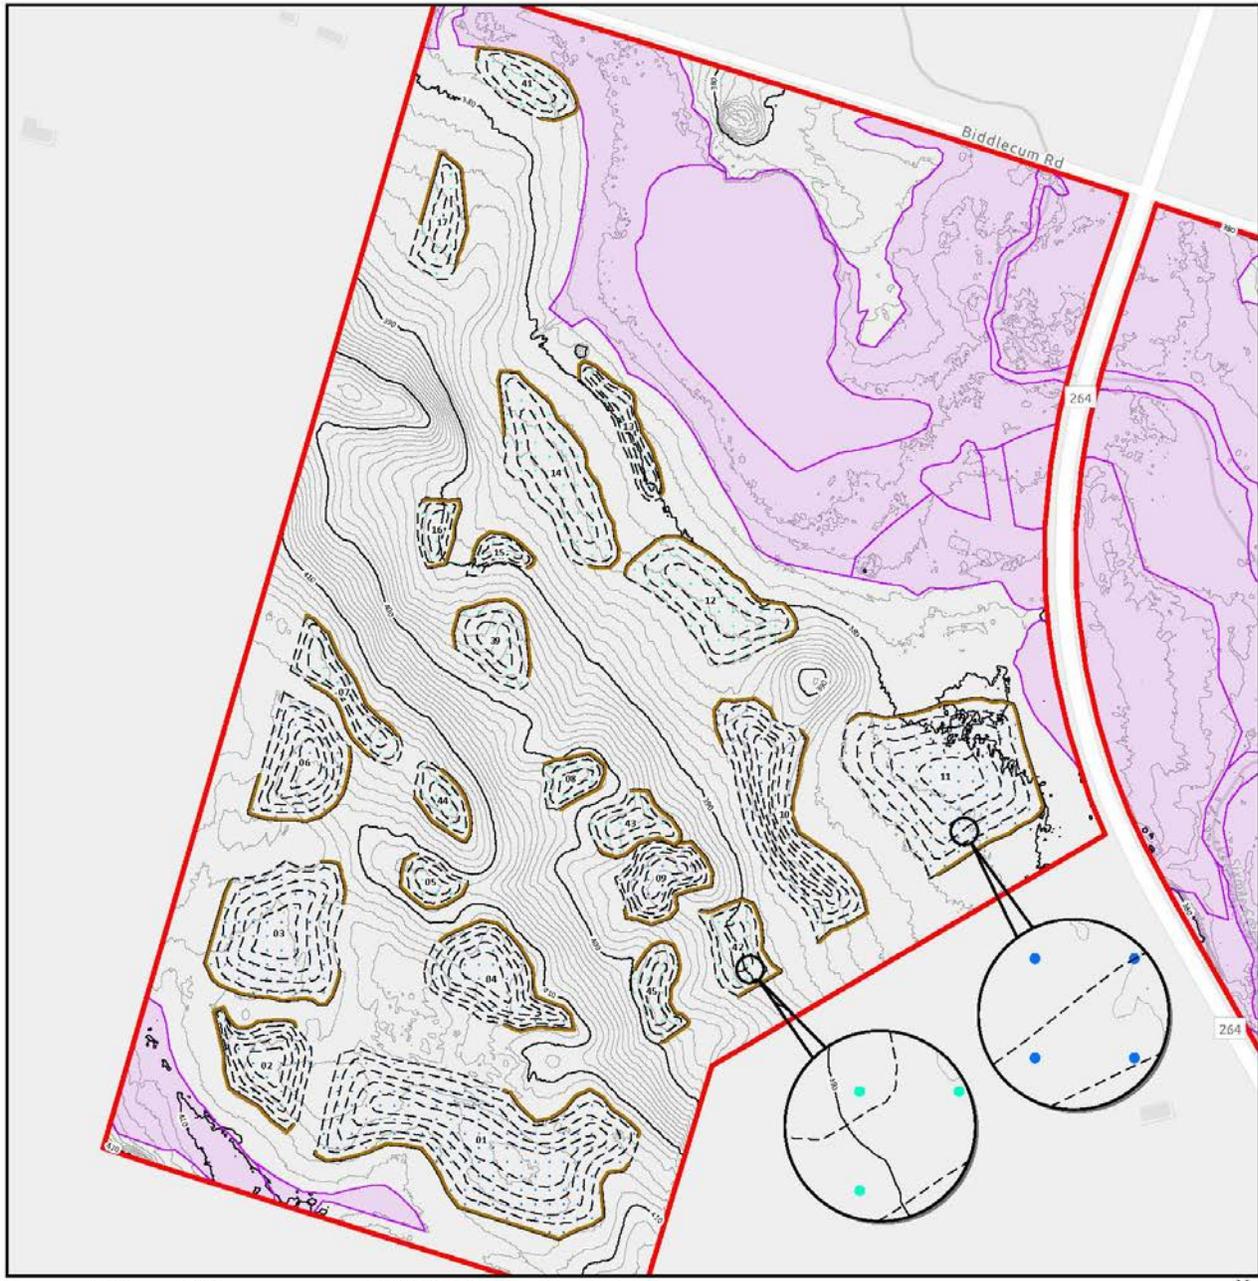
Figure 5-4. Wetland Grading Plan- West

Wetland Grading Plan - West
Sixmile Creek
Town of Schroepfel,
Oswego County, NY

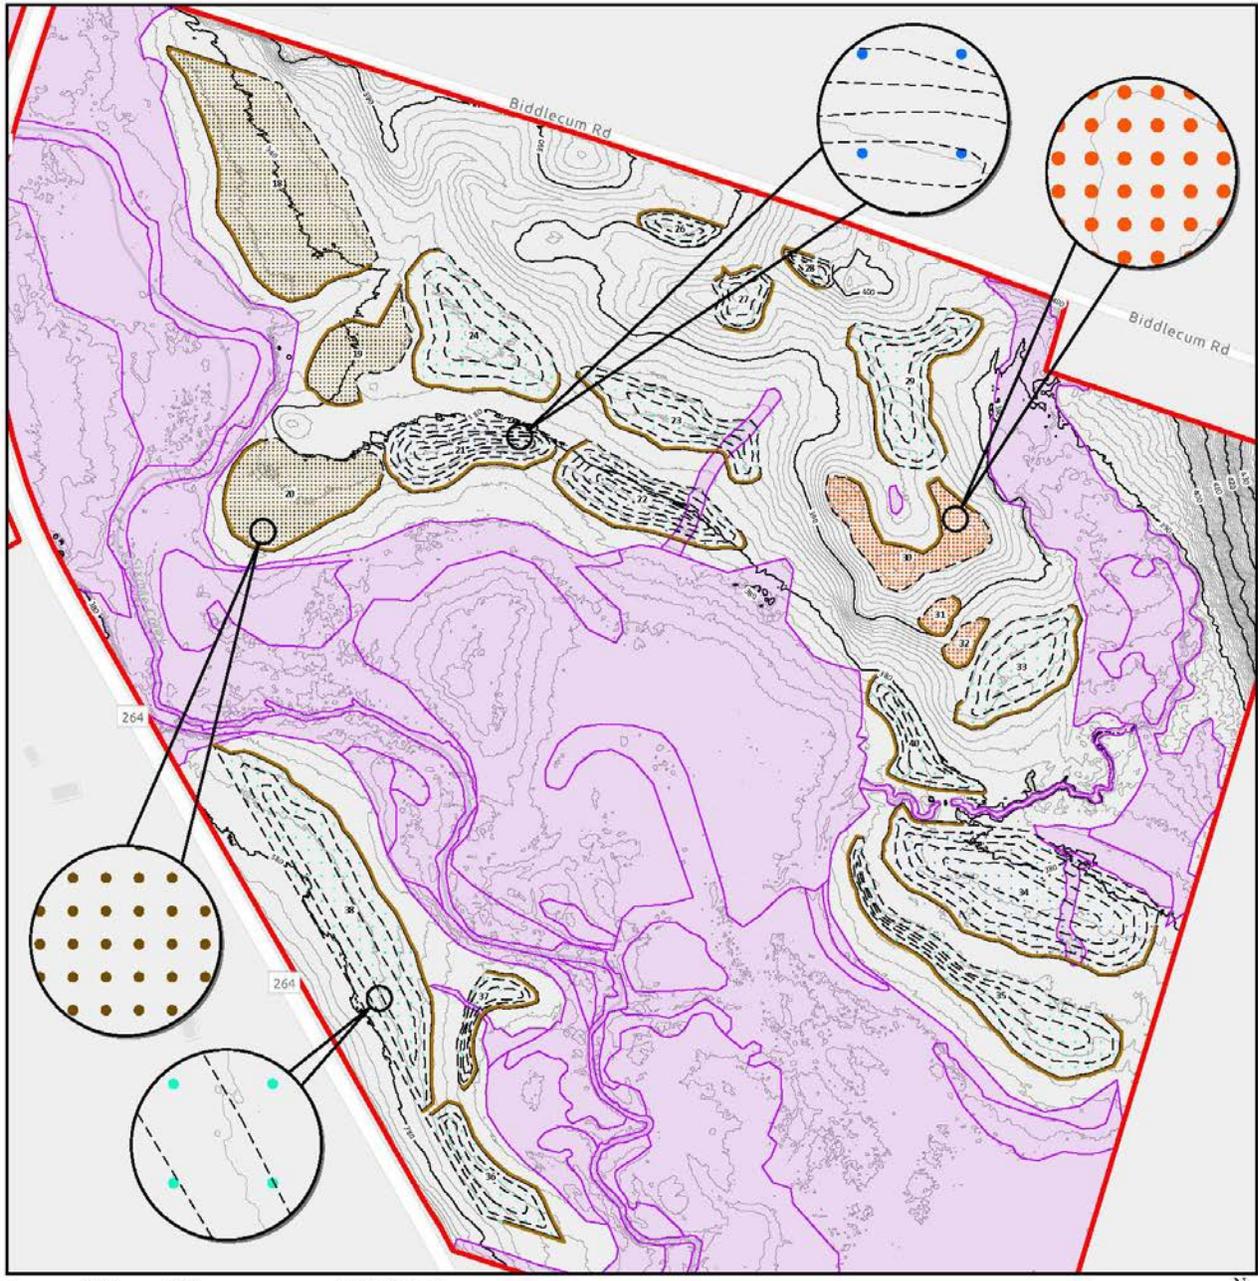
Figure 5-5. Wetland Grading Plan- East

Wetland Grading Plan - East
 Sixmile Creek
 Town of Schroepel,
 Oswego County, NY

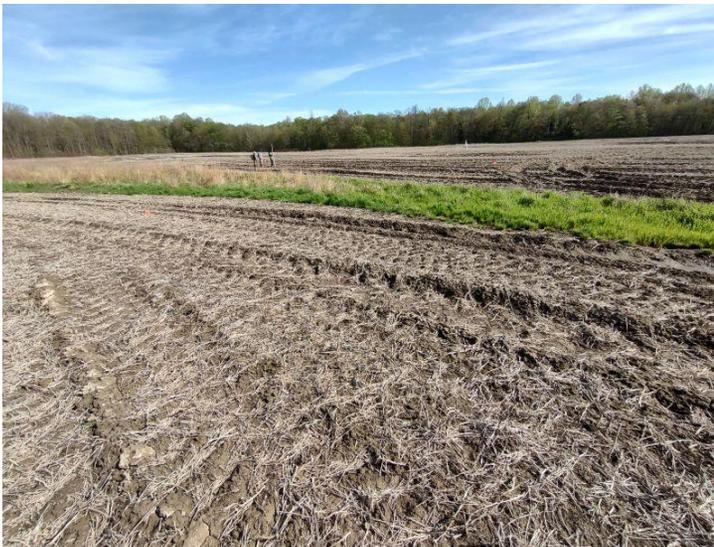
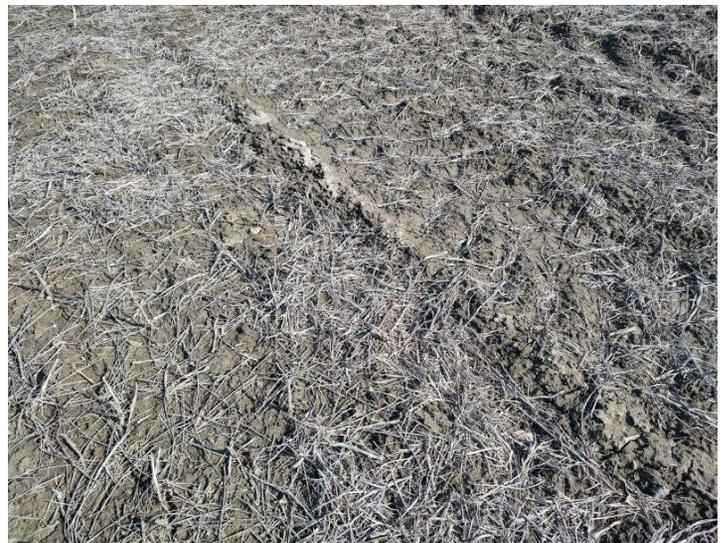
Wisner 1

Hydric soil present near the surface? No	Elevation-change upper to lower edge of designed wetland: 2.0-feet
Test Hole location: 43.308288°N 76.221014°W	
Soil texture: 0-12-inches = topsoil, 12-29-inches = clay, 29-32-inches = sand, 32-34-inches = silt loam.	
Rock armor the inlet and outlet for the wetland? Yes	
Inlet: 12-foot wide x 50-foot long x 1.5-foot thick = 900 feet³/27 feet³/yard³ = 33 yards³ x 1.5 tons/yard³ = 50 tons	
Outlet = 12-foot wide x 50-foot long x 1.5-foot thick = 900 feet³/27 feet³/yard³ = 33 yards³ x 1.5 tons/yard³ = 50 tons	
Total = 100 tons	
Head-cuts located uphill or downhill of the planned wetland. Yes, in the ditch.	
Woody debris source: Not available on site. Would need to be brought in by truck.	
Construction notes: Build a groundwater dam along the lower perimeter of the wetland being built. Fill ditch. Build an above ground dam that is no higher than 12-inches. Spread soil to the south. Shape and armor with rock an inlet and an outlet. Add pits, scrapes, and mounds and then plant with native trees and shrubs.

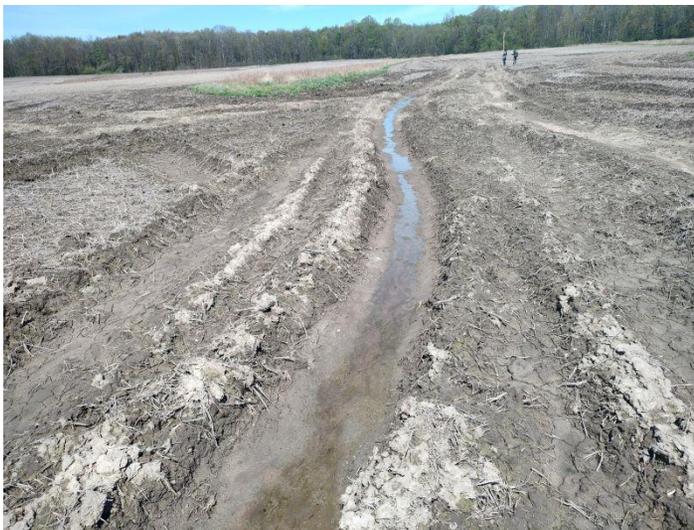
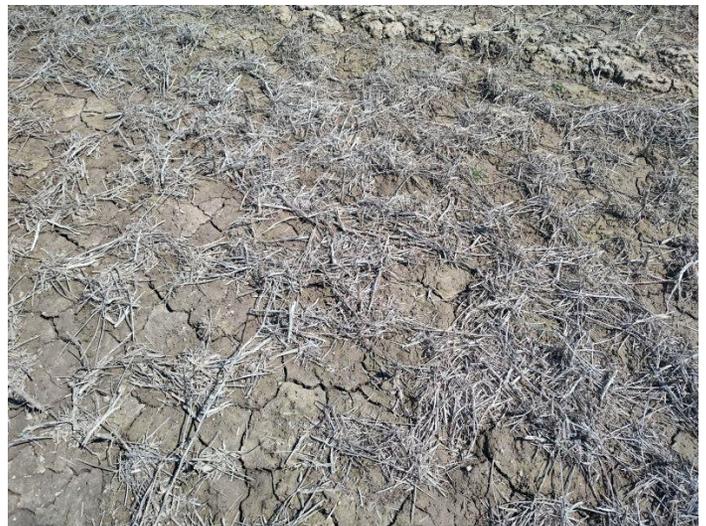
Wisner 4

Hydric soil present near the surface? No	Elevation-change upper to lower edge of designed wetland: 1.5-feet
Test Hole location: 43.307781°N 76.219098°W Soil texture: 0-13-inches = topsoil, 13-34-inches = clay, 34-40-inches = sand, 40-48-inches = clay.	
Rock armor the inlet and outlet for the wetland? Yes Inlet: 12-feet wide x 50-feet long x 1.5-feet thick = 900 feet ³ /27 feet ³ /yard ³ = 33 yards ³ x 1.5 tons/yard ³ = 50 tons Outlet = 12-feet wide x 50-feet long x 1.5-feet thick = 900 feet ³ /27 feet ³ /yard ³ = 33 yards ³ x 1.5 tons/yard ³ = 50 tons Total = 100 tons	
Head-cuts located uphill or downhill of the planned wetland. Yes, in the ditch.	
Woody debris source: Not available on site. Would need to be brought in by truck.	
Construction notes: Build a groundwater dam along the lower perimeter of the wetland being built. Fill ditch. Build an above ground dam that is no higher than 10-inches. Spread soil to the south. Shape and armor with rock an inlet and an outlet. Add pits, scrapes, and mounds and then plant with native trees and shrubs.

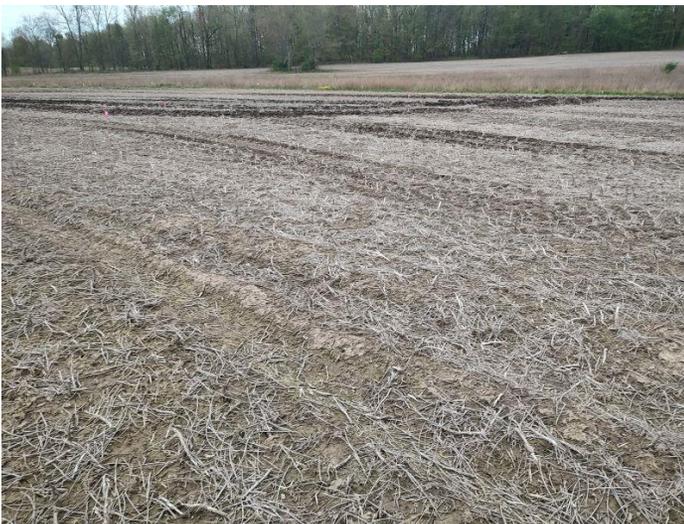
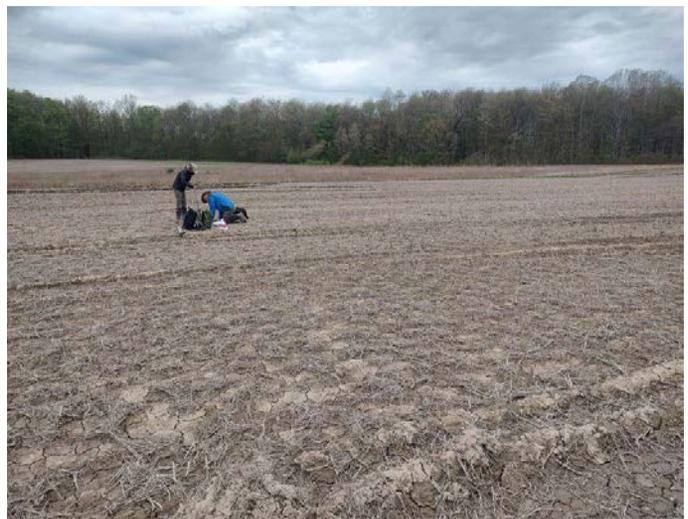
Wisner 14

Test Hole location: Not dug Soil texture: Like Wisner 13	
Rock armor the inlet and outlet for the wetland? Not needed.	
Head-cuts located uphill or downhill of the planned wetland. None	
Woody debris source: Not available on site. Would need to be brought in by truck.	
Construction notes: Build a groundwater dam along the lower perimeter of the wetland being built. Fill ditch. Build an above ground dam that is no higher than 12-inches. Spread soil downhill to the south. Add pits, scrapes, and mounds and then plant with native trees and shrubs.
