DC Voltage Breakdown of Relied Upon Insulator Materials: Test Method Development and Results From Artificially Weathered Specimens

David C. Miller¹, Bernt Åke-Sultan², Axel Borne³, Joshua J. Eafanti¹, Rene Eugen⁴,
Bradley L. Givot⁵, Jürgen Jung⁶, Trevor Lockman¹, Steven W. MacMaster⁷, Byron K.
McDanold¹, Ulf H. Nilsson², Nancy H. Phillips⁷, Ian A. Tappan¹, and Nick S. Bosco¹

¹National Renewable Energy Laboratory (NREL), 15013 Denver West Parkway, Golden, CO 80401, USA

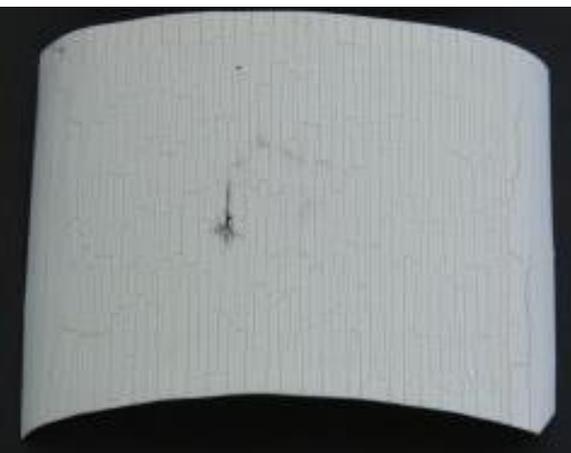
TPE-1: Failure was observed to interact with cracks on the sun side. Similar interaction may not have occurred for TPE-3.

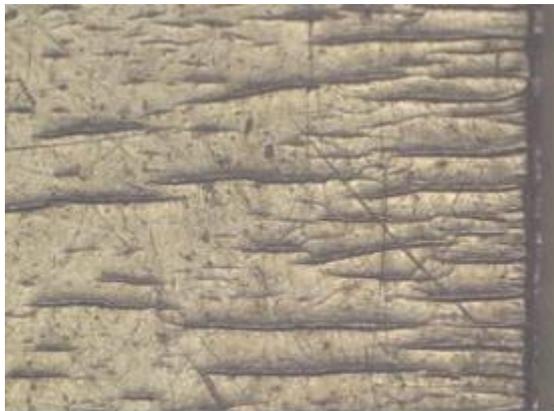
1 mm

TAPE: Cracking observed for the sun side (EVA) is shown in a microscopy image of the surface.

- $\Delta V_{BD} \sim 37\%$, with significant variability for weathered specimens.
- Major new peaks as well as peak broadening observed in FTIR for sun side (EVA). Similar to TPE's.
- Macroscopic cracking of sun side observed, with microscopic cracking of air side... both *only after bend test*.

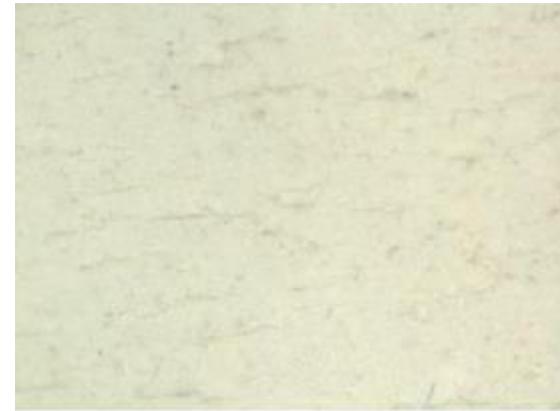
200 μm

TAPE: Cracking observed for the air side (PVF) is shown in a microscopy image of the surface.

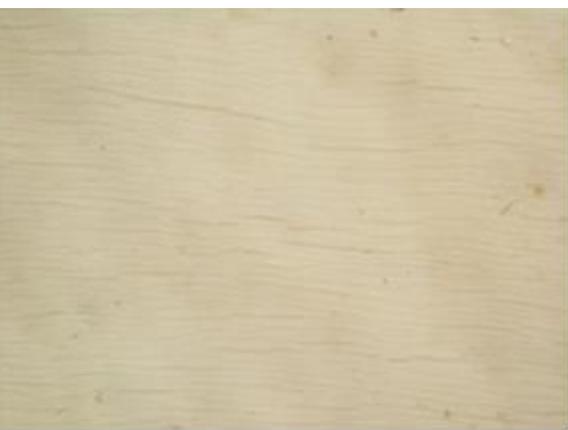
PA: Cracking observed for the air side (PA) is shown in a microscopy image of the surface.

- $\Delta V_{BD} \sim 13\%$ for weathered specimens.
- Major and minor changes observed, both intensity changes and new peaks.
- Similar changes on air (PA) and sun (PA) surfaces.
- Micro-scale cracking of air surface observed only after bend test.

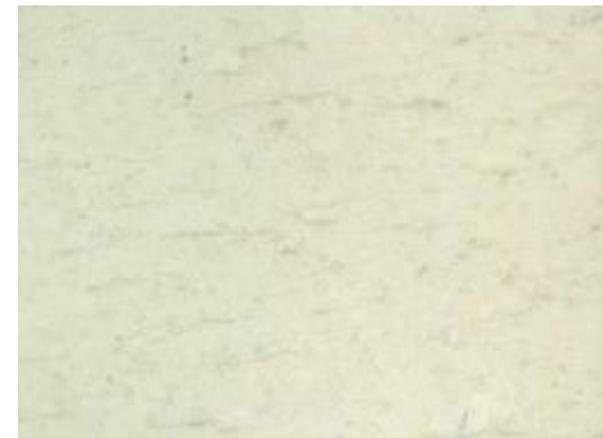
200 μm

TPT-1: Cracking observed for the air side (PVF) is shown in a microscopy image of the surface.

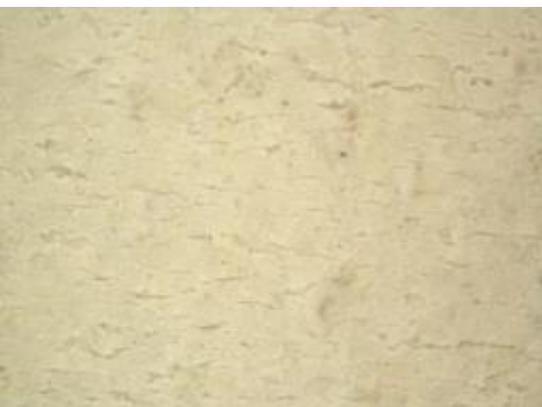
— 200 μm

TPT-3: Cracking observed for the air side (PVF) is shown in a microscopy image of the surface.

- Minor effect of weathering is suggested. (not outside 90% confidence bounds).
- Changes in peak intensity observed in FTIR for air side (PVF).
- Cracking of air side (PVF) observed in microscope, only after bend test.
