# Summary of Hurricane Maria NCST Investigation Progress

## *NCST Advisory Committee Meeting*

# NIST Hurricane Maria Investigation

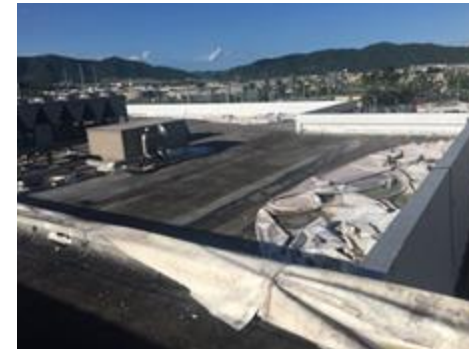
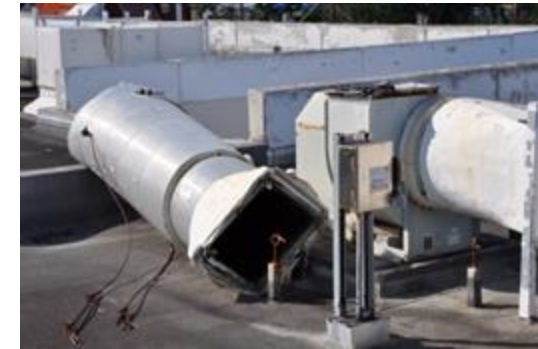
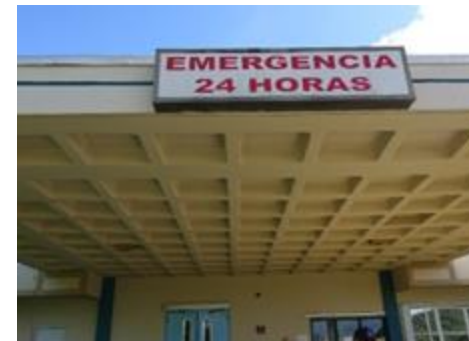
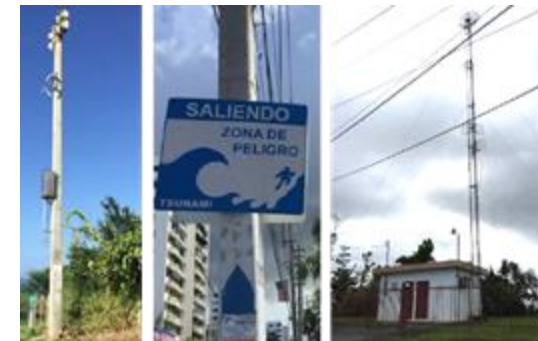
- **Hazard Exposure:** Strong Category 4 hurricane, peak gusts near 140 mph (greater with topographic speedup), over 30" rain, extensive flooding, landslides
- **Exposed Population:** Entire Commonwealth (~3.3M people)
- **Mortality:** Challenges attributing hurricane-related deaths; excess mortality est: 2,975
- **Engineered Buildings:** Extensive nonstructural damage, rainwater intrusion, loss of function
- **Emergency Response:** Challenges with rescues in flooded areas, complicated by loss of communications for extended periods

Peak gust wind speeds without topographic effects

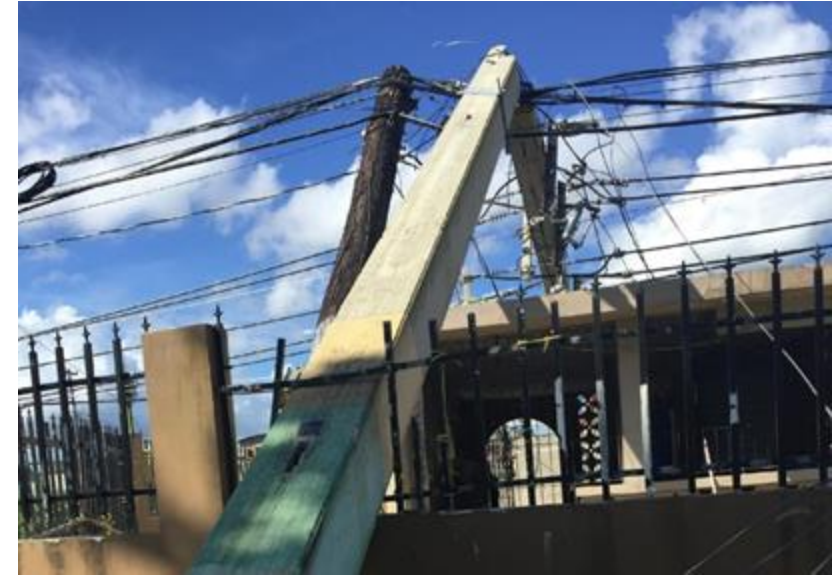
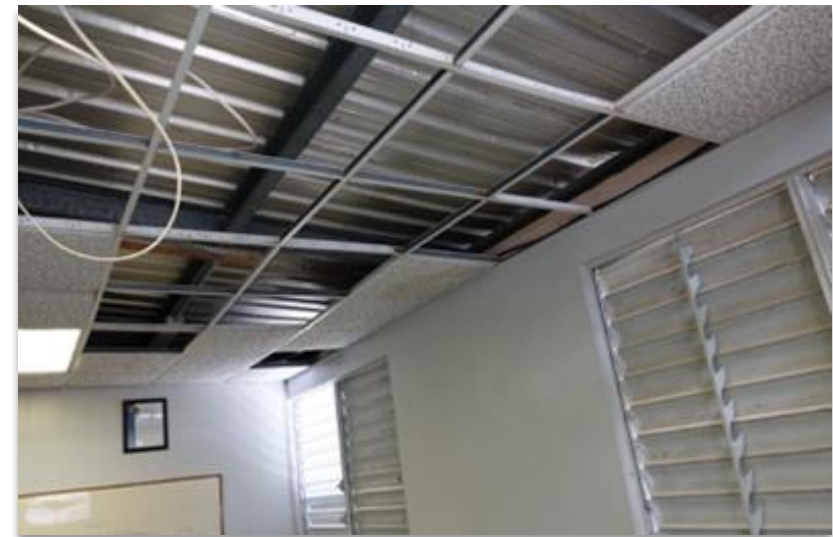
- **Infrastructure Systems:** Severe physical damage and complete/near complete loss of function for electrical and communications systems presented emergency response and recovery challenges
- **Education, Healthcare and Businesses:** Impacts on recovery due to power loss, non-structural building damage, generator failures, road closures

Wireless communications status at 1 month

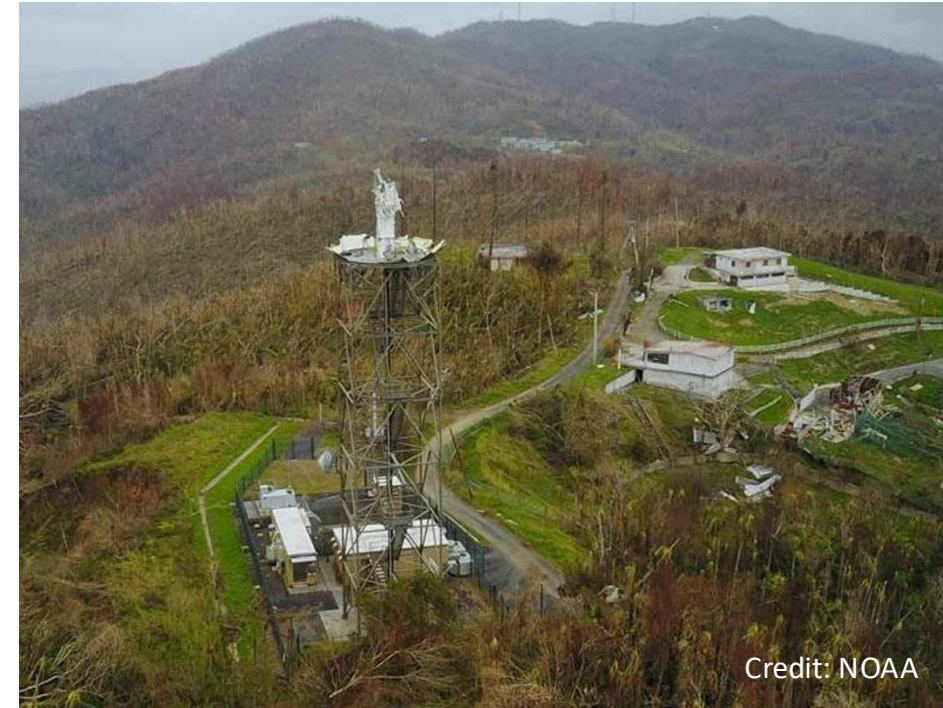
**Failures of wind and rainfall measurement and reporting systems posed significant challenges in quantifying the severity of Hurricane Maria's hazard exposure across Puerto Rico, both during the event and in post-storm assessments.**

- Puerto Rico's Doppler weather radar was destroyed by strong winds, the majority of weather stations failed to capture the hurricane's maximum wind speeds, and many rain gauges were damaged or destroyed.
- Reporting failures for weather stations resulted from several factors, including wind damage, loss of electrical power, and limitations in local storage capacity when communications were lost.
- These widespread reporting failures, which are common during landfalling hurricanes in the U.S., left emergency managers with limited information on hazard exposure and increased the likelihood that some of the highest hazard levels were not captured.

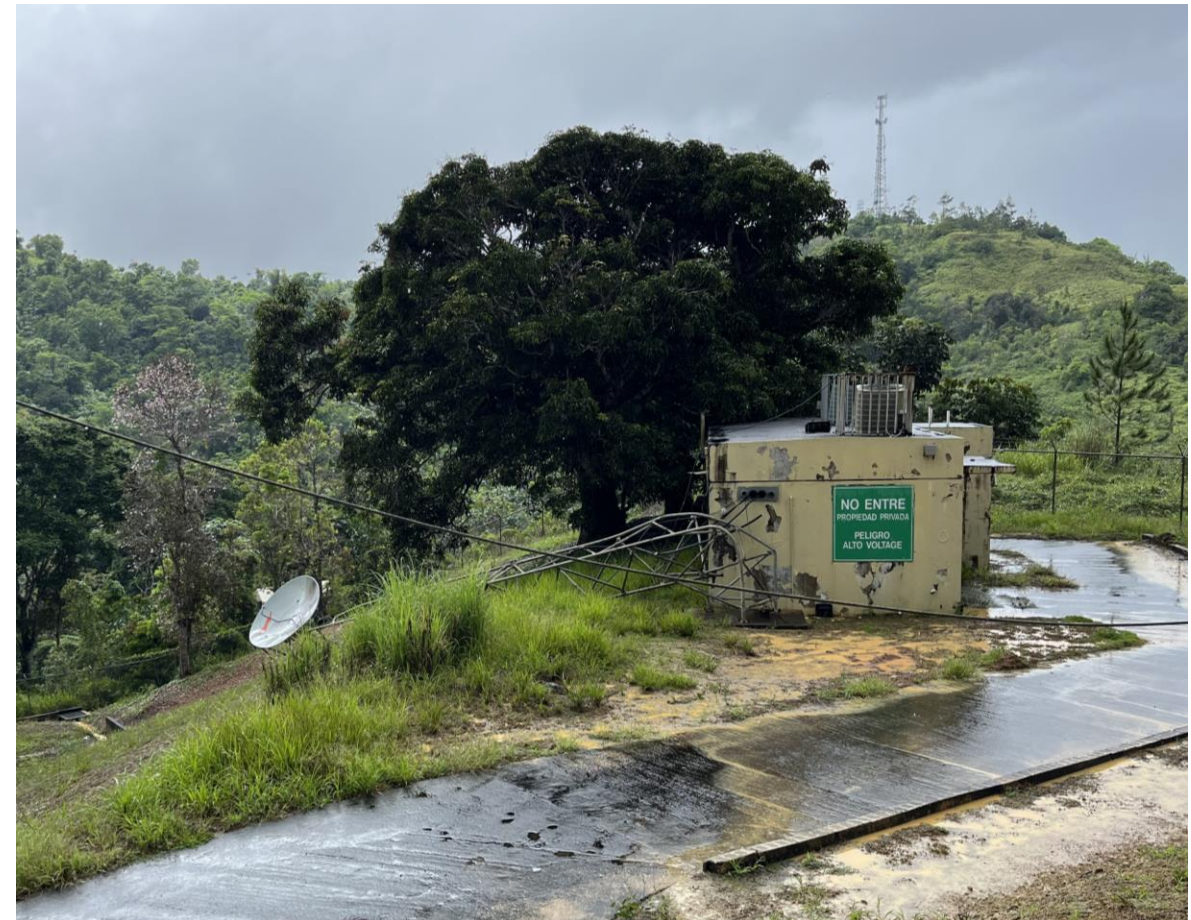
**While power outages and damage to the wireline portion of the communications network were the most important factors in the extended duration of wireless communications outages, wind damage to communications towers and equipment played a significant contributing role.**

- Wind and wind-borne debris damage to tower-mounted equipment was common, including damage to and misalignment of antennas and microwave dishes, antenna mounting platforms, and data and power cables.
- Of 594 communications towers in NIST's sample, 27 collapsed (4.5%).
- Severe damage to surrounding trees changed the ASCE 7 wind exposure category for about 50% of the towers in Exposure B (suburban/wooded) to Exposure C (open) during the storm, resulting in increased wind loads.

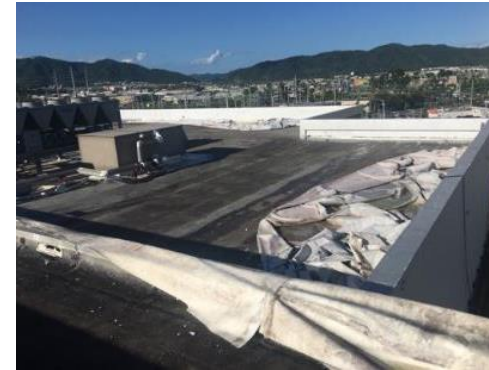
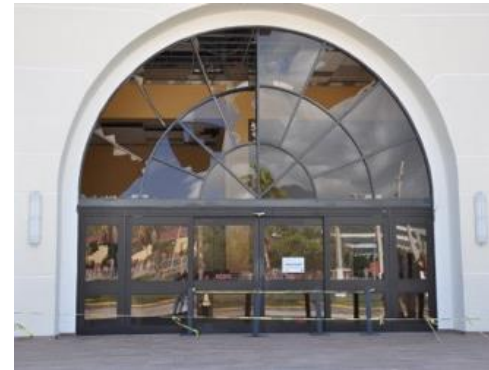
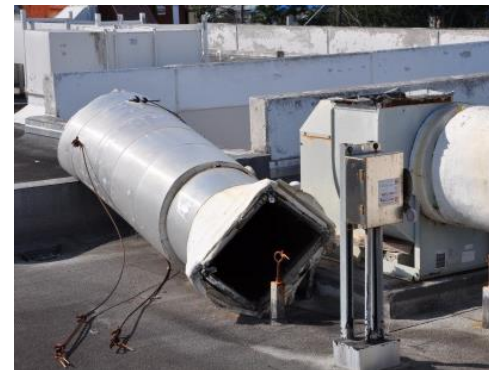
**While most hospital and school buildings in Puerto Rico experienced minimal structural damage during Hurricane Maria, hurricane-force winds and wind-borne debris caused extensive damage to building enclosures, which allowed significant rainwater intrusion.**

- The most prevalent source of rainwater intrusion in buildings was through damaged roof coverings, with additional rainwater entry through damaged windows, doors, and rooftop equipment.

- Clogging of roof drains by storm-generated debris contributed to increased water retention on flat roofs, exacerbating the intrusion of rainwater through damaged roof coverings.

- Intrusion of wind-driven rain through windows included windows dislodged from the framing and windows with broken glass, as well as intact windows with significant leakage around the seals.

- Wind damage to roof-mounted equipment was widespread across hospitals and some schools. This included shifting and toppling of rooftop units and, in some cases, removal from the roof.

- Damaged and dislodged rooftop equipment not only allowed rainwater intrusion through openings in the roof but also became a source of windborne debris, which punctured roof coverings and created additional pathways for water intrusion.

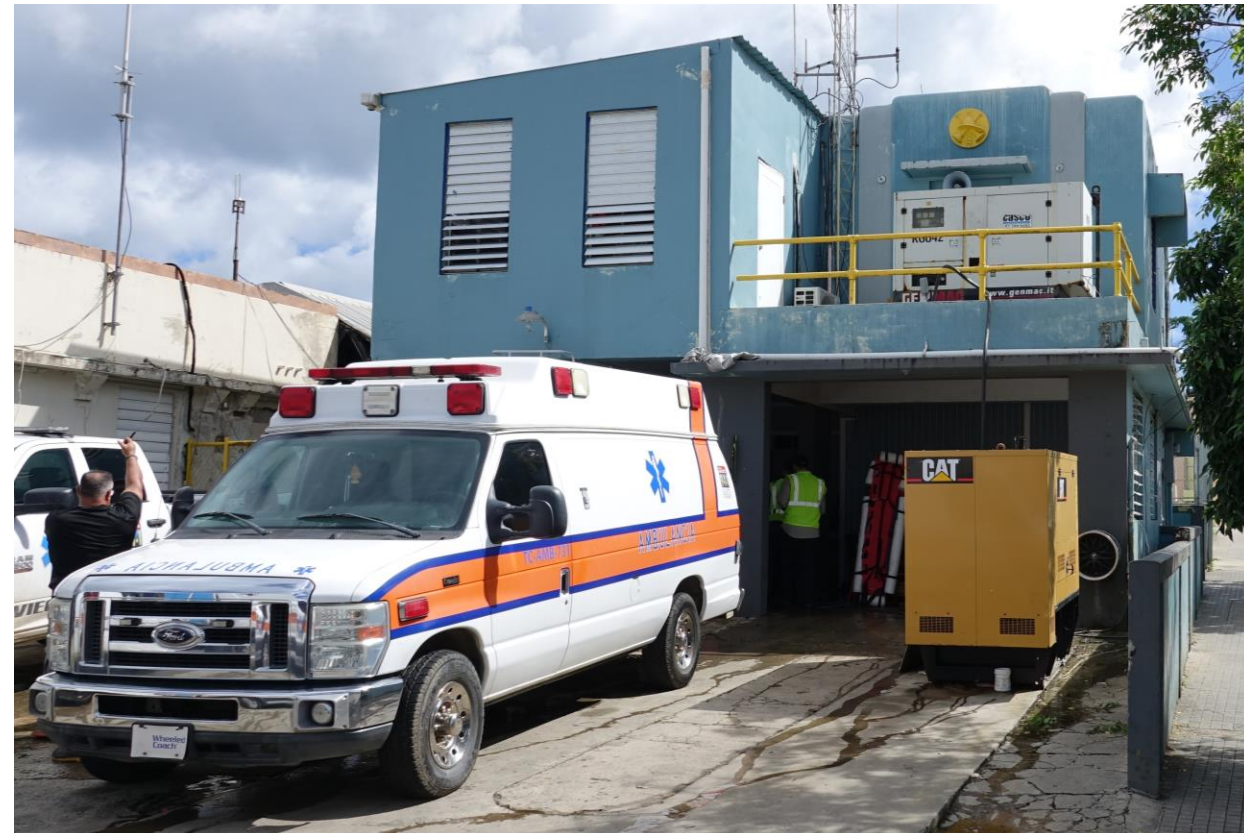
**With the loss of utility power, hospitals had to operate on backup power systems for extended periods, and backup power systems at hospitals often did not power air-conditioning systems or elevators.**

- The lack of air-conditioning exposed patients and staff to high heat and humidity, and the lack of elevator service made it difficult to relocate patients from one floor to another (e.g., when required due to flooding).
- Generators typically functioned well during the first three days of operation, but issues were reported with extended generator use, including fuel scarcity and the need for maintenance, as well as damage to generators during operation.

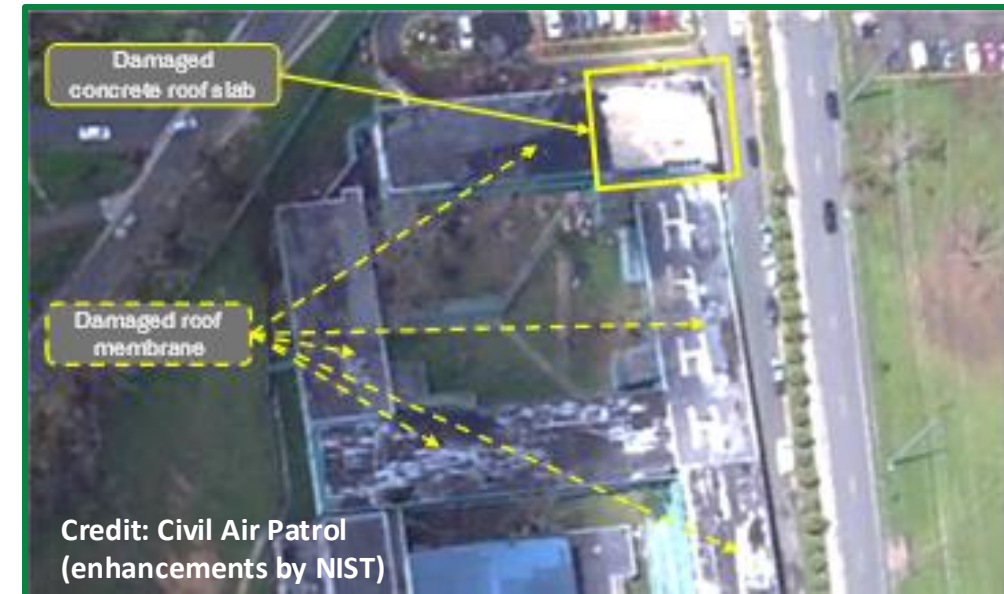
**Refuge areas in designated shelter facilities preserved life safety, successfully protecting occupants from hurricane winds and wind-borne debris. However, occupants were exposed to other hazards, and significant operational challenges were encountered in these facilities.**

- Refuge areas were affected by rainwater intrusion and flooding, especially accessible ground-floor refuge areas, requiring relocation of occupants.
- Shelters generally had higher occupancies than expected and were used far longer than expected.
- Shelter occupants experienced conditions that were not ideal for longer-term occupancy, including lack of air conditioning, mold/mildew exposure, and sanitation problems. These conditions were driven by loss of power, subsequent failure of generators, and lack of water service.
- Multiple groups were involved in managing shelters, and a lack of clear roles and responsibilities exacerbated shelter operational challenges.

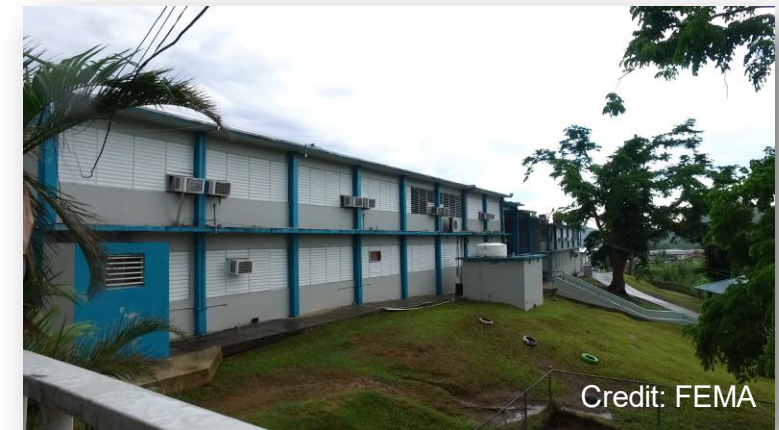
### Deferred maintenance, particularly for schools, compounded building and site damage from Hurricane Maria.

- Older buildings and unaddressed maintenance from before Hurricane Maria represented increased vulnerabilities for existing building stock.
- The resulting damage directly impacted functions served by these buildings such as healthcare, sheltering, education, and business particularly when combined with existing vulnerabilities.
- For both hospitals and schools, resources such as funding and staff for building maintenance were lacking or absent in some facilities.
