NIST Facilities Overview

Facilities Overview

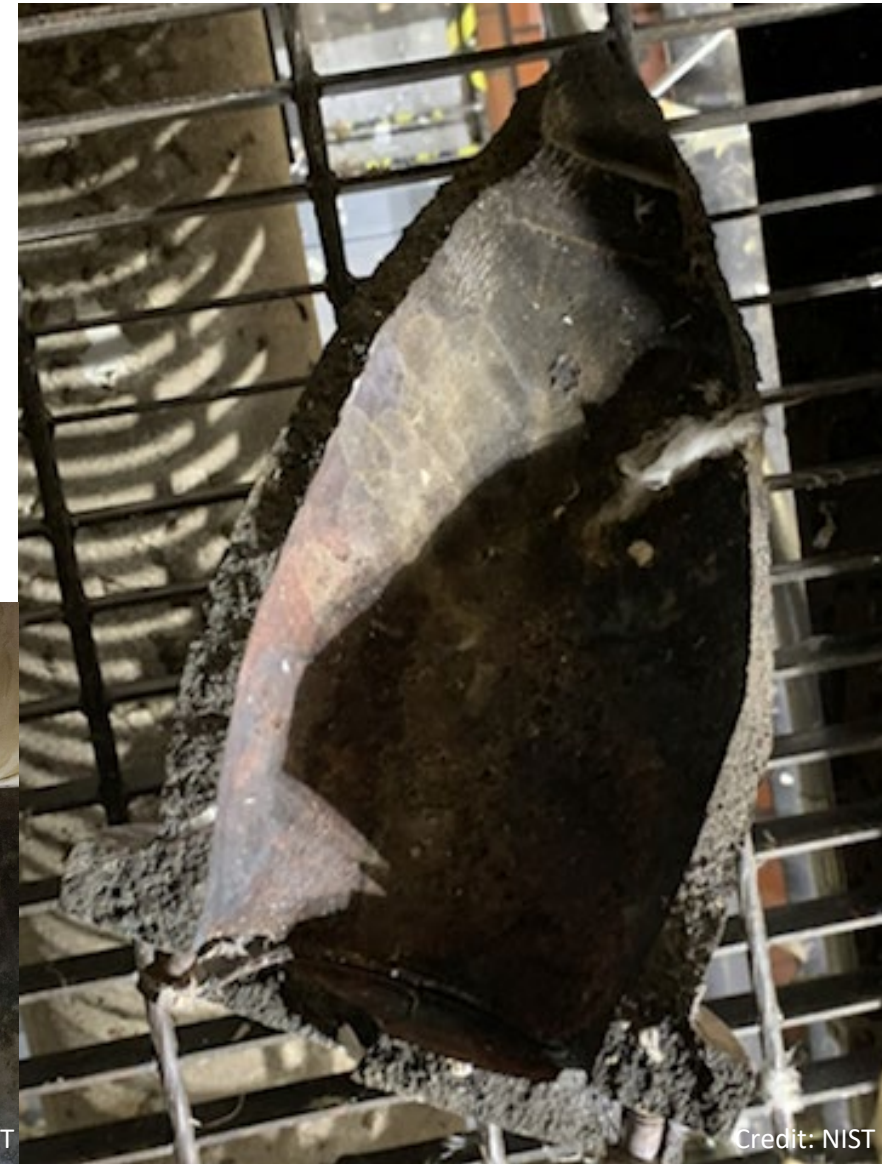
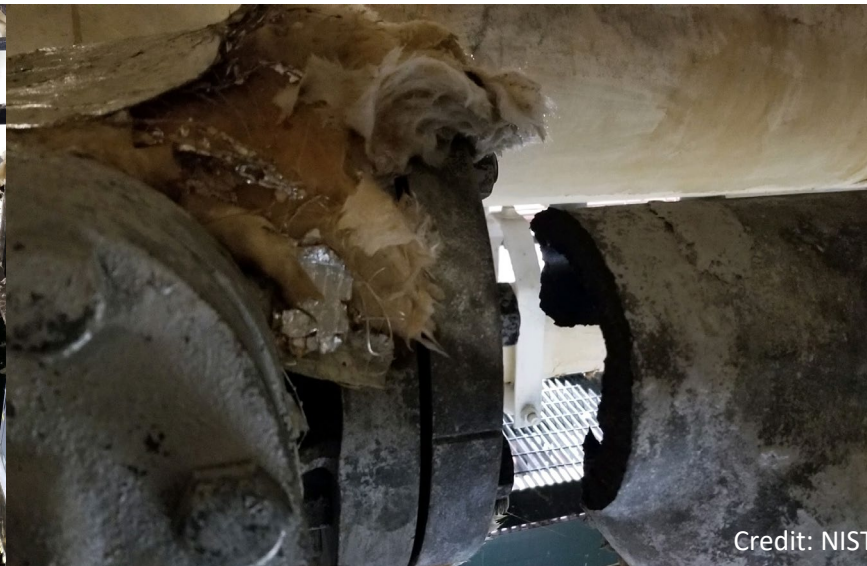
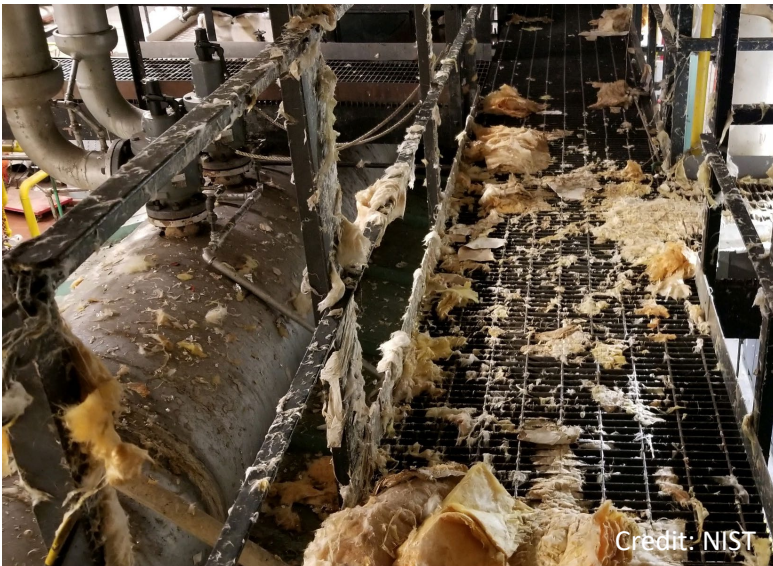
Impact Examples: (G) CUP Steam Strainer

Date: AUG 30, 2020

Cause: Porosity & lack of tensile strength in cast iron, corrosion due to age

Damage: 4" steam line, fitting, insulation, hangers, lights & platform

Impact: Lab program delayed deliverable to DOD, DHS & others. Forensic investigation identified need to replace entire steam system piping in this facility which will have numerous future impacts to researchers.

- Summer 2020 catastrophic failure of steam strainer; complete piping systems replacement required.
- Major Electric components need replacement
- Numerous components need replacement
- Central Command Center for campus utility systems
- Modernization Program required
- Life Safety Requirements project recently awarded
- Boiler Replacement award late FY22
- \$15.4M deferred maintenance backlog does not account for all work required

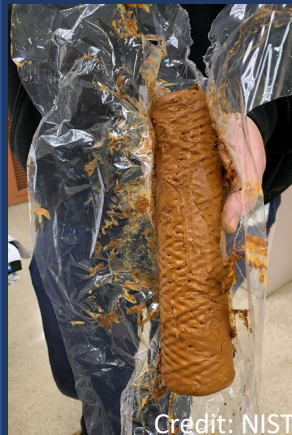
From: Bowers, Charles E. (Fed)
Sent: Wednesday, February 2, 2022 1:52 PM
To: 235sponsors; Building 235 Staff
Cc: ccsponsors
Subject: Emergency Outage for Domestic Water to Bldg 235 B-Wing.

OFPM has secured domestic water to B-Wing of building 235 to repair a water main break. This affects restrooms, lab hot & cold water, and heating systems. All pure steam systems were also secured since they require make-up water to keep the system on-line. We will flush all lines in the building today once the service is restored. You should check your areas that use these building systems to ensure no issues. If you have any concerns or questions, you may call the Service Desk on extension 6928.

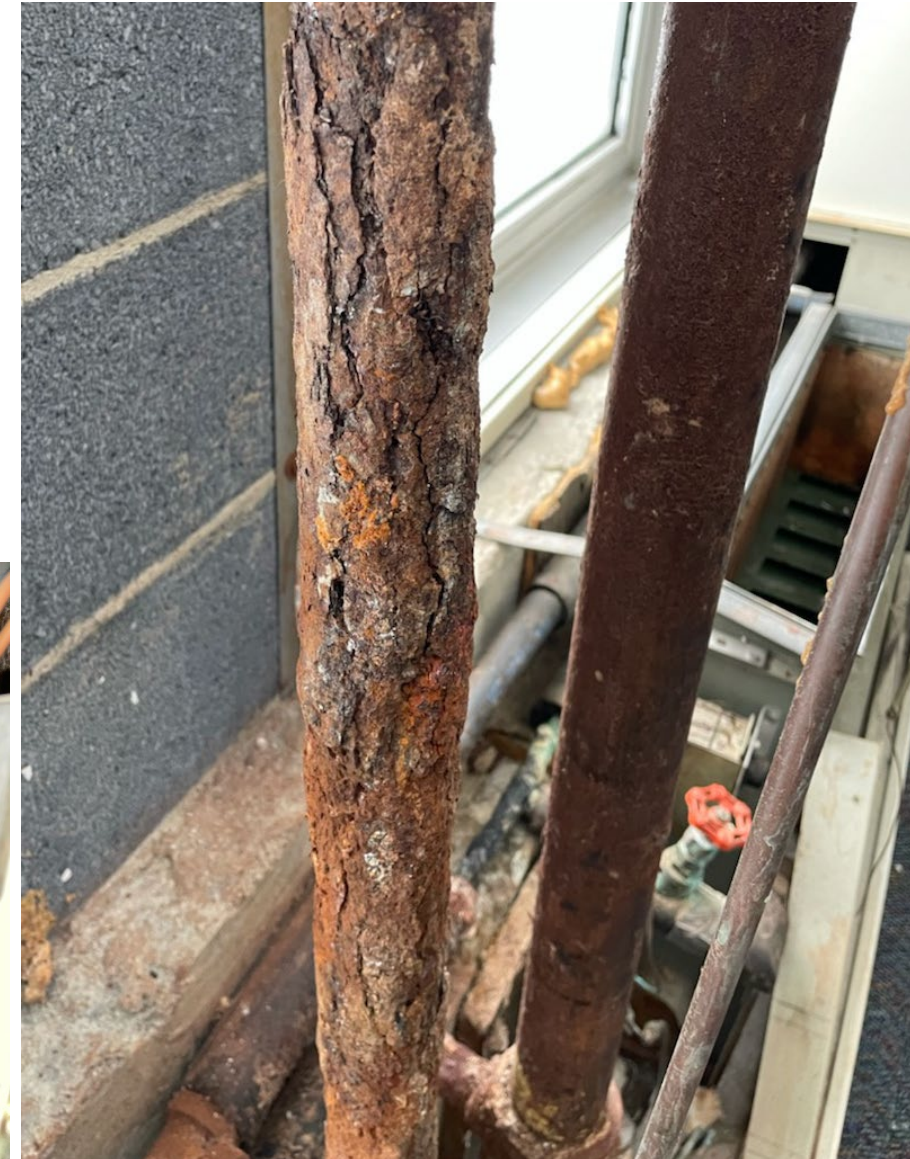
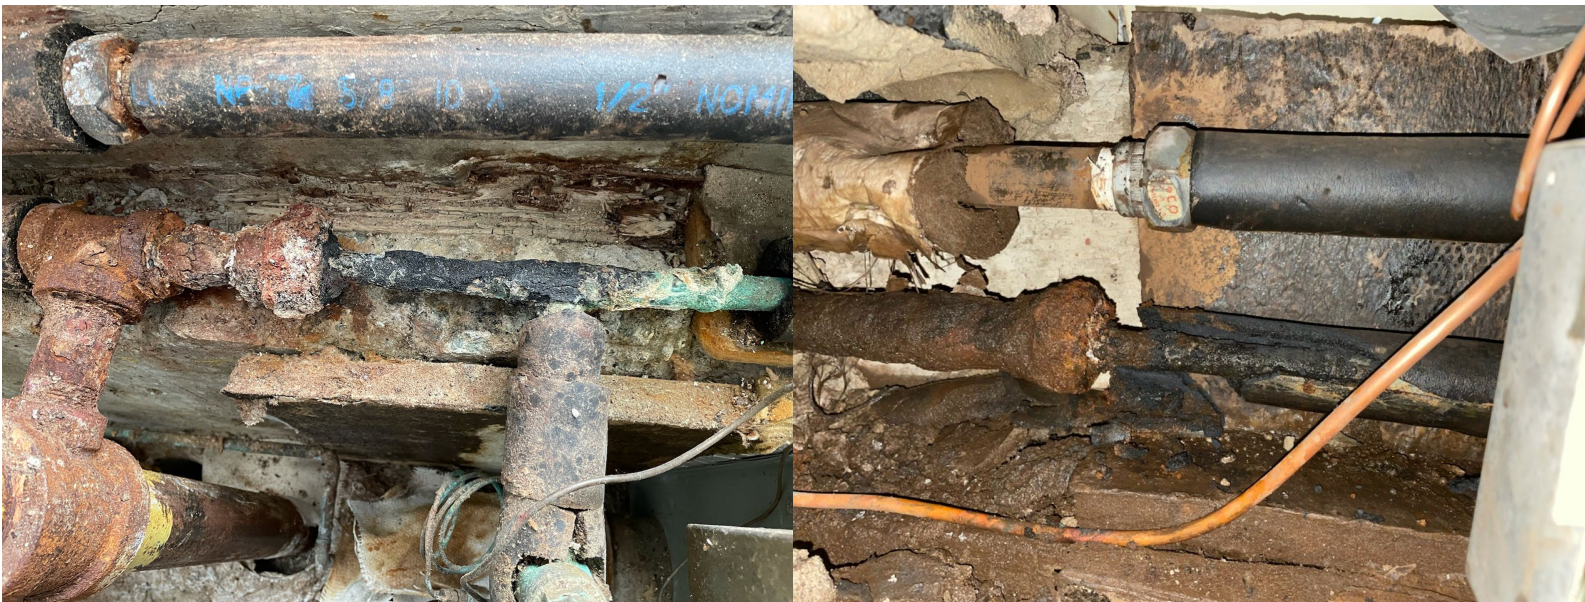
Impact Examples: Building 101 Water Leaks

Date: Ongoing; photos from DEC 2021

Cause: Failing heating water risers and dielectric fittings for floors 2-11, failed mechanical piping fittings for 1st Floor Human Resources spaces

Damage: 2-5 floods annually in tower, 1-2 floods annually on 1st floor

Impact: Office spaces unavailable for use in NIST headquarters building & disruptions to daily functions as well as remediation expenses.

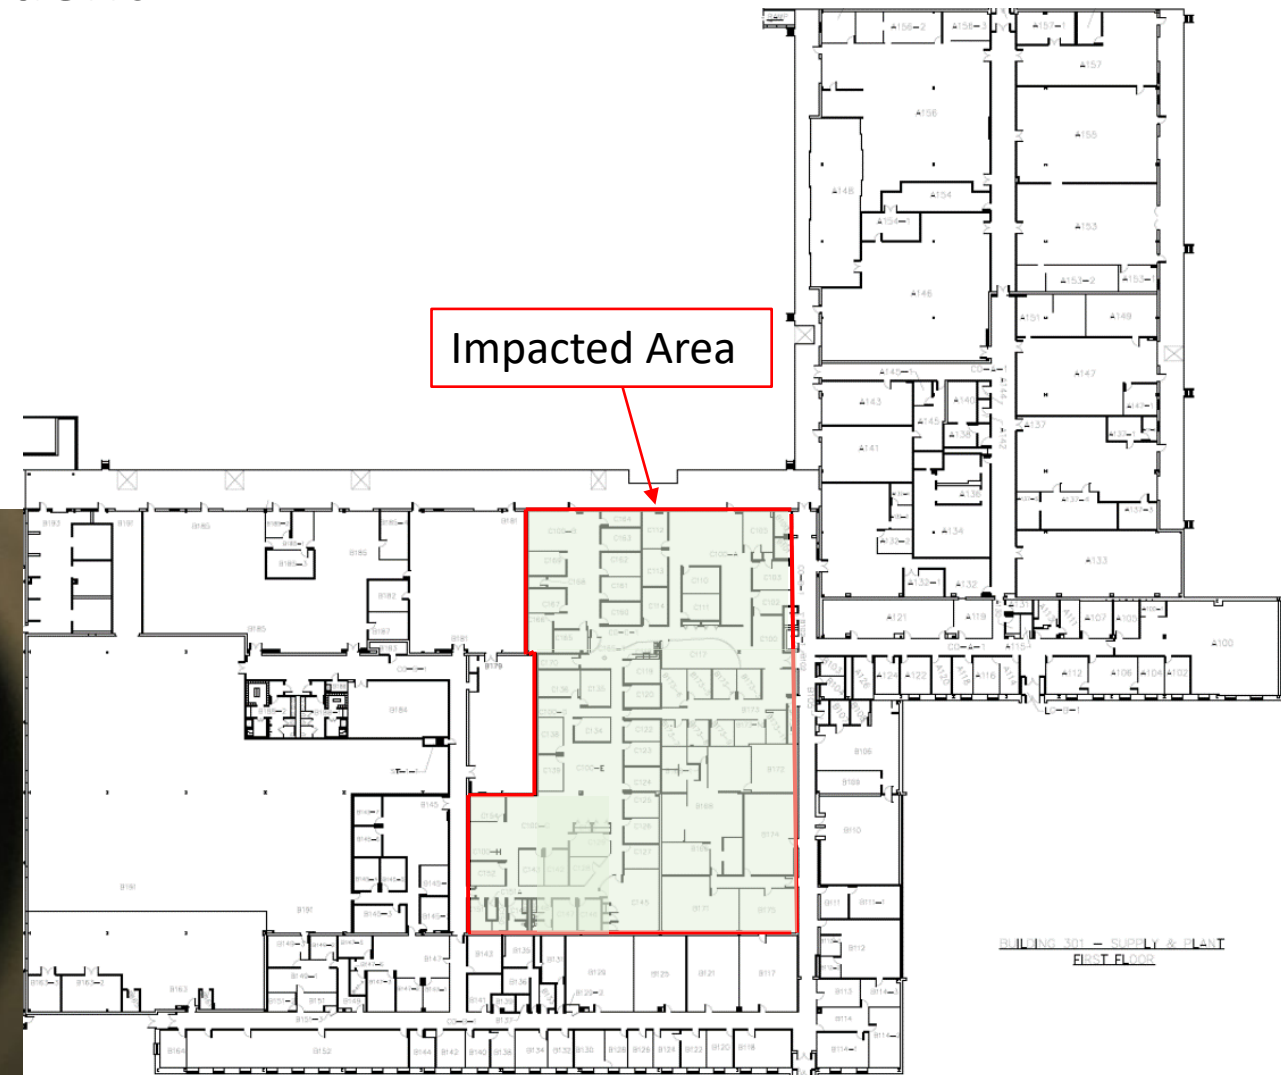
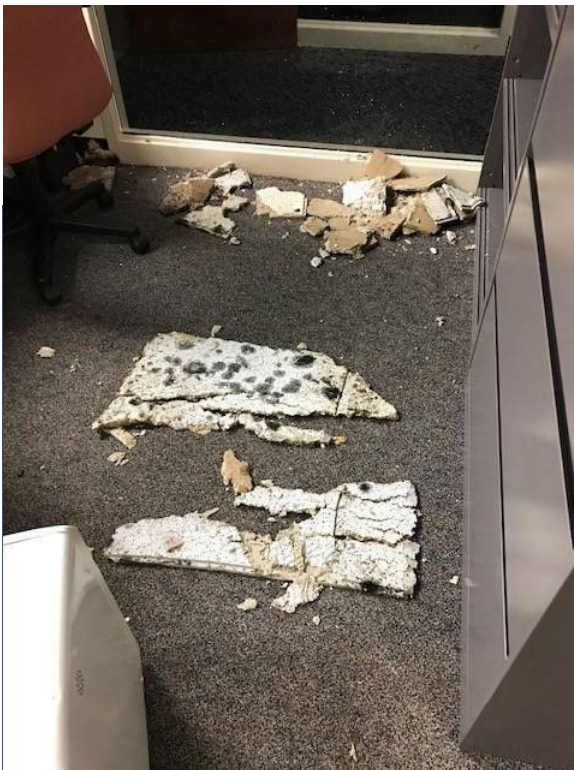
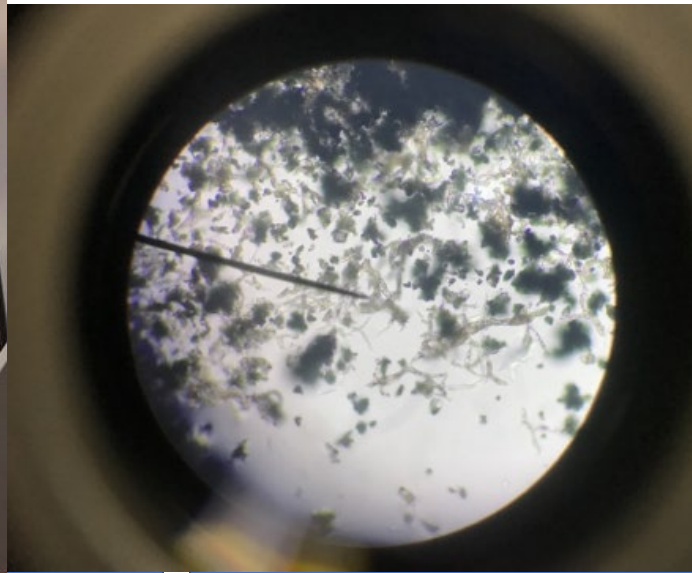
Impact Examples: Building 301 Mold Incident

Date: Fall 2018: Evacuation notice on OCT 12, 2018

Cause: Leaking HVAC system, piping in overhead

Damage: Required complete remediation of impacted area

Impact: Nearly 80 staff received evacuation notice. Almost 3 years to move back into space. >\$6M in direct costs.

Impacted Area

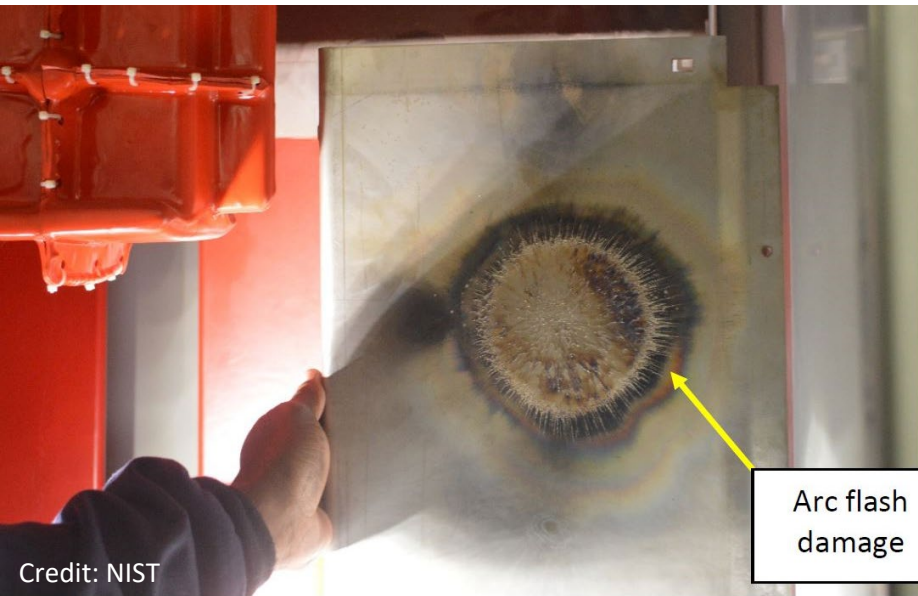
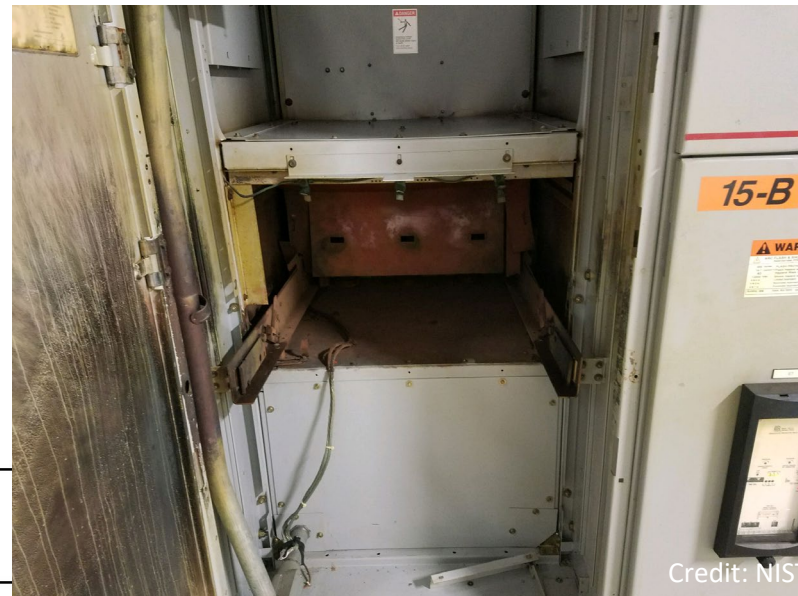
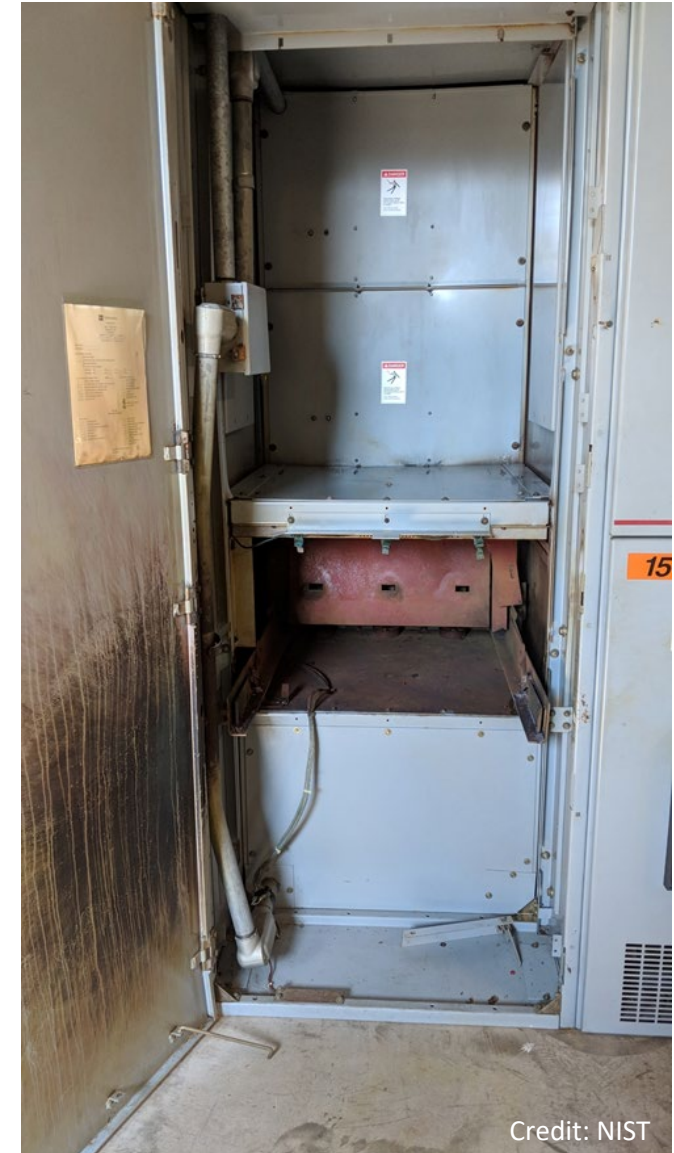
Impact Examples: (G) Electrical Substation

Arc Flash

Date: May 17 & June 13, 2018

Cause: Lack of preventive maintenance

Damage: 2 switchgear cubicles destroyed

Impact: Power bumps across the Gaithersburg campus with unknown impacts to research projects or equipment.

Figure 6: Arc flash evidence on the inner side of the inner panel.
