NCST Technical Investigation of Hurricane Maria (Puerto Rico)

Performance of Critical Buildings Project

Objective: To characterize the performance of critical buildings in Hurricane Maria by evaluating damage and loss of function for representative hospitals, schools, and storm shelters with respect to the hazards they experienced, including an evaluation of selection criteria and design requirements for storm shelters.

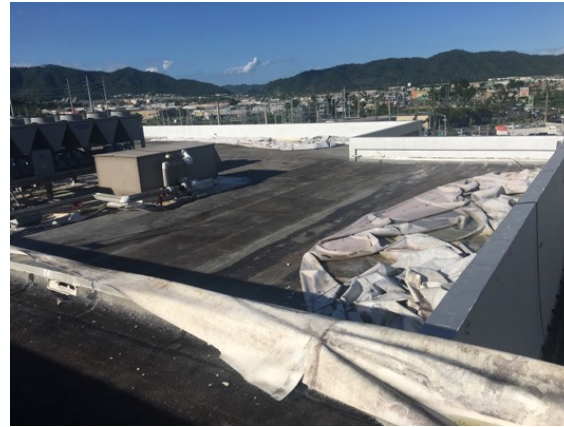
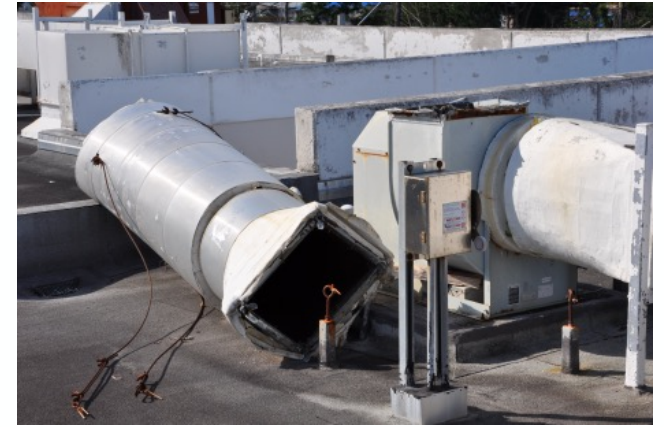
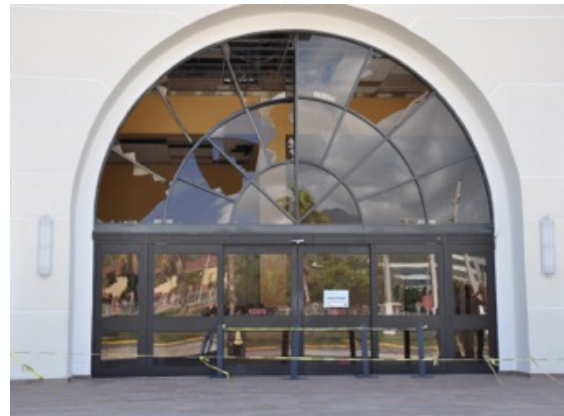
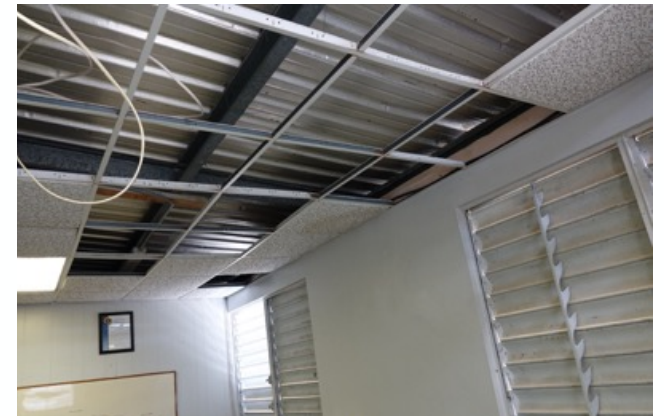
Many engineered buildings with good structural performance suffered extensive ***nonstructural damage*** and ***loss of function*** due to rainwater penetration of the building envelope, caused by:

- roof covering and rooftop equipment damage from wind and windborne debris;
- window and door damage caused by wind and windborne debris;
- rainfall ponding on the roof due to excessive rainfall rates and debris blocking drains; and
- wind-driven rain penetration through undamaged cladding, such as windows and doors.

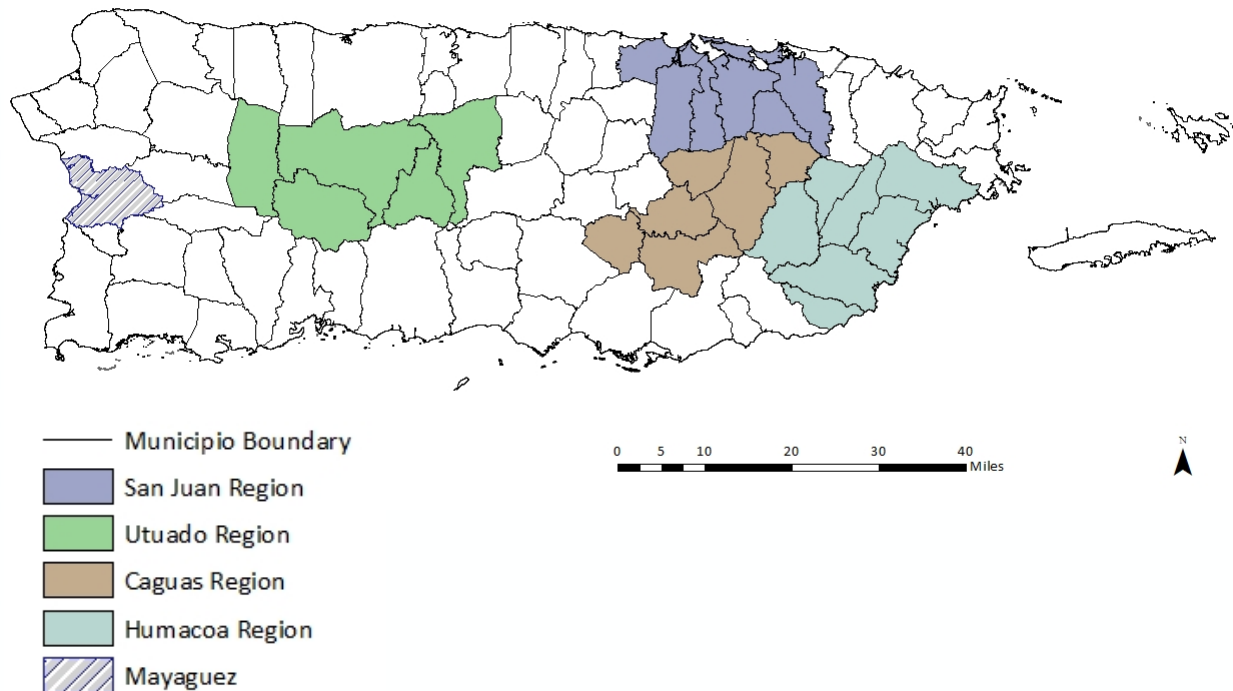
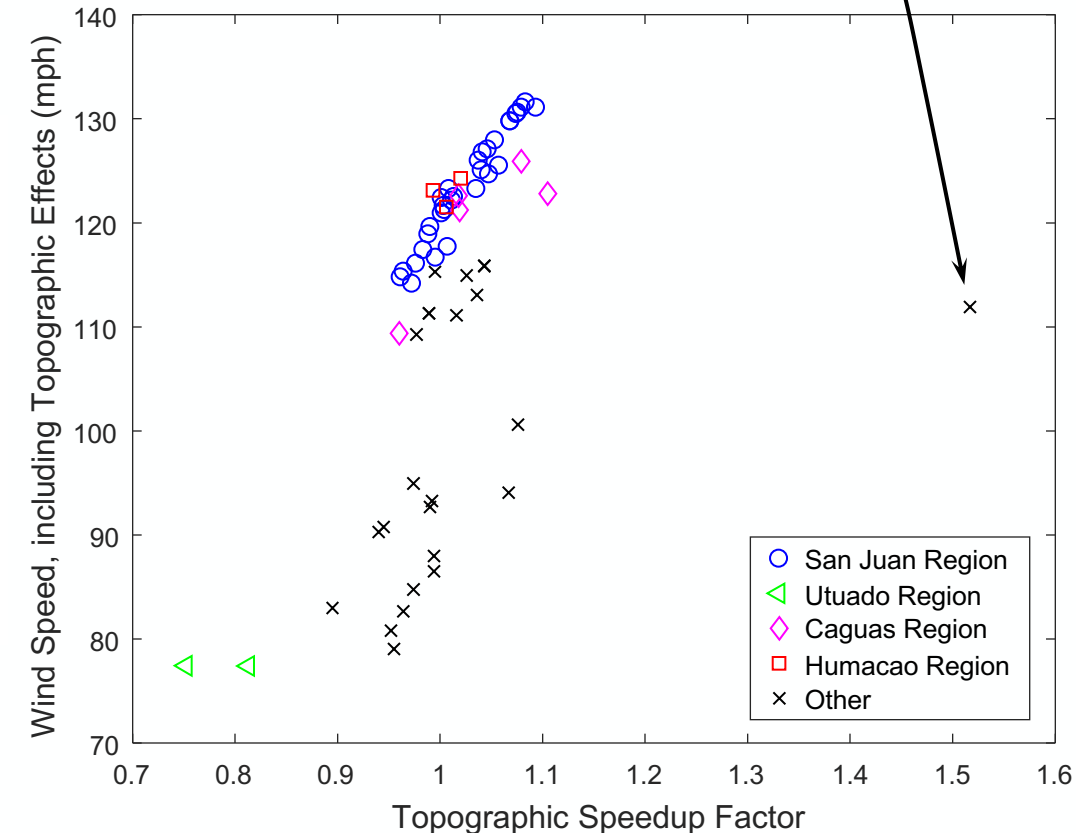
- Selecting hospitals from each region provides variation in the hazard exposure:
 - Lowest wind speeds in Utuado region (topographic sheltering)
 - Highest wind speeds in San Juan region
- Highest topographic speedup factor for Hospital Bella Vista in Mayagüez

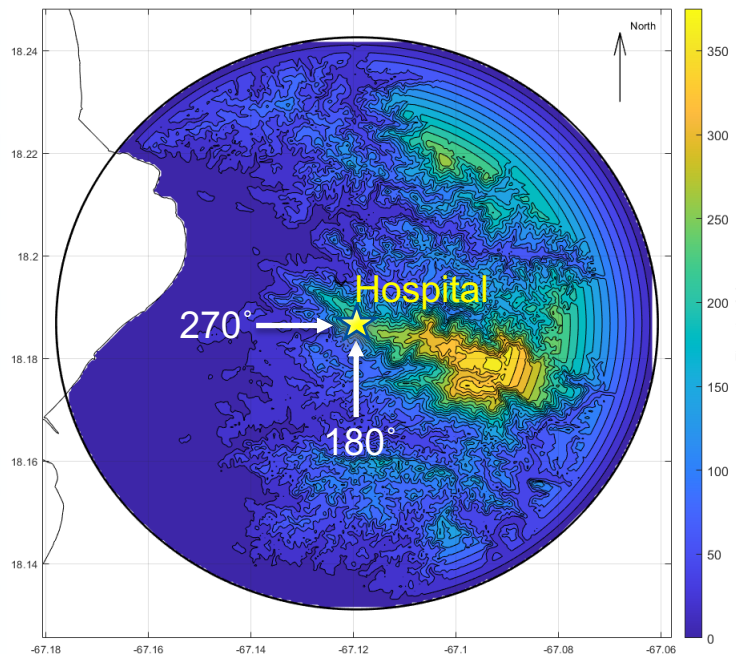
Topographic Model of Mayaguez

- Hospital Bella Vista planned as first facility for wind tunnel testing
- Plans developed to characterize topographic effects on incoming flow:
 - Topographic model of Mayaguez region to be tested at 1:3100 scale
 - Flow field at hospital site to be measured using Particle Image Velocimetry (PIV) for wind angles from 180° to 360° in 10° increments
- Design of model, measurement systems, and testing plan in progress
