## Common ADA Discrepancies

### **ADA Inspections Nationwide, LLC**

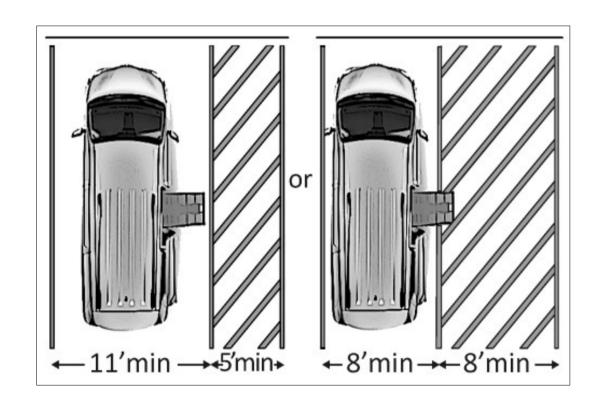
## Van Accessible Parking Spaces

One out of every six ADA parking spaces must be
 Van Accessible

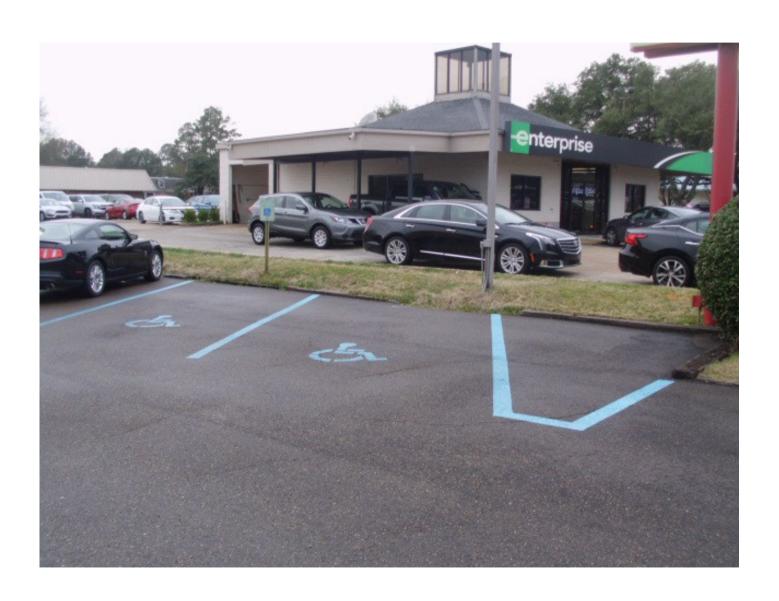
# One Sign Missing

# Each ADA Parking Space Must Have a Vertical Sign

- Can be posted at the end of the parking space, or
- Can be attached to the building
- Must 60 inches above the surface

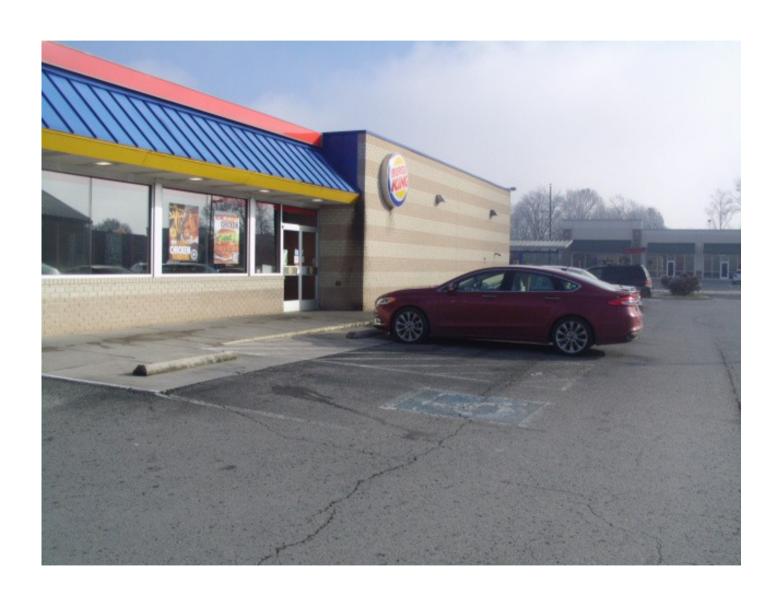
# **Both Signs Missing**

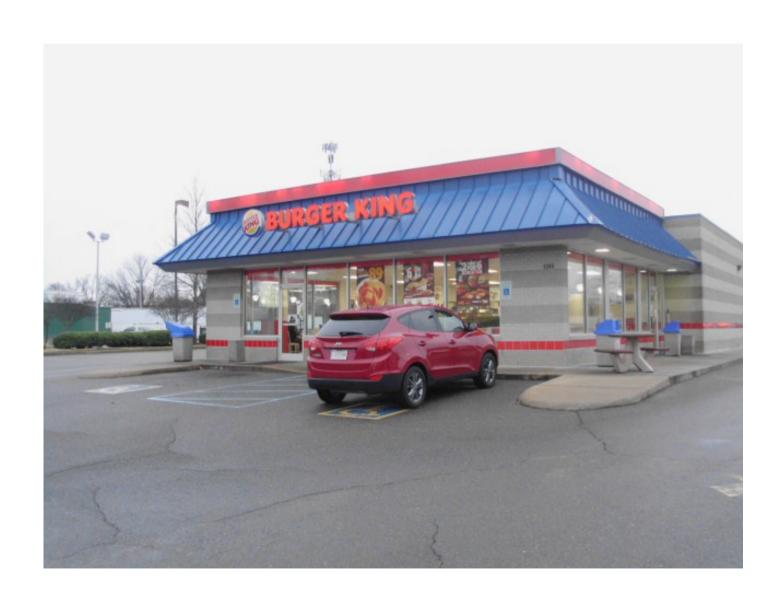
# Twp Spaces, Two Signs, Good!

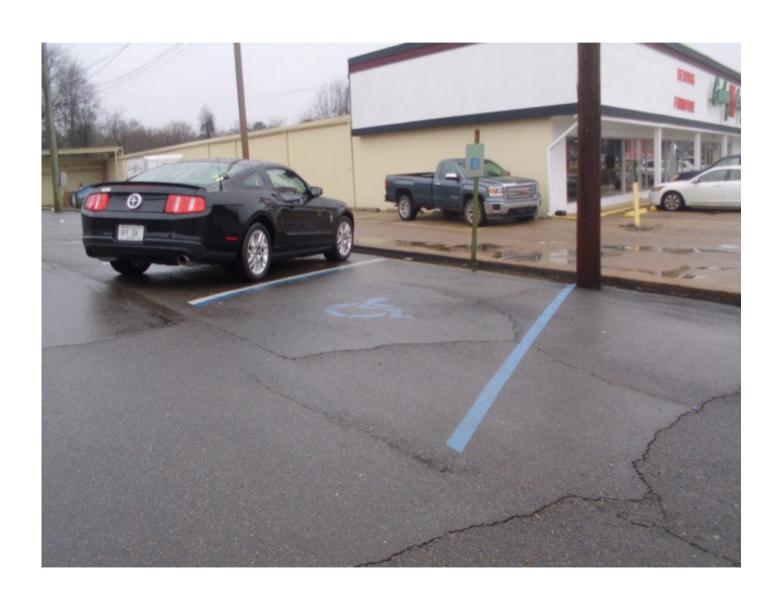
# Excessive Slope at 5%

Maximum slope or grade across the parking spaces and aisle(s) is 1:48, or 2.08%, any direction

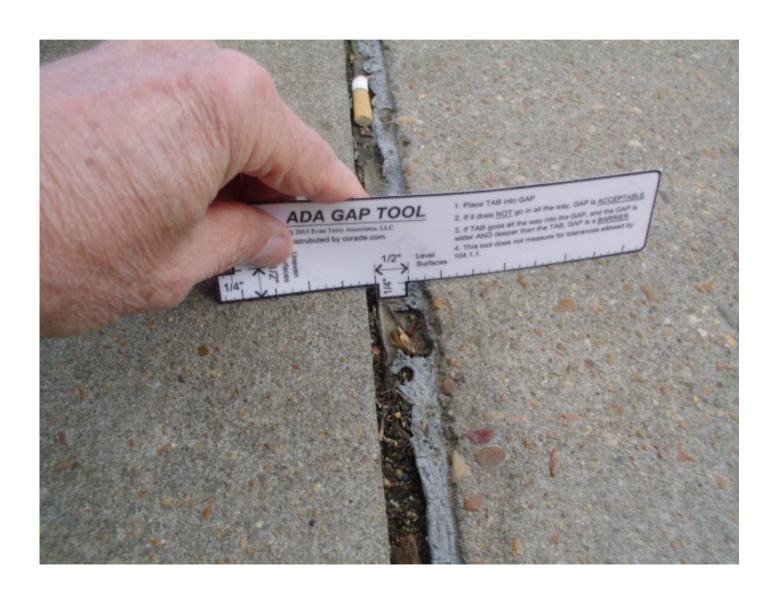
# **Excessive Gap or Vertical**

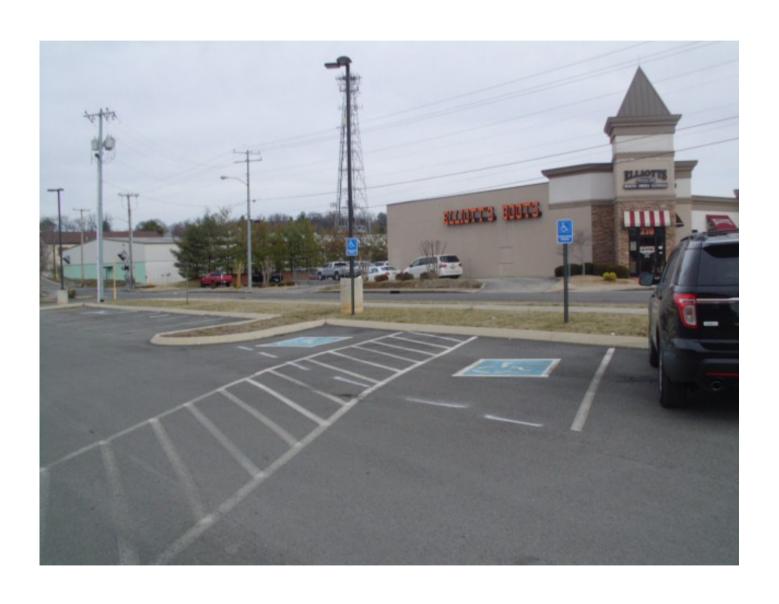
# Parking Aisle Example

- Parking space aisles must be at least 60 inches wide
- Aisle must be marked
- Two spaces can share an aisle
- Aisles shall adjoin an accessible route

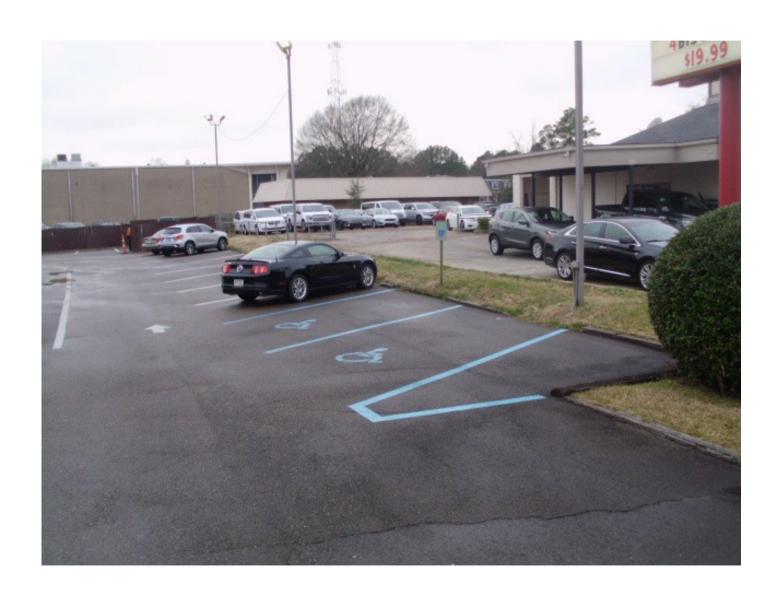
# Missing Parking Aisle

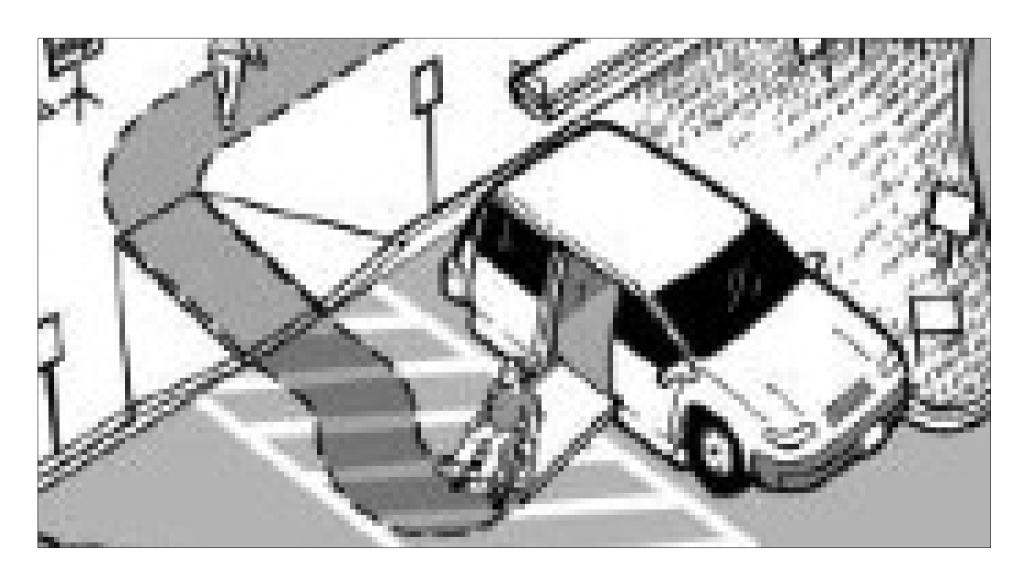
# Parking Space Aisle Must Connect to an Accessible Route

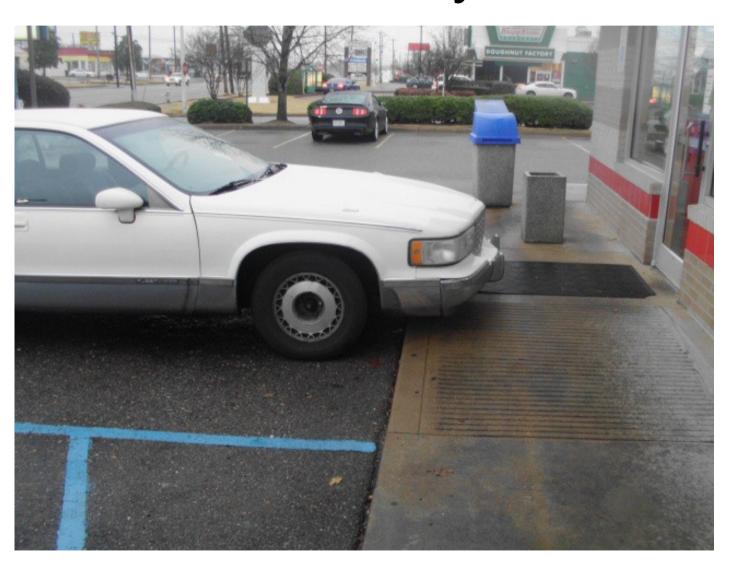
# Vehicle Cannot Overrun the Walkway

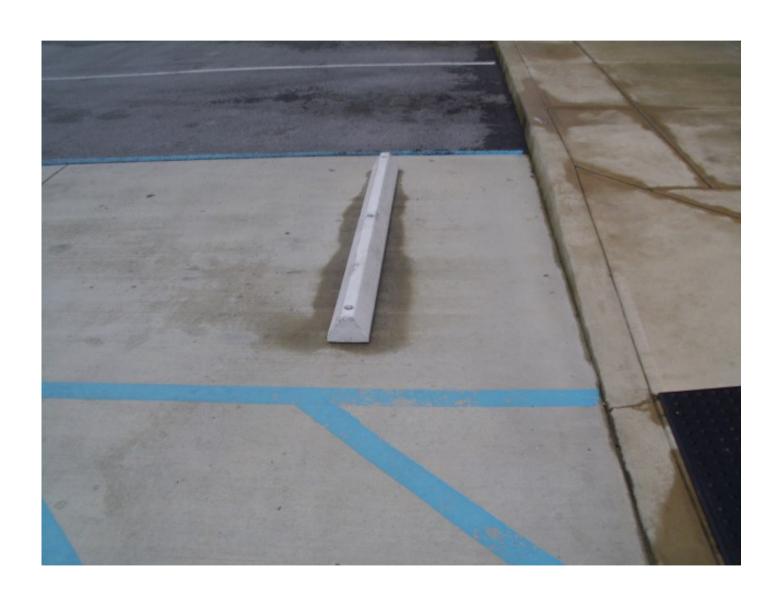
# Install Wheel Stops

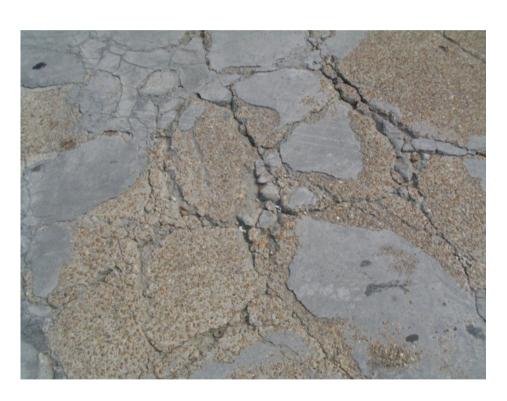
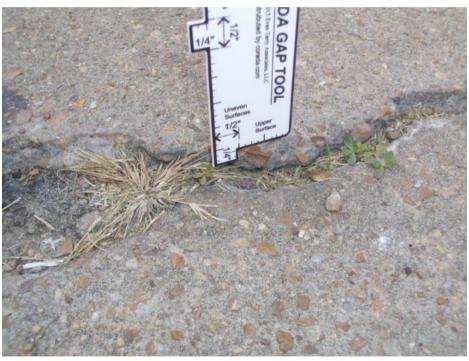
# **Excessive Abrupt Vertical Change**

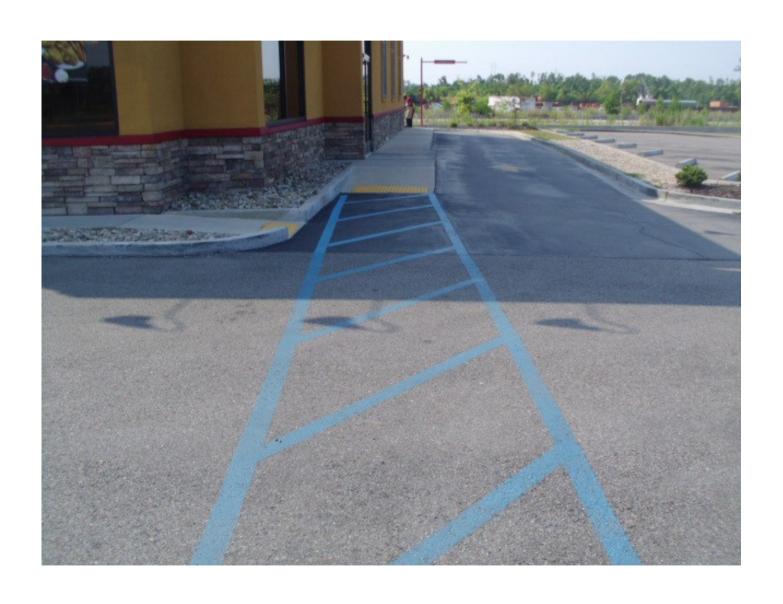
# Good Looking Route

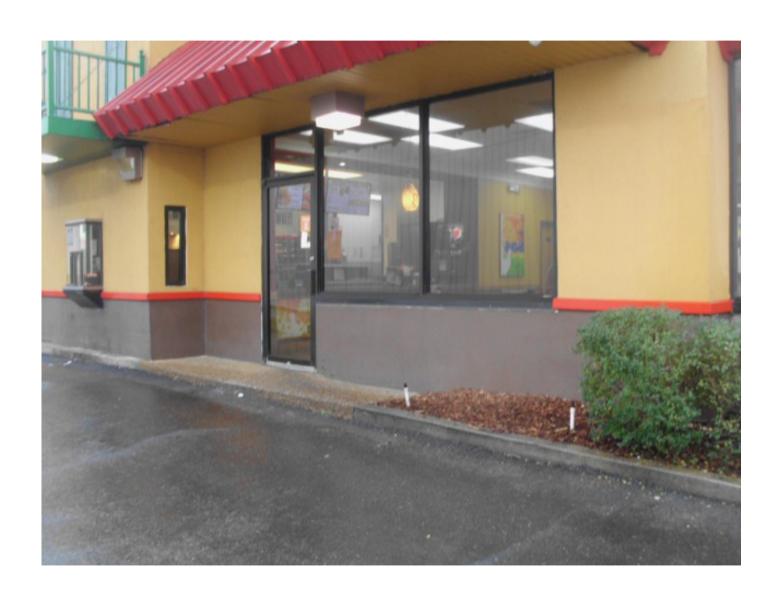
### Route To Nowhere

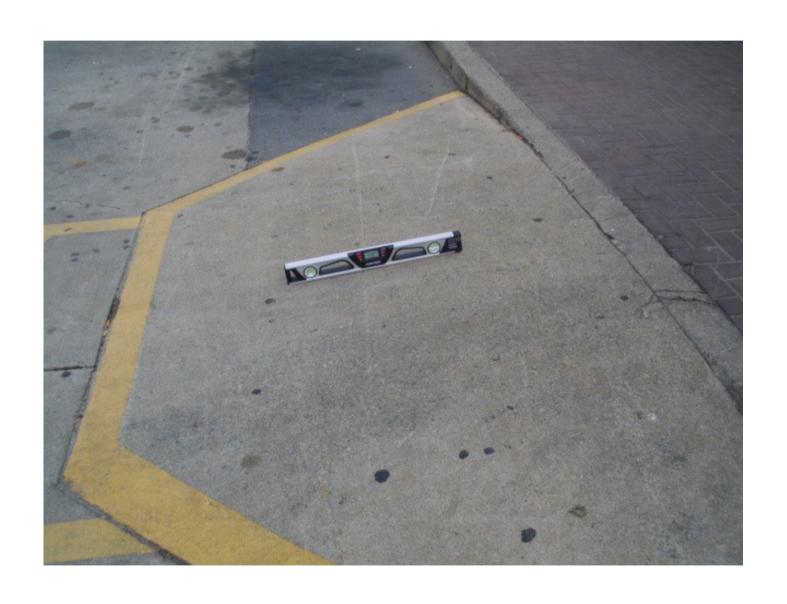
# Steep Curb Ramp [11%]

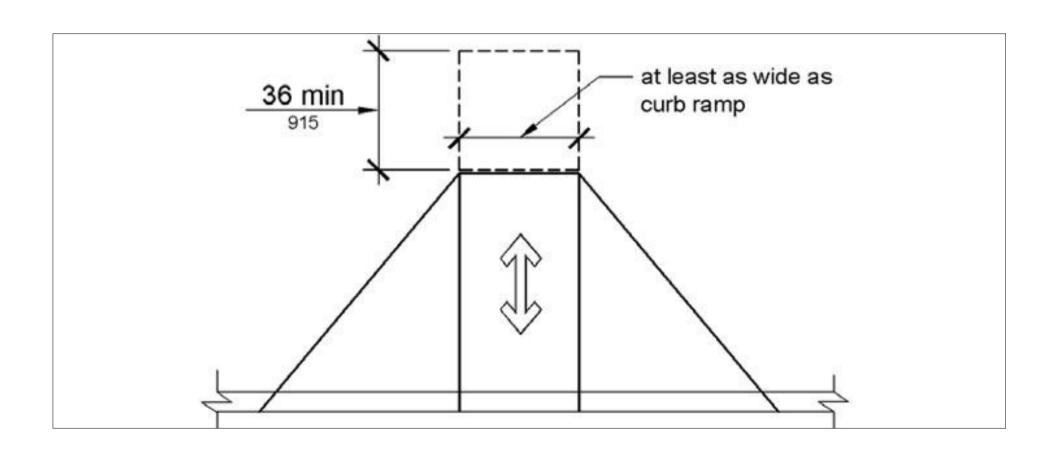
## Flat Landing Needed at the End

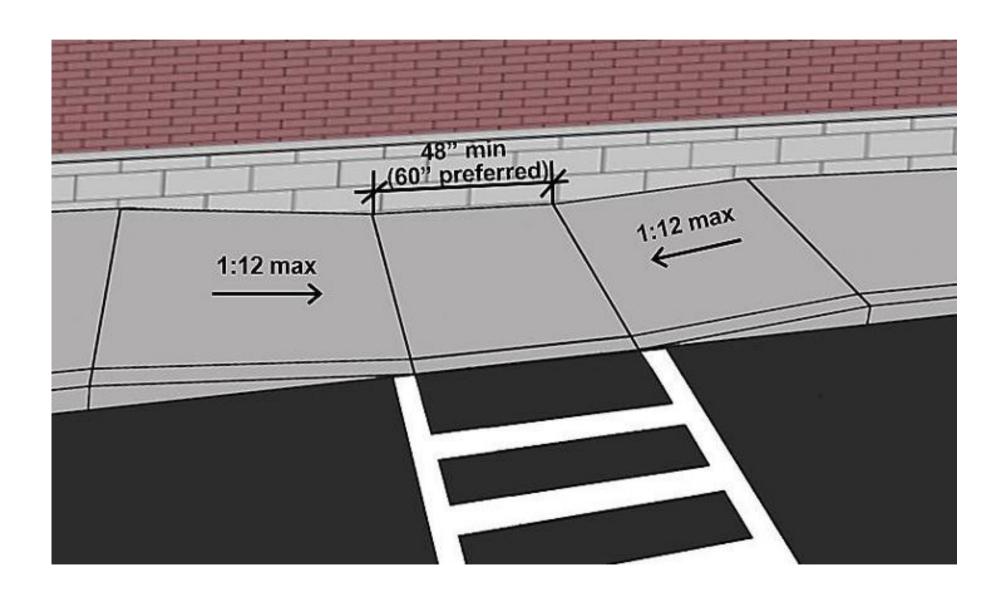
#### No Room? Do This

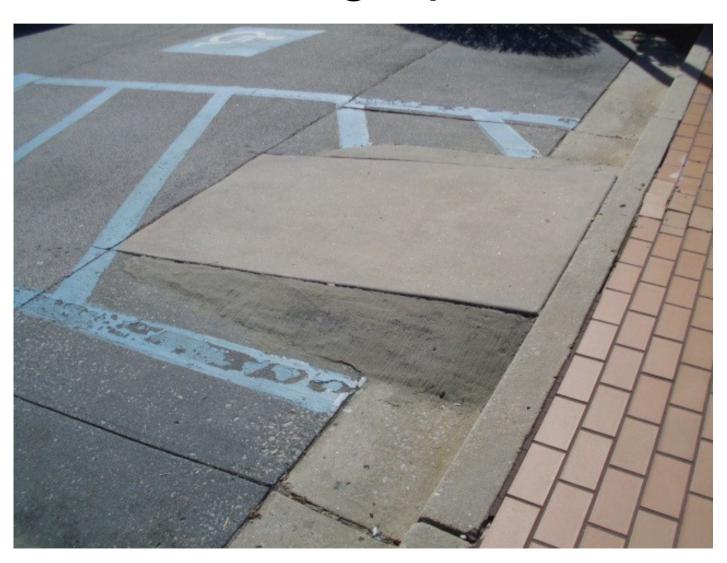
# Cannot Be Installed in Aisle or Parking Space

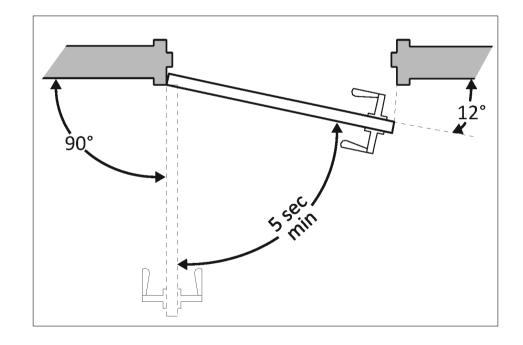
### Open/Close Door Issues

5# max to open interior doors

5 seconds min in closing test

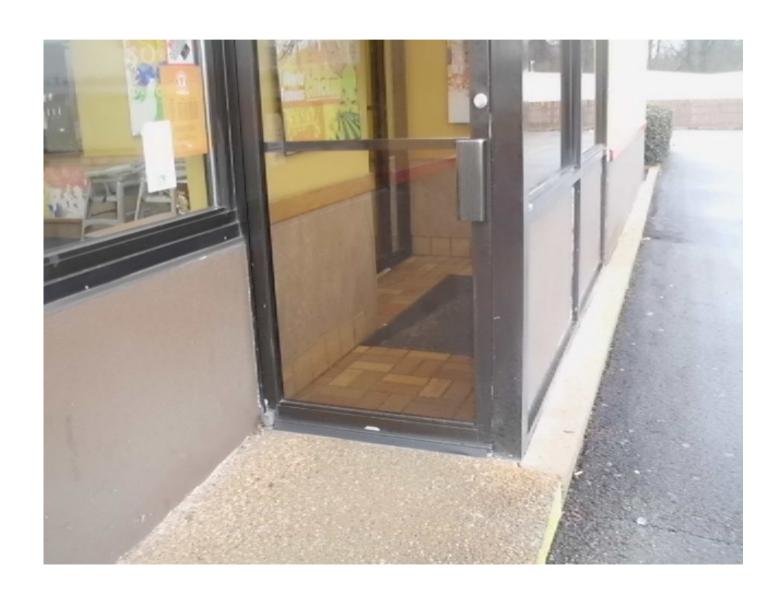
# Inadequate Maneuvering Space

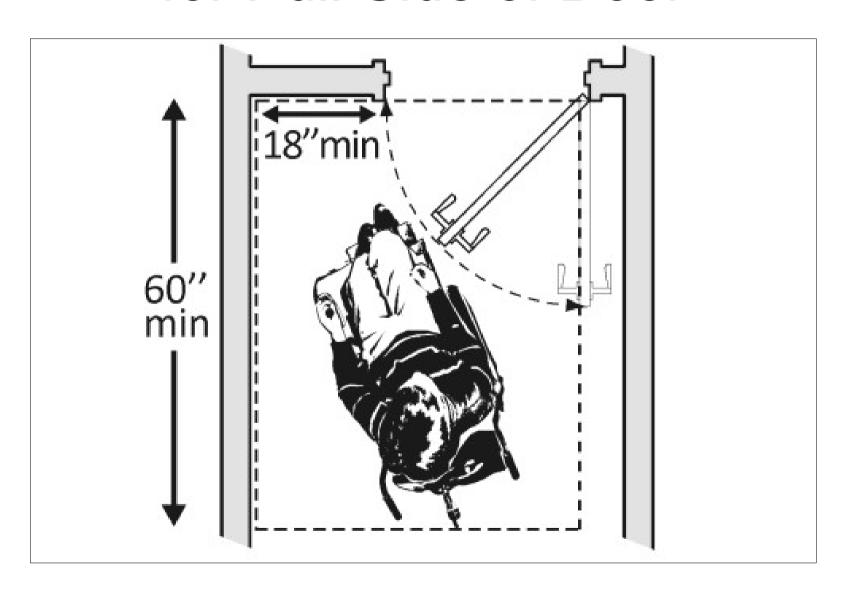
# Recommended Maneuvering Space for Pull Side of Door

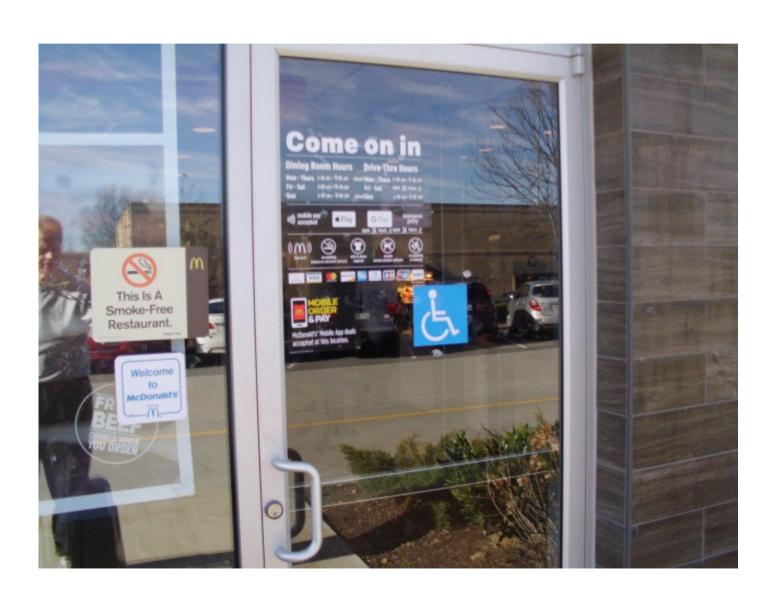
# ISA at Exterior Accessible Door(s)

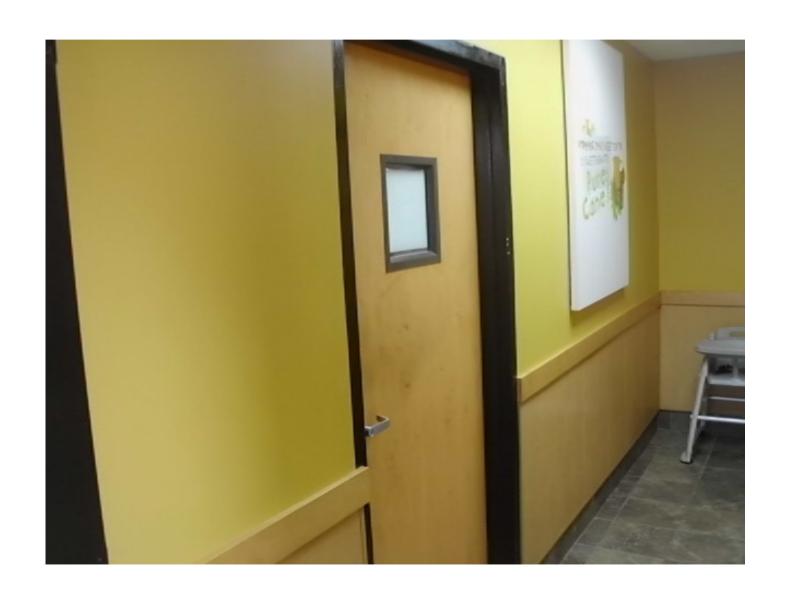
# Door Windows too High

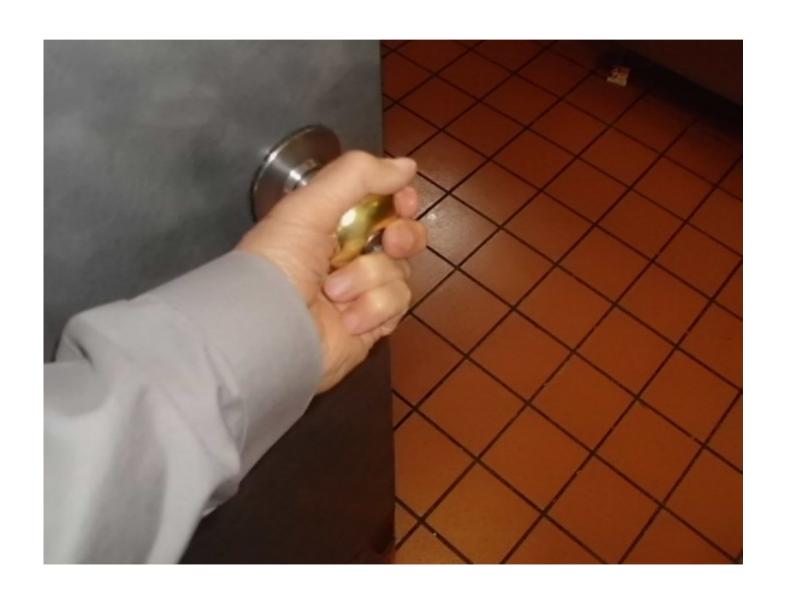
# Wrong Door Handle

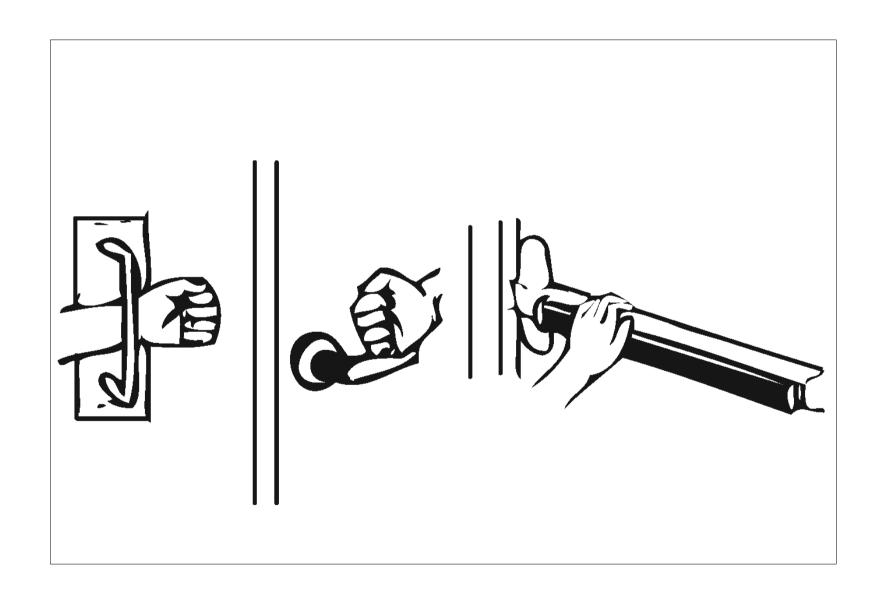
### Accessible Door Handles

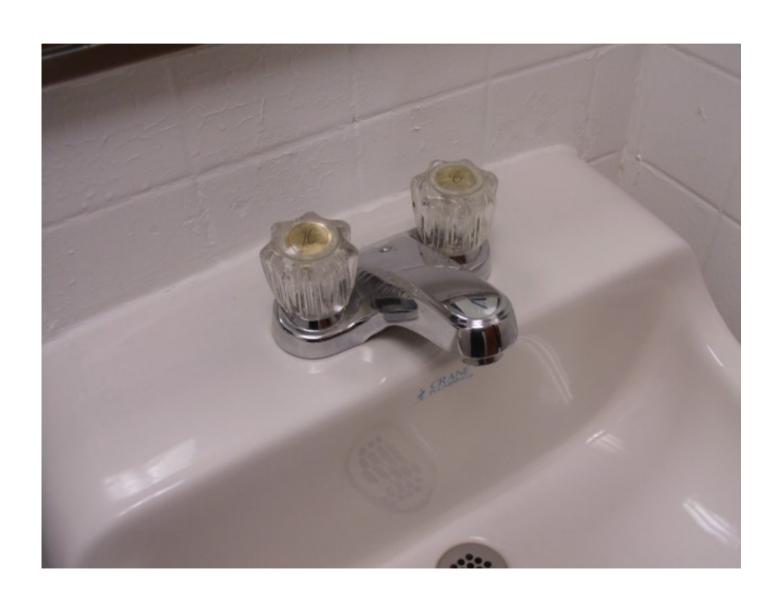
# Wrong Faucet Handles

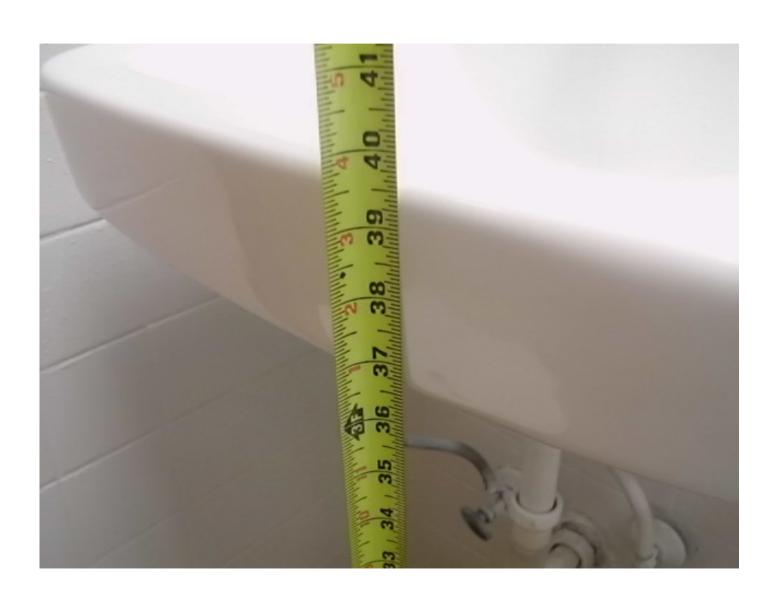
# Sink Installed Too High

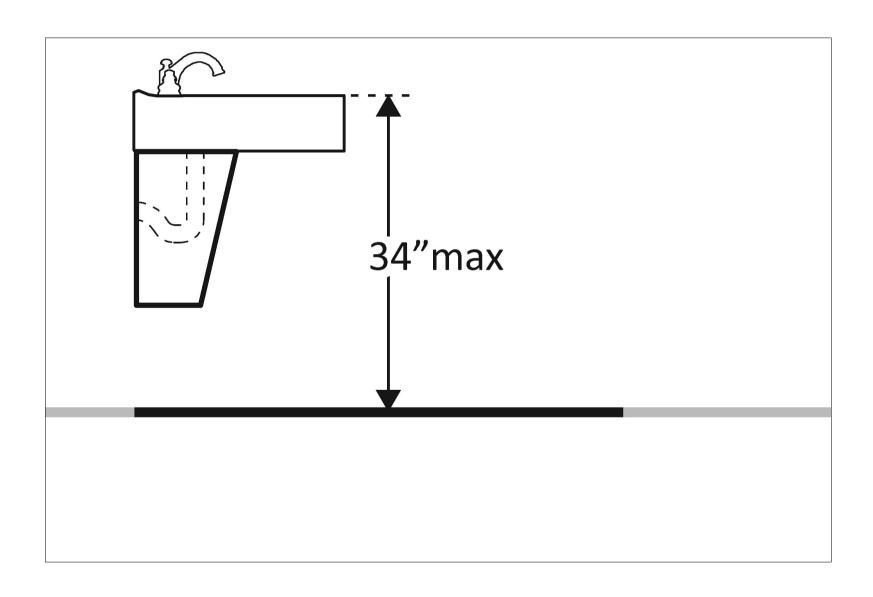
# Sink Height Maximum 34"

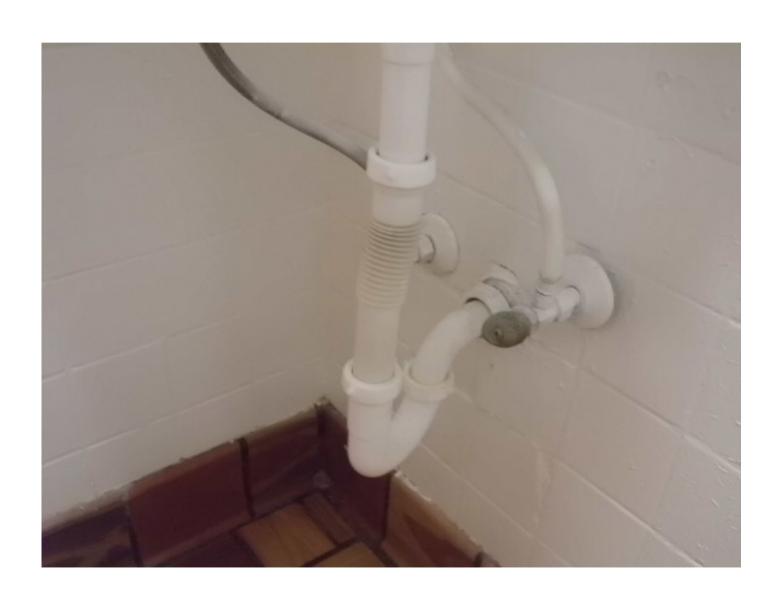
# Pipes Below Sink Exposed

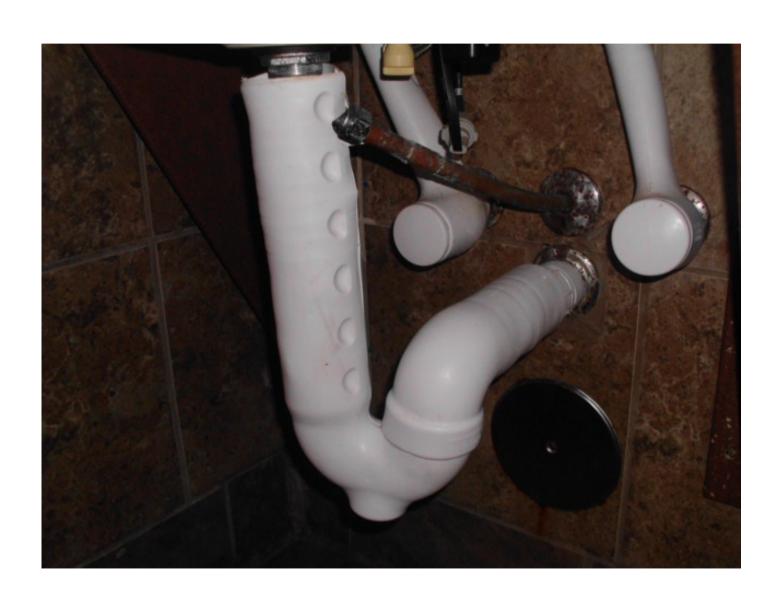
# Pipes Properly Covered

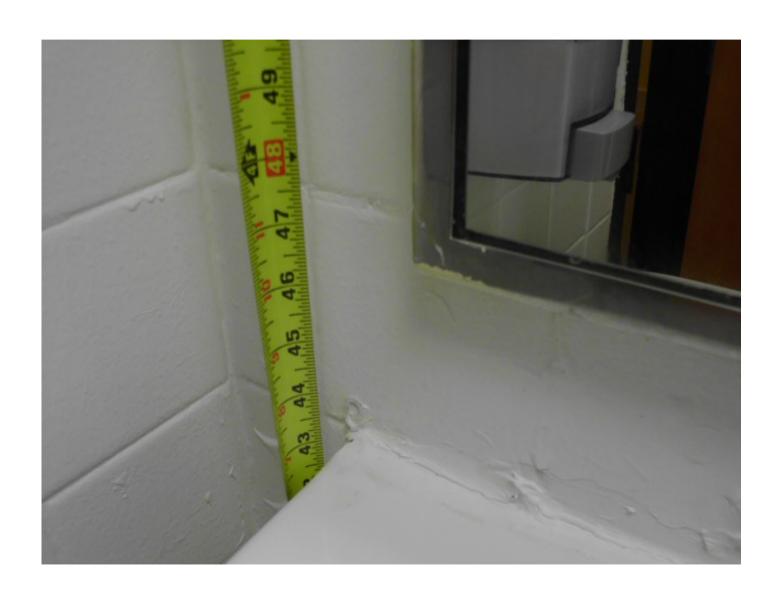
### Mirrors Installed Too High Above Floor

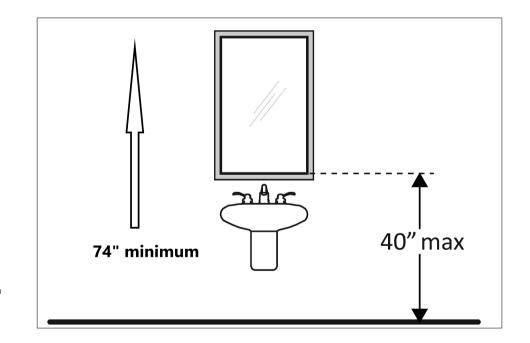
#### Mirror Installation

Should be 40 inches above the finished floor maximum

Top should be 74 inches AFF minimum.

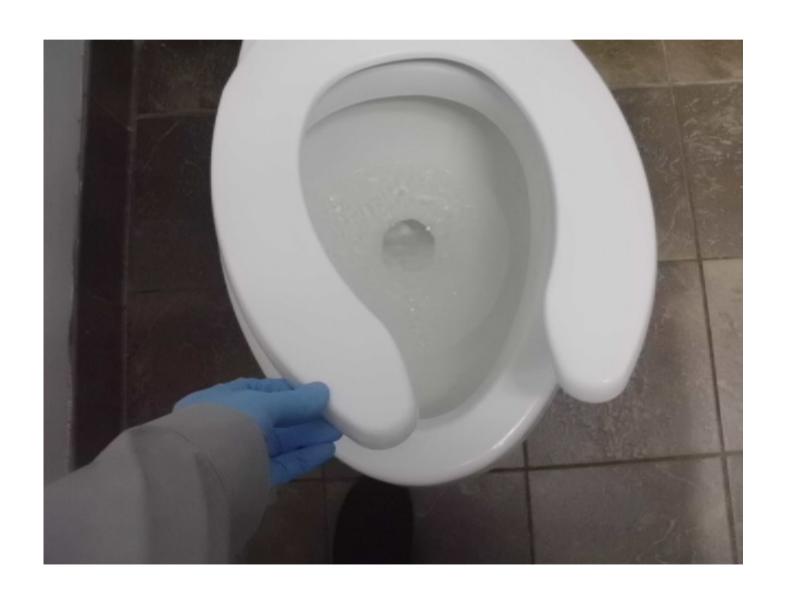
## **Loose Toilet Seat**

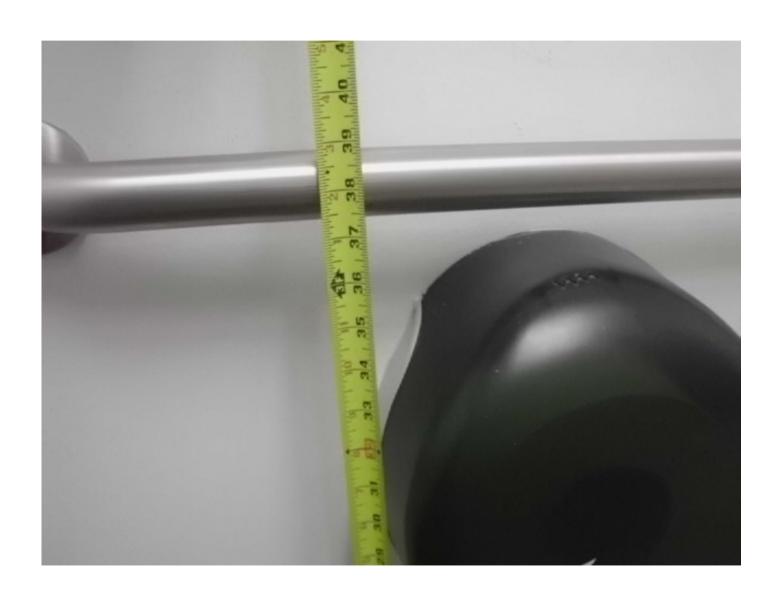
## Grab Bars Not Installed Correctly

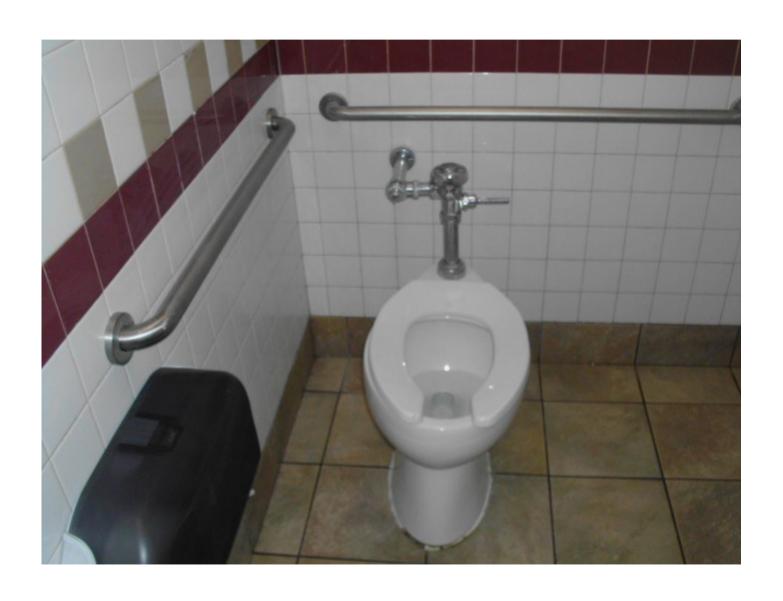
## **Grab Bars Reversed**

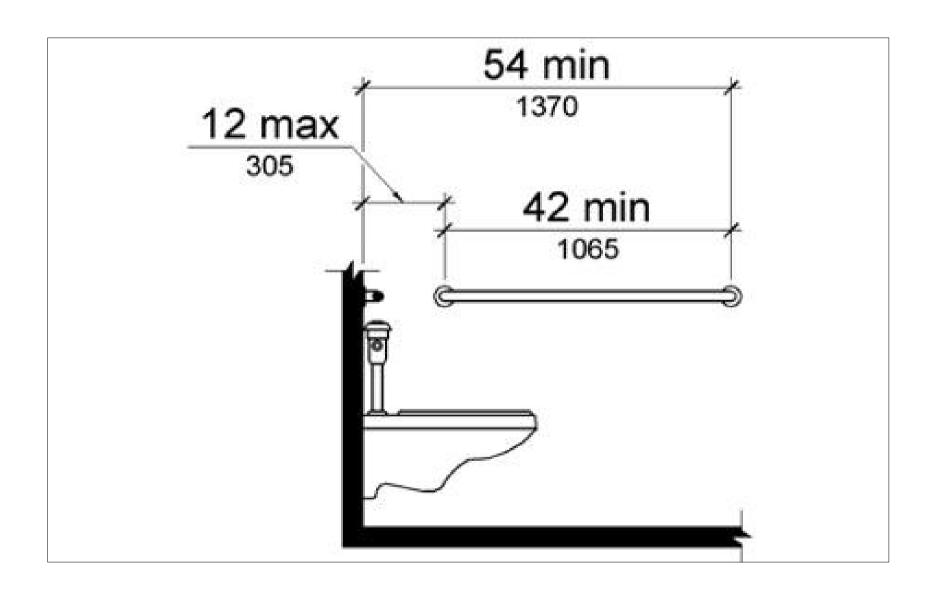
### Side Bar Schematic

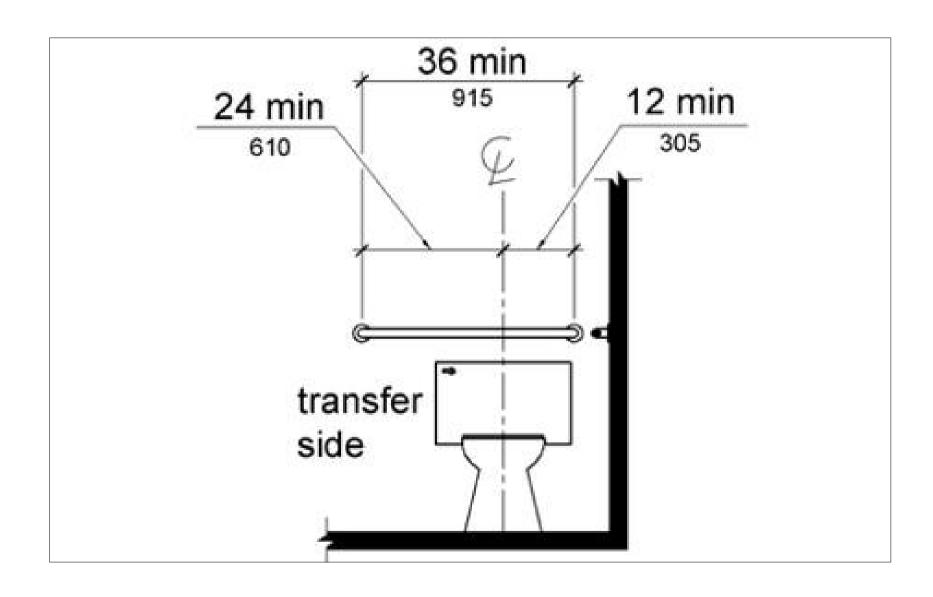
### Rear Grab Bar Schematic

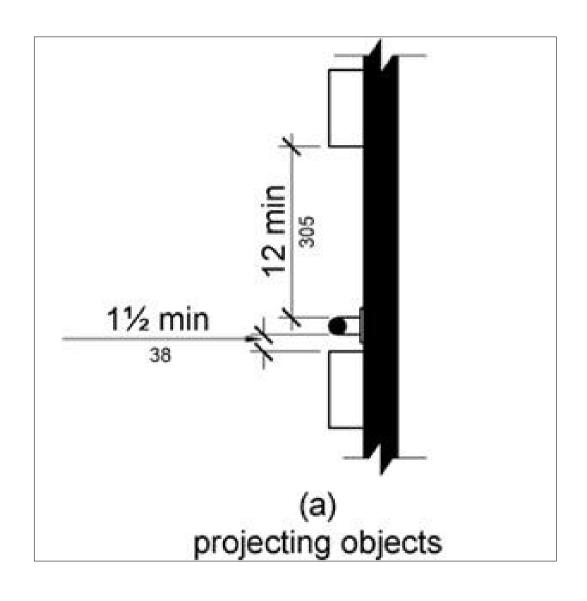
## Grab Bar Spacing for Projections

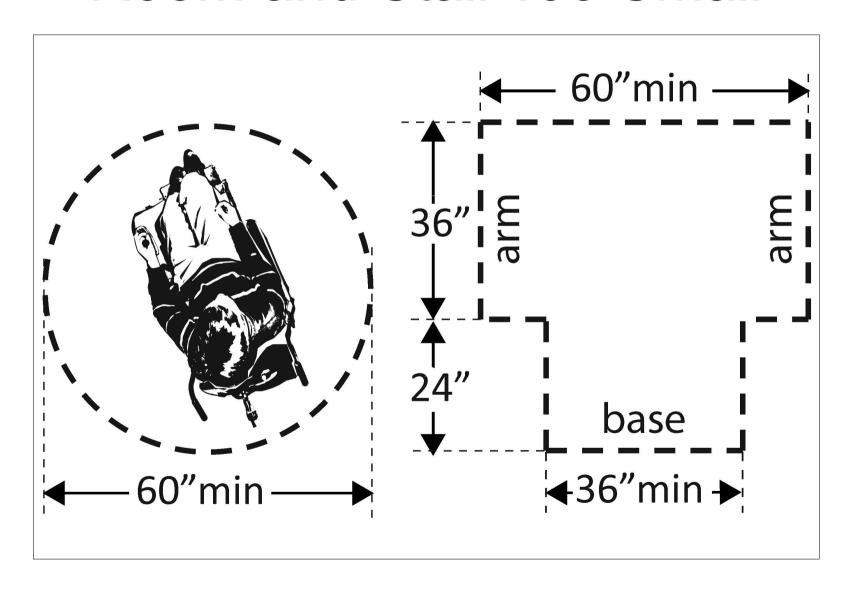
# 8. Maneuvering Space in Toilet Room and Stall Too Small

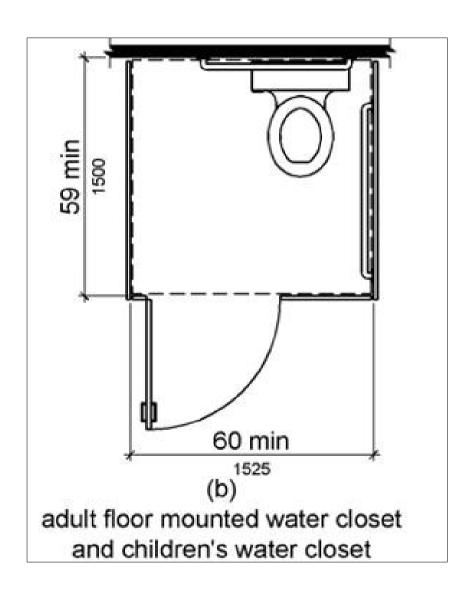
## **Toilet Stall Plan View**

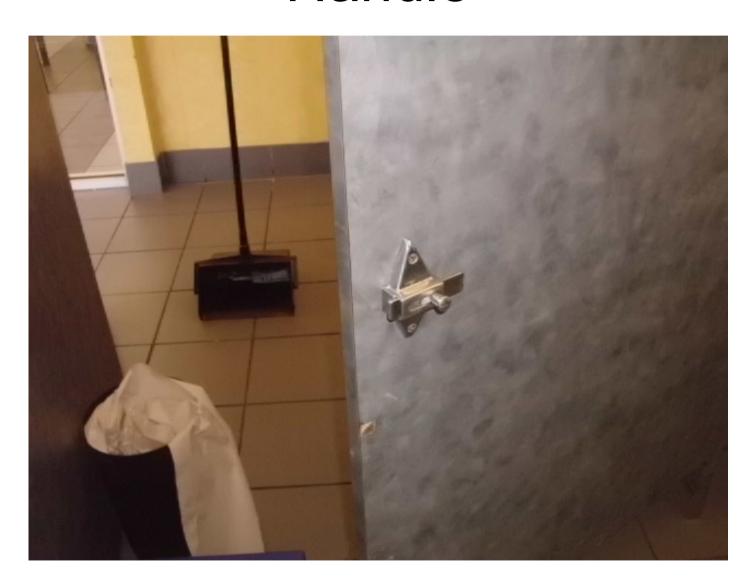
# Wrong, or Missing, Stall Door Handle

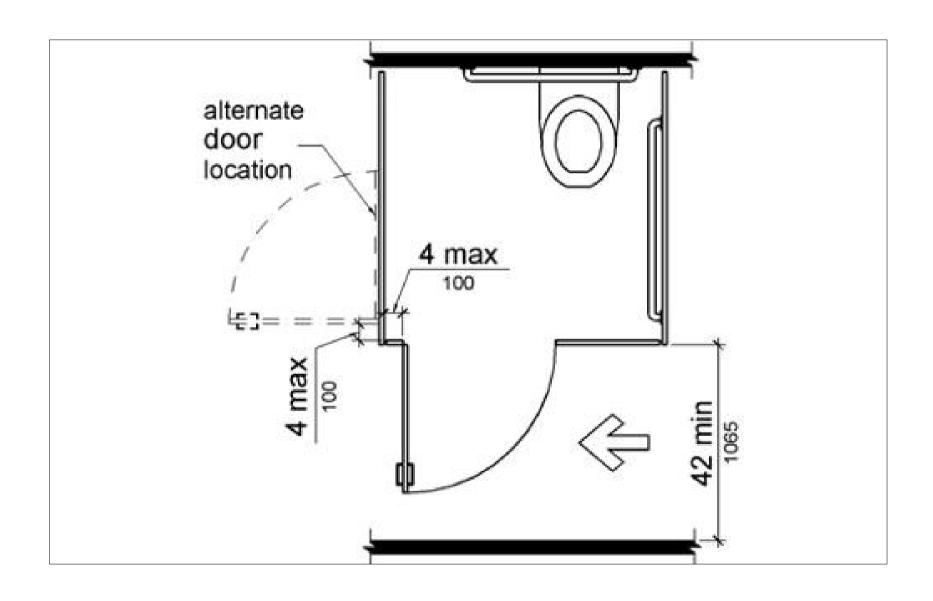
#### Inadequate Stall Door Maneuvering Clearance

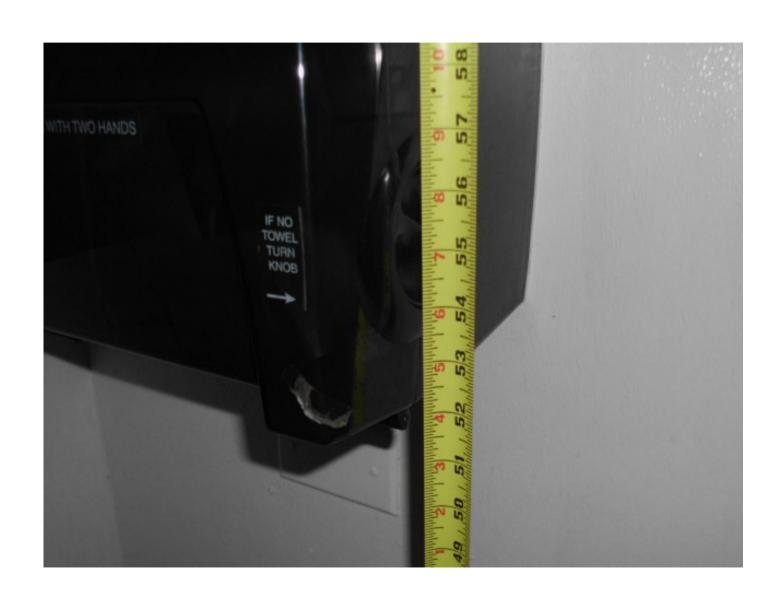
# Generally not Allowed Above 48"

# 10. Toilet Room Accessories Installed Too High Above the Floor

Accessories include coat hook, soap dispenser, paper towel dispenser, automated hand dryer, or light switch
