December 10, 2012
NCST Advisory
Committee Meeting

Technical Investigation of the May 22, 2011, Tornado in Joplin, MO

Emergency Communications and Public Response

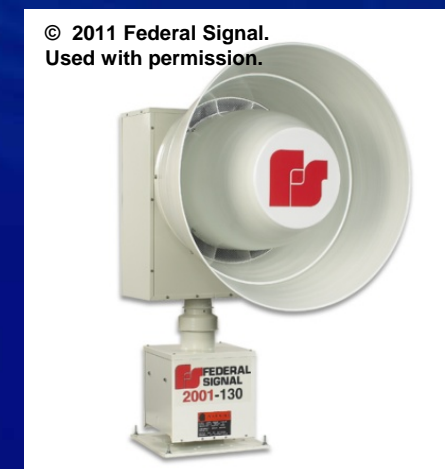
- Emergency communications systems
 - Outdoor warning sirens (Source: Joplin/Jasper County Emergency Management Agency)
 - 25 sirens in Joplin “zone,” all tied to the same system (if one activated, they all activated)
 - Tested weekly at 10:00 AM (CDT) on Mondays, sounded for 1 min only
 - Other channels (Source: Joplin/Jasper County Local Emergency Operations Plan)
 - Primary and local Emergency Alert System (EAS) TV and radio stations
 - Reverse 911
 - NOAA Weather Radios

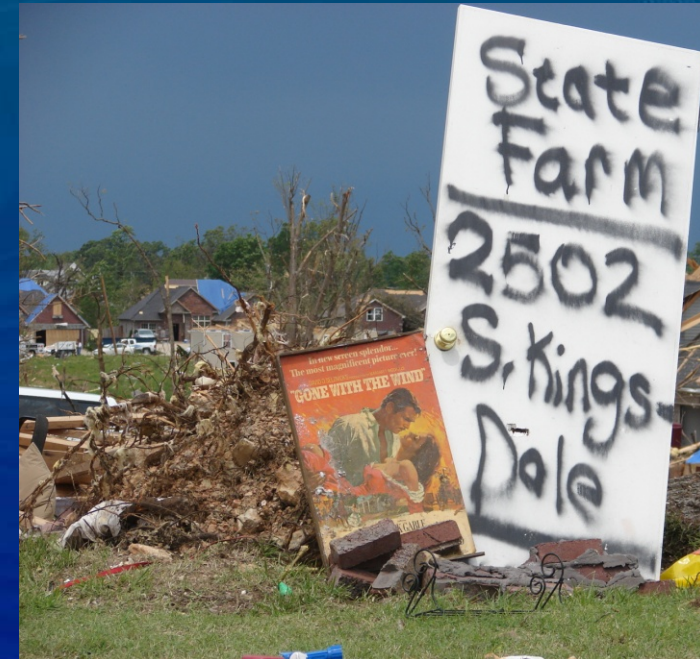
- Survivors' Behavior
 - Sirens – alert rather than warning
 - People did not react until perceiving danger or being told to take action
 - only a few risk averse, hypervigilant
 - Residents delayed taking protection (limiting shelter options)
 - some did not take shelter in time
- Conceptual model developed of human behavior during Joplin, MO tornado
