**Federal Building and Fire Safety Investigation
of the World Trade Center Disaster**

**Visual Evidence, Damage Estimates, and Timeline
Analysis**

September 14, 2005

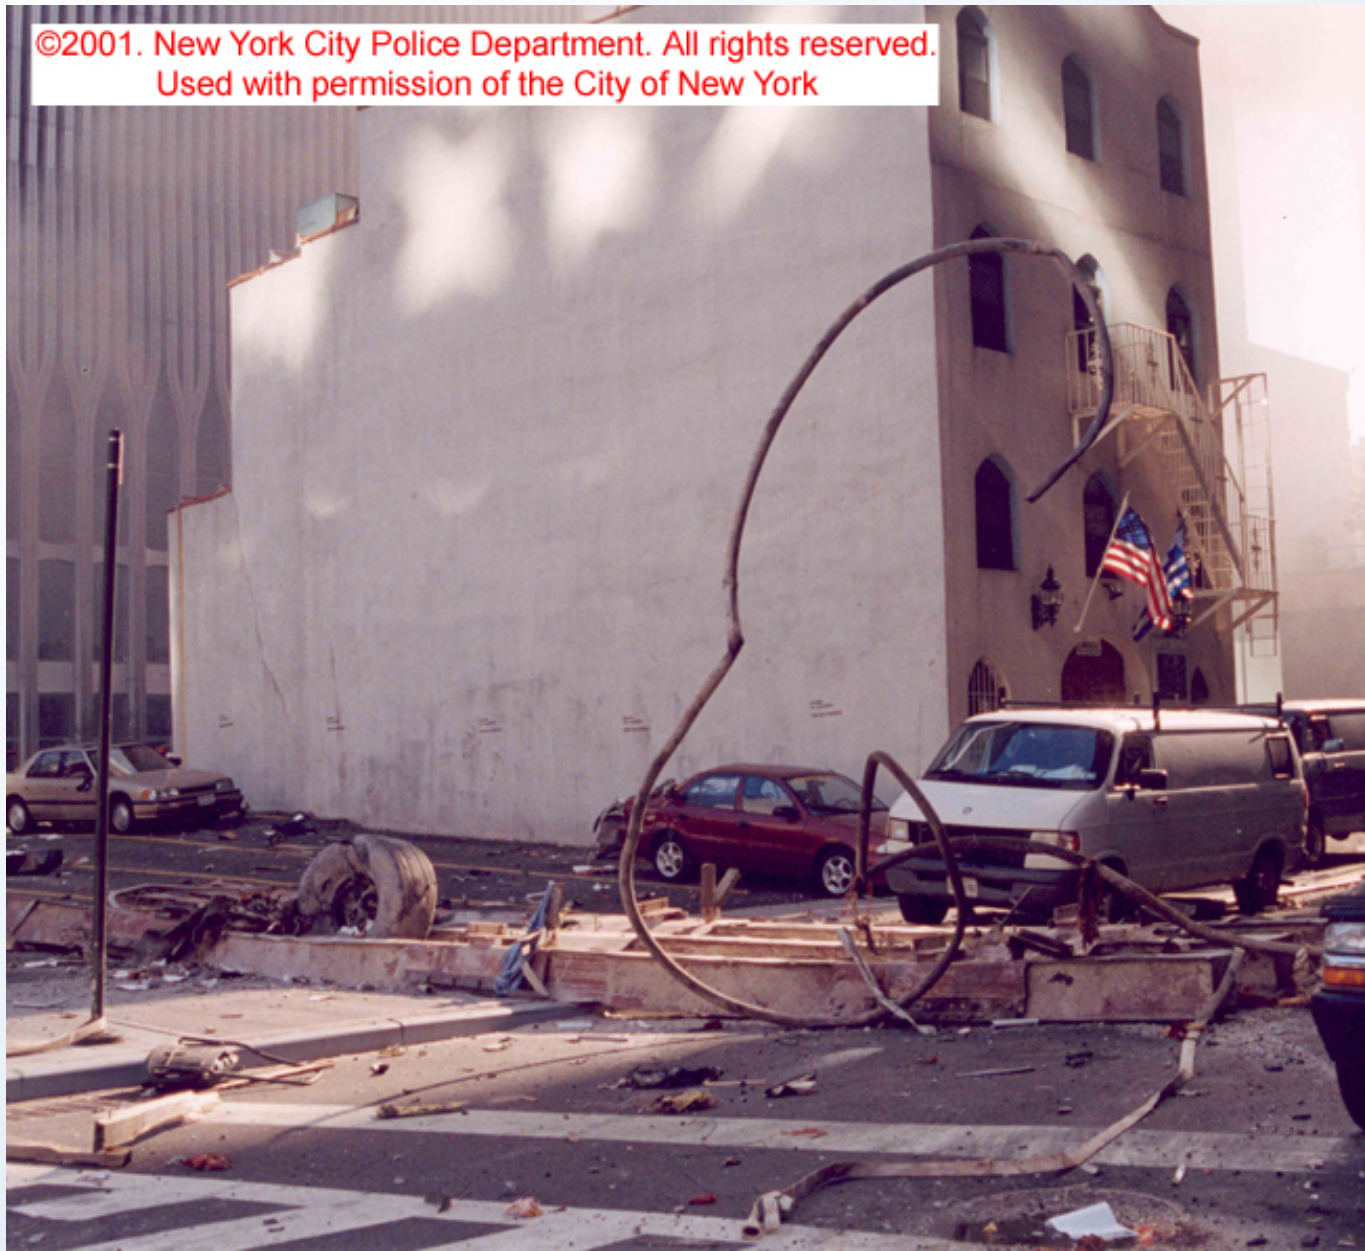
WTC 1, North Face

8:47 a.m.

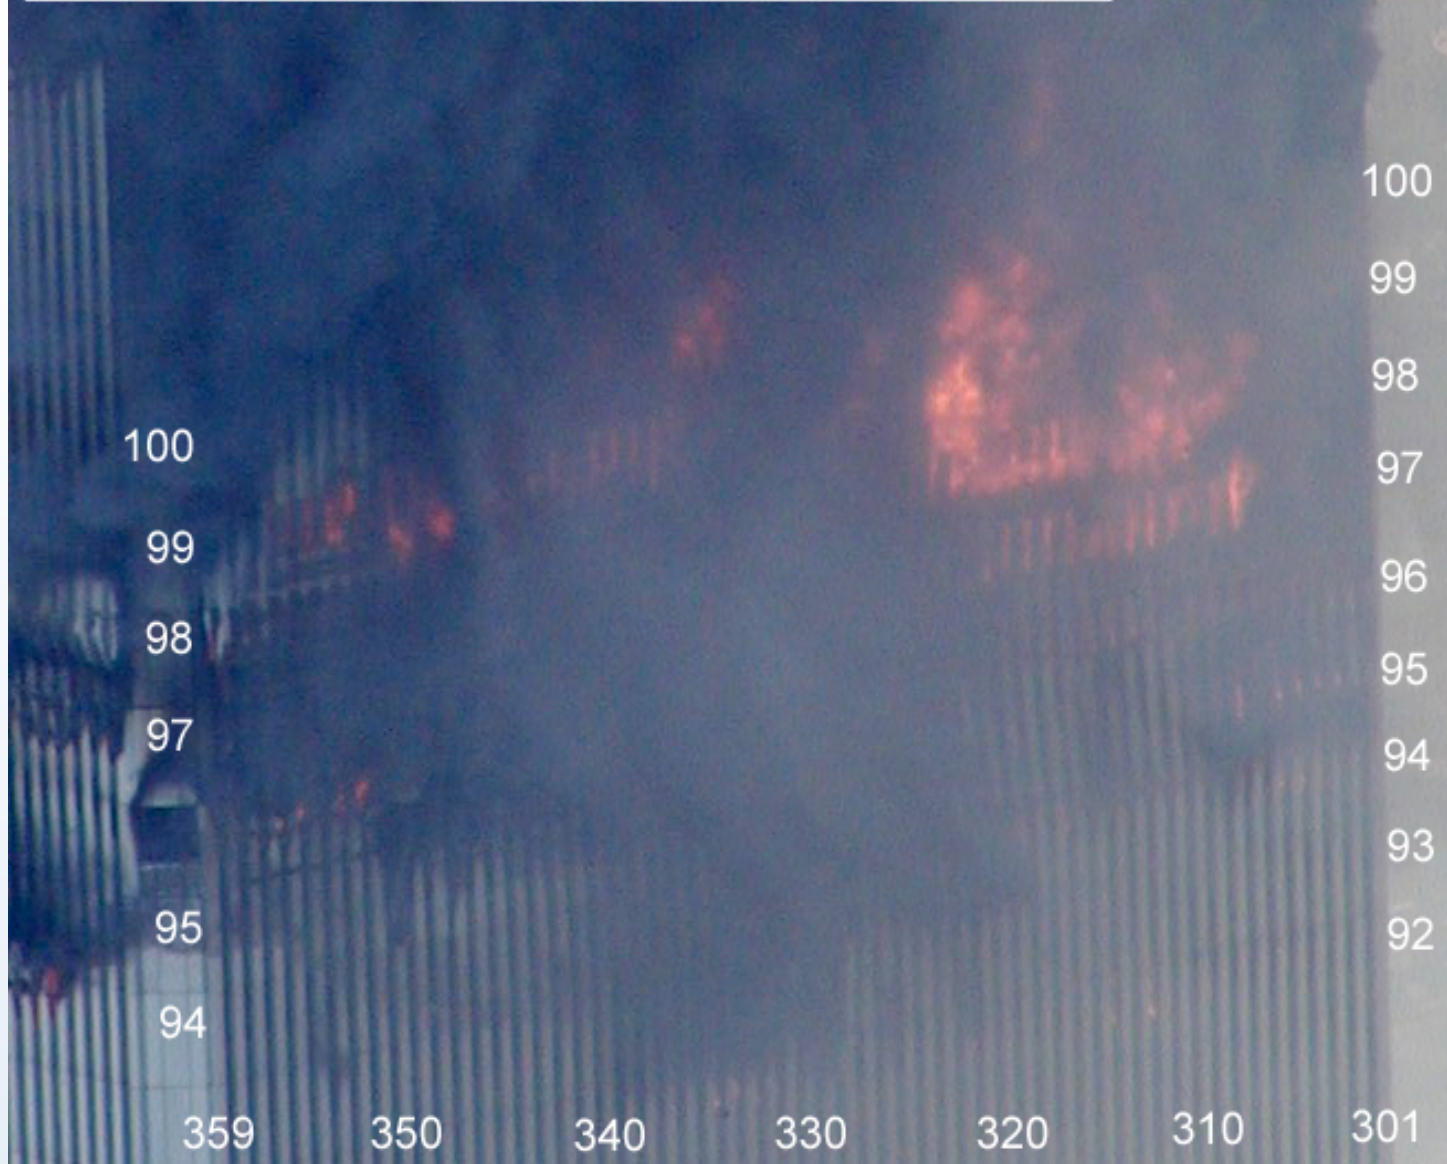
WTC 1, South Face

8:47 a.m.

- Extensive fire spread on multiple floors
- Short periods of rapid fire spread and growth
- Southeast quadrant of tower appeared to be relatively undamaged and fire did not appear in area until after an hour
- Fires appeared to jump upwards over floors
- Inward bowing of columns on south face

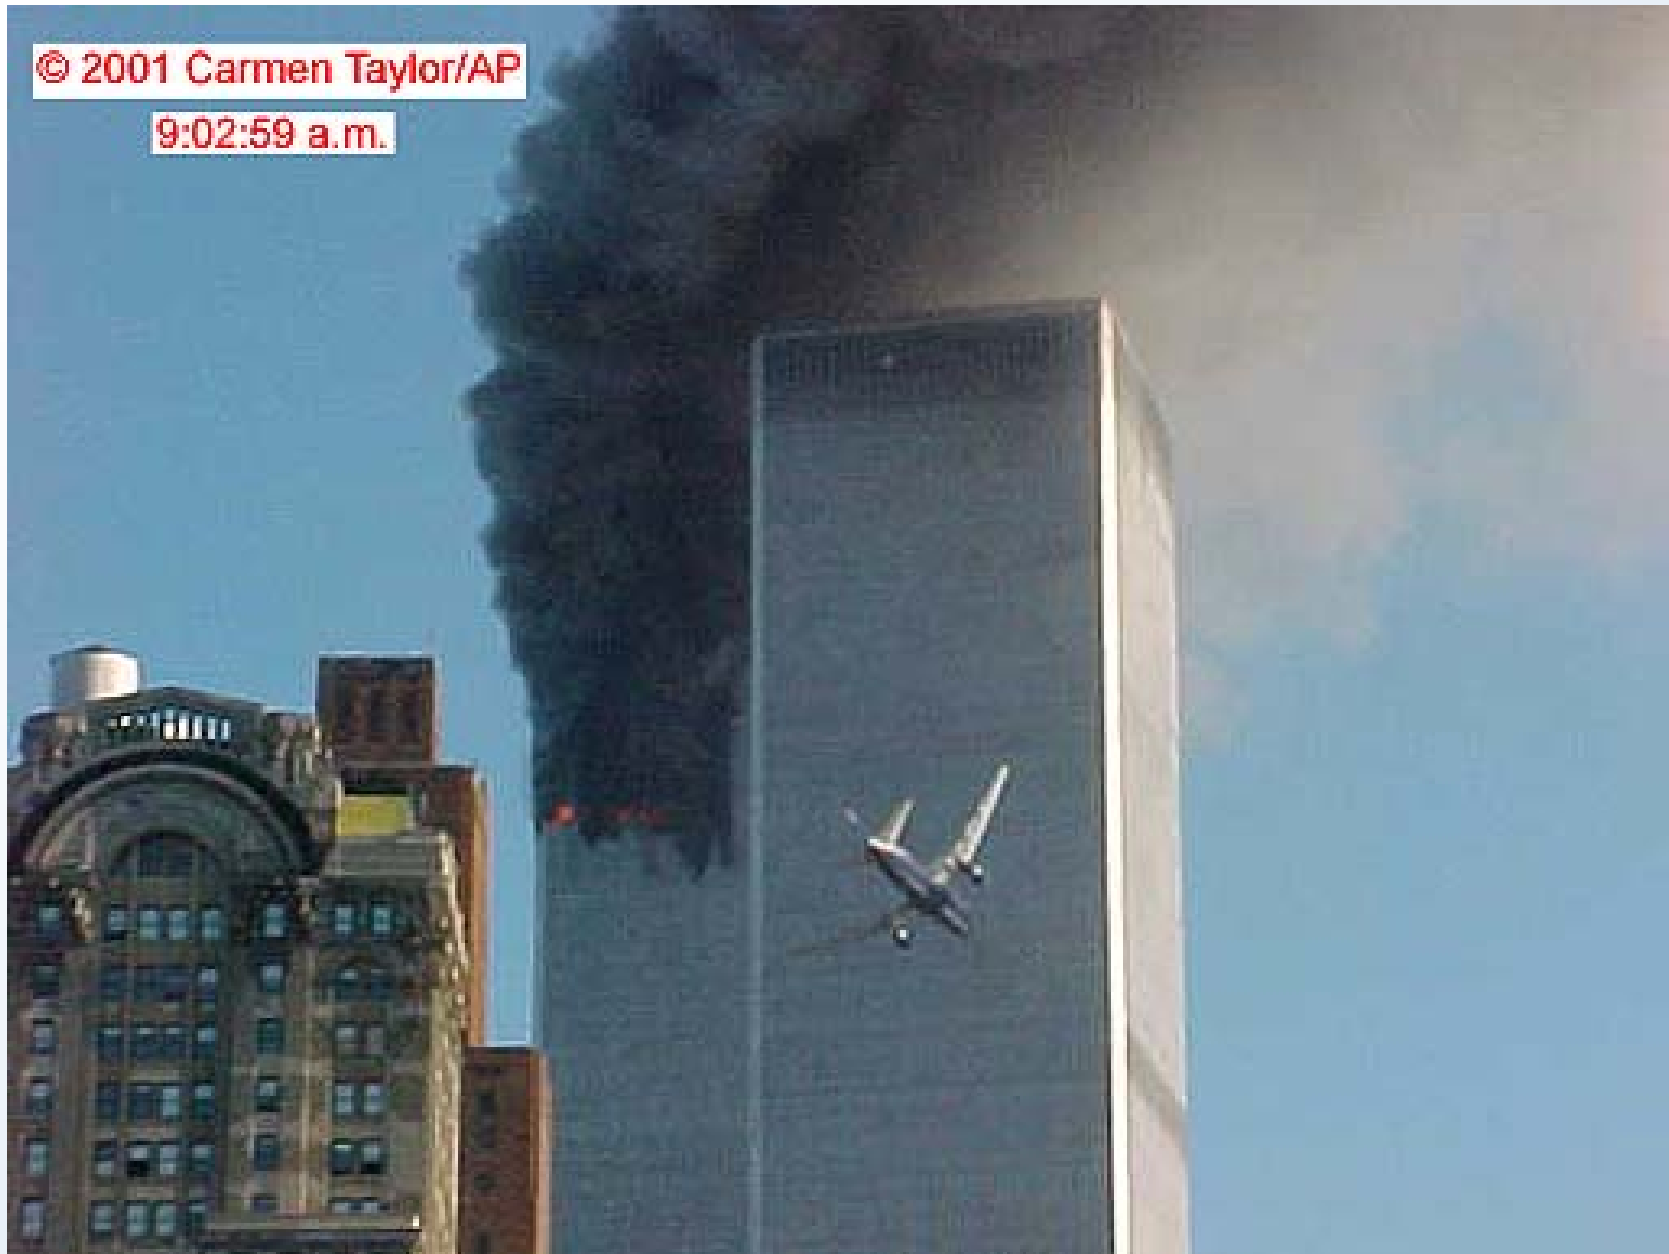
9:02:59 a.m.

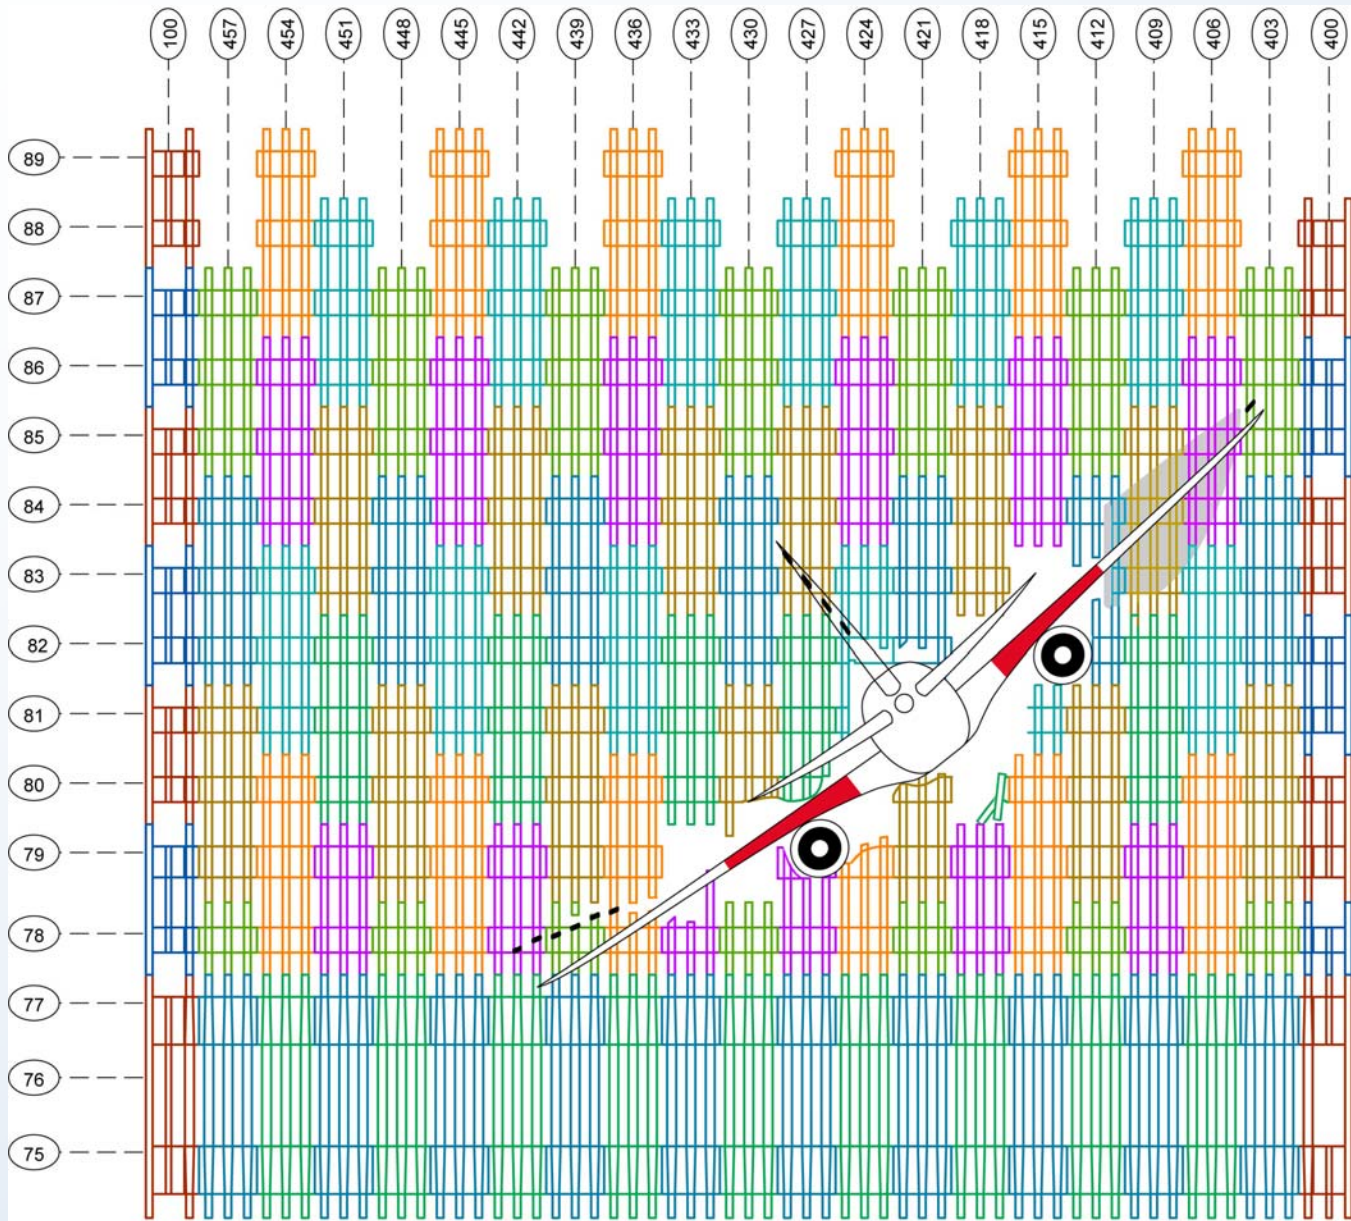
Damage in shaded area cannot be accurately determined.

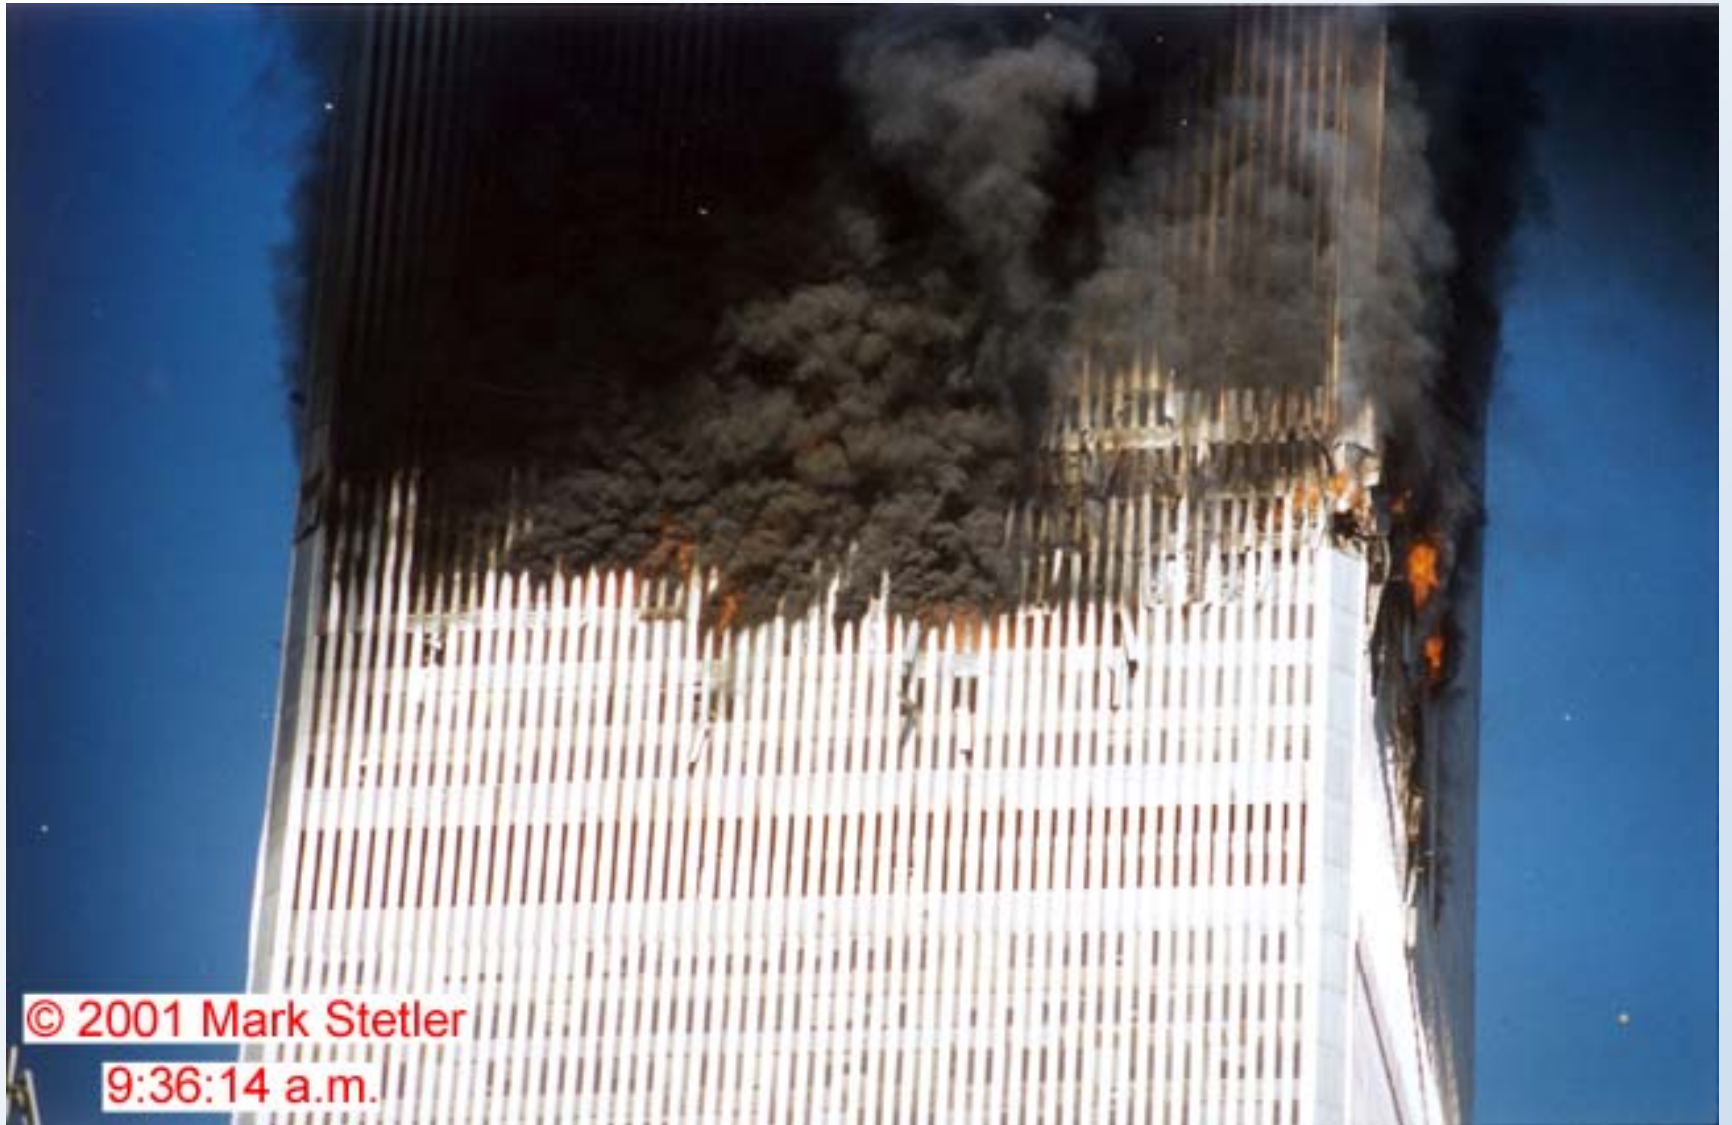
9:37:32 a.m.

- Large, long-lived fires on debris piles in northeast corner (81st floor) and on north face (79th floor) following aircraft impact
- Limited fire spread compared to WTC 1
- Short, intense burning periods likely due to presence of unburned aviation fuel
- Large section of 83rd floor on east side likely dislodged during aircraft impact, continued to shift downwards during event
- Bowing observed on the east face prior to collapse
