# Technical Conference on the Federal Building and Fire Safety Investigation of the World Trade Center Disaster

## Session VI - Structural Fire Response and Collapse Analysis

# Probable Collapse Sequence and Key Findings

September 15, 2005

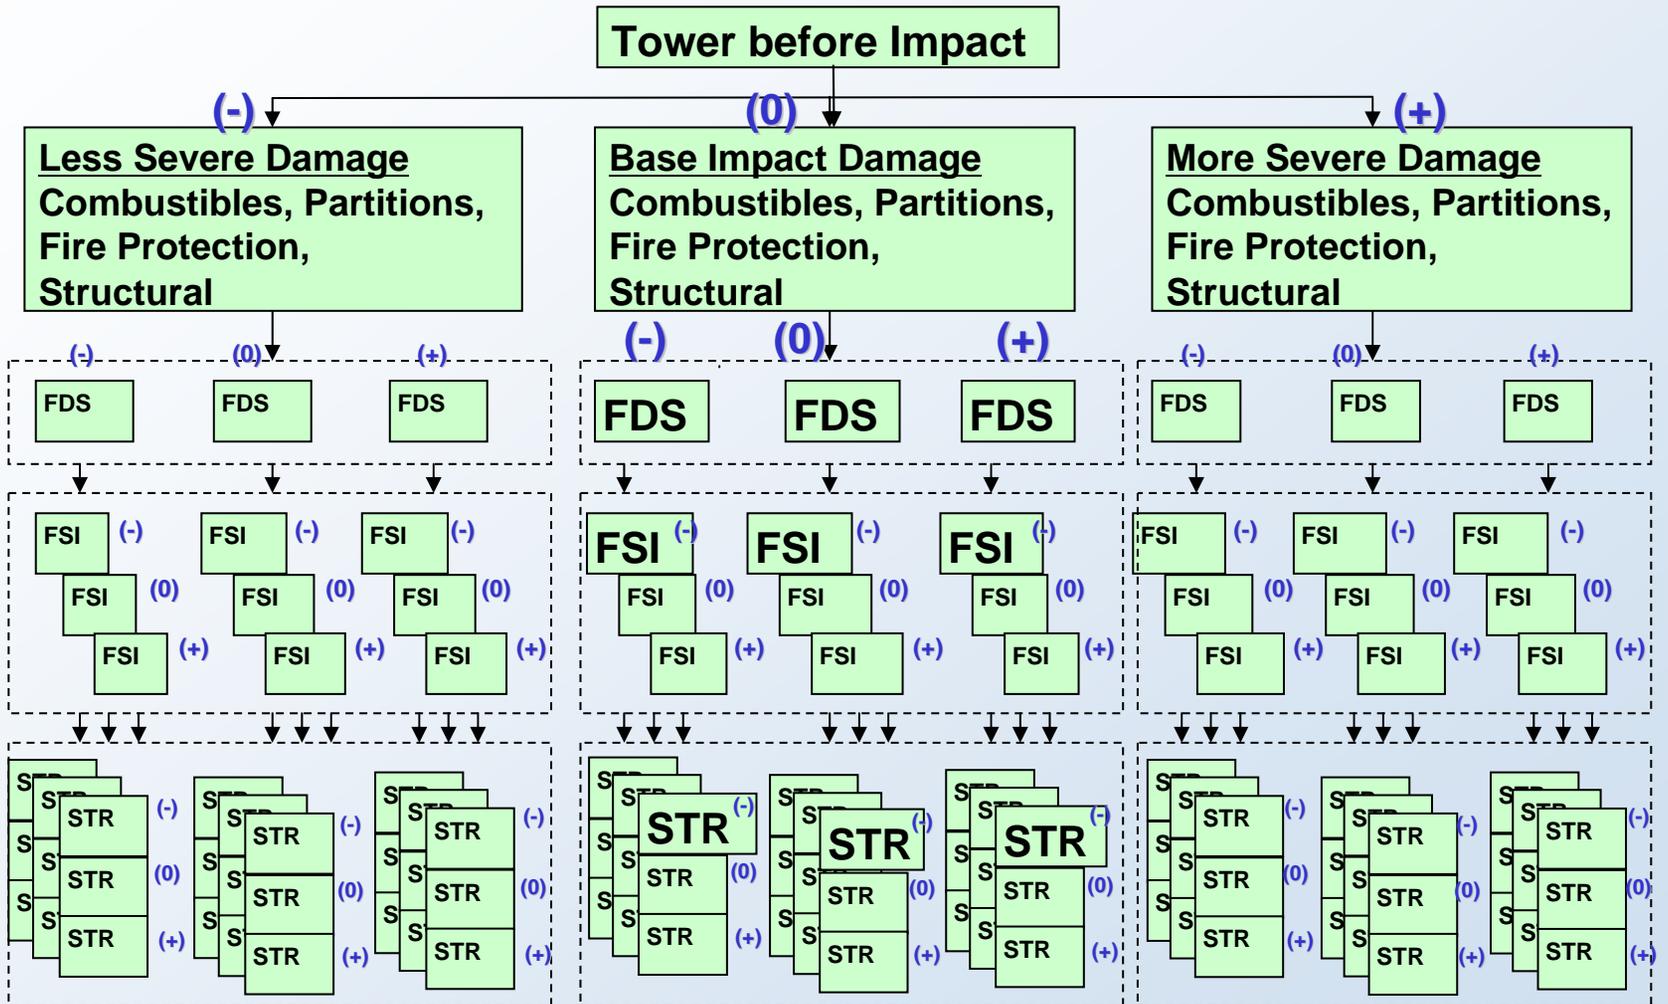
# Analysis Tree for All Influential Parameter Combinations

Evaluated analysis results for each data set against observed structural behavior, with adoption of event tree techniques, pruning, and updating of tree branches.

- ❑ Perform analyses for parameter sets that provide different levels of damage.
- ❑ Compare results to observations.
- ❑ Discard (prune) branches that do not reasonably match.
- ❑ Use observations to constrain model parameters and analysis results.

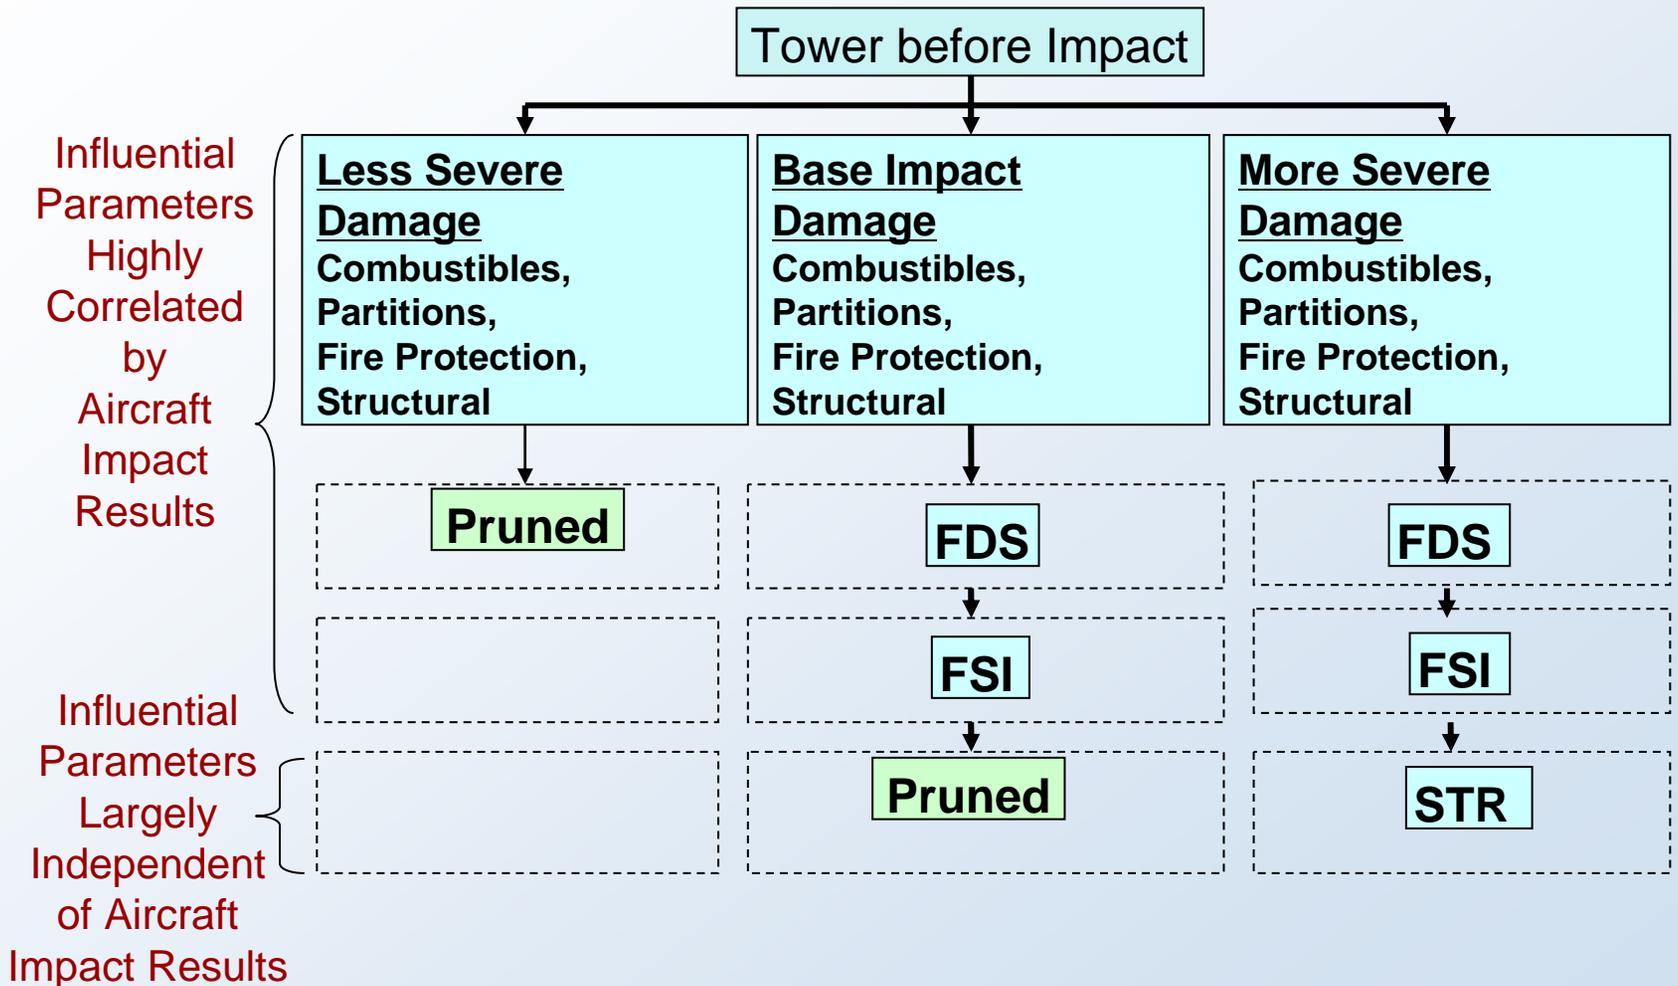
# Pruned Analysis Tree

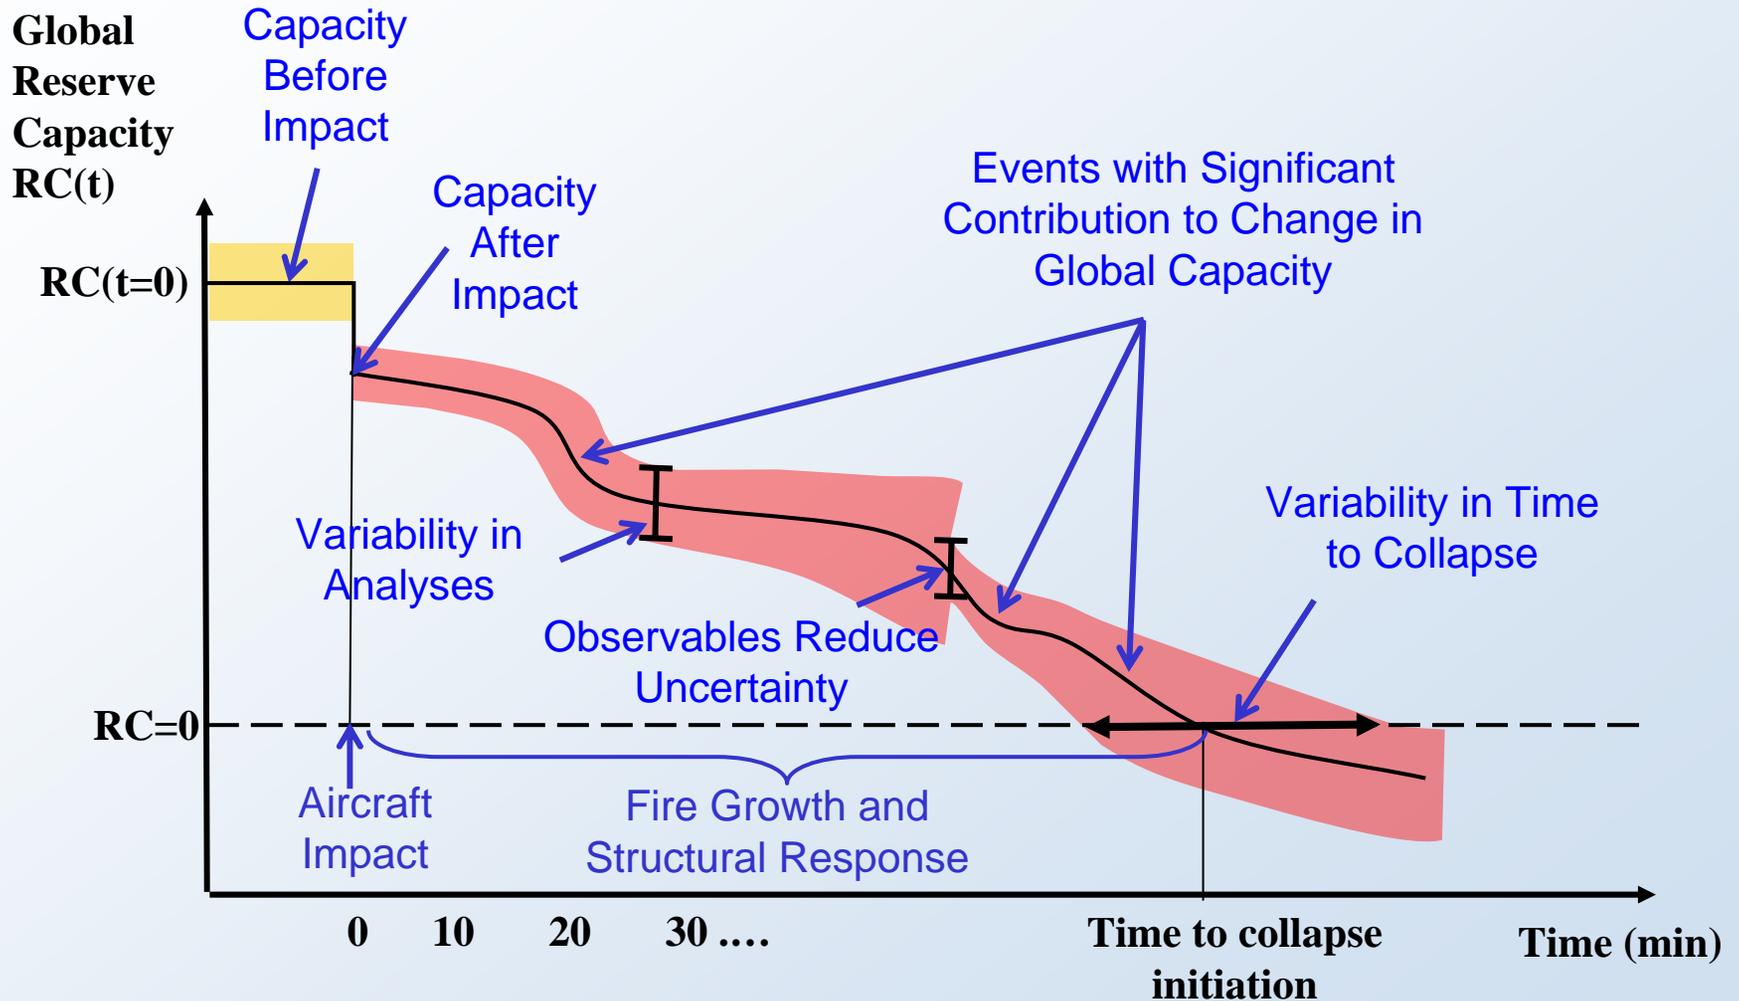
# Variability in Sequential Analyses Due to Imperfect Information

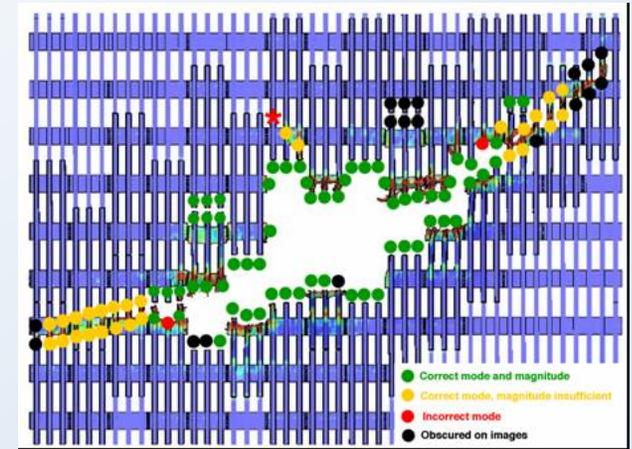
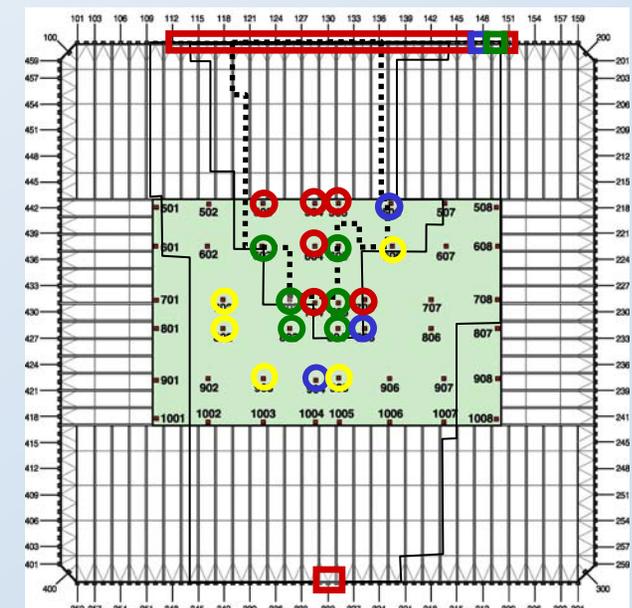
## Aircraft Impact Damage

- ❑ Exterior columns, floor sections, and core columns were severed through the building center. An exterior panel was severed at the south wall.
- ❑ Fire protection was damaged through the building center to the south exterior wall.
- ❑ Loads were redistributed mostly to adjacent columns and the hat truss resisted downward movement of the north wall.
- ❑ North and south walls carried 7% less load, east and west wall carried 7% more load, core carried 1% more load.

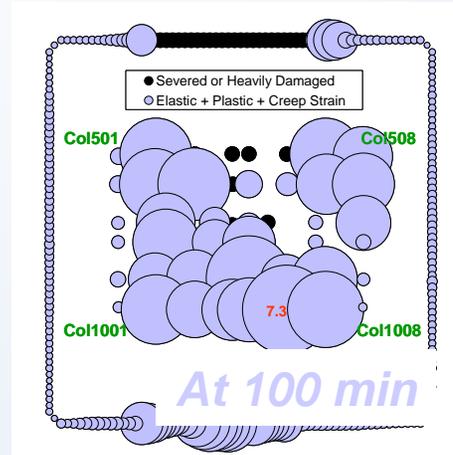
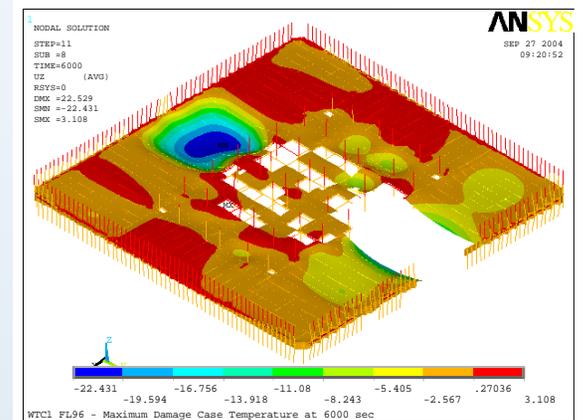
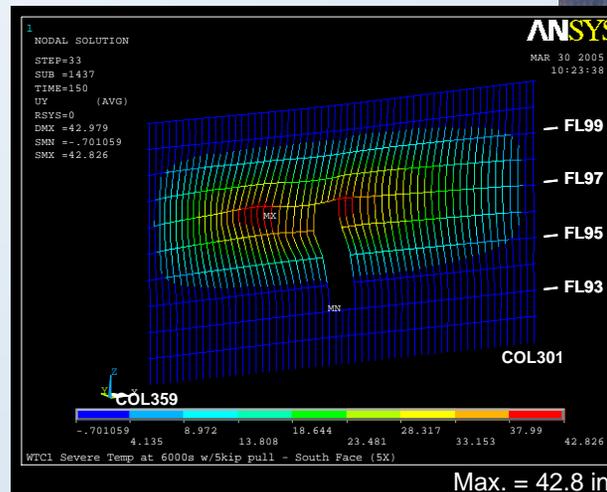
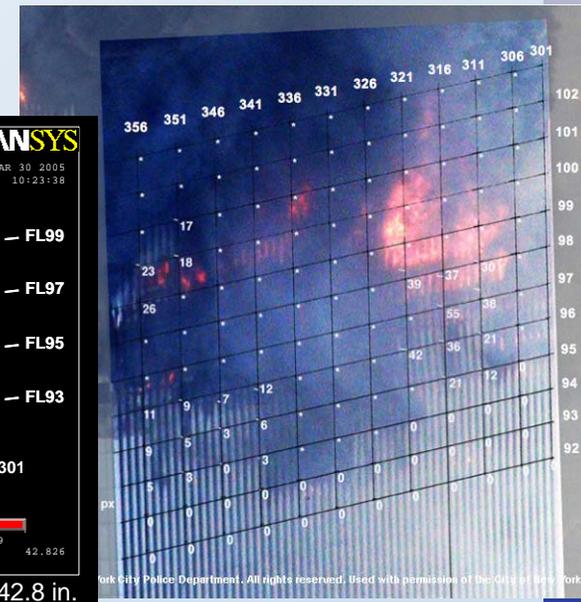
## Thermal Weakening

- ❑ Core columns developed high plastic and creep strains, after initial thermal expansion. Hat truss resisted core column shortening.
- ❑ Long span south floors sagged and pulled inward on the south exterior wall after the fires reached the south side.
- ❑ The south wall bowed inward due to inward pull by intact sagging floors.

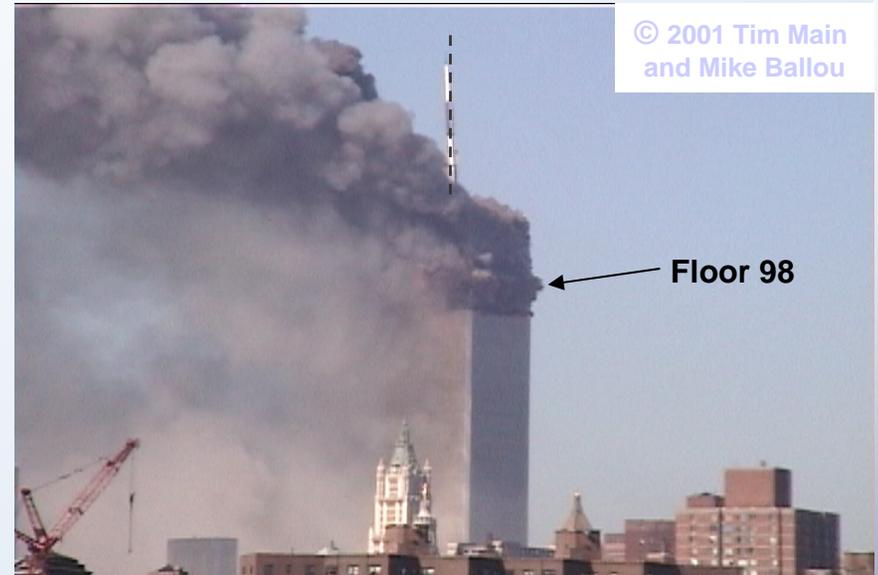
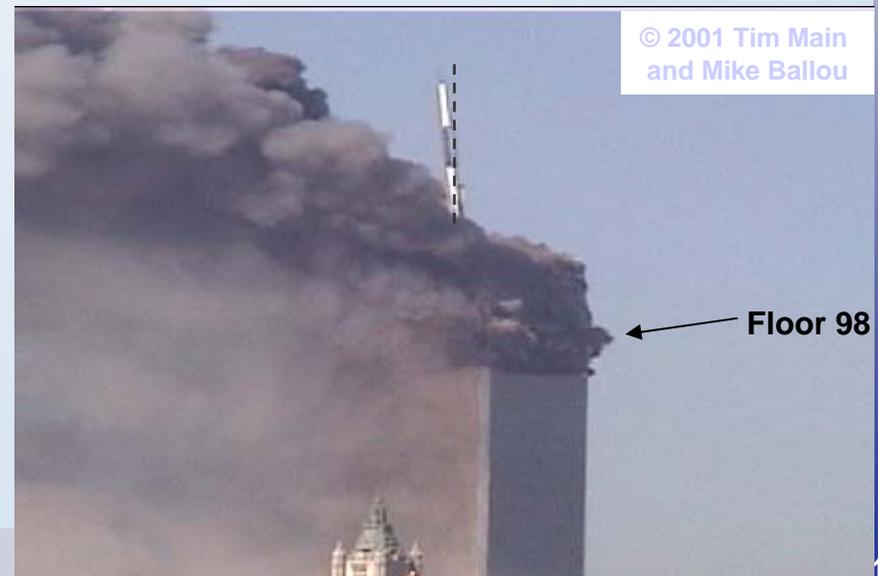
## Collapse Initiation

- ❑ The south wall buckled and transferred its loads to the weakened core through the hat truss and to the adjacent exterior walls through the spandrels.
- ❑ The upper building sections began to tilt to the south as a rigid block.
- ❑ Instability progressed along the east and west exterior walls.
- ❑ Collapse ensued as the released potential energy could not be resisted by the structure.

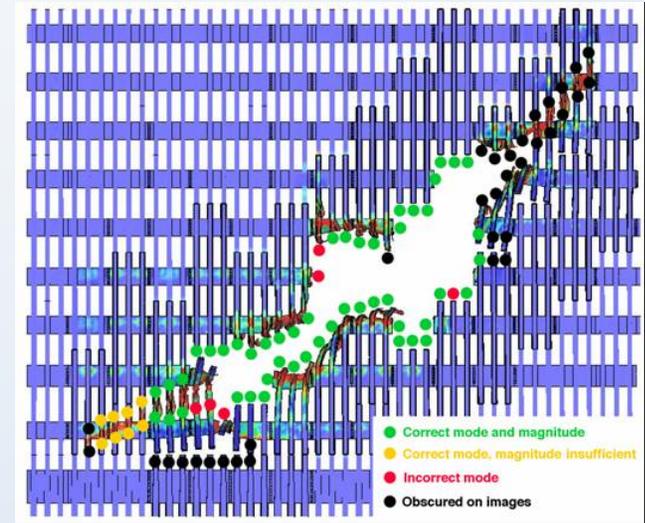
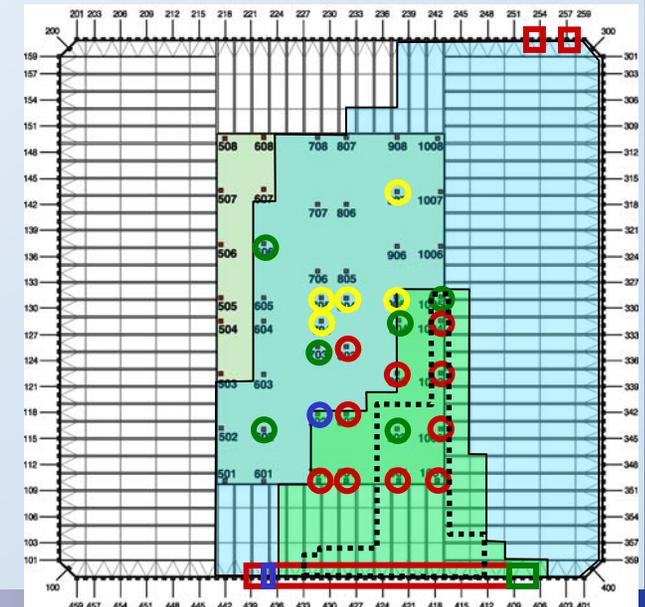
## Aircraft Impact Damage

- ❑ Exterior columns, floor sections, and core columns were severed through the southeast corner and east side of the building.
- ❑ Loads were redistributed mostly to adjacent columns and the east exterior wall.
- ❑ Fire protection was damaged in the east side of the building.
- ❑ After impact, the core was leaning slightly toward the east and south walls. The exterior walls restrained the tendency of the core to lean through the hat truss and intact floors.
- ❑ East wall carried 24% more load, south and west wall carried 2-3% more load, north wall carried 10% less load, and the core carried 6% less load.

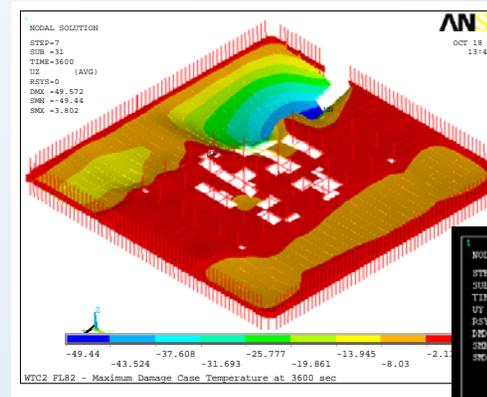
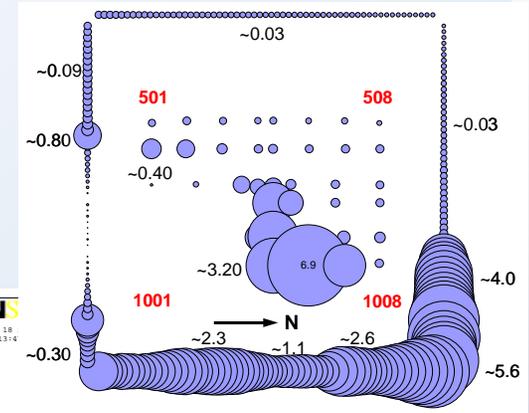
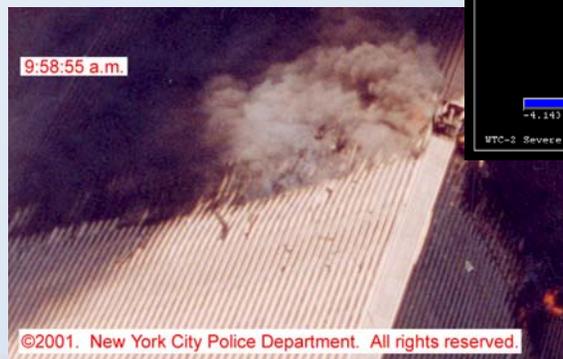
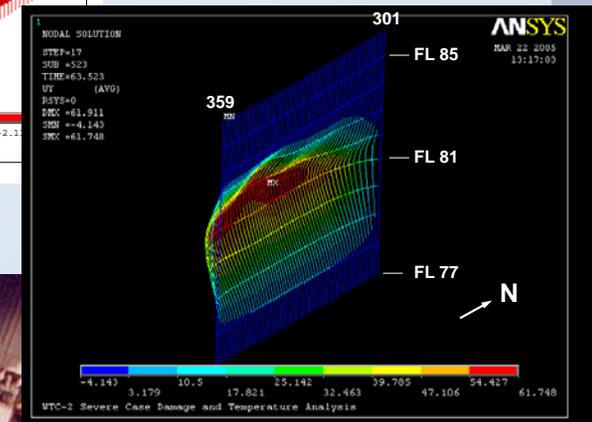
## Thermal Weakening

- ❑ Several core columns on the east side developed high plastic and creep strains, after initial thermal expansion.
- ❑ The long-span east floors sagged and pulled inward on the east exterior wall shortly after impact, due to the damage and fires on the east side.
- ❑ About 1/3 of the remaining Floor 83 connections to the exterior wall failed.
- ❑ The east wall bowed inward due to inward pull by intact sagging floors.

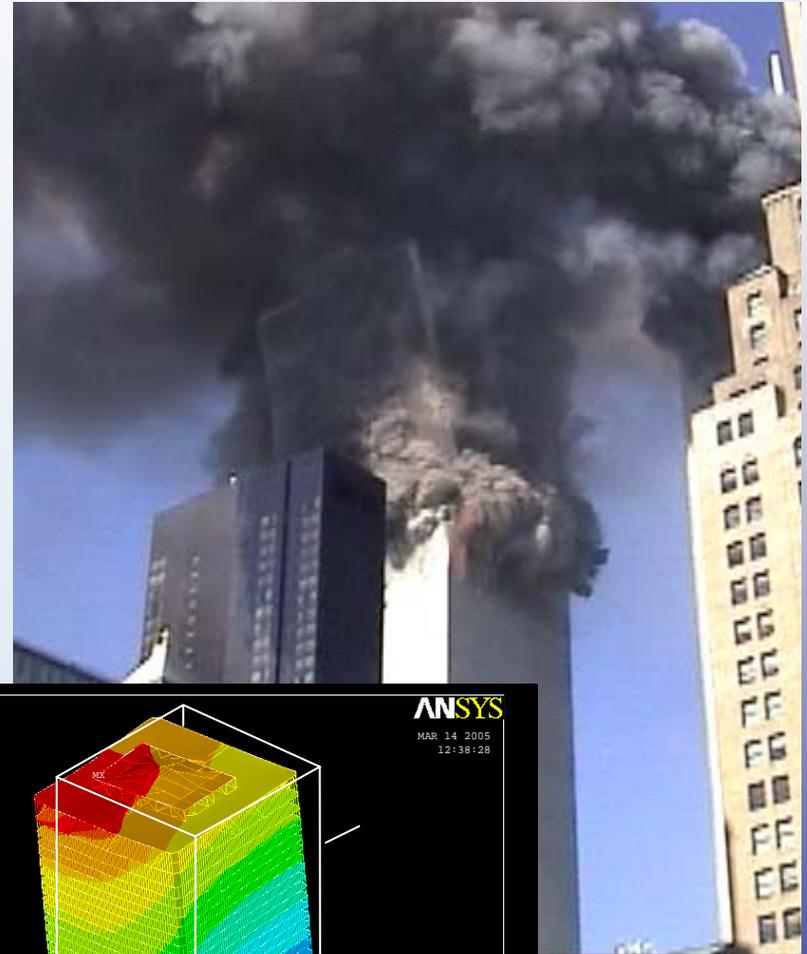
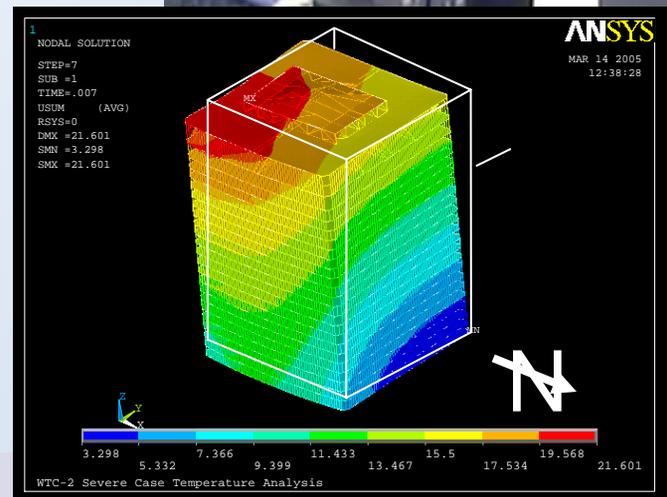
## Collapse Initiation

- ❑ The east wall buckled and transferred its loads to the weakened core through the hat truss and to the adjacent exterior walls through the spandrels.
- ❑ The upper building sections began to tilt to the east and south as a rigid block.
- ❑ Instability progressed along the north and south exterior walls.
- ❑ Collapse ensued as the released potential energy could not be resisted by the structure.
