Wafer [Mask] Inspection for Sub-20nm Patterning

Wolf Staud, AMAT PDC

FCMN

Grenoble, May 2011

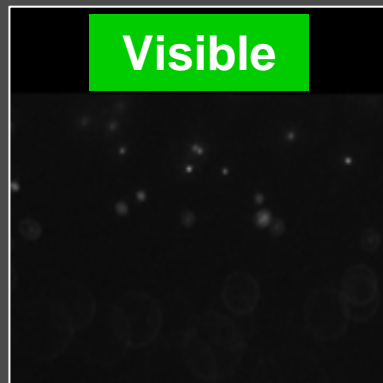
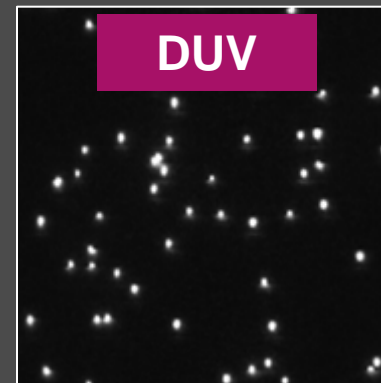
40nm PSL on bare Si:

Light Scattering $\sim 1/\lambda^4$

Higher light scattering
with shorter wavelength

SNR increases at shorter wavelength

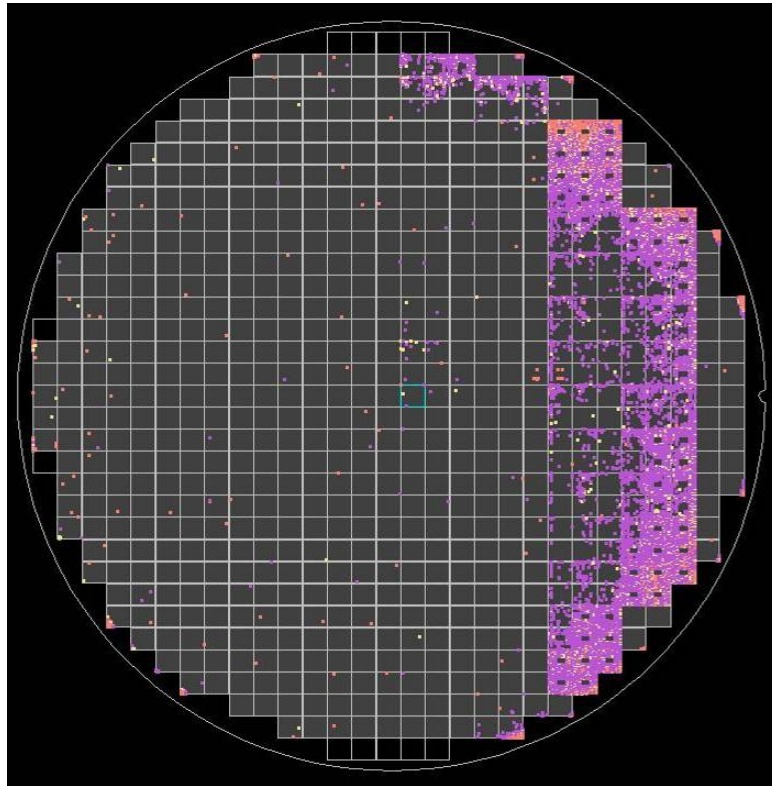
Full wafer scan: SCM vs MC5

Single-column scan: 183 min

Multi-column scan: 47 min

TPT = 40 cm²/hr

- Thinning 1/6 (17%)

TPT = 160 cm²/hr

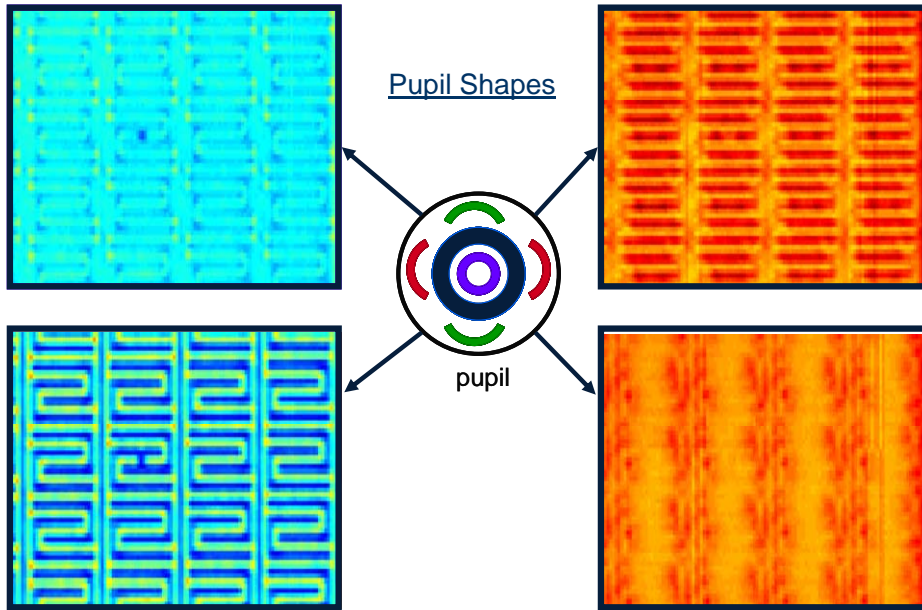
Using DUV RET Illumination Modes for Detection

L/S 1:1 128nm CD

Optimizing illumination pupil and polarization can enhance defect signal

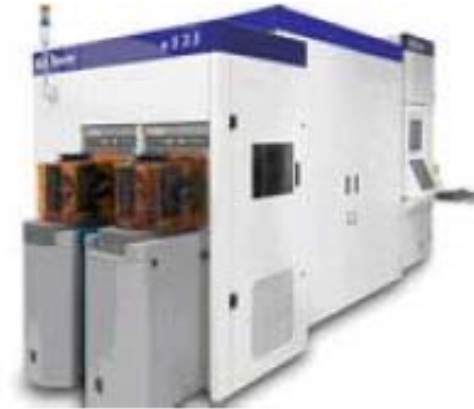
▶ KLA-Tencor eS35

- Die-to-die
- Image contrast inspection
- Pixel size: 15, 20, 25nm
- Landing energy 1750V
- Data rate 50mpps

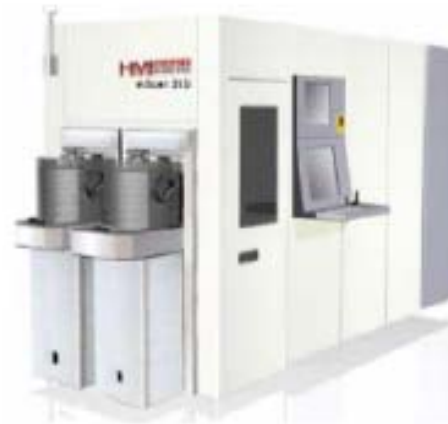
▶ Hermes Microvision eScan 315

- Die-to-die
- Image contrast inspection
- Pixel size: 10, 15nm
- Landing energy: 2000V
- Data rate 100mpps

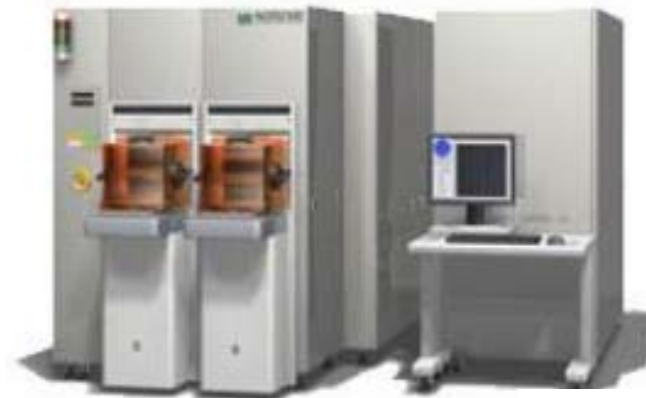
▶ NGR 2100

- Die-to-database
- Fast CD inspection
- Pixel size: 3nm
- Landing energy 2600V
- Data rate 50mpps
