**Federal Building and Fire Safety Investigation
of the World Trade Center Disaster**

Post-Impact Frequency Analysis

**Building and Fire Research Laboratory
National Institute of Standards and Technology
U.S. Department of Commerce**

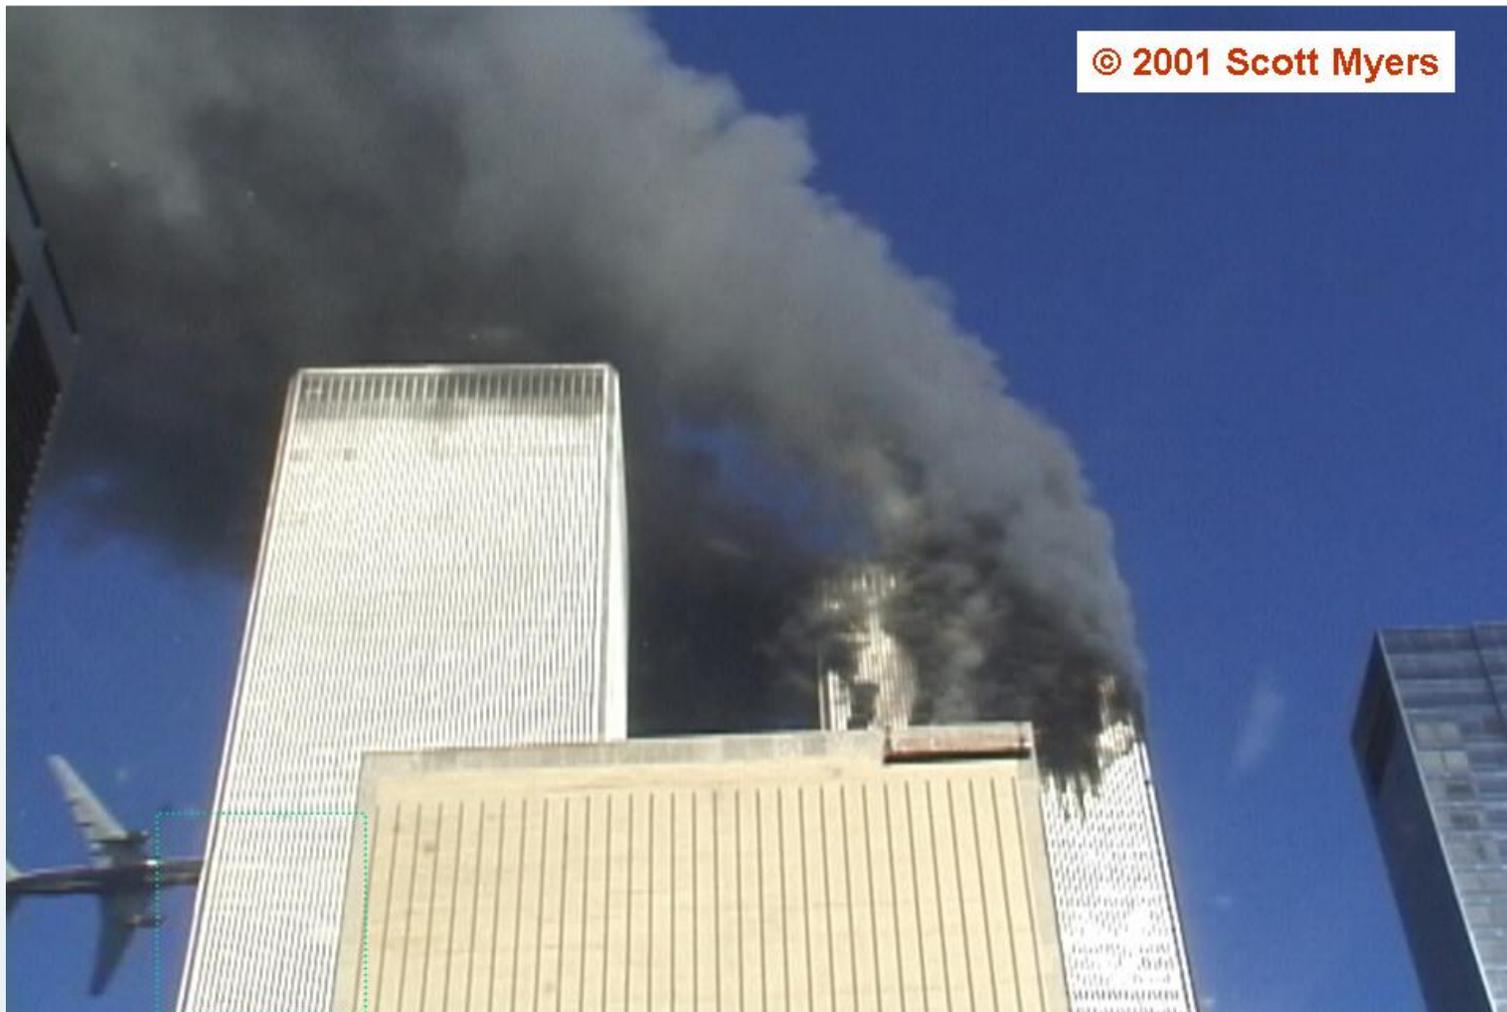
Video shot from east of WTC 1 and 2

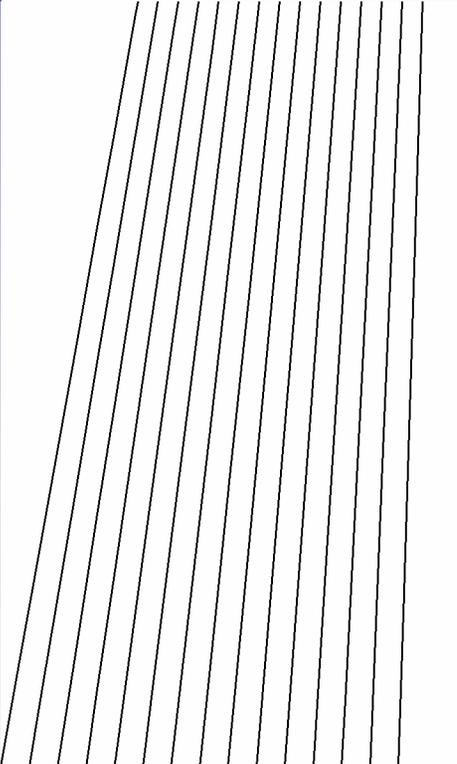
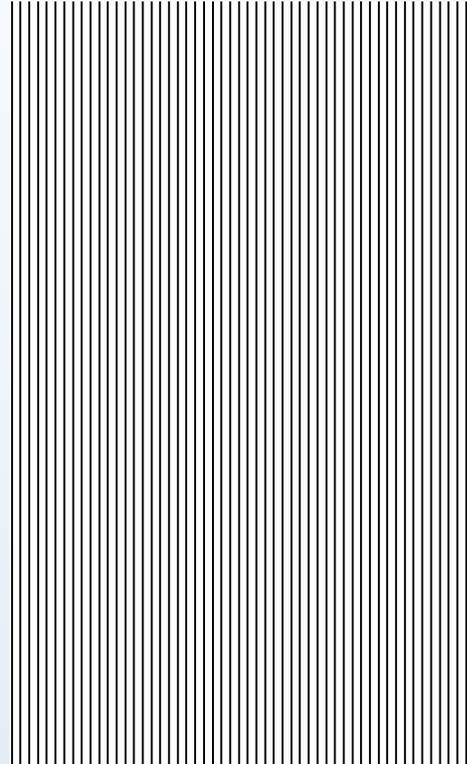
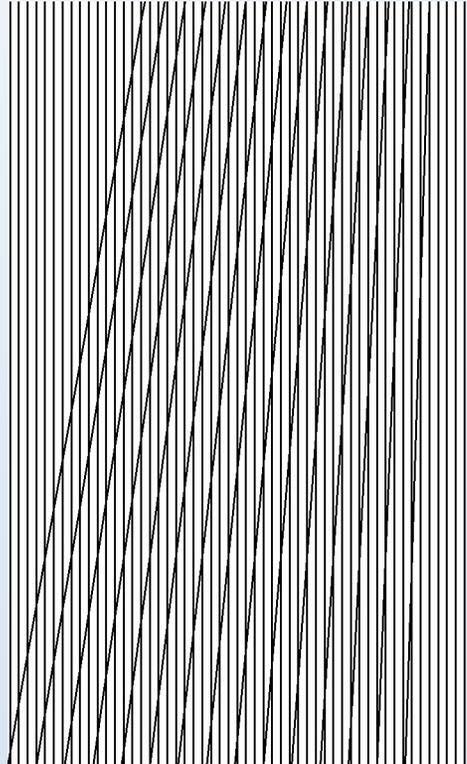
Moiré Pattern

Window Lines

Pixel Columns

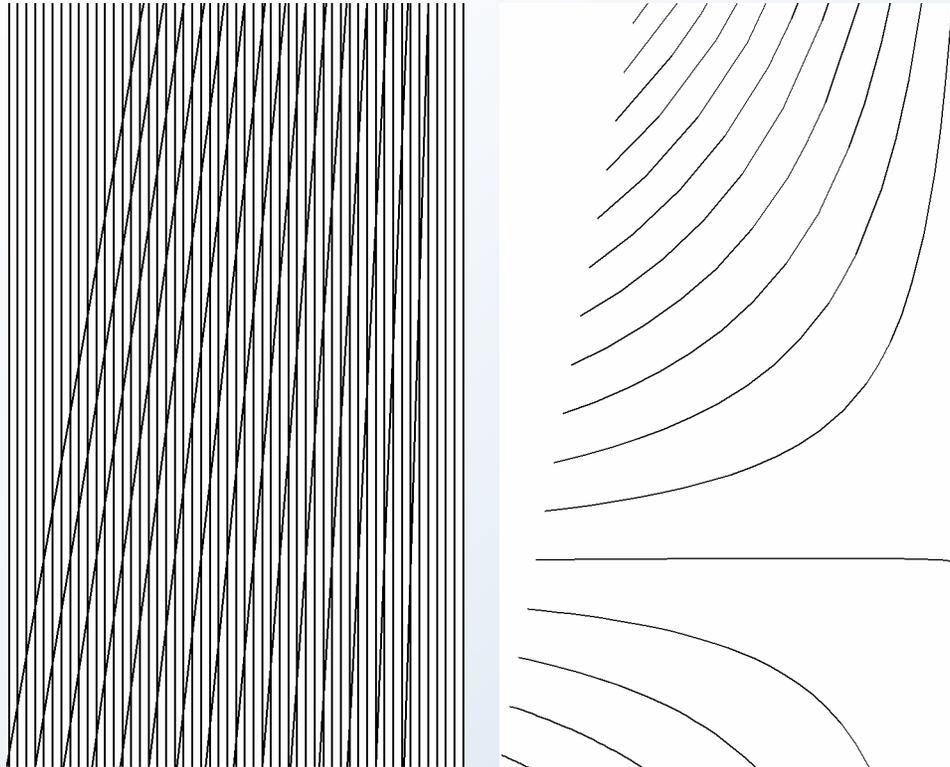
Moiré Pattern Equation

Parameters:

Displacement
Window spacing
Left angle
Angle increment

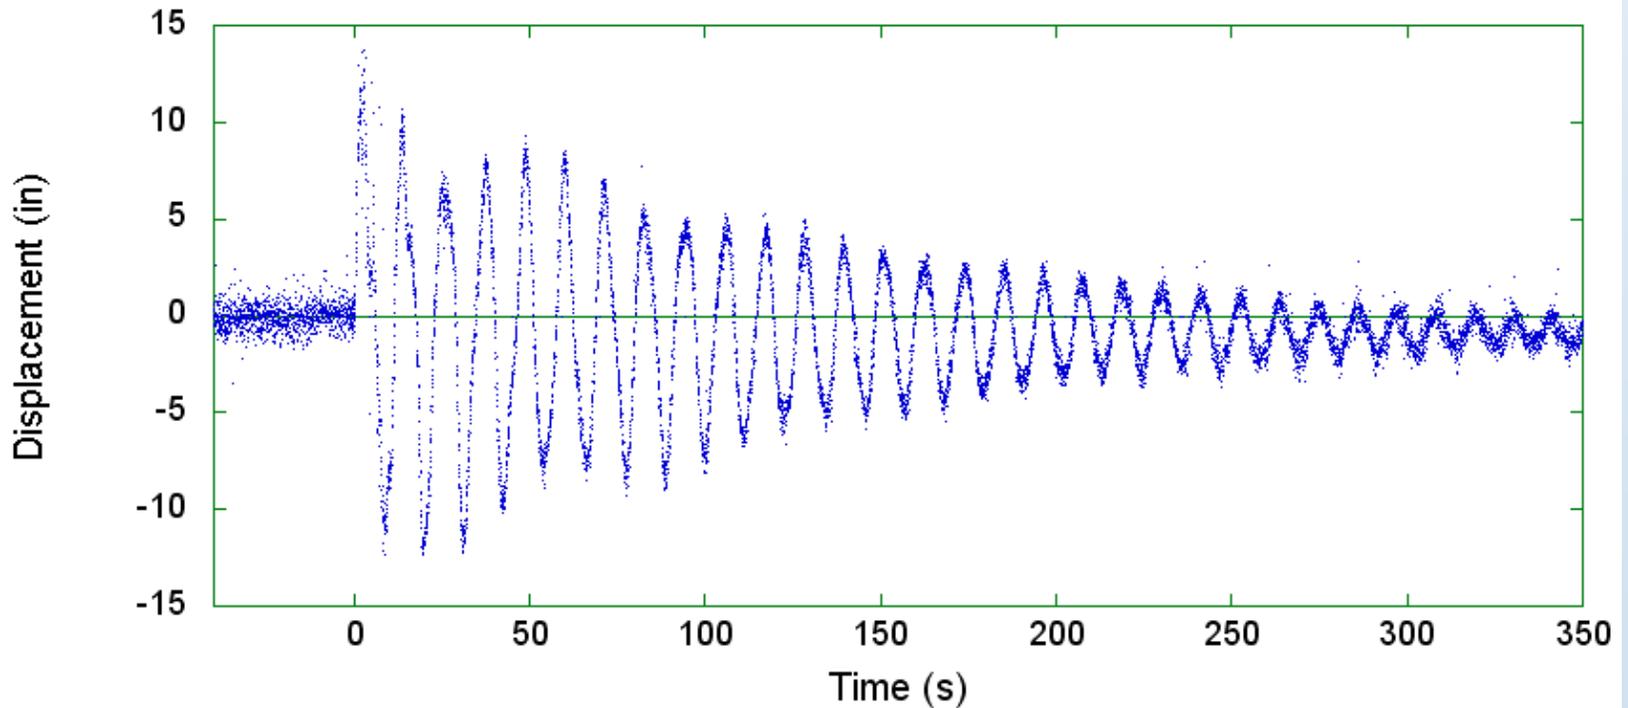
Displacement at 70th floor of WTC 2

Mode of vibration	Structural Model	Video Analysis
Fundamental N-S mode with P-Delta Effects	11.2 s	11.4 s
First torsional mode	5.2 s	5.3 s
Second translational mode	3.8 s	3.9 s
Second torsional mode	2.4 s	2.1 s

Initial sway in N-S direction	Amplitude
70th floor	12 in. ± 1 in.
Roof level	22 in. ± 5 in.
