Performance of Physical Structures in Hurricane Katrina and Hurricane Rita

Reconnaissance Findings and Recommendations

June 9, 2006

**Building and Fire Research Laboratory
National Institute of Standards and Technology
Technology Administration
U.S. Department of Commerce**

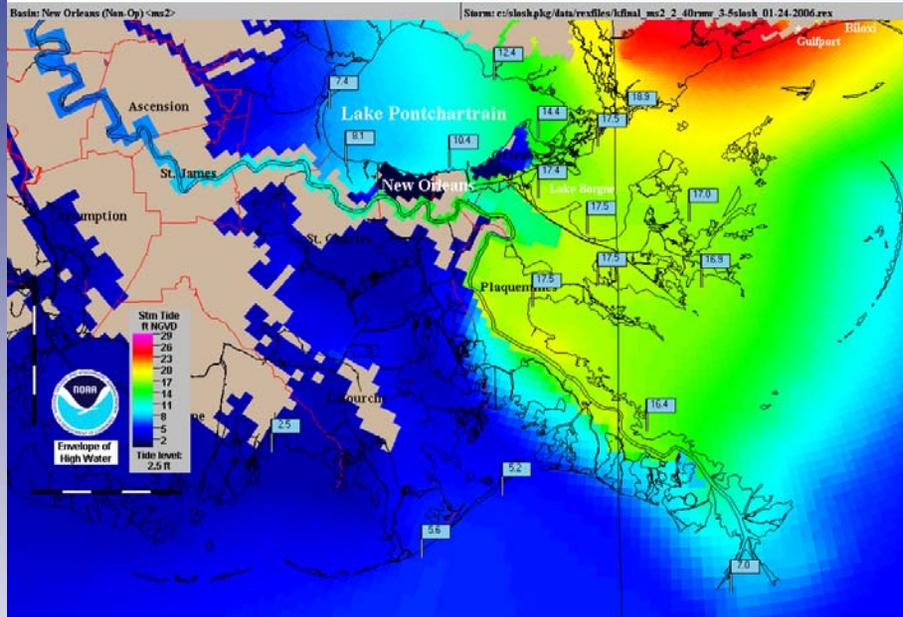
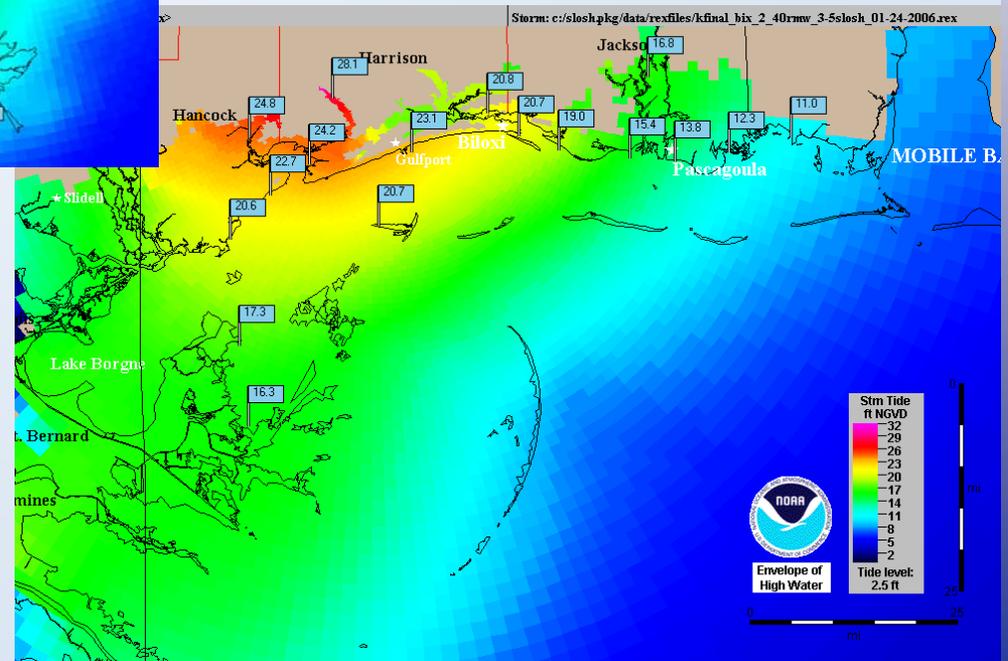
- Hindcasts of storm surge due to Hurricane Katrina for Gulf Coast and New Orleans.

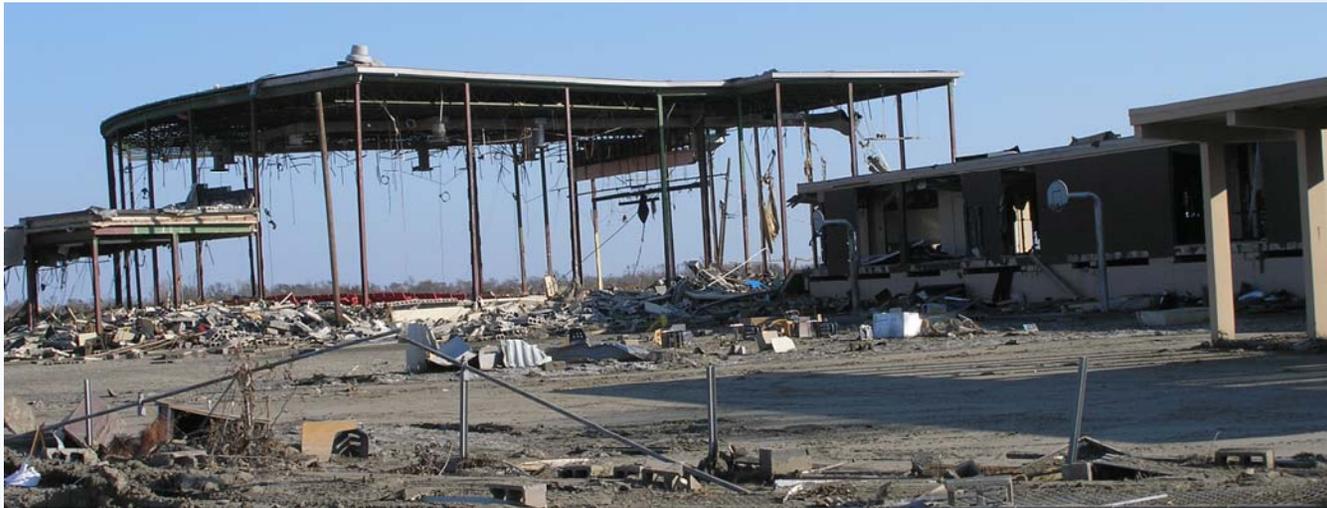
Damaged school recreational facility, Cameron, LA

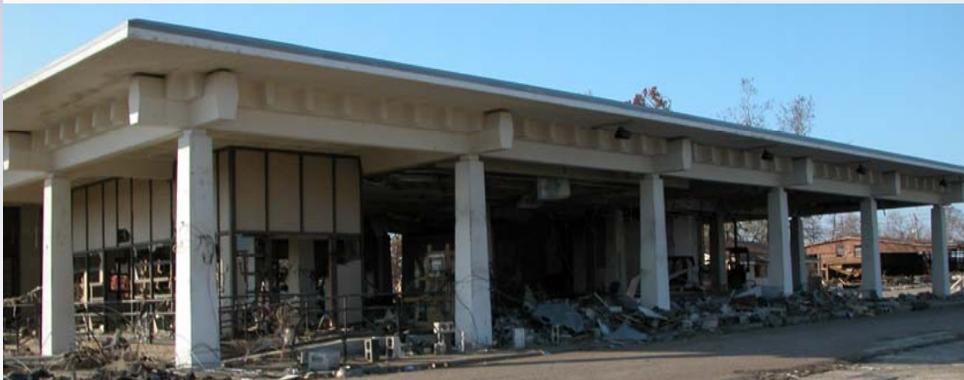
Hibernia Bank building, Cameron, LA

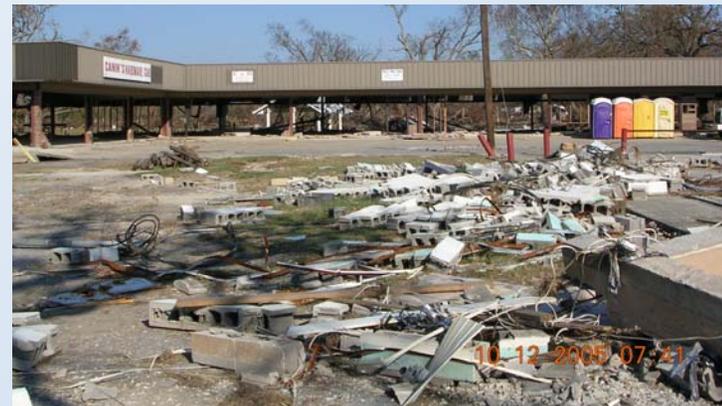
Damaged strip mall, Creole, LA

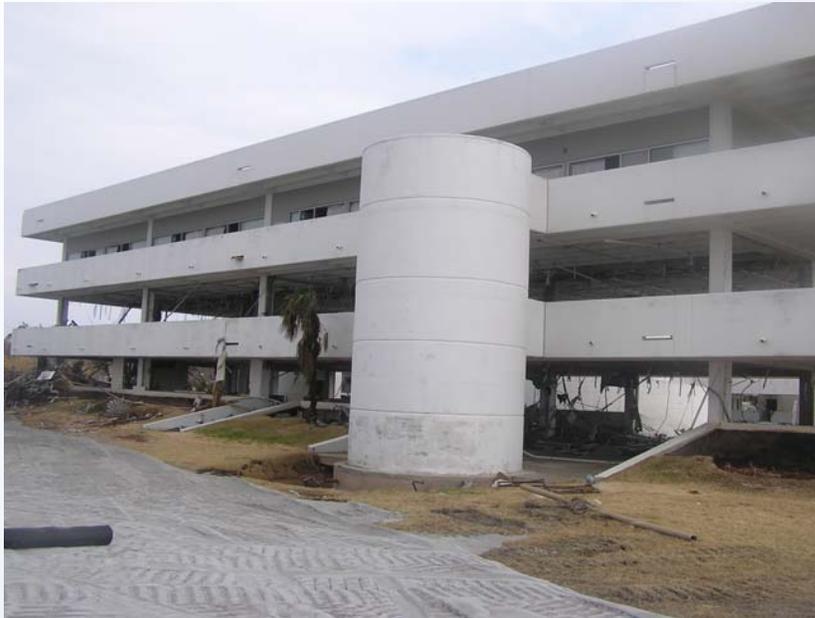
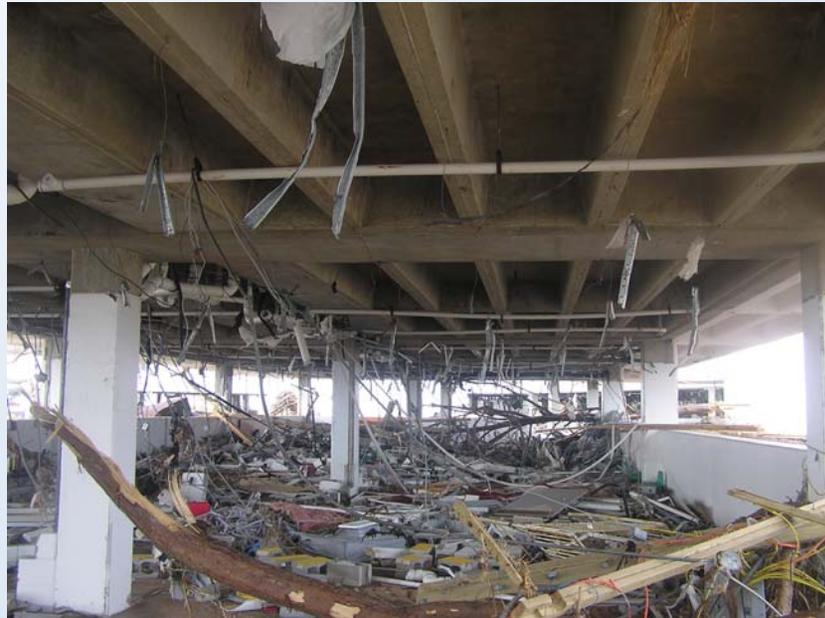
- Bay St. Louis, MS
- Surge reached second floor of building.

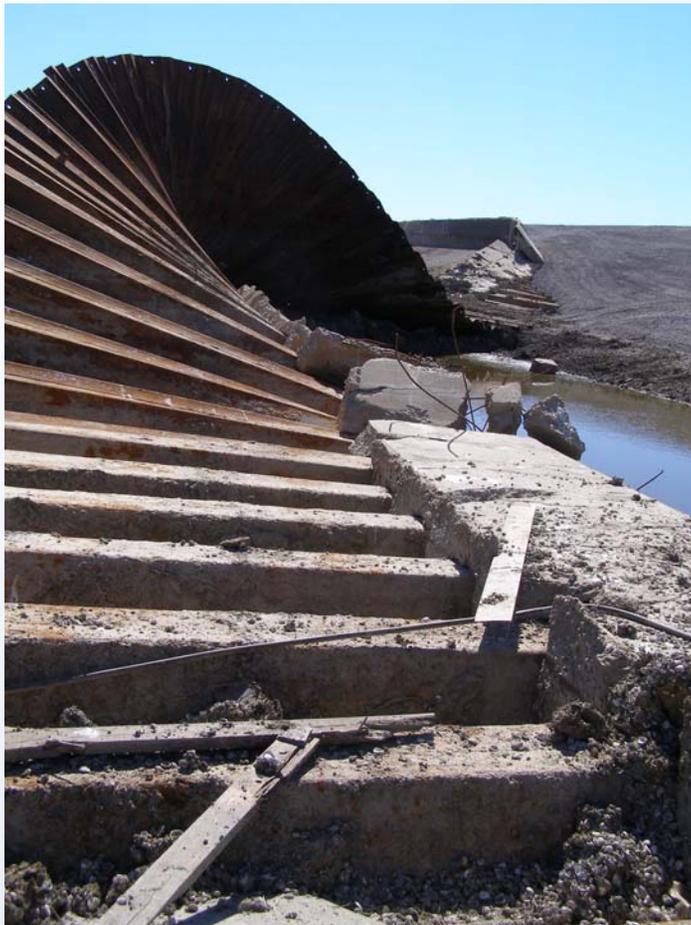
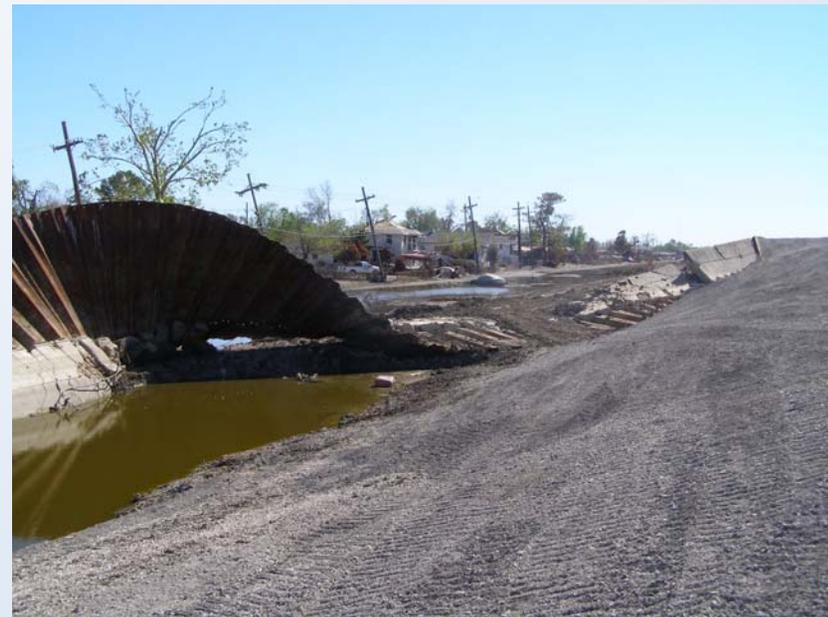
Inner Harbor Navigation Canal (Lower Ninth Ward)

- Rotational failure of floodwall-sheetpile due to overtopping and scour on protected side of levee.

Improve the design, construction, and performance of the ***New Orleans levees and floodwalls*** by: (1) conducting a comprehensive review and upgrade of the design hazard, criteria, and manuals for levees and floodwalls to develop a risk-based approach for storm surge that is similar to risk-based design for wind; (2) performing a systematic review of the existing, as-constructed levees and floodwalls relative to design requirements in USACE design manuals; and (3) developing methodologies for levee and floodwall design, construction, and repair that allow for overtopping without subsequent failure of the floodwall or levee structures. Major steps are already underway that will fulfill this recommendation. USACE promptly took action (a) to repair damage to the New Orleans flood protection system and (b) to conduct a detailed performance evaluation that will provide credible scientific and engineering information for guiding the immediate repair and future upgrade of the system. #1

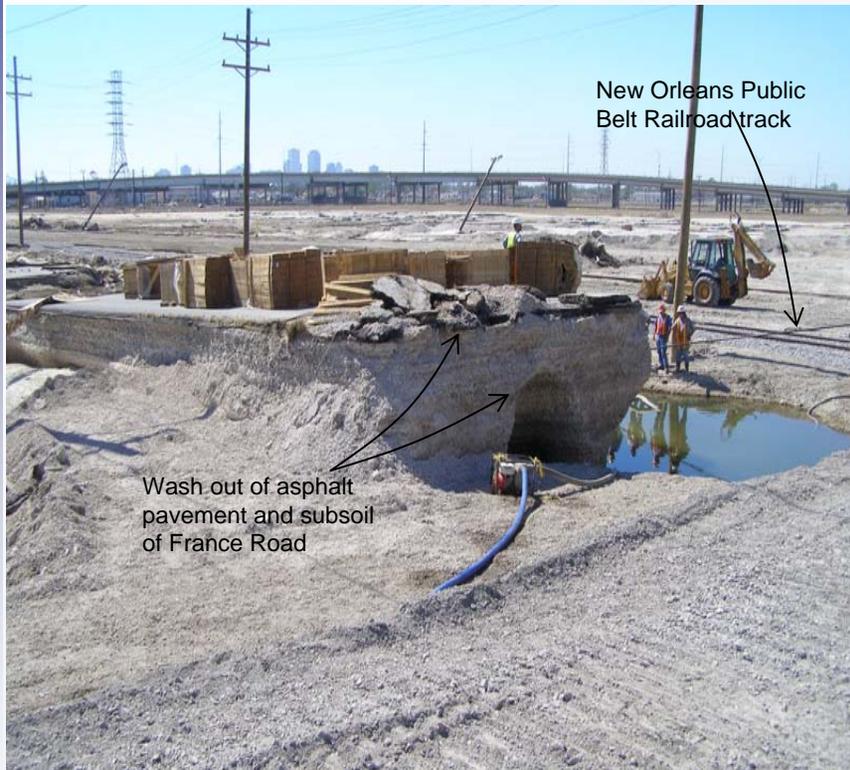
- Failure of pavement and subsoil due to scour

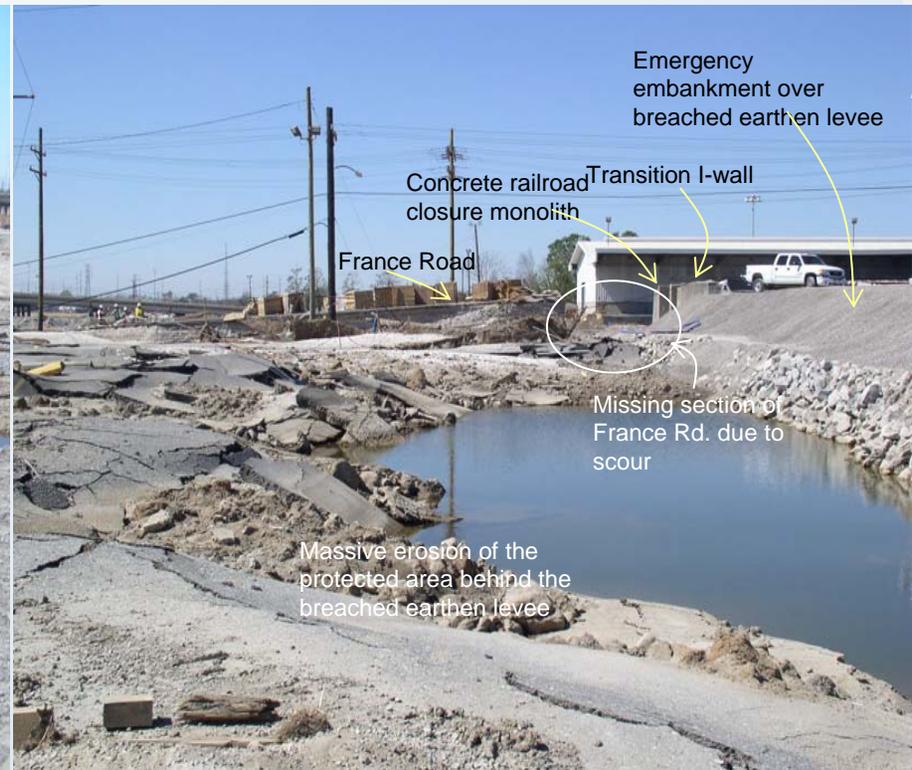
- Levee breach due to erosion on water side

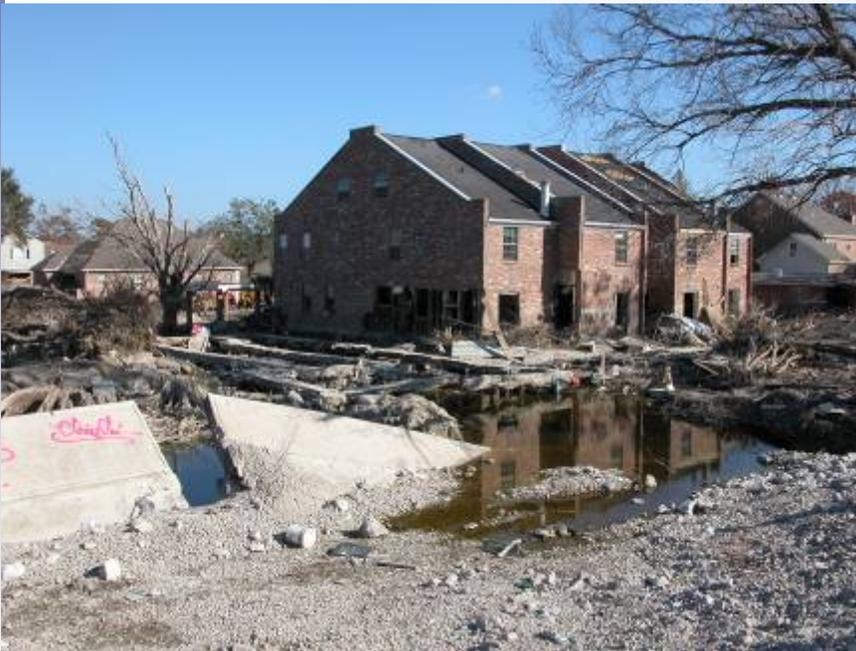
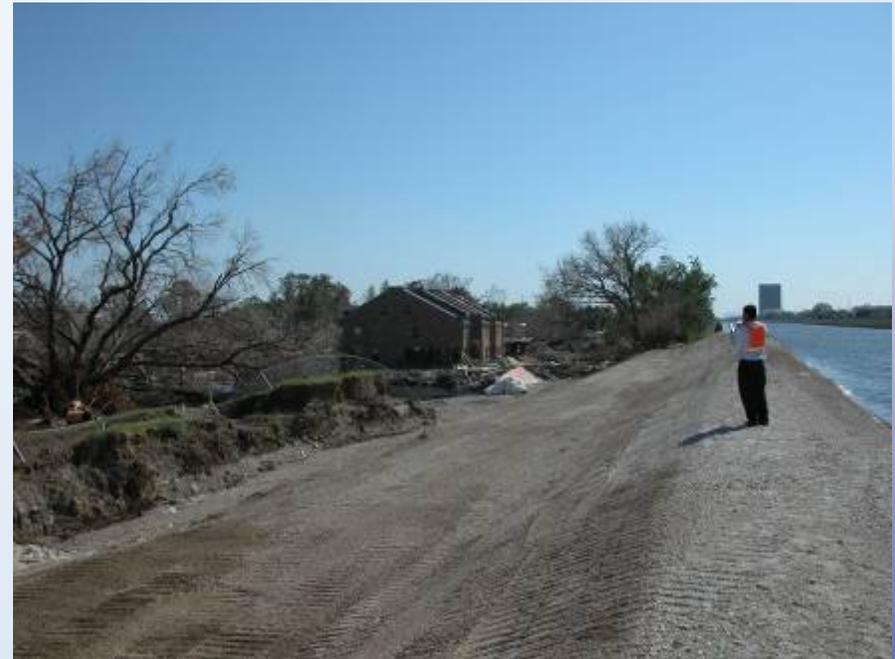
17th St Canal Outfall Canal

- Foundation failure likely caused by shear failure within the clay in the foundation beneath the levee and floodwall, according to IPET Study.

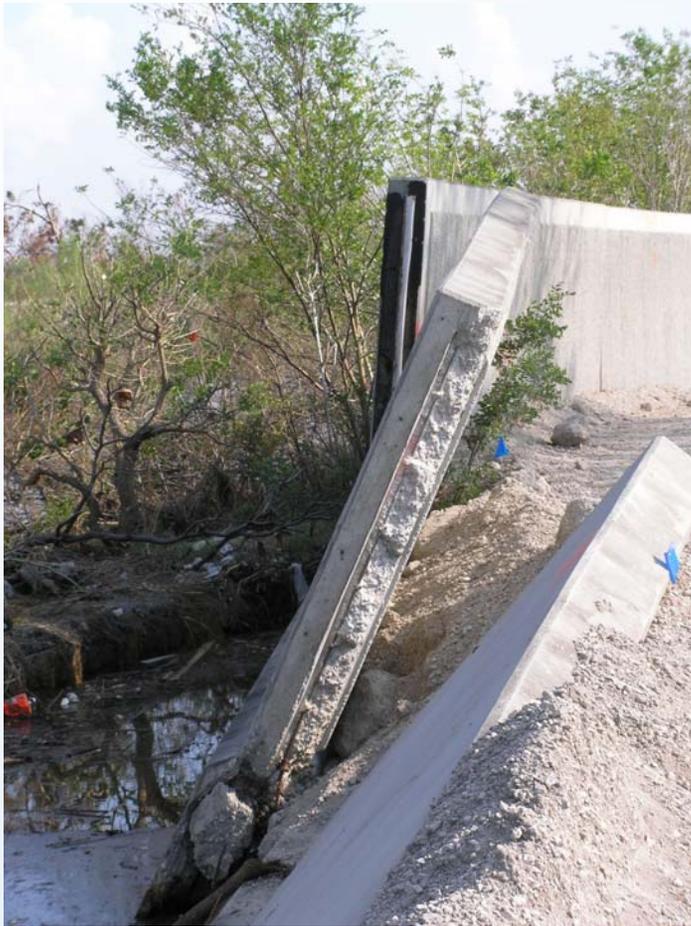
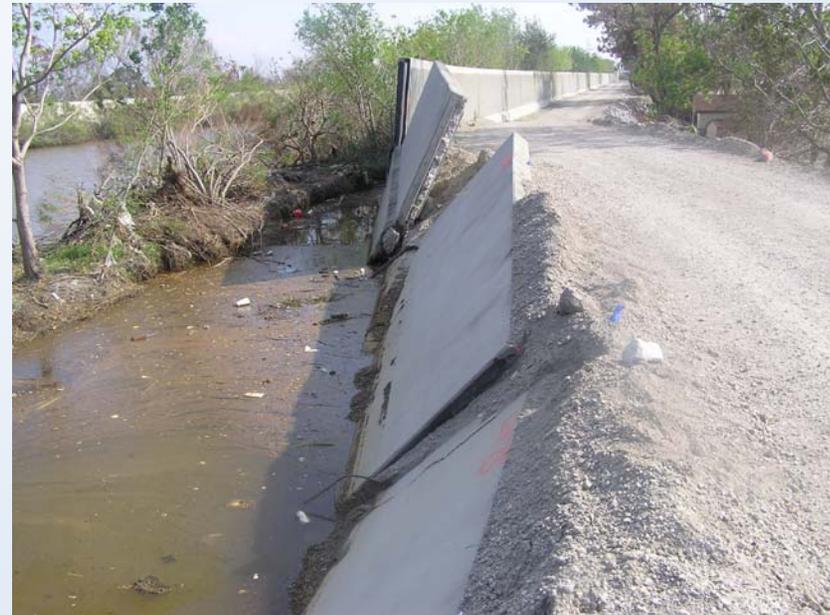
London Avenue Outfall Canal

- Failure was likely triggered by erosion and piping of soil due to underseepage according to IPET study.

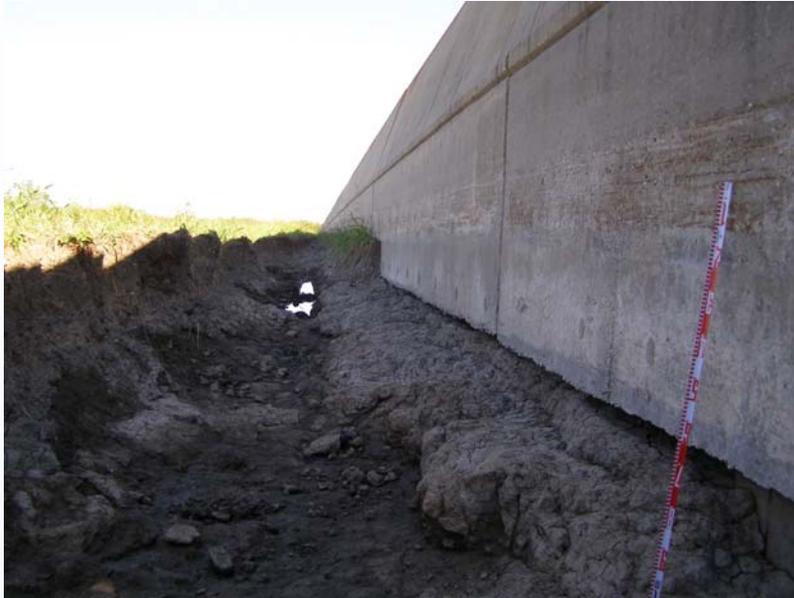
- Evidence of overtopping at this location.
- Scour on protected side of levee due to overtopping.
- Floodwall remained in place.

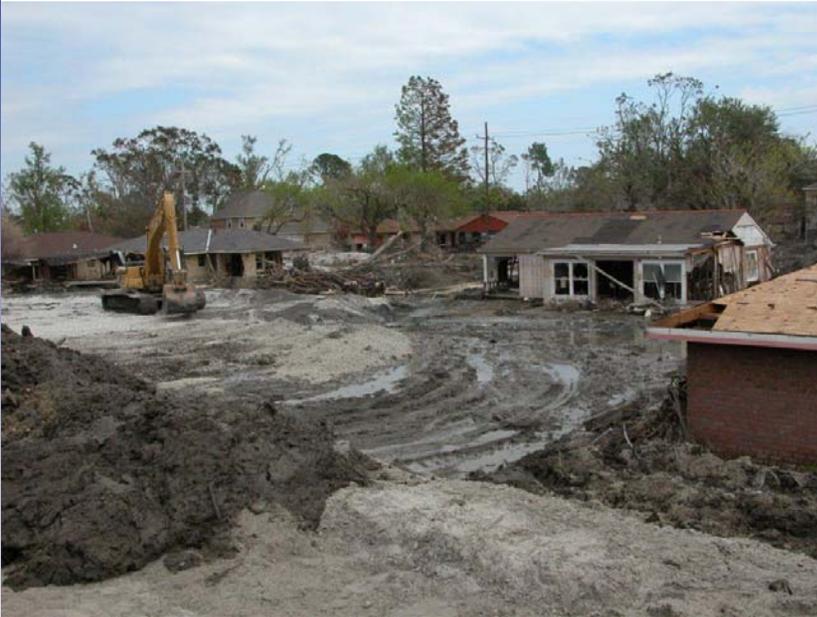
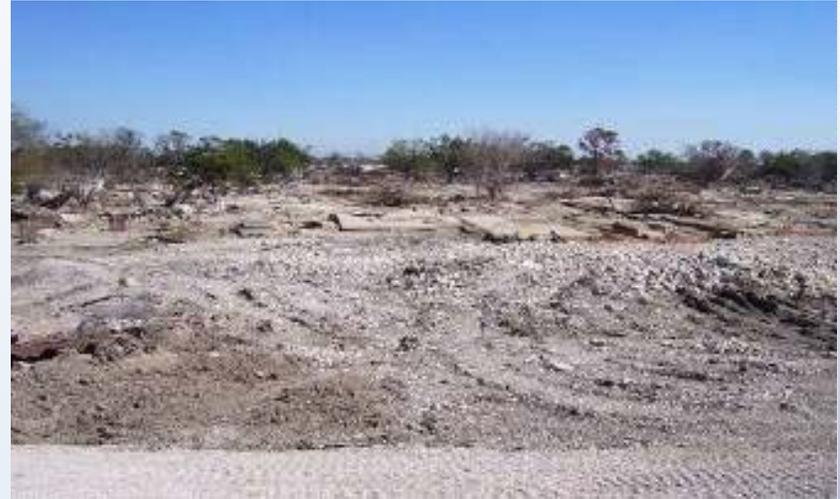
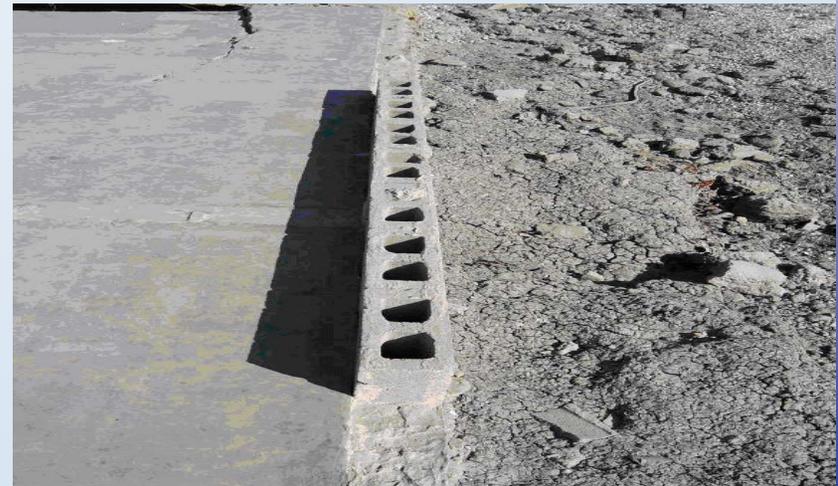
- **Damage to residential structures adjacent to levee breaches**

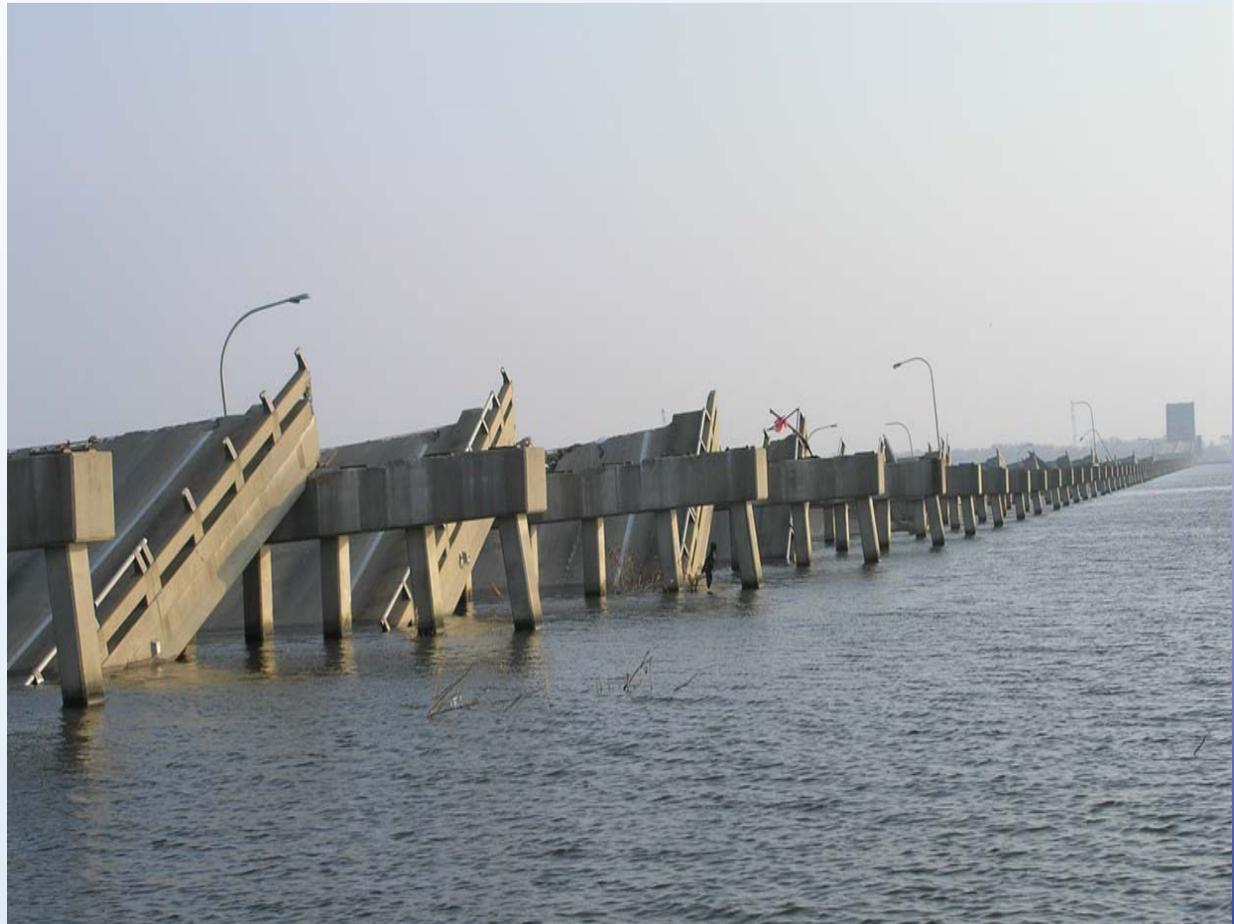
- Deck sections lifted and displaced by storm surge and wave action.
- Decks were simply connected to bridge piers (no shear key present).

Conduct detailed performance assessments of **coastal highway and railroad bridges** to fully understand and document the factors that contributed to their failure or survival and make recommendations for improvements to future designs. This work should include: (1) evaluation of design methods and connection details to improve the resistance to storm surge-induced uplift and lateral forces; (2) development of measures to prevent widespread loss of functionality of moveable bridges following a hurricane due to inundation of electrical and mechanical equipment; (3) development of means to mitigate the impacts of debris and massive objects carried by storm surge on the performance and functionality of bridges; and (4) development of methods for armoring bridge approaches against scour and erosion to avoid losing the use of a bridge. #15

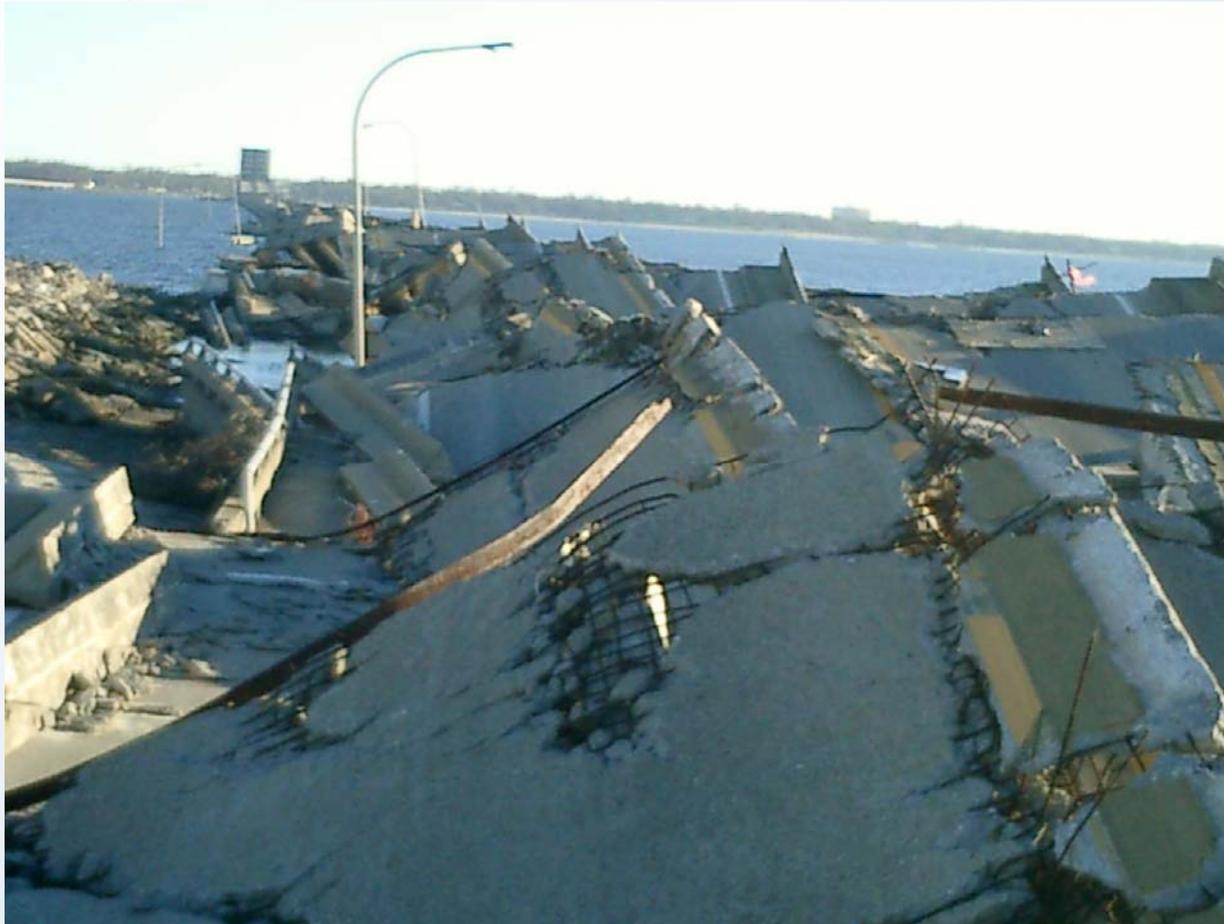
- Failure due to uplift and lateral displacement from storm surge and wave action.

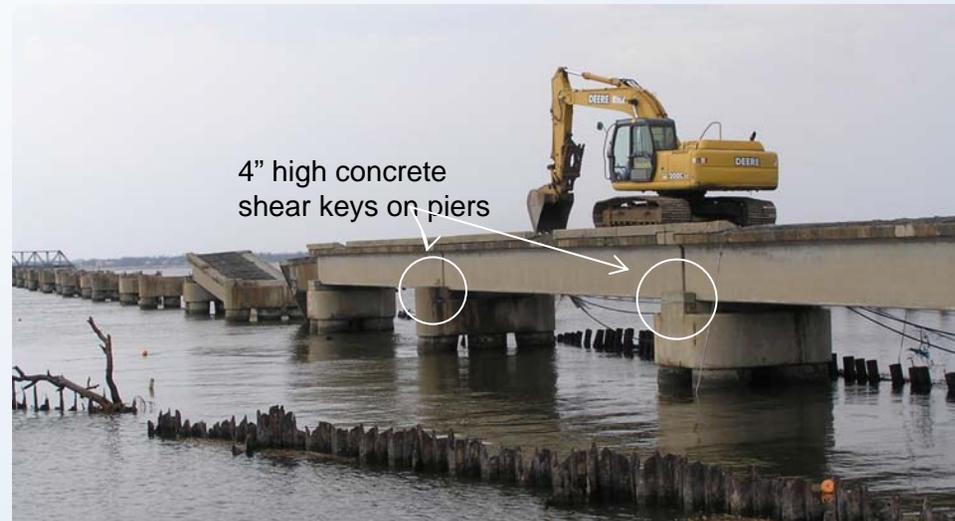
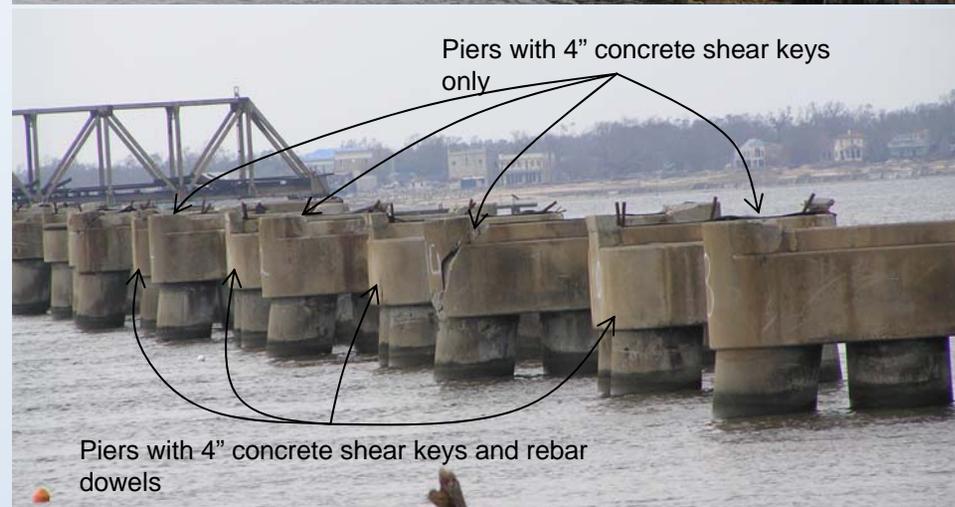
- Bridge deck sections lifted and displaced by storm surge.
- Displaced deck sections lifted above the height of concrete shear keys.

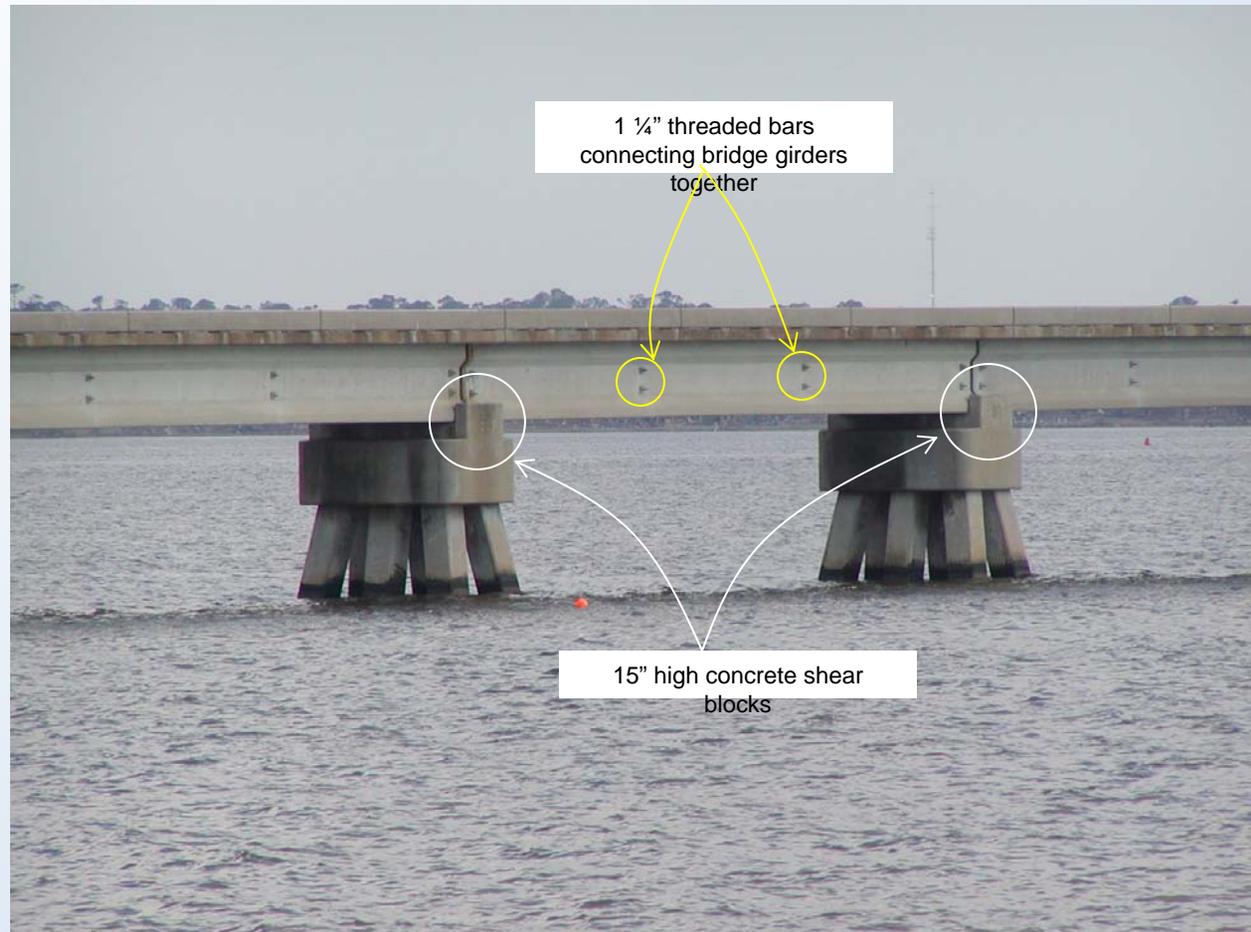
- Bridge subjected to storm surge.
- Deck sections were not lifted above the height of shear key and remained in place.

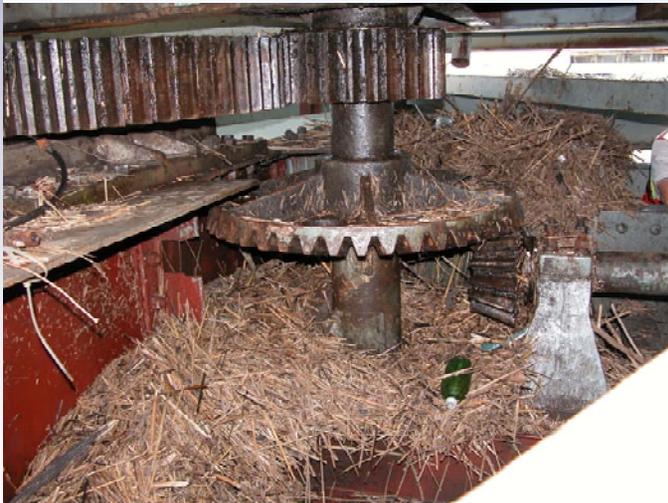
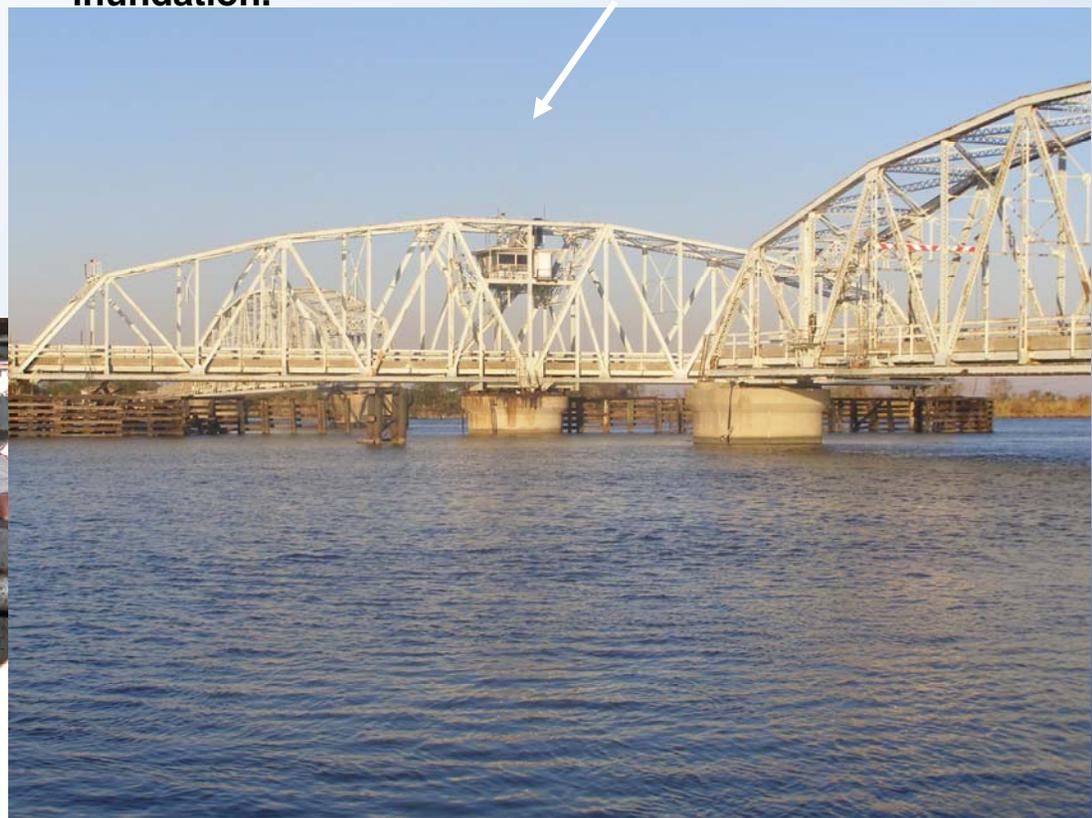
- Swing span bridge in open position.
- Electrical and mechanical equipment damaged due to inundation.
- Debris accumulation due in bridge mechanism due to inundation.

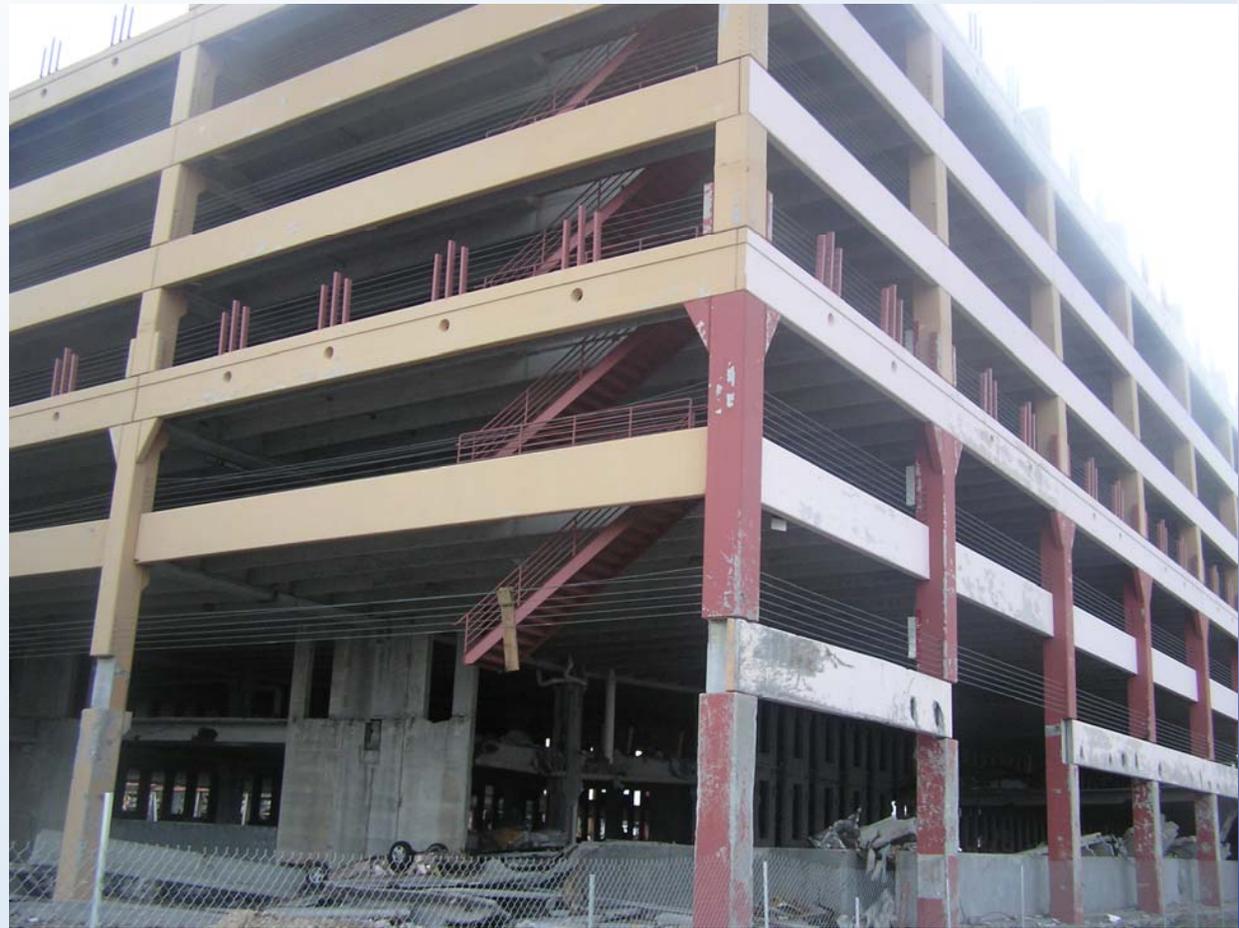
- Failure of first level deck of pre-cast concrete parking garage due to storm surge.
- Storm surge lifted and displaced simply supported deck.

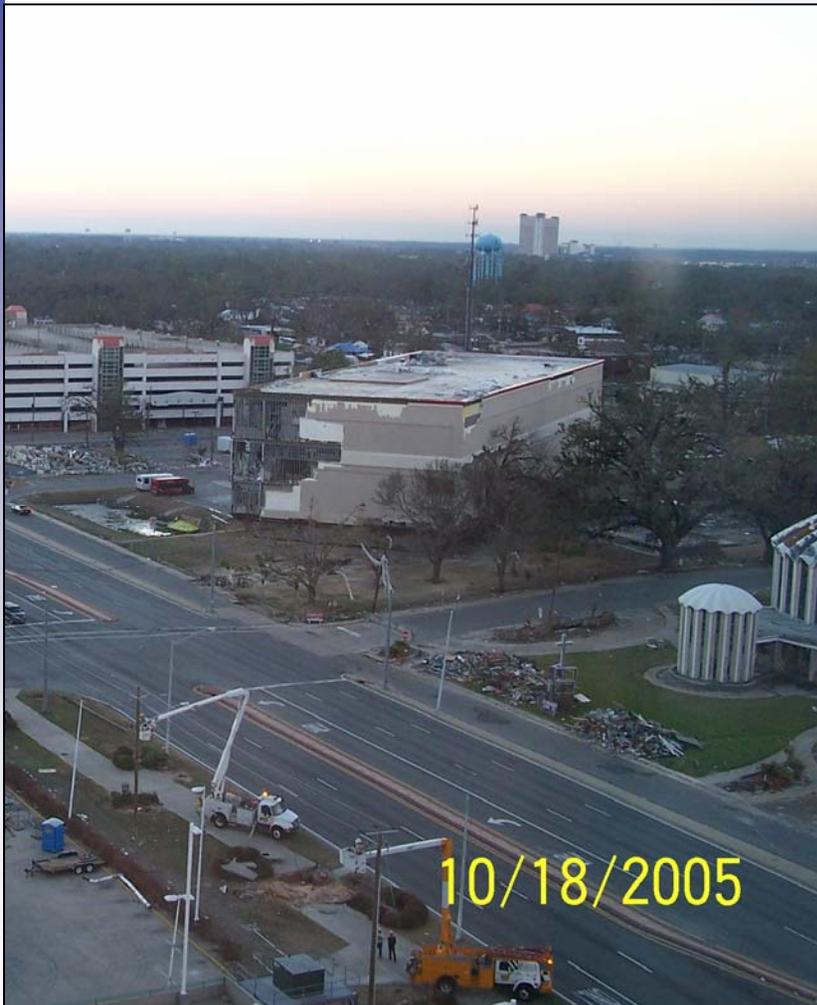
- Casino barge that broke free of moorings and floated inland.

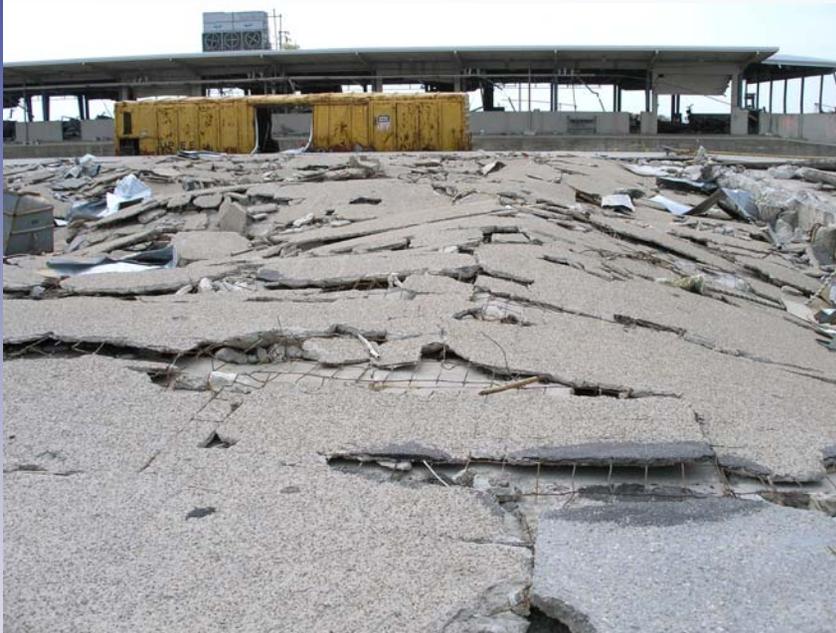
- Failure of concrete wharf at Port of Gulfport due to uplift from storm surge.

Conduct detailed performance assessments of the **wharves** in the Gulf States that were exposed to uplift and lateral forces due to storm surge to fully understand and document the factors that contributed to their performance during Hurricane Katrina or Rita and make recommendations for improvements to future designs. #18

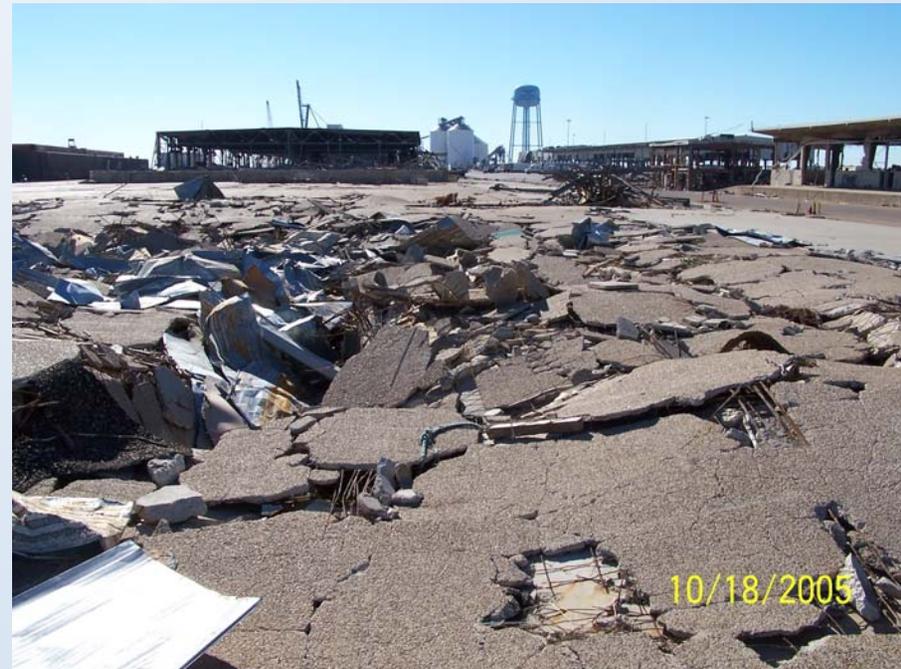
- Collapse of wharf at Port of Gulfport due to pile failure.

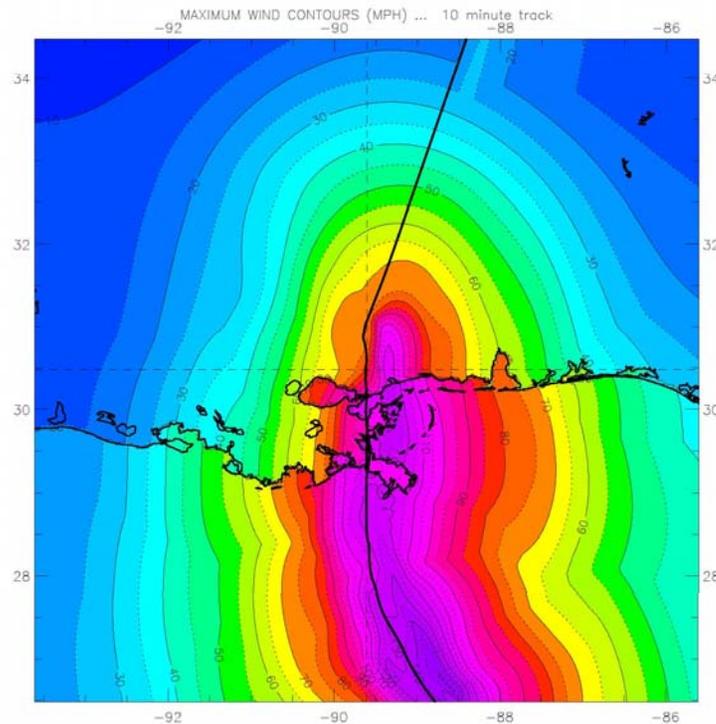
Katrina

- Wind speeds in affected areas were at or below design wind speeds.

- Wind speeds diminish rapidly as hurricane passes over land.

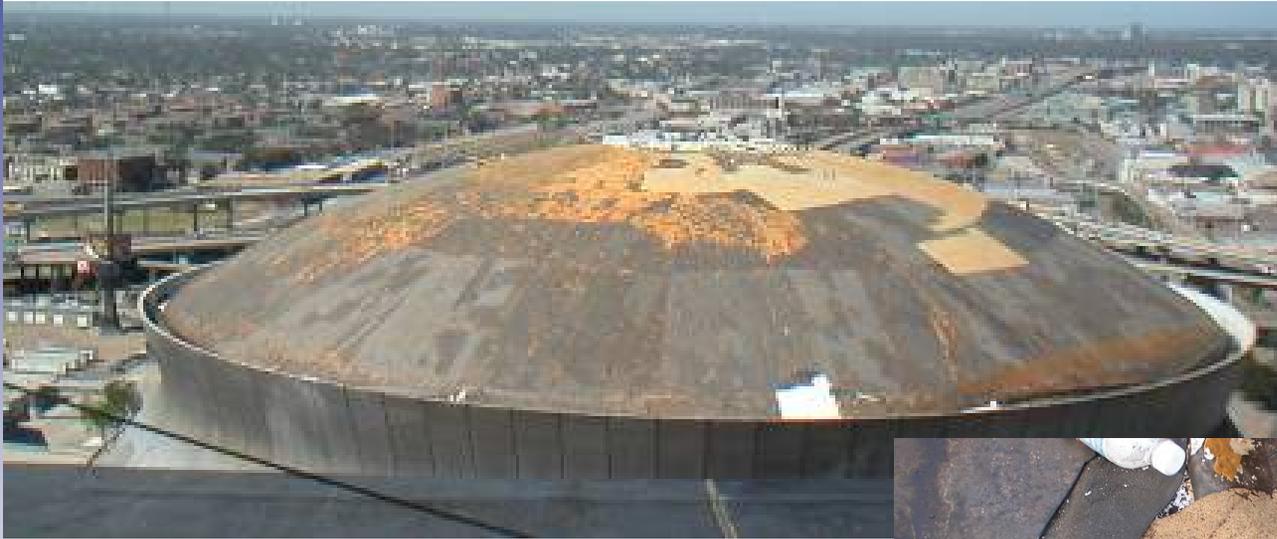
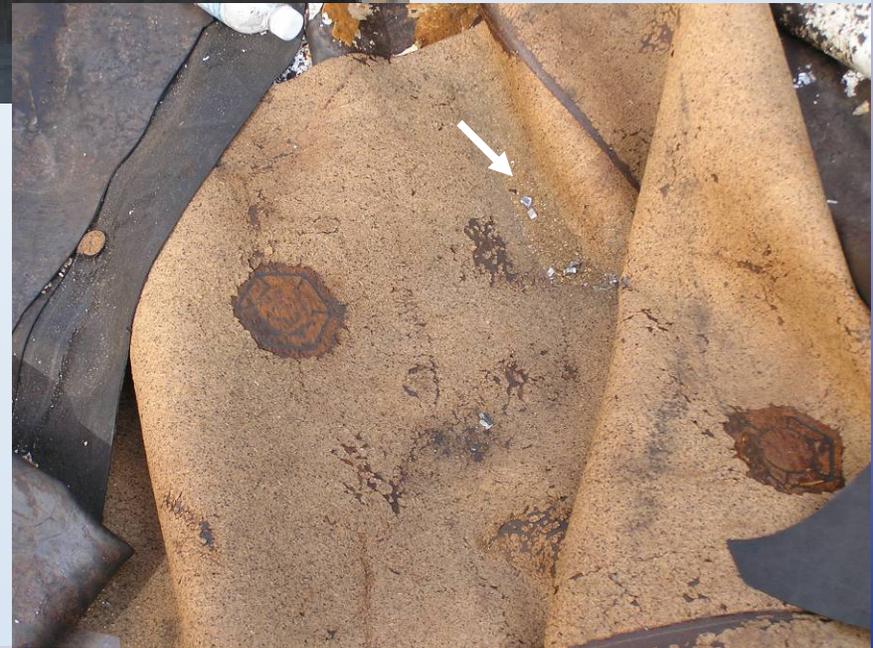
- Failure of roofing membrane on Superdome

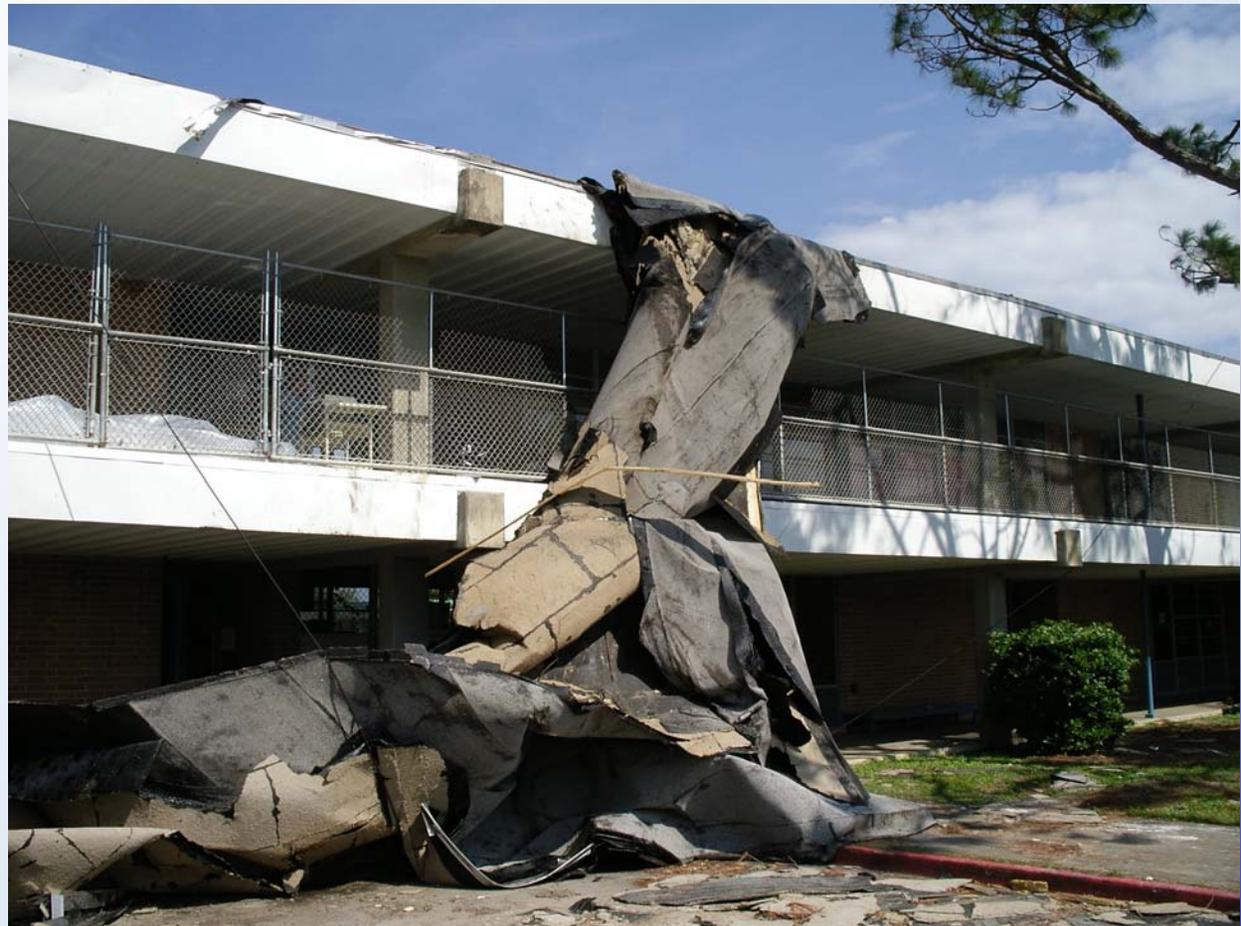
- Failure of bituminous roofing membrane.
- Roof failure precipitated by failure of metal edge flashing allowing wind under roof membrane.
