Performance of Physical Structures in Hurricane Katrina and Hurricane Rita

Reconnaissance Findings and Recommendations

June 9, 2006

**Building and Fire Research Laboratory
National Institute of Standards and Technology
Technology Administration
U.S. Department of Commerce**

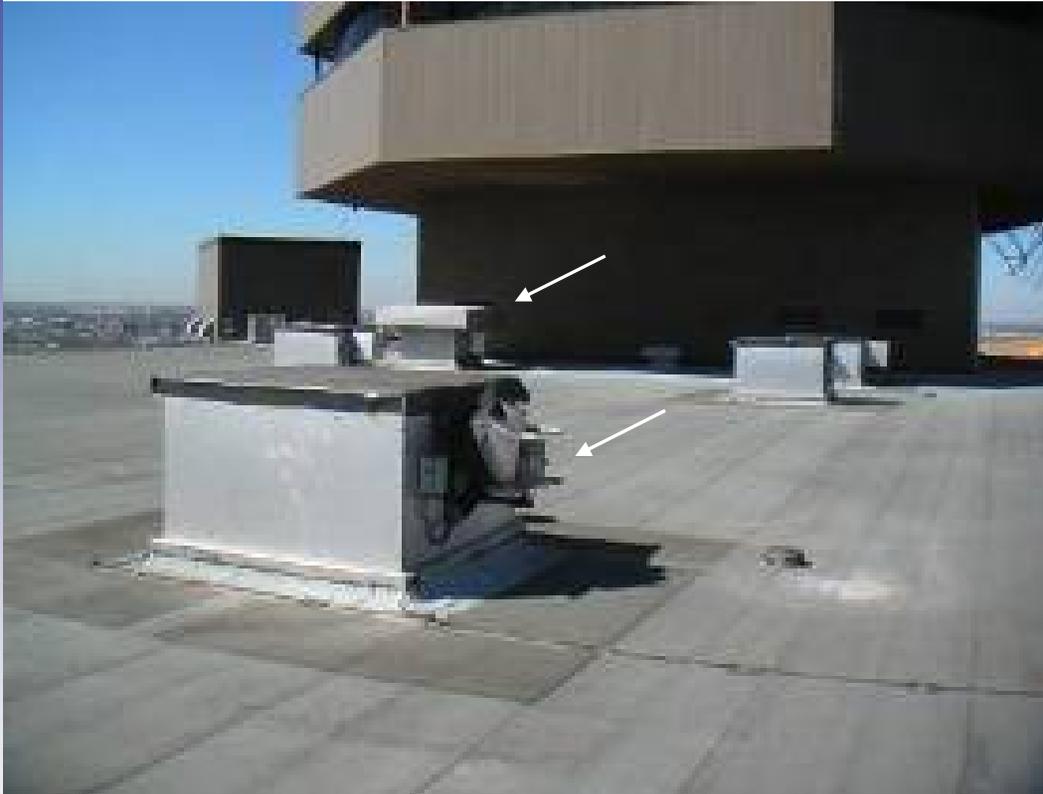
- Wind-induced damage to rooftop equipment.
- Missing vent covers provide path for water ingress.

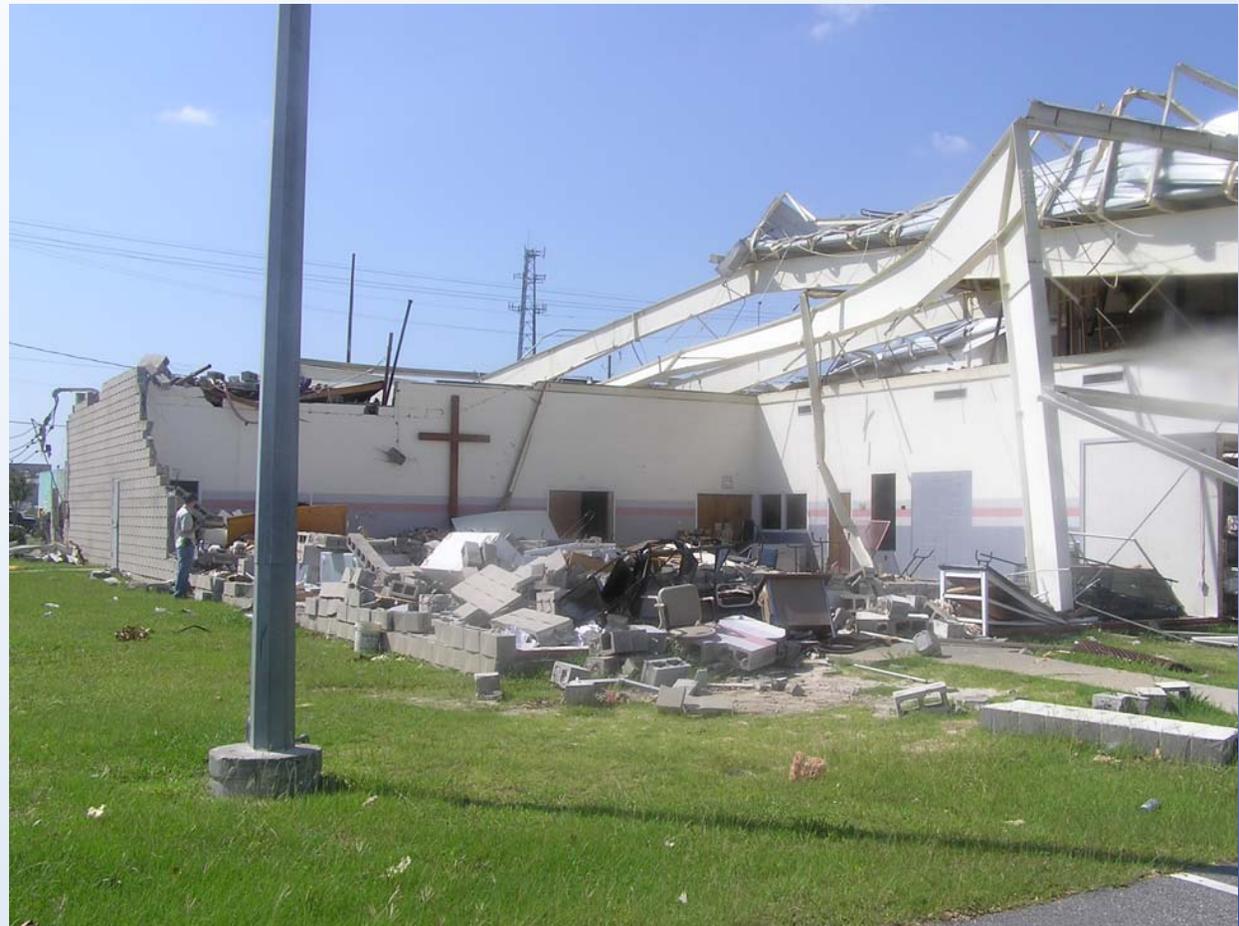
- **Gulfport, MS**
- **Collapse of community center building due to wind.**
- **Engineered metal building with masonry in-fill walls.**

Conduct detailed studies of the performance of **metal buildings** subjected to hurricane force winds to fully understand and document the factors that contributed to their performance and make recommendations for improvements to future designs. #20

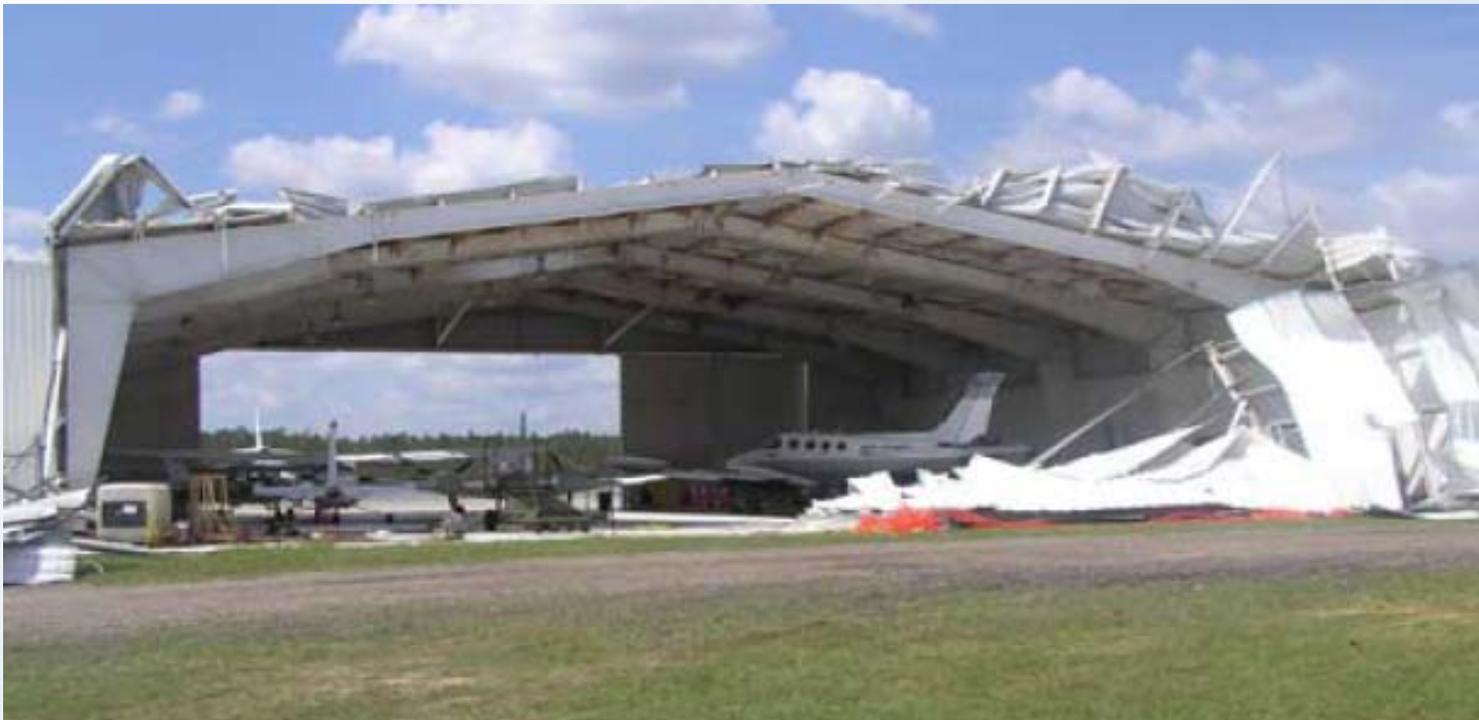
- Wind damage to aircraft hangar at Stennis Airport, MS.

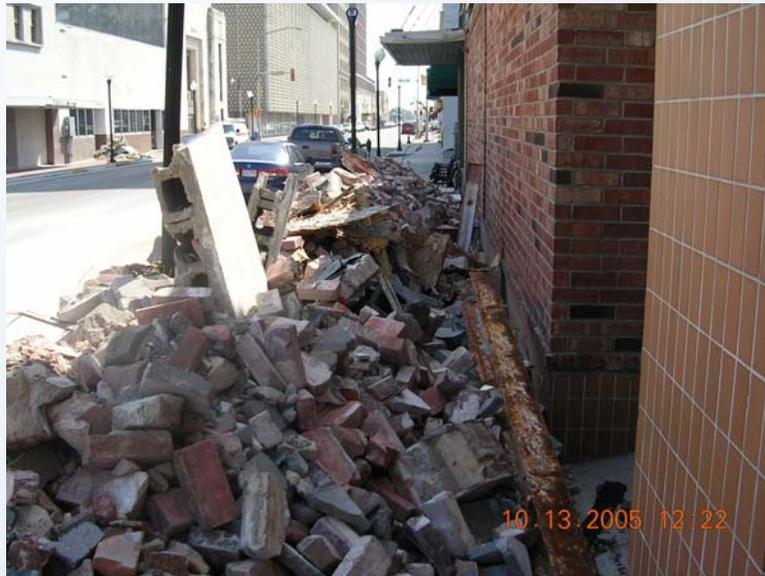
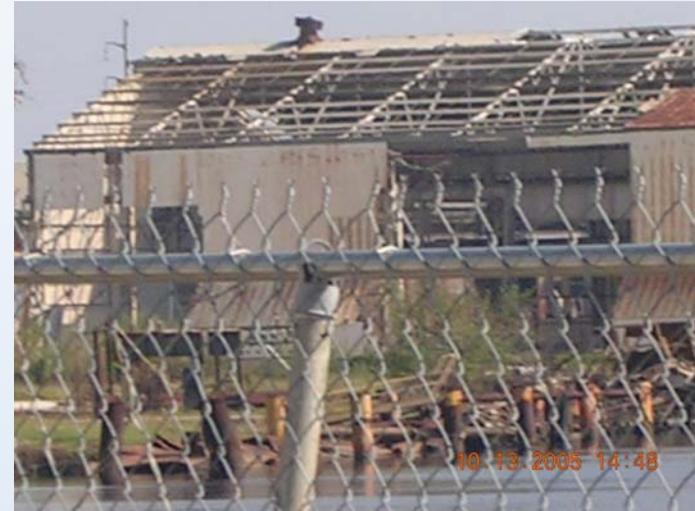
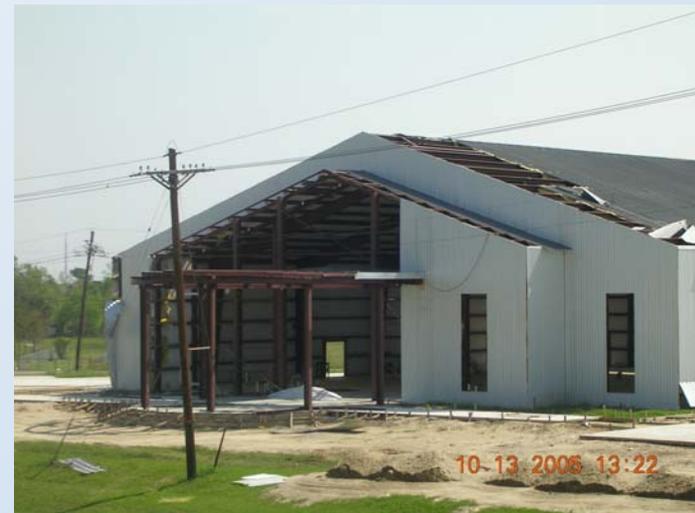
- Metal roof and wall cladding
- Brick veneer
- Membrane roofing

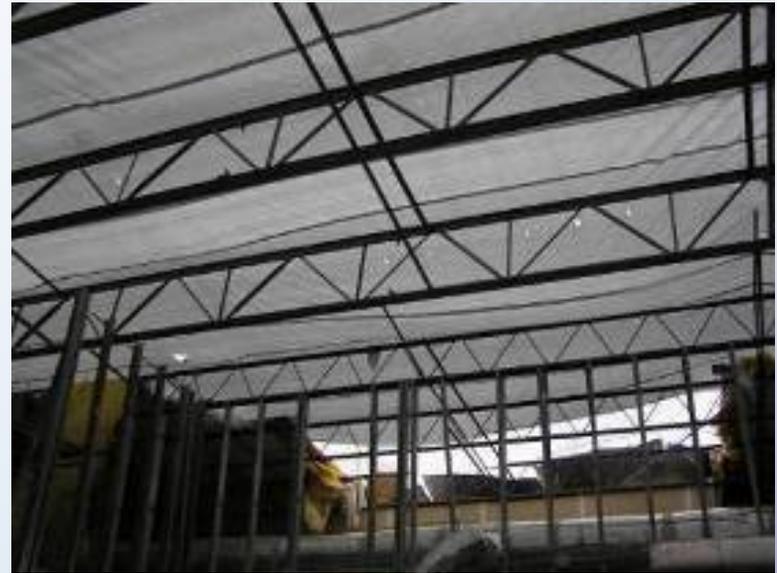
- Loss of metal roof panels and supporting structure due to wind
- Joists supporting roof have been replaced with larger members.

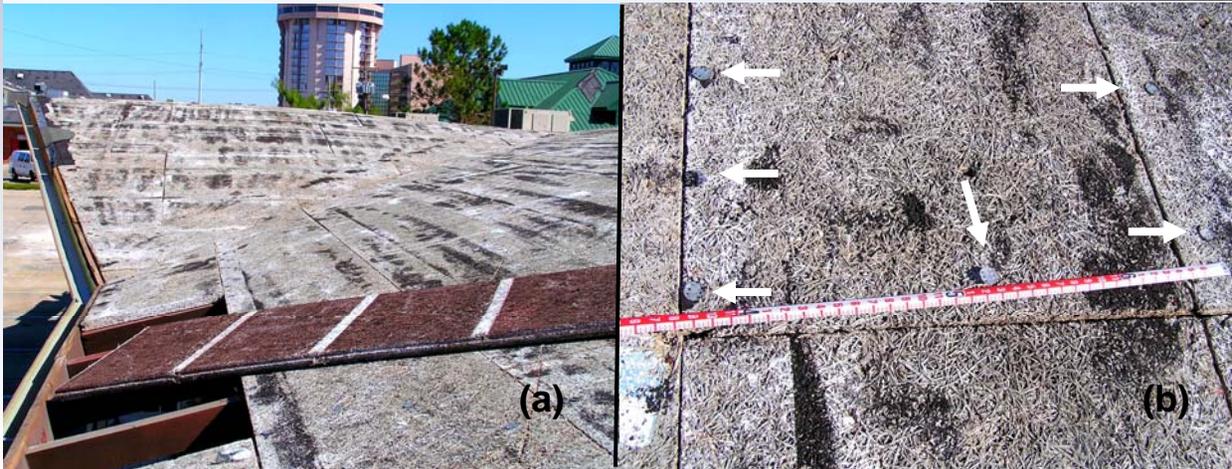
- Failure of bituminous membrane from wood fiber cementitious panel.
- An insufficient number of fasteners had been installed.

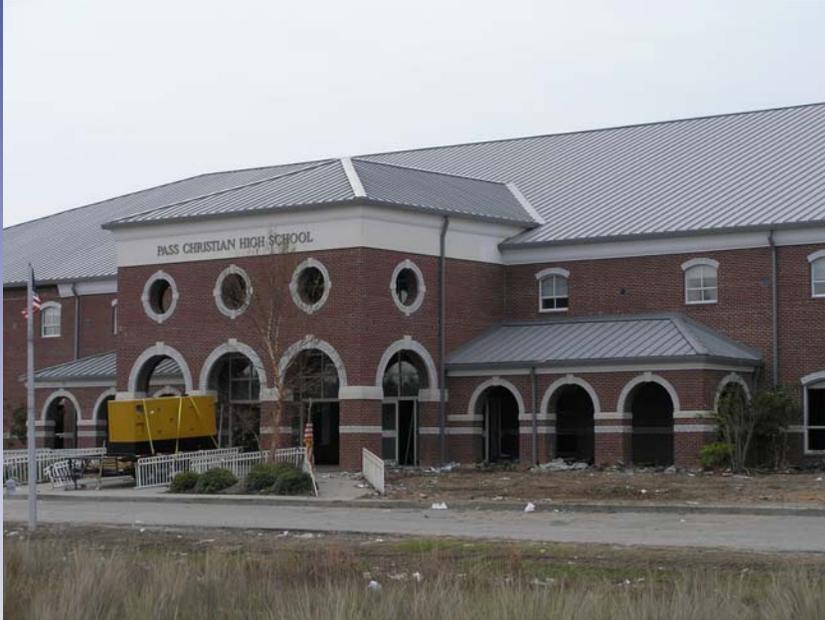
- Undamaged metal roof on school building in Pass Christian, Mississippi.

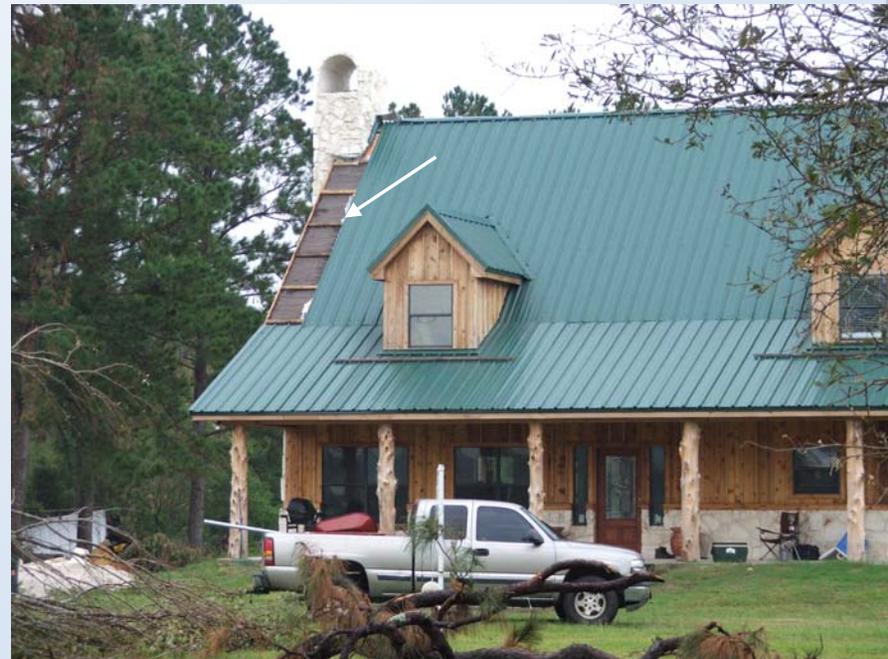
- Limited damage to metal roof on a house.

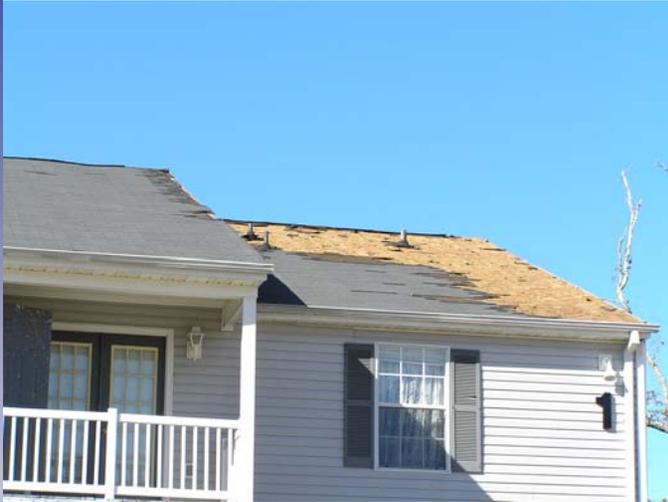
- Wind-induced failure of three-tab shingles on residential roof.

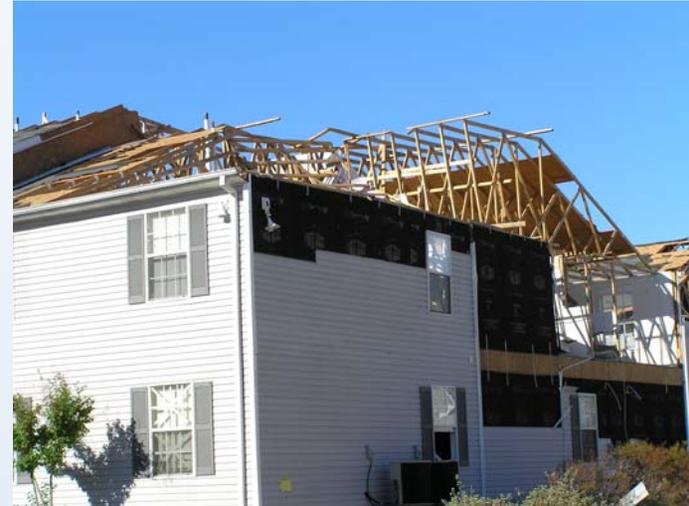
- Wind damage to roof of an apartment building.
- Plywood sheathing lost and roof trusses damaged.

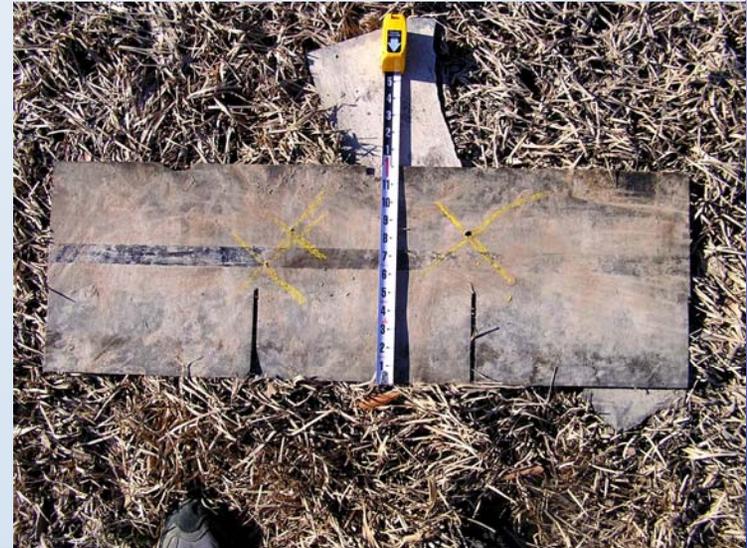
- Typical example of improper installation of three-tab shingle.
- Number of fasteners is insufficient.
- Fasteners not properly located.

- Many roofing shingle failures resulted from installers using an inadequate number of fasteners or installing fasteners in the wrong locations.
 - Wind-borne gravel from building rooftops caused a great deal of damage to windows on nearby structures.

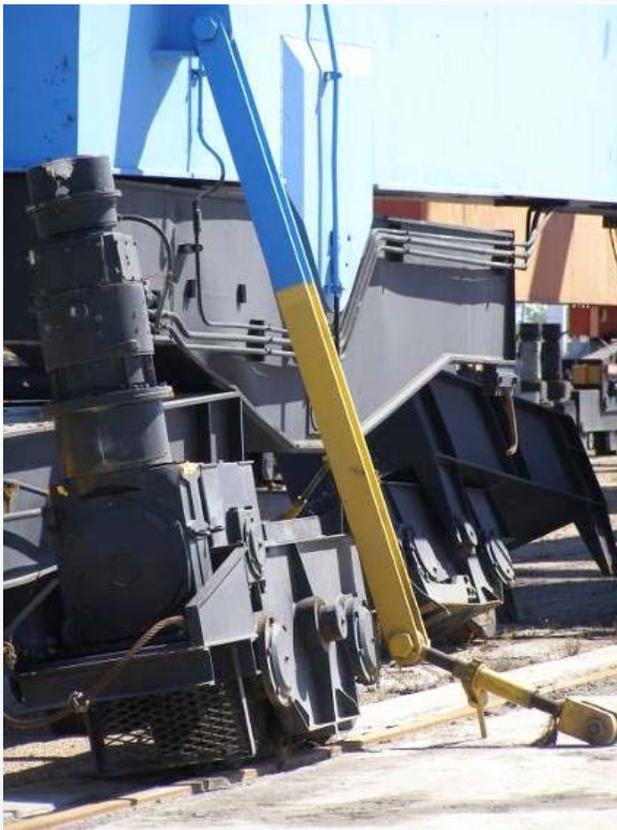
- Wind-induced failure of restraint.
- Carriage damage visible in background.

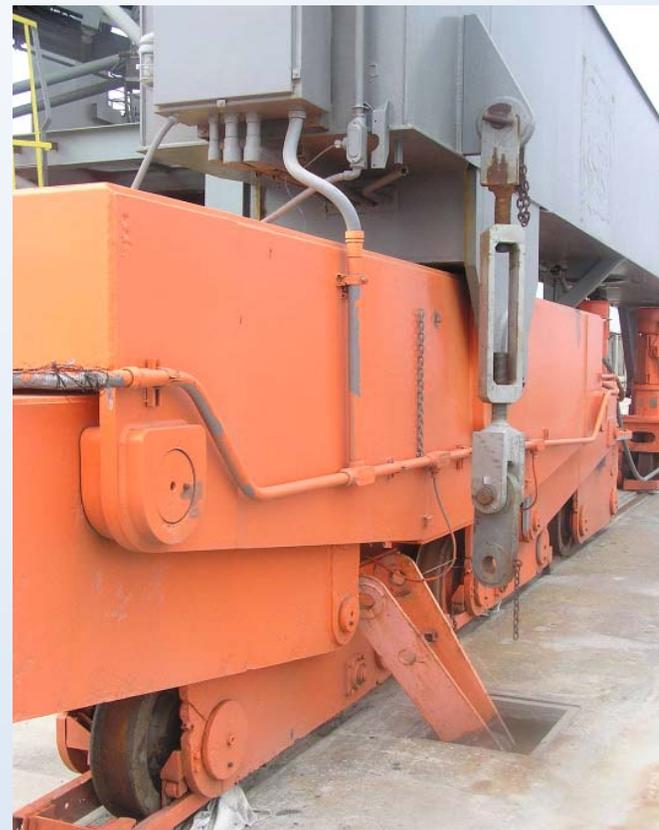
- Storm surge-induced failure of restraint.
- Three of four restraints failed.
- Crane remained in-place on rails.

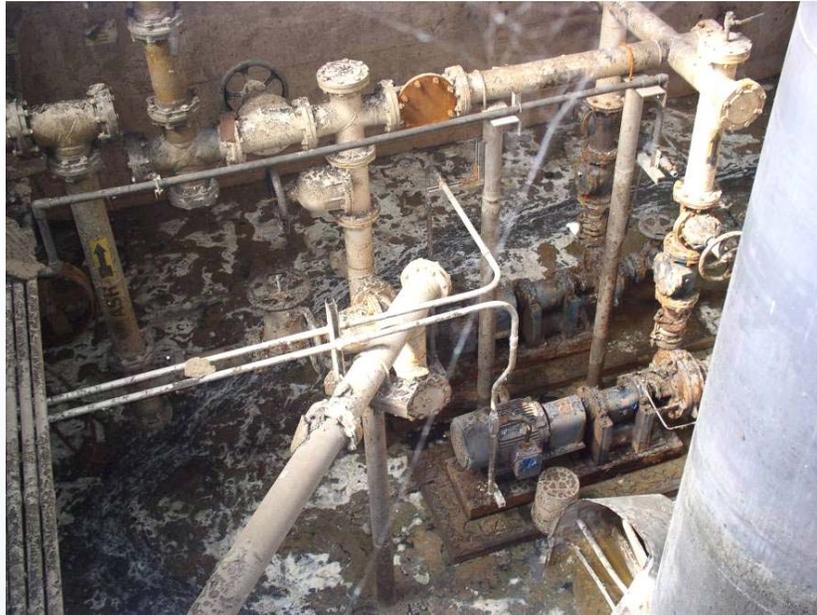
- **Water inundation damage to equipment at wastewater treatment facility.**
- **Facility was underwater for three weeks.**

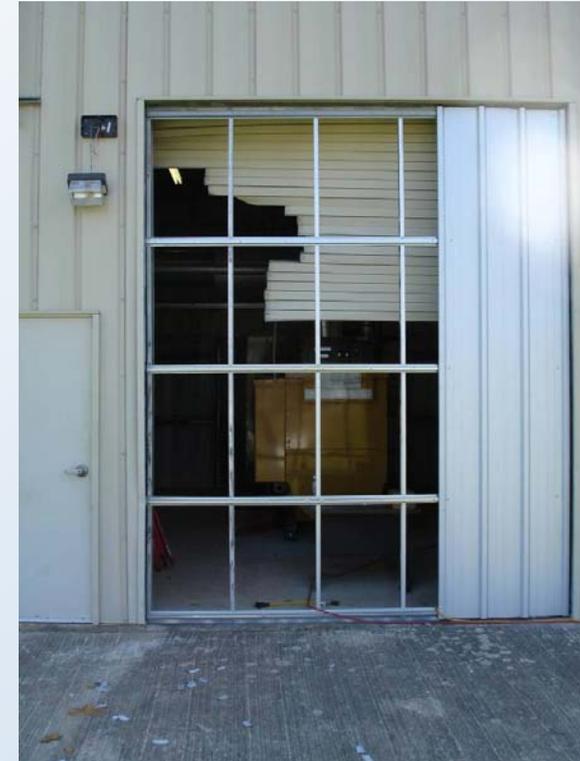
- **Wind-induced failure of roller door led to damage of transformer shutdown of backup generator at wastewater treatment plant.**

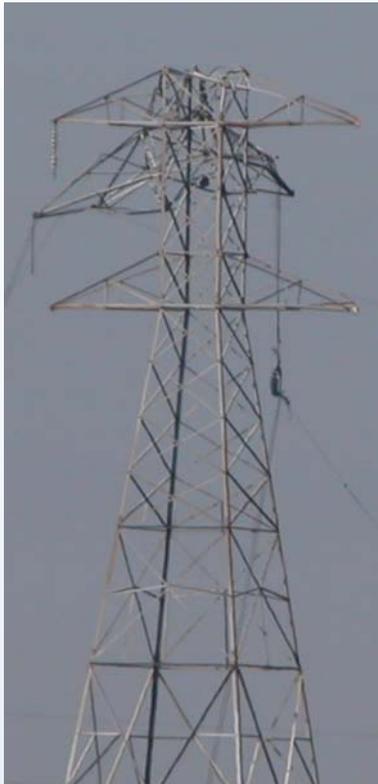
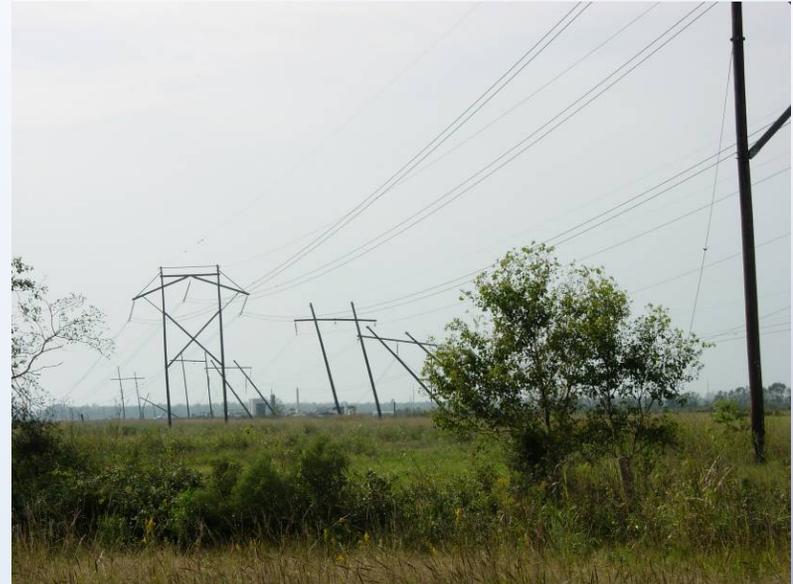
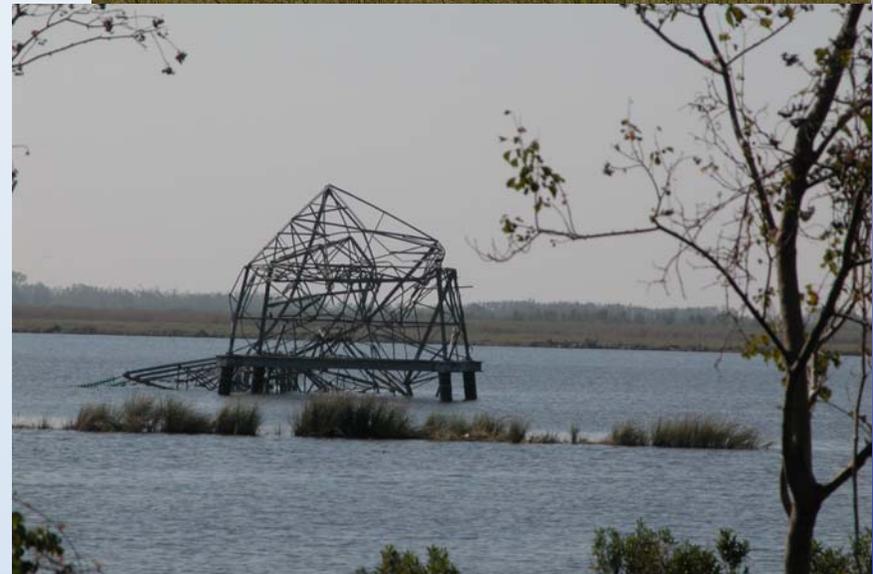
- ~300 towers, steel poles lost
- Many cascade failures
- Failures caused by wind

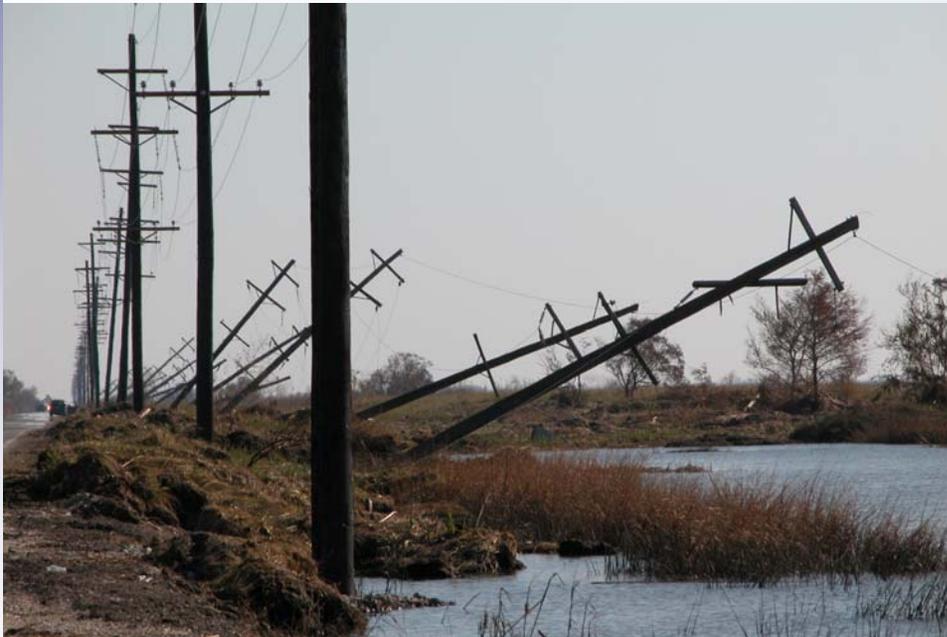
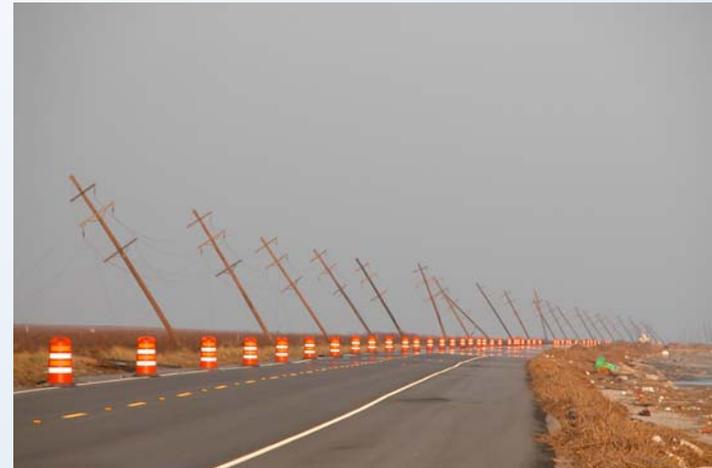
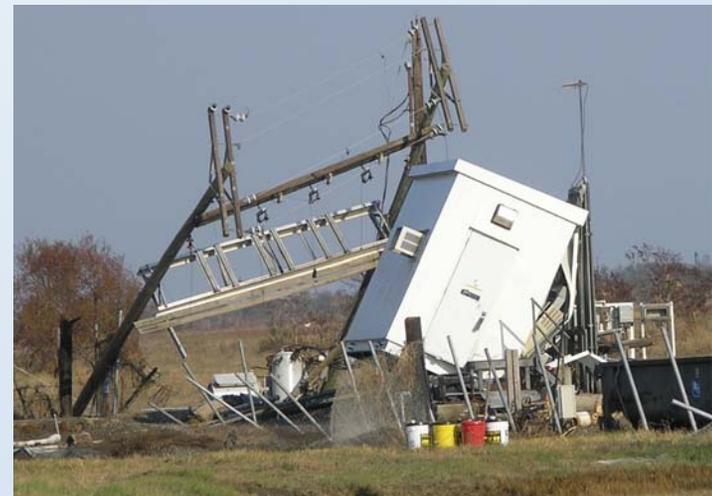
~1,000,000 poles lost as a result of both hurricanes

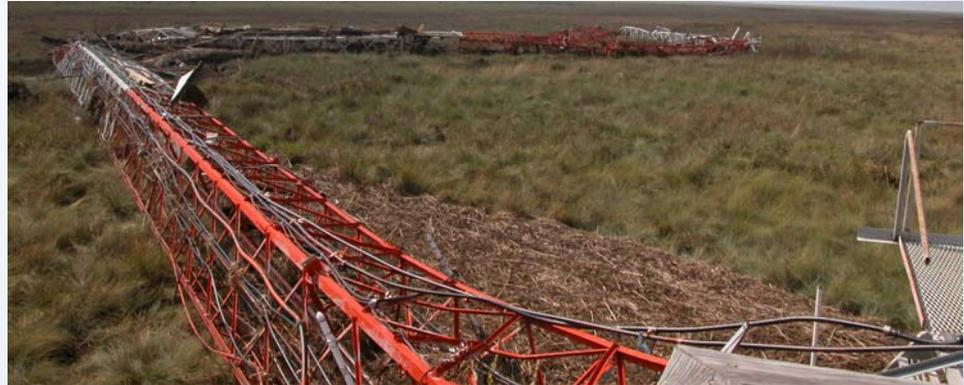
Cell tower failure, Route 82, coastal
LA

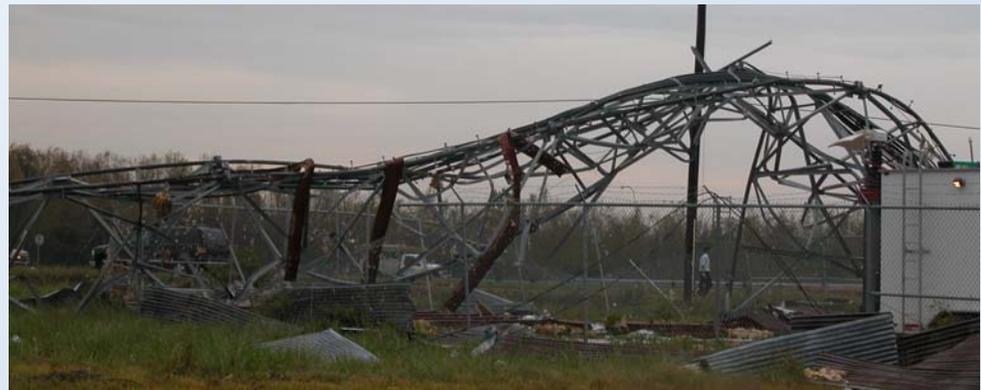
Photo credit: Christopher Letchford, Texas Tech University
Sabine Pass tower failure

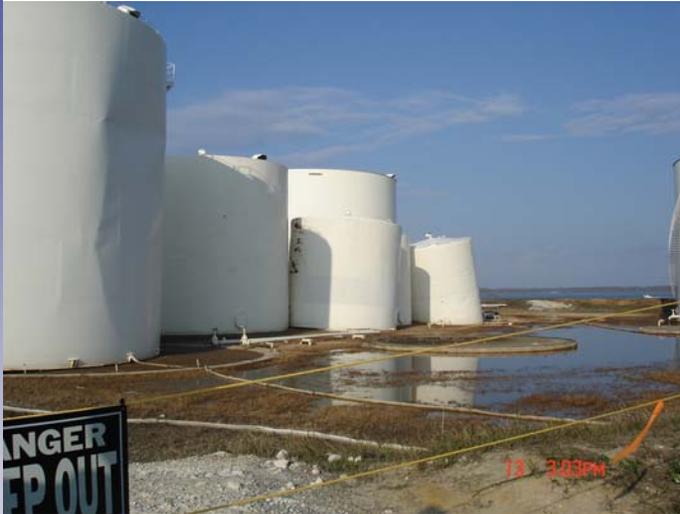
- Oil storage tanks shifted due to flooding.

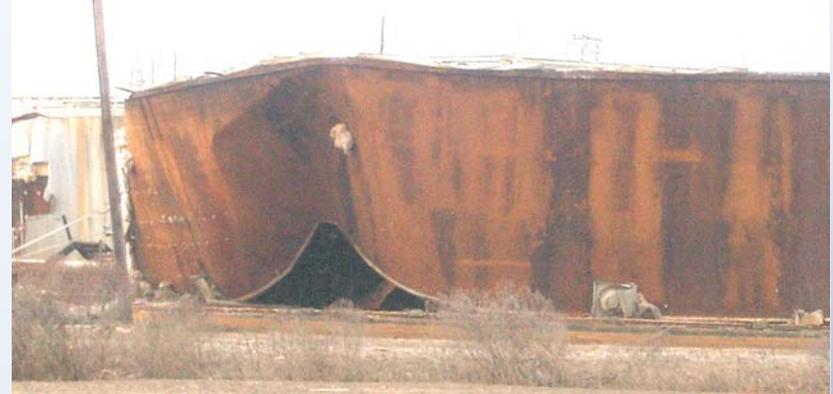
- Buckled oil storage tank. Failure due to wind loads.
