Engineering Laboratory

**NIST Preliminary
Reconnaissance, Building
Performance and Emergency
Communications, Joplin,
Missouri Tornado,
May 22, 2011**

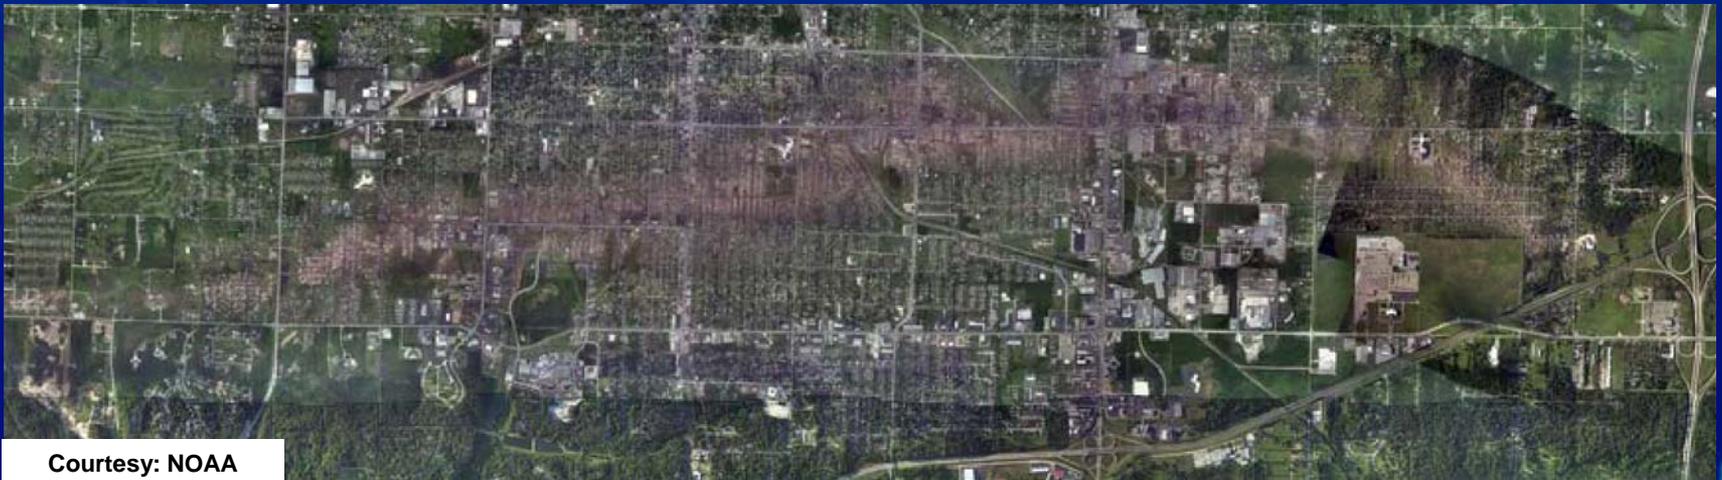
- Touched down in Joplin beginning at 5:41 PM CDT
- Initially rated a “high-end” Enhanced Fujita (EF)-4 tornado with estimated maximum wind speeds from 190-198 mph on May 23rd
- Upgraded to EF-5 on May 24th
 - Estimated maximum wind speeds 200+ mph
 - Maximum path width: $\frac{3}{4}$ mile, length: 13.8 miles (6 miles in Joplin)
 - Source: National Weather Service
- Track: generally West to East across Joplin (Newton and Jasper counties)

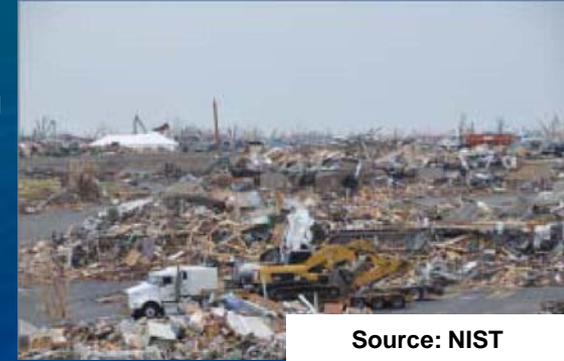
Source: NIST

- Wind Speed (NWS)
 - Estimated EF-5 at 200+ mph in heaviest damage swath
 - EF-5 rating partially based on indicators not in EF scale
 - EF-1+ damage estimated over larger area (86+ mph)
- Debris
 - Estimated 3 million cubic yards of debris (USACE)
Fill a football field (end zones included)~470 yards high (over 120 stories tall)
- Significant portion (20-30%) of Joplin affected resulting in:
 - Estimated 4,000-8,000 structures damaged or destroyed (USACE/FEMA)
 - Critical¹, institutional, commercial, residential and lifeline facilities damaged and destroyed
- NIST surveyed 20+ non-residential structures and multiple residential structures

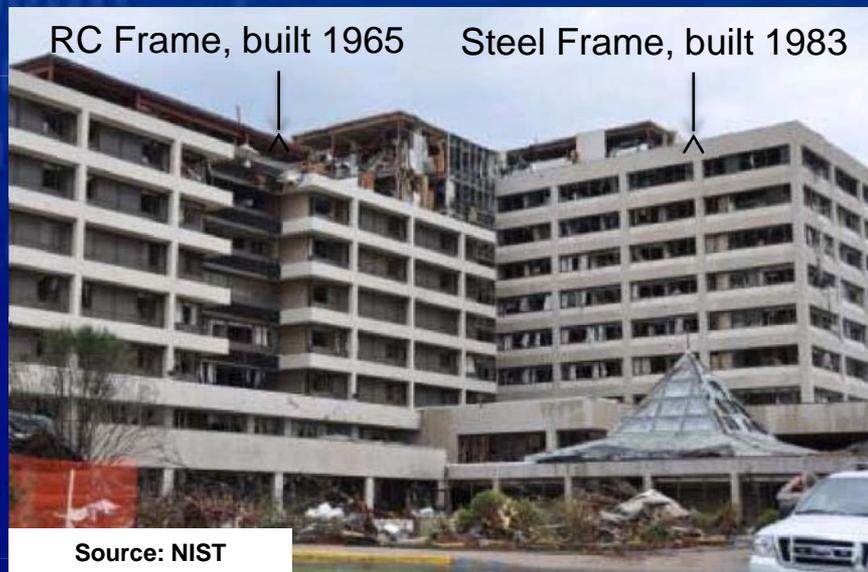
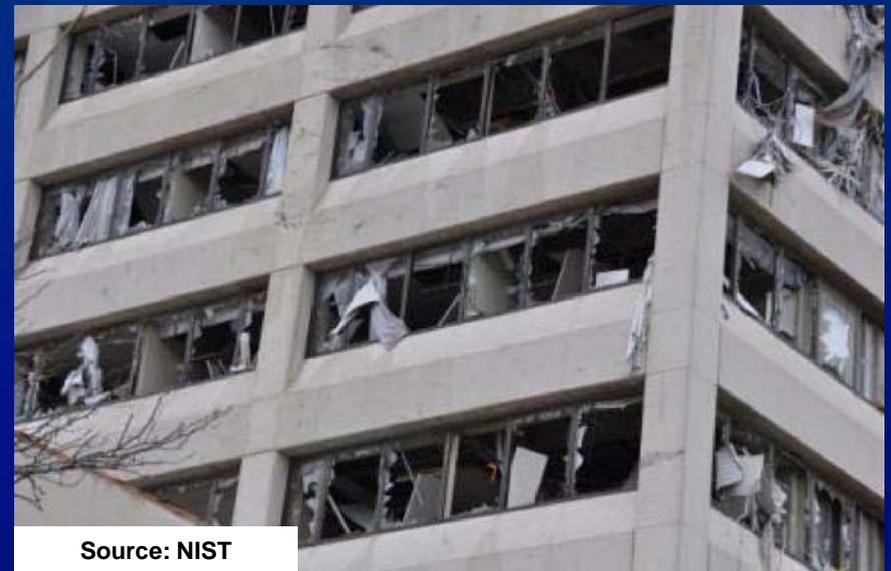
St. John's Medical Center

- RC and Steel Frame Buildings
 - Extensive damage to building envelope and interior
 - Loss of function
 - No observed damage to main wind force resisting systems

- Reinforced concrete frame and steel frame buildings that were surveyed also suffered total loss of function and major damage to the envelope and the interior, but the structural frame remained largely intact

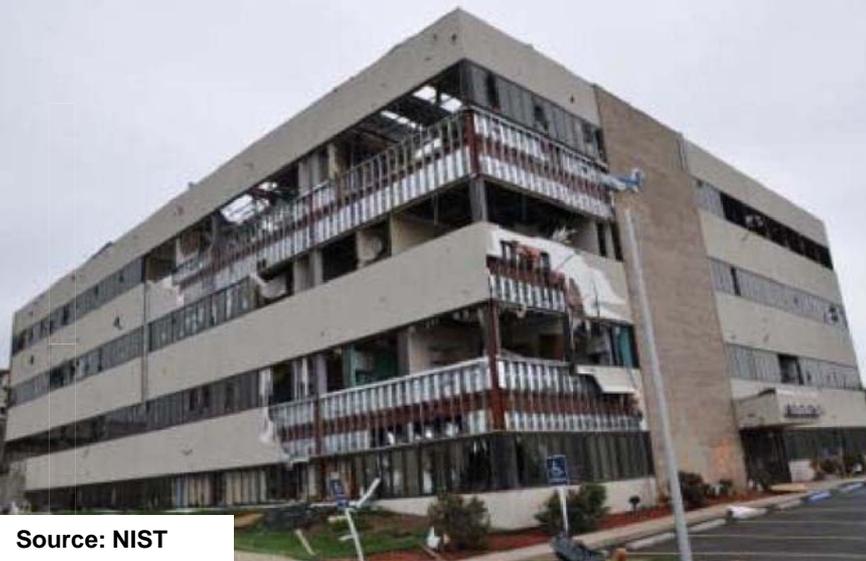
St. John's Medical Center

Steel Frame, built 1983

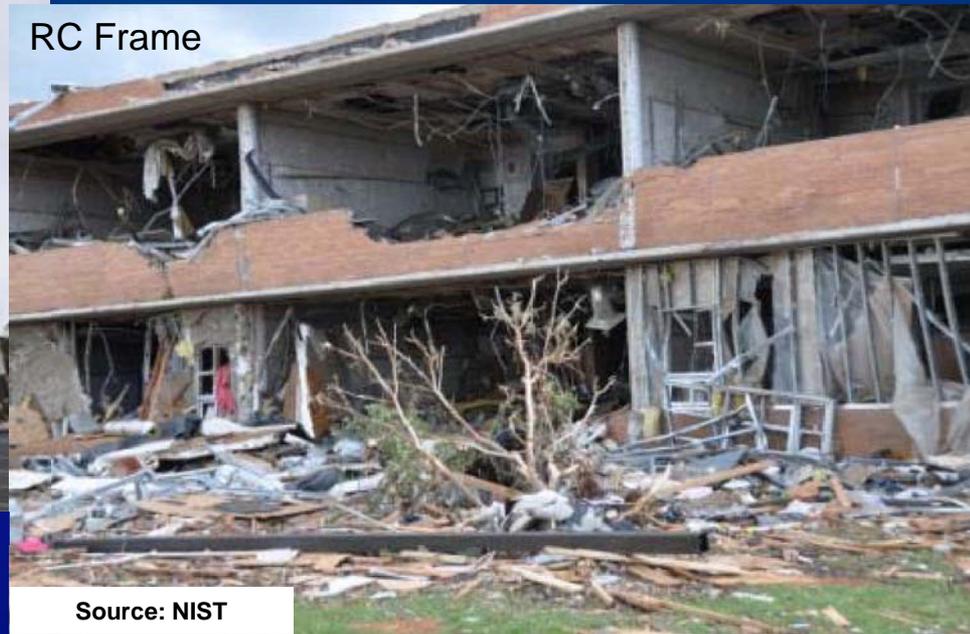
Joplin High School

RC Frame

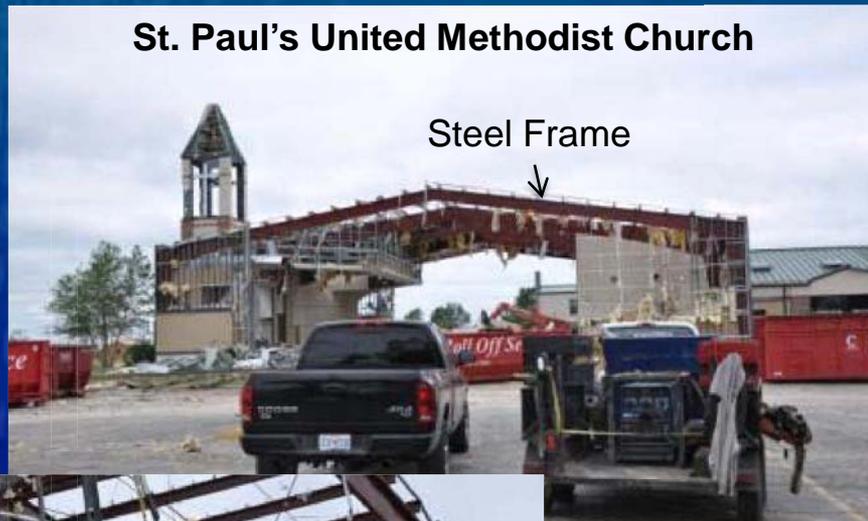
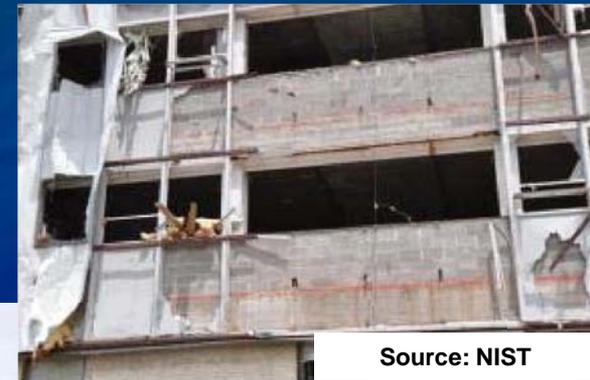
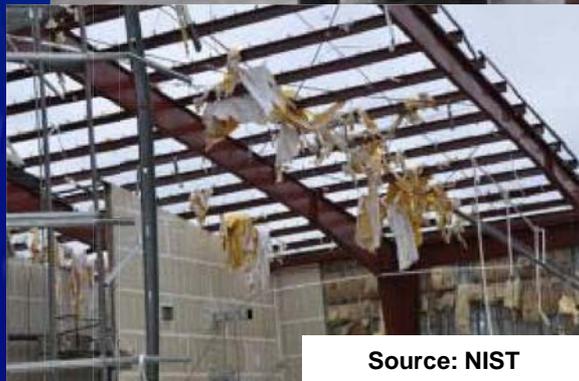
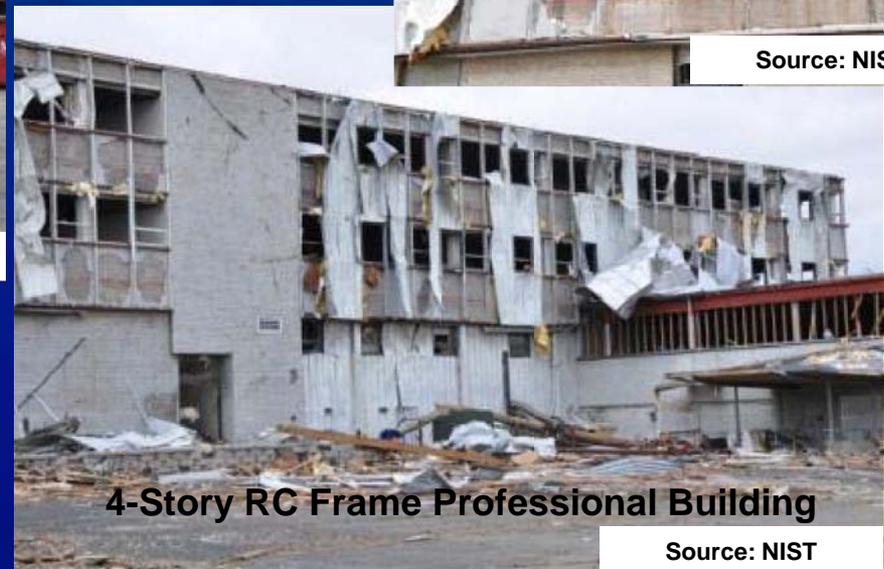
Responses of Buildings, Tornado Shelters and Designated Safe Areas (cont'd)

- RC and Steel Frame Buildings

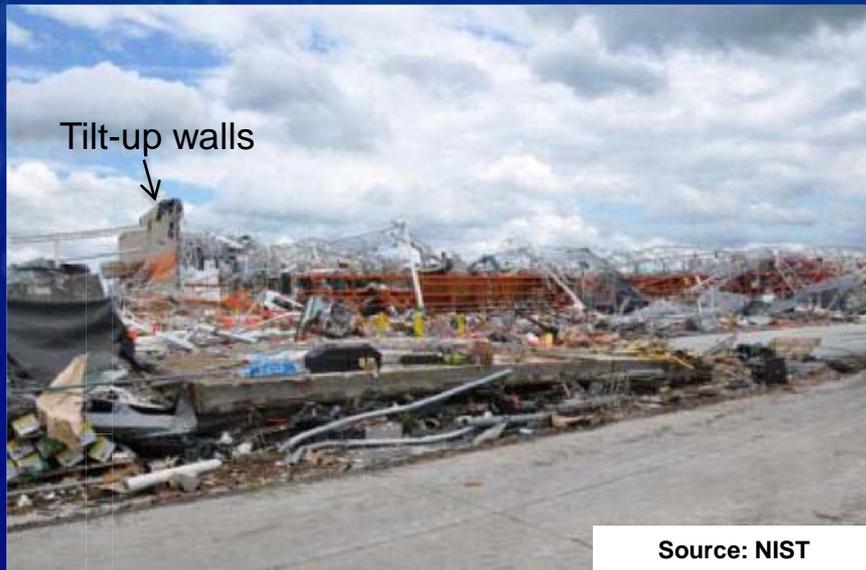
Home Depot

- Precast Concrete Wall Buildings
 - Partial or complete loss of roofing system
 - Failure of roof to wall connections
 - Collapse of wall panels

- Most other buildings, including pre-cast concrete wall construction, metal buildings, concrete and brick masonry, and wood-frame construction, suffered partial or complete collapse

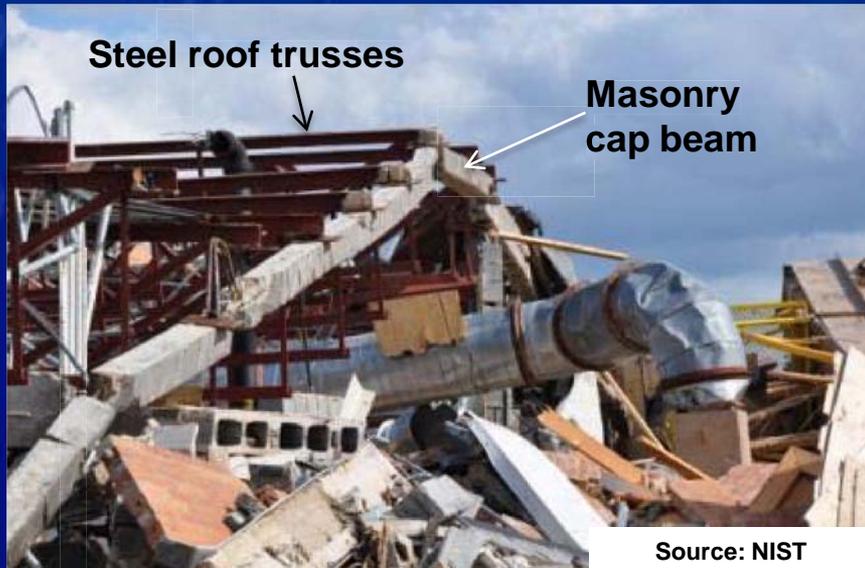
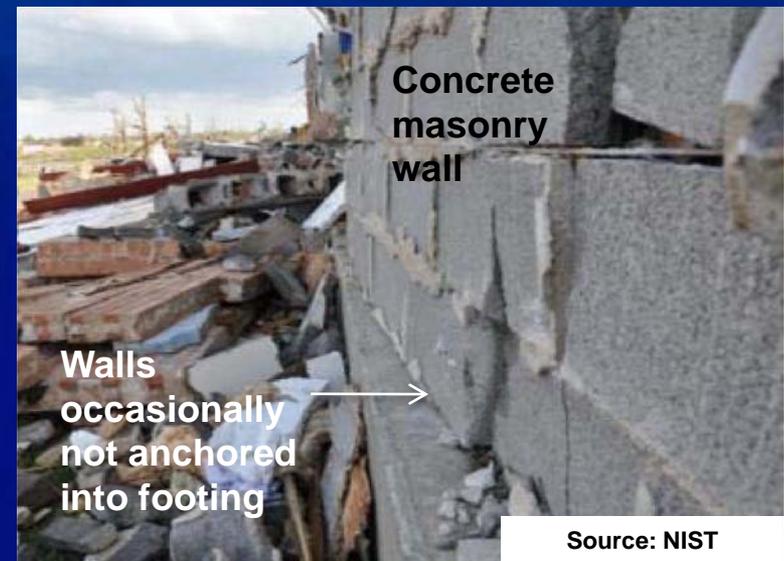
- Concrete Masonry Wall Buildings
 - Partial or complete loss of roofing system
 - Failure of roof to wall connection
 - Collapse of walls

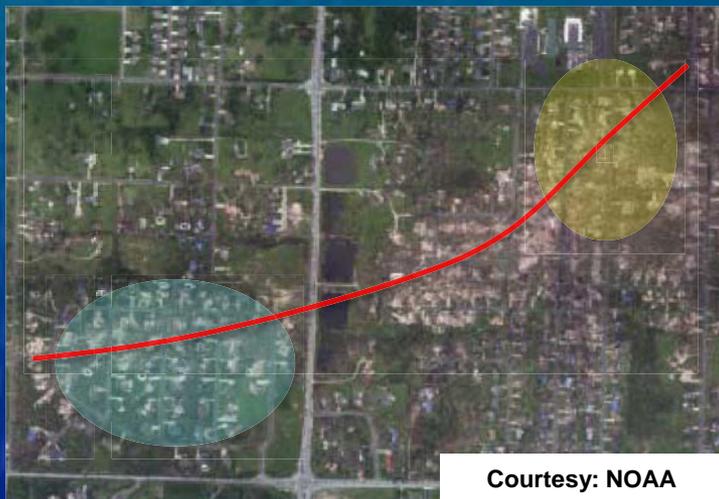
- Surveyed two representative subdivisions near the beginning of the tornado track on the west side of Joplin within damage path

- Different ages of subdivision construction
- Avg. Age: Yellow – Late 1980's, Blue – Early 2000's
- Both types sustained heavy roof damage

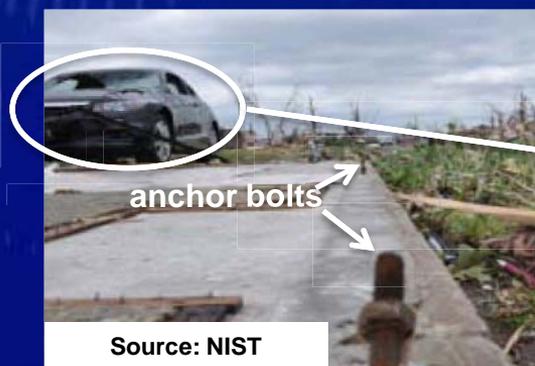
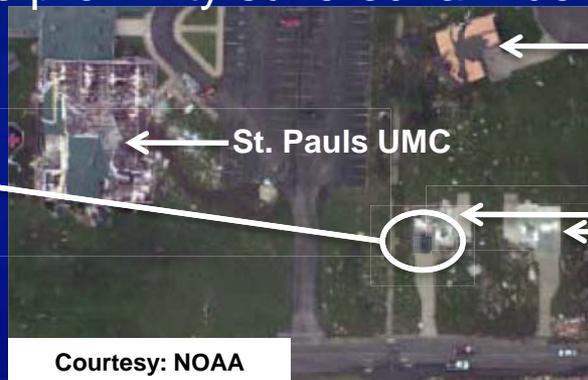
- Houses removed from foundation leaving only anchor bolts in some instances
- In some instances, homes in close proximity suffered a wide range of damage

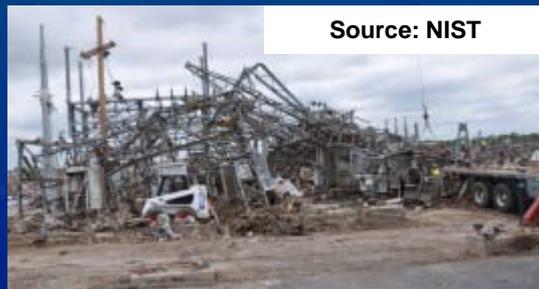
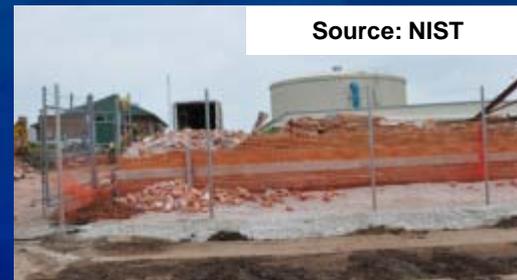
- Power substation damaged, supporting steel frame collapsed
- Unreinforced brick storage building at water treatment plant collapsed. Plant remained operational on back-up power (Source: Missouri American Water Engineering Manager)
