NIST Response to the World Trade Center Disaster

World Trade Center Investigation Progress

May 7, 2003

S. Shyam Sunder, Lead Investigator
Building and Fire Research Laboratory
National Institute of Standards and Technology
U.S. Department of Commerce
sunder@nist.gov

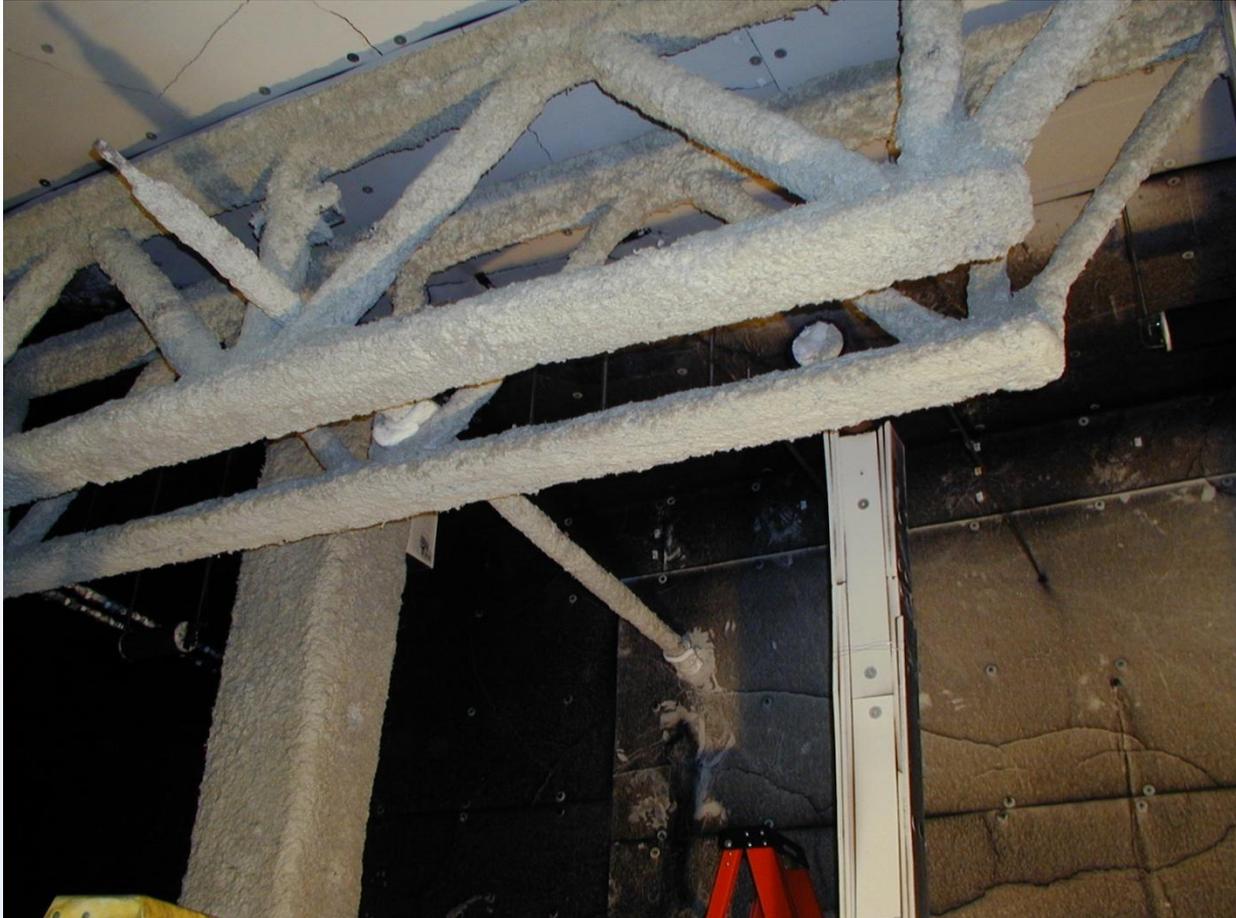
Figure 2. Insulated steel components in place prior to Test 5. In the foreground are two steel trusses and a steel rod, supported across the lower chord panel points, positioned near the ceiling above the fire pan. The steel column is located between the air inlet and the fire pan.

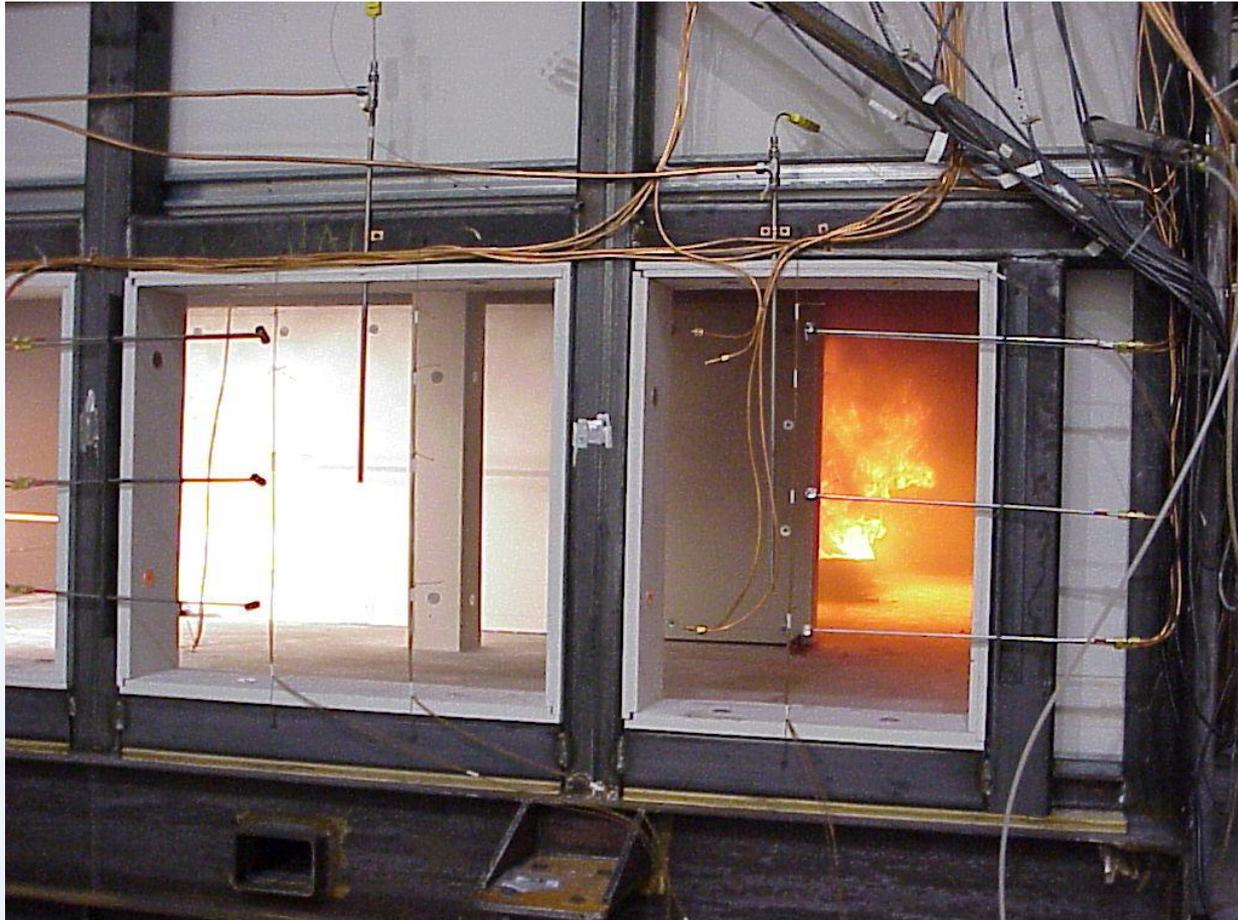
Figure 3. Inlet side of the compartment 5 minutes after ignition in Test 2. The fire is in the background. The foreground shows instrumentation for characterizing the air flow at the inlet. A baffle is located in front of the fire.

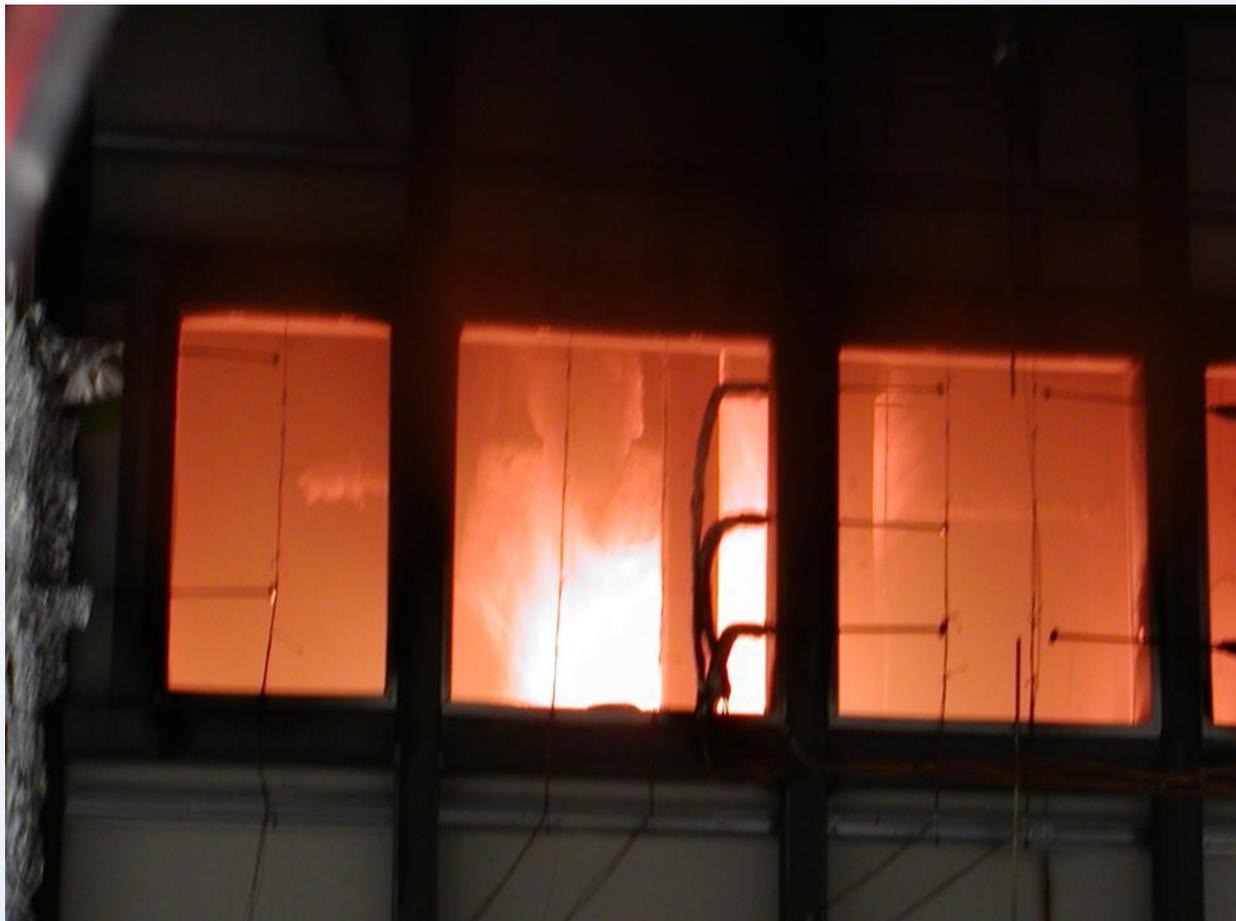
Figure 5. View of compartment from air exhaust outlet several minutes after the start of test 6. Note the flame impingement on the steel trusses and bar.

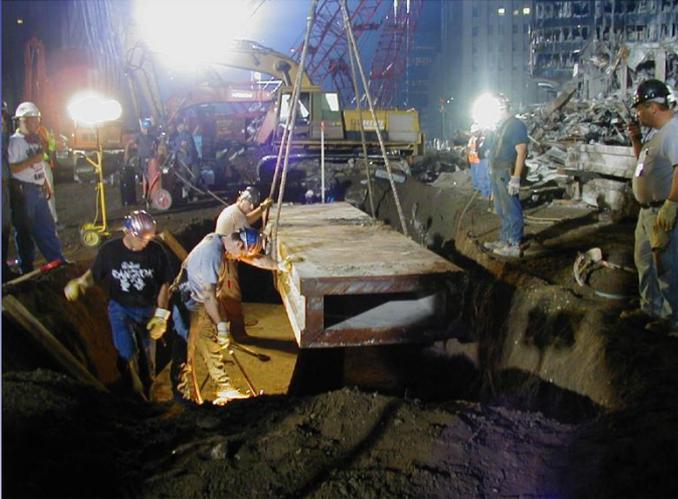
Clean weld fracture of Interior columns

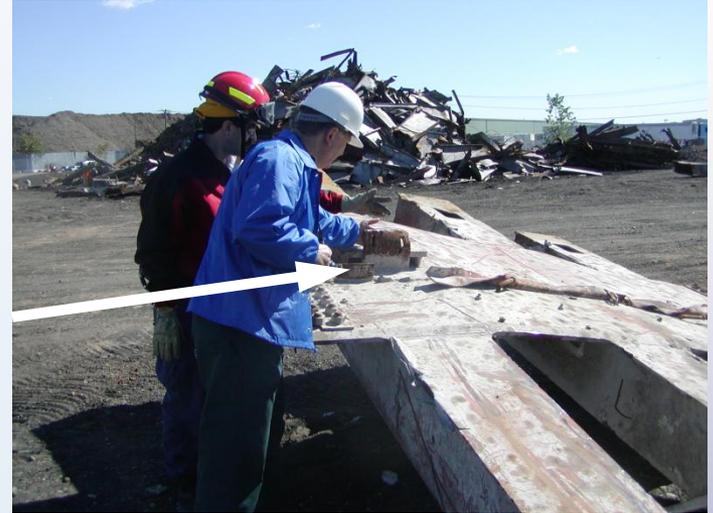
Failure at
connection
between floor
system and
exterior
columns

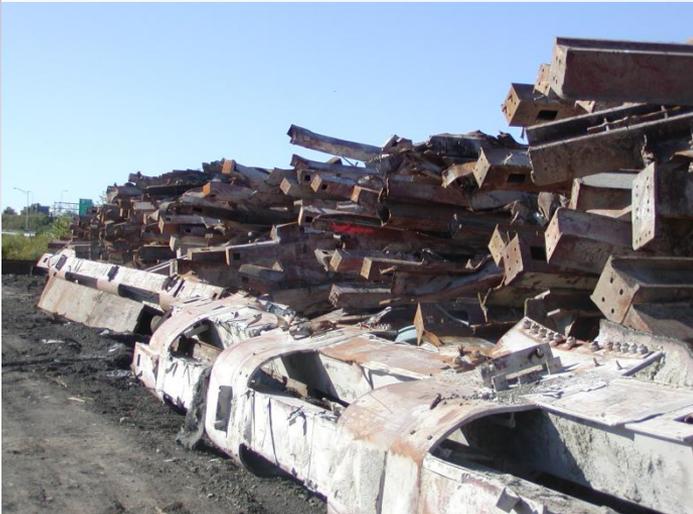
WTC steel columns

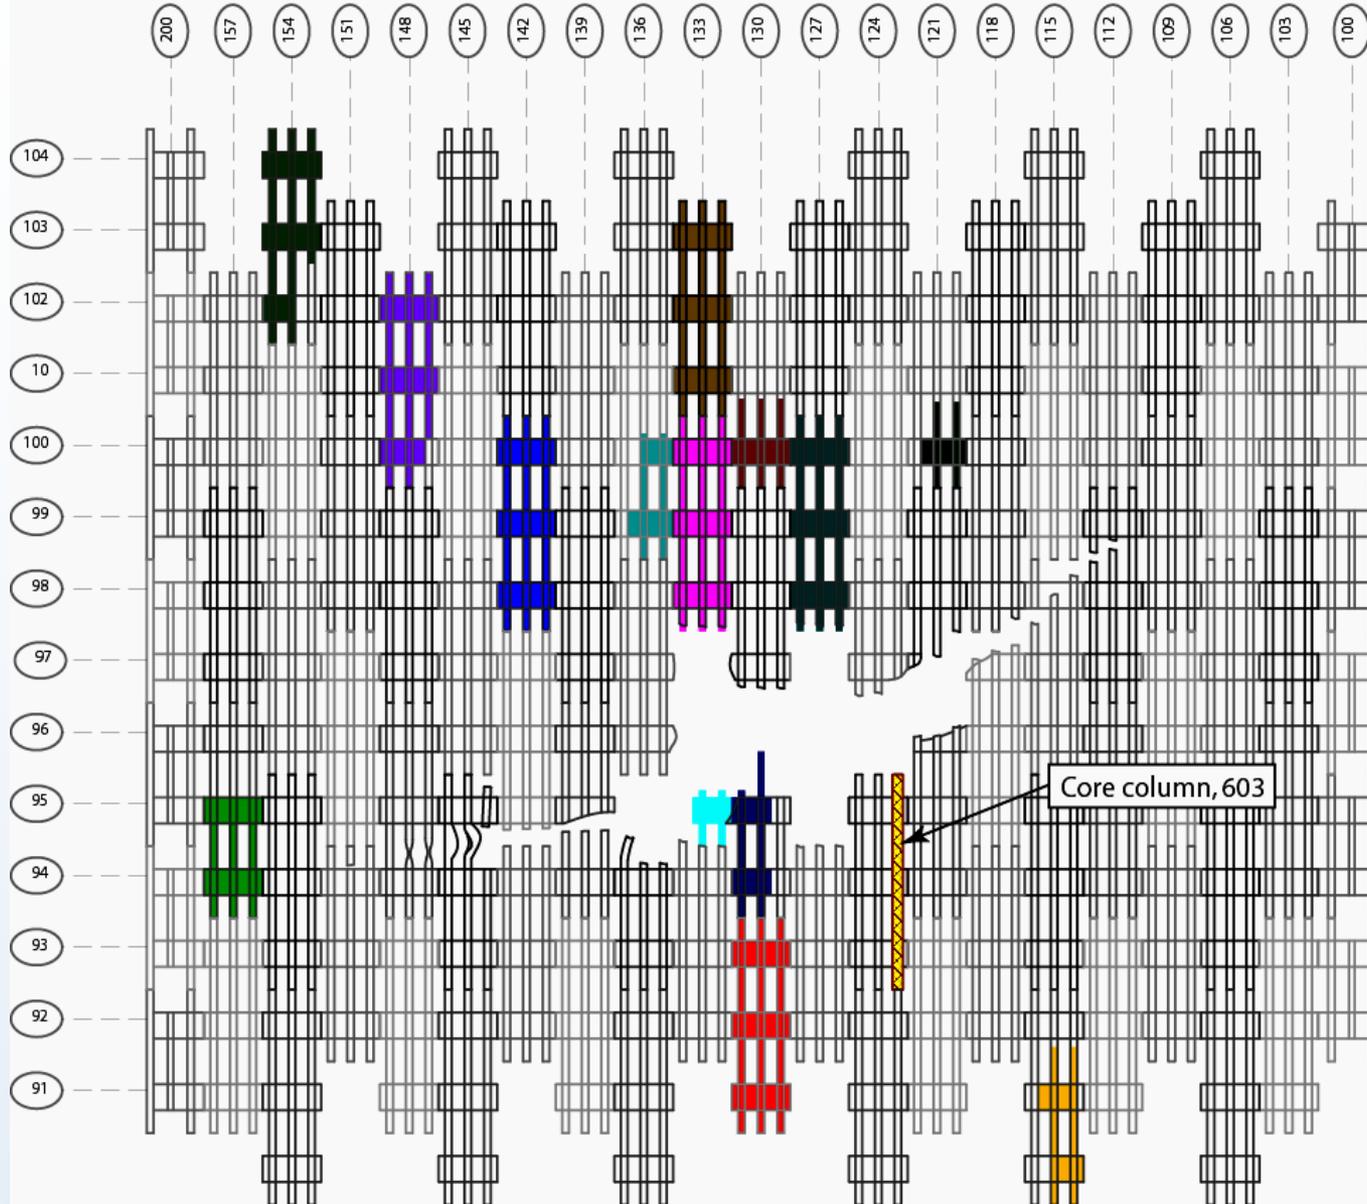
Sections Identified as of February 6, 2003

As determined by the NIST Metallurgy Division

- Identified locations:
 - Exterior panels: 28 with identified locations; several from impact zone
 - Core columns: 11 with identified locations; two from impact zone
- Identified grades:
 - Exterior panels: All 14 specified strengths; 10/14 columns; 10/12 spandrels
 - Core columns: 2 specified strengths; represent 99 percent of columns
 - Floor trusses: Both specified strengths; 2/2 for rods; 2/2 for angles
- **NIST believes the collection of steel from the WTC towers is adequate for purposes of its investigation**

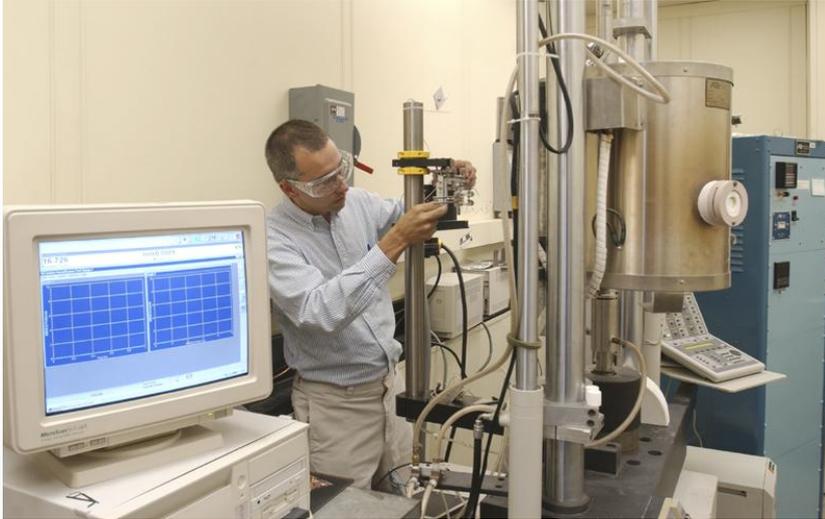
Checking the calibration of the contact extensometer used in the high-temperature mechanical testing system

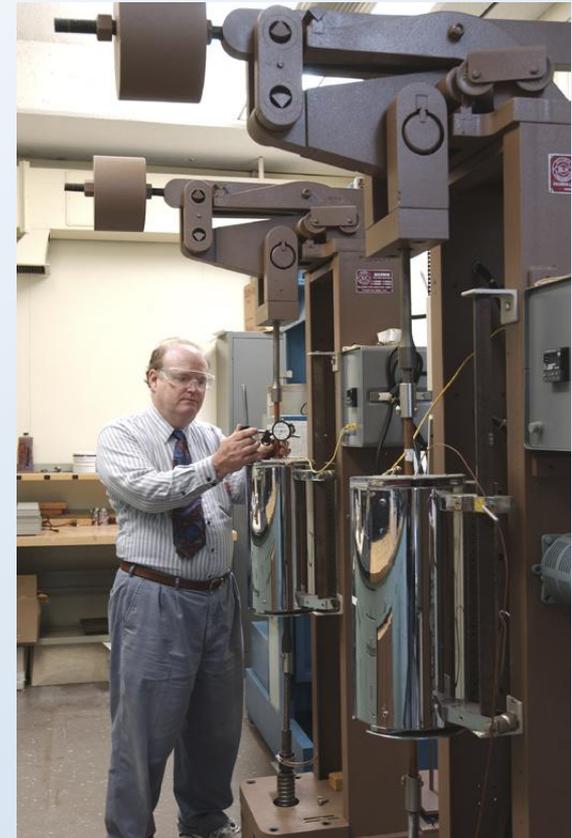
Adjusting a dial gauge on one of several creep testers that will be used to evaluate the high-temperature, time-dependent properties of WTC steel

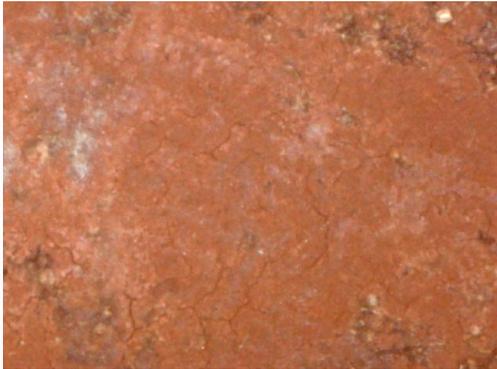
No burn
faint cracks from drying of paint 1 mm

Observations of condition of primer paint could be used to detect pieces that did not exceed 250 °C, and those that exceeded 250 °C but did not exceed 750 °C

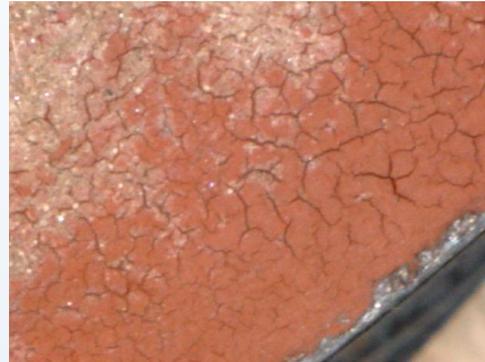
250 deg C for an hour
mud cracks much more visible

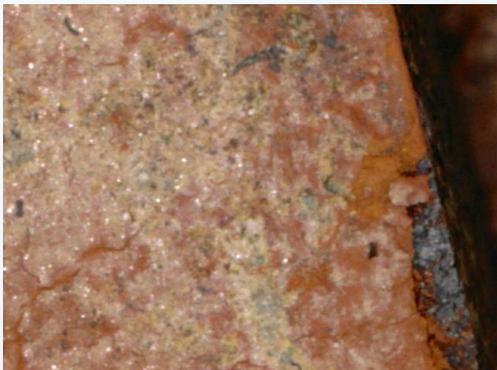
700 deg C for an hour
mud cracks partially obscured by formation of
whiteish "sandy" phase on surface
delamination easy with finger

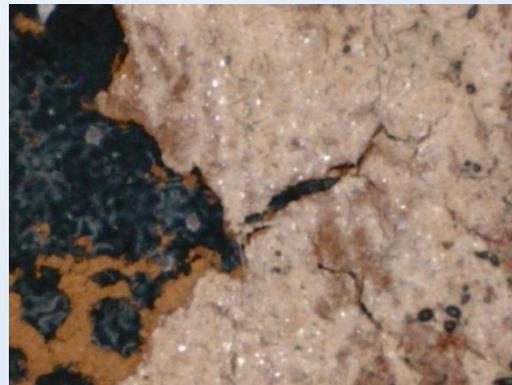
1000 deg C for an hour
wholesale spalling of paint, falls off
thick scale forms between paint and steel
