RESEARCH FOUNDATION

Fire Safety Challenges of Tall Wood Buildings – Phase 2: Task 2 & 3 – Cross Laminated Timber Compartment Fire Tests

February 2018

Report number: FPRF-2018-01

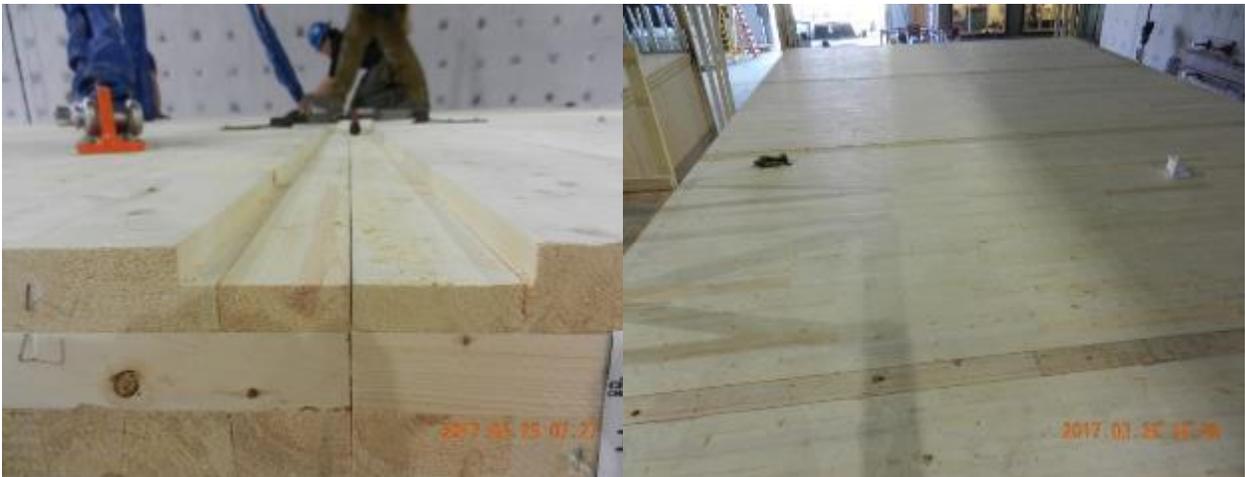
Figure 7. Ceiling panels connected with spline joints.

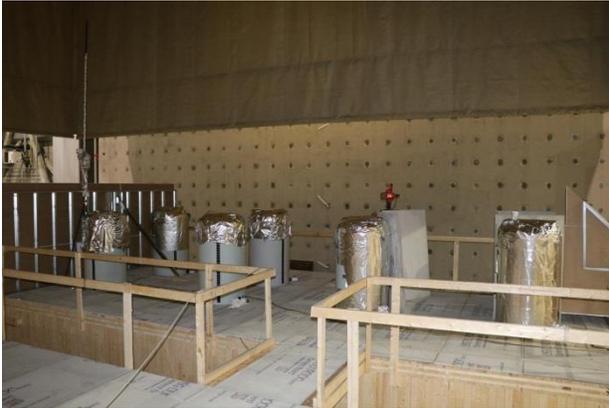
(a) cement board on top of ceiling

On the top of the fire compartment, as shown in Figure 9(a), the CLT ceiling panels were covered by one layer of 12.7 mm (1/2 in.) thick cement board fastened with 38 mm (1½ in.) long wood screws of size 8 with 610 mm (24 in.) spacing in the two baseline tests (cement board was not used in other tests). For the two tests (Test 1-4 and Test 1-6) with exposed CLT ceiling on the interior side, 38 mm (1-1/2 in.) thick and 305 mm (12 in.) wide gypsum concrete was poured on top of each of the ceiling panel joints, as shown in Figure 9(b).

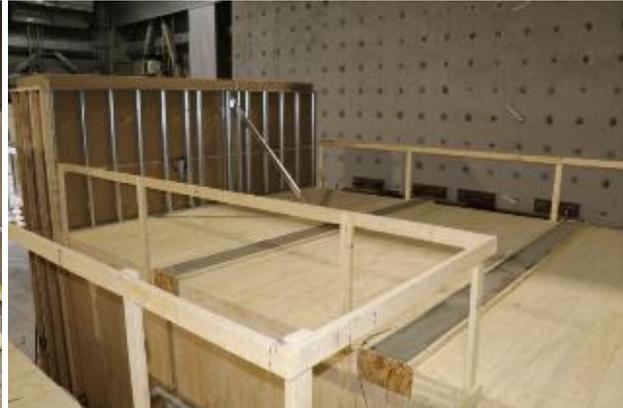
(b) gypsum concrete on top of ceiling joints

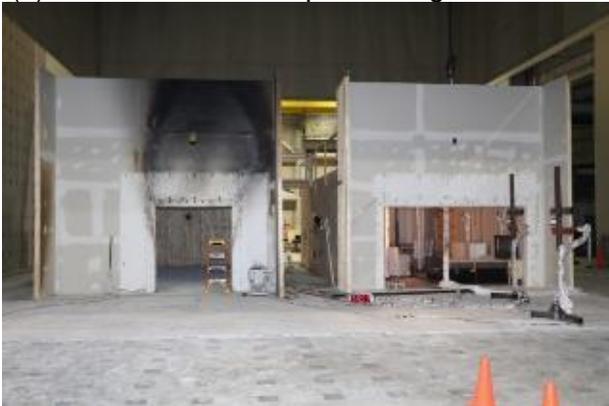
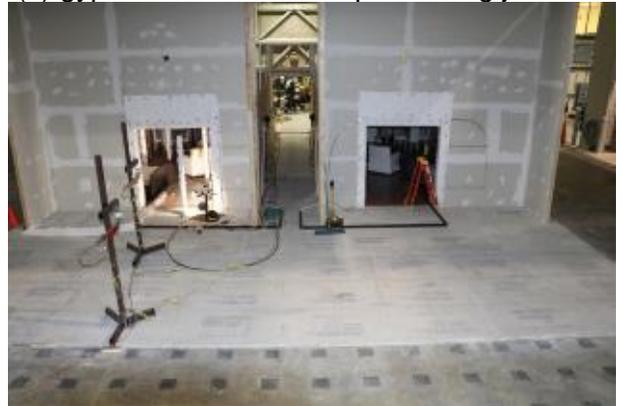
Figure 9. Ceiling top and exterior wall extension.

(c) W2 exterior wall with extension

(d) W2 exterior wall with extension

The exterior wall (W2) was covered with one layer of 15.9 mm (5/8 in.) thick Type X gypsum board. The edges of the rough opening were lined with two layers of 15.9 mm (5/8 in.) thick Type X gypsum board followed by a layer of 25 mm thick ceramic fiber insulation wrapped around. A 2-m high extension was added on top of the W2 exterior wall to better simulate the geometry of exterior façade, as shown in Figure 9.

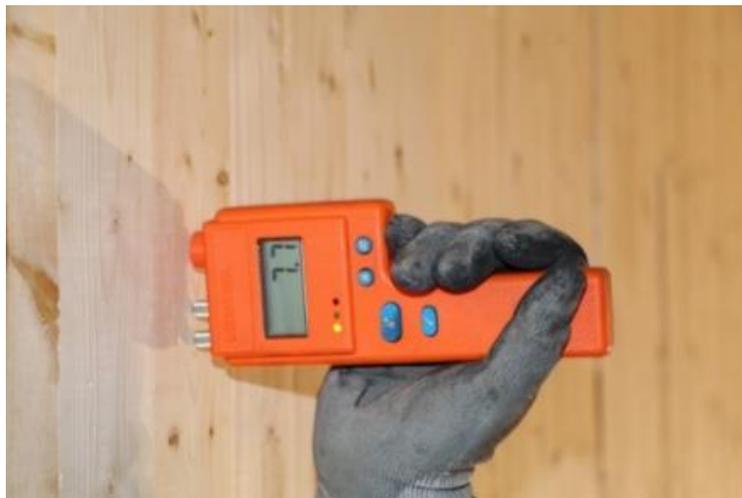
Figure 10. Measurement of panel moisture content using Delmhorst (BD-2100) meter.

Prior to fire testing the compartments, the moisture content of each wall was sampled using a handheld moisture meter (Figure 10). For Test 1-1 and Test 1-2, the measurements were made on the outside surface of the compartment after the gypsum board had been applied because there was no longer access to the inside surfaces. In Test 1-3 to Test 1-6, the measurements were made on the inside surfaces of the compartments shortly prior to installation of the gypsum board. Three measurements were made at random locations on each wall.

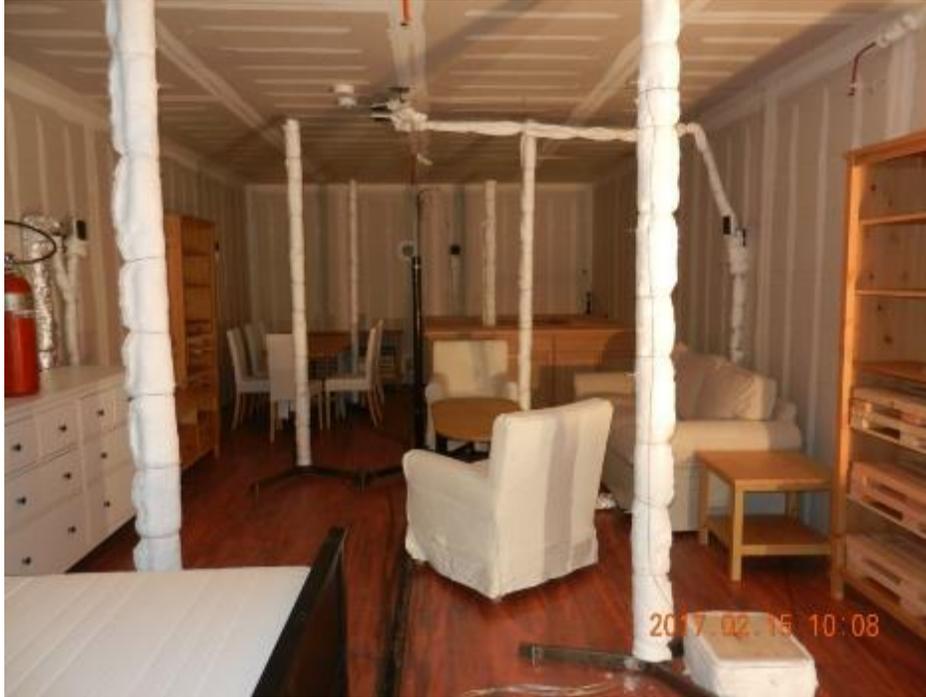
Figure 13. Photograph of the movable fuel as installed.

(mirrored furniture layout) is provided in Figure 13 and photographs of select furnishings in Figure 14.

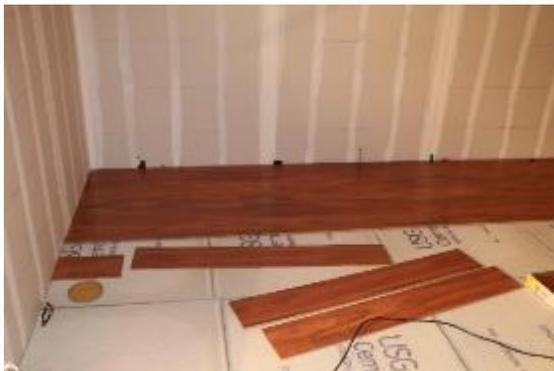
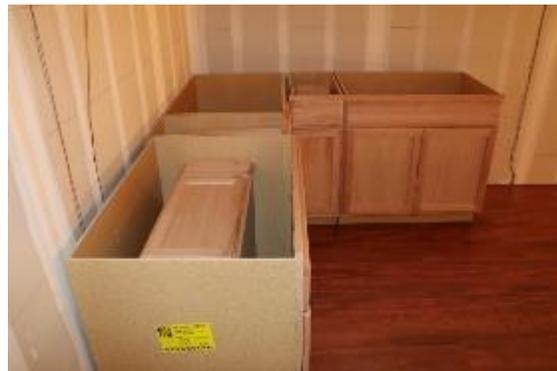
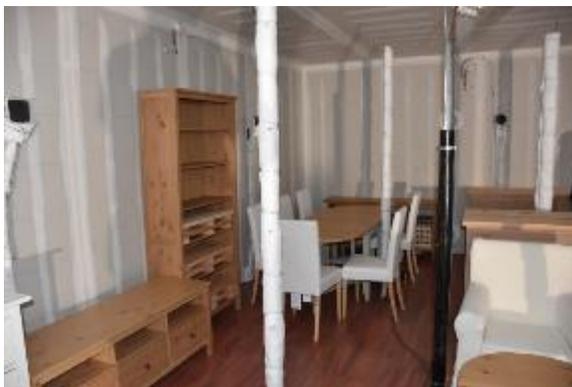
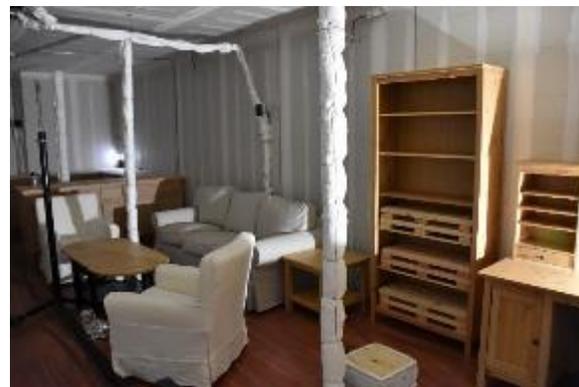
Figure 14. Photographs of (a) installation of wood flooring, (b) kitchen cabinets with end cabinet placed inside to increase walkway, (c) and (d) detailed interior views.

The concrete floor of the lab was protected using two layers of 15.9 mm (5/8 in.) thick Type X gypsum board and then two layers of 12.7 mm (1/2 in.) thick cement board (see Figure 5 and Figure 9). Laminated wood flooring was installed on top of the cement board in the CLT compartments. The laminated flooring was 7 mm thick (each piece had a dimension of 7 mm x 194 mm x 1290 mm (9/32 in. x 7-9/16 in. x 50-25/32 in.)).

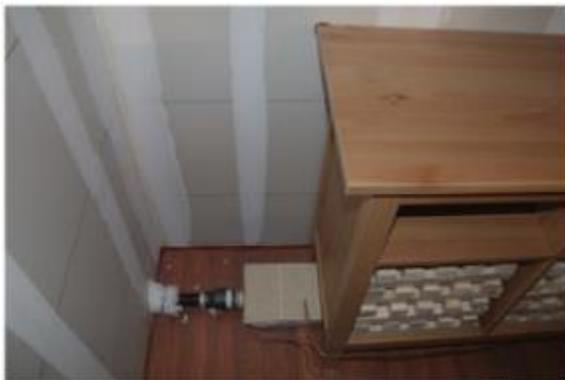
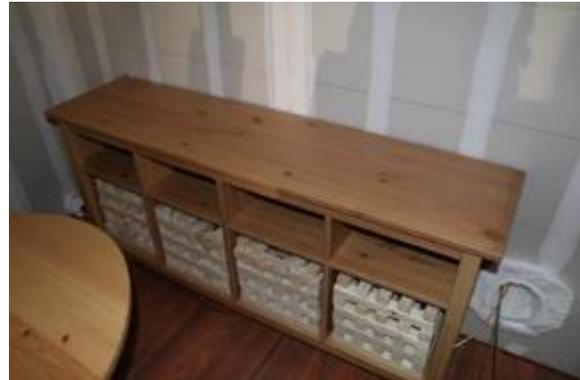
Figure 18. Photographs of (a) burner with copper tube for pilot flame and (b) the object of first ignition (console table with wood cribs).

A room corner ignition scenario was used in the CLT compartment fire tests. The ignition corner was formed by the adjacent W1 and W4 walls. The ignition source used was a natural gas diffusion burner (200 mm x 400 mm or 8 in. x 16 in.) placed in the corner partially under the shelving unit (console table). The natural gas flowed into a cavity below porous ceramic plates in the burner and then diffused upward. A small pilot flame was used to ignite the burner. The shelving unit (console table) was the first item ignited (Figure 18). A heat release rate of 50 kW (similar to a burning waste basket) from the burner was maintained until the total measured heat release rate from the compartment exceeded 1000 kW (due to ignited contents), at which time the burner was shut off. Four small wood cribs (85 MJ each) were placed in the console table to achieve a reliable ignition (Figure 18b). Two 'mock-up' tests of the ignition scenario were performed using a corner burn setup prior to the compartment test (Figure 19). The mock-up tests showed a reproducible fire growth and heat release sufficient to ignite neighboring contents in the compartment.

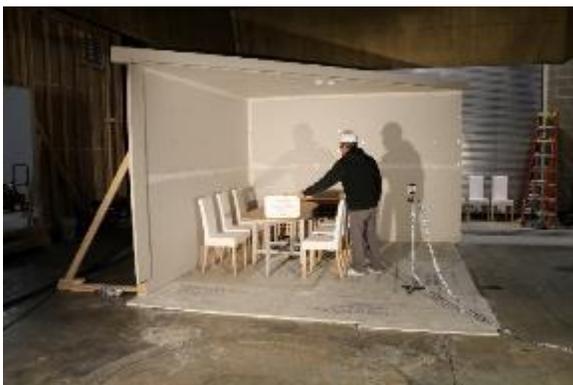
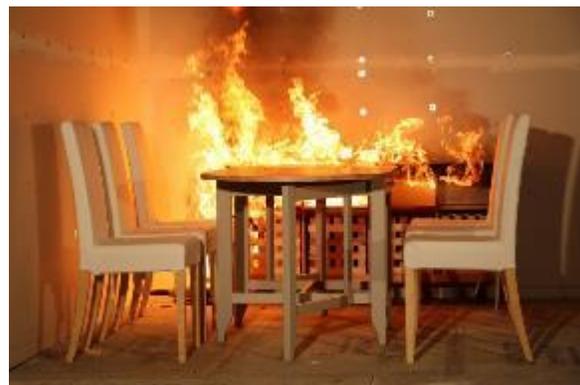
Figure 19. Photographs of (a) mock-up corner burn setup and (b) the object of first ignition catching fire.

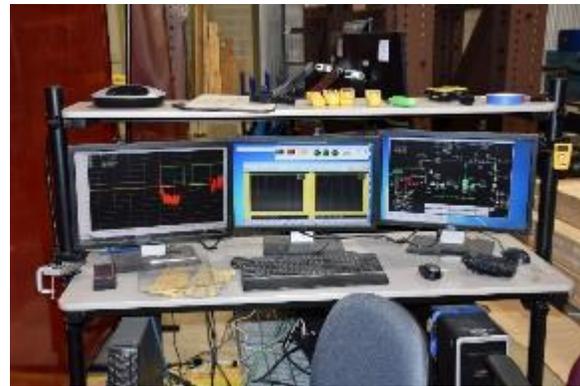
Figure 28. Photographs of (a) cDAQ-9188 chassis populated with I/O-modules and (b) setup used to control the NFRL calorimeter and data acquisition.

An in-house software developed in LabVIEW™ called MIDAS (Modular In situ Data Acquisition System) was used to allocate channels and control the data acquisition (Figure 28b). Each channel was sampled at 90 Hz and data were averaged and recorded at a rate of 1 Hz along with the standard deviations from the averaging process. The I/O-Modules had at least 16-bit precision, resulting in uncertainties from the DAQ that were orders of magnitude lower than those from other sources in all of the measurements reported here.

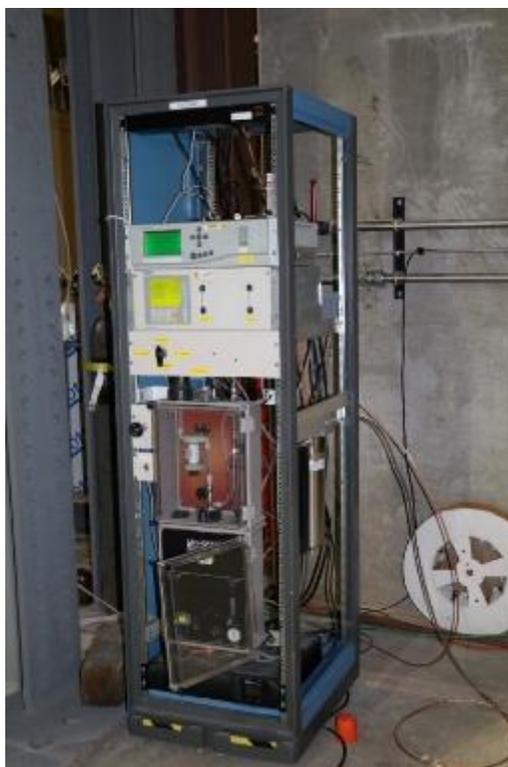
Figure 31. Photograph of gas analyzer rack.

Room gases were extracted and analyzed using the gas measurement rack shown in Figure 20, Figure 21 and Figure 30. A Permapure MiniGASS sample conditioning system was used to filter and dry the sample gas. The sample gas flow rate was set to 1 slpm for these tests. The delay time from the room inlet port to the gas rack was approximately 60 s. The oxygen was measured using a paramagnetic oxygen analyzer. Carbon dioxide and carbon monoxide were measured using a nondispersive infrared (NDIR) analyzer. The analyzers were calibrated prior to each test using calibrated zero and span gases. Nitrogen gas was used to zero each analyzer and room air was used to span the oxygen analyzer. Room air was assumed to have an oxygen concentration of 20.95% \pm 0.05 %. The carbon dioxide span gas consisted of 9.0% \pm 0.09% CO_2 in N_2 and the carbon monoxide span gas consisted of 4.0 % \pm 0.04% CO in N_2 . A high pressure air line was used to blow out the sample line during the test if the sample line became clogged by soot. The maximum range of the CO and CO_2 measurements was 20 %. This range was exceeded during several of the tests. There were other periods where gas sample data was invalid due to loss of sample flow and loss of sample tube support. The sample tube deformed and fell onto the room floor during several of the tests. The gas sample measurements were more reliable early in the tests. All gas measurements are reported on a dry basis.

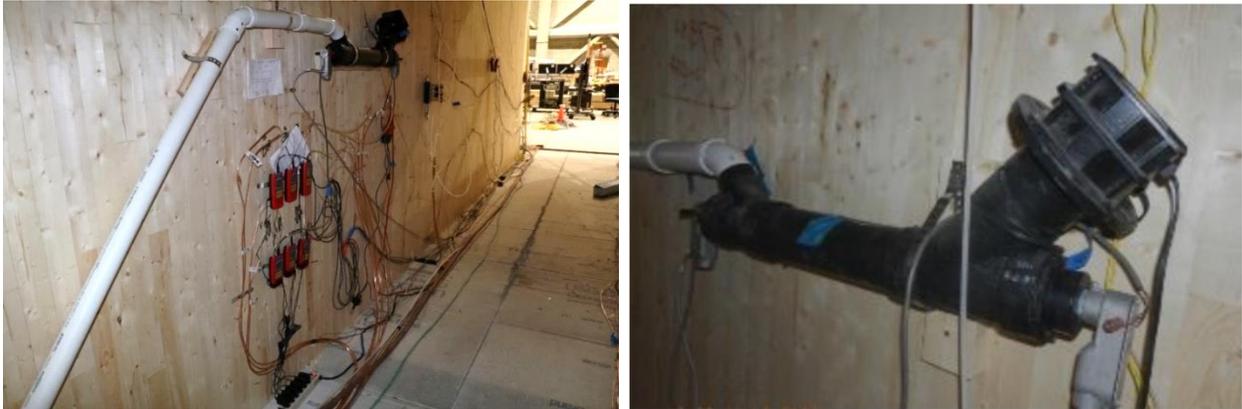
Figure 33. Photograph of smoke density meter (PVC pipe) and manometers mounted outside of the compartment.

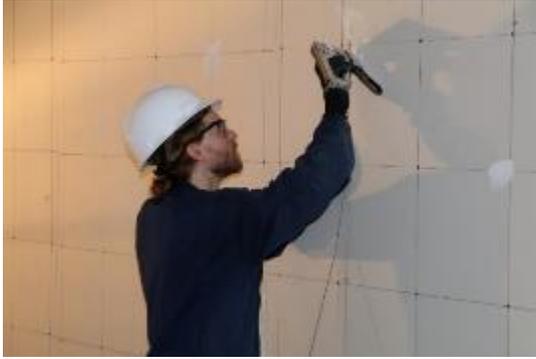
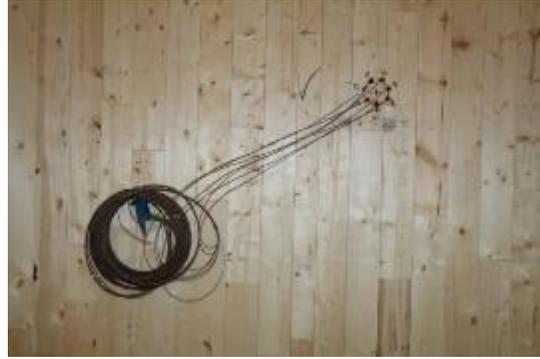
Figure 34. Photographs of typical thermocouple applications; (a) layer interface temperature, (b) temperature through panel, (c) gas temperature near plate thermometer, (d) cooling water temperature, (e) roof tree, and (f) compartment tree.

The majority of the thermocouples were glass-sheathed, 24-gauge, 0.5-mm diameter bare-bead thermocouples (Model GG-K-24-SLE-1000). The wire was purchased in 305 m (1000 ft) spools, cut to length and a bead was created in-house using a thermocouple welder. These thermocouples were used to measure the temperatures at the interface between gypsum layers (Figure 34a), CLT panel temperatures (Figure 34b) as well as other gas-phase temperatures (e.g., Figure 34c,e).

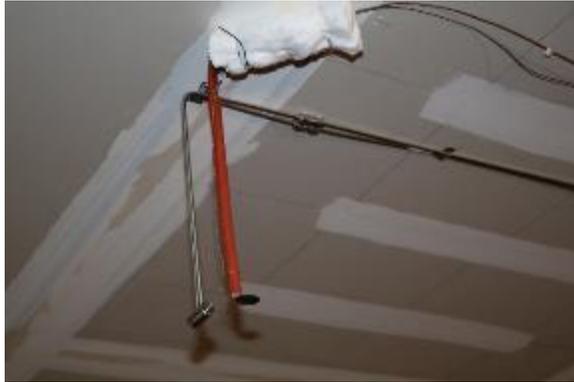
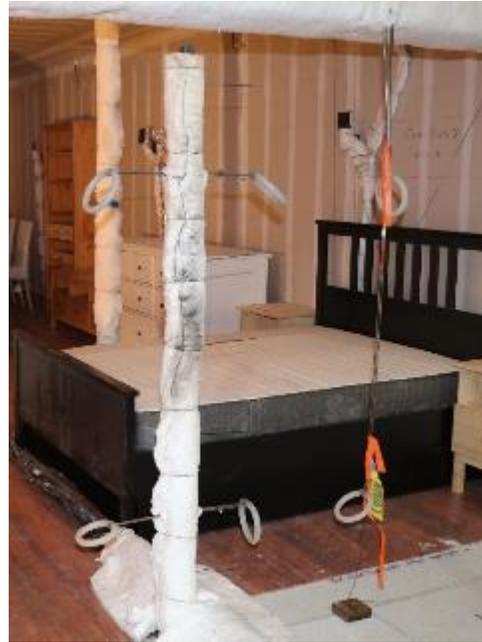
Figure 37. Photographs of bi-directional velocity probes located (a) on the ceiling (co-located STE visible) and (b) on stand in doorway (tubes for zeroing sensor visible).

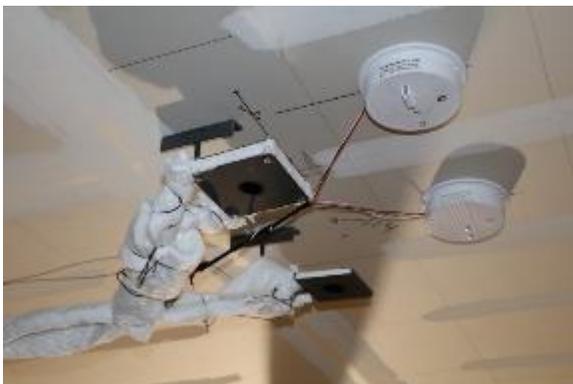
Figure 38. Photographs of (a) installed smoke and heat alarms and (b) circuit for power supply and signal extraction from alarms.

A commercially-available photoelectric non-ionizing smoke detector (Kidde PE120) and heat alarm (Kidde HD135F) were located on the ceiling near the centre of the compartment in each test (Figure 38a). The devices were modified to generate a voltage drop when the alarms triggered, which could be measured by the data acquisition system (Figure 38b).

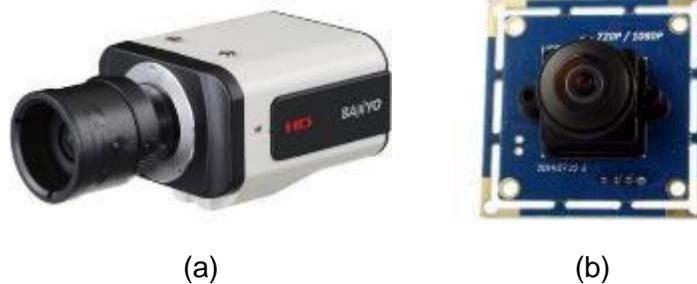
Figure 39. Photographs of (a) networked video camera and (b) web USB camera.

Various networked high-definition video cameras (Figure 39) and handheld cameras were used to document the experiments.

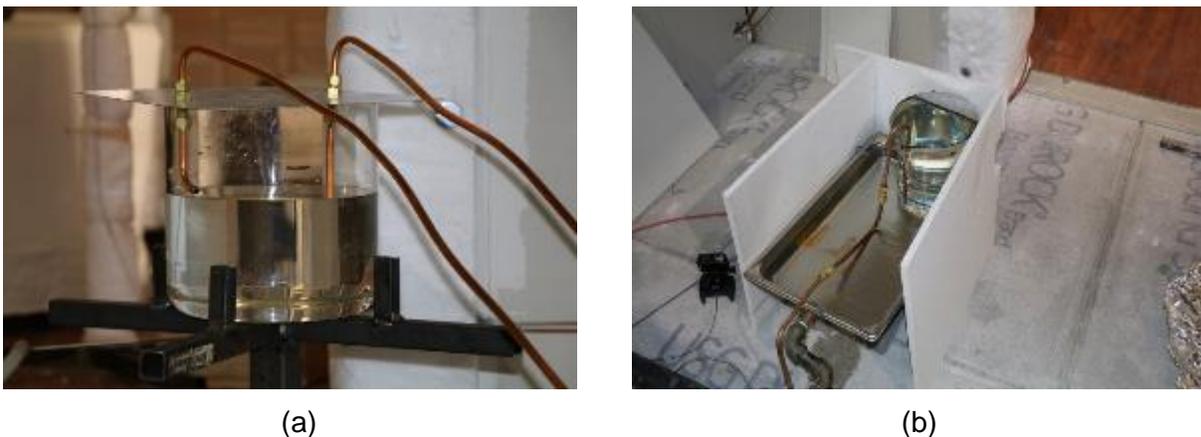
Figure 40. Photographs of water-cooled camera setup (a) 1st attempt and (b) improved setup.

High-definition video footage of the inside of the compartment during the fire was captured from the doorway using a waterproof GoPro camera placed in a water bath. The water served dual purposes of cooling the camera and filtering out the thermal radiation produced by the fire; water is very efficient at absorbing energy in the infrared spectrum. For the first test, a partially-filled borosilicate (Pyrex) container supported on a stand was continuously supplied with tap water (23 °C +/- 5 °C) and a pump was used to extract the water as it heated (Figure 40a). This worked for about 10 min after flashover, but the high thermal gradient caused the vessel to fracture. For the subsequent tests, a thinner borosilicate container was filled completely to the top with water that could overflow out the back of the container where it was collected and drained (Figure 40b). Additionally, the field of view for the camera was minimized using thermal ceramic boards to reduce the view factor. This approach allowed the camera to capture images indefinitely (limited by battery life).

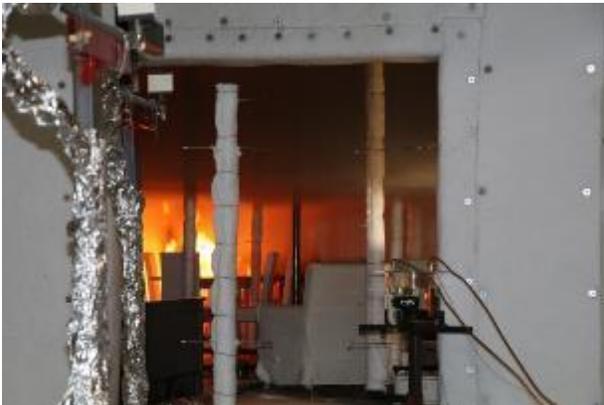
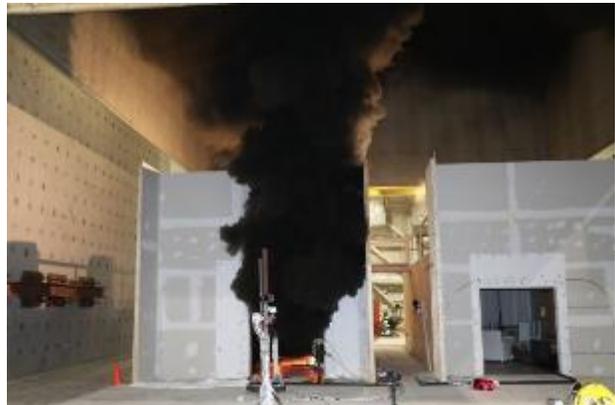
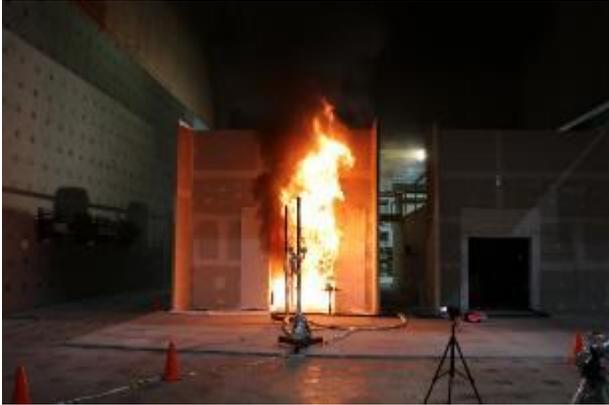
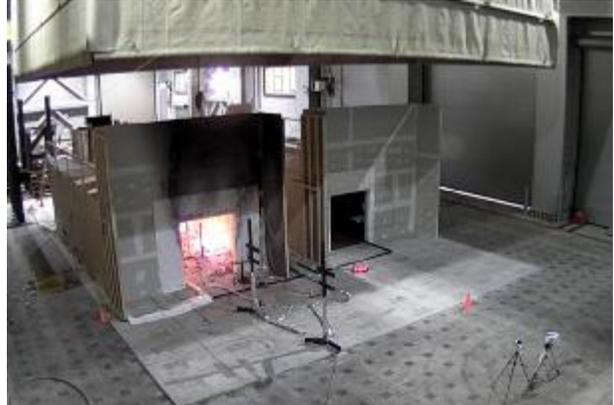
Figure 41. Photographs (a)-(h) of the CLT compartment during and after Test 1-1 including subsequent cleanup and removal of gypsum board.

(a) at 7 min after ignition

(b) at 14.5 min – just before flashover

(c) at 15 min – flashover

(d) at 60 min

The test started with ignition. The first item ignited was the shelf (console table) in the room corner (Figure 18). The smoke alarm and heat alarm activated at 2.1 min and 3.5 min, respectively. Between 1.3 min and 5.4 min, all ten STEs reached 68 °C, which is a typical temperature rating for residential sprinklers. By this time, the fire involved only a portion of the console table (first item ignited). The console table was fully involved at 7 min with the smoke layer descending to mid height in the compartment. At 12.6 min, the smoke optical density measured at the 1.6 m height in the room centre reached 3.4 m⁻¹, at which occupants would not be able to see their hands in front of their faces [24]. The loss of visibility resulted from the first item ignited alone. At 14 min, the fire spread from the shelf to the adjacent dining table and chairs and dark smoke completely filled the room with dramatic changes of O₂, CO₂ and CO concentrations. Flashover occurred at 14.9 min and a large fire plume issued from the opening. After flashover, an intense burning of room contents lasted for approximately 30 min. The fire started to decay at 45 min and the fire plume ceased to issue from the opening at 50 min and thereafter; O₂ recovered to above 15% in the compartment. The test lasted over 2 h and was terminated at 134 min after continuous fire decay (the heat release rate falling to 300 kW at the end). A household garden hose was used to mist water over the debris on the floor to terminate the test. Figure 41 shows some photographs during and after Test 1-1.

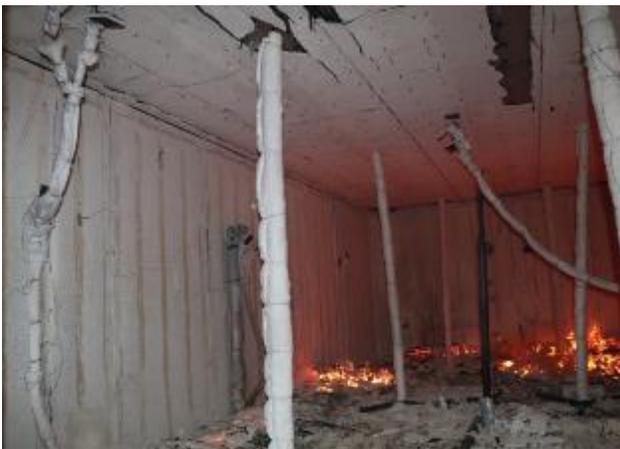
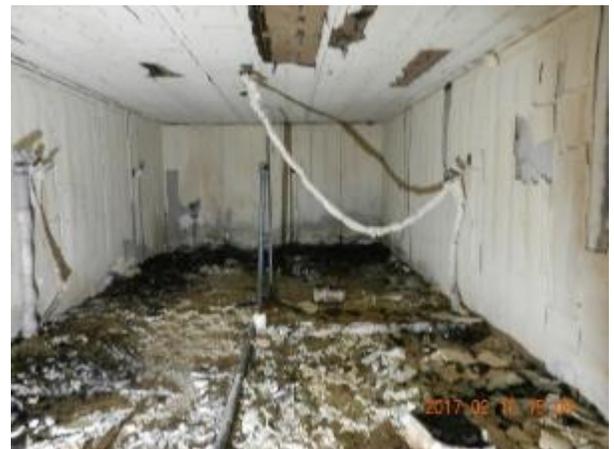
(e) at 130 min – near end of test, gypsum board remained: 2 layers on ceiling; 3 layers on walls

(f) after Test 1-1 – gypsum board remained: 2 layers on ceiling; 3 layers on walls

As shown in Figure 41 (e) and (f), two layers of gypsum board remained on the ceiling except the absence of small pieces of the mid layer, and all three layers of gypsum board remained on the walls, until the end of the test. Figure 41 (g) and (h) show CLT compartment #1 after Test 1-1 with gypsum board removed, indicating no char was developed during the test. This CLT structure was re-used later in Test 1-4 with an exposed CLT ceiling.

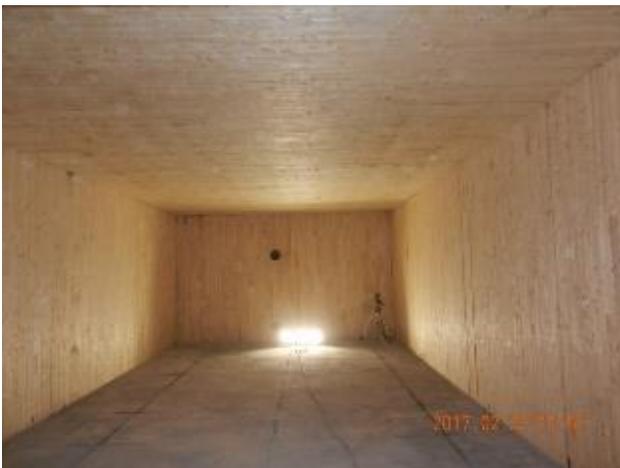
(g) after cleanup and removal of gypsum board

As shown in Figure 41 (g) and (h), the entire interior surface of the CLT compartment had no char; neither did the exterior surface. Although no sealant was used to seal the compartment, there was no char developed at any CLT panel joints. However, there was minor smoke deposition outside the two back corners at the wall-ceiling junction, which could have been prevented if the joint had been sealed.

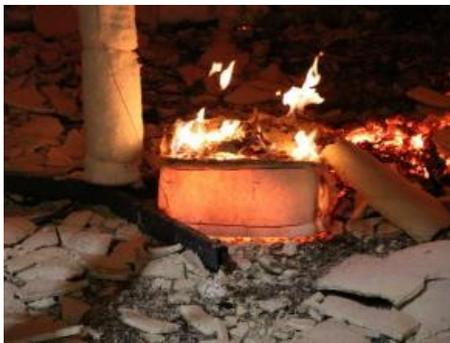
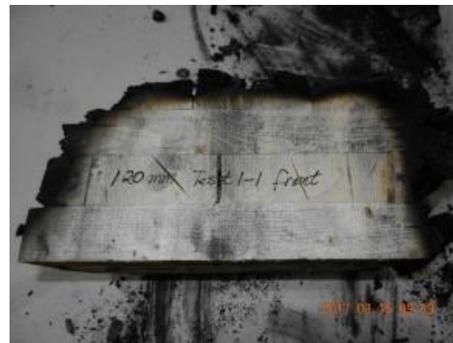
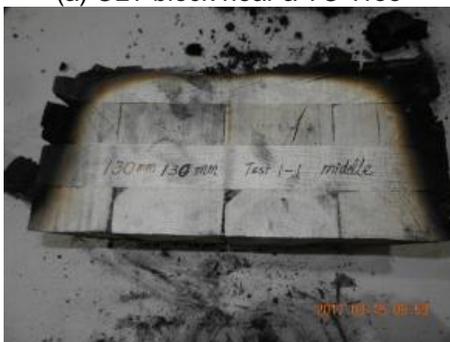
Figure 46. Char of small CLT blocks in Test 1-1 (cut to half to show remaining thickness).

(a) CLT block near a TC Tree

(b) front block near TC Tree 3 charred 55 mm

(c) middle block near TC Tree 6 charred 45 mm

Three small CLT blocks (305 mm x 203 mm x 175 mm) were placed on the floor in Test 1-1 for char measurements (only the top surface was exposed). After the test, each block was cut to half at the middle. Figure 46 shows the remaining thickness of the CLT blocks after Test 1-1. The char depth was 55 mm, 45 mm and 42 mm for the blocks placed at the front, middle and rear sections of the compartment floor, respectively.

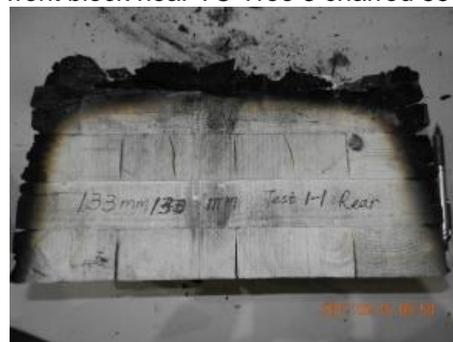
(d) rear block near TC Tree 4 charred 42 mm

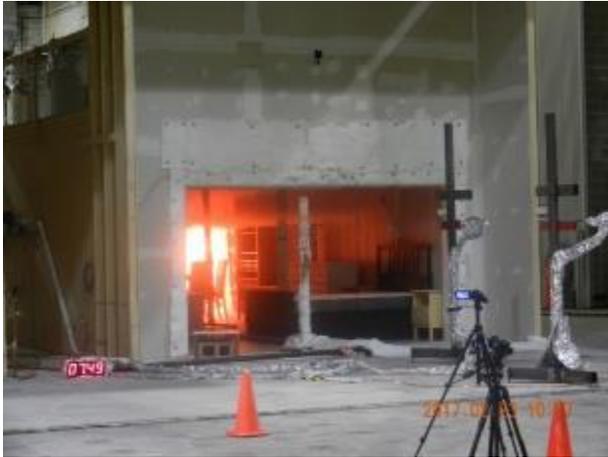
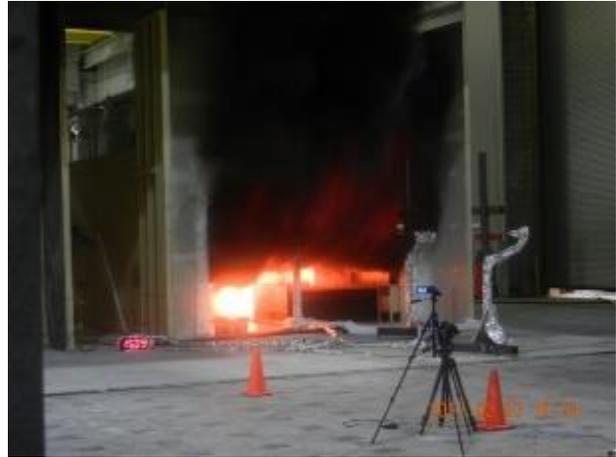
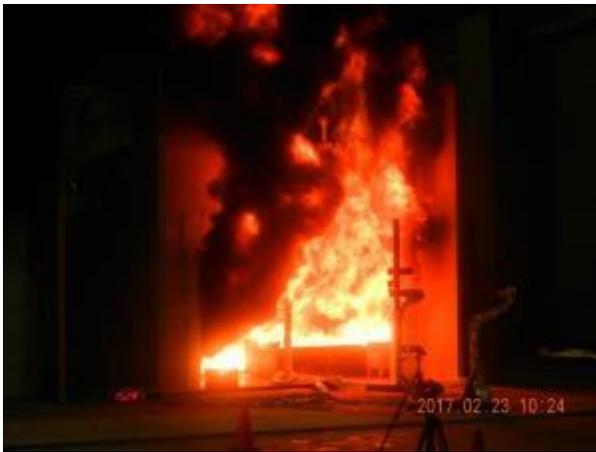
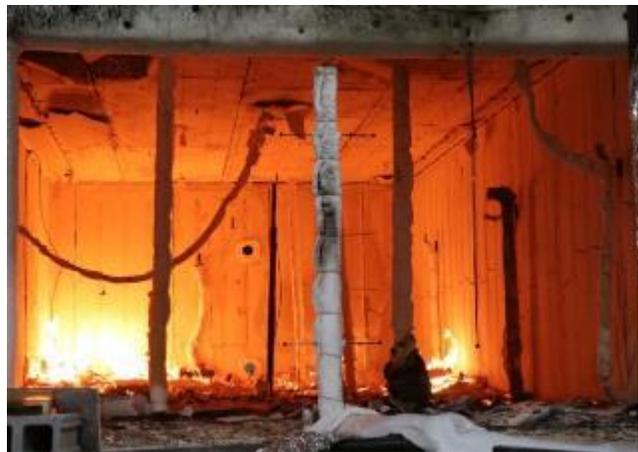
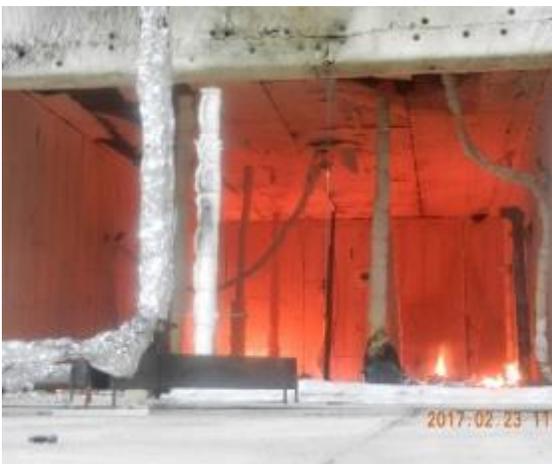
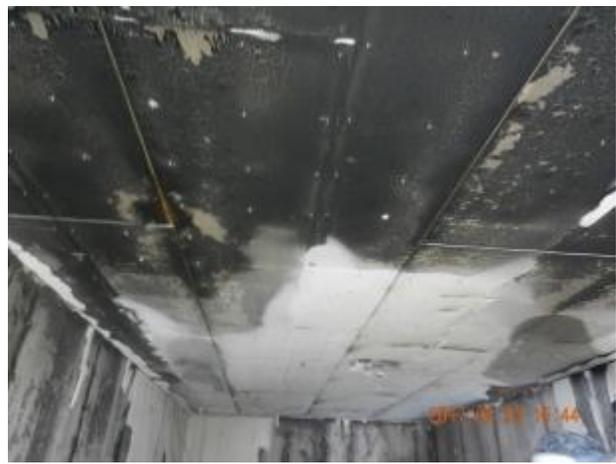
Figure 47. Photographs of the CLT compartment during and after Test 1-2.

(a) at 7 min 49 s after ignition

(b) at 15 min 9 s – just before flashover

(c) at 15 min – flashover

(d) at 67 min

(e) at 100 min – near end of test, gypsum board remained: base layer on ceiling; 2 layers on walls

(f) after Test 1-2 – gypsum board remained: 1 layer on ceiling; 2 layers on walls

The test also started with the ignition of the console table in the room corner. The smoke alarm and heat alarm activated at 3.4 min and 2.9 min, respectively. Between 1.5 min and 4.6 min, all ten STEs reached 68 °C, which is a typical temperature rating for residential sprinklers. The console table (first item ignited) was fully involved at 5 min. As the fire progressed in the dining area, the smoke layer descended to the mid height in the compartment and stayed at this height until flashover. At 15.2 min, the smoke optical density measured at the 1.6 m height in the room centre reached 3.4 m⁻¹. Flashover occurred at 15.3 min with dramatic changes of O₂, CO₂ and CO concentrations; large fire plume was issued from the opening. After flashover, an intense burning of room contents lasted for approximately 24 min. As expected, the combustion of the room contents accelerated with the larger opening. The fire started to decay at 37 min and fire plume ceased to issue from the opening at 40 min and thereafter; O₂ recovered to above 15% in the compartment at 47 min. The test lasted for 104 min and was terminated after continuous fire decay (the heat release rate falling to below 500 kW at the end). A fire hose was used to lightly spray water over the debris on the floor to terminate the test. Figure 47 shows some photographs during and after Test 1-2.

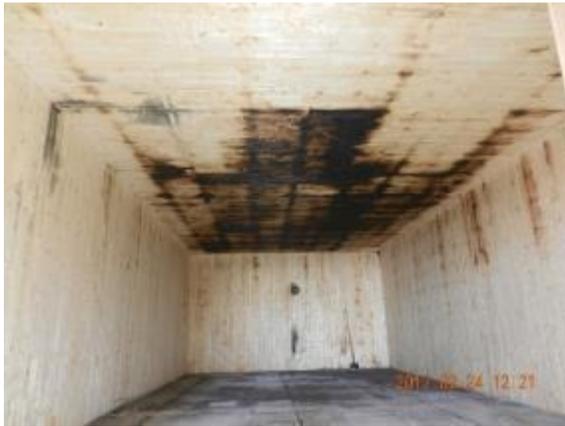
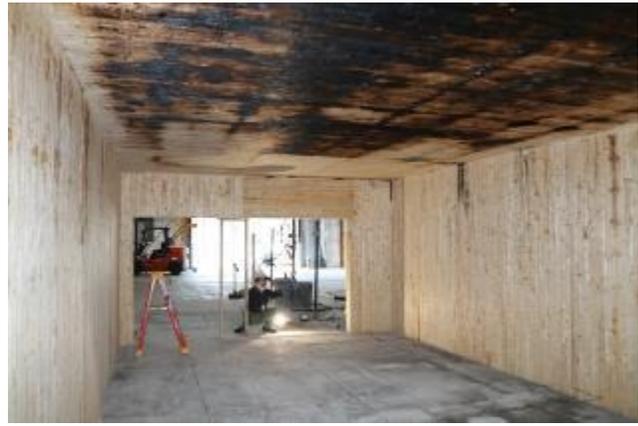
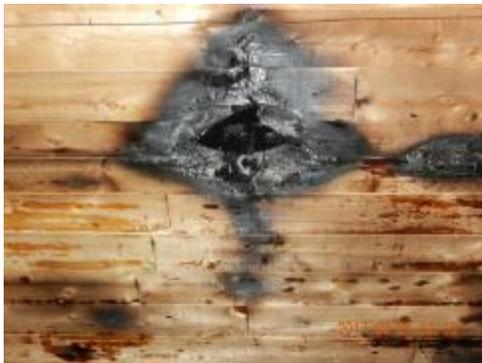
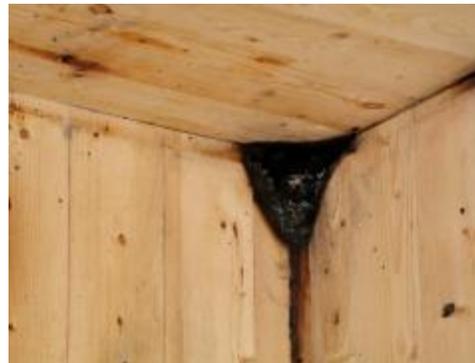
Figure 52. Photographs of CLT compartment #2 with localized charring after Test 1-2 after cleanup and removal of gypsum board.

(a) after cleanup and removal of gypsum board

(b) after cleanup and removal of gypsum board

(c) joint of ceiling panels 11_006 and 11_007

(d) corner joint at ceiling and W1 and W4 walls

Figure 52 (a) and (b) show CLT compartment #2 after Test 1-2 with gypsum board removed. No char was developed on the CLT walls (except some smoke deposition). However, the CLT ceiling had surface char in the rear and middle sections, which were consistent with the CLT interface temperatures shown in Figure 51. The char depth ranged from 0 mm to 15 mm. The char pattern generally reflected the gypsum board joint layout. The char was more pronounced along the gypsum board joints and the CLT panel joints. However, there was deeper charring (approximately 50 mm) at two spots – the mid ceiling joint between panels 11_006 and 11_007 and the ceiling-wall corner joint – as shown in Figure 52 (c) and (d). Two layers of gypsum board were used for the CLT protection and one layer was lost in this test. Although the base layer gypsum board remained in place but the tape and joint compound were not applied on the base layer gypsum board joints, hot gases could get through these joints to reach the CLT joints which were also not sealed. This could be the reason for the deeper charring at the two spots. The exterior surface of the CLT compartment had no char except for some smoke deposition along the middle spline joint of the ceiling (no burn through). Had the panel joints been sealed, the char at these two spots could have been reduced.

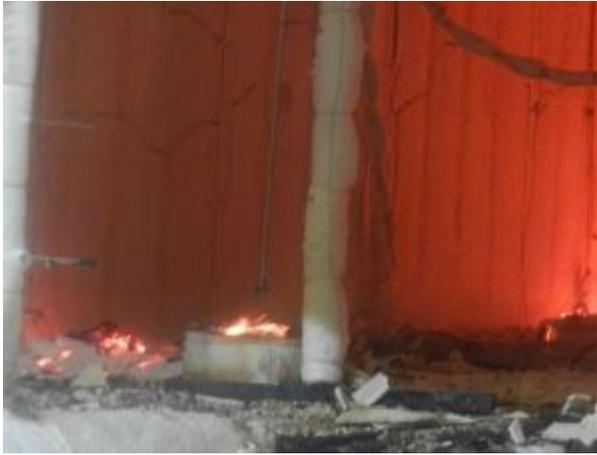
Figure 53 shows the remaining thickness of the three small CLT blocks placed on the floor (only the top surface was exposed), each cut to half at the middle after Test 1-2. The char depth was 46 mm, 35 mm and 35 mm for the blocks placed at the front, middle and rear sections of the compartment, respectively.

(a) CLT block near a TC Tree

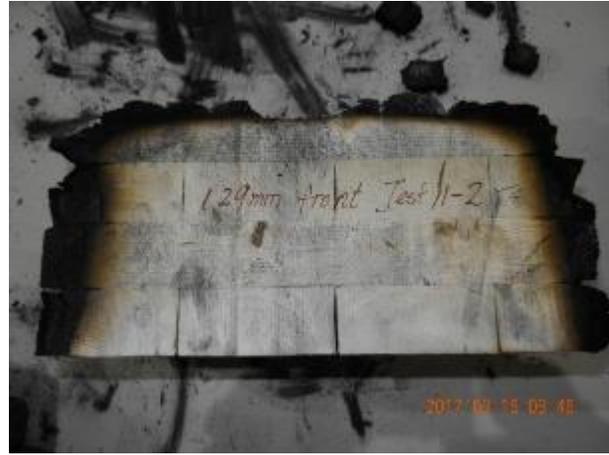
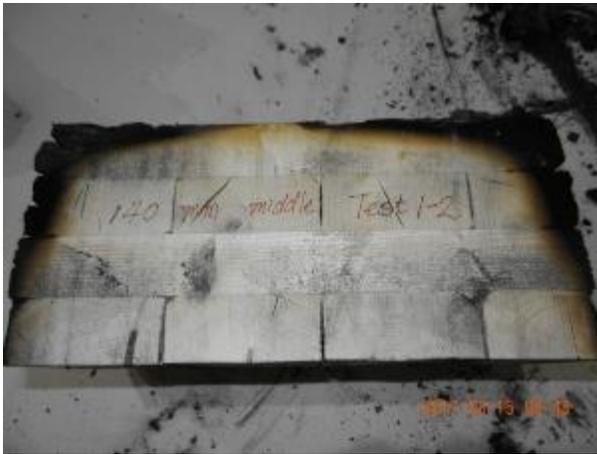
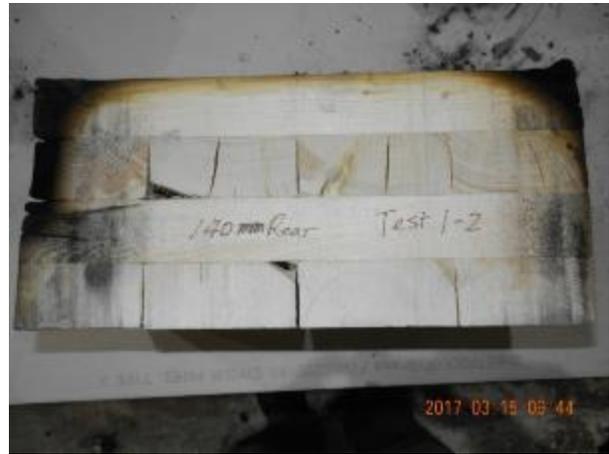
Figure 53. Char of small CLT blocks in Test 1-2 (cut to half to show remaining thickness).

(b) front block near TC Tree 3 charred 46 mm

(c) middle block near TC Tree 6 charred 35 mm

(d) rear block near TC Tree 4 charred 35 mm

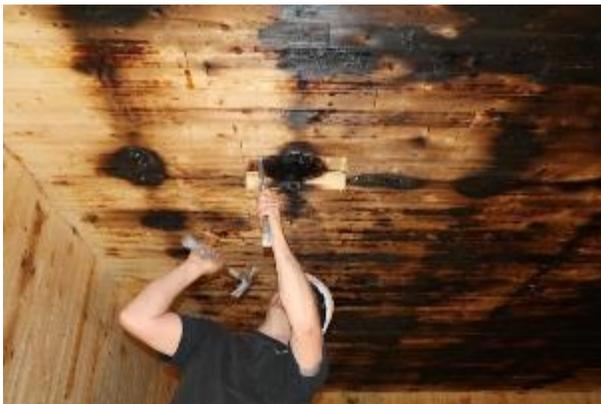
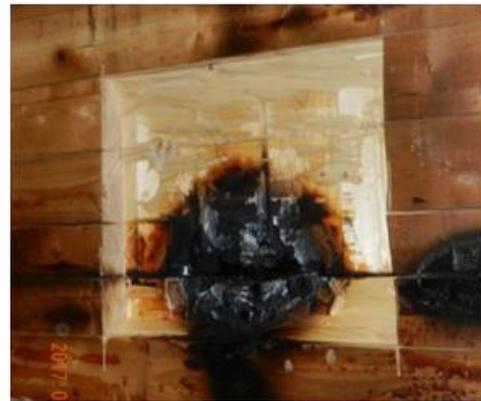
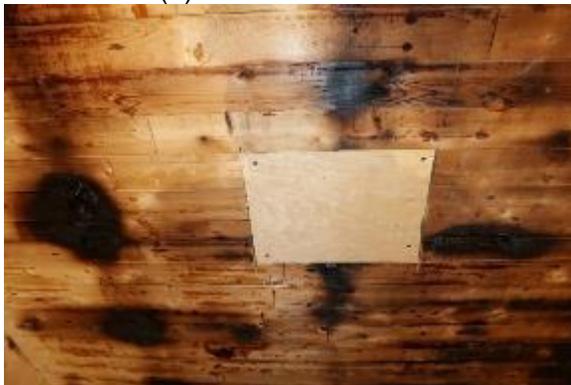
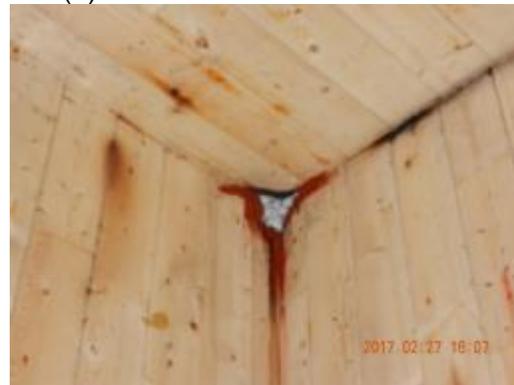
Figure 59. Repair of localized charring on ceiling after Test 1-2 before Test 1-3.

(a) char chiseled out

(b) 0.3 m x 0.3 m chiseled area

(c) plywood piece screwed in

(d) ceiling-W1-W4 corner spot filled

After Test 1-2, a cleanup operation was conducted in the CLT compartment #2 and all the remaining gypsum board was removed. The CLT compartment #2 was repaired, as shown in Figure 59. The deep charred spots between ceiling panels 11_006 and 11_007 and at the ceiling-W1-W4 corner joint were chiseled out. Plywood (0.3 m x 0.3 m) was screwed into the chiseled spot between panels 11_006 and 11_007. Fire caulking was used in repairing these two damaged spots. Ceramic fiber material was also filled into the ceiling-W1-W4 corner spot. Fire caulking was also used (only in this test) to seal limited CLT panel joints – between ceiling panels 11_006 and 11_007, between ceiling panels 11_007 and 11_008, and along the ceiling joint with the W1 wall.

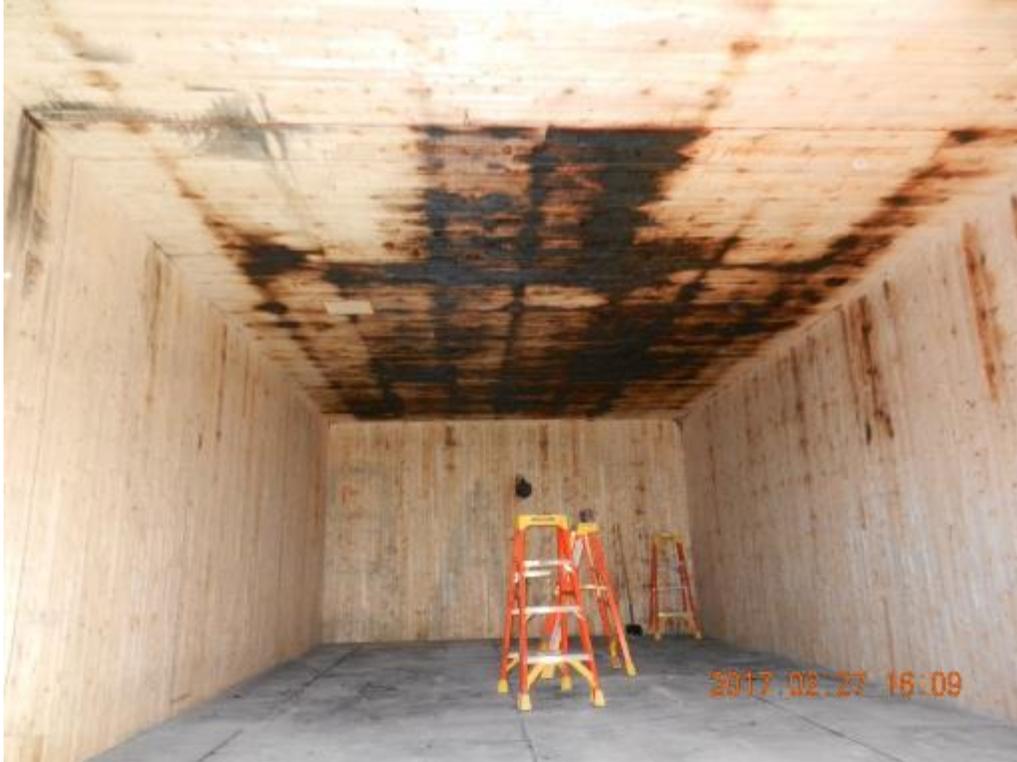
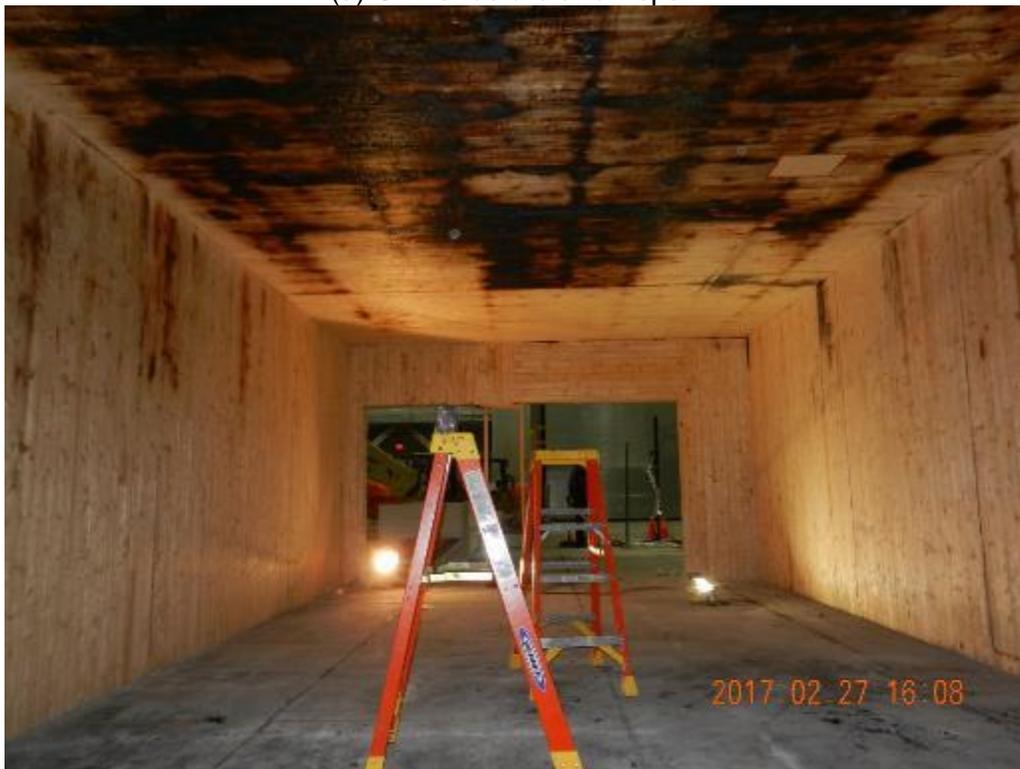
Figure 60. Photographs of CLT structure before Test 1-3.

(a) CLT structure after repair

(b) CLT structure after repair

Figure 60 shows photographs of the CLT structure after the repair. The repaired CLT compartment #2 was relined with new gypsum board and re-used in Test 1-3. Three layers of 15.9 mm (5/8 in.) thick Type X gypsum board were installed on the ceiling, two layers on the W2, W3 and W4 walls. The entire W1 wall was exposed – bare CLT surface on W1.

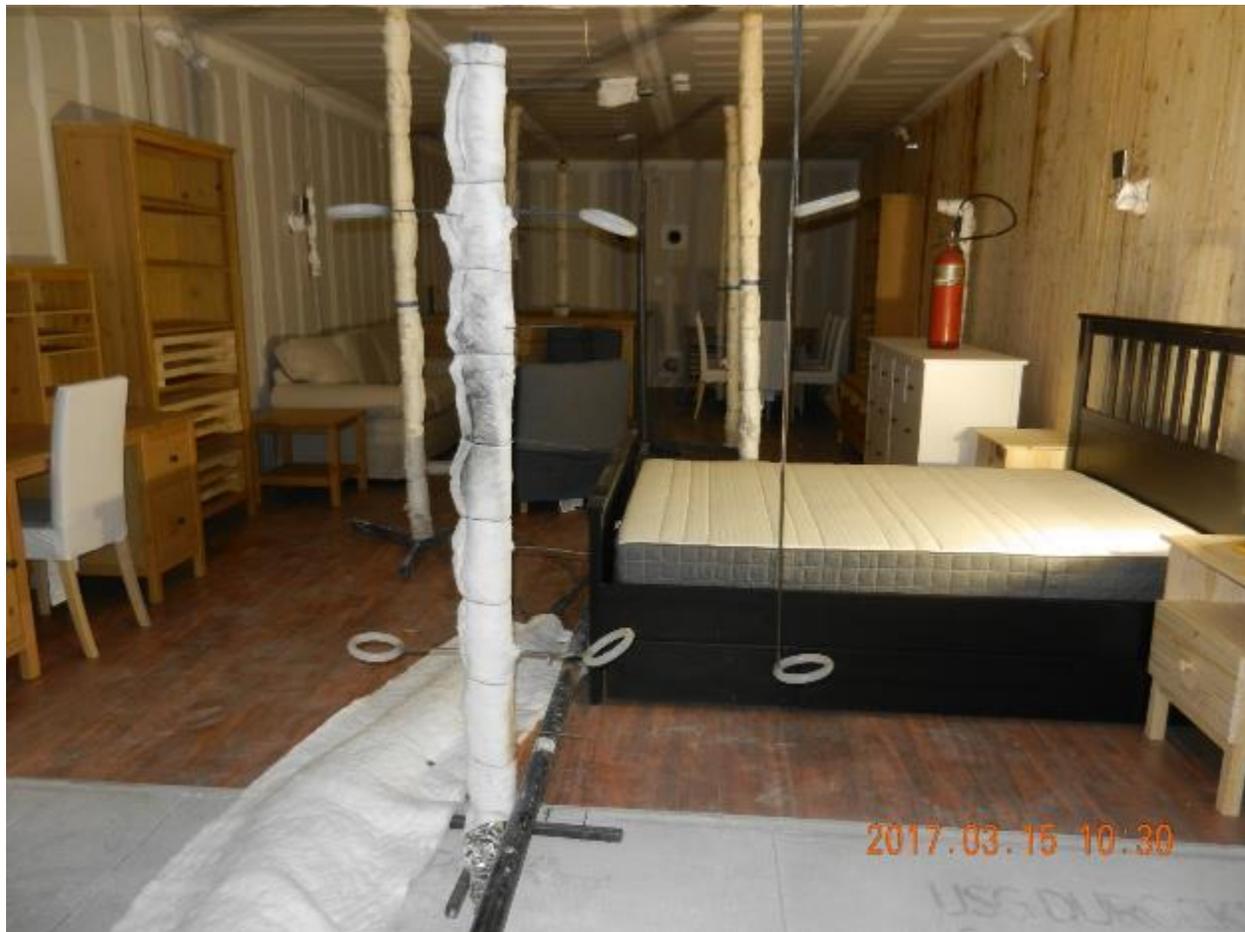
Figure 61. Photograph of CLT compartment with exposed W1 wall for Test 1-3.

Test 1-3 was conducted on March 16th, 2017 and designed to quantify the contribution of the exposed W1 wall to the compartment fire with Test 1-2 as the baseline with the 3.6 m x 2.0 m ventilation opening. Figure 61 shows the fully furnished CLT compartment before Test 1-3.
