RESEARCH FOUNDATION

Fire Safety Challenges of Tall Wood Buildings – Phase 2: Task 2 & 3 – Cross Laminated Timber Compartment Fire Tests

February 2018

Report number: FPRF-2018-01

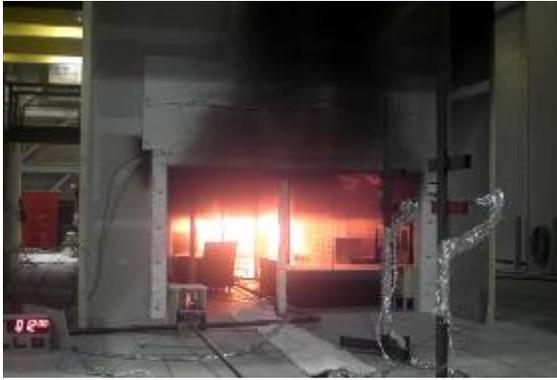
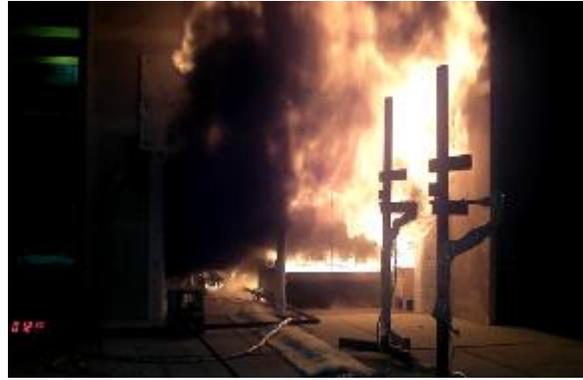
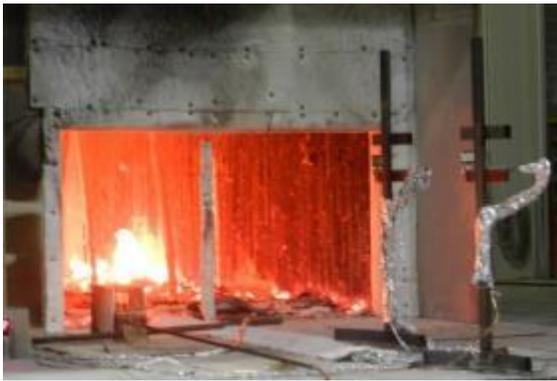
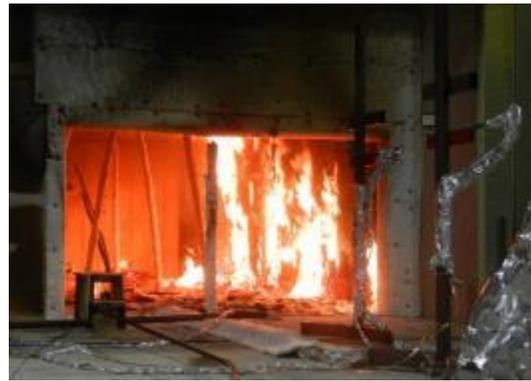
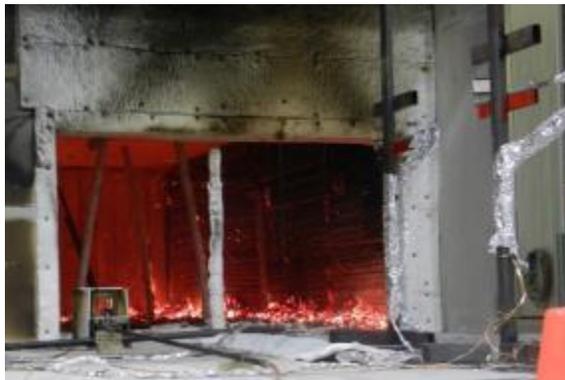
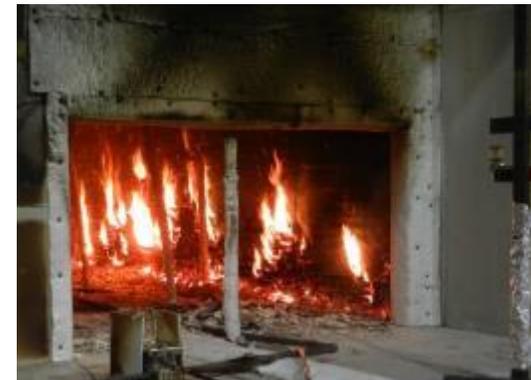
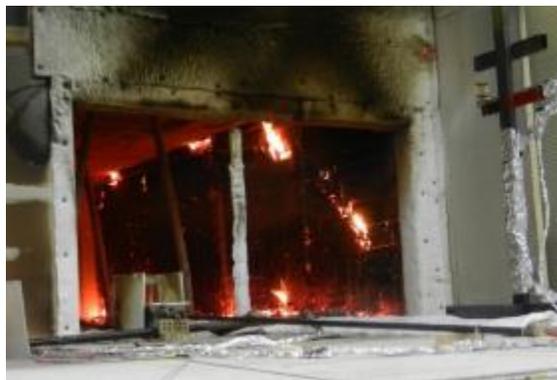
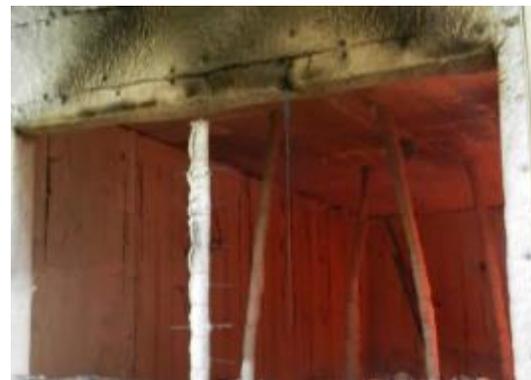
Figure 62. Photographs of the CLT compartment during Test 1-3.

(a) just before flashover at 12 min

(b) flashover at 12.5 min

(c) exposed W1 at 48 min: charred, no visible flame

(d) exposed W1 at 85 min before 1st ply falling off

(e) exposed W1 at 120 min after 1st ply falling off

(f) exposed W1 at 190 min before 2nd ply falling off

(g) exposed W1 at 240 min after 2nd ply falling off

(h) two GB layers on ceiling and W3 and W4 at 240 min

The test started with ignition of the console table in the dining area corner. The smoke alarm and heat alarm activated at 5.5 min and 2.9 min, respectively. Between 2.4 min and 5.8 min, all ten STEs reached 68 °C, which is a typical temperature rating for residential sprinklers. The console table was fully involved at 6 min and the smoke layer descended to the mid height in the compartment and stayed at this height until flashover. At 11.3 min, the fire from the console table ignited the upper portion of the W1 wall and the tall bookcase in the dining area. At 12 min, the dining table and chairs were fully involved in the fire. The smoke optical density measured at the 1.6 m height in the room centre reached 3.4 m⁻¹ at 12.4 min. Flashover occurred at 12.5 min with dramatic changes of O₂, CO₂ and CO concentrations. Large fire plume issued from the opening. Figure 62 shows some photographs of the CLT compartment during Test 1-3.

After flashover, an intense burning of room contents, along with the exposed W1 wall, lasted for approximately 23 min. The gypsum board face layer was seen to start falling off the ceiling at 31 min. The fire started to decay at 35 min. Fire plume ceased to issue from the opening at 38 min and the compartment became visible inside. From 40 min to 80 min, the exposed W1 wall surface was noticeably charred but had little visible flame during this period as shown in Figure 62(c). O₂ was recovered to above 15% in the compartment. From 80 min to 100 min, flaming combustion re-occurred to the W1 wall (Figure 62(d)), starting at the joint between panels 10_018 and 10_019; then, the charred first ply started to fall off and the flame diminished on the W1 wall. Fire decayed again in the subsequent 80 min (from 100 min to 180 min (Figure 62(e))). At 190 min, another flaming combustion occurred to the charred second ply of CLT panels on the W1 wall (Figure 62(f)), starting at the joint between panels 10_017 and 10_018. This flaming of the charred second ply lasted for 20 min and was less intense than the first re-occurrence. When the charred second ply started to fall off, the flame on the W1 wall diminished again from 205 min to the end of the test (Figure 62(g)). The test was terminated at 242 min (4 h after ignition). A fire hose was used to lightly spray water over the W1 wall and the debris on the floor to terminate the test. At the end of the test, two layers of gypsum board were still on the W3 and W4 walls and the ceiling (Figure 62(h)).

As shown in Figure 62(h), two layers of gypsum board remained on the ceiling and W3 and W4 walls until the end of the test. In general, the CLT panels in the ceiling, W2, W3 and W4 walls did not contribute to the growth of the compartment fire during the test. The exposed W1 wall was fully involved and contributed to the fire.

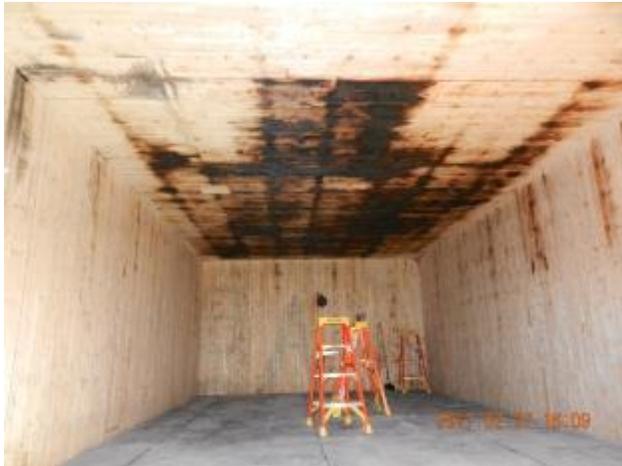
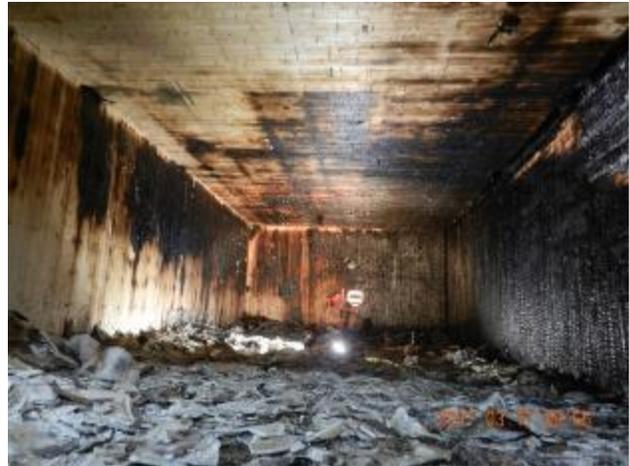
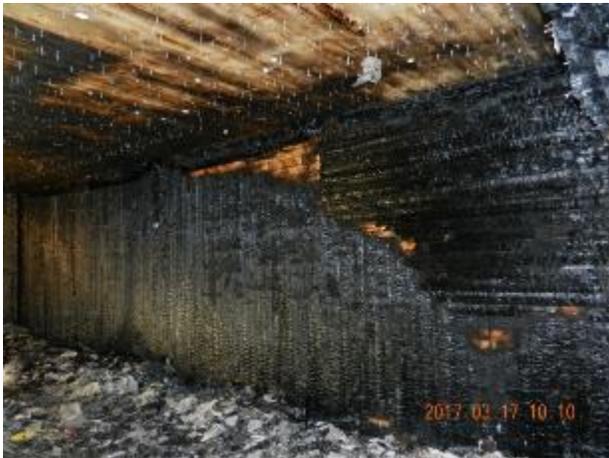
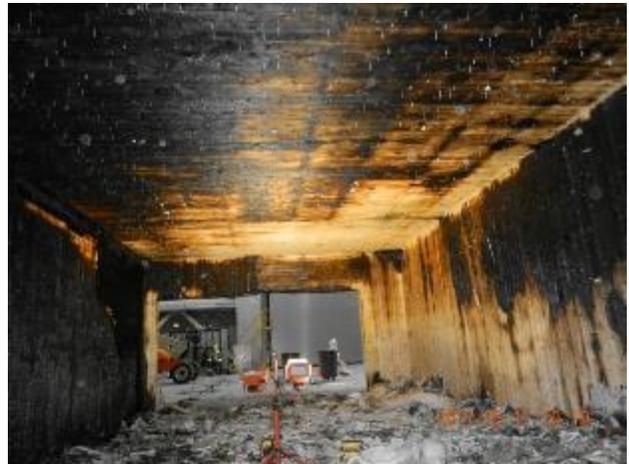
Figure 67. Char in CLT compartment before and after Test 1-3.

(a) W3, W4 W1 and ceiling CLT before Test 1-3.

(b) W3, W4 W1 and ceiling CLT after Test 1-3.

(c) W1 and ceiling after Test 1-3.

(d) W1, W2, W3 and ceiling CLT after Test 1-3.

After the fire test, the CLT compartment was examined for char. Figure 67 shows photographs of the CLT compartment interior surface before and after Test 1-3. On the exposed W1 wall, 85% of the CLT surface charred to the third ply of the CLT panels with a total char depth of approximately 80 mm; 15% of the surface close to the opening in the upper portion of the wall charred to the second ply with a total char depth of approximately 60 mm. On the W3 wall,

protected with two layers of gypsum board, only 35% of the CLT surface at the upper portion had char of 10 mm maximum; the remaining 65% had no char. On the W4 wall, 50% of the CLT surface developed char of up to 20 mm deep mainly in the section close to the W1 wall. For the ceiling, which was protected using three layer of the gypsum board, most of the CLT surface was unaffected by the fire; the char shown in the photo was mostly left from the previous Test 1-2. However, the ceiling surface adjacent to the W1 wall charred another 10 mm depth in Test 1-3. The char was measured more accurately at several selected positions and the results are shown in Table 6 and Table 7.

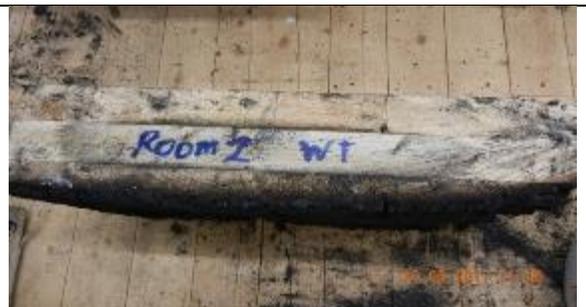
The photo in Table 8 shows the CLT sample that was cut from the W1 panel 10_018 where the embedded thermocouples were installed. The thickness of the char was 86 mm (remaining CLT thickness was 89 mm). This confirms the measurement of the char depth by the embedded thermocouples (65 mm < char depth < 90 mm).

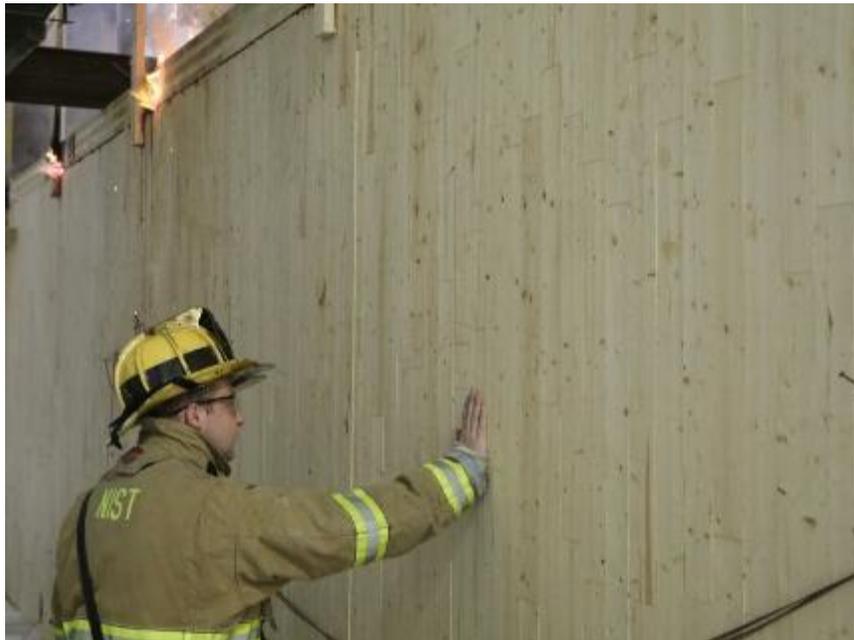
Figure 68. Exterior of the W1 wall at 198 min in Test 1-3.

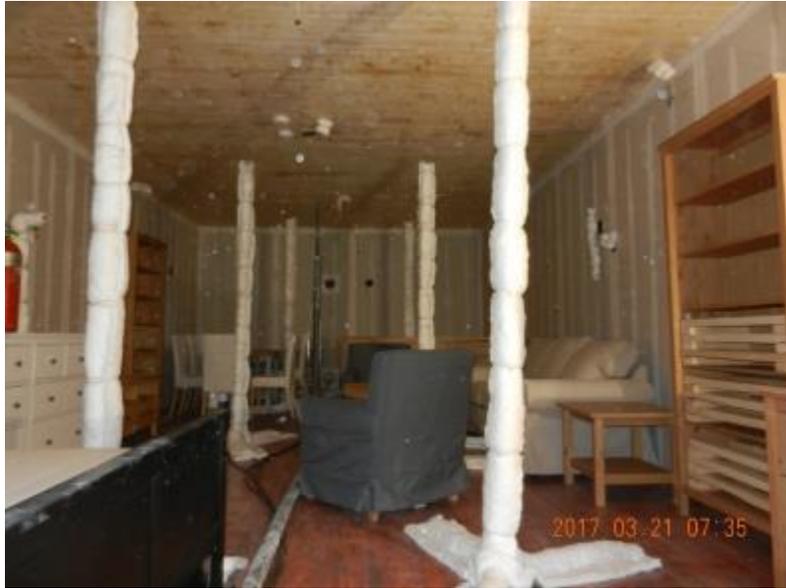
Figure 71. Photograph of CLT compartment with exposed ceiling for Test 1-4.

Test 1-4 was conducted on March 21st, 2017 for quantifying the contribution of the exposed CLT ceiling to the compartment fire with Test 1-1 as the baseline using the 1.8 m x 2.0 m ventilation opening. Figure 71 shows the fully furnished CLT compartment before Test 1-4.

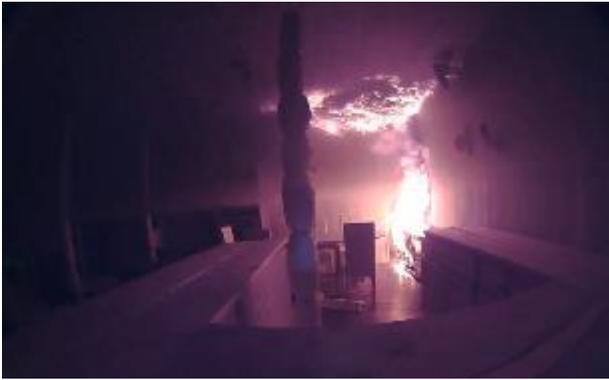
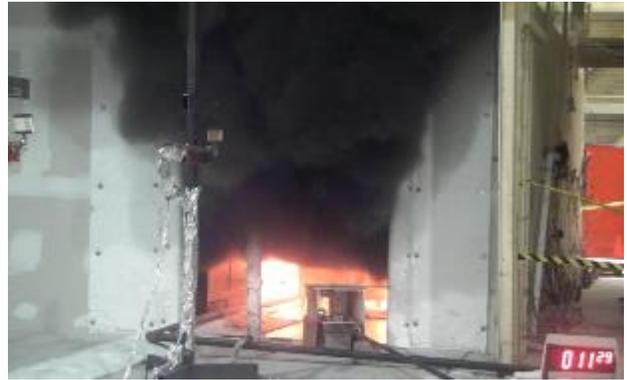
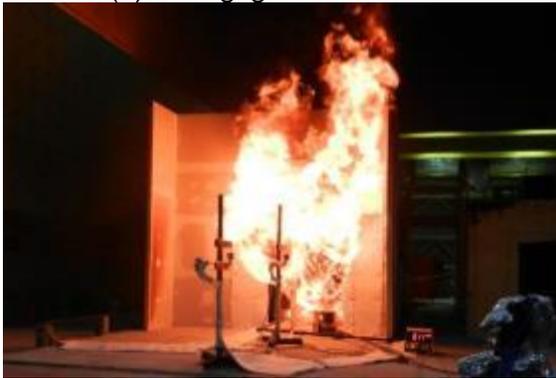
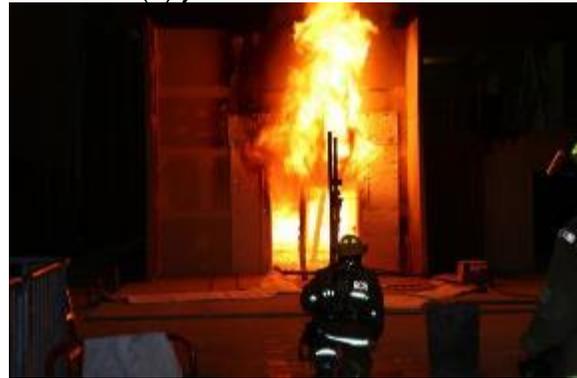
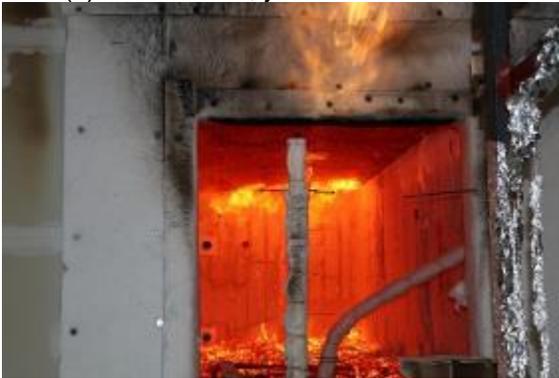
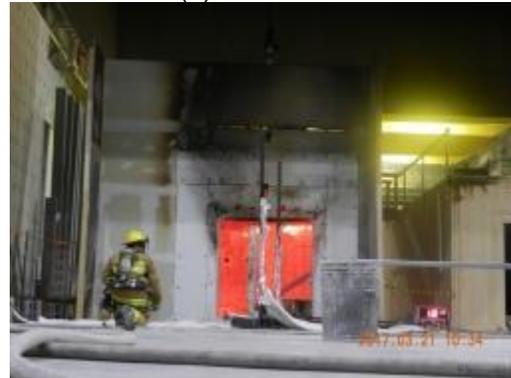
(a) ceiling ignited in corner

(b) just before flashover

(c) at 11.8 min; just after flashover

(d) at 60 min

(e) at 85 min

(f) at 90 min

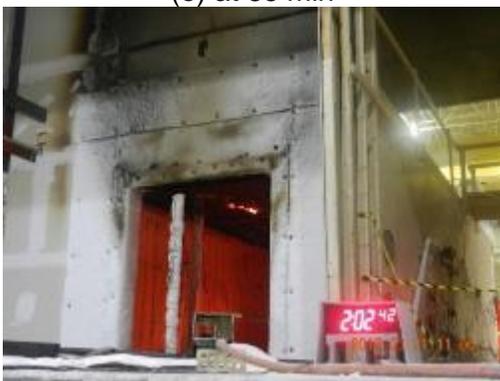
(g) at 122 min

From 90 to 140 min, the exposed second ply of the CLT ceiling continued to char with intermittent localized burning, as shown in Figure 72(f)(g). At 150 min, flaming combustion reoccurred on the CLT ceiling (Figure (h)), causing the second flashover with a large fire plume issuing from the opening again. The test was terminated by manual fire suppression at 159 min after the second ply of the CLT panels fell off the ceiling and the third ply became involved. Two fire hoses were used to spray water to the compartment to terminate the test. (The laboratory safety criterion was to terminate the test when more than two plies of CLT ceiling were charred or lost.) At the end of the test, two layers of gypsum board were still on all the walls. After the test, there was a 46-mm (1 7/8") deflection occurred and two and half plies of CLT were lost at the centre of the ceiling.

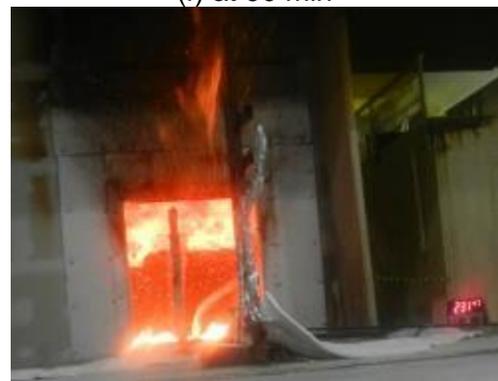
(h) at 151 min, second flashover

Once the fire started to decay at 75 min, the compartment temperatures decreased continuously until 140 min. After the second ply of the CLT panels fell off the ceiling and the third ply started flaming combustion, the compartment temperatures increased again rapidly to over 900 °C after 150 min. The test was terminated at 159 min.

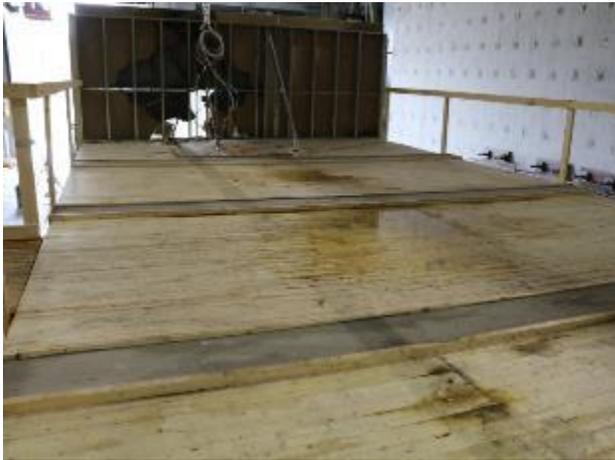
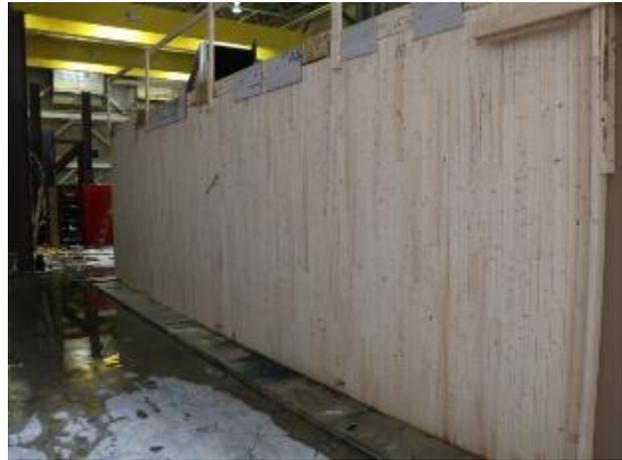
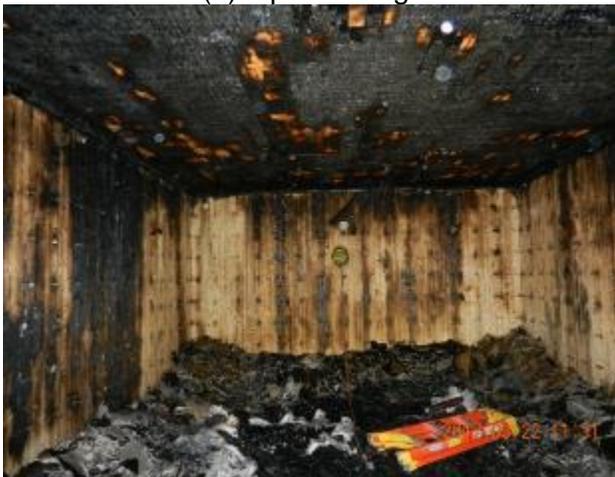
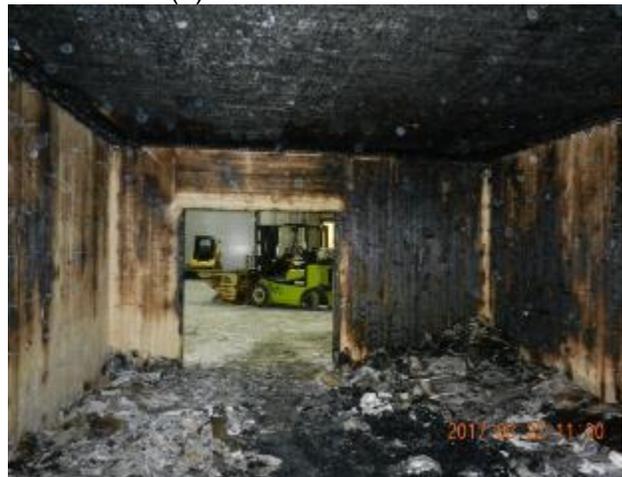
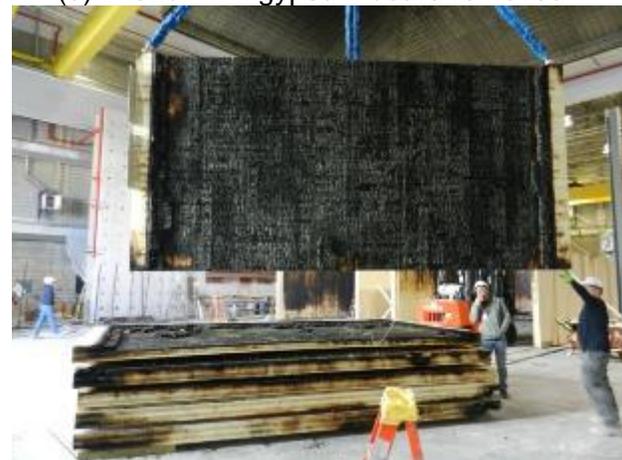
Figure 77. Photograph of CLT compartment and panels after Test 1-4.

After the fire test, the CLT compartment was examined for char. Figure 77 shows photographs of the CLT compartment after Test 1-4. Table 9 and Table 10 list the char depths measured at several selected positions. Most areas of the ceiling lost more than two plies (70 mm) of CLT and 55% of the area charred to the third ply with a total char depth of up to 90 mm. On the W1 wall, 40% of the surface had char of 4 mm to 14 mm depth; 60% of the surface had no char. On

the W3 wall, 25% of the CLT surface had char of 2 mm to 10 mm; the rest of 75% had no char. On the W4 wall, 90% of the CLT surface had no char and 10% of the CLT had only surface char. Additional charring would have occurred if the test had been allowed to continue.

As shown in Figure 77, the exterior surface of the CLT ceiling and walls had no char; neither did the exterior surface. The ceiling panel spline joints were covered with gypsum concrete on top but no sealant was used at any CLT joint of the compartment. Neither the wall panel joints nor the ceiling panel joints developed char. However, there was minor surface char developed outside the two back corners at the wall-ceiling junction (no burn through), which could have been prevented if the wall-ceiling joint had been sealed.

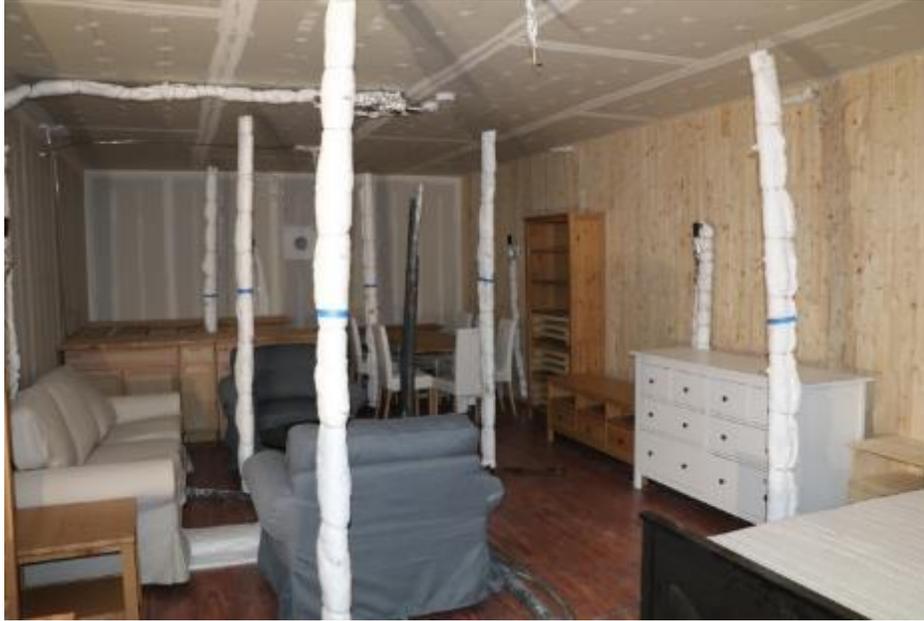
Figure 80. Photograph of CLT compartment with exposed W1 wall for Test 1-5.

A new CLT compartment was constructed using 5-ply 175 mm thick CLT panels for Test 1-5. As shown in Figure 80, the entire W1 wall was exposed – bare CLT surface. Three layers of 15.9 mm (5/8 in.) thick Type X gypsum board were installed on the ceiling and the W2, W3 and W4 walls. Necessary adjustment was made to thermocouple locations for Test 1-5. For the gypsum protected W3 and W4 walls and ceiling, the embedded thermocouples, originally planned for 140 mm depth, were moved to the second glueline at 70 mm deep in the CLT. Additional thermocouples were embedded in the exposed W1 wall to the CLT’s first and second gluelines (35 mm and 70 mm) at ten locations. Test 1-5 was conducted on April 13th, 2017 and designed to quantify the contribution of the exposed W1 wall to the compartment fire with Test 1-1 as the baseline (1.8 m x 2.0 m ventilation opening). (Test 1-5 had the same exposed wall surface (W1) as Test 1-3 but a smaller ventilation opening and one more layer of gypsum board on the W2, W3 and W4 walls than Test 1-3.)

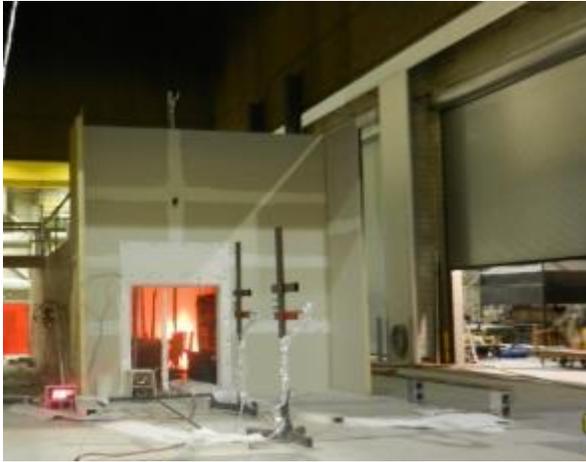
(a) ignition

Figure 81 shows some photographs of the CLT compartment during Test 1-5. The test started with ignition of the console table in the corner (Figure 81(a)). The smoke alarm and heat alarm activated at 1.8 min and 2.5 min, respectively. Between 1.2 min and 3.6 min, all ten STEs reached 68 °C, a typical temperature rating for residential sprinklers.

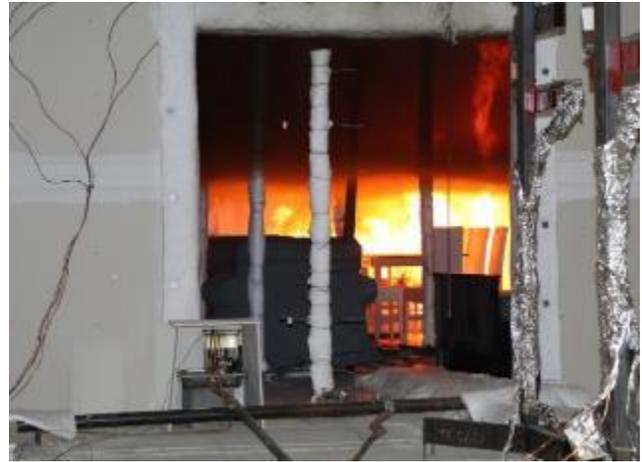
(b) W1 wall ignited at 9 min.

As shown in Figure 81(b), the fire ignited the exposed W1 wall panels in the dining area at 9.2 min. The first dining chair nearest to the corner was ignited by the fire at 10 min, the tall bookcase near the dining area at 10.2 min, and the dining table at 10.3 min. By 10.5 min, the whole dining area was on fire. The smoke optical density measured at the 1.6 m height in the room centre reached 3.4 m⁻¹ at 11.0 min. The W1 wall was then fully involved.

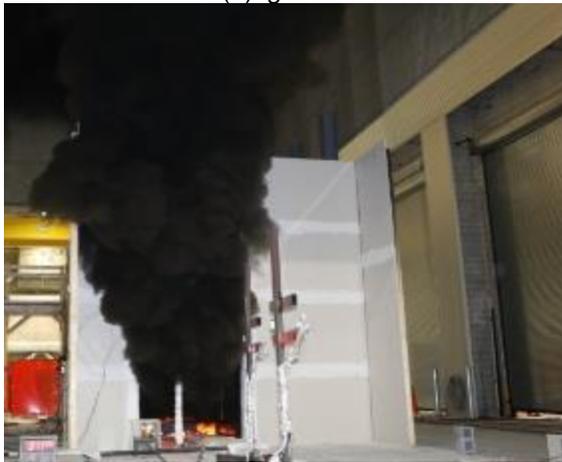
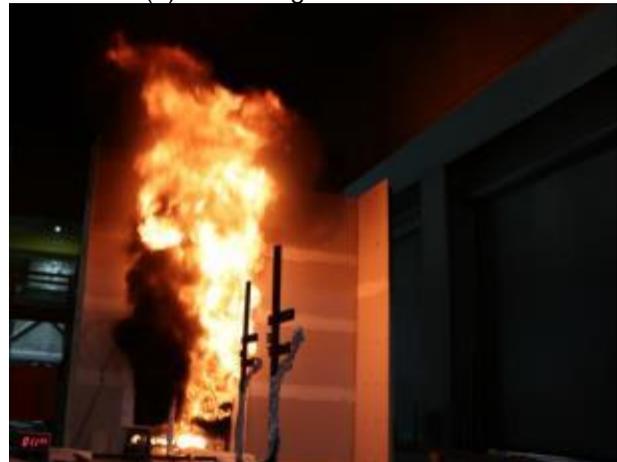
Flashover occurred at 11.5 min, as shown in Figure 81(c) and (d). The concentrations of O₂, CO₂ and CO concentrations changed dramatically. Large fire plume issued from the opening. While the room content was consumed by 40 min, the W1 wall continued to burn. At 52 min, pieces of the charred first ply of the W1 panels started to fall off gradually and the fire started to decay significantly. The fire plume ceased to issue from the opening at 67 min and the W1 wall was clearly seen burning inside the compartment. Char of the CLT first ply was falling off the W1 wall until 75 min. The CLT second ply continued to burn on the W1 wall until 100 min. From 100 min to 130 min, the CLT second ply showed charring but little visible flame (Figure 81(e)).

(c) just before flashover

(d) flashover at 11.5 min

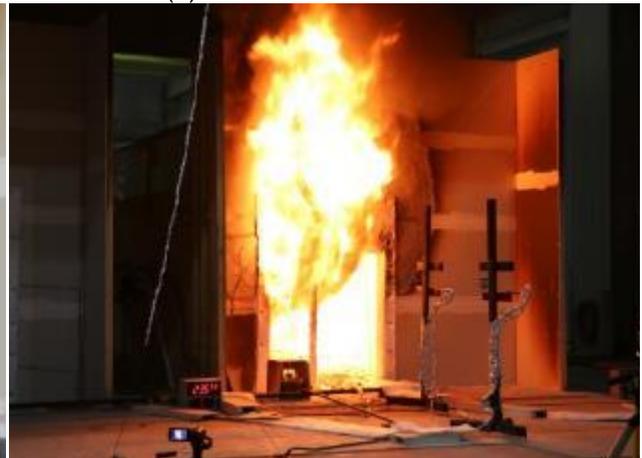
(f) second flashover at 155 min

From 130 min to 140 min, visible flame re-occurred and spread over the W1 wall again. Fire plume re-issued from the front opening at 140 min. The ceiling started full involvement in the fire at 150 min and the W3 and W4 walls also became fully involved at 185 min, after losing all gypsum board protection (see subsection 3.5.5). By this time, all CLT panels in the compartment contributed to the compartment fire. The test was terminated at 202 min with fire suppression using two fire hoses spraying water to the compartment.

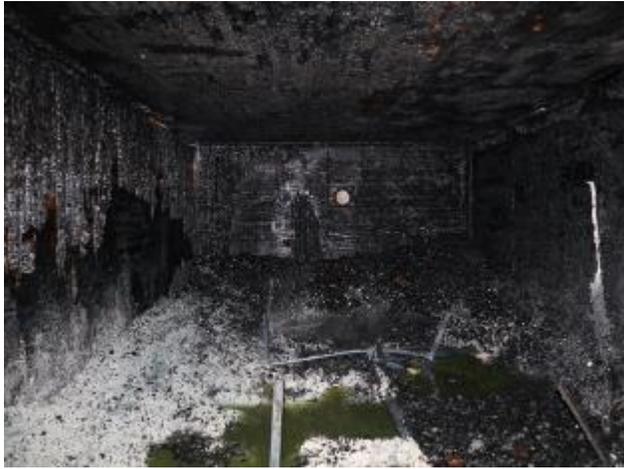
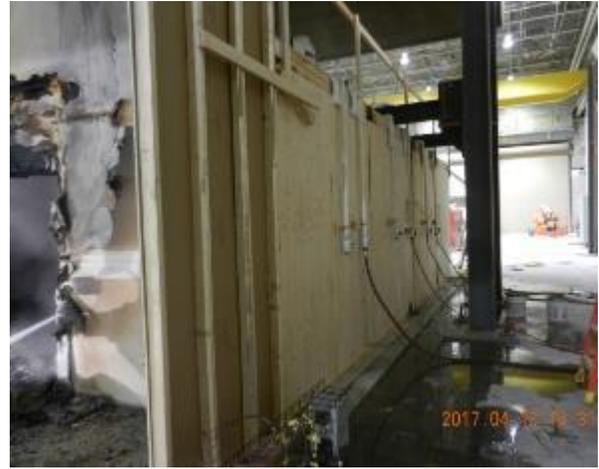
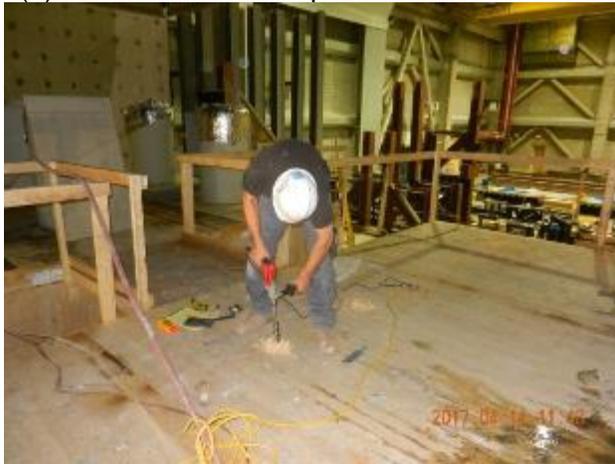
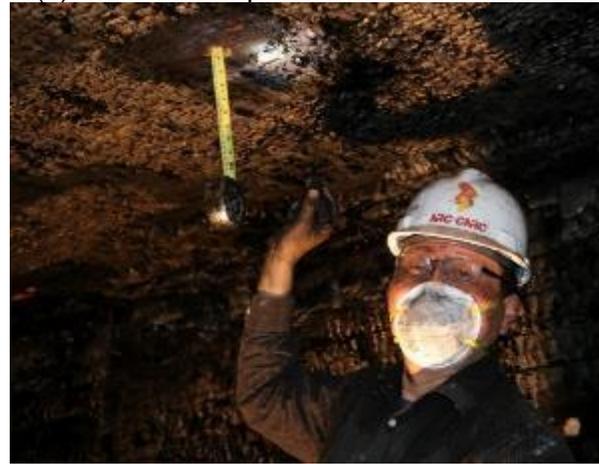
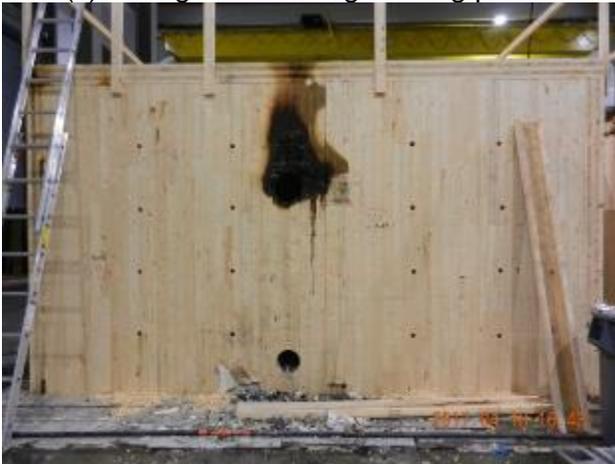
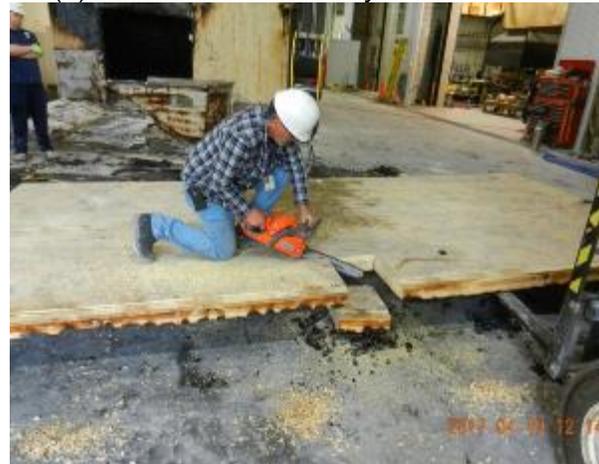
Figure 86. Observation and measurement of char after Test 1-5.

After the fire test, the CLT compartment was examined for char. Figure 86 shows photographs of the CLT compartment and char measurement after Test 1-5. Eight sampling holes were drilled through each CLT panel for char measurements. Table 12 and Table 13 list the char depths measured at the sampling-hole locations for each panel. The exposed W1 wall charred up to 141 mm (with the last ply supporting the ceiling structure), the ceiling up to 79 mm, the W3

and W4 walls up to 52 mm, at the sampling locations. Additional charring would have occurred if the test had been allowed to continue.

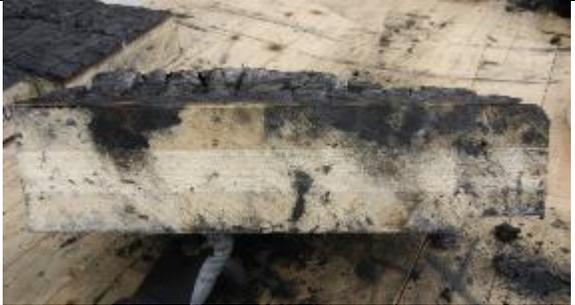
CLT cut sample	Remaining thickness (mm)	Char depth (mm)	Image
Test 1-5 Ceiling centre Panel 11_007 (TC 98, 1-7)	106	69

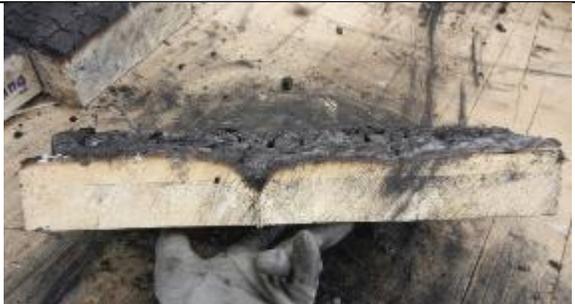
Test 1-5 W1 – front 0.6 m high Panel 10_019 (TC 62, 63, 64)	47	128

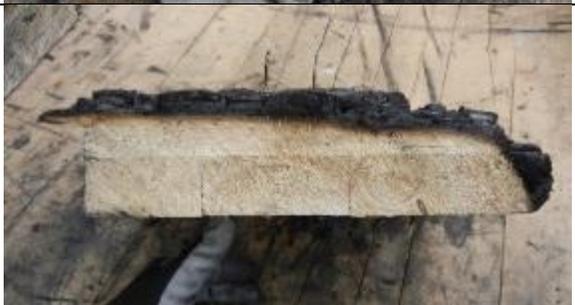
Test 1-5 W1 – rear 0.6 m high Panel 10_016 (TC 65, 66, 67)	52	123

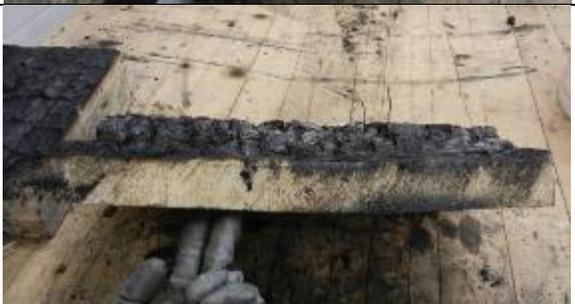
Test 1-5 W1 – front 1.8 m high Panel 10_019 (TC 56, 57, 58)	45	130

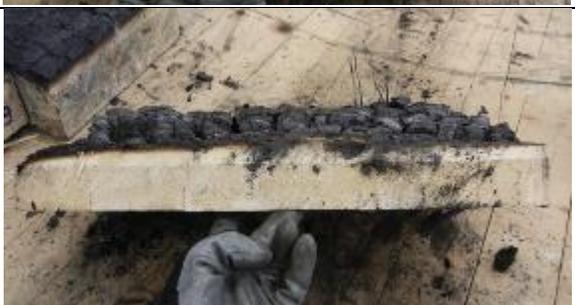
Test 1-5 W1 – mid length 1.8 m high Panel 10_018 (TC 49, 8-14, 55)	57	118

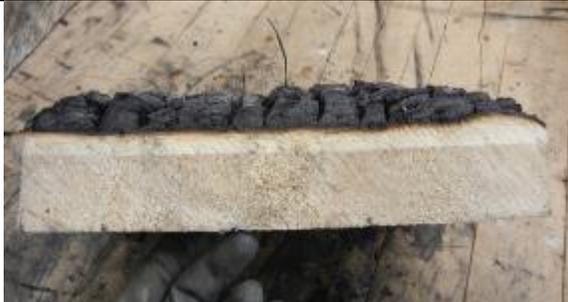
CLT cut sample	Remaining thickness (mm)	Char depth (mm)	Image
Test 1-5 W1 – rear 1.8 m high Panel 10_016 (TC 59, 60, 61)	58	117

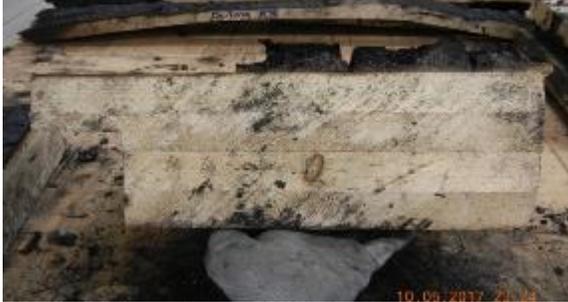
Test 1-5 W3 – mid length 1.8 m high Panel 10_022 (TC 70, 15-21)	142	33

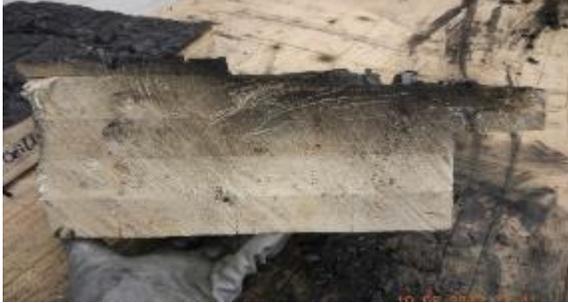
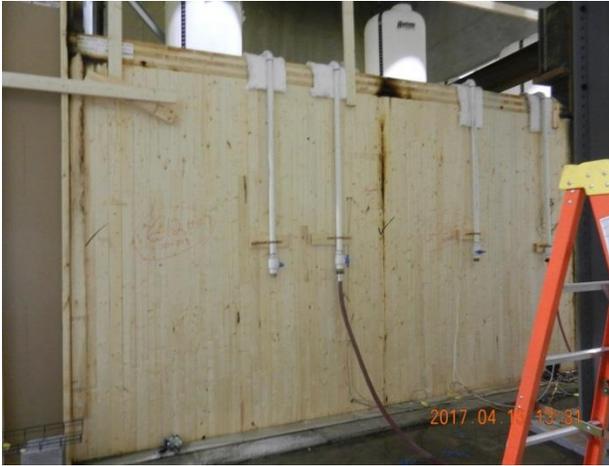
(a) W1 wall

Figure 87 shows the exterior surface of the CLT ceiling and walls after the test. Although no sealant was used at any CLT joints of the compartment, there were only a few spots at the ceiling-wall joints and at the W1 panel joints where smoke escaped and char appeared. However, there was no burn through during the test.

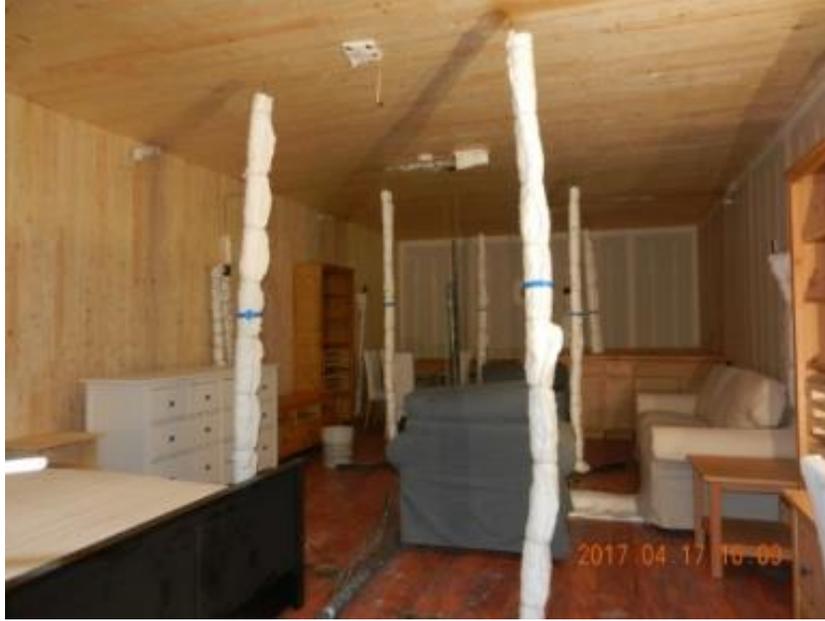
Figure 93. CLT compartment with exposed ceiling and W1 wall for Test 1-6.

A new CLT compartment was constructed using 5-ply 175 mm thick CLT panels for Test 1-6. The entire ceiling and W1 wall were exposed (bare CLT surface), as shown in Figure 93. Three layers of 15.9 mm (5/8 in.) thick Type X gypsum board were installed on the W2, W3 and W4 walls. Gypsum concrete (38 mm thick x 305 mm wide or 1-1/2 in. thick x 12 in. wide) was poured on the top of each spline joint of the ceiling panels on the outside,

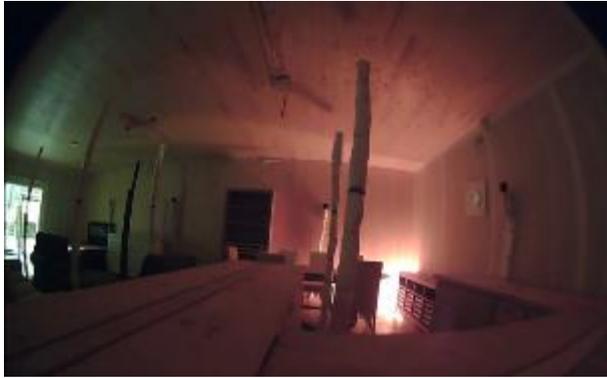
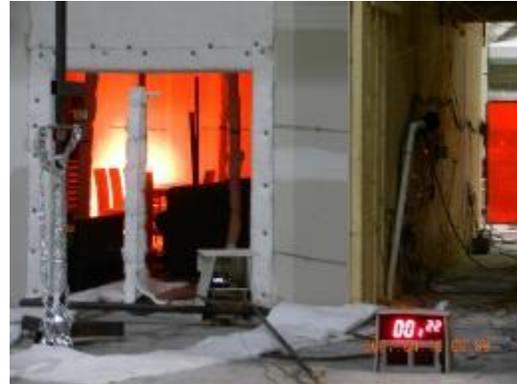
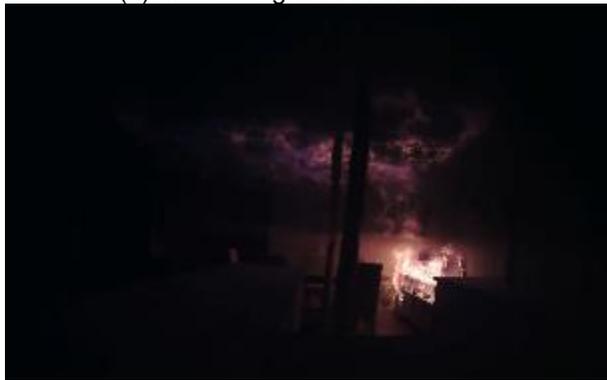
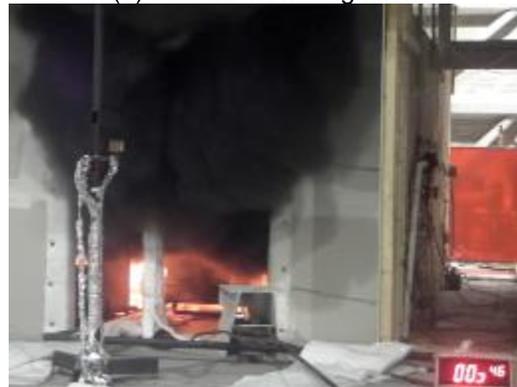
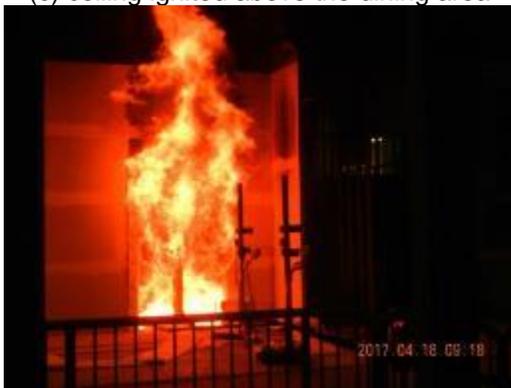
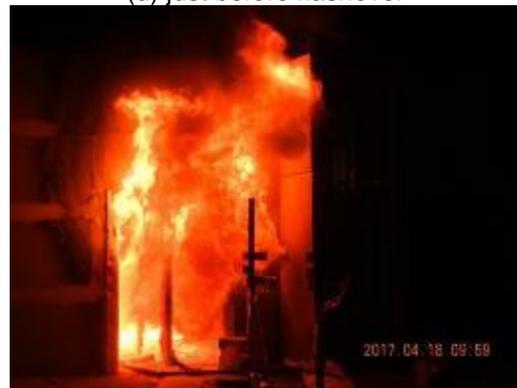
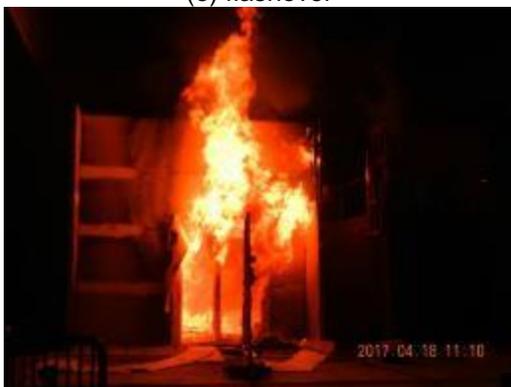
Flashover occurred at 9.8 min. Large fire plume issued from the opening. After the room content was consumed, the exposed ceiling and W1 wall continued to burn with large fire plume issuing from the opening. At 80 min, the fire plume reduced in size and mainly issued from the upper right part of the opening and the interior of the compartment became partly visible. Most of the face layer gypsum board already fell off the W3 wall while the face layer gypsum board on the W4 wall started to fall. At 90 min, the W3 wall was seen to have lost some middle layer gypsum board with flare at several gypsum board joints on the base layer. At 100 min, the fire plume increased in size obstructing the view into the compartment. As the fire continued to grow, the ceiling appeared to sag at 120 min. At 150 min, flames burnt through a hole at the ceiling-wall junction between panels 10_009 and 11_003 near the ceiling spline joint. At 156 min flames burnt through the ceiling joint between ceiling panels 11_003 and 11_004.

(a) first item ignited in the corner

(b) outside view of ignition

(c) ceiling ignited above the dining area

(d) just before flashover

(e) flashover

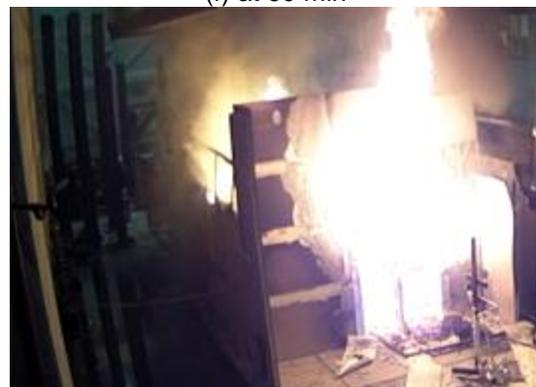
(h) at 160 min

Figure 94. Photographs of the CLT compartment during Test 1-6.

Figure 94 shows some photographs of the CLT compartment during Test 1-6. The test started with ignition of the console table in the dining area corner. The smoke alarm and heat alarm activated at 2 min and 3 min, respectively. Between 1.6 min and 3.9 min, all ten STEs reached 68 °C, a typical temperature rating for residential sprinklers.

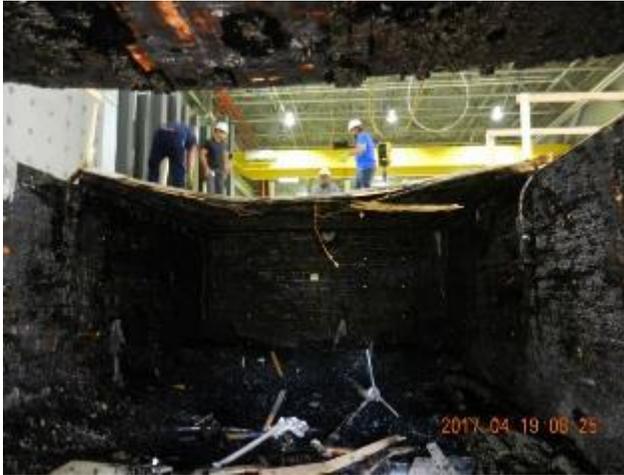
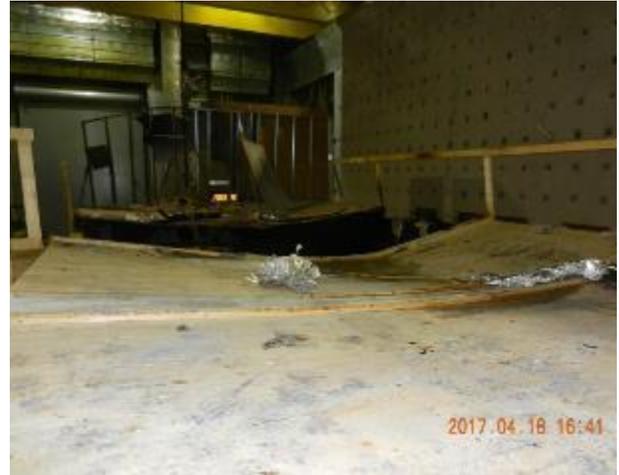
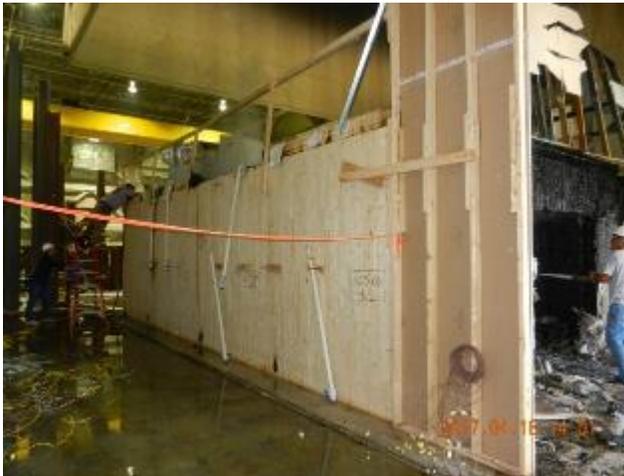
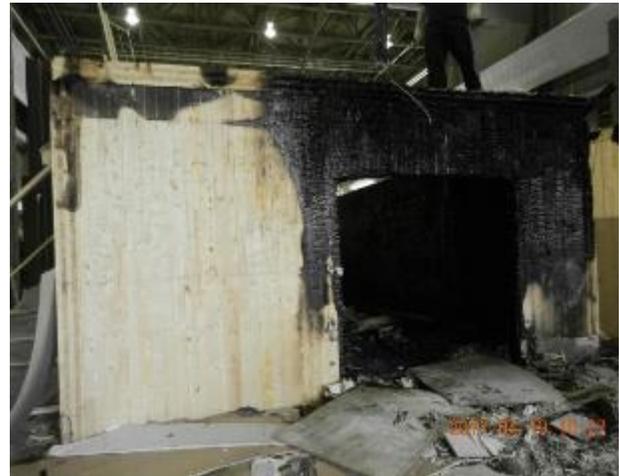
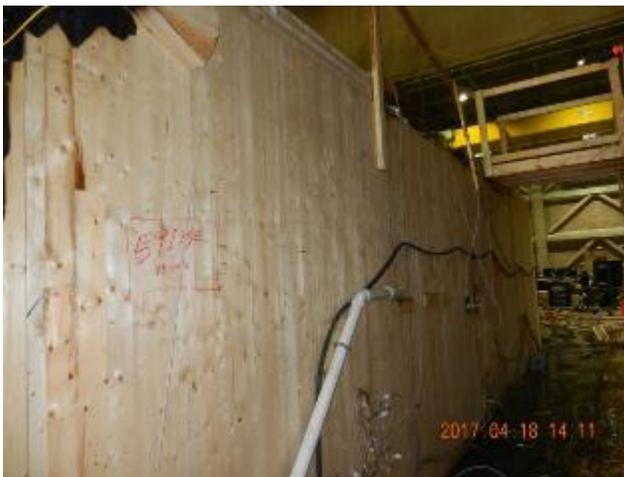
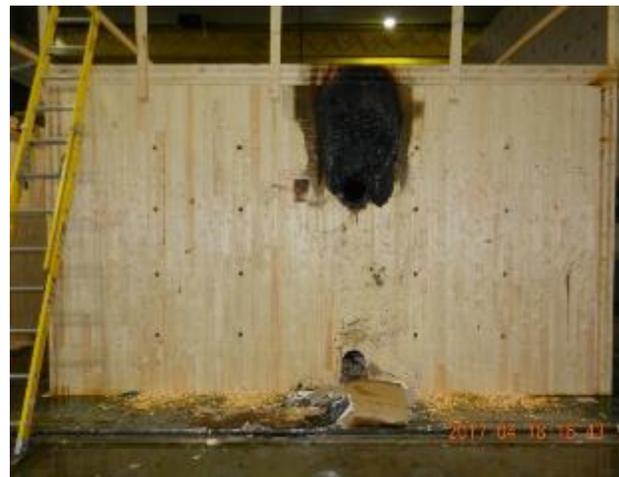
Figure 99. CLT compartment after Test 1-6.

After the fire test, the CLT compartment was examined for char. Figure 99 shows photographs of the CLT compartment after Test 1-6. After the test, there was a 406-mm (16 in.) deflection for the remaining ceiling panels.

As shown in Figure 99, eight sampling holes were drilled through each CLT panel for char measurements. Table 15 and Table 16 list the char depths measured at the sampling-hole locations for each panel. The exposed ceiling charred 116-154 mm, the exposed W1 wall 88-143 mm, the W3 wall 5-66 mm and the W4 wall 25-68 mm at the sampling locations. Additional charring would have occurred if the test had been allowed to continue.

As shown in Figure 99, other than the char formed around the openings, the exterior surface of the CLT panels had char localized at the joint between the W1 wall and ceiling near the ceiling spline locations. Had sealant been used in the joints, the smoke leaked from the W1-ceiling junction could have been reduced and the burn through at the W1-ceiling junction spot and at one of the ceiling spline joints could have been delayed. However, based on the amount of char formed at these locations, the absence of sealant in joints had a negligible impact on the quantification of CLT contribution to the compartment fire.

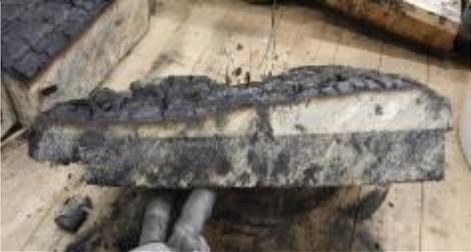
CLT cut sample	Remaining thickness (mm)	Char depth (mm)	Image
Test 1-6 Ceiling centre Panel 11_003 (TC 98, 1-7, 100)	51	124

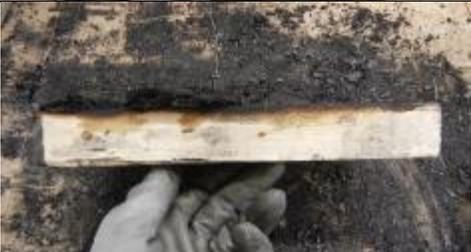
Test 1-6 Ceiling above Tree 1 Panel 11_002 (TC 86, 87, 88)	36	139

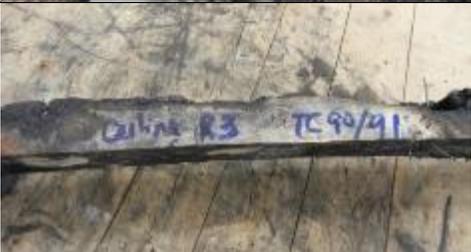
Test 1-6 Ceiling above Tree 2 Panel 11_003 (TC 89, 90, 91)	21	154

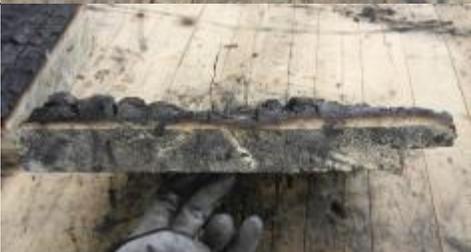
Test 1-6 Ceiling above Tree 3 Panel 11_003 (TC 92, 93, 94)	42	133

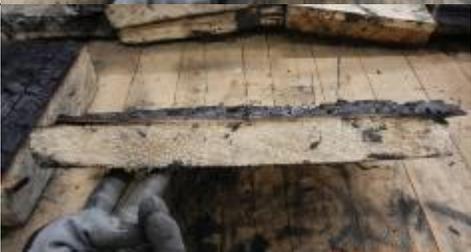
Test 1-6 Ceiling above Tree 4 Panel 11_002 (TC 95, 96, 97)	44	131

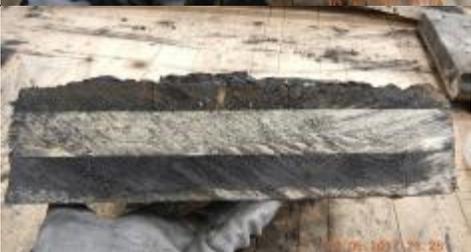
Test 1-6 W1 – front 0.6 m high Panel 10_010 (TC 62, 63, 64)	66	109

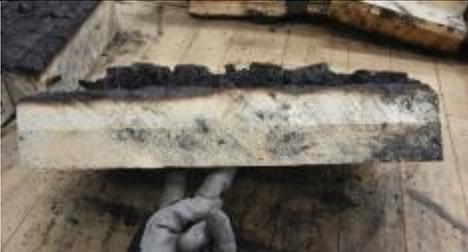
CLT cut sample	Remaining thickness (mm)	Char depth (mm)	Image
Test 1-6 W1 – rear 0.6 m high Panel 10_007 (TC 65, 66, 67)	68	107

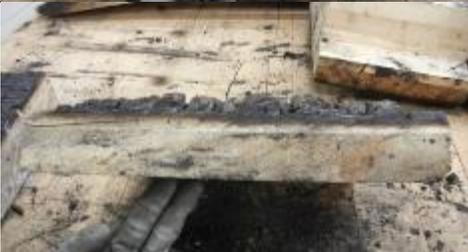
Test 1-6 W1 – front 1.8 m high Panel 10_010 (TC's 56, 57, 58)	52	123

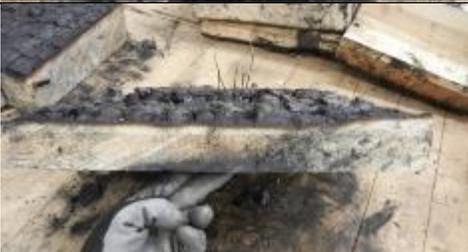
Test 1-6 W1 – mid length 1.8 m high Panel 10_009 (TC 49, 8-14, 55)	52	123

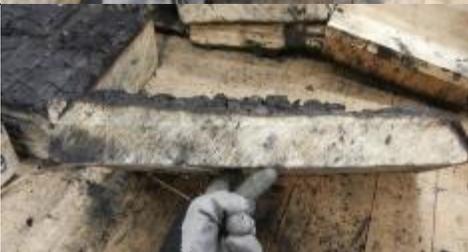
Test 1-6 W1 – rear 1.8 m high Panel 10_007 (TC 59, 60, 61)	53	122

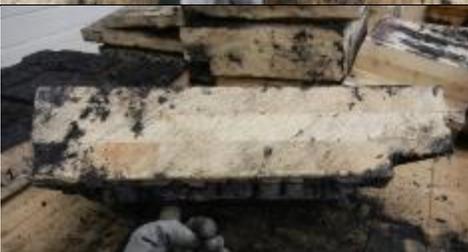
Test 1-6 W3 – mid length 1.8 m high Panel 10_005 (TC 70, 15-21)	119	56
