Real-world and Accelerated Degradation of PV Module Backsheets

Laura S. Bruckman

Associate Research Professor
Materials Science and Engineering
Case Western Reserve University

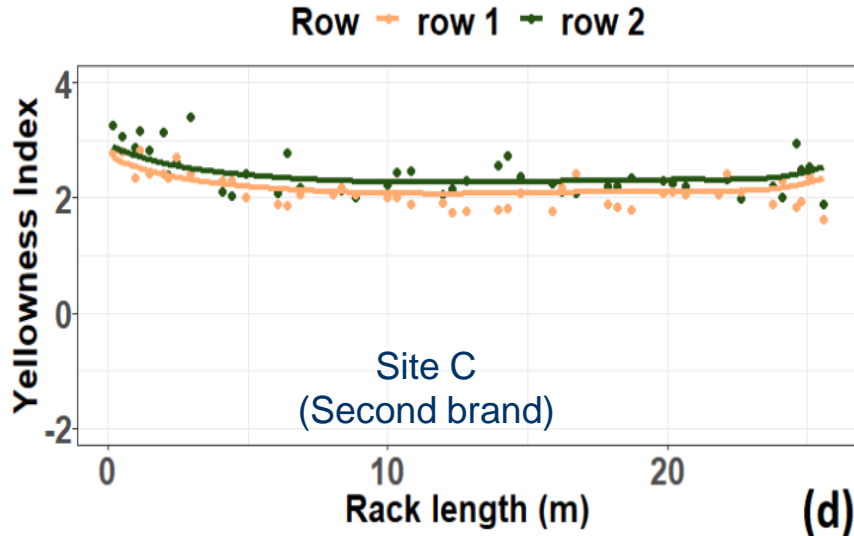
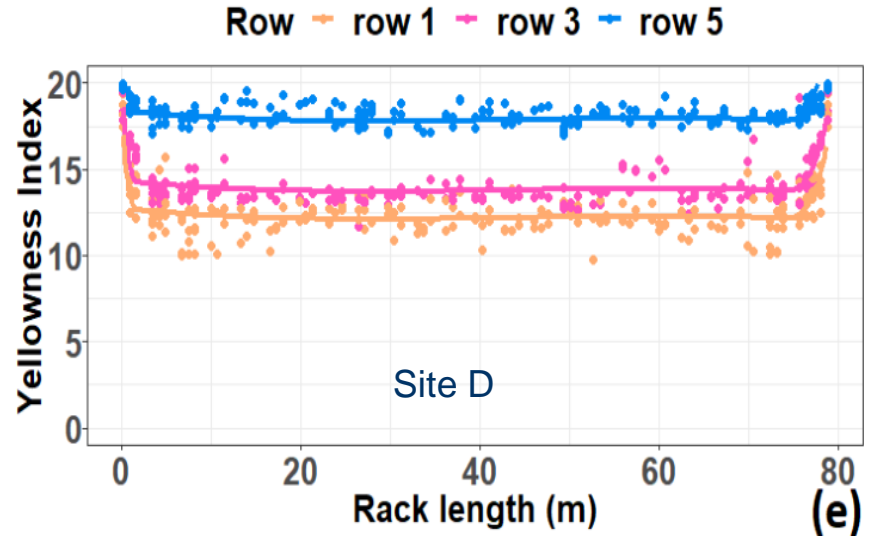
Field Survey Results

Non-uniform degradation

- gives insight into unique degradation stressors
- same climate zone

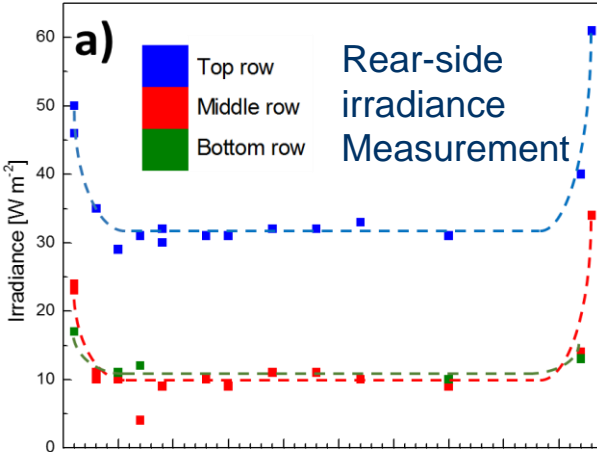
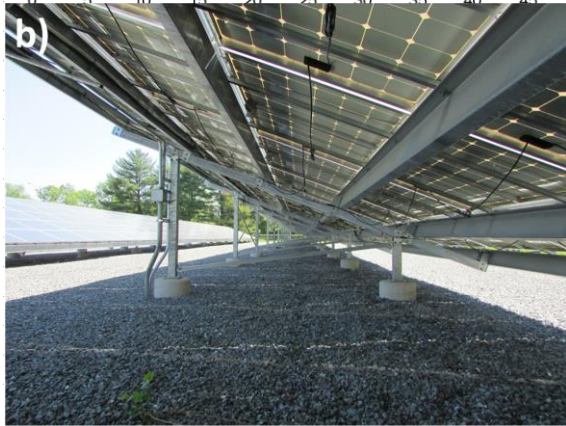
Non-uniform Irradiance

Similar rear-side irradiance distribution with YI pattern

- Measurement: rear-side irradiance measured in site D
- Simulation: physical model for ordinary PV rack^[1]

Different temperature distribution YI pattern

- Measurement: no significant difference of temperature in site D
- Simulation: Higher temperature at center of rack^[2]

Inhomogeneous rear-side irradiance

- May cause non-uniform backsheet degradation
- Within one rack in the PV site

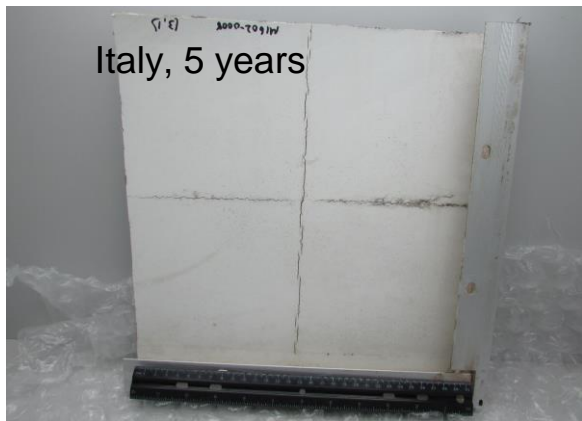
Italy, 5 years

Cracks of Polyamide(PA/PA/PA): Retrieved and Films

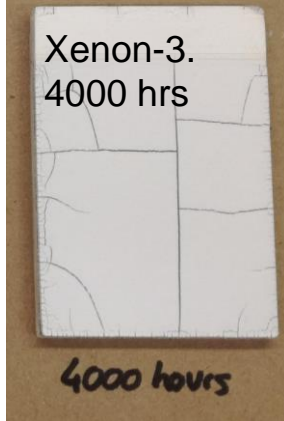
Xenon-3.
4000 hrs

Xenon-3: High Irra, High T, Low RH, Water spray

- Xenon-3: Removal of air-side layer, degradation and crack of core layer
- Xenon-4: Micro cracks Degradation of sun-side and core layer between cells
- No Cracking in films
- Chromatography confirmed molecular weight loss

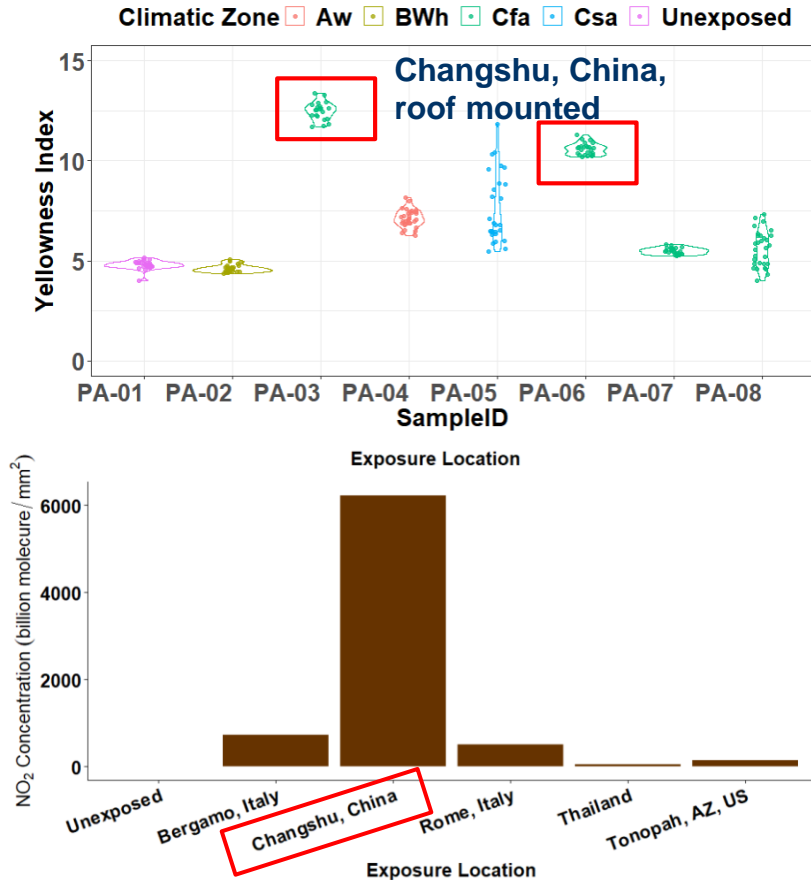
Pollution Effect on Backsheet

Air pollutant

- NO₂ causes yellowing of polyamide^[1]
- More prominent effect of NO₂:
 - Roof mounted modules
 - Potentially higher irradiance & temperature
- Lower yellowness index value
 - With grass ground cover

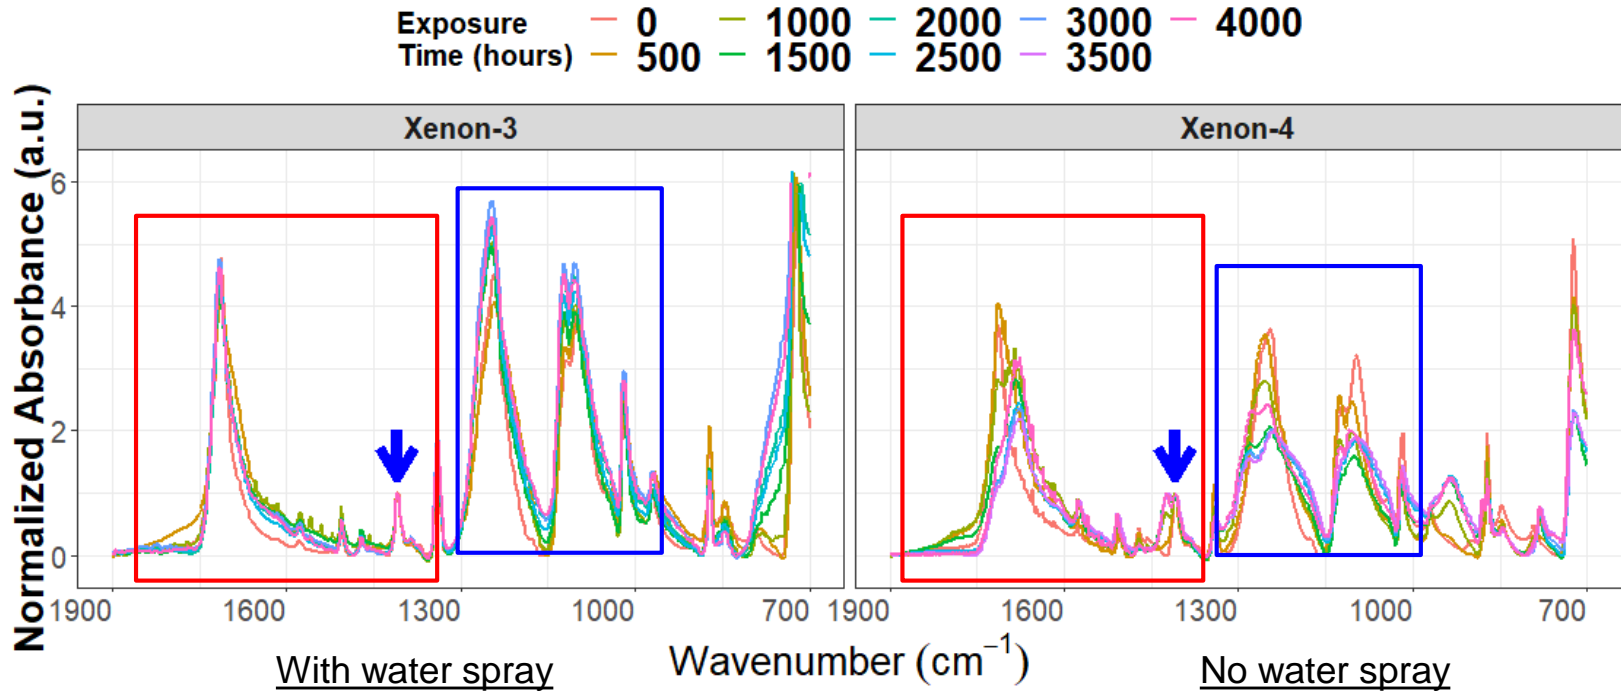
Effect of Water Spray on PET Backsheets

Water spray removes degraded materials for PET

- **No observable degradation product peaks** observed in Xenon-3 FTIR
- Small **decrease of PET peaks**

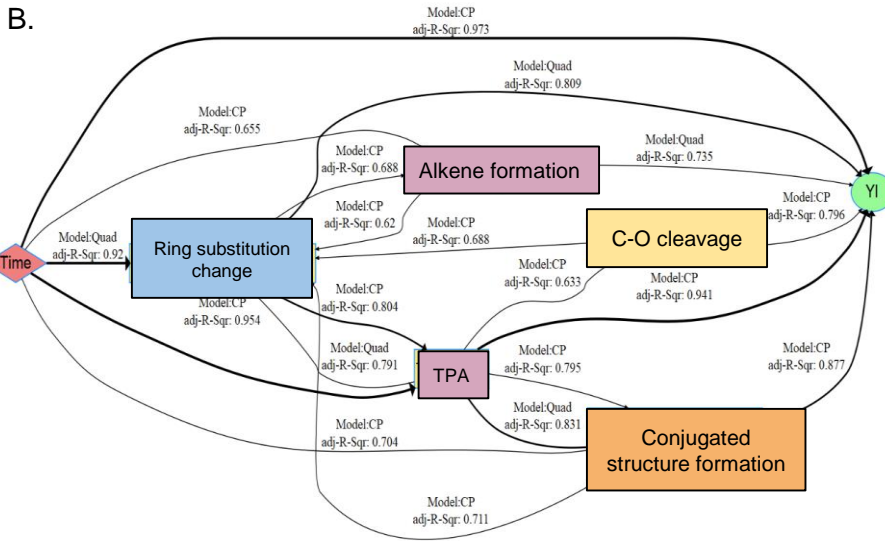
netSEM modeling of PET: Network Structural Equation Modeling

PET exposed to 0.8 w/m²/nm at 340 nm, 80°C

- with water spray (A)
- without water spray (B)

ATR-FTIR indicated

- Surface removal of degraded products with water spray
- Identify degradation products without water spray

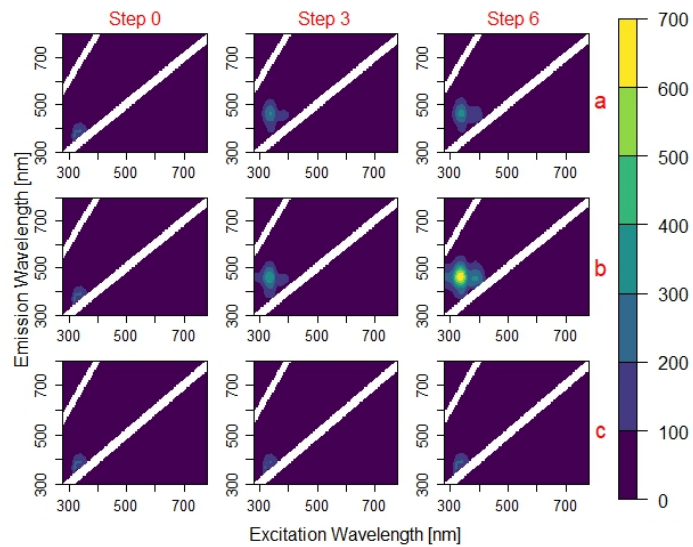
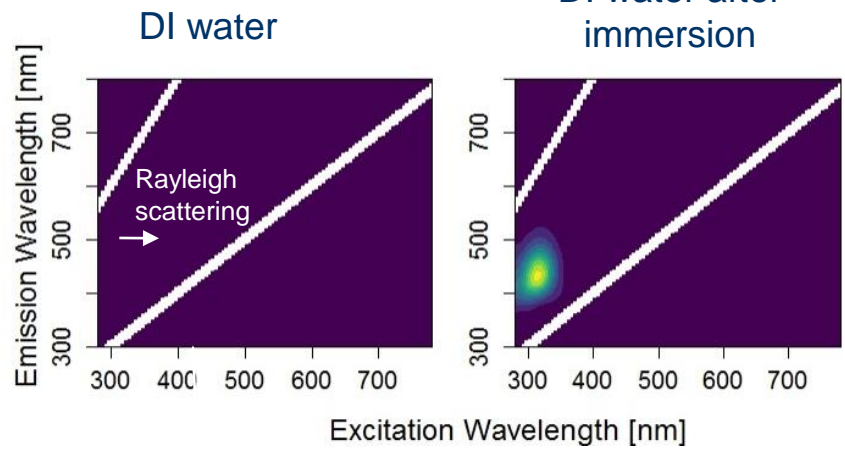
Degraded Surface Loss: Water Spray

Degradation product observed in DI water

- Parallel Factor Analysis
- Excitation/Emission Fluorescence
- Relative concentrations of
 - Mono- (A) or di-hydroxy (B) species

- Parallel factor analysis identified degradation products

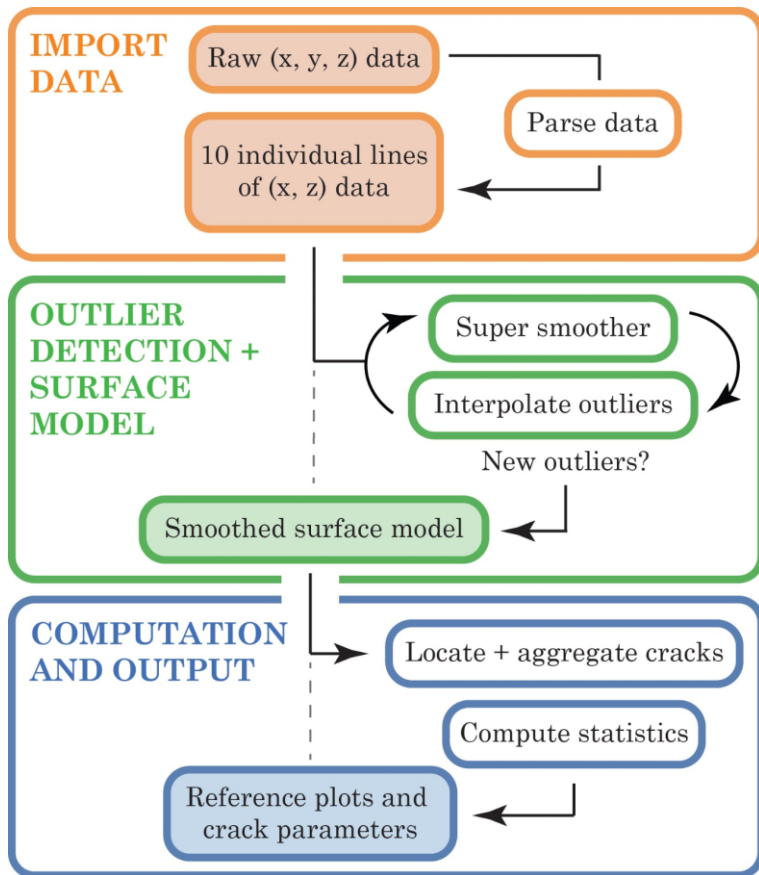
Crack Quantification Algorithm and Extraction of Parameters: R

Localized Regression

- Non-parametric statistical technique that weights model at each point towards the closest data
- Friedman's Super Smoother optimizes the span parameter for each x-value (sample width)
- Iterative application allows simultaneous outlier detection to decrease computational time (average 2.7 iterations)

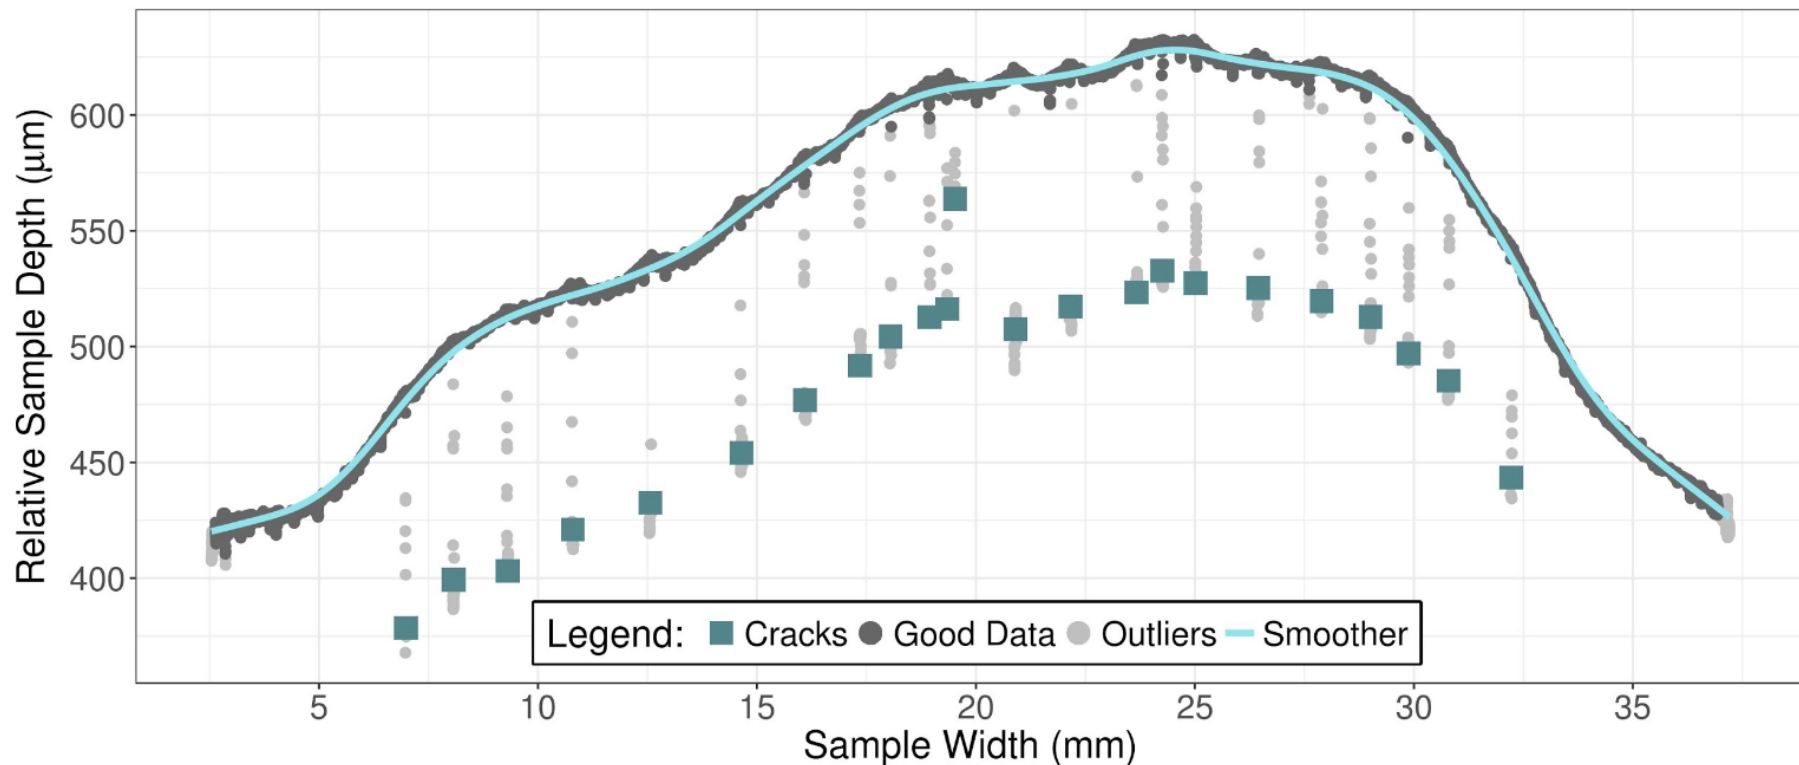
Automatically Generated Reference Plots - Parallel Cracks (FPE2)

- Parallel cracks and consistent surface (no deadhesion) are easily handled by the algorithm
- Most samples had these characteristics

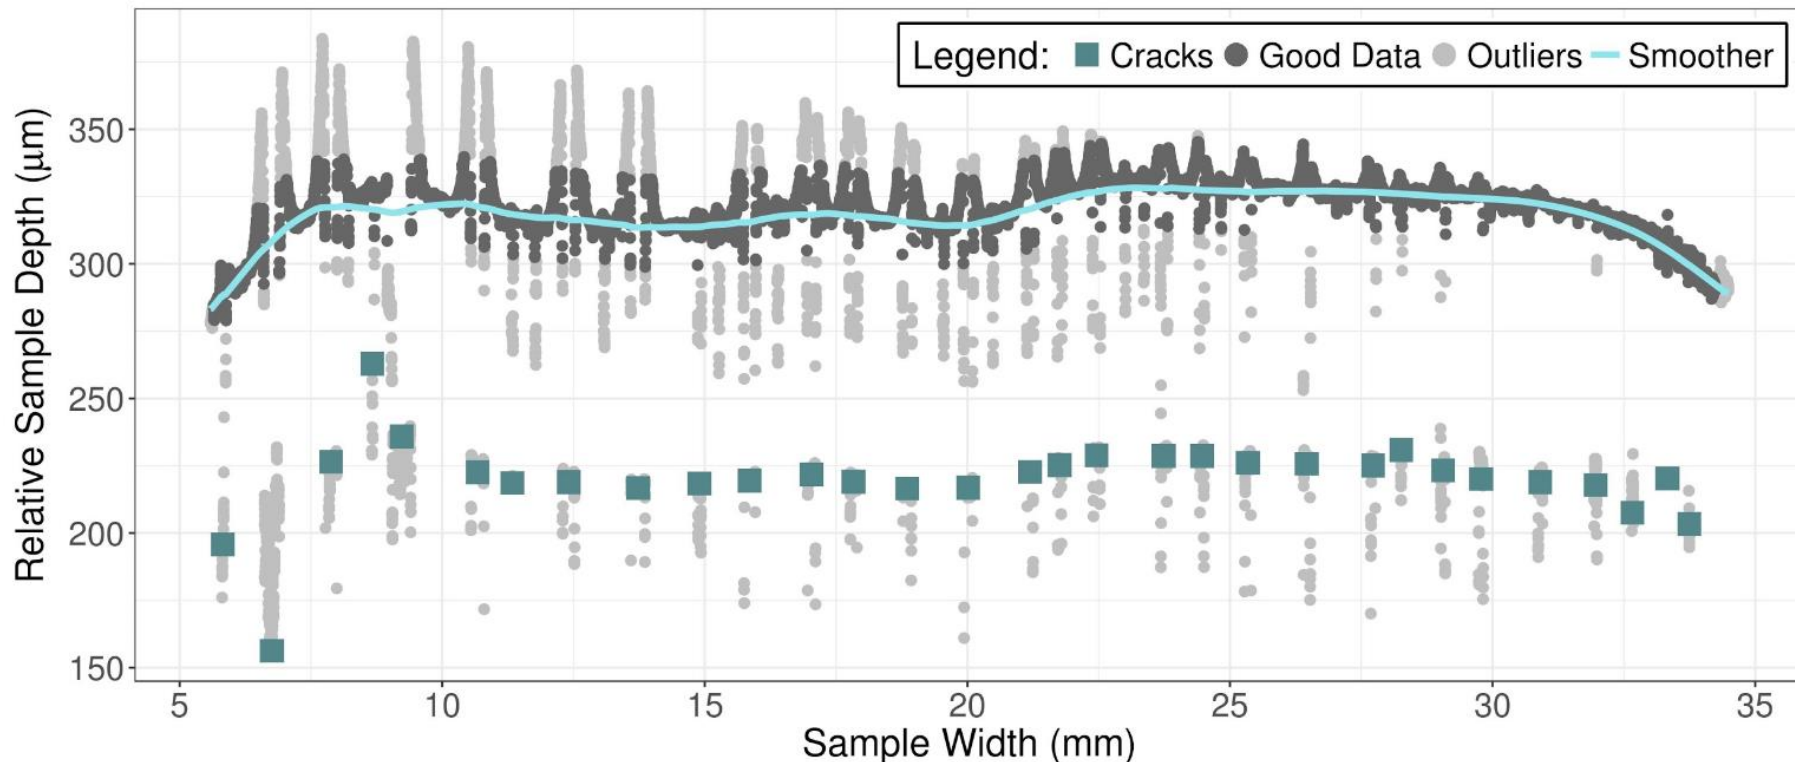
Automatically Generated Reference Plots - Blistering (FPE2)

- Data points associated with blistering are successfully detected as outliers
- Super Smoother follows the expected surface

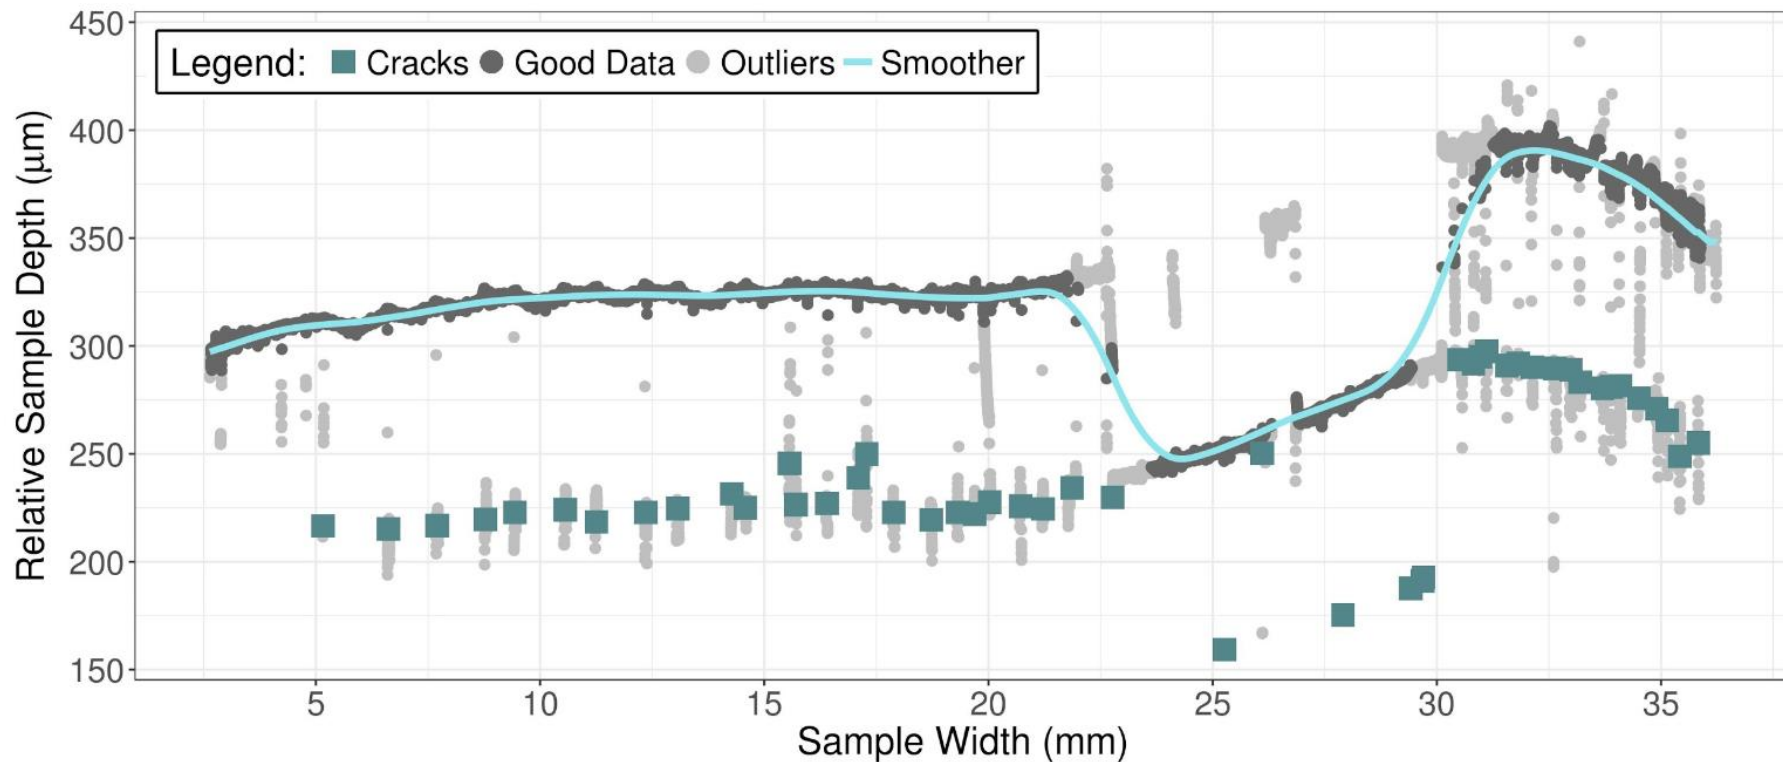
Automatically Generated Reference Plots - Delamination (FPE2)

- Delamination (right side of profile) results in large trough
- Incorrectly handled by outlier detection → now part of the “surface” is on the inner/core layer interface

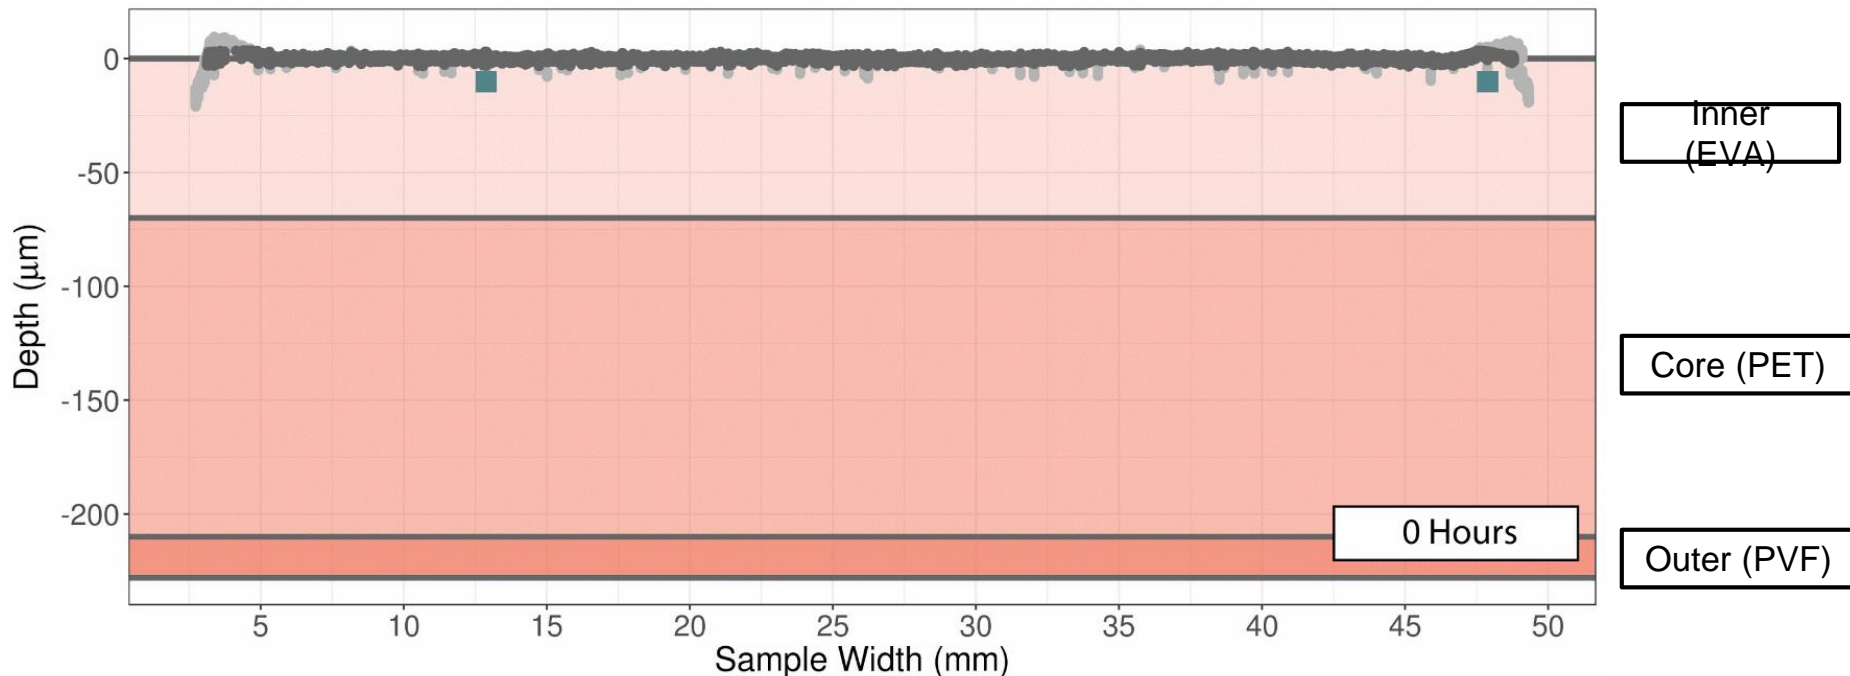
Crack Progression Over Time: Residual Plots (FPE1 Cyclic QUV)

- Density, depth, and number of cracks increases with exposure
- Can visualize propagation of cracks through backsheet layers
