NCST Technical Investigation of Hurricane Maria (Puerto Rico)

Performance of Critical Buildings Project

Objective: To characterize the performance of critical buildings in Hurricane Maria by evaluating damage and loss of function for representative hospitals, schools, and storm shelters with respect to the hazards they experienced, including an evaluation of selection criteria and design requirements for storm shelters.

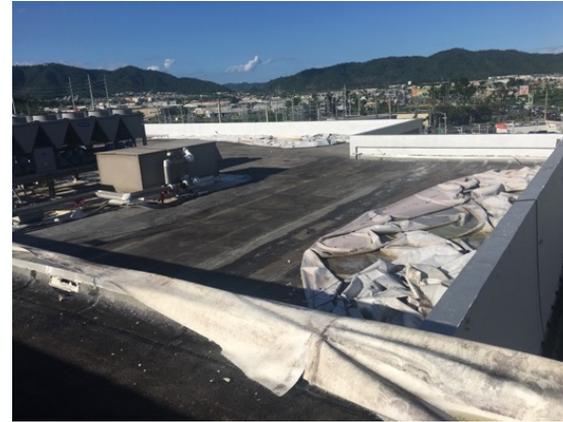
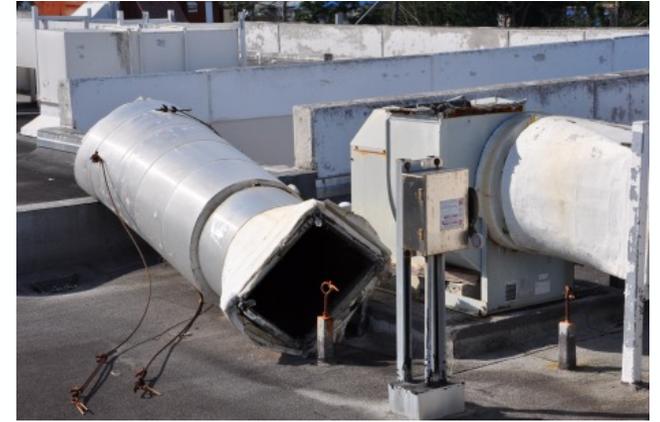
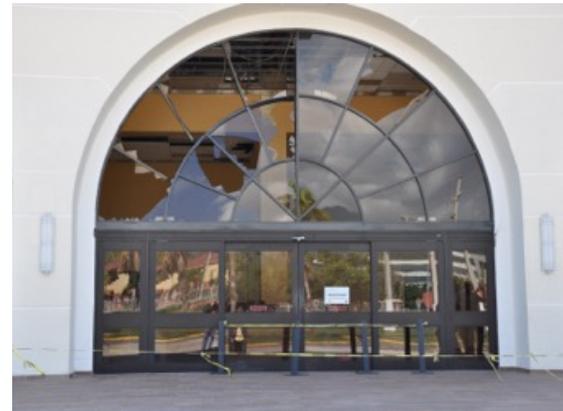
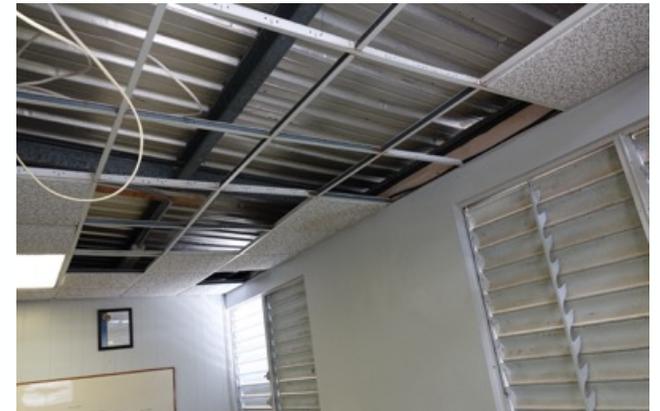
Many engineered buildings with good structural performance suffered extensive ***nonstructural damage*** and ***loss of function*** due to rainwater penetration of the building envelope, caused by:

- roof covering and rooftop equipment damage from wind and windborne debris;
- window and door damage caused by wind and windborne debris;
- rainfall ponding on the roof due to excessive rainfall rates and debris blocking drains; and
- wind-driven rain penetration through undamaged cladding, such as windows and doors.

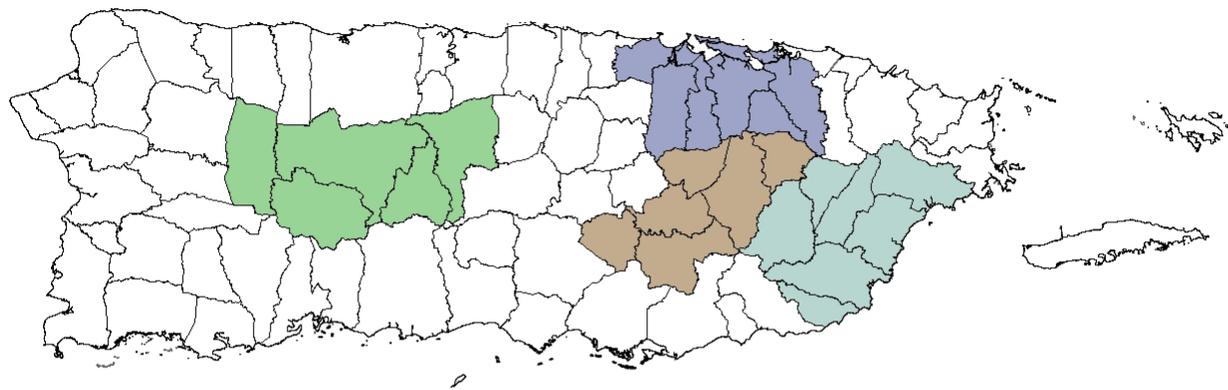
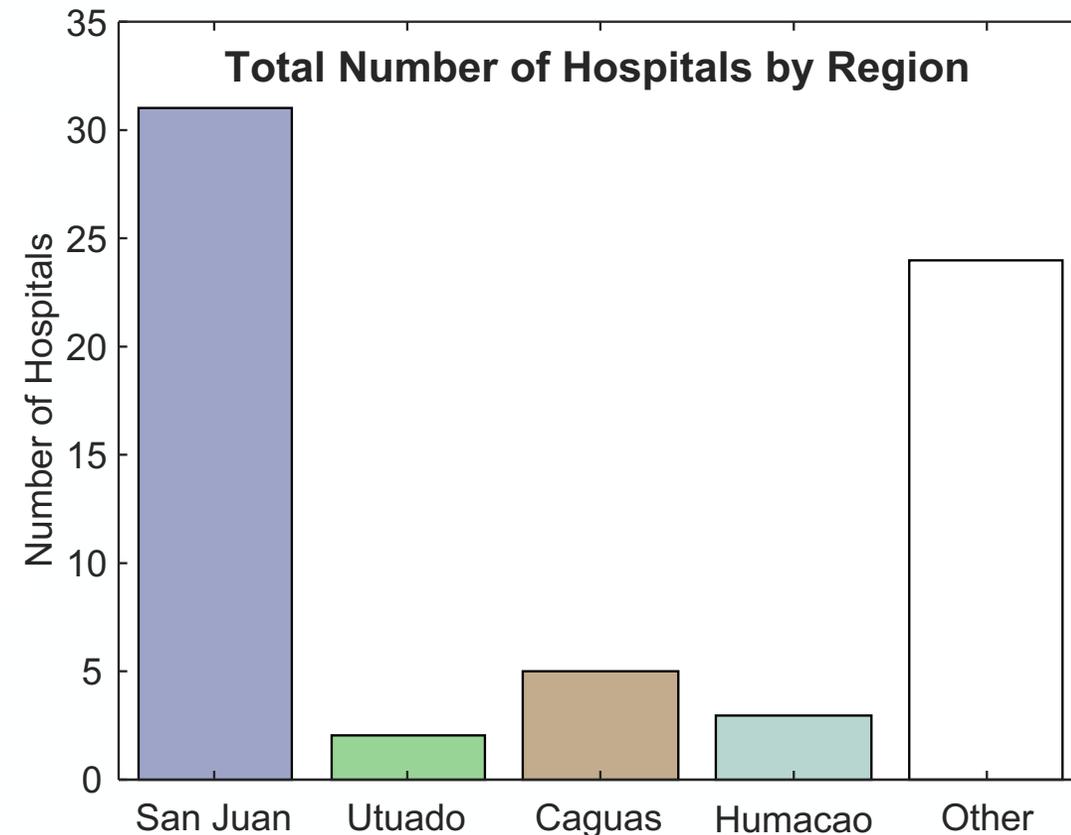
Sampling strategy developed to select hospitals for evaluation

- Each hospital assigned a score based on consideration of available data
- Scores used to rank the hospitals within each selected region
- At least one hospital from each selected region included in sample

- Selecting hospitals from each region provides variation in the hazard exposure:
 - Lowest wind speeds in Utuado region (topographic sheltering)
 - Highest wind speeds in San Juan region
- Highest topographic speedup factor for Hospital Bella Vista in Mayagüez

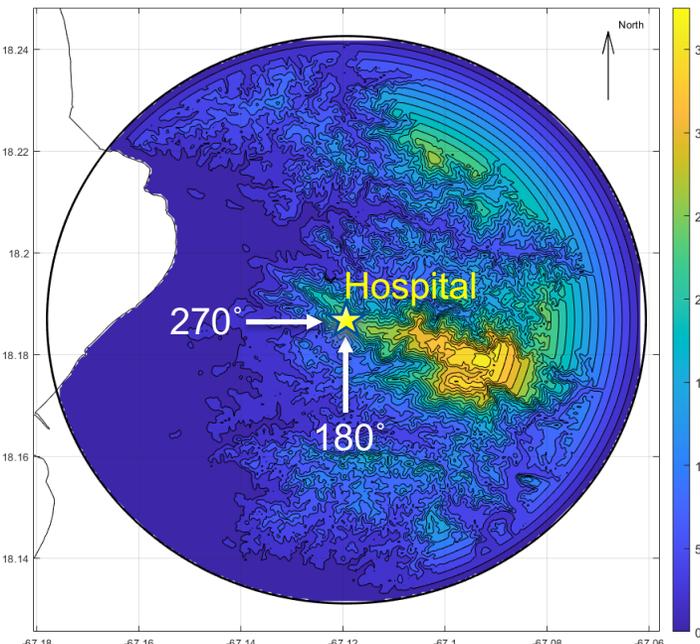
Topographic Model of Mayaguez

- Hospital Bella Vista planned as first facility for wind tunnel testing
- Plans developed to characterize topographic effects on incoming flow:
 - Topographic model of Mayaguez region to be tested at 1:3100 scale
 - Flow field at hospital site to be measured using Particle Image Velocimetry (PIV) for wind angles from 180° to 360° in 10° increments
- Design of model, measurement systems, and testing plan in progress
