# NCST Investigation of the Champlain Towers South Collapse

## 3D Visualization of Evidence

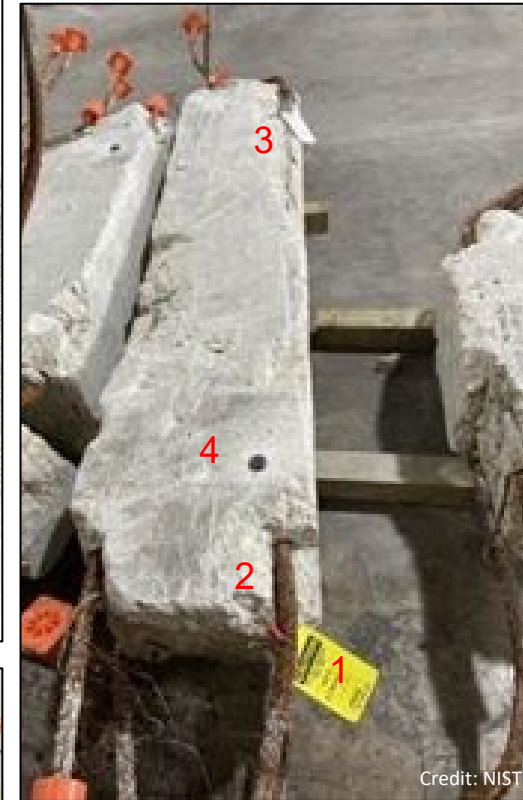
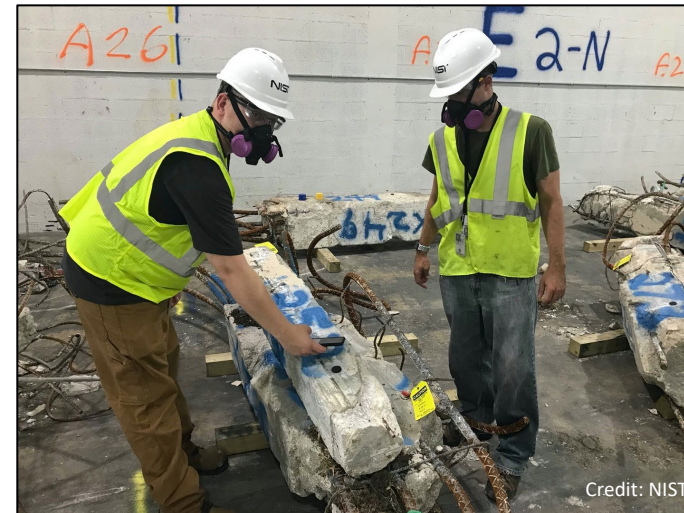
# Physical Evidence Tagging

Physical evidence specimens were tagged with (1) paper tags and (2) wire lock tags

Physical evidence specimens were next tagged with (3) detailed paper tags and (4) radio-frequency induction (RFID) tags

NIST physical evidence database entries for specimens are securely accessed by reading RFID tags with a NIST mobile device.

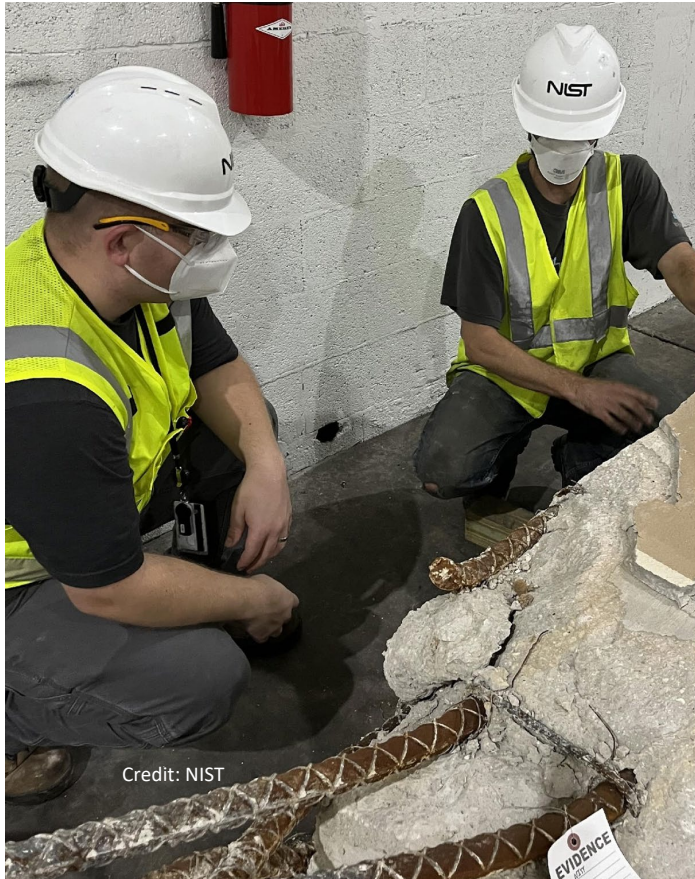
## Sample: 450 DEMO

# Identification Clues and Documentation

Probable location determined

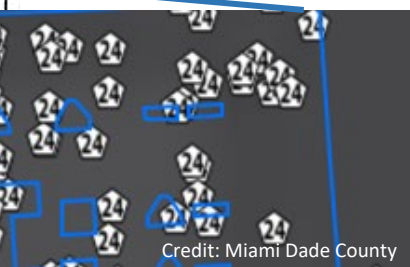
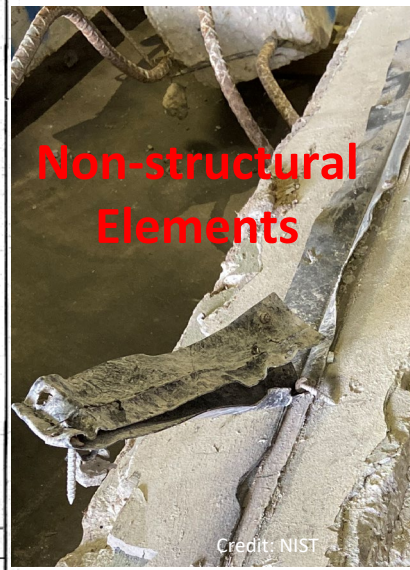
Drone photo, field photos, and LIDAR can help to increase confidence of one location versus another.
