# NCST Investigation of the Champlain Towers South Collapse

## Cross-Project Panel Theme 2: Analysis and Testing Updates

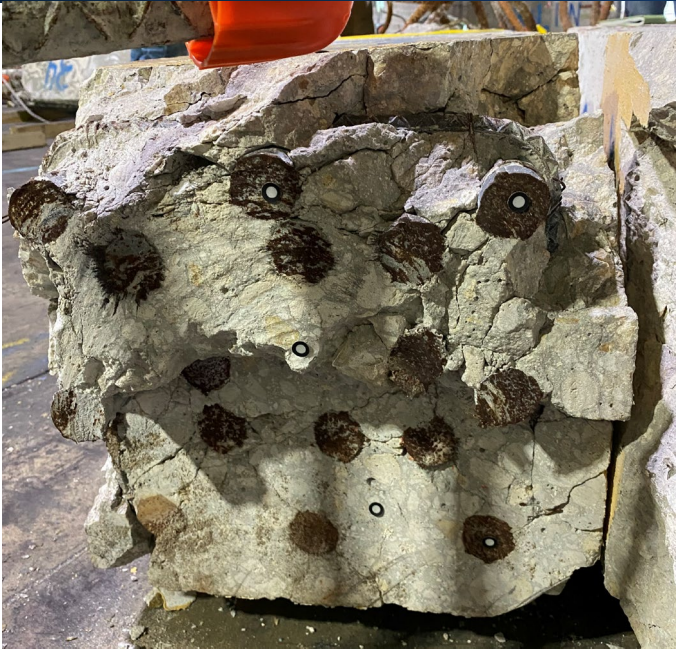
## Congestion:

**Inadequate cover:** over reinforcement in balcony slabs exposed to weather

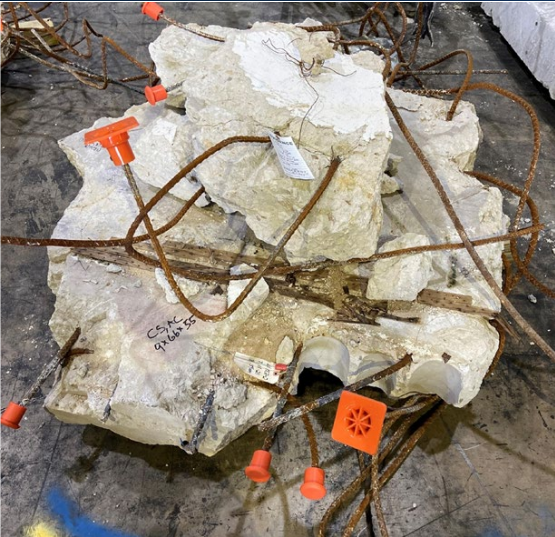
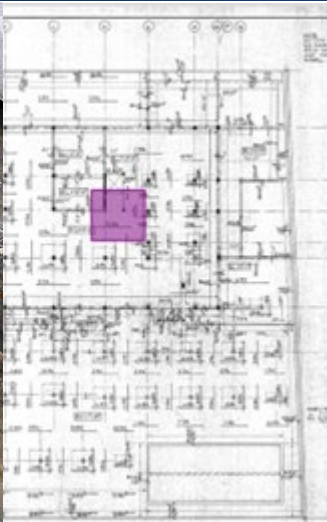
## Placement of top bars in column strips:

Example: measured 7 spaces between east-west top bars: average is 9.0 in; would be 5.75 in per drawings. Also have excessive cover on top bars

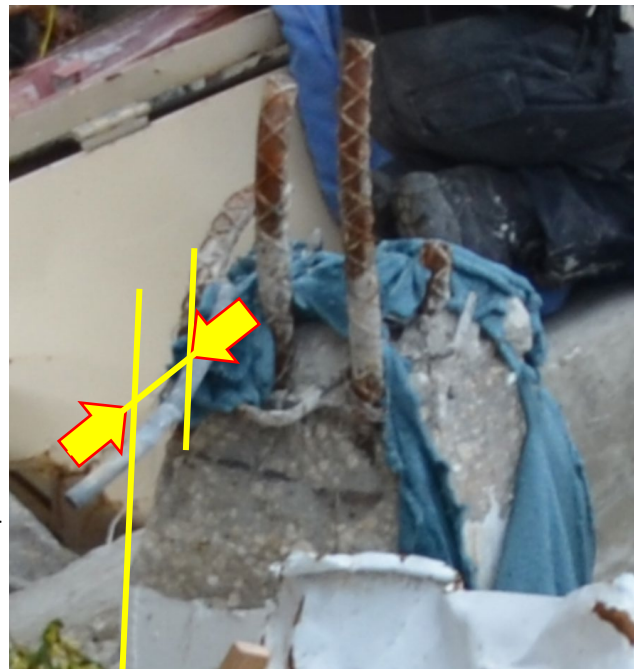
## Position of reinforcing cage within columns:

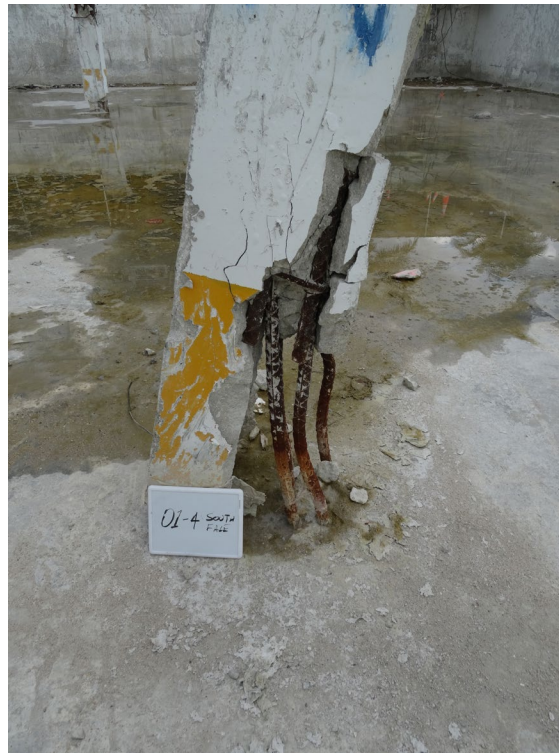
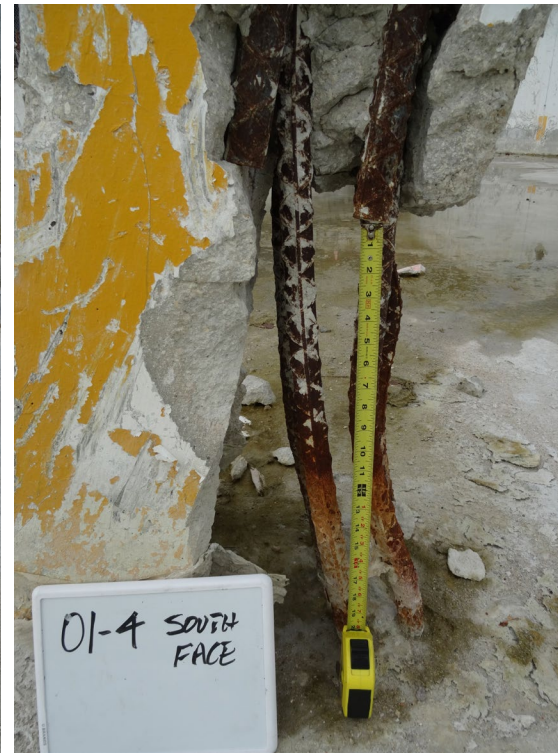
Several columns found with longitudinal bars where the lap splice is shorter than specified.

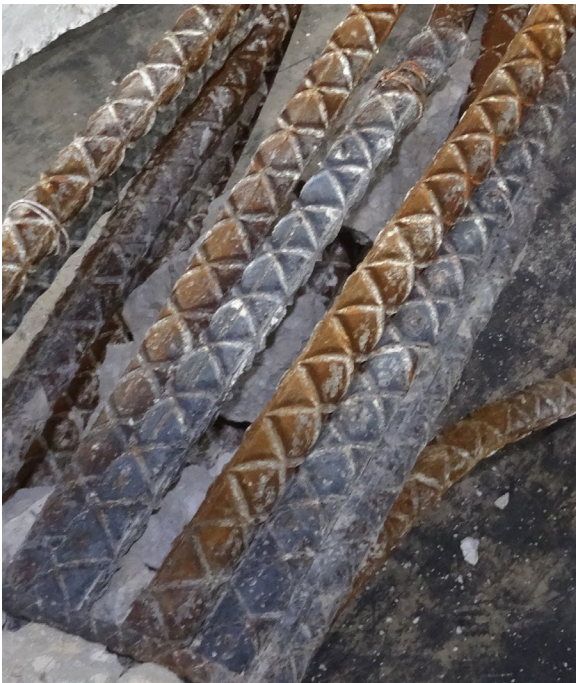
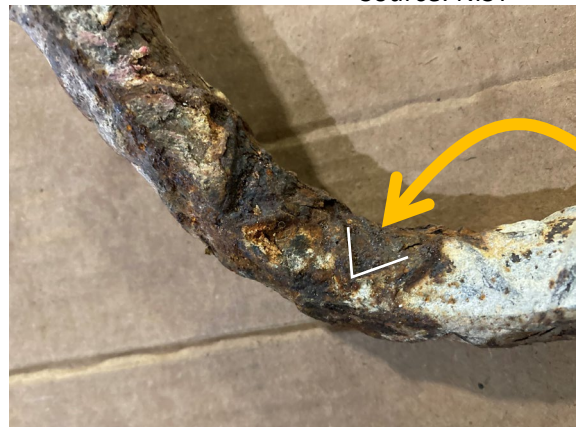
## Expansion of Corrosion Products

“Rust” volume occupies up to 6 times vol. of parent metal

- Bursting stresses can crack concrete
- Reduced area of steel

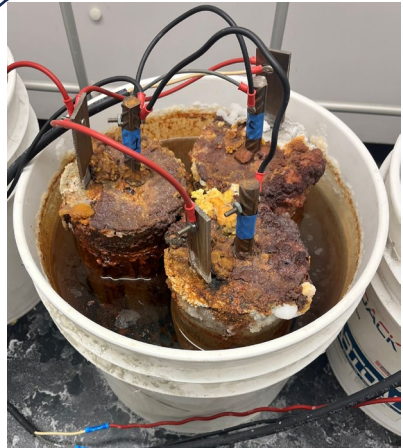
Accelerated corrosion:  
steel-in-concrete "Lollipops"

½-in diameter reinforcing bars  
in 4-in diameter cylinders

127 days, low current flow  
20-25 % mass-loss
