The Fallacy of Monitoring Surge Voltages: SPDs and PCs Galore!

Reprinted from Proceedings. PQA '99 Conference

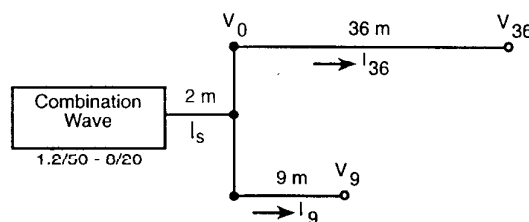
Figure 1 - Upside-Down House branch circuits

To illustrate the effect of nonlinear SPDs as well as linear capacitors connected across the mains, the Power Electronics Applications Center (PEAC) “Upside-Down House” [Key et al., 1994] was used to inject surges into the service entrance of the Upside Down House with various combinations of SPDs and/or personal computer (PC) power supplies connected at the end of two branch circuits, one 9-m long, the other 36-m long. In Figure 1, currents in the branches and voltages at the nodes are identified respectively as I_s , I_9 , I_{36} , and V_0 , V_9 , V_{36} . The charging voltage setting of the Combination Wave surge generator was kept constant to provide a 2 kV, 1.2/50 μ s open-circuit voltage (OCV). In a second series of experiments, the setting was increased to 4 kV. This second series, not reported here in detail because of limited space, confirmed the expected nonlinear response of varistors and the linear response for capacitors only.

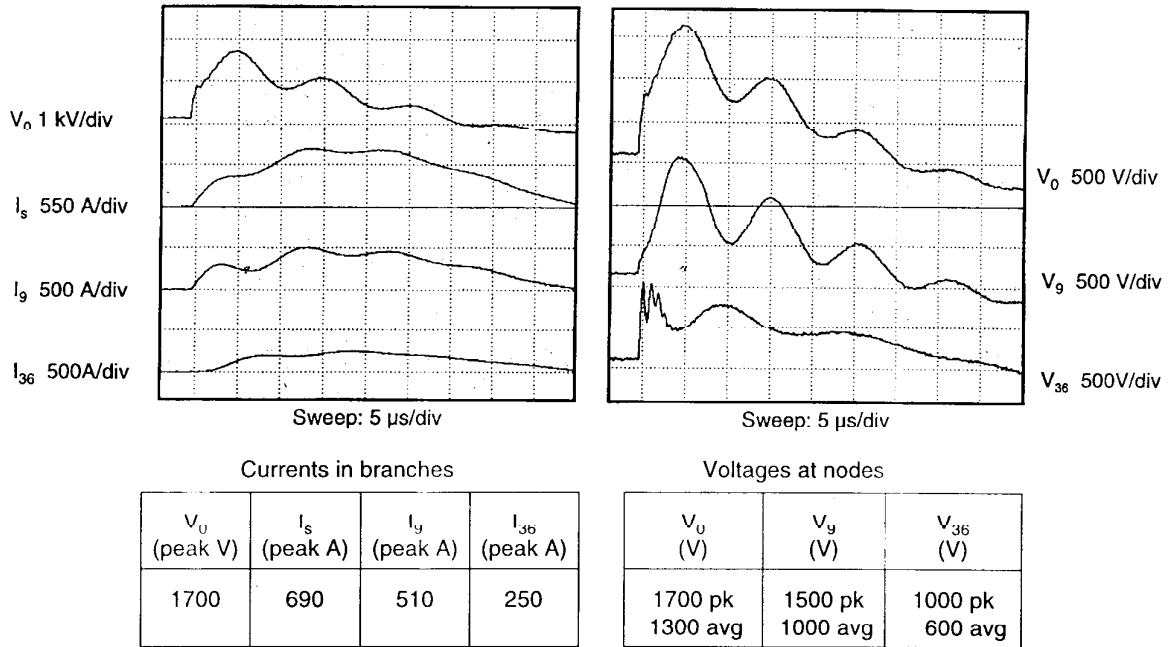
Figure 3 - Typical recordings made during the second experiment – Capacitors only

In Figure 3, the voltage at the service entrance, V_0 , is mitigated from the 2 kV open-circuit voltage supplied by the generator. However, because of the interaction between the RLC components in the wave-shaping network of the Combination Wave generator on the one hand, and the capacitances of the PC power supplies and inductances of the branch circuits on the other hand, this voltage rings around an average voltage level of 1300 V, reaching a peak of 1700 V. To reflect this situation, the tabulation of the voltages in the figure shows two lines, peak and average. Thus, the mitigation effect is degraded by the ringing. Nevertheless, one can expect that as more PCs would be added, the ringing frequency would become lower and the voltage peaks lower.

In a second set of experiments, less easily predictable would be the behavior of the still all-linear circuit involving the capacitors of a PC power supply (440 μF each in this experiment) when receiving a surge originating from the complex RLC wave-shaping network of a Combination Wave surge generator (Figure 3).

Experiments 2 and 3 (Figures 3 and 4) do show decreasing levels of voltage surges at various points of the Upside Down House, compared to the open-circuit conditions. However, the interactions between the capacitors of the generator RLC wave-shaping network on the one hand, and the PC capacitors on the other hand, make detailed interpretation of the waveforms tedious and beyond the scope of our illustrative examples. Numerical modeling with a current source, as reported in the following section, avoids this interaction and provides further evidence on the “PCs Galore” effect. For readers interested in the details, Table 1 documents the results concerning peak voltages noted from the oscillograms kept on file but not reproduced here. Readers interested primarily in the big picture may skip a close examination of this table.

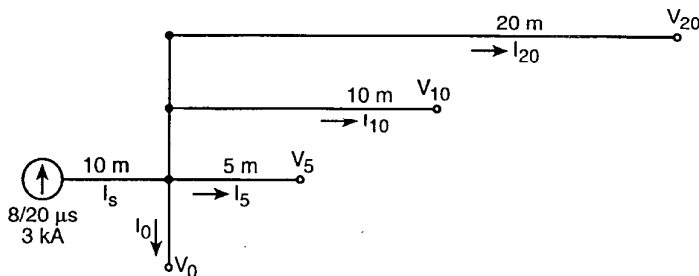
Figure 5 - Service drop and branch circuits for modeling combinations

In a series of modeling runs similar to the combinations of the experimental measurements, the model used the circuit of Figure 5. A current source feeds a fixed current surge via a common service drop to the panel bus of the service entrance, where three branch circuits made of 2-mm diameter conductors (#12 AWG) take off, with length of respectively 5 m, 10 m, and 20 m. The choice of these lengths was based on curiosity about the effect of the long distance connection (and thus an effect that might be delayed or degraded) to the immediate occurrence of an overvoltage at the end of shorter branch circuits. The currents in the circuit are identified in Figure 5 respectively as I_s , I_0 , I_5 , I_{10} , and I_{20} , with the node voltages at the service bus and branch circuit ends respectively as V_0 , V_5 , V_{10} , and V_{20} .

As in our previous modeling applications, the EMTP program [EPRI, 1989] was used. To avoid computational artifacts, a finite 10 kΩ resistance was always postulated at the ends of all branch circuits, whether these were left in “open” or “loaded” condition. The loads that were modeled included combinations of SPDs, capacitors, and 100 Ω resistors. The SPDs were all 20-mm diameter, 130-V rated MOVs. The capacitors included a capacitance of 440 μF and a series resistance (“ESR”) of 0.25 Ω to represent an electrolytic capacitor. Initial conditions for the models stipulated an initial charge on the capacitor to represent the normal condition of the DC link. The 100 Ω resistor was selected as a typical value for a 150-W power-consuming appliance connected at the end of the branch circuit.

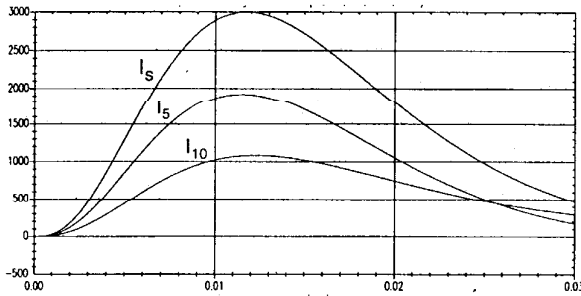
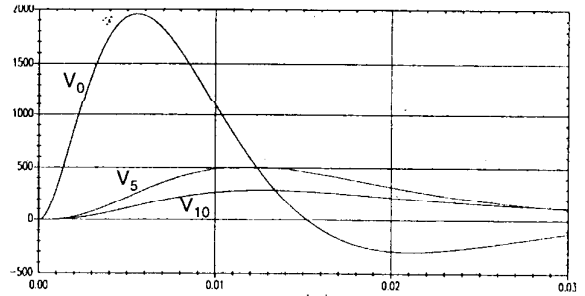
Figure 7 - Currents and voltages for the case of two PCs without SPDs

Figure 7 shows the example of two PCs, one at the end of the 5-m branch circuit, the other at the end of the 10-m branch circuit: the surge current is shared (unequally) between the two capacitors, with a corresponding decrease of the voltage level at each DC link, and also a reduction of the voltage at the open end (unprotected) of the 20-m branch circuit. This example shows the beginning of the “PCs Galore !” effect. Several intermediate and further steps were modeled by adding combinations of surge-mitigating devices to build our case file and confirm the expected effects, but we will spare the reader from a tedious recitation.

Currents in branches: Time in milliseconds, peaks in amperes

I_s	I_0	I_5	I_{10}	I_{20}
3000	0	1920	1080	0

Voltages at nodes: Time in milliseconds, peaks in volts

V_0	V_5	V_{10}	V_{20}
1960	507	290	1960

The voltage results are especially worth noting, in the context of what a power quality monitor would report in such an installation, depending upon its point of connection.

- From the (impossible) high voltages of the 100 Ω baseline (no SPDs), the voltage that would be recorded by a monitor installed at the service entrance is now reduced to “only” 1960 V.

- A **voltage-only monitor** installed at the point of use of the power (typical selection of point of installation in many surveys), namely the two receptacles at 5 m and 10 m feeding the PCs, would report respectively 510 V and 290 V, **creating the illusion (fallacy) that there is no significant surge activity** at these points.

- In reality a current surge I_5 of nearly 2000 A is carried by the PC rectifier into the capacitor, via a line fuse. Such a high current — **undetected by a voltage-only monitor** — could very well be fatal for the rectifier or the input fuse, or for the capacitor of the PC power port. Such failures were found in post-mortems of equipment recently performed at PEAC. That scenario is also what occurred in the experimental test of Section 3 for a 4 kV open-circuit voltage and capacitor-MOV combination (shown in next-to-last row of Table 1).
