APPENDIX K
SOLID WASTE HAZARDOUS WASTE, AND HAZARDOUS MATERIALS

Appendix K-1
Solid Waste, Hazardous Waste, and Hazardous Materials Methodology

AKRF, Inc. (AKRF) is pleased to submit this Phase I Environmental Site Assessment Report for the above-referenced Subject Property. This report includes the findings of a reconnaissance of the Subject Property, and an evaluation of readily available historical information and selected environmental databases and electronic records. The report meets the requirements of ASTM Standard E1527-21, unless noted otherwise in Section 8.0, "Limitations and Data Gaps."

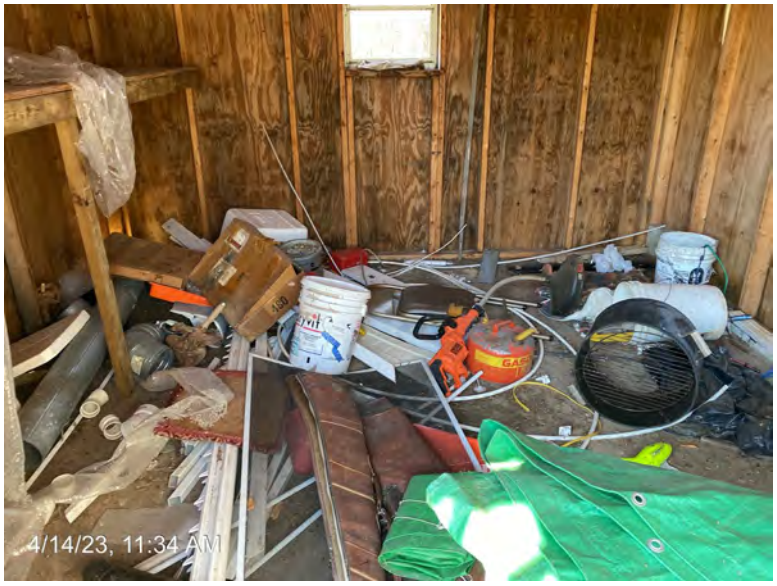
Photograph 22: Various household items and debris inside garage. View facing west.

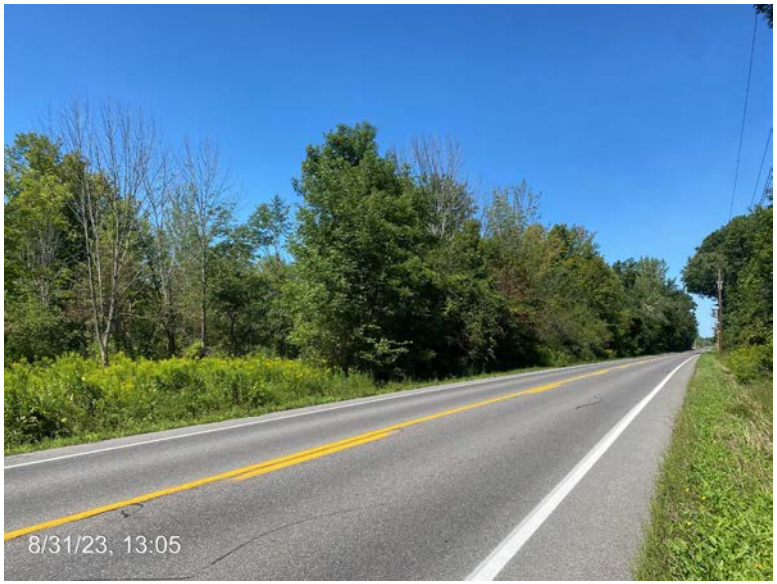
Photograph 1: Caughdenoy Road, proposed utility infrastructure site. View facing southwest.

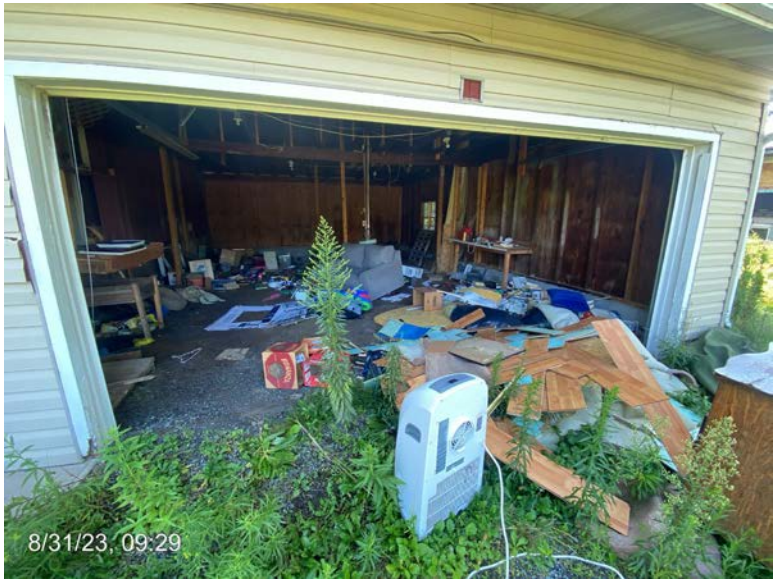
Photograph 10: 8450 Burnet Road. Habitat for humanity deconstruction in progress. View facing east.
