**NISTIR 7661**

# **Final Report on the Collapse of the Dallas Cowboys Indoor Practice Facility, May 2, 2009**

John L. Gross  
Joseph A. Main  
Long T. Phan  
Fahim H. Sadek  
Stephen A. Cauffman  
*Building and Fire Research Laboratory  
National Institute of Standards and Technology*

January 2010

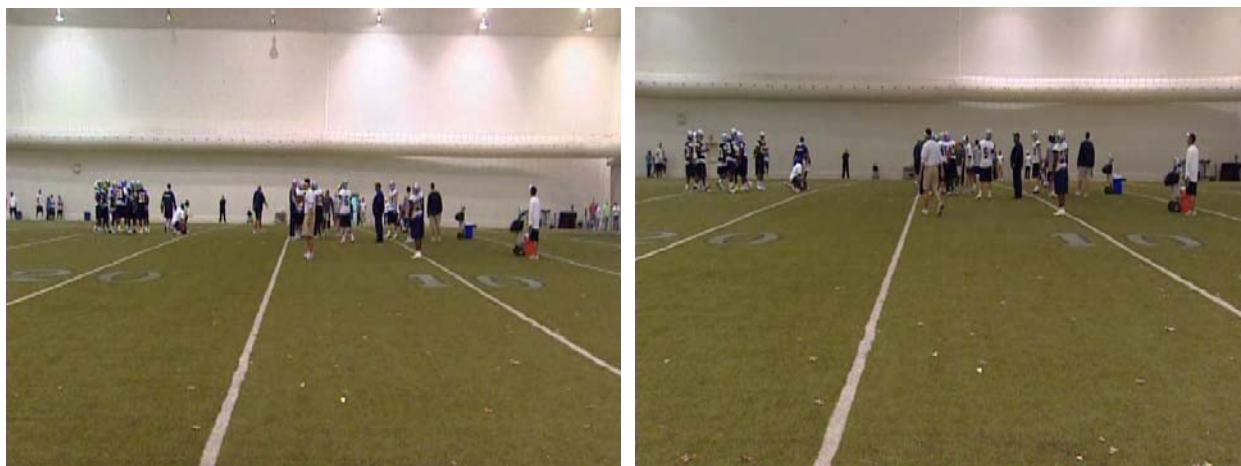
- Inner fabric liner appeared to move noticeably, as evidenced by the change in the shadows shown in Figure 3–1. The term “breathe” was used by the eyewitness (see Section 3.2).
- Lighting suspended from the steel frames swayed violently, as shown in Figure 3–2.
- A roll-up door on the south end came off its track and flapped in and out (see Figure 3–3).
- The south end wall appeared to sway toward the east and a personnel door came open.

**Figure 3–1 Two frames from the video showing motion of inner fabric liner  
(Video credit: WFAA-TV – used with permission)**

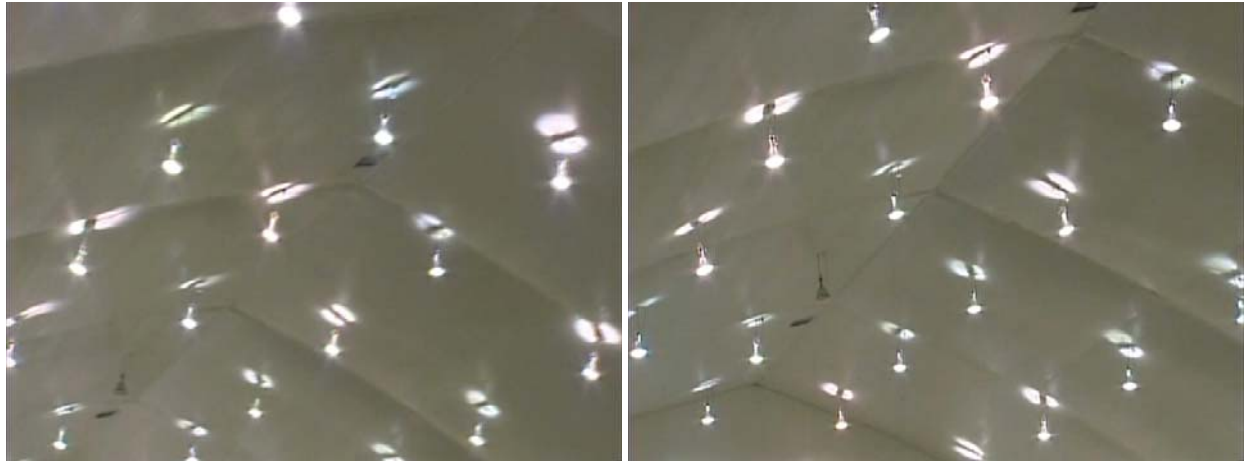
**Figure 3–2 Two frames from the video showing swaying of the lights**  
(Video credit: WFAA-TV – used with permission)

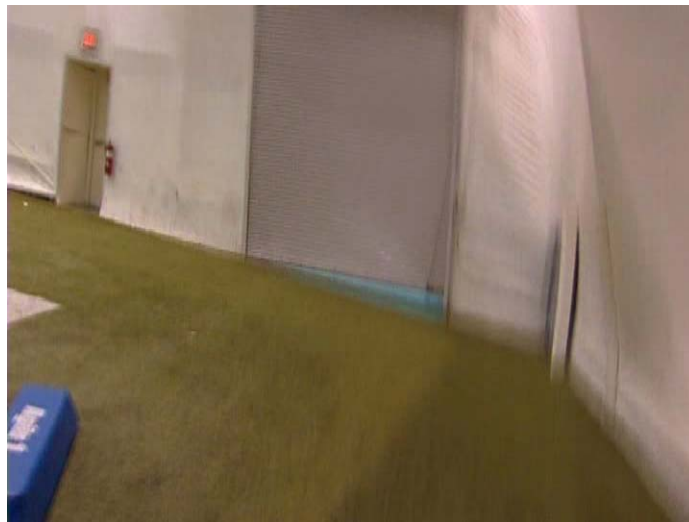
**Figure 3–3 Frame from the video showing opening of roll-up door**  
(Video credit: WFAA-TV – used with permission)

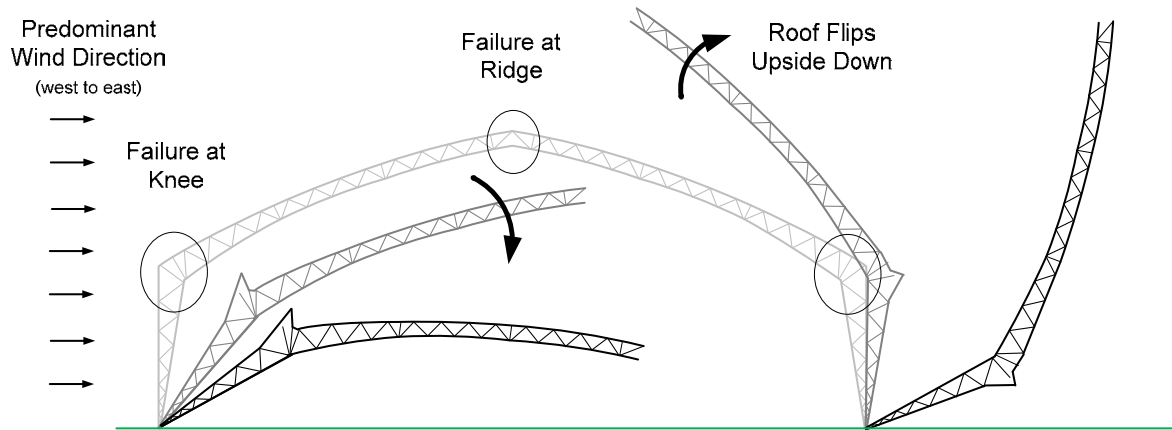
- Failure at the keystone and failure at the west knee allowed the west knee to straighten as the west leg rotated about its base toward the east.
- The west half of the roof collapsed downward, landing on the field.
- Failure at the keystone and failure at the east knee allowed the east knee to straighten as the east half of the structure rotated about its base toward the east.
- The east half of the roof rotated up and the east wall collapsed to the east, with the east half of the roof landing upside down.

**Figure 3–5 Pattern of overall collapse of the southern portion of the structure**

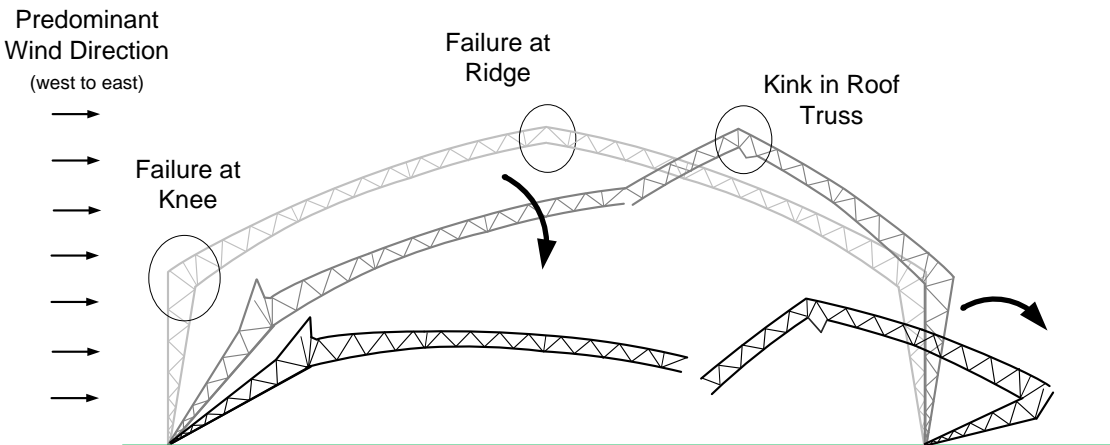
- Failure at the keystone and failure at the west knee allowed the west knee to straighten as the west leg rotated about its base toward the east.
- The west half of the roof collapsed downward landing on the field.
- The east half of the roof failed by buckling of the roof chords and, with failure at the knees, the east wall collapsed to the east as the east half of the roof collapsed downward onto the field.

**Figure 3–6 Pattern of overall collapse of the northern portion of the structure**

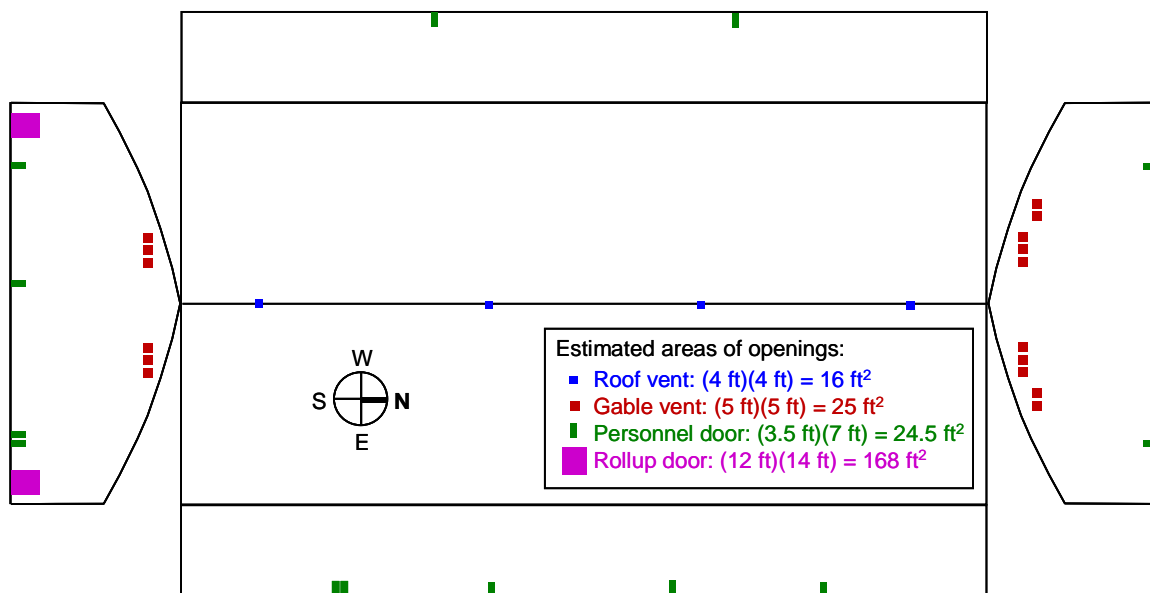
internal pressure build-up. As such, the structure is considered as enclosed for the purpose of internal pressure calculations.” However, in reality, there is no guarantee that this condition could be maintained. In addition, this structure is flexible and under design wind loading conditions, the structure deforms significantly (see Table 5–3), resulting in substantial distortions to the door framings that can cause the doors to fail to remain closed or latched during a wind storm (see Figure 3–3). Moreover, as is discussed in Section 4.2.2, a variety of circumstances could cause the fabric to tear, which could result in higher internal pressures during wind storms than those obtained if the fabric covering remained intact.

**Figure 4–1 Openings in the building envelope**

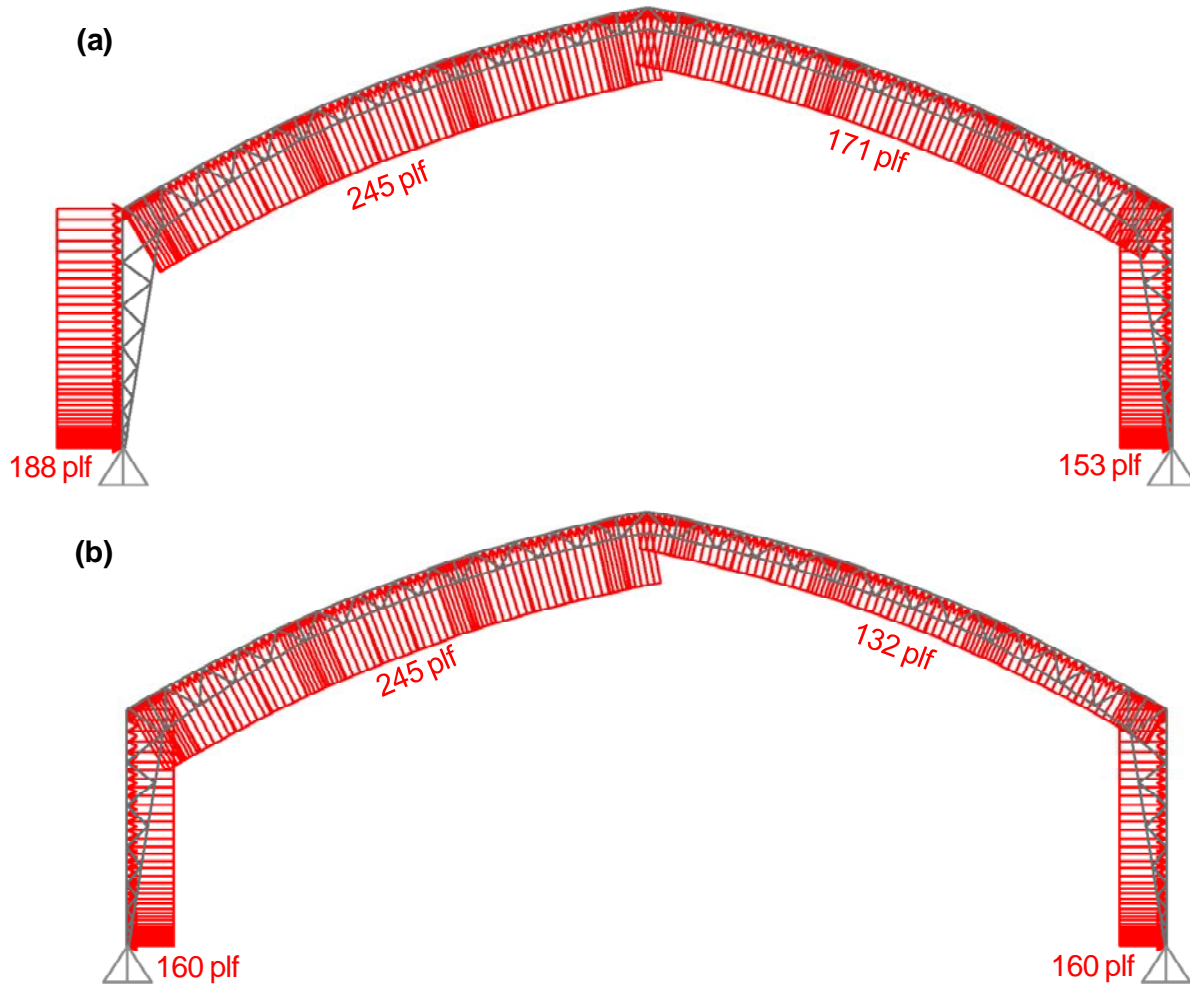
Figure 4–5 shows the external wind loads that were used in the original 2003 design. Wind loads corresponding to Case A and Case B (for definition, see Table 6-4 of ASCE 7-98) are shown for a single frame of the structure. Comparing the wind load values in Figure 4–5 with those in Figure 4–2 and Figure 4–3, one observes that there are significant differences between the external wind loads from the original 2003 design and those based on the ASCE 7-98 Standard as outlined in Section 4.1.1. In addition, as noted above, internal pressures were not included in the original design calculations.

**Figure 4–5 External wind loads from the original 2003 design: (a) Case A; (b) Case B**

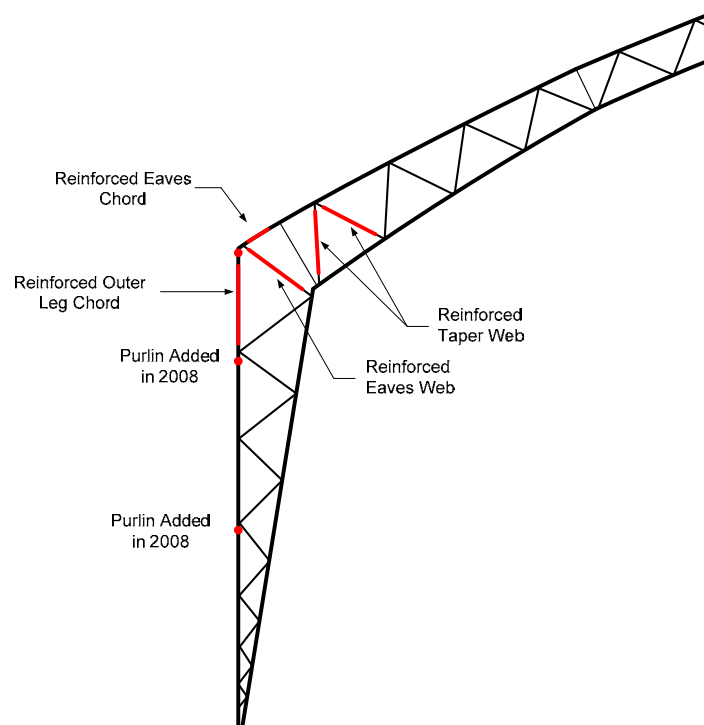
**Figure 4–10 Reinforcement added in 2008**

The structural frames supporting the fabric cover were designed and constructed in 2003. In 2008, the frames were reinforced by adding structural angles to selected chord members, rectangular structural tubes to the web members at the knees, and square structural tubes to two webs in the taper section. Figure 4–10 shows the locations of the reinforcement. All three reinforcing schemes can be seen in the photograph of one of the collapsed knees shown in Figure 4–11. Note that in many cases, the reinforcing detached from the original member during the collapse of the facility due to the failure of the screws used to attach the reinforcing.

1. The angles and both square and rectangular tubes were attached to the original members using self-tapping metal screws. The ability of such screws to fully mobilize the added member is not certain.
2. The added sections did not extend the entire length of the member to which they were attached. Thus, the critical section for tension yielding, tension rupture, flexural failure, shear failure, or compressive yielding was the original section; the only effect of the reinforcement would be to increase the buckling capacity.
3. The addition of reinforcement shifted the centroid of the composite section and therefore the reinforced sections were no longer concentrically loaded. This eccentricity would tend to reduce the effectiveness of the reinforcement.

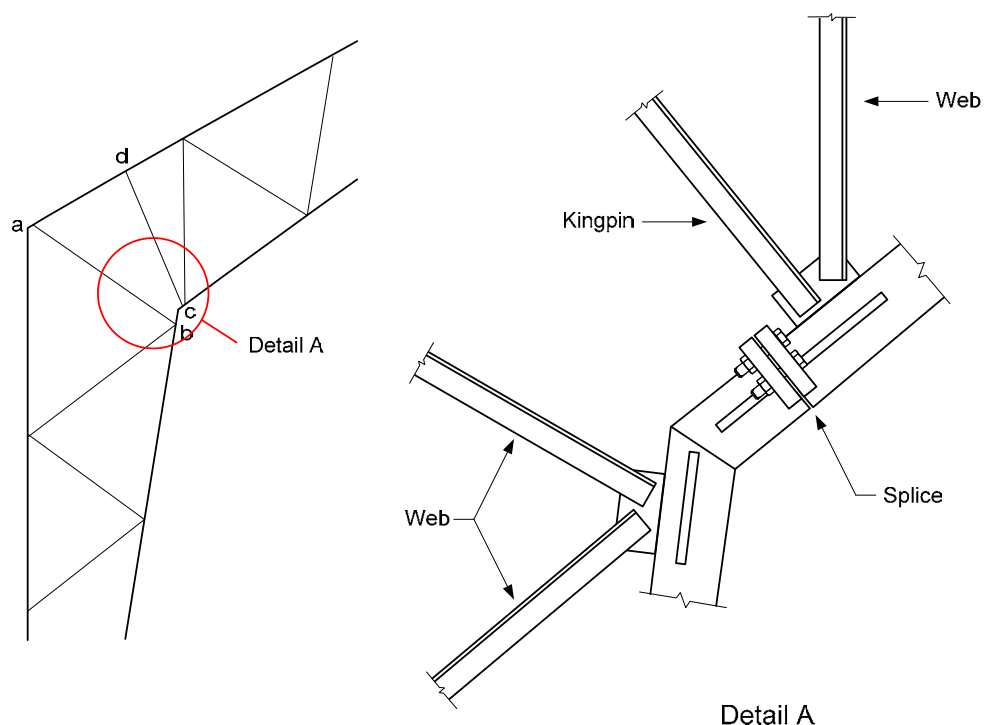
**Figure 4–12 Schematic of inner knee**

At the knees, however, the centroidal axes of the load-carrying members did not intersect at a common point. Indeed, as seen in Figure 4–12, the panel defined by points **a**, **b**, **c**, and **d** did not contain a web member. The result of this design detail is that large bending moments and shears are produced in the chord members in this region (see Chapter 5). According to the design documents, these bending moments and shear forces were not considered in the original 2003 design or the 2008 upgrade. In Chapter 5, DCRs are presented for (1) moment-axial interaction, (2) axial force only, and (3) shear forces only (Section 5.2).

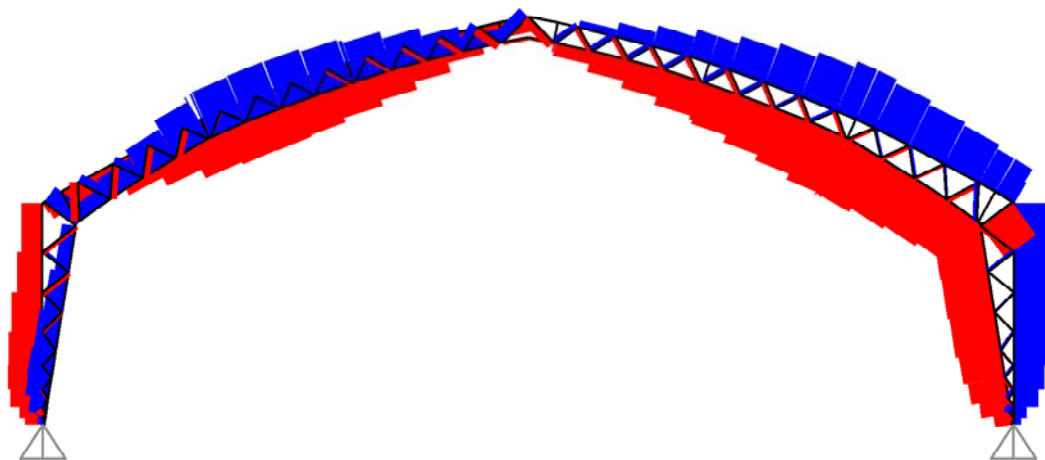
**Figure 5–4 Axial forces under load combination  $1.2 D + 1.6 W_4$**   
(Red: compression; blue: tension; wind from left)

The most critical wind load case, i.e., that which produced the largest DCRs in the frame, was found to be case  $W_4$  above, with wind normal to the ridge, positive pressure on the windward roof, and negative internal pressure. The most critical load combination for this case was combination  $C_2$ . Sample analysis results from this critical load combination ( $1.2 D + 1.6 W_4$ ) are presented in Figure 5–4 through Figure 5–7. Axial forces are shown in Figure 5–4, bending moments are shown in Figure 5–5, shear forces are shown in Figure 5–6, and deflections are shown in Figure 5–7. The wind direction is from the left in these figures. Figure 5–4 shows large compressive axial forces in the inner chord on the leeward side of

the frame, particularly near the knee and near the splice between the taper section and the straight section of the roof truss. Figure 5–5 and Figure 5–6 show large bending moments and shear forces in the inner and outer chords near the connection eccentricities at the knee, particularly on the leeward side.

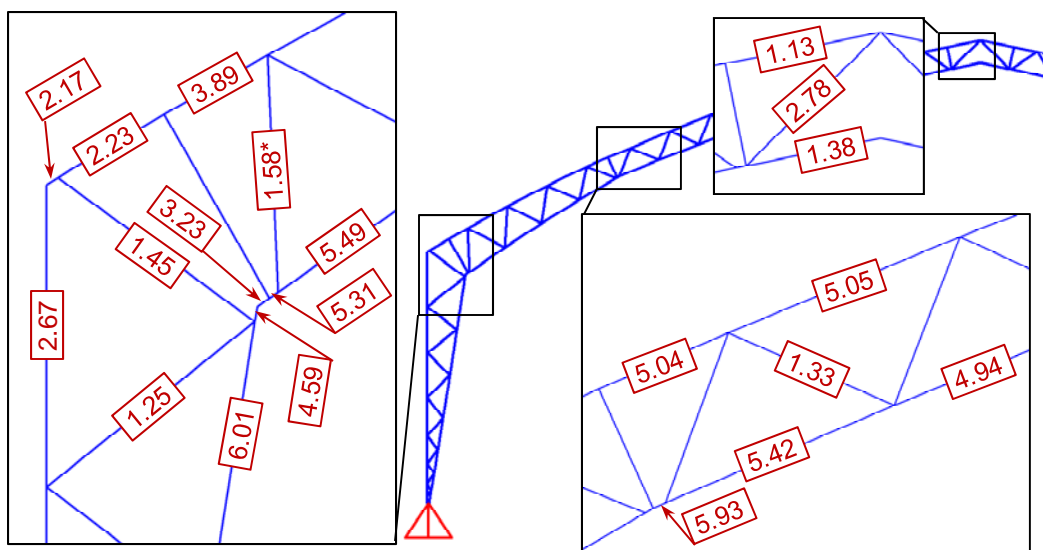
**Figure 5-8 Demand-capacity ratios for moment-axial interaction ( $DCR_{P/M}$ ) under design wind load combinations  $C_1$  and  $C_2$  (Member Capacity Set B)**

Figure 5–8 shows values of  $DCR_{P/M}$  as large as 6.01, while Figure 5–9 shows values of  $DCR_P$  as large as 5.44, and Figure 5–10 shows two members with values of  $DCR_V$  exceeding 3.0. The difference between the  $DCR_{P/M}$  values in Figure 5–8 and the  $DCR_P$  values in Figure 5–9 is attributable to bending moments produced primarily by connection eccentricities. The ratio of  $DCR_{P/M}$  to  $DCR_P$  ranges from 1.02 to 2.43 for the various chord members shown, indicating that consideration of bending moments due to connection eccentricities can lead to increases up of to 143 % in DCRs. The large values of  $DCR_V$  in Figure 5–10 are also due to connection eccentricities, which require large shear forces to be carried directly through the inner and outer chord tubes at the knees. Although connection eccentricities were included in the structural analysis model used in the original 2003 design (Summit Structures 2003a), the design calculations indicate that the bending moments and shear forces resulting from these connection eccentricities were not considered in the design of the chord members.

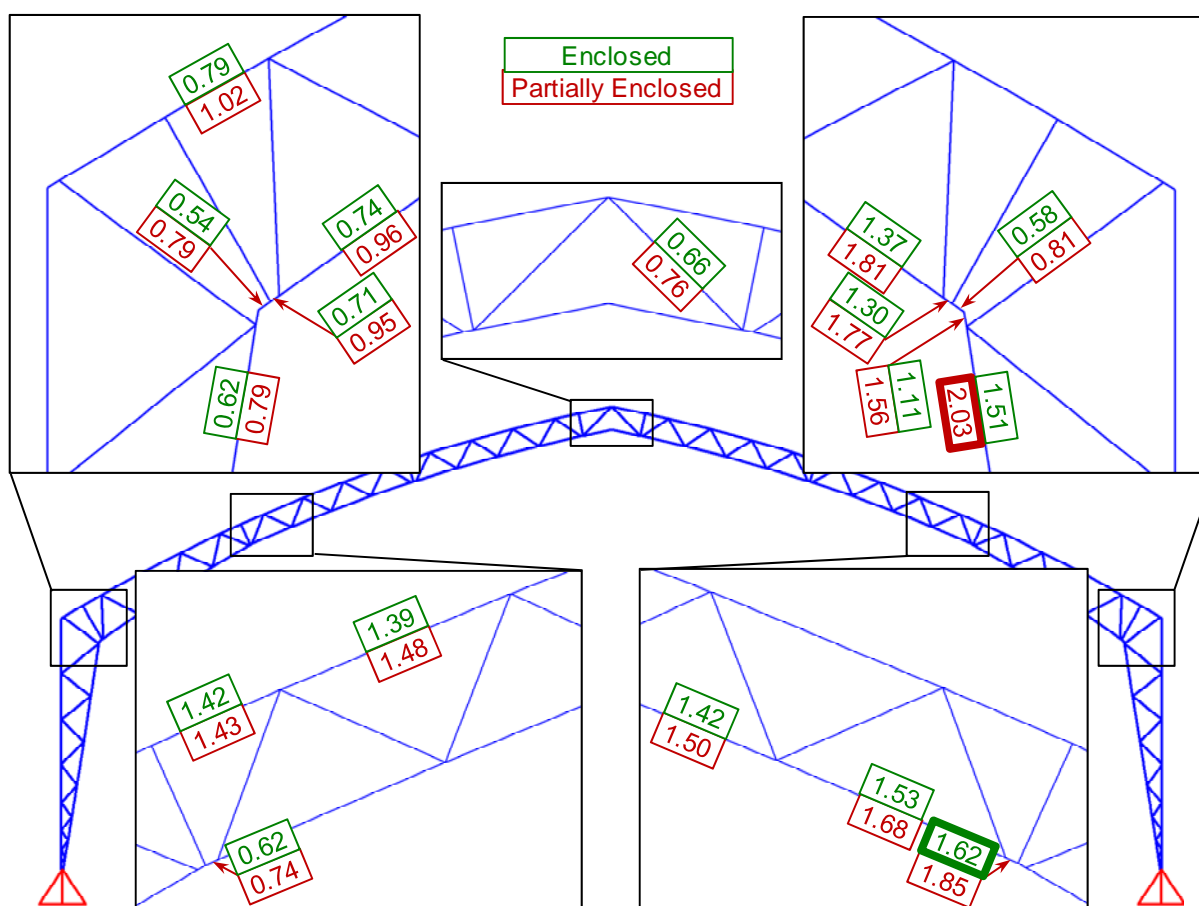
**Figure 5–11 Unfactored  $DCR_{P/M}$  values for 60 mph wind normal to ridge (wind from left)**

The largest values of  $DCR_{P/M}$  are observed in the leg inner chord on the leeward side, with values as large as 1.62 for the enclosed condition and as large as 2.03 for the partially enclosed condition. For the enclosed condition, the largest value of  $DCR_{P/M} = 1.62$  is observed in the straight inner chord 1 (see Figure 1–4) on the leeward side, and values as large as 1.51 are also observed in the inner chord at the leeward knee. For the partially enclosed condition, the largest value of  $DCR_{P/M} = 2.03$  is observed in the inner chord at the leeward knee, and values as large as 1.85 are also observed in the straight inner chord 1 on the leeward side. Values of  $DCR_{P/M}$  exceeding unity are observed in a number of other locations, including the straight outer chord 1 (see Figure 1–4) on the windward side and the windward knee region (only for the partially enclosed condition). These DCR values exceeding unity indicate that some members were not capable of resisting wind loads corresponding to an estimated wind speed of 60 mph normal to the ridge. The failures observed in the field (discussed in Chapter 3) are consistent with the locations in which large DCR values are observed in Figure 5–11 and Figure 5–12.
