# Technical Study of the Sofa Super Store Fire - South Carolina, June 18, 2007

# **Technical Study of the Sofa Super Store Fire - South Carolina, June 18, 2007**

*Fire Research Division  
Engineering Laboratory  
National Institute of Standards and Technology*

October 2010

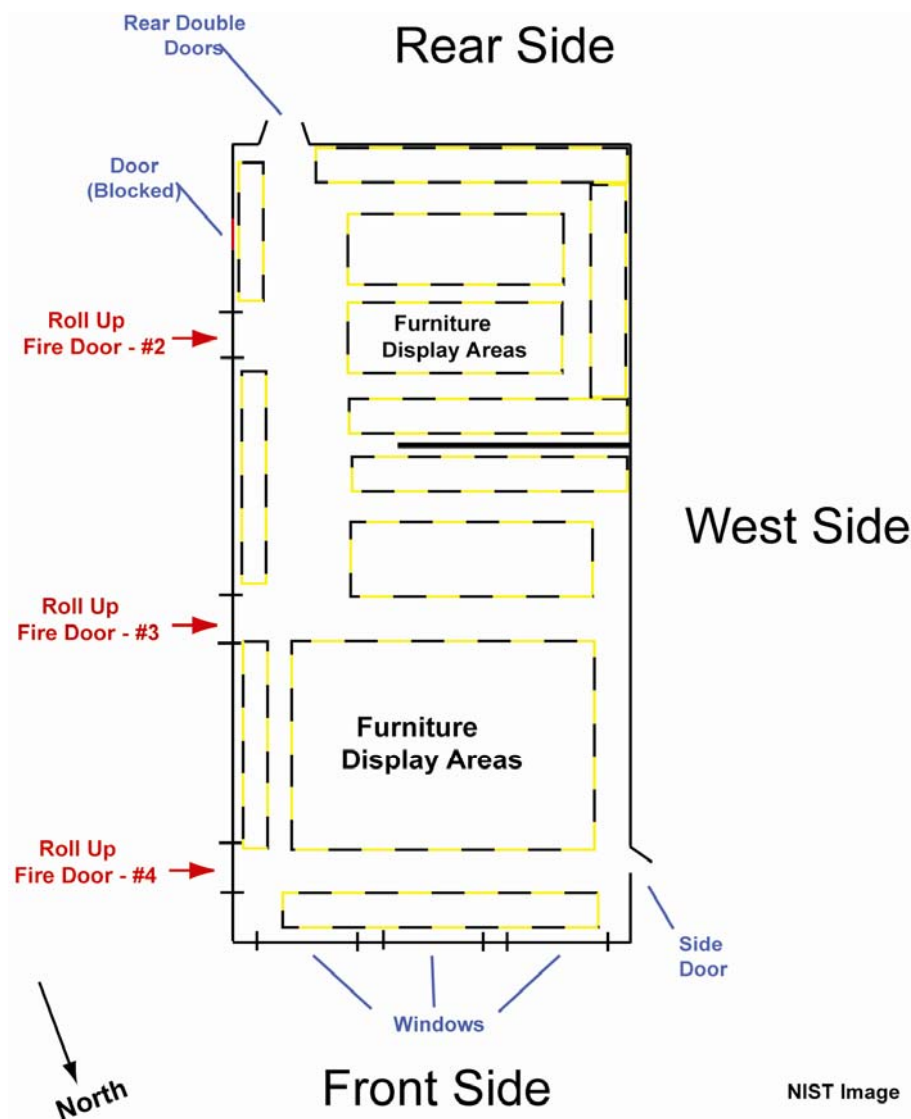
**Figure 1-10. Floor space utilization plan for the west showroom.**

O-22, and O-29). Based on post-fire residue, the single door which would have opened into the closet within the holding area appeared to be blocked with supplies in the storage closet. According to employees, these fire doors between the west and main showrooms were used to reposition furniture and to move furniture from the warehouse into the retail areas. The space utilization was based on post-fire evidence and observations during visits to other stores that were part of the Sofa Super Store chain.

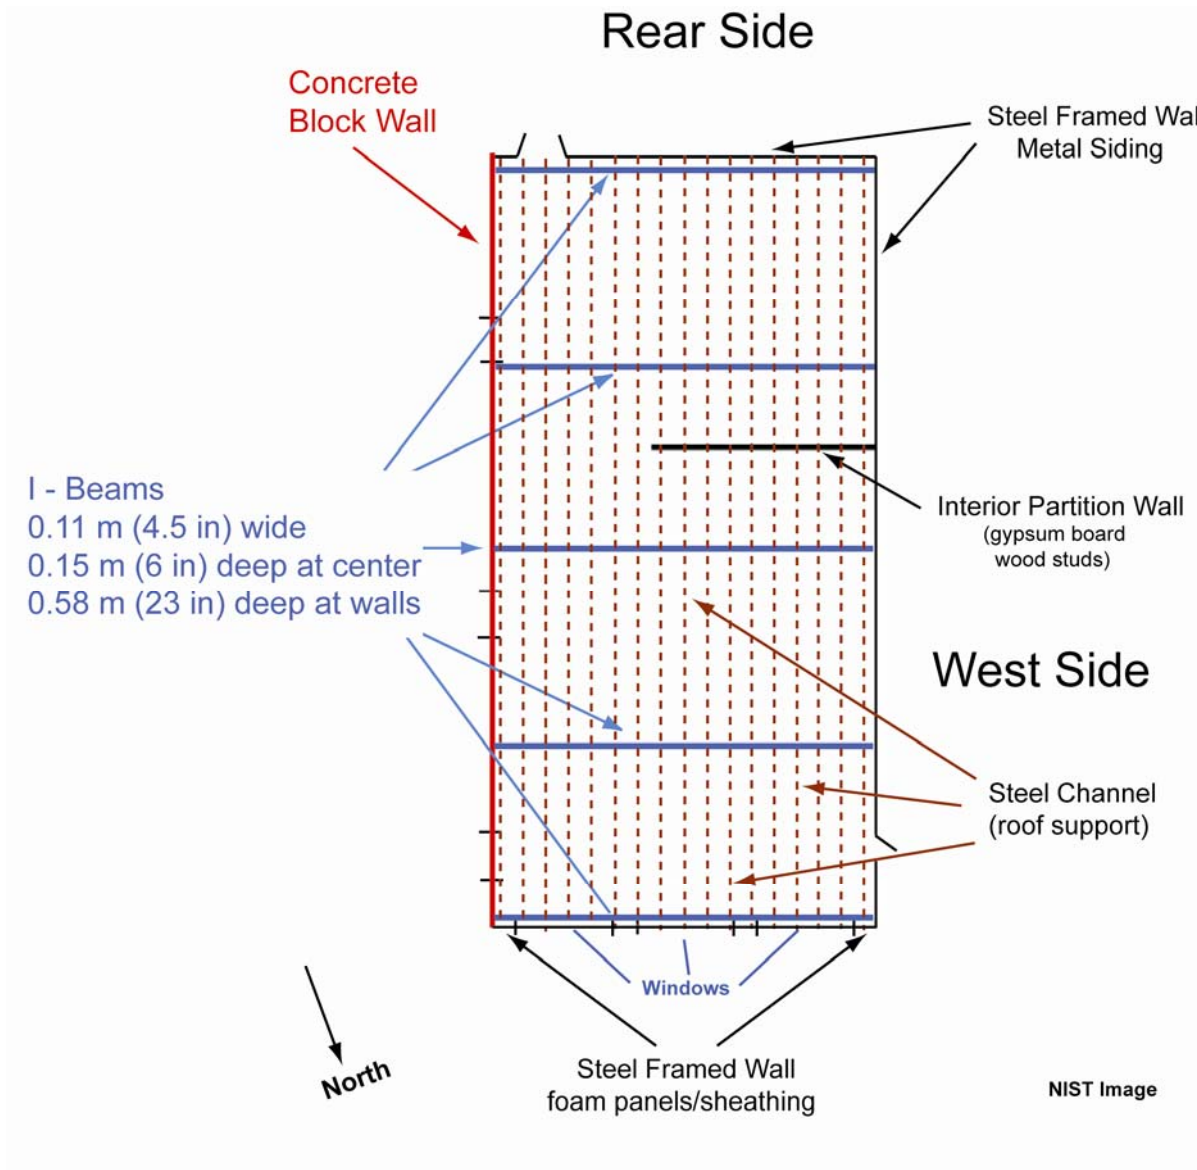
**Figure 1-11. Wall and I-beam configuration for the west showroom.**

Over the west showroom, a sheet metal roof was supported by “Z” shaped steel channel which ran roughly north to south or perpendicular to the front wall (see Figures 1-11, E-16, and E-17). To support the steel channel, the west showroom incorporated steel I-beam columns (see Figure E-18), that supported horizontal beams that were 0.15 m (6 in) deep at center of span and 0.58 m (23 in) deep at the east and west walls. Along the east wall adjacent to the main showroom, the top of the horizontal I-beams were 4.32 m (14.2 ft) above the “Z” shaped steel channel. The roof sloped down toward the west wall where the top of the horizontal beam was 3.56 m (11.7 ft) above the concrete slab. Sections of “Z” channel were also installed horizontally between the vertical I-beams (east and west walls) and vertical columns (south and north walls). The exterior south and west walls were corrugated metal siding that was attached to horizontal “Z” channel between the vertical members.

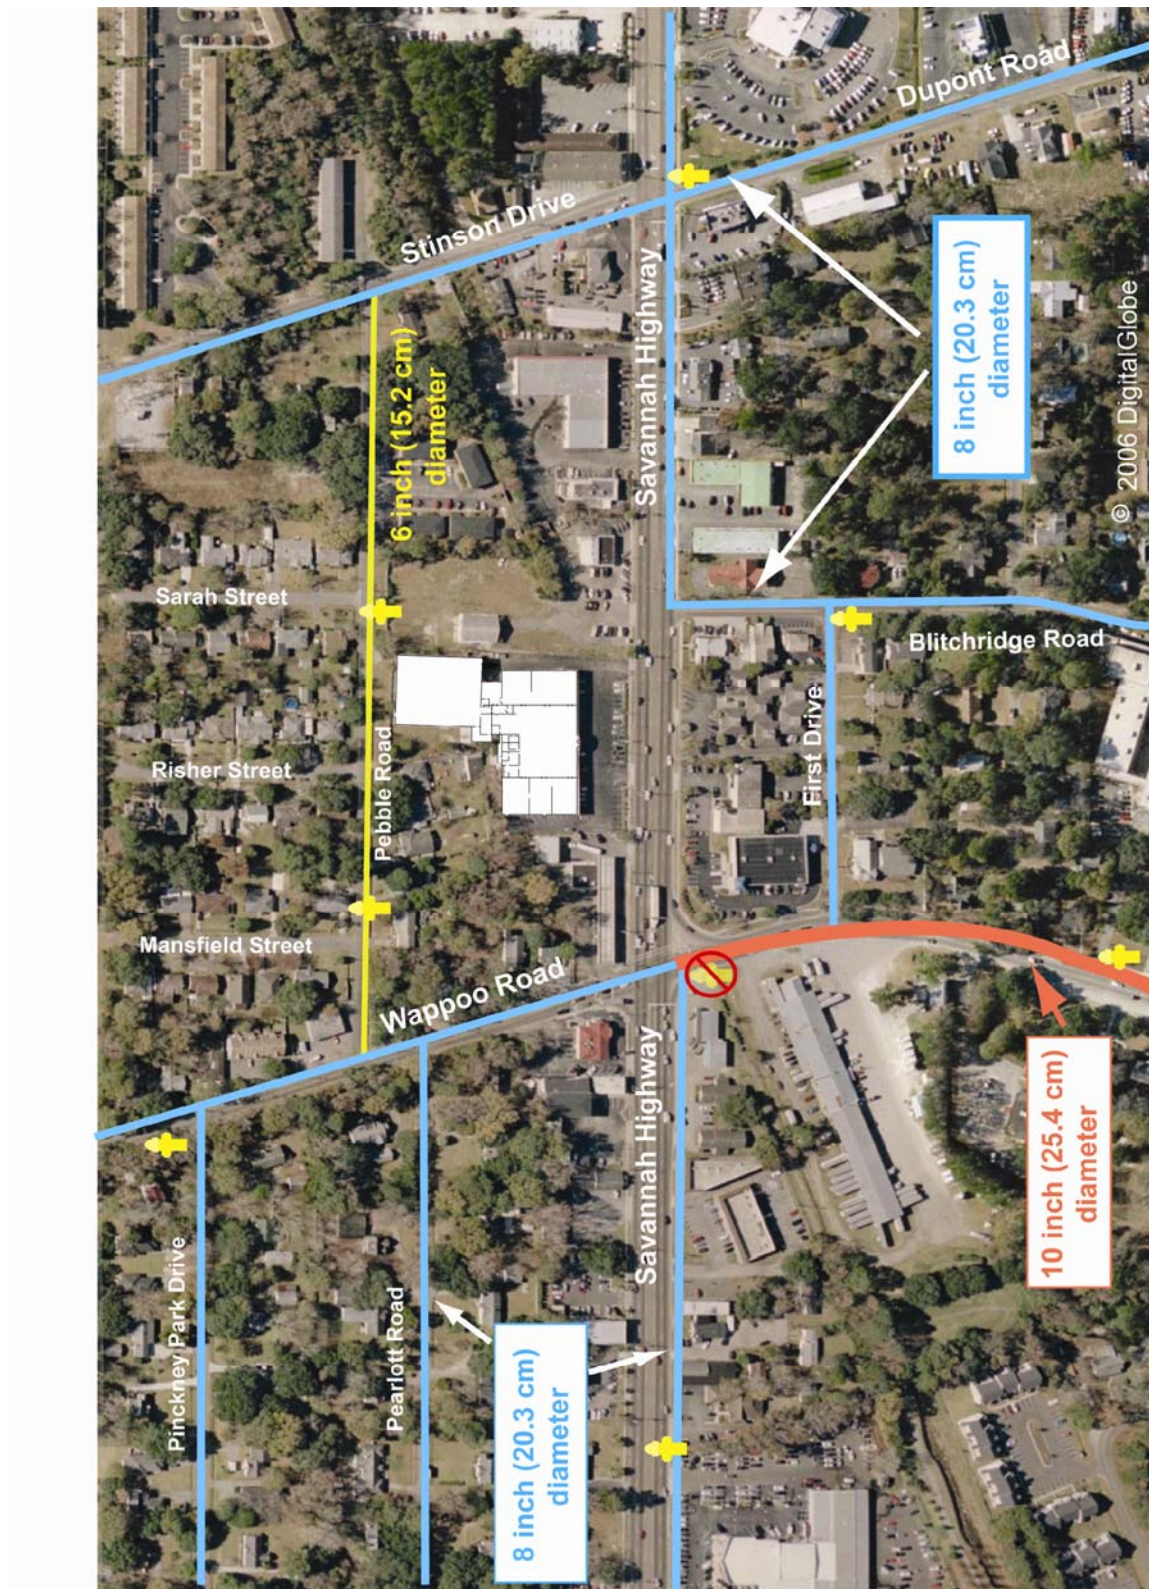
Figure 1-18. Water supply lines near Sofa Super Store. Hydrants behind store on Pebble Road were on 15.2 cm (6 in) diameter lines while hydrants located along Savannah Highway were on 20.3 cm (8 in) diameter lines. Background image used with permission of DigitalGlobe. Enhancements by NIST.

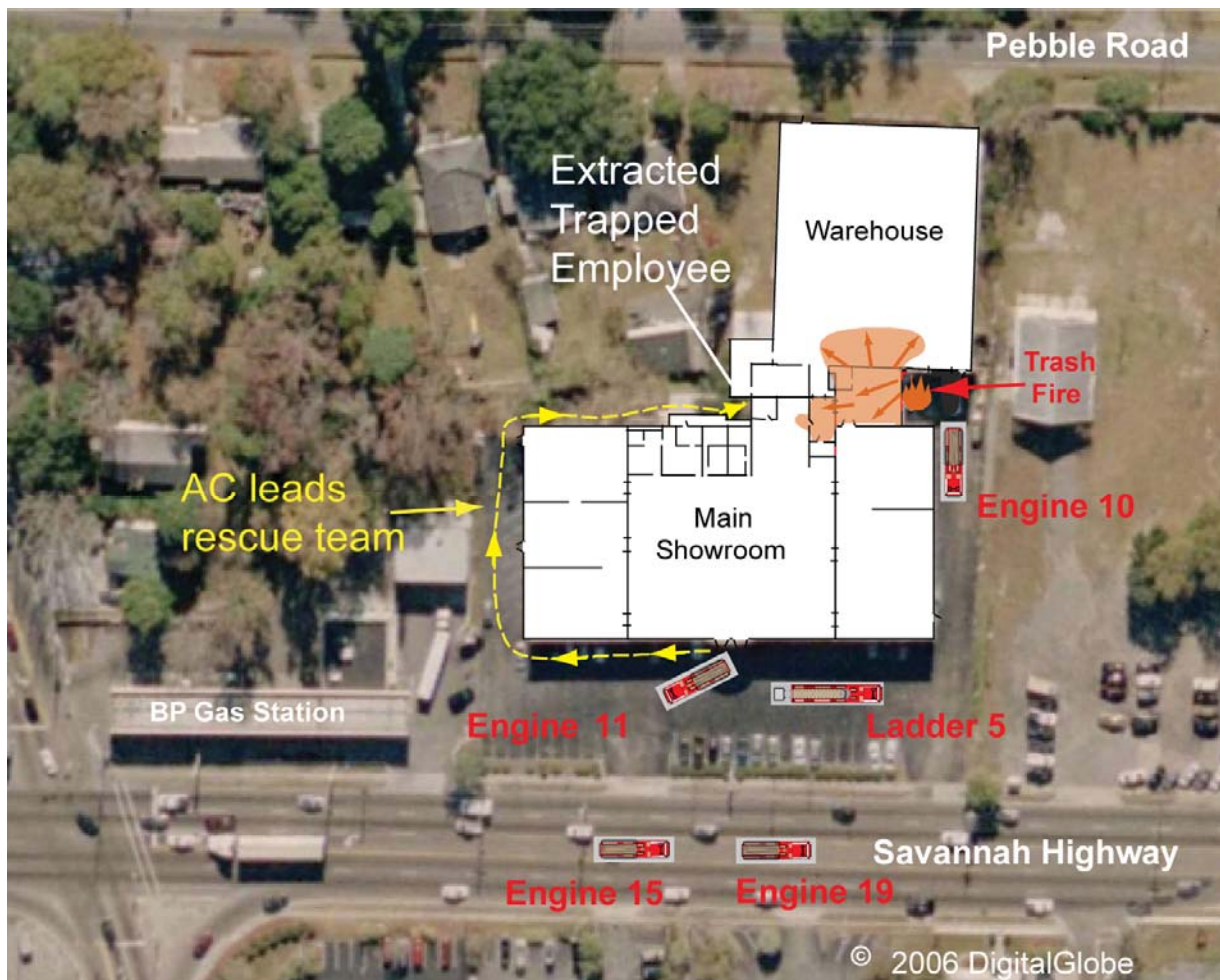
**Figure 2-4. An Assistant Chief directed rescue of the trapped employee. The team moved around the east side of the store and located the trapped employee at the rear of the store. This occurred between approximately 7:27 p.m. and 7:31 p.m. Background image used with permission of DigitalGlobe. Enhancements by NIST.**

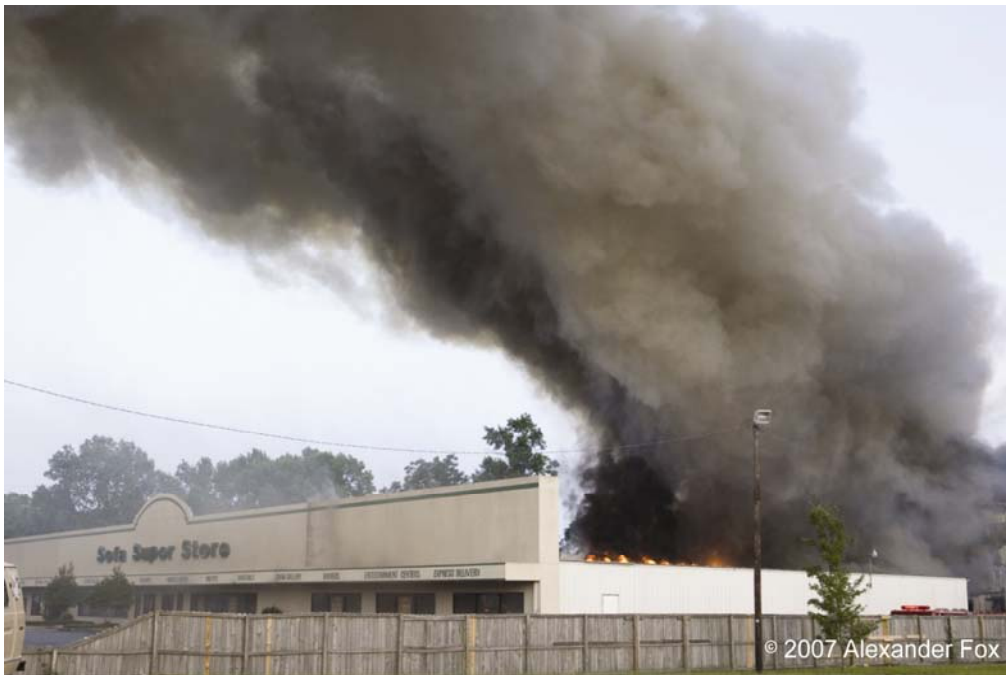
Photographs taken during the early stages of the fire show heavy smoke and flames exiting at the roof level. Figure 4-6 shows a photograph taken at 7:28:15 p.m. This photo shows heavy smoke venting from the loading dock and rear of the main showroom. Flames are also visible and appear to be coming from the roof of the main showroom. Because it was not possible to determine the exact location or size of the holes in the ceiling and roof, several holes were used in the simulations to represent the ventilation that took place. Table K-4 summarizes the ventilation conditions used in the simulations.

**Figure 4-6. Photograph showing the north and west sides of the showroom. Photo was taken at 7:28:15 p.m.**

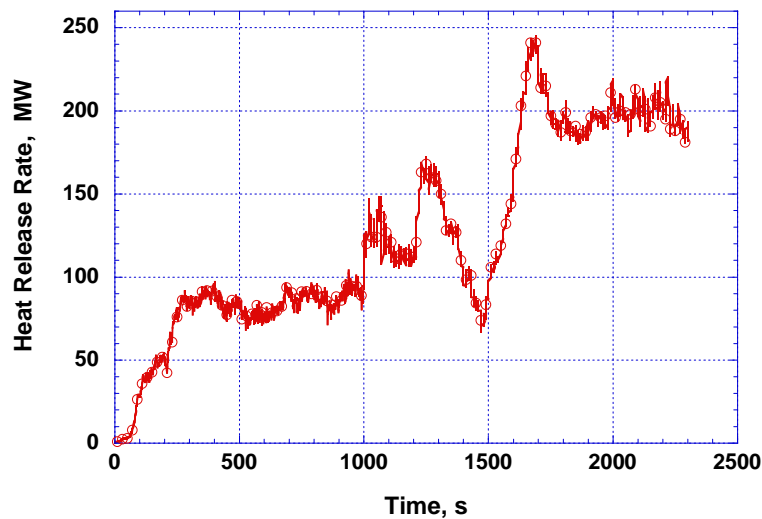
The total HRR for the fire, excluding the warehouse, is plotted as a function of time in Figure 4-9. The HRR produced by the warehouse contents dominated the total HRR in the mid and late stages of the simulation, but since the breezeway door closed early in the fire time line, there was no flow or transfer of

Figure 4-9. Total heat release rate, excluding the warehouse.

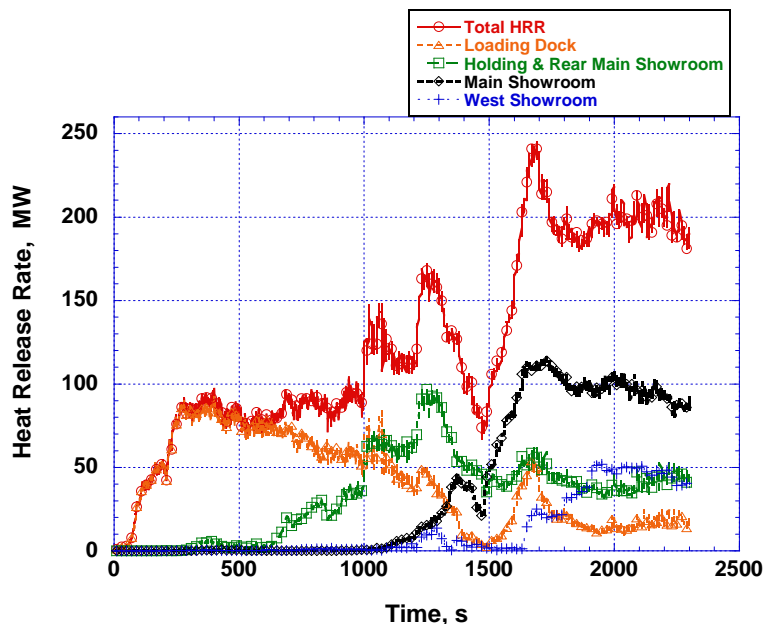
The HRR grew quickly from the initiating 700 kW fire, reaching 90 MW in 280 s as fire spread through the loading dock and into the holding area. Figure 4-10 separates the HRR events in the loading dock, holding area and rear showroom, main showroom, and west showroom. During the first 500 s, the loading dock fire dominated the HRR at about 85 MW. As the fire spread into the holding area and rear of the main showroom the HRR for the holding area and the rear of the main showroom began to increase to about 100 MW at around 1200 s. This increase in fire-spread to the holding area and main showroom was simulated by turning on Source 1 and 2 (Figure 4-8) in the computer model. As the fire spread into the rear of the main showroom, the fire became underventilated and began to decrease in HRR. The total HRR continued to decrease until about 1450 s when the removal of the windows in the main showroom, beginning at 1457 s (7:35:10 p.m.), provided a fresh influx of oxygen leading to the subsequent rapid fire growth. The HRR of the fire grew to over 100 MW in the main showroom and 50 MW in the west showroom. The energy release rate of the holding area/rear main showroom increased slightly and then leveled out at about 40 MW. The loading dock HRR exhibited a transient peak at about 50 MW and then decreased to about 15 MW.

Figure 4-10. Component heat release rates for the loading dock, holding area, main showroom, and west showroom.

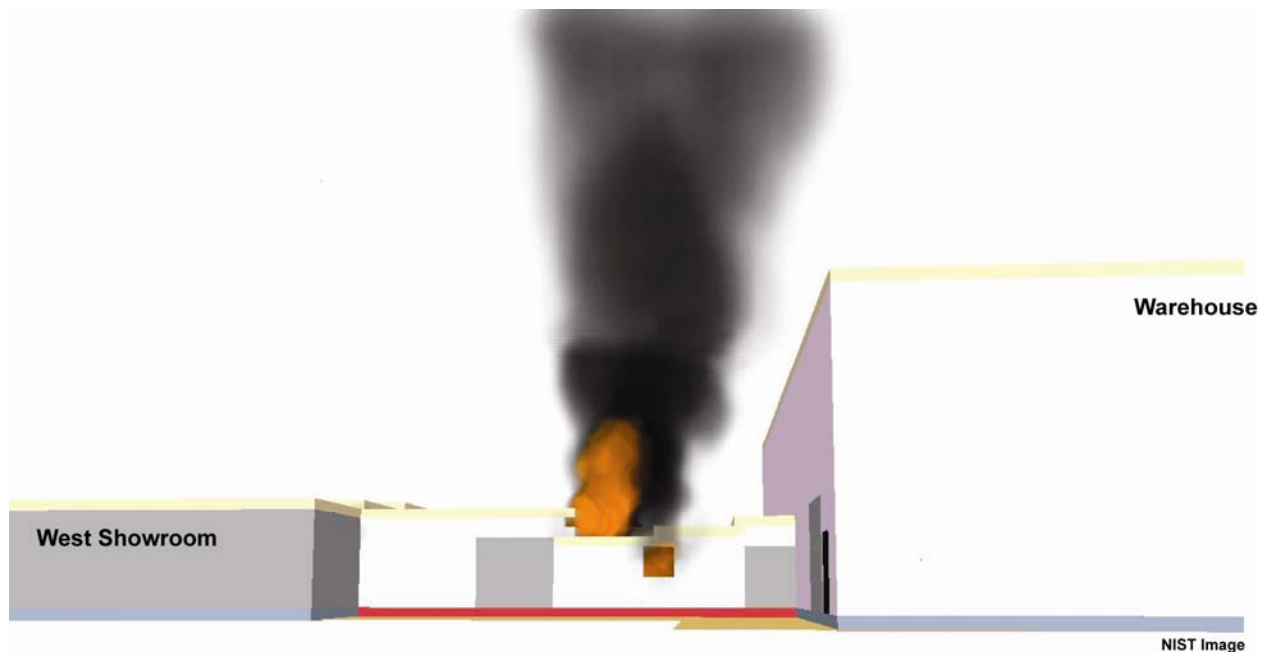
had progressed to the point that flames were venting from the exhaust fan in the west wall as well as through a gap between the roof sections of the loading dock. Figure 4-11 is an image rendered 110 s into the simulation viewing the west side of the structure that shows fire and smoke venting from the loading dock wall and roof.

**Figure 4-11. Rendered image showing the west side of the loading dock 110 s into the simulation.**

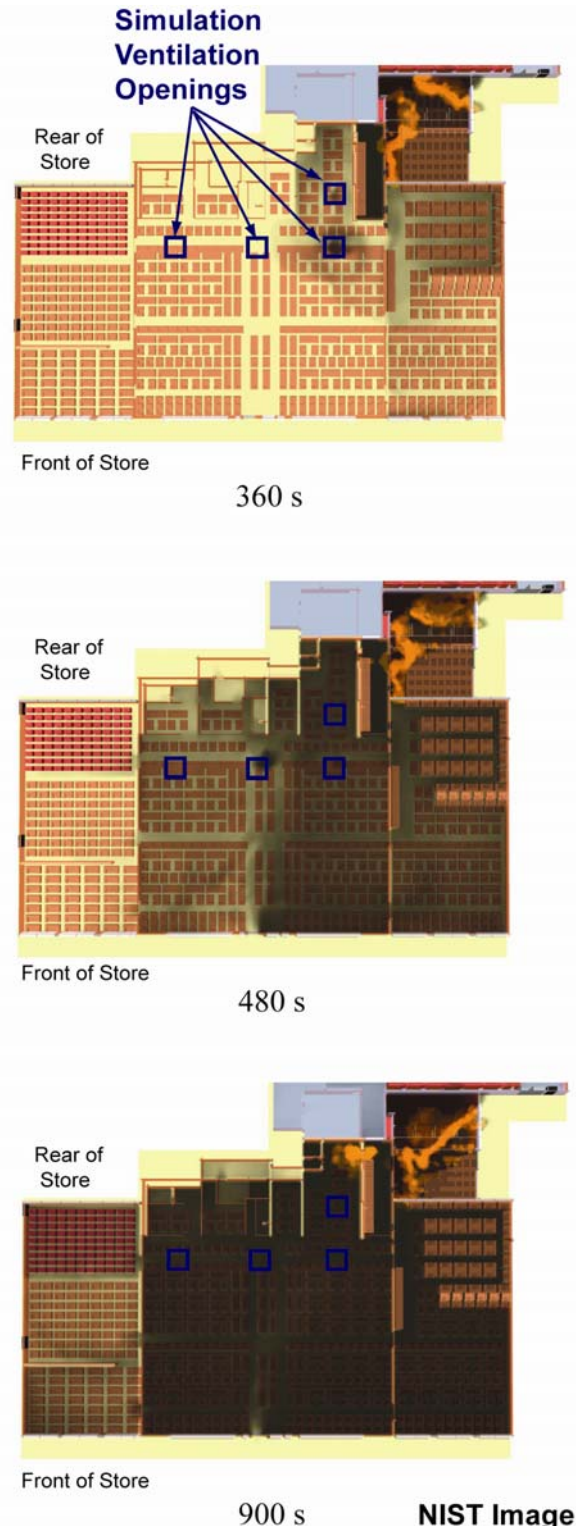
Smoke penetration through the ceiling was modeled by creating an opening in the rear of the main showroom when the adjacent temperature reached 50°C. Figure 4-15 shows the progression of fire and smoke below the ceiling level (2.6 m) throughout the loading dock, holding area and showrooms between 300 s (7:15:53 p.m.) and 900 s (7:25:53 p.m.). The images in this figure have been clipped down to the level of the ceiling in the showrooms.

At 300 s (7:13:53 p.m.) there is light smoke in the rear of the main and west showrooms. Initially, smoke in the west showroom entered through the double doors while the smoke in the main showroom entered through the ceiling. The ventilation openings in the ceiling in the main showroom (blue colored squares in Figure 4-15) opened between 261 s (7:15:14 p.m.) and 976 s (7:27:09 p.m.).

By 600 s (7:20:53 p.m.), the smoke layer had permeated the west and main showrooms, and there was evidence of a “tunneling” as fresh air was being pulled into the front door to supply oxygen. This is consistent with the account of Engineer 6, who entered the structure at approximately 7:24 p.m. (787 s) and reported a tunnel of clear space that extended several feet inside the showroom as fresh air was being pulled through the open door. Beyond this space he reported heavy smoke conditions. By 900 s (7:25:53 p.m.), the fire in the rear of the main showroom had grown to approximately 23 MW.

**NIST Image**  
**Figure 4-15. View of fire and smoke progression from above the showrooms from 300 to 900 s (7:15:53 p.m. to 7:25:53 p.m.). The images are clipped to view conditions below the ceiling.**

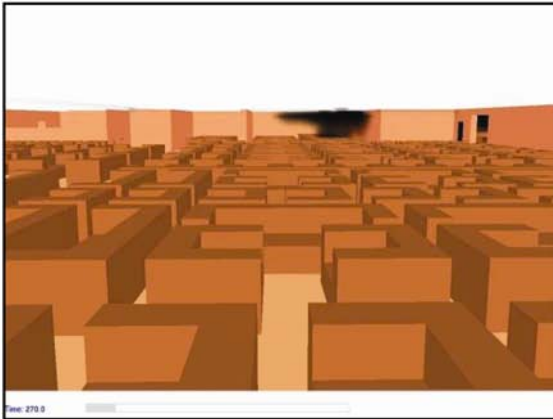
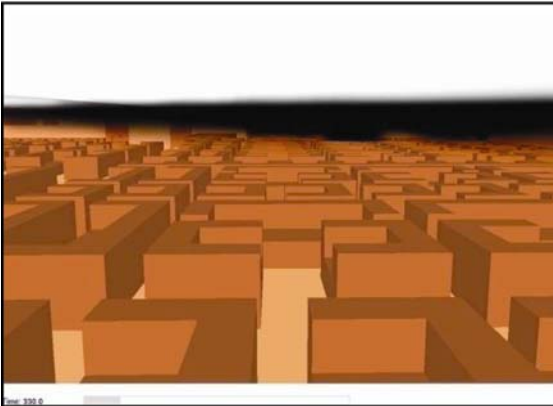
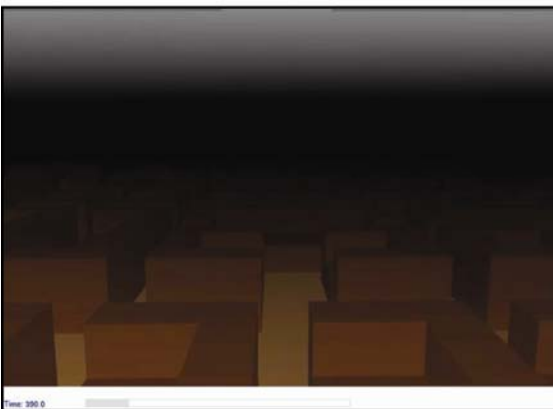
Figures 4-17 and 4-18 show smoke filling in, respectively, the main and west showrooms from the perspective of someone at the front of the room. The sequence in Figure 4-17 begins at 270 s (7:15:23 p.m.), after smoke began penetrating the ceiling. The sequence in Figure 4-18 begins at 270 s (7:15:23 p.m.). In both showrooms, conditions deteriorate considerably within a 120 s span.

**Figure 4-17. Smoke progression inside the west side of the main showroom between 270 s to 390 s (7:15:23 p.m. to 7:17:23 p.m.).**

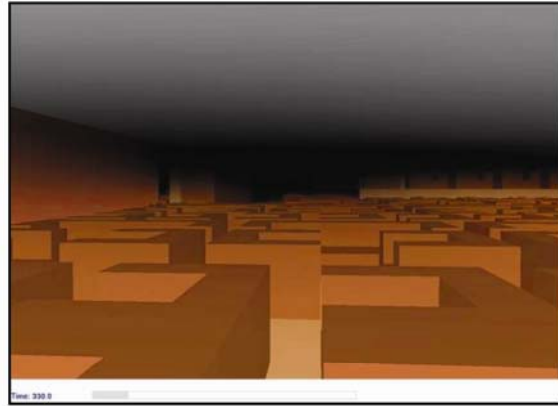
**Figure 4-18. Smoke progression inside the west showroom between 270 s to 390 s (7:15:23 p.m. to 7:17:23 p.m.).**

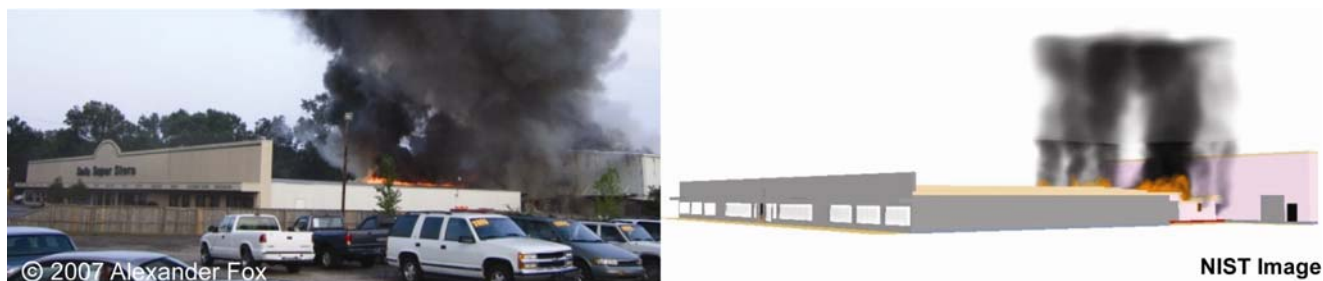
Figures 4-20 through 4-24 show comparisons of the fire and smoke progression with available photos at various times during the critical time between 7:23 p.m. and 7:45 p.m. (740 s through 2040 s). Figure 4-20 shows one of the earliest photos that were obtained of the fire, taken at 7:23:16 p.m. (743 s). At this time the fire was still mainly concentrated in the loading dock and holding area. Although the showrooms were charged with smoke, there was no smoke pushing out the open door at the front of the store. The fire had impinged on the underside of the roof over the holding area and flames were visible from the exterior at the roof level. At 1530s (7:36:23 p.m.), shown in Figure 4-21, the main sections of the front windows had been broken out and smoke was pushing out the front of the main showroom. At this

**Figure 4-20. Comparison between photo and rendered image from the simulation at 743 s (7:23:16p.m.). The view is of the north west corner of the structure.**

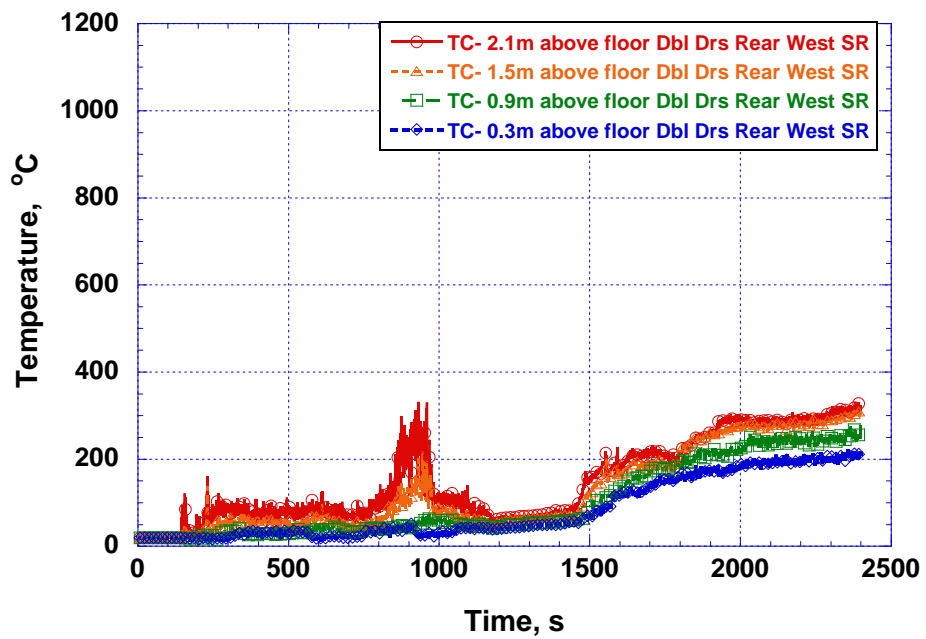
Figure 4-27 shows a chart of temperatures recorded in the west showroom, near the double doors. The data are from sensors located 0.3 m (1 ft), 0.91 m (3 ft), 1.52 m (5 ft), and 2.13 m (7 ft) from the floor. Figure 4-27 shows that temperatures remained below 100 °C through approximately 750 s (7:23:23 p.m.). The fire was positioned near the double doors to the loading dock; however, during the early stages much of the heat was venting through the loading dock roof and later through the main showroom roof. Air was being pulled through the doorway to feed oxygen to the fire in the loading dock and holding area. There was a surge in temperature in the upper layer lasting several minutes caused by fire progression into the showroom. At 900 s (7:25:53 p.m.), a section of the roof above the holding area was removed and this resulted in the subsequent temperature drop. Temperatures dropped below 100 °C, but as the fire increased in the main showroom the temperatures in both showrooms began to rise quickly. A second temperature surge, which began at approximately 1460 s (7:35:13 p.m.), was due to the fire entering the west showroom through the open roll-up door as it moved to the front of the main showroom. It should be noted that the focus of suppression efforts was in this area of the showroom, and that the simulation does not take this into account.

Figure 4-27. Temperatures at different elevations, 0.3 m (1 ft), 0.91 m (3 ft), 1.52 m (5 ft), and 2.13 m (7 ft) in rear of west showroom near double doors.

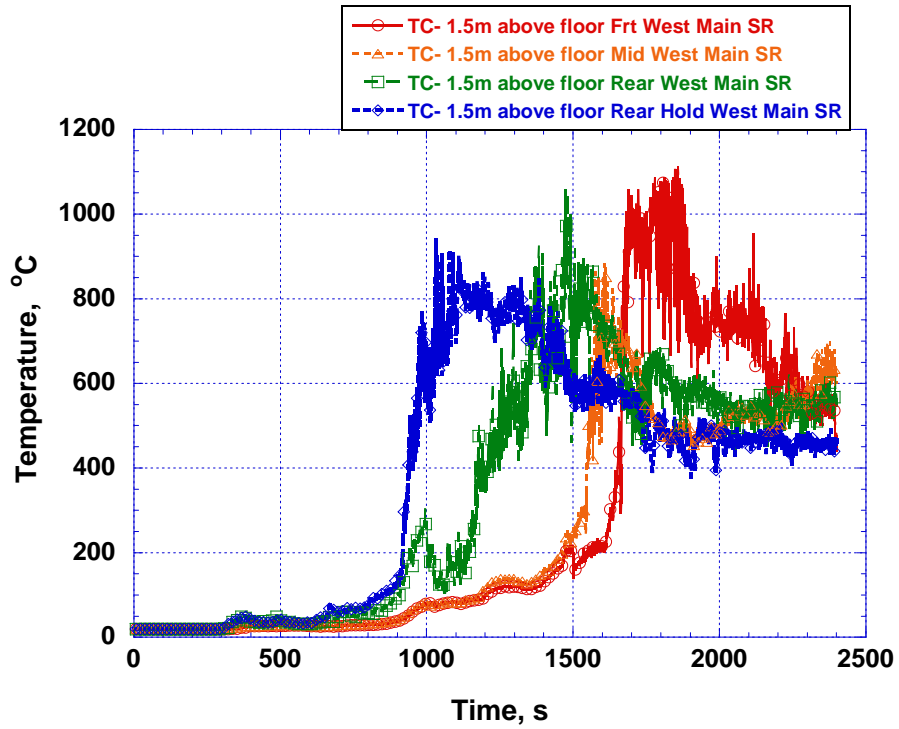
Figure 4-29 shows a temperature chart that displays data from sensors located on the west side of the main showroom. This chart contains a fourth data location, labeled Rear Hold, which was identified in Figure 4-25. Temperatures in the west side of the main showroom became elevated at an earlier point than in the other areas of the showroom because the fire moved across these sensors as it moved to the front of the showroom. The rear holding area location reached 120 °C at 864 s (7:25:17 p.m.); the rear location was roughly 30 s behind, reaching 120 °C at 900 s (7:25:53 p.m.). The mid and front locations reached 120 °C simultaneously at 1250 s (7:31:43 p.m.). Temperatures in the center and east areas of the main showroom showed similar trends.

Figure 4-29. Main showroom west temperatures for 1.5 m (5 ft) above floor.

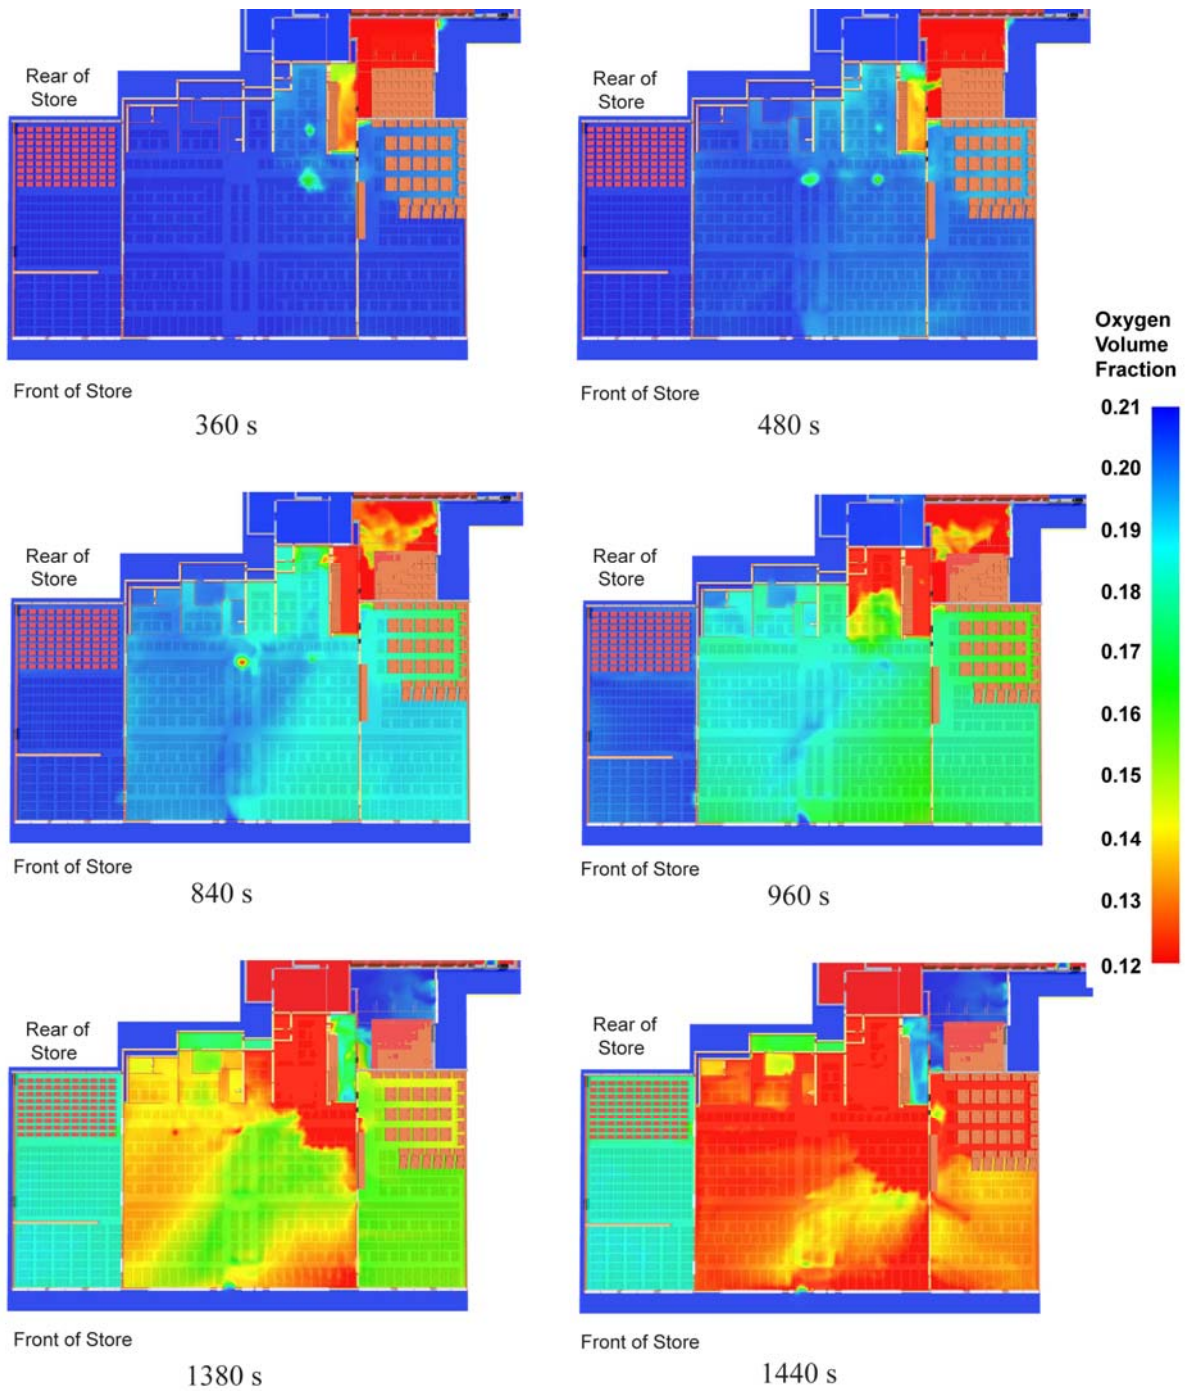
Figure 4-31 shows a series of images with an oxygen slice 1.5 m (5 ft) from the floor rendered at a range of times between 360 s and 1440 s (7:16:53 p.m. through 7:34:53 p.m.).

**Figure 4-31. Oxygen volume fractions (slice images) for 1.5 m (5 ft) above the floor.**

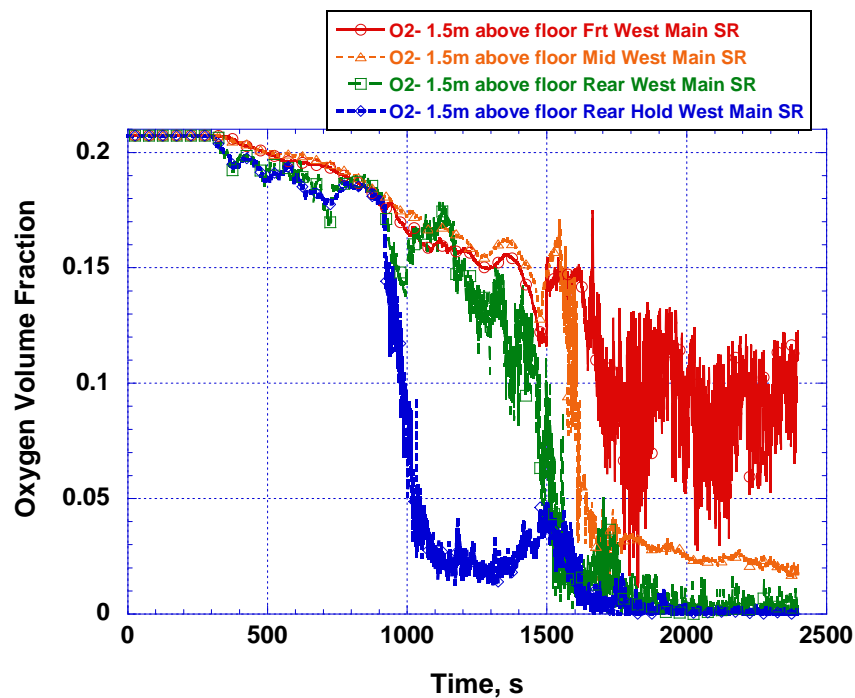
Figure 4-33 shows a chart that displays oxygen data from sensors located on the west side of the main showroom. Oxygen in the west side of the main showroom became depleted at an earlier point than in the other areas of the showroom because this was the path of the fire as it moved to the front of the showroom. The holding area location reached 0.12 volume fraction at 950 s (7:26:43 p.m.); the rear location was roughly six minutes behind, reaching 0.12 volume fraction at 1250 s (7:31:43 p.m.). The mid and front locations initially reached 0.12 volume fraction approximately the same time at 1400 s (7:34:13 p.m.). The mid and front locations then increased up to 0.15 volume fraction as the front windows were broken. Oxygen volume fractions in the center and east areas of the main showroom had similar trends.

Figure 4-33. Main showroom (west) oxygen volume fractions for 1.5 m (5 ft) above the floor.

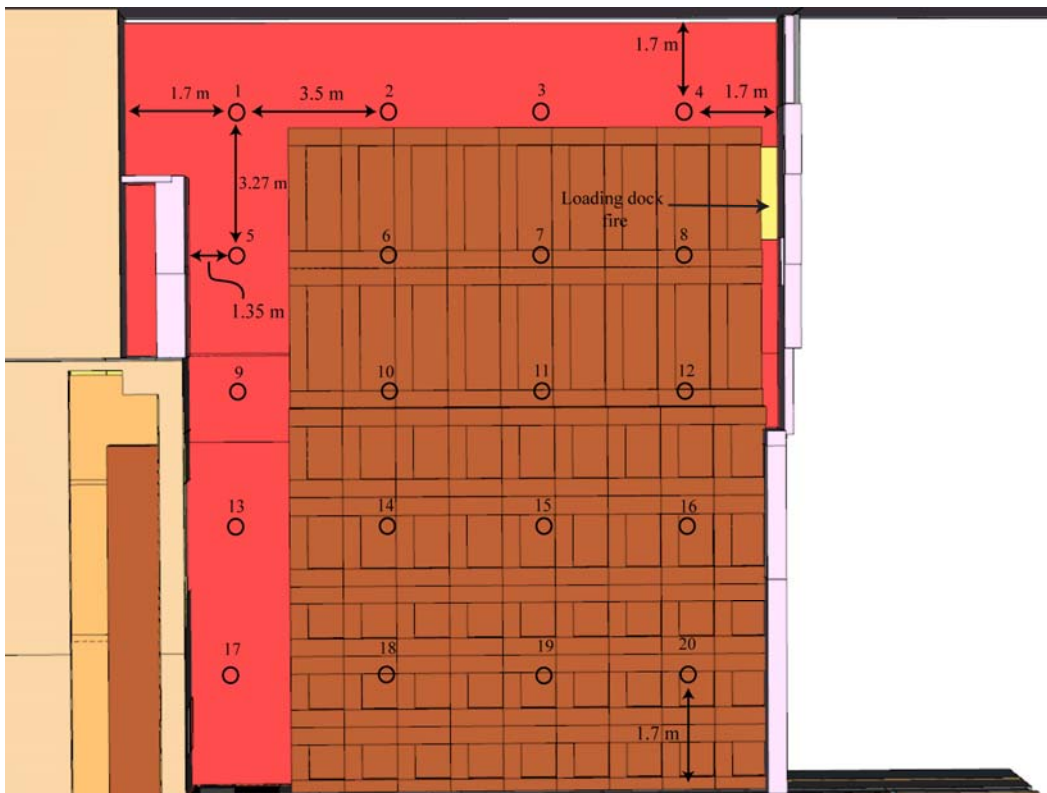
Figure 4-35. Sprinkler layout inside the enclosed loading dock.

Twenty sprinklers were placed inside the loading dock in a 3 x 4 mesh, as shown by the black circles in Figure 4-35. The sprinkler specifications that were used in the simulation are detailed in Appendix K, Table K-6. In this configuration, the coverage for each sprinkler was 6 L/min/m<sup>2</sup> (0.15 gpm/ft<sup>2</sup>). Two sprinklers, labeled 3 and 6 in Figure 4-35, activated in the simulation. Sprinkler 3 was the first to activate, at 50 s, while sprinkler 6 activated at 75 s.

The sprinkler system layout was designed in accordance with NFPA 13, *Standard for the Installation of Sprinkler Systems* [17]. The system was designed as a light hazard wet pipe system, assuming that the enclosed loading dock area was heated. A light hazard sprinkler system was utilized in order to provide a conservative estimate for the area/water density for the simulations. The locations of the sprinklers within the enclosed loading dock are shown in Figure 4-35. Note that given the dimensions of the cells in the simulation, the locations of the sprinklers in the simulation vary somewhat from the layout shown. The specific locations of the sprinklers are given in the FDS input file. The sprinkler characteristics and operating parameters are given in Table K-7.

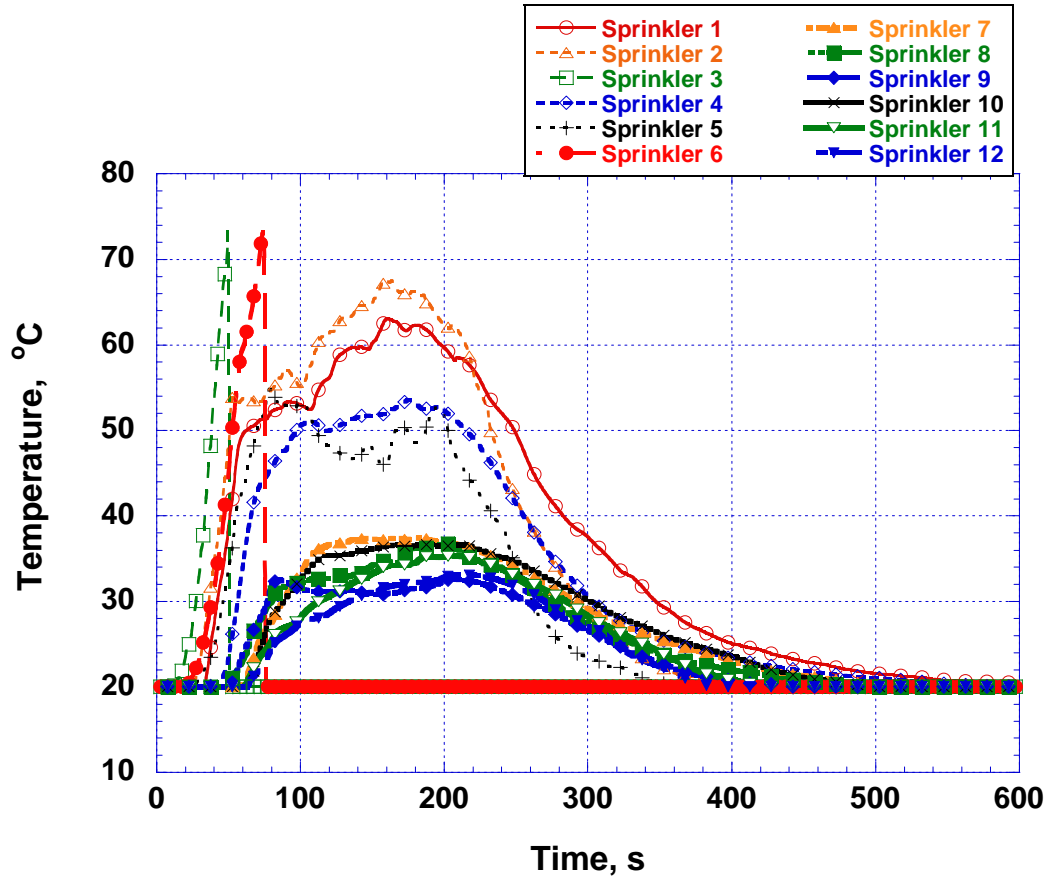
Figure 4-37 shows the temperature at each of the sprinkler locations. The graph indicates that the temperature at locations 3 and 6 reached 74°C, at which point the sprinklers were activated in these locations. Temperatures at locations 1 and 2 peaked in the 60°C to 70°C range but never reached the threshold for activation.

**Figure 4-37. Temperatures near sprinkler head inside the loading dock.**

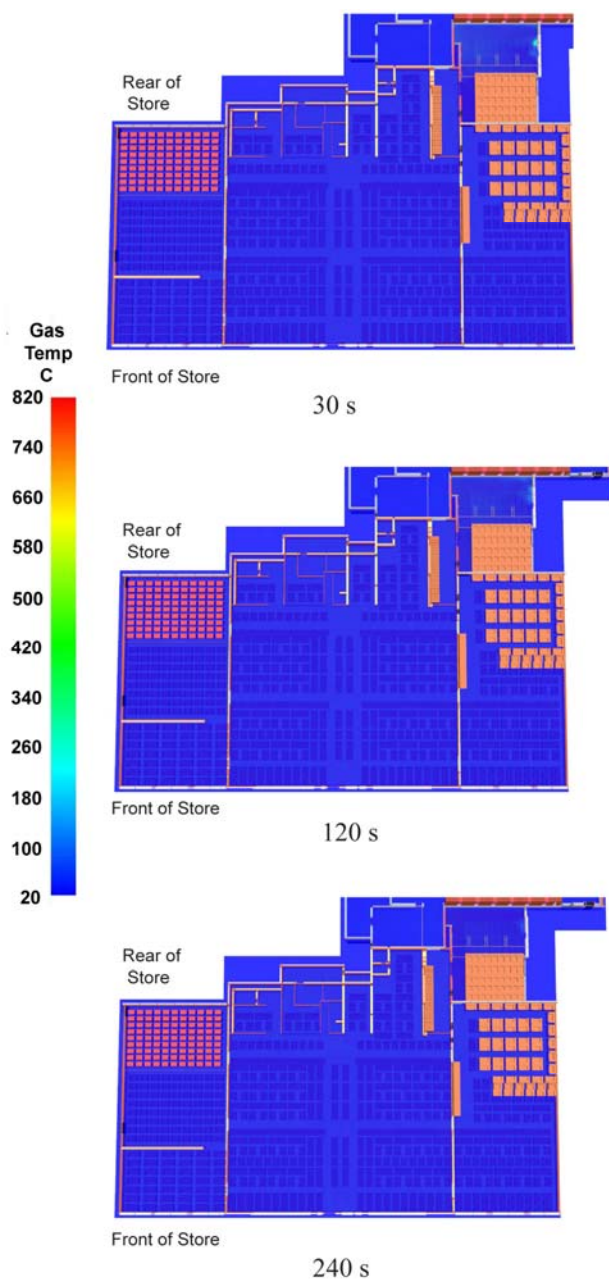
Figure 4-38 shows a series of images with a temperature slice 1.5 m (5 ft) from the floor rendered at a range of times between 30 s through 240 s. Note that the scale on these images is consistent with those in Figure 31. These images show that the area of elevated temperatures is limited to the immediate vicinity of the fire inside the loading dock.

**Figure 4-38. Temperatures 1.5 m (5 ft) above the floor in the sprinklered simulation.**

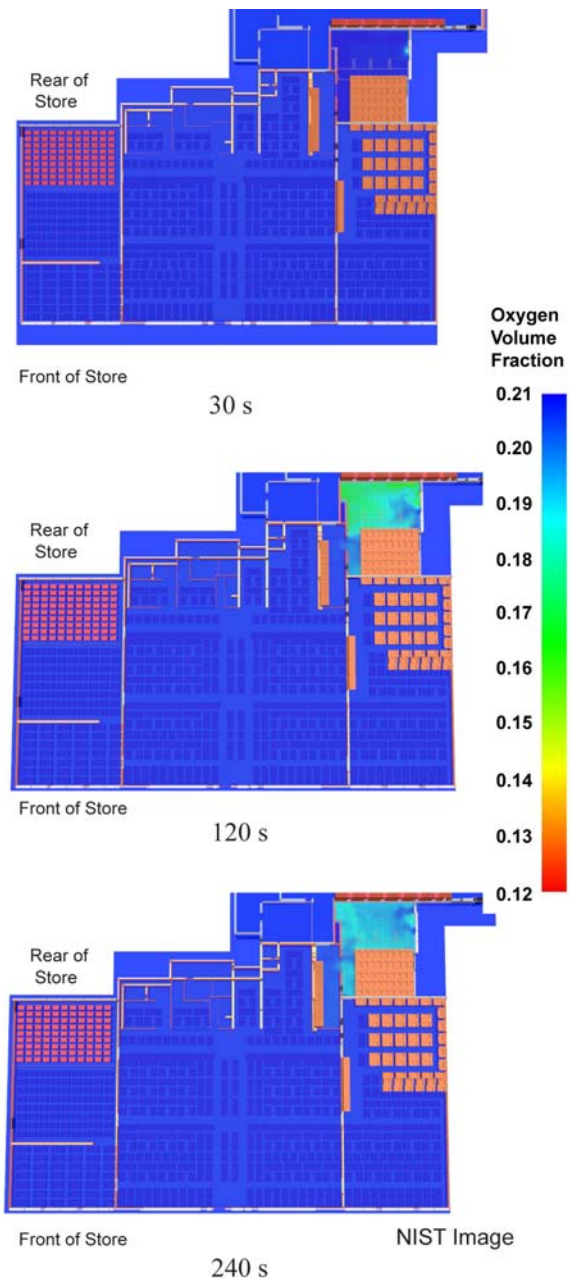
A similar result is seen in the oxygen volume fraction data, shown in Figure 4-39. This figure shows a series of images 1.5 m (5 ft) from the floor at times between 30 s through 240 s. Depleted oxygen levels are observed in the vicinity of the holding area. The oxygen volume fraction at 1.5 m never drops below the tenability threshold of 0.12 (volume fraction). There is an increase in oxygen volume fraction between the final two images, as fresh air enters the holding area.

**Figure 4-39. Oxygen volume fractions 1.5 m (5 ft) above the floor in the sprinklered simulation.**

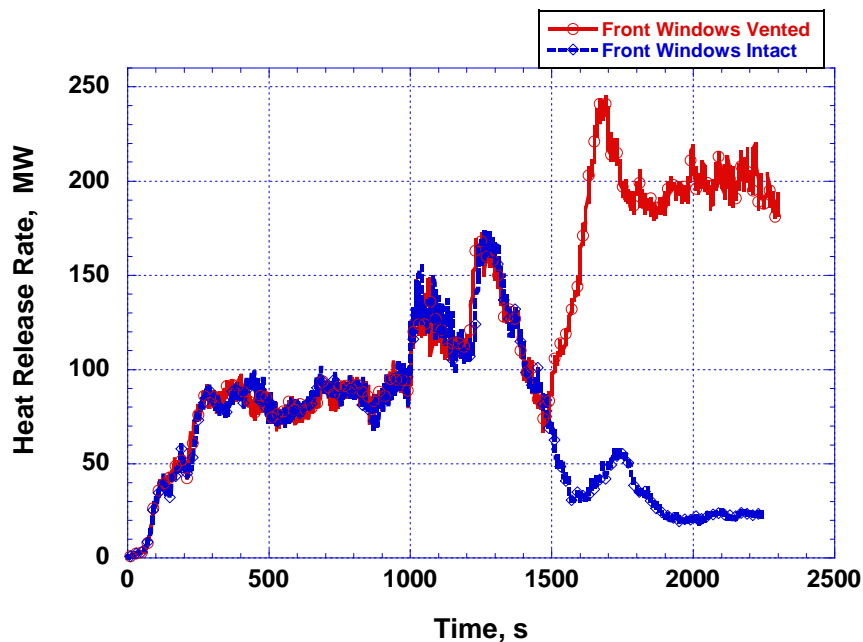
Figure 4-41 shows the change in HRR over time for this scenario and the baseline simulation. In both scenarios, HRR peaked at 120 MW at around 1300 s after which the HRR decreased. This would be consistent with the fire becoming underventilated. The venting of the front windows in the main showroom at 1457 s corresponds with the subsequent rapid increase in HRR for the base case. In the simulation with the windows intact, the HRR did not increase at approximately 1500 s, but continued to decrease until about 1600 s.

**Figure 4-41. Comparison of the heat release rate in the main showrooms for front windows vented and front windows intact.**
