# Technical Study of the Sofa Super Store Fire - South Carolina, June 18, 2007

# **Technical Study of the Sofa Super Store Fire - South Carolina, June 18, 2007**

*Fire Research Division  
Engineering Laboratory  
National Institute of Standards and Technology*

October 2010

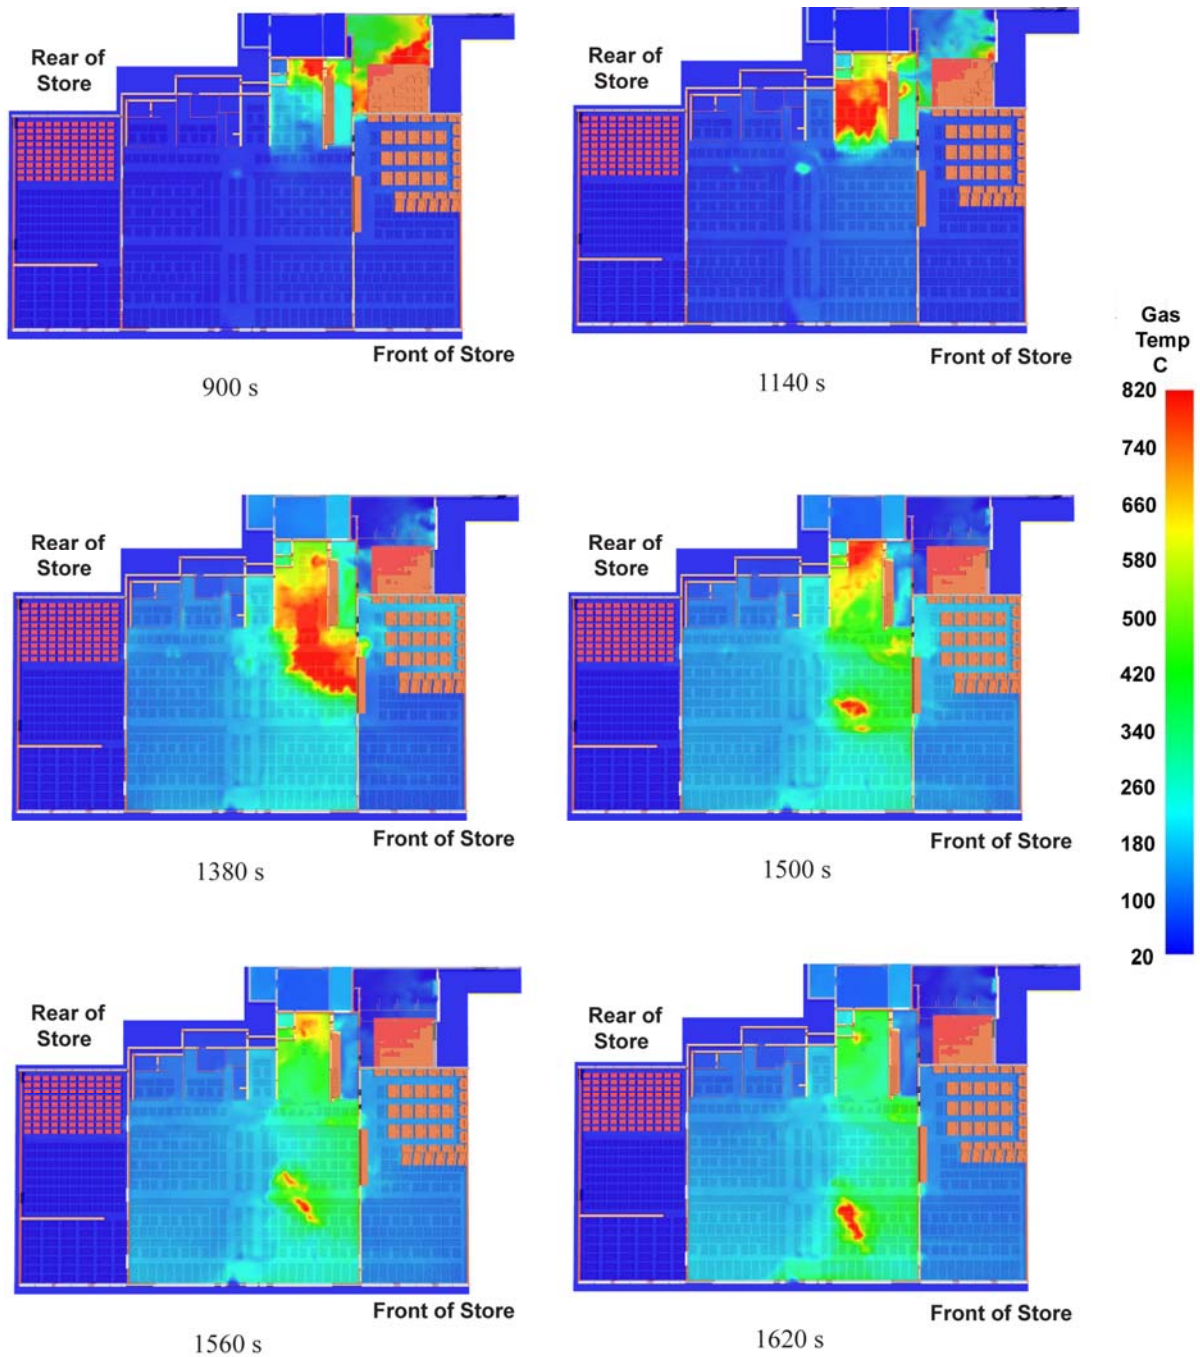
Figure 4-42 shows a series of images with a temperature slice 1.5 m (5 ft) from the floor rendered at a range of times between 900 s through 1620 s (7:25:53 p.m. through 7:37:53 p.m.). The trends in this figure are similar to those seen in Figure 4-28 for the baseline simulation. For the windows intact scenario the high temperature areas, shown in red, diminishes between 1380 s and 1500 s. After 1500 s the simulation displays less red areas in the windows intact case than for the same times in the baseline case (Figure 4-28).

**Figure 4-42. Temperature slices located 1.5 m (5 ft) above the floor in simulation with front windows intact.**

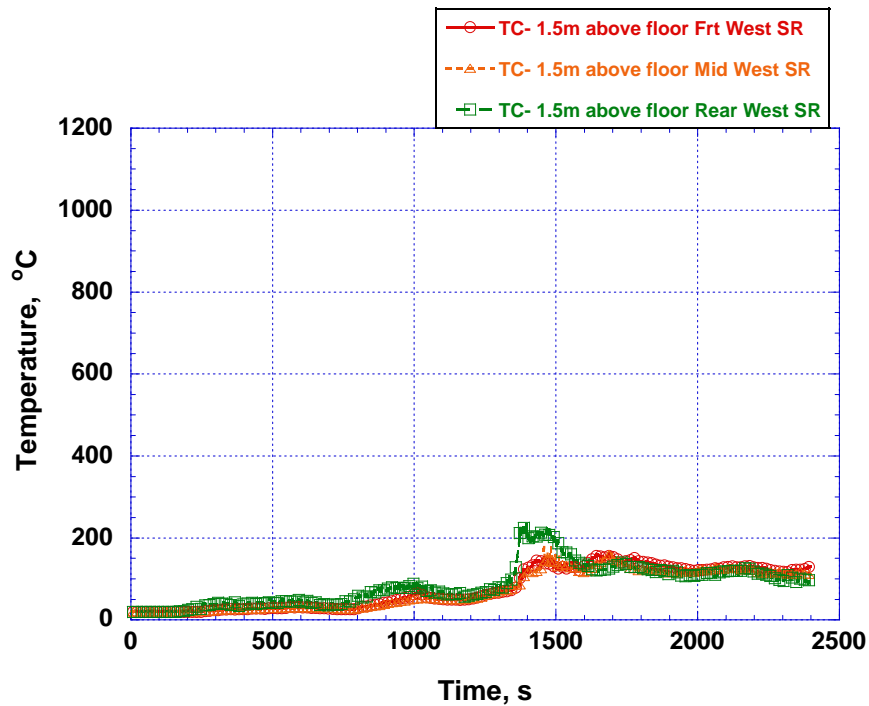
Figures 4-43 through Figure 4-46 show temperature data recorded at the same sensor locations used in Figure 4-25 for the baseline simulation. For comparison purposes, the scale in these figures was kept the same as the corresponding scale in Figure 4-27 through Figure 4-30. After 1500 s, the temperatures were lower in the scenario with the front windows intact as compared to the base case. The temperatures with the windows intact exceeded the 120 °C tenability threshold at each sensor location before the time at which the windows would have been broken out.

Figure 4-44. West showroom temperatures for 1.5 m above the floor.

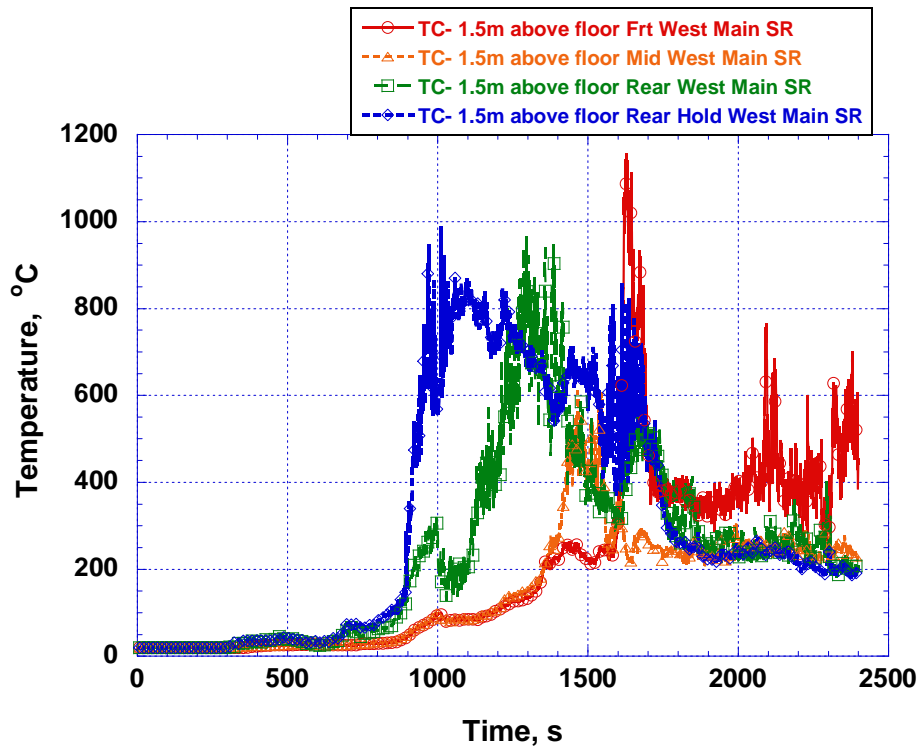
Figure 4-45. West main showroom temperatures for 1.5 m above the floor.

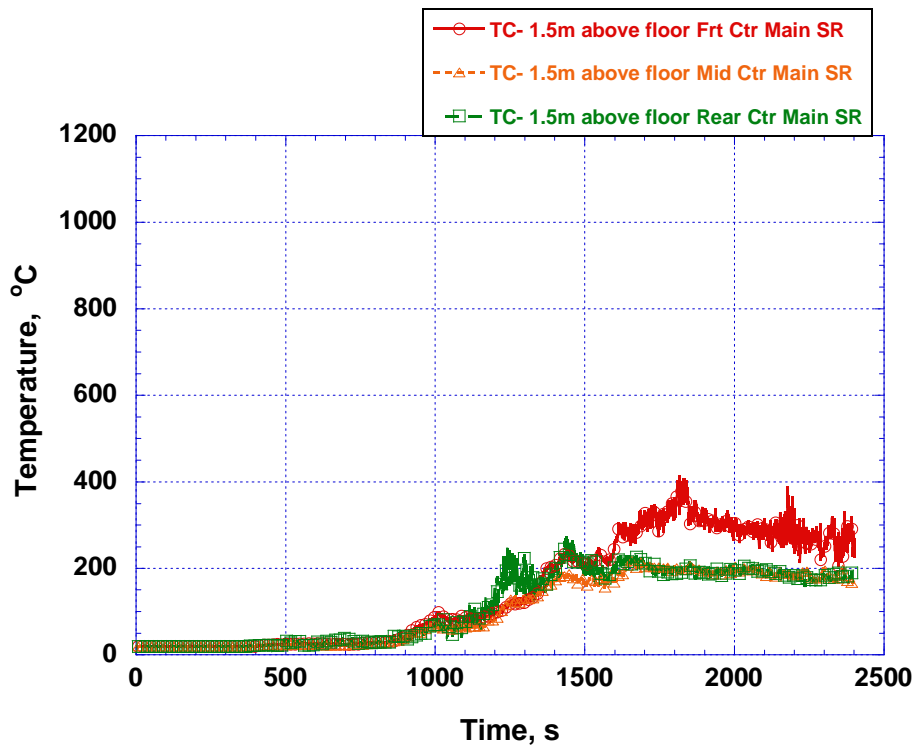
Figure 4-46. Center main showroom temperatures for 1.5 m above the floor.

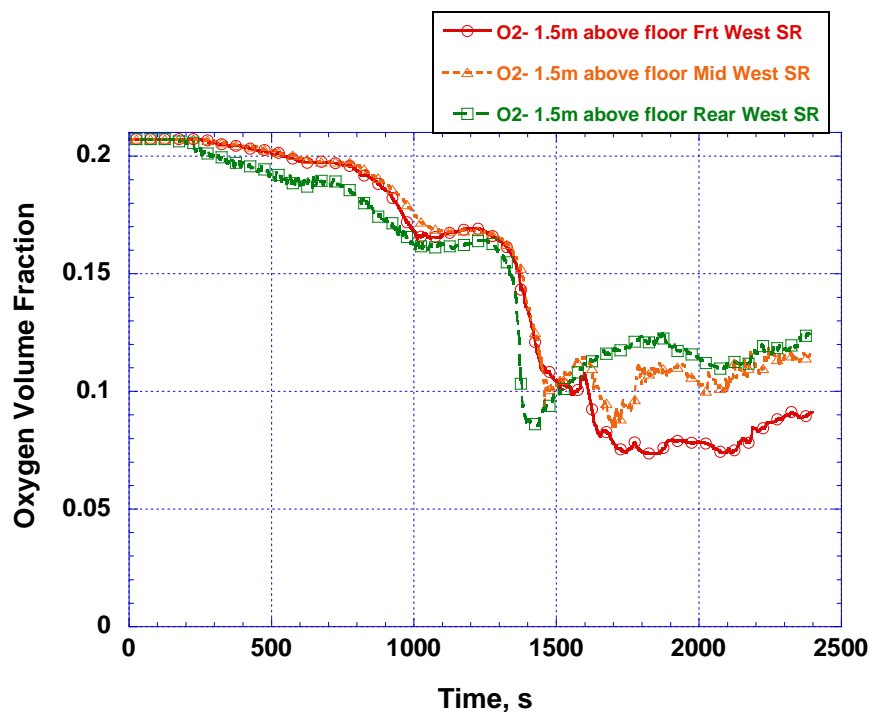
Figures 4-47 through 4-49 show oxygen volume fraction data for the front windows intact case that were recorded at the same sensor locations (Figure 4-25) as the baseline case. For the first 1000 s, the oxygen volume fraction in the west showroom (Figures 4-47 and 4-32) drops to about

0.16 for both cases. For about the next 400 s, the oxygen volume fraction decreases more slowly in both cases. By 1400 s the volume fraction drops below 0.1 for the windows intact case, but decreases to 0.15 for the base scenario. For the windows intact case, after the time when the windows would have been broken at 1457 s, the oxygen volume fraction in the rear of the west showroom begins to increase and peak at about 0.12 at 1850 s. The oxygen volume fractions in the mid and front of the west showroom decrease to 0.09 and 0.07, respectively. The oxygen volume fractions in the rear of the main showroom (Figures 4-48 and 4-33) show similar trends during the first 1300 s. For the windows intact case, the oxygen volume fraction became more steady between 0.07 and 0.09. The oxygen volume fraction for the same location in the base scenario continues to drop to less than 0.02. For the base case, after 1700 s, the oxygen volume fraction is less than 0.03 for the holding area, rear, and mid showroom. For the windows intact scenario, at about the same time, 1700 s, the oxygen volume fraction for the rear, mid, and front showroom locations are all above 0.07. Overall, the trends for both cases are similar during the early portion of the simulations, but after the time at which the windows were broken out in the base scenario, the oxygen volume fractions appear lower than in the front windows intact case for the rear holding, rear, and mid showroom locations.

Figure 4-47. West showroom oxygen volume fractions for 1.5 m above the floor.

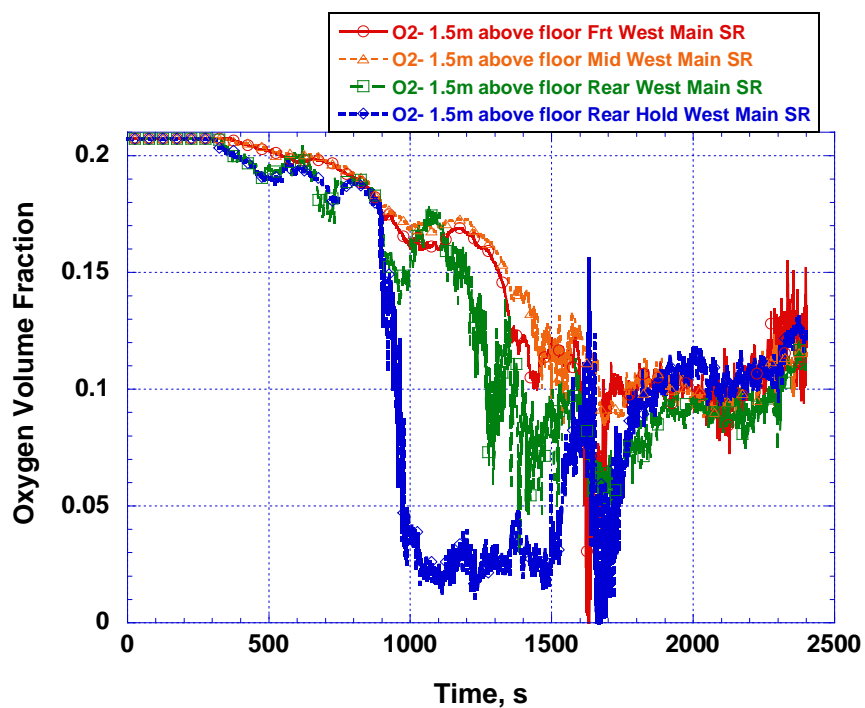
Figure 4-48. West main showroom oxygen volume fractions for 1.5 m above the floor.

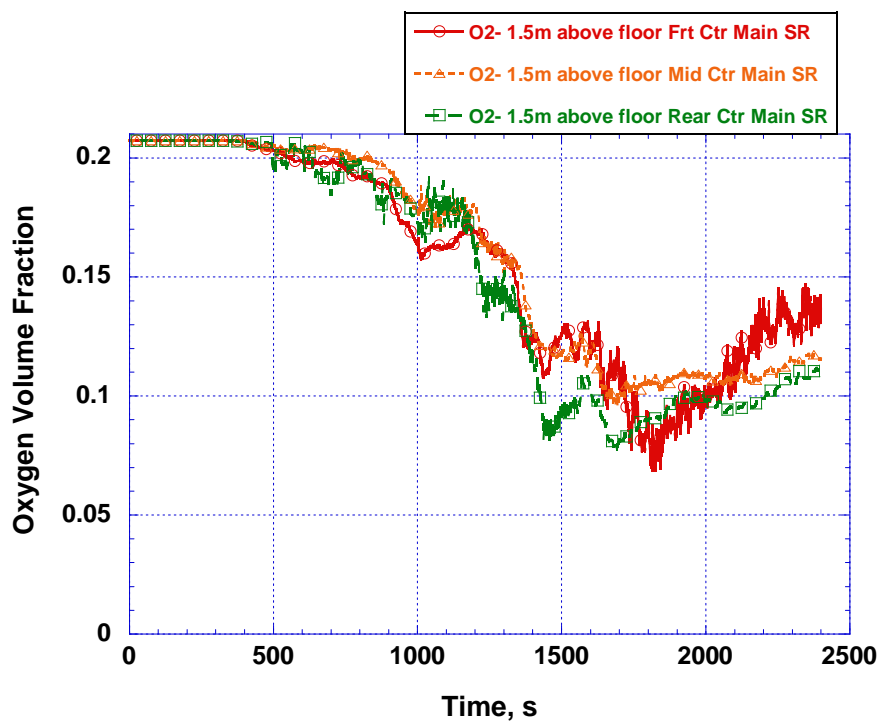
Figure 4-49. Center main showroom oxygen volume fractions for 1.5 m above the floor.
