Investigation of Wind Damage in the Metropolitan Washington, D.C. Area, April 3-4, 1975

F. Y. Yokel, C. W. Yancey,
L. E. Cattaneo, and R. D. Marshall

Center for Building Technology
Institute for Applied Technology
National Bureau of Standards
Washington, D.C. 20234

Issued May 1976

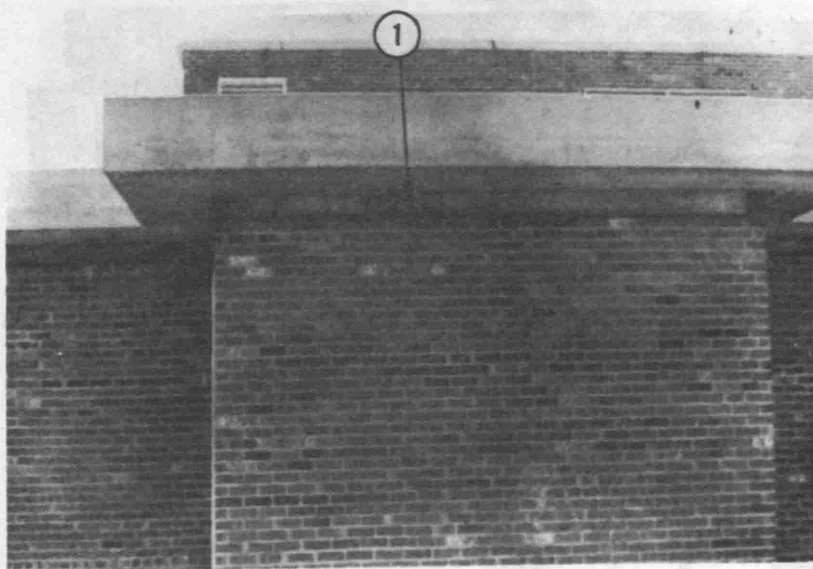
Figure 5 - Front elevation of similar wall located in undamaged building. Looking west.

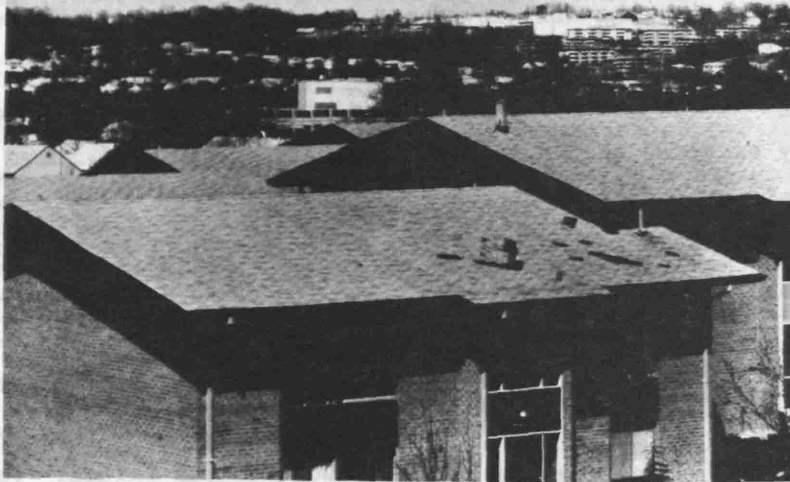
Figure 10 is a rooftop view which shows a portion of a garden apartment complex consisting of two and three-story, wood-frame, brick veneer structures. The end walls of three buildings in this complex were damaged as a result of the brick veneer flexing and separating from the sheathing and wood framing. Figure 11 shows the most severe of the three cases of endwall damage. The brick veneer failed over a large area of the wall. Eyewitnesses reported a transverse deflection of approximately 6 to 8 inches (15 to 20 cm) in the brick veneer before the failure occurred. The walls in the other two similarly affected buildings were shored (or braced) before substantial flexural failure of the veneer occurred. The prevailing wind direction is shown by the arrow in figure 11. The brick veneer was connected to the wood framing by corrugated steel ties. Evidence of broken ties as well as of the ties which were pulled out from the wood construction was found in the field investigation.

Figure 10 - Rooftop view of garden apartments damaged by wind.
Looking northwest.

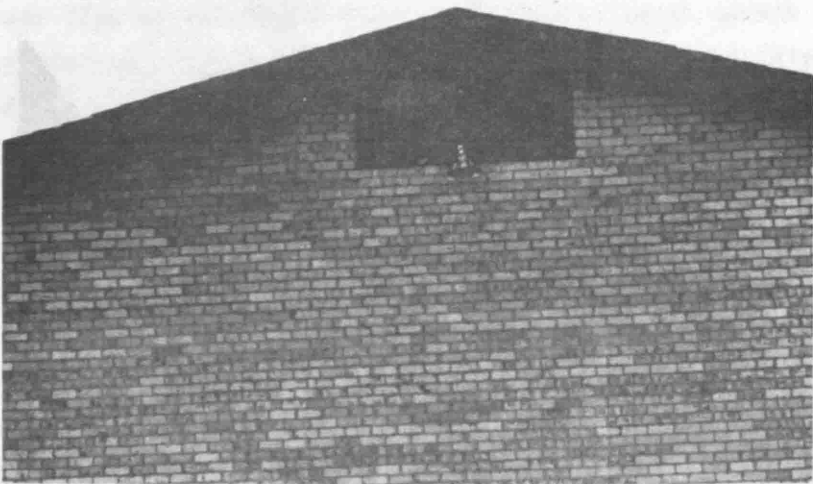
An overall view of the damaged building under repair is shown in figure 18. Figure 19 shows a closer view of the damaged wall and roof overhang. Figure 20 shows a similar undamaged wall in an adjacent building.

Figure 20 - Elevation view of an undamaged gable wall.

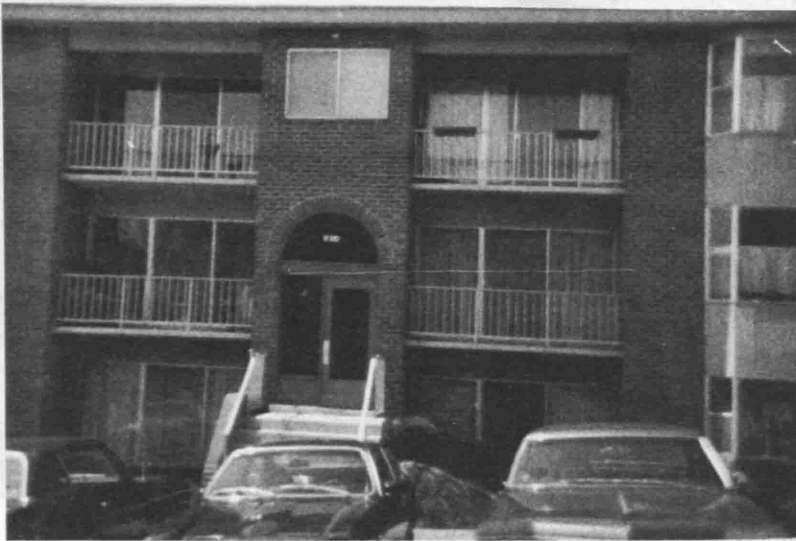
Figure 27 shows a front elevation of a typical three-story unit of a garden apartment complex with flat mineral surface built-up roofs. Figures 28 -31 show overall views of the roof damage suffered by the apartment complex. The prevailing wind direction is shown in figure 28. The figure also shows that the roofs overhanging the balconies were ripped off by the wind. The view through the window on the upper left of figure 29 shows that part of the roof and ceiling over the living unit is removed. Another front view of the damage is given in figure 30 and a side view in figure 31. Figure 32 shows some of the debris of the collapsed roof. The roof construction consisted of 2 x 8 (5 x 20 cm nominal) wooden joists 24 inches (61.0 cm) on centers with plywood on both sides of the joists. This flat roof was then covered with a composite roofing. No information was available on the anchorage between the joists of the roof structure and the masonry walls of the building and no evidence of anchorage could be found in the field examination. Apparently, the wind exerted substantial uplift on the overhanging portions of the roof and in particular on sections of the roof covering the balconies. Evidence of this uplift can be seen in Figure 33. Note the separation between the roof (which is in this case still in place) and the masonry wall. Figure 34 shows that the portion of the roof overhanging the balcony was supported by a beam which in this case stayed in place while the roof was demolished. In figure 35 a case is shown where the beam was also pulled out from its bearing socket. An overall view of the roof under repair is shown in figure 36. The areas under repair in this figure give an indication of the extent of the damage suffered.

Figure 27 - Front elevation of a typical three-story apartment building.

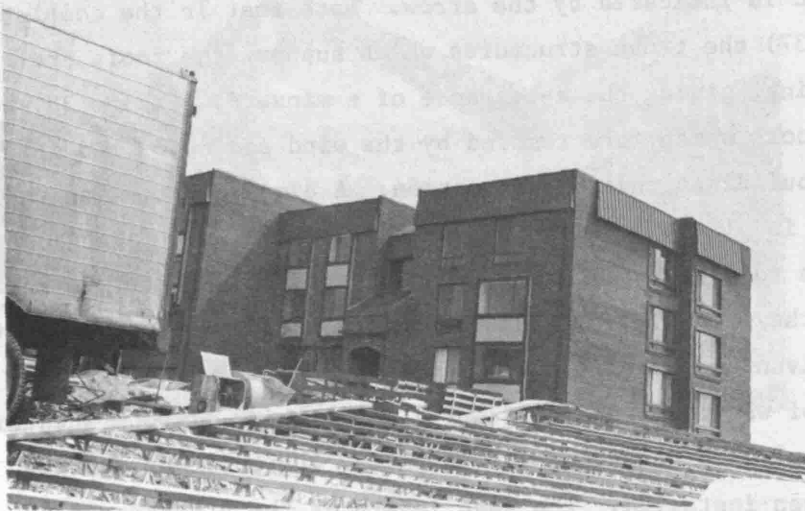
Figure 37 shows a three-story garden apartment building. This is one of the completed units which suffered no damage. Figure 38 shows a row of the same type of units under construction. The prevailing wind direction is indicated by the arrow. Note that in the completed unit (figure 37) the truss structures which support the roofs are closed by siding, giving the appearance of a mansard. Figure 38 shows part of the roofs which were removed by the wind and deposited in front of the buildings under construction. A closer look at an undisturbed roof assembly in place is shown in figure 39. Figures 40 and 41 show details of the roof assemblies which were lifted up, overturned and deposited on the ground. The truss structure had wooden top and bottom chords and galvanized steel tubing as diagonal truss members. The top of the roof was covered by 1/2 in (1.3 cm) thick plywood sheathing. Although this plywood sheathing was in place, the built-up roofing had not yet been installed. The span length of the trusses was 49 ft (14.9m) and spacing between trusses was 24 in (61.0 cm). Connections of the roof trusses to the masonry walls are shown in figures 42, 43 and 44. Figure 44 shows that not only was the roof truss structure removed, but also a steel beam which served as a lintel over a window opening. One of these lintels, in place, is marked by the arrow in figure 45. Two of the displaced lintels are seen, still attached to the trusses in figure 38. The failure of these roofs is probably attributable to two causes: 1. the sides of the trusses were open and the windows were not completed, thus providing openings which caused pressure buildup on the underside of the roof sheathing; this pressure, together with suction acting on the top of roof surface exerted a considerable upward force; 2. the built-up roofing was not yet in place to add weight which could have contributed to the resistance to uplift pressure. Figure 45 shows the details of roof trusses on units which were under construction and which were not damaged by the wind.

Figure 37 - A completed three-story garden apartment building.

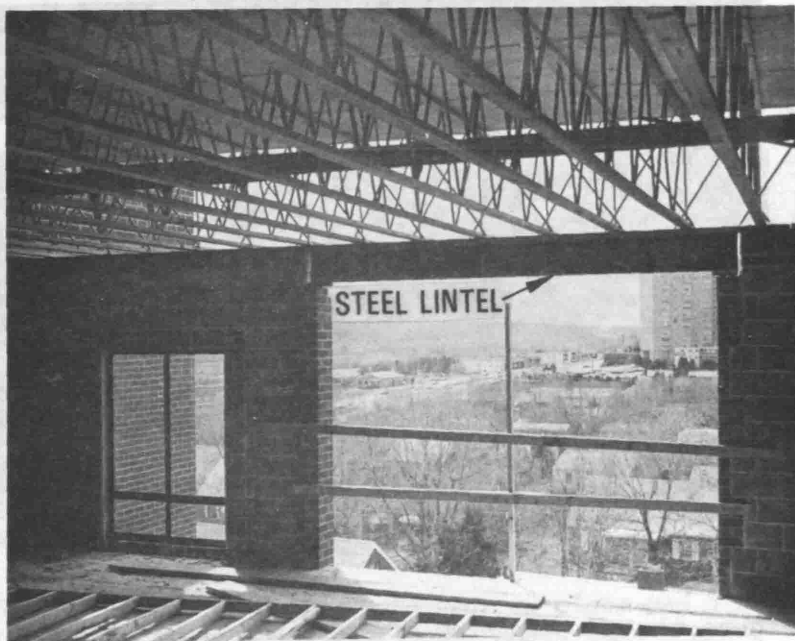
Figure 39 - Closeup view of the underside of a typical roof assembly.

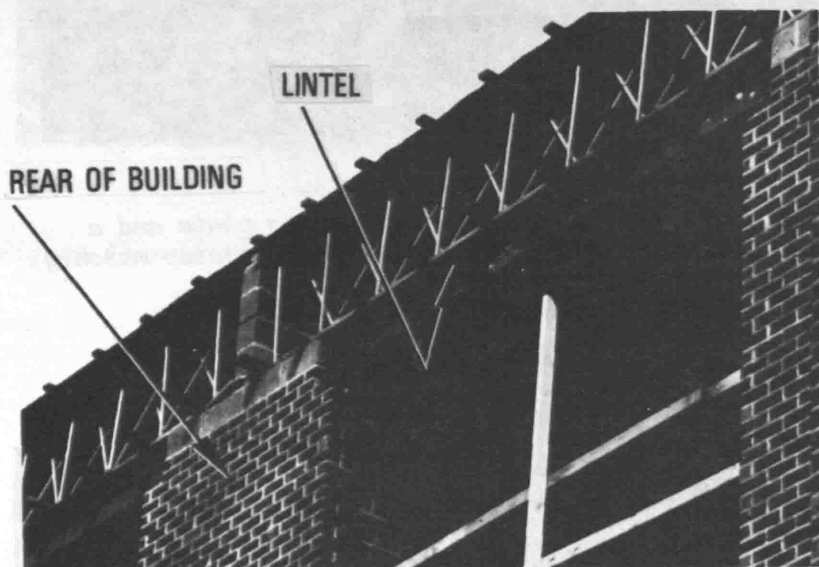
Figure 45 - Rear view of roof truss support in an undamaged building. Looking east.

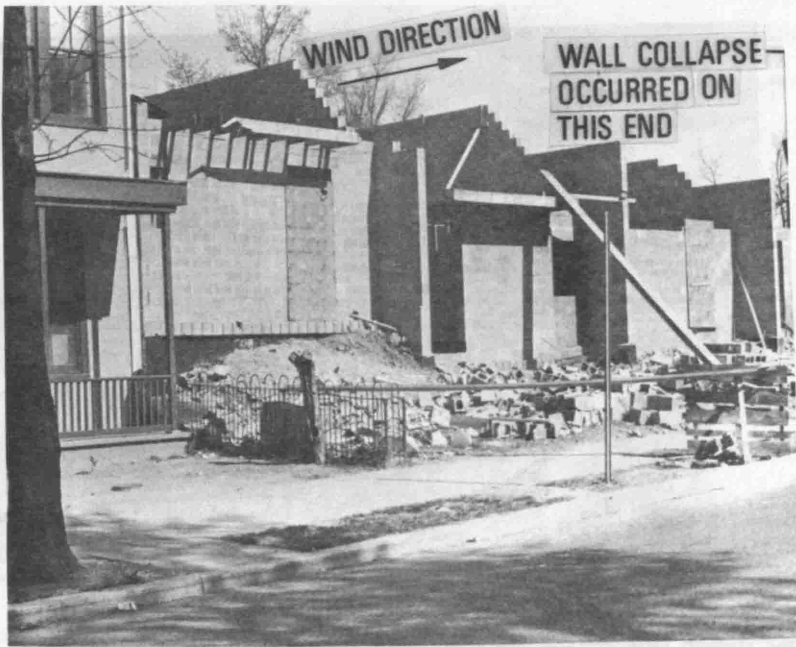
Figure 46 shows the end unit of a four-unit concrete masonry row house under construction. The exterior side wall of this unit collapsed and fell into the street causing two fatalities. (See the debris in the foreground of the photograph). Figures 47 and 48 are other views of the same structure taken from another street at right angles to the one into which the wall collapsed. The direction of the prevailing wind is shown by the arrow in figure 47. Note the partial collapse (figure 48) of cross-walls in other portions of the structure which were parallel to the exterior wall that collapsed. Details of the pulled-out joint reinforcement in one of the damaged cross-walls is shown in figure 49. The construction was 8 in (20 cm) unreinforced hollow concrete block with joint reinforcement. The incident illustrates the vulnerability of masonry walls in the construction stage before they are fully braced at their tops.

Figure 47 - Front elevation of three of the living units in row house complex.
