TECHNICAL NOTE 569

Hurricane Camille - August 1969

A Survey of Structural Damage
Along the Mississippi Gulf Coast

Robert D. Dikkers, Richard D. Marshall
and H.C.S. Thom

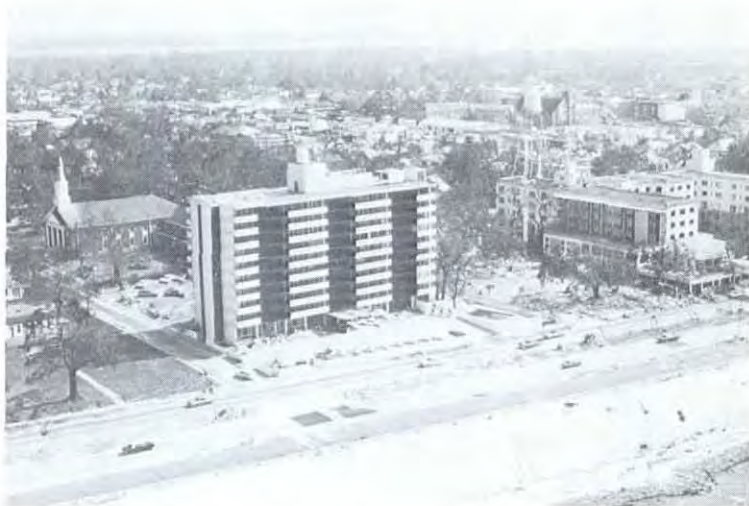
Figure 8. Coastal area, Biloxi, Mississippi.

Structures on slightly higher ground fared much better even though their ground floors and basements were flooded (fig. 8). Generally, surge damage was limited to those areas within two blocks of the beach.

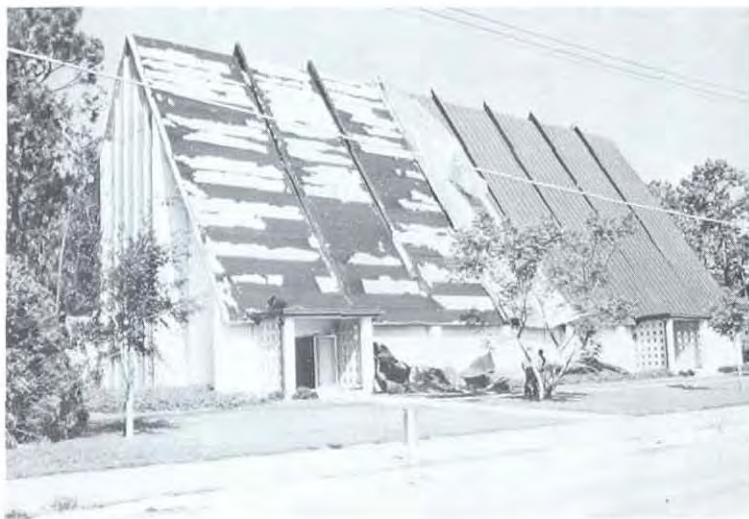
Figure 9. Chapel, Keesler Air Force Base, Biloxi.

Keesler Air Force Base - Damage to buildings was limited to loss of cladding and roofing with some flooding occurring in housing developments located along the back bay. The chapel shown in figure 9 suffered the most serious damage with the loss of copper roofing and subsequent water damage to the interior furnishings. Single-family dwellings with wind-resistant shingles exhibited very little damage (fig. 10).

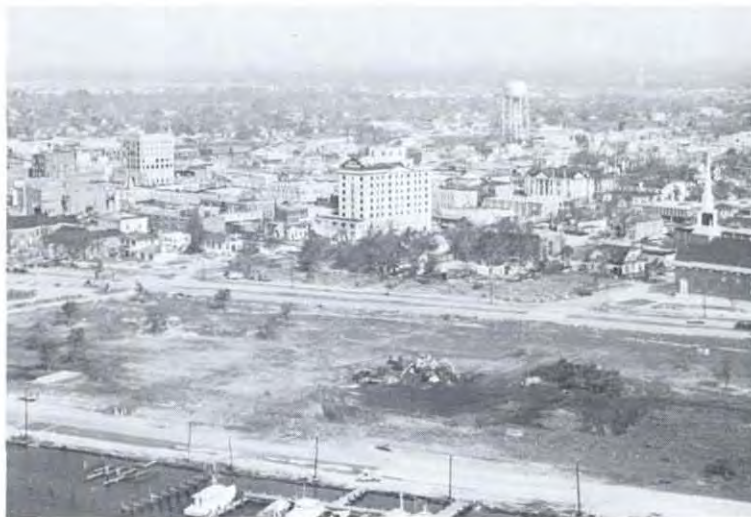
Figure 16. Marine Life Aquarium, Gulfport.

20-ft storm surge. One group of buildings in this area comprised the Marine Life Aquarium (fig. 16). The large steel-arched building at the left provided shelter for a display tank and a concrete seating area. Detailed description of the damage to these structures has been reported by another survey team [10].

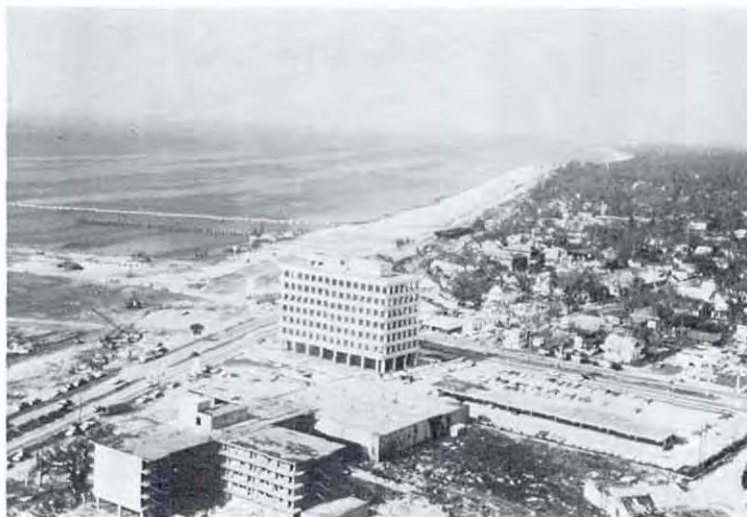
Figure 20. Close-up view of Mississippi Power Company building.

through seventh floors (fig. 20) [11]. The large first-floor windows were protected from flying or floating debris by a wire fabric screen which was erected just prior to the storm. The windows consist of one-inch thick panels of insulating reflective glass set in bronze anodized aluminum framing with neoprene gaskets. The neoprene gaskets provide a resilient mounting for the glass and prevented metal-to-glass contact and minimized breakage. After the storm, it was reported that, out of more than 500 windows, a total of 13 lights had to be replaced [11].

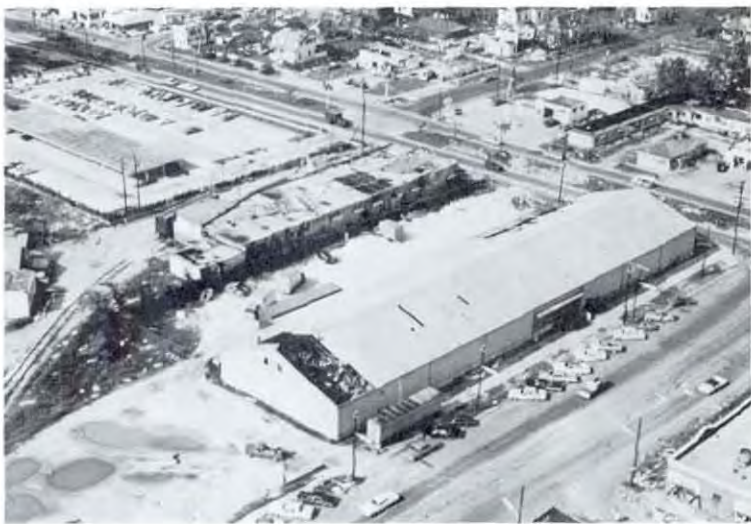
Figure 23. Area directly east of Mississippi Power Company building, Gulfport, Mississippi.

Figures 22 through 24 indicate the general level of damage in the area surrounding the Mississippi Power Company. The prefabricated metal building in figure 22 again points up the importance of local wind effects when designing roof elements. The random distribution of damage shown in figure 23 is typical of the entire area covered by the survey. Failures of roofing are usually progressive as is indicated in figure 24. Gravel from this built-up roof contributed considerably to the flying debris.

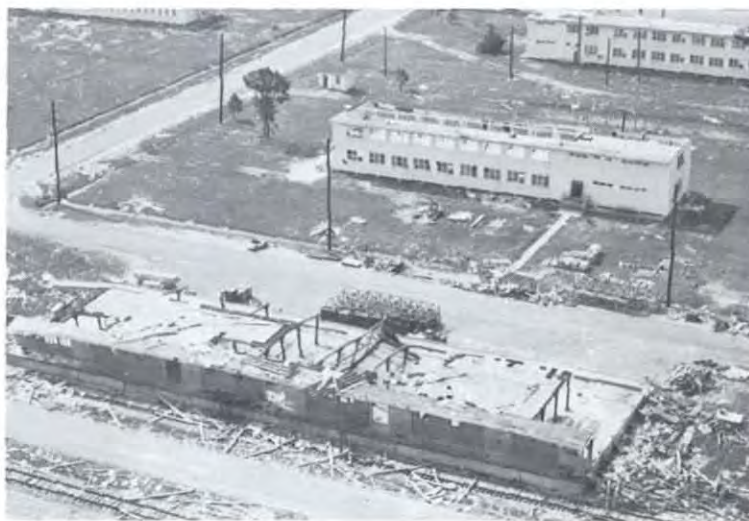
Figure 36. U.S. Naval C. B. Center, Gulfport.

broken off some distance above the ground (fig. 36).

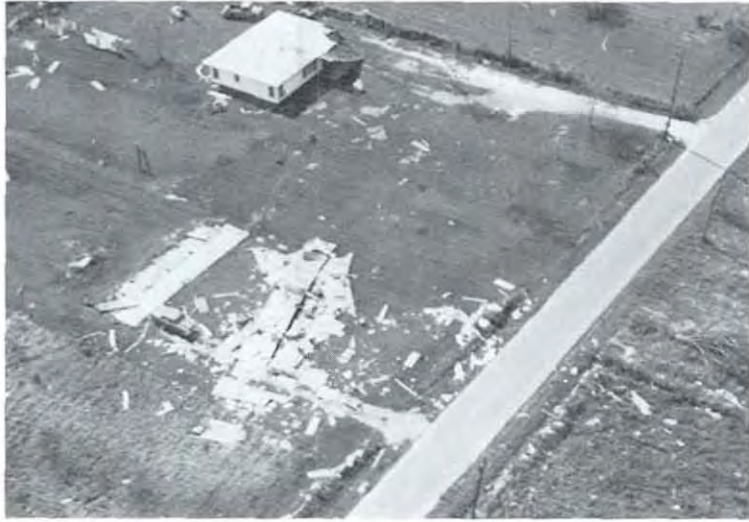
Figure 43. Saint Thomas Catholic Church, Long Beach, Mississippi.

Figure 43 shows a wood-frame church which was badly damaged by wave action. Commercial buildings located in a shopping center on U.S. Highway 90 are shown in figures 44-46. A small store constructed with masonry walls and located on the coastal side from the supermarket shown in figures 45 and 46 was completely destroyed. The church building shown in the center background of figure 45 had considerable storm surge damage to its interior although its exterior walls and roof were only slightly damaged.

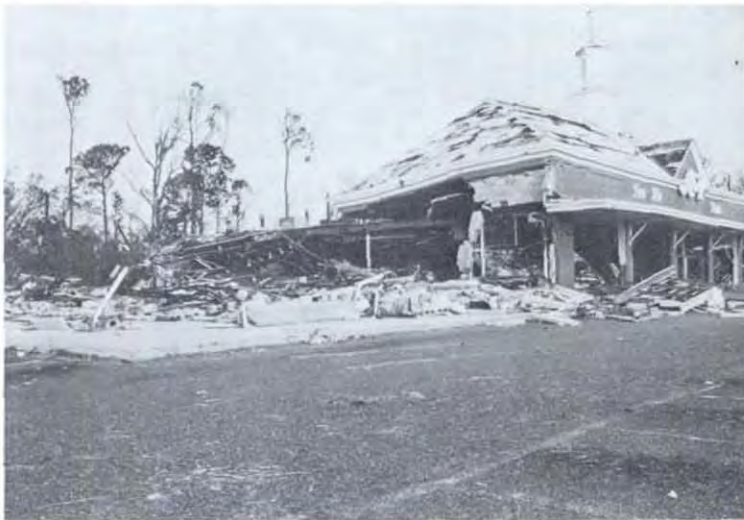
Figure 47. Close-up view of residential building, Long Beach, Mississippi.

Water-borne debris piled up in front of a damaged masonry veneer wood-frame building (probably a motel) is illustrated in figure 47.

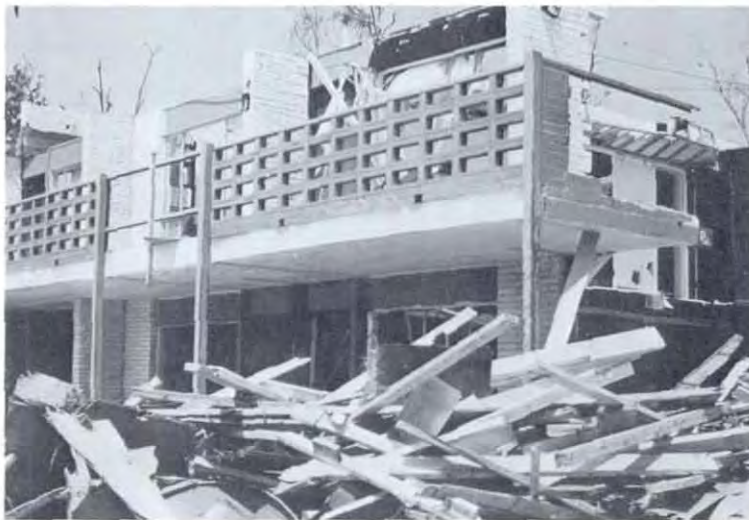
Figure 48. Ramada Inn, Long Beach, Mississippi.

Ramada Inn - This motel (fig. 48) consists of a main building parallel to the highway (U.S. Route 90) plus two wings perpendicular to and behind the main building. As shown in figure 48, the motel wing on the right (east wing) suffered more damage than the other wing, probably because of its clearer exposure to the waves. The main building including

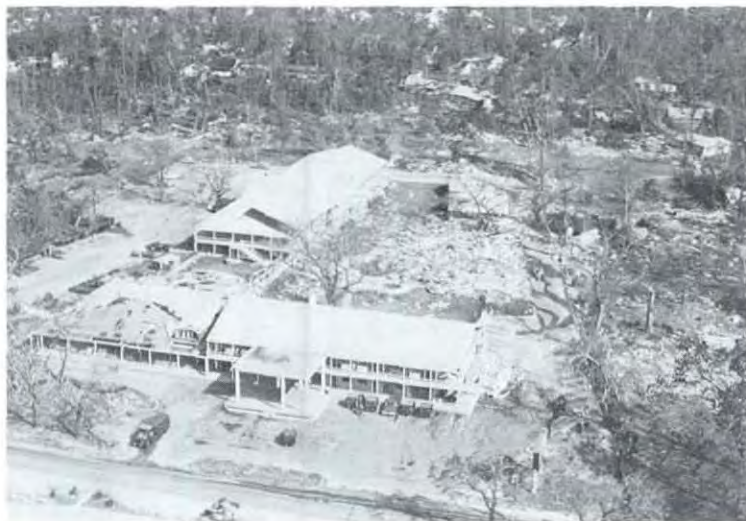
Figure 49. Restaurant area on west end of main building, Ramada Inn, Long Beach.

the restaurant area (fig. 49) experienced extensive water damage. On the east end of the main building, the top-story portion of a masonry wall had collapsed (fig. 50). An inspection of this brick and block wall indicated it contained some vertical reinforcement; however, the block cells containing this reinforcement did not contain any grout or concrete (fig. 51).

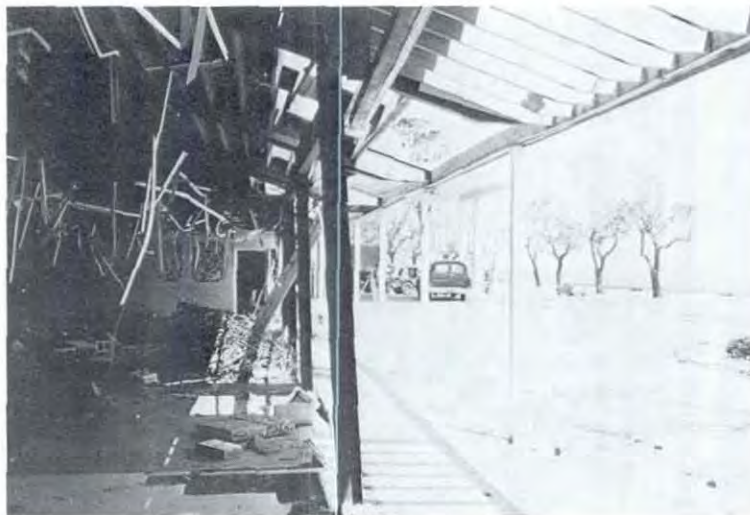
Figure 50. Damaged masonry wall on east end of main building, Ramada Inn.

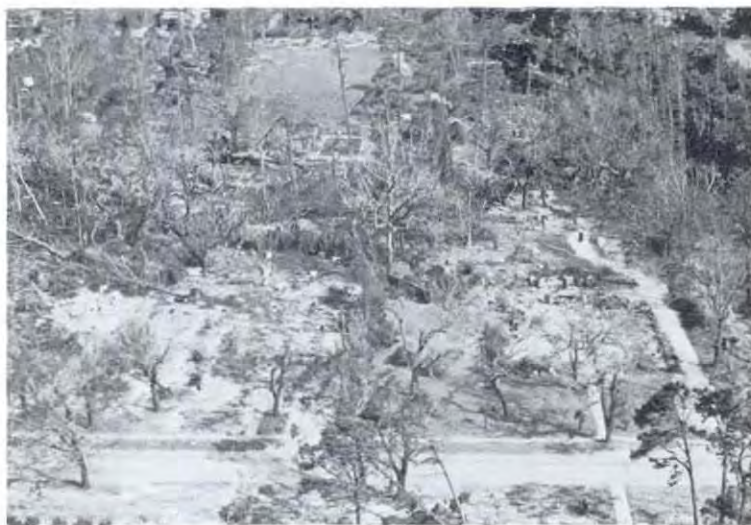
Figure 53. Coastal area, Long Beach.

Figures 52 and 53 illustrate the total destruction of numerous small residential buildings along the Long Beach and Pass Christian coastal area. The distance which the storm surge traveled inland is also evident in these figures.

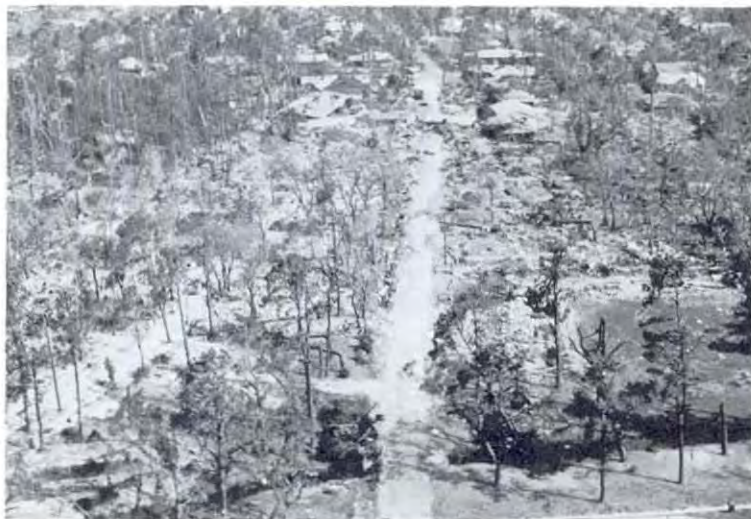
Figure 54. Richelieu Apartments, Pass Christian.

Along the coastal area in Pass Christian, several apartment buildings were totally destroyed by wave action. One of these buildings was the Richelieu Apartments (fig. 54) where 23 persons were killed because they failed to heed warnings to evacuate. A close-up view of the remains of the Richelieu Apartments, a three-story brick veneer and wood-frame building is shown in figure 55.

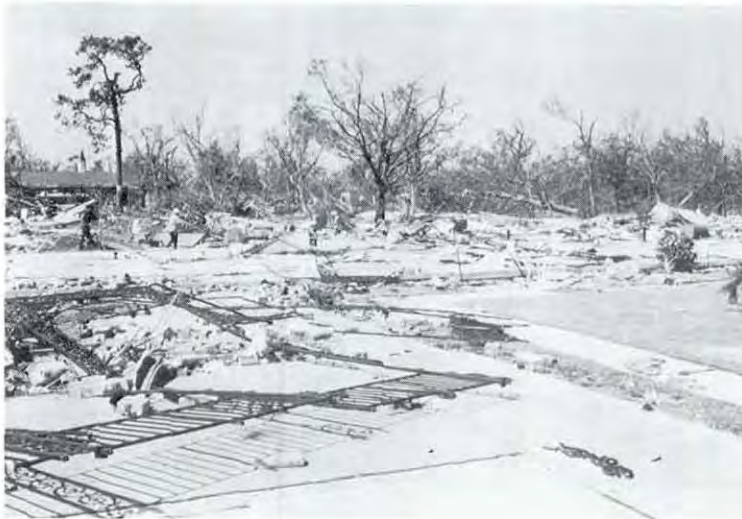
Figure 56. Remains of an apartment building, Pass Christian, Mississippi.

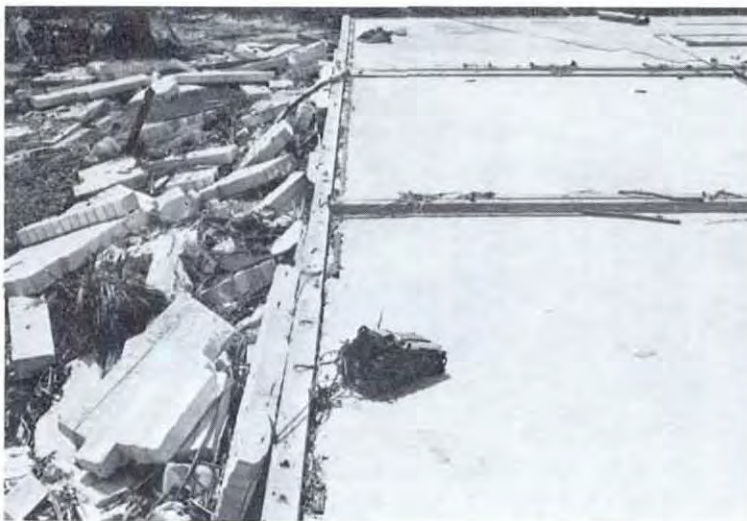
Figure 57. Brick veneer from destroyed apartment building, Pass Christian.

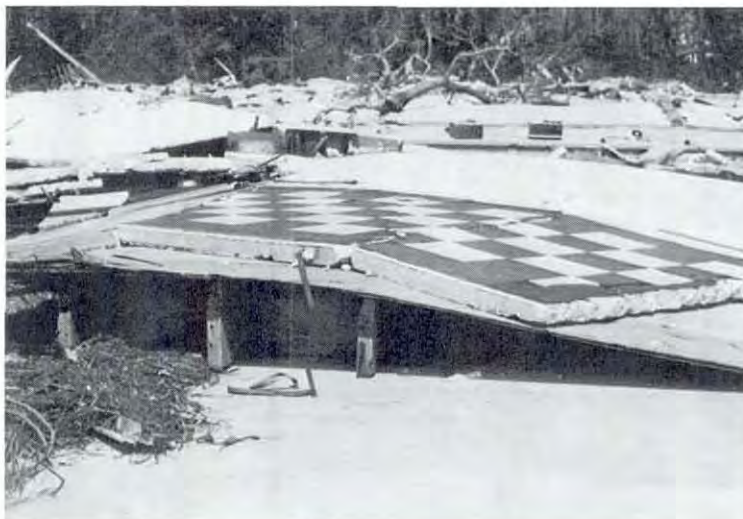
Figure 58. Floor construction used in some apartment buildings, Pass Christian.

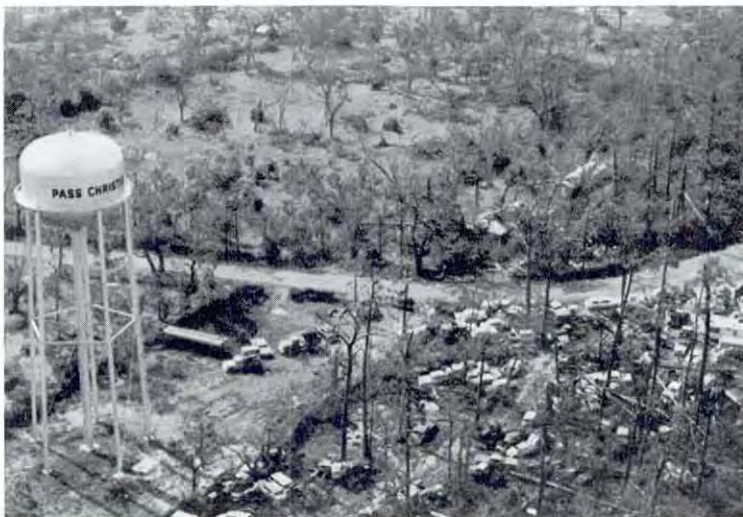
A residential area of Pass Christian is shown in figure 59. Fallen trees indicate that maximum winds were from the east (fastest mile speeds were probably in excess of 140 mph). The Pass Christian business

Figure 59. Residential area, Pass Christian, Mississippi.

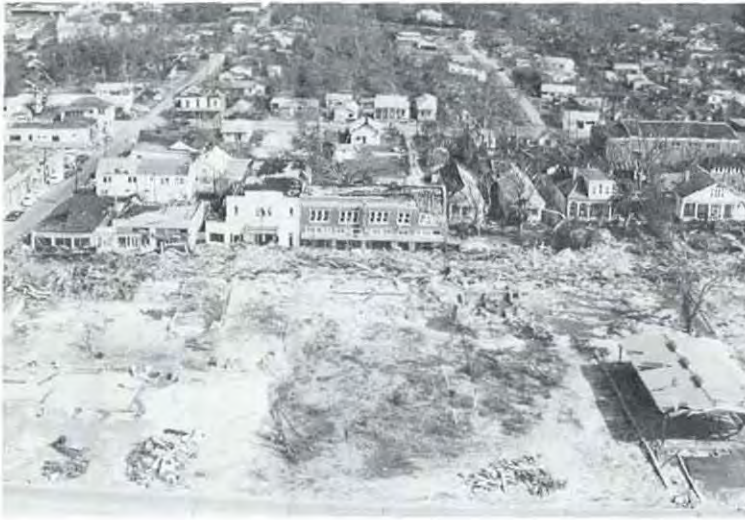
district suffered extensive damage as illustrated in figure 60. The debris in the center of the figure is all that remains of the commercial buildings which were located on the south (near) side of the street. Note U.S. Highway 90 in the foreground. Accumulations of debris were particularly heavy in the back bay areas and along the beaches of Mississippi Sound as indicated in figure 61.

Figure 60. Business area, Pass Christian, Mississippi.

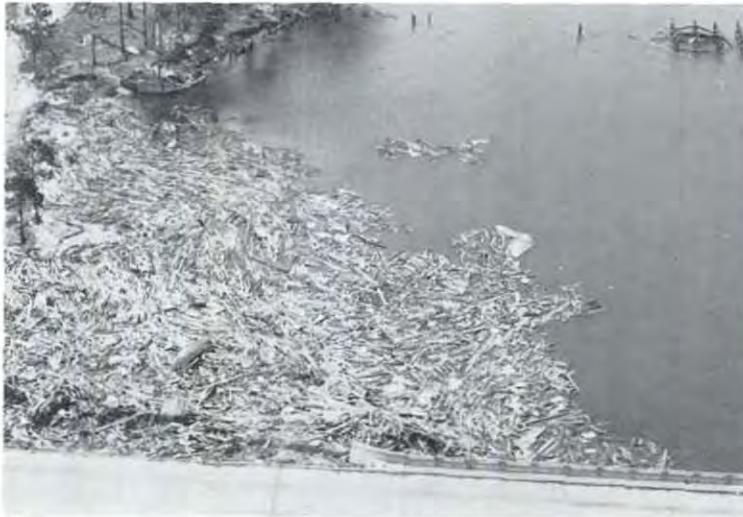
Figure 61. Debris along east abutment of Bay St. Louis Bridge.

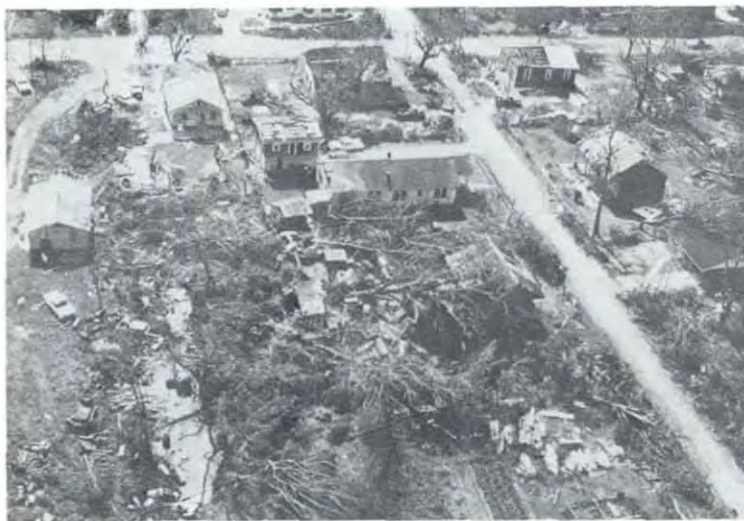
Figures 64 and 65 indicate the intensity of damage in the Bay St. Louis residential area. It is believed that the center or "eye" of Camille passed directly over this portion of the city. Note that most of the trees have been uprooted rather than broken off.

Figure 65. Residential area, Bay St. Louis.

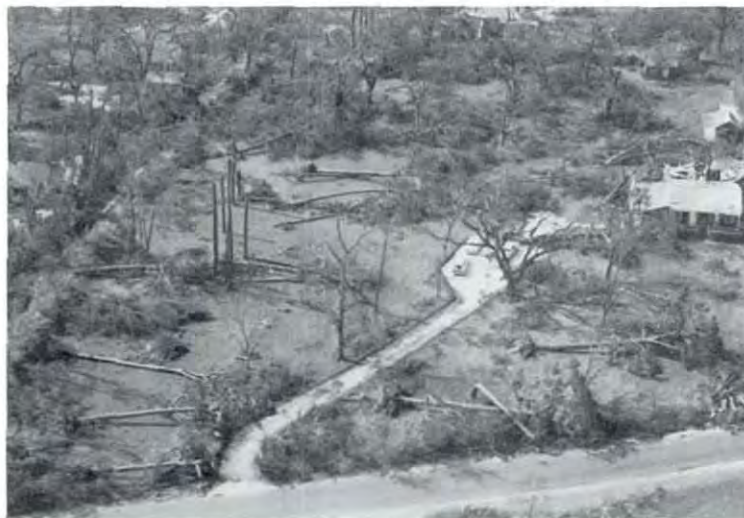
One of a group of modern single-family dwellings near Bay St. Louis, which suffered only minor wind damage, is shown in figure 66. In this and several other dwellings, it was noted that the corner supports for the carports were either slightly damaged or completely destroyed. The wind-resistant asphalt shingles on the houses performed very well.

Figure 66. Single-family residence near Bay St. Louis.

In general, wood-frame residential buildings (figs. 10, 25, 27, 66) performed very well where they were constructed in accordance with current recommendations [7, 14, 15]. As demonstrated in Hurricane Camille as well as in previous hurricanes, it is essential that wood-frame buildings be properly anchored to their foundations, and walls, floors and roofs adequately tied together.

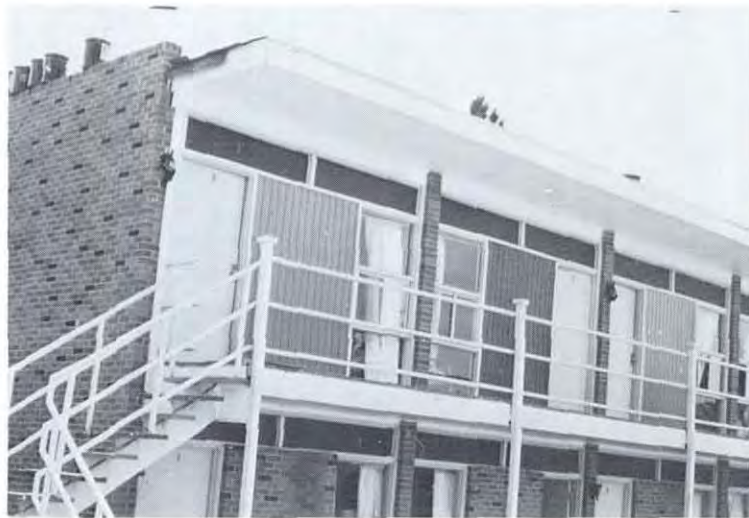
A small two-story motel located about 3 miles from the coast and on U.S. Route 90 near Waveland, Mississippi, is shown in figure 69. This brick-veneer and wood-frame building was arranged in a U-shaped plan and had a flat roof overhanging the second floor exit balcony. The direction of the wind was such that it resulted in one wing of the motel losing only part of its built-up roofing (fig. 69), while the other motel wing (fig. 70) was stripped of its entire roof structure due to the uplift forces acting on the roof overhang.

Figure 70. Damaged wing of motel shown in figure 69.
