NIST Response to the World Trade Center Disaster

World Trade Center Investigation Status

June 22, 2004

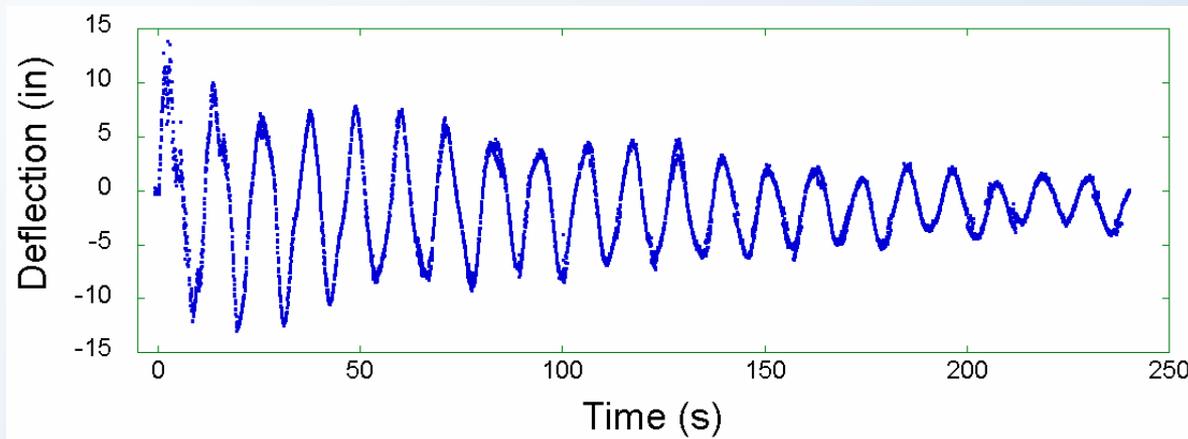
- The two WTC towers withstood the initial impact of virtually identical aircraft (Boeing 767-200ER) during the terrorist attacks of September 11, 2001.
- The robustness of the perimeter frame-tube system and large dimensional size of the WTC towers helped the buildings withstand the aircraft impact.

- The WTC towers displayed significant reserve capacity, vibrating immediately following impact with amplitudes that were about half the amplitudes for design wind conditions expected by the building designers and an oscillation period nearly equal to that measured for the undamaged building.

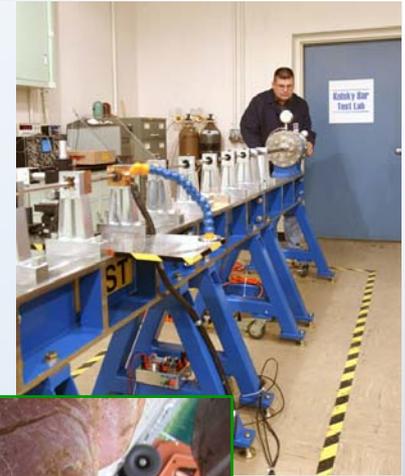
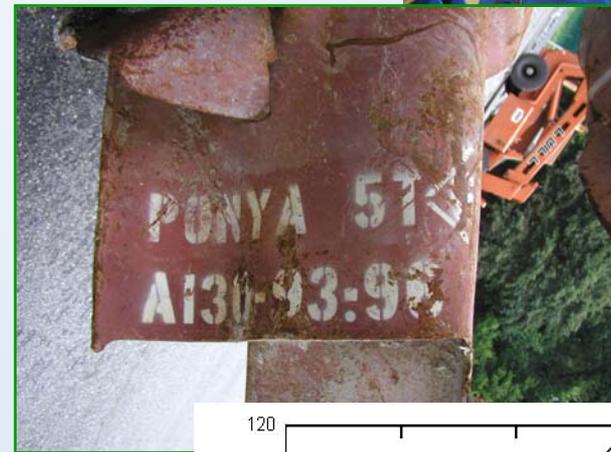
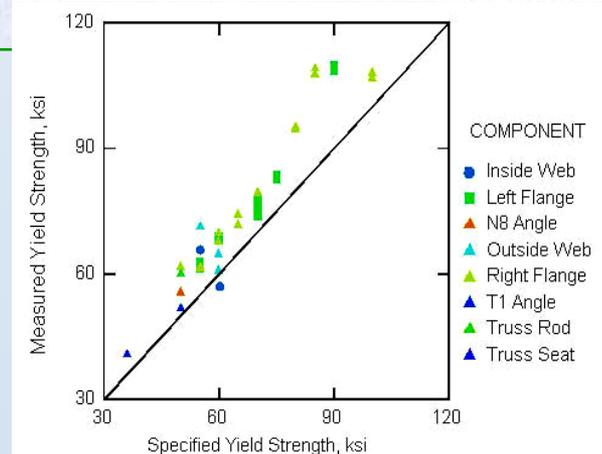
- ❑ Metallography and mechanical property tests indicate that the **strength and quality of the steel used in the towers was adequate, typical of the era, and likely met all qualifying test requirements.**

- ❑ **The room-temperature strength of steel used in the WTC towers met relevant standards** and, in many instances, exceeded requirements by 5 to 10 percent.
