NIST Response to the World Trade Center Disaster

World Trade Center Investigation Status

October 19, 2004

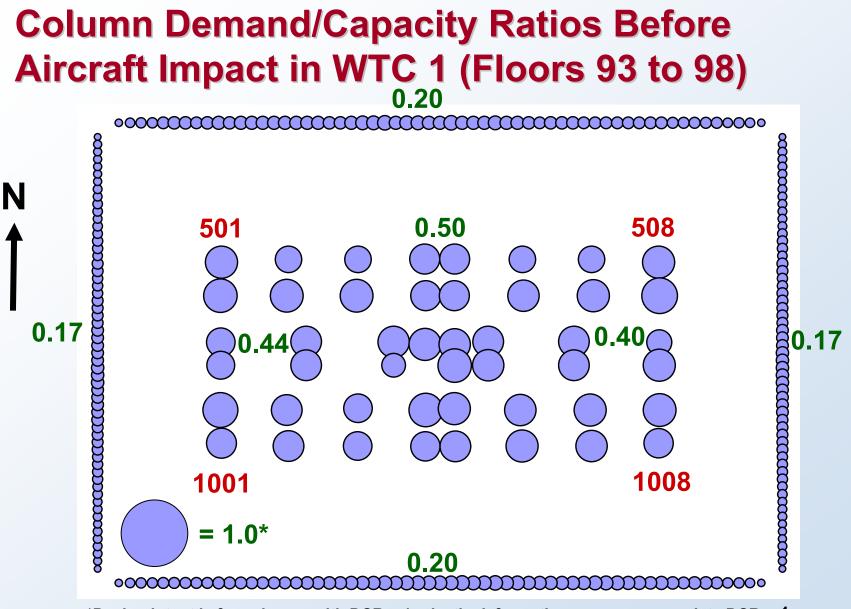
Aircraft Impact Damage to WTC 1

*Design intent is for columns with DCR < 1; plastic deformations can accommodate DCR > 1

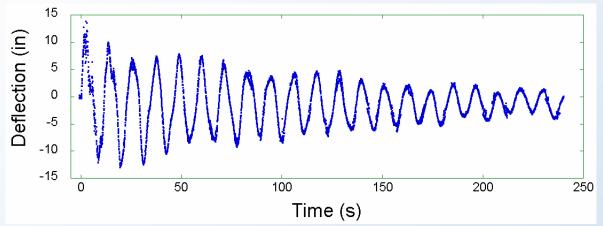
Aircraft Impact Damage to WTC Tower Structures

- The two WTC towers withstood the initial impact of virtually identical aircraft (Boeing 767-200ER) during the terrorist attacks of September 11, 2001.
- The robustness of the perimeter frame-tube system and large dimensional size of the WTC towers helped the buildings withstand the aircraft impact.

- The WTC towers displayed significant reserve capacity, vibrating immediately following impact with amplitudes that were about 40 percent of the amplitudes for design wind conditions expected by the building designers and an oscillation period nearly equal to that measured for the undamaged building.
- Calculations of demand to capacity ratios due to aircraft impact damage showed that for the floors
 affected by the aircraft impacts, the majority of the core and perimeter columns in both towers
 continued to carry their loads after the impact. The loads from damaged and severed columns were
 taken over by nearby undamaged columns.
- The above finding supports the fact that the WTC towers withstood the initial aircraft impact and the finding that they would have continued to remain standing indefinitely but for another significant event such as the subsequent fires.

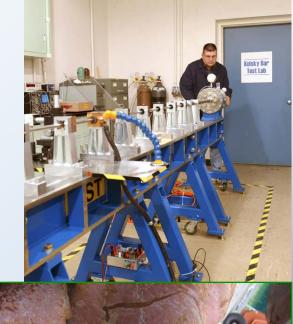
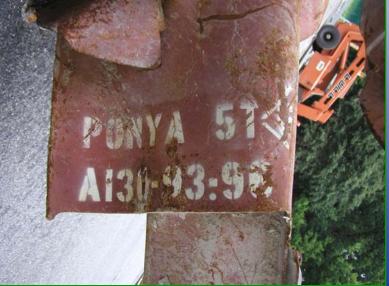
Analysis of Recovered WTC Steel

- NIST has a total of 236 WTC steel pieces in its possession; collection was adequate for determining the quality and properties of steel for the investigation.
 - Impact/fire damage region emphasized
 - All 14 grades of steel for perimeter columns
 - Both grades for steel trusses
 - Two grades (representing 99%) for core columns
- Based on stampings on steel and mechanical tests, analysis indicated that the correct specified materials were provided for specified elements; when these data are combined with available pre-collapse photographs, aircraft impacted pieces from WTC 1 were in precise locations specified in design drawings

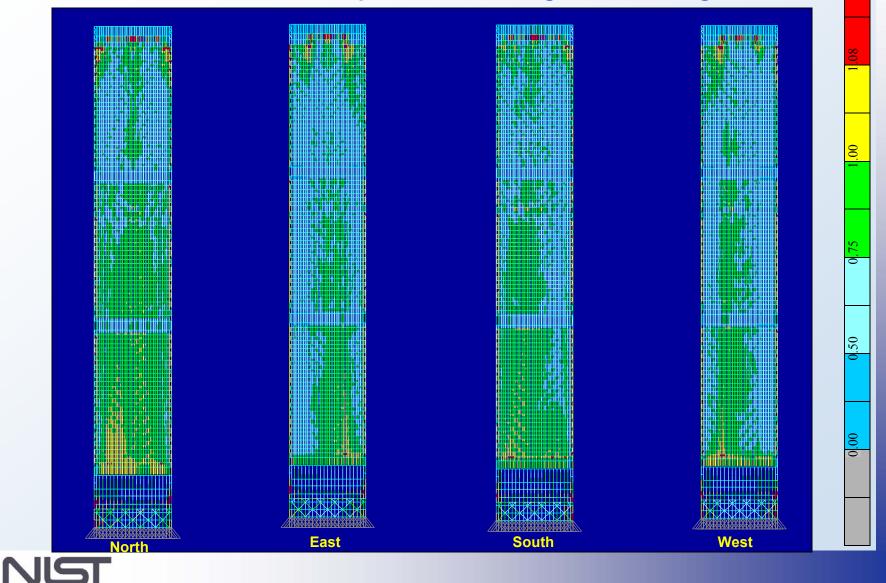
Results of Baseline Analysis for WTC 1

DCRs for Structural Components under Original WTC Design Loads
