NIST Ionizing Radiation Safety Committee Initial Report of Plutonium Contamination at NIST Boulder

July 30, 2008

IRSC Initial Report of Plutonium Contamination at NIST Boulder

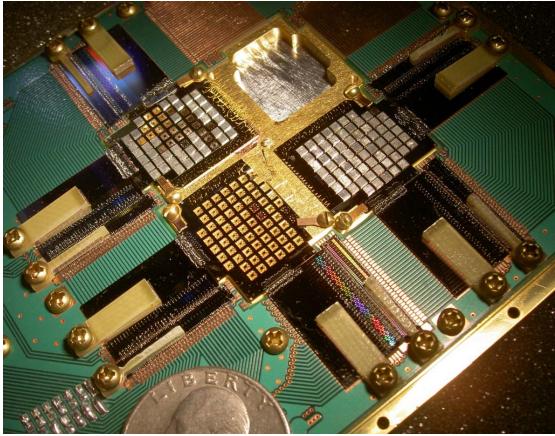
Figure 5. Photograph of gamma-ray microcalorimeter arrays and SQUID readout circuitry. Silvergrey squares are individual sensing elements and are 1.5 mm on a side. The accident of June 9 occurred during testing of the sub-array on the right side of the figure.

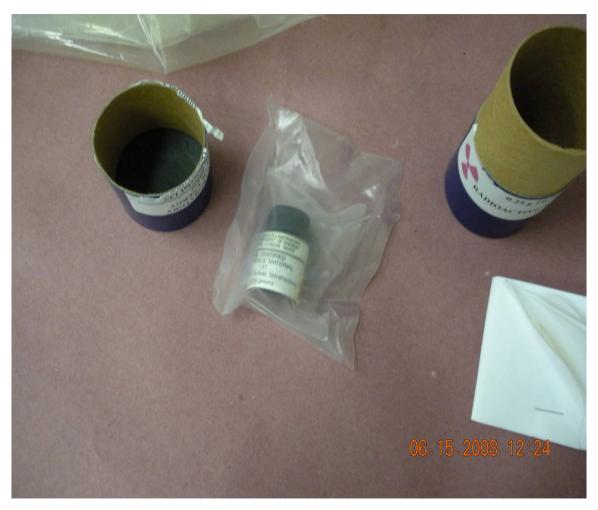
Figure 7. Photograph from the DOE RAP team investigation of one of the undamaged sources (CRM 137) still in the original sealed plastic bag.
