# NIST Building 101

## Historic Structure Report and Condition Assessment

Final Submission  
March 15, 2020

**John Milner Associates Preservation**

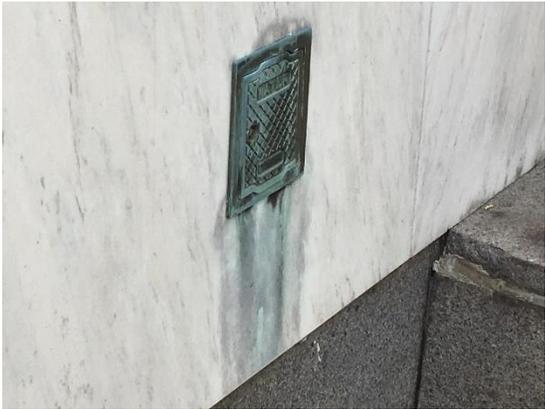
<p>A rectangular bronze access panel covers each hose bib location. The face of each panel door features an embossed cross hatch pattern. Raised block letters spell out “WATER” in all capitals. Bronze panels are corroding and staining surrounding marble bluish green and gray.</p>

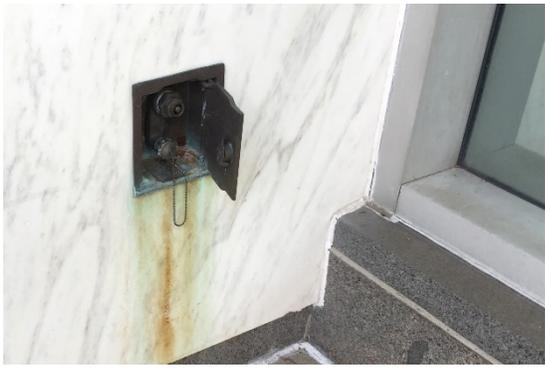
<p>A rectangular bronze access panel covers each hose bib location. The face of each panel door features an embossed cross hatch pattern. Raised block letters spell out "WATER" in all capitals. Bronze panels are corroding and staining surrounding marble bluish green and gray.</p>

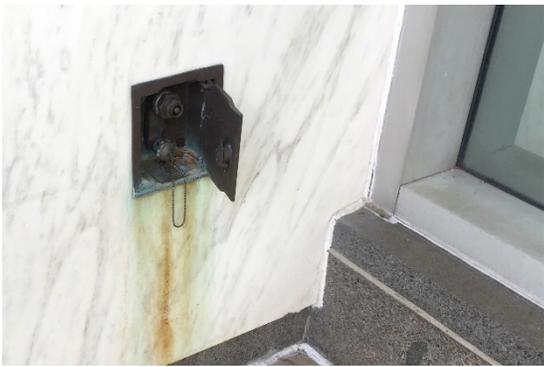
<p>A rectangular bronze access panel covers each hose bib location. The face of each panel door features an embossed cross hatch pattern. Raised block letters spell out “WATER” in all capitals. Bronze panels are corroding and staining surrounding marble bluish green and gray.</p>

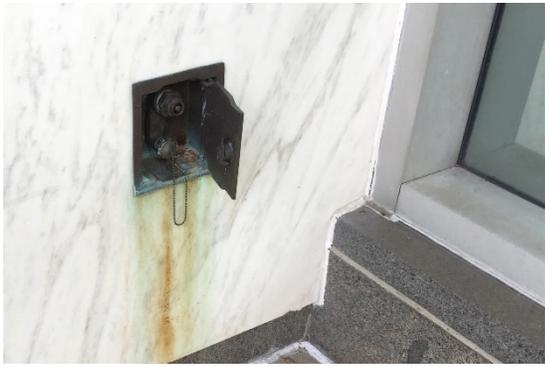
<p>A rectangular bronze access panel covers each hose bib location. The face of each panel door features an embossed cross hatch pattern. Raised block letters spell out “WATER” in all capitals. Bronze panels are corroding and staining surrounding marble bluish green and gray.</p>

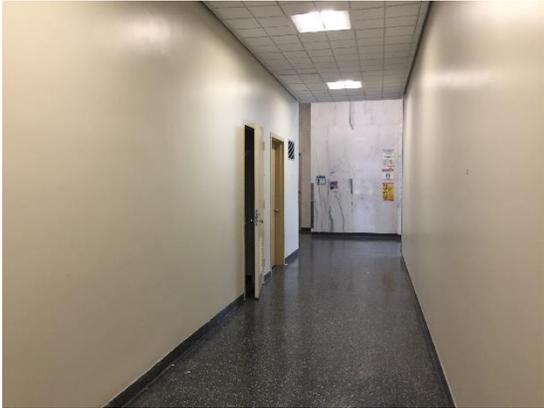
Base	Terrazzo	Polished	1966	
<p>The corridor to the north of the Green Auditorium has painted plaster walls. This corridor is much more utilitarian than the other corridors in Wing B. It provides access to the two stairwells behind the Green Auditorium, two janitor's closets, and two small conference rooms.</p>				
Curtain Wall	Anodized Aluminum/ Glass	Clear Satin/ Clear	1966

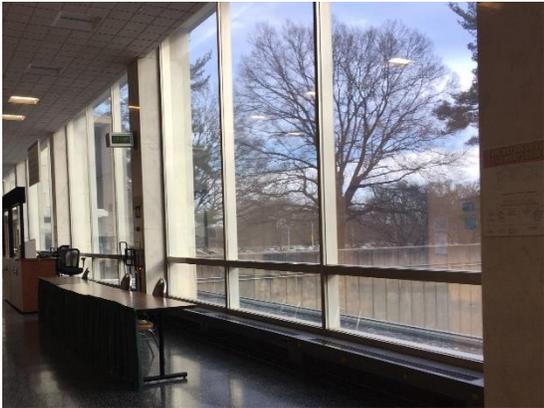
<p>All exterior walls are aluminum-and-glass curtain wall. Tripartite bays of aluminum-and-glass curtain wall span between marble-clad concrete columns. Each tripartite bay features six lites – three large vertical lites above and three smaller horizontal lites below.</p>				
Door – Double-Leaf	Aluminum/ Glass	Clear Satin/ Clear	1966

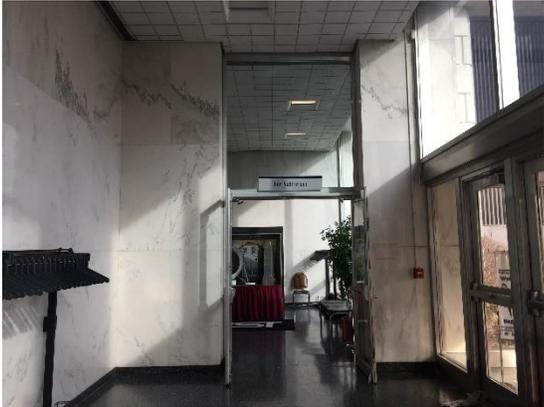
Frame	Aluminum	Clear Satin	1966	
<p>There are two doors of this type. They lead from the corridor into the Red Auditorium Lobby. Doors are full lite. A panic bar visually divides the single lite on the lobby side. It is attached at either end to the two aluminum stiles. There are lever handles on the corridor side and a face-mounted closer on the lobby side. Original hardware has been replaced as part of the retrofit. Each door has a large square transom window that extends from the lintel to the ceiling.</p>

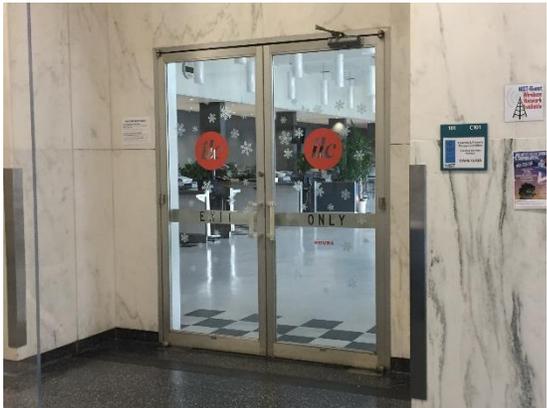
Frame	Aluminum	Clear Satin	1966	
Hardware	Aluminum/ Acrylic	Satin/ Semi-translucent	1966	
<p>This door type leads into the Cafeteria. Doors are full lite. A push bar visually divides the single lite on the Cafeteria side. It is attached at either end to the two aluminum stiles. Pull bar handles are plastic molded into a simple cylinder shape. One door has a face-mounted closer on the corridor side.</p>

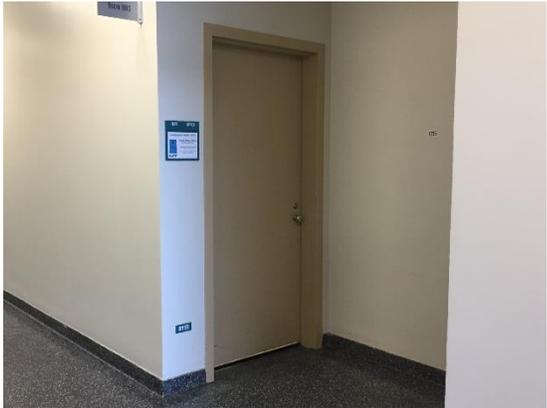
Frame	Steel	Painted	1966	
Hardware	Aluminum	Satin	1966	
<p>Simple hollow metal doors lead into two small conference rooms. Original hardware includes door knobs and deadbolts.</p>				
Door – Single-Leaf	Hollow Metal	Painted	1966

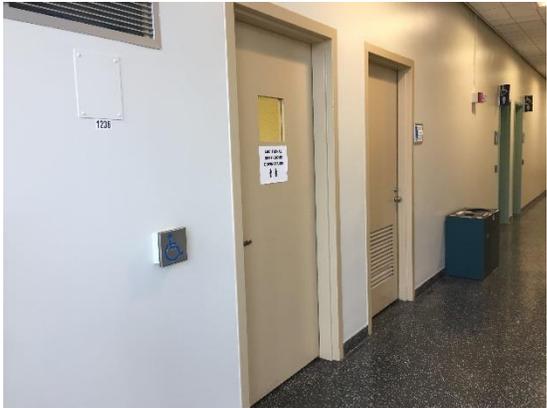
Frame	Steel	Painted	1966	
Hardware	Aluminum	Satin	1966	
<p>Hollow metal fire doors lead into the two stairwells to the north of the Green Auditorium. The single square lite is set with wire glass.</p>

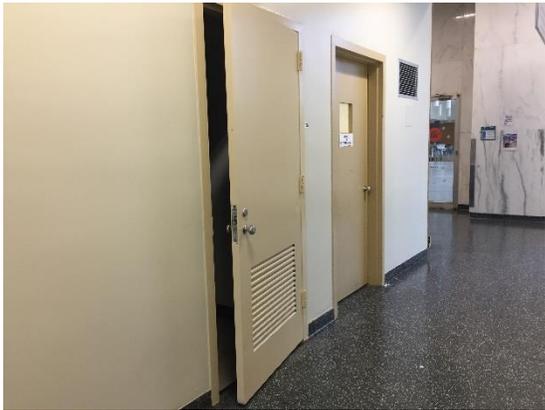
Frame	Steel	Painted	1966	
Hardware	Aluminum	Satin	1966	
<p>Hollow metal doors with louvered vents are found at janitor’s closets in the small corridor to the north of the Green Auditorium.</p>				
Door – Single-Leaf	Stainless Steel	No. 4 Satin Finish	1966

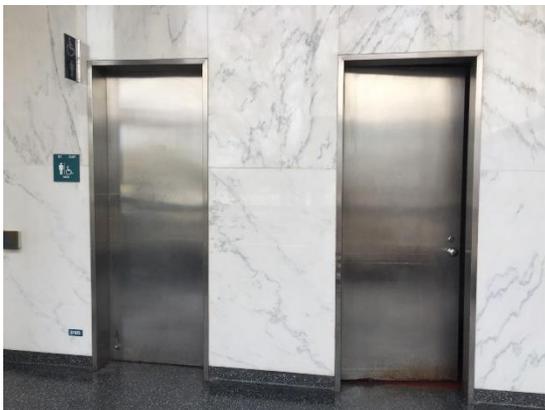
Frame	Stainless Steel	No. 4 Satin Finish	1966	
Hardware	Stainless Steel	Satin	1966	
<p>Single-leaf stainless-steel doors are found at restrooms and a janitor’s closet in the corridor leading to the Red Auditorium. Restroom doors have a flush push plate on the corridor side and a simple pull bar handle on the restroom side. Janitor’s closet doors are fitted with a door knob and deadbolt.</p>				
Door – Single-Leaf	Wood w/ American Walnut Veneer	Stained Lacquer Finish	1966

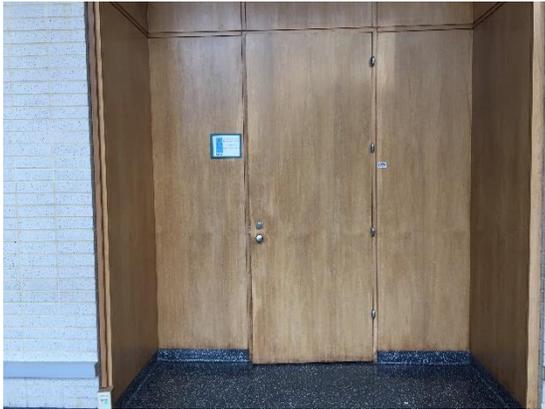
<p>Classroom and lecture room doors are single-leaf with walnut veneer. Each door has four stylized modernist butt hinges. The original hardware set is an aluminum door knob and deadbolt. Some have been altered to a pull bar/push plate and dead bolt. Doors have a face-mounted closer on the room side.</p>

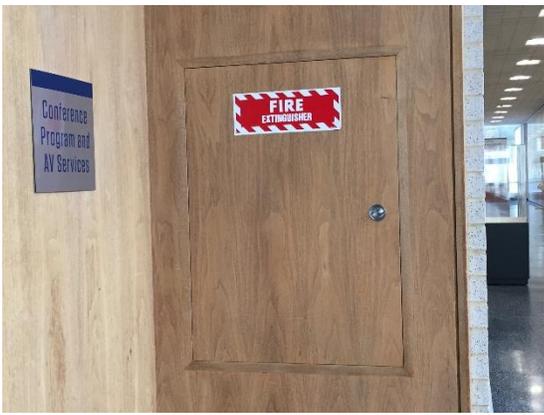
<p>Walnut fire extinguisher cabinets are recessed into the wood paneling at the entrances to lecture halls and classrooms. Original lettering has been removed and replaced with high-visibility signage.</p>

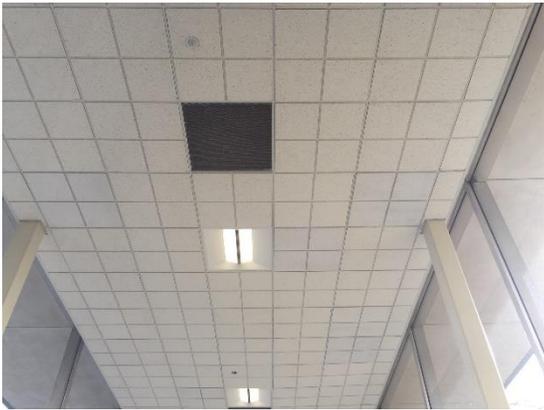
<p>Original corridor ceilings were 12" x 12" prefab acoustic mineral plaster tiles. The existing acoustic tile ceiling was installed after 2001. It has an exposed metal grid.</p>				
Wall	Plaster	Painted	1966

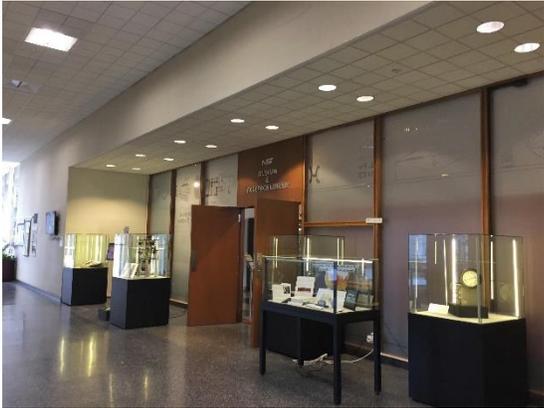
<p>The wall at the museum lobby is glass panels set within a walnut frame. The glass panels are frosted and etched with symbols and documents relevant to the history of NIST. Glass panels were original clear.</p>				
Door – Double-Leaf	Wood w/ American Walnut Veneer	Stained Lacquer	1966

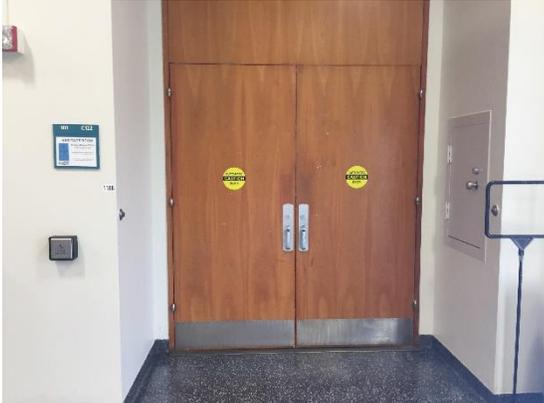
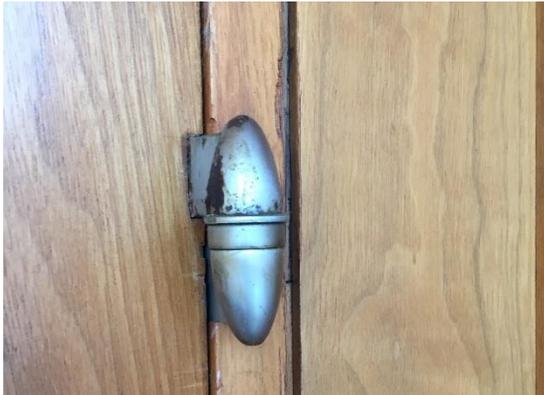
<p><i>Modernist stainless-steel hinge</i></p>
Frame	American Walnut	Stained Lacquer	1966	
Hardware – Hinges	Stainless Steel	Satin	1966	
<p>Walnut doors lead into the Portrait Room, the Heritage Room, and the museum lobby. Doors to the Portrait Room and Heritage Room have been retrofitted as ADA-compliant automatic doors. Original hardware has been replaced as part of the retrofit, except for original modernist hinges that remain.</p>				
Door – Double-Leaf	Anodized Aluminum/ Glass	Clear Satin/ Clear	1966

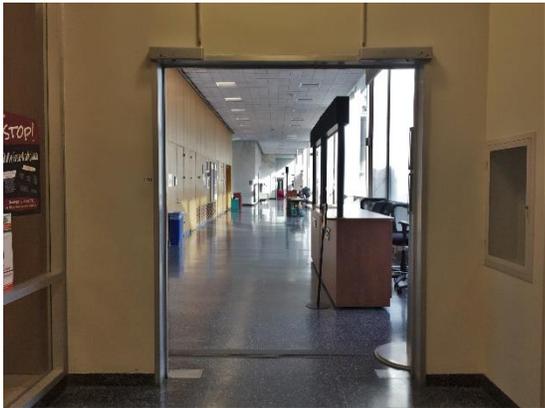
<p>This opening leads from the Wing C Corridor into the Wing B Corridors. The presence of closers and threshold plates indicates there was once a double-leaf door here.</p>				
Floor	Terrazzo	Polished	1966

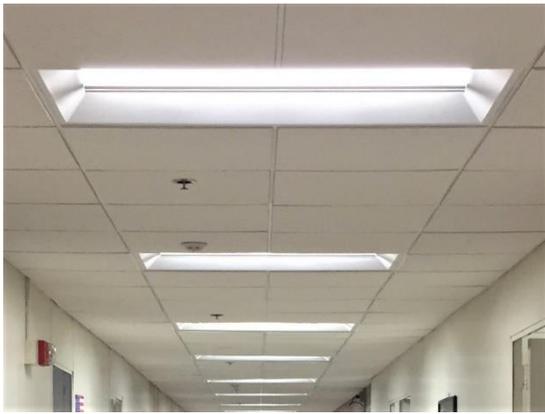
<p>This is the typical ceiling in interior corridors and lobbies. The ceiling height has been lowered.</p>				
Ceiling	Acoustic Tile	Smooth	N/A

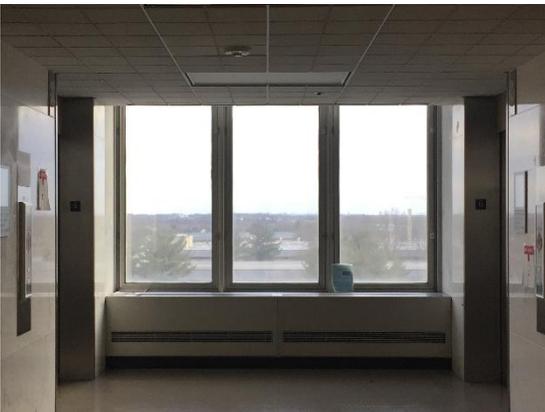
<p>Three rectangular windows are set in the south wall of the elevator lobby on each level. The heads of the windows extend above ceiling height. Originally, ceiling heights were higher in all upper-level corridors.</p>				
Door – Elevator	Stainless Steel	No. 4 Satin	1966

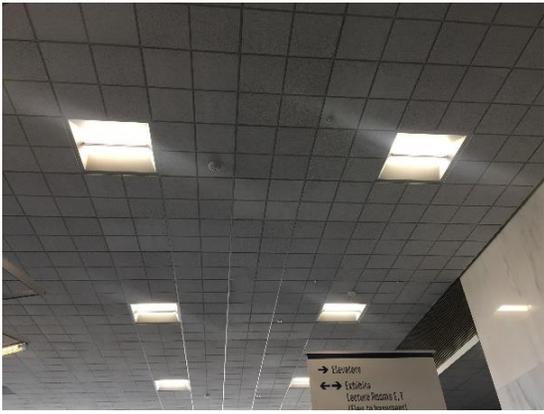
<p>The ceiling consists of smooth acoustic tiles set within an exposed metal grid. Original construction drawings indicate that the ceiling in this location was to be acoustic plaster on metal lath. The acoustic tile ceiling sits at the original ceiling height as depicted in interior elevations in the original drawing set. Therefore, it is unlikely that an earlier plaster ceiling still exists beneath the suspended acoustic tile ceiling. The existing ceiling dates to corridor ceiling modifications that took place sometime during or after 2001.</p>				
Wall	Marble – VT. Meadow White	Polished	1966

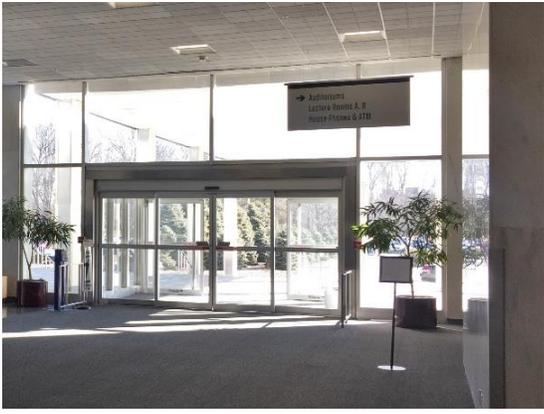
<p>The automatic sliding door assembly is not original to the building. Two rectangular lites flank the bank of sliding doors. Four lites span the area above the doors. The automatic sliding doors were installed in 1980.</p>

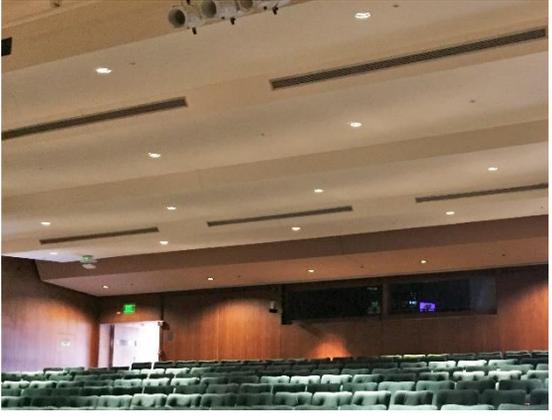
Ceiling	Plywood	Painted	2000	
<p>A stepped acoustical plaster ceiling is suspended above the auditorium seating. This ceiling was replaced in-kind in 2000. Around the auditorium perimeter, a plywood ceiling is recessed above the height of the plaster ceiling. Original drawings indicate the ceiling at the room perimeter was to be perforated plywood panels with American walnut veneer. Existing ceiling panels are solid with a painted finish. These likely date to the replacement of the suspended plaster ceiling.</p>				
Ceiling	Wood	Stained Lacquer	2000

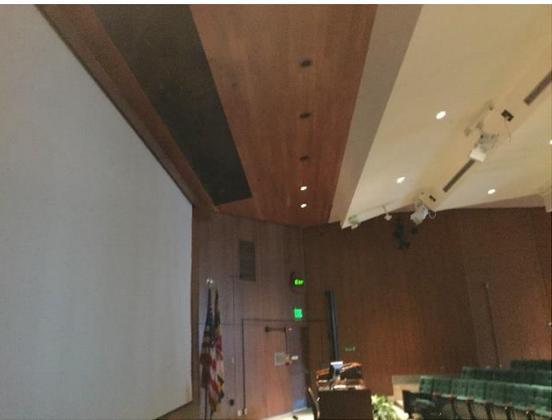
<p>There is currently modern wood cladding on the flat ceiling above the stage area. Original drawings indicate this ceiling was to be perforated plywood panels with American walnut veneer. The original ceiling was likely replaced during renovations in 2000.</p>				
Wall	Plywood w/ American Walnut Veneer	Stained Lacquer	1966

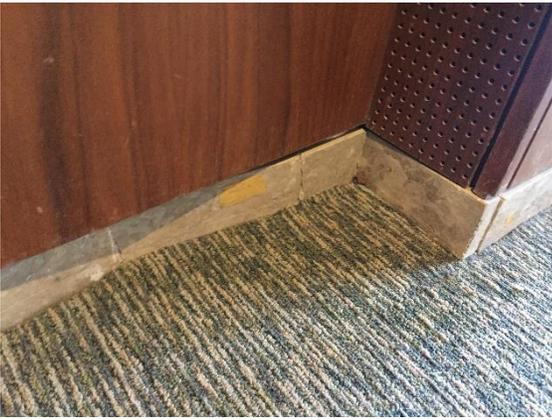
Base	Marble – MO. Cliffdale	Polished	1966	
<p>Walls are clad in plywood panels with American walnut veneer. The wall base is brown Cliffdale marble tiles with a simple rectangular profile. The marble base is cracked in some locations.</p>				
Wall	Plywood w/ American Walnut Veneer	Perforated w/ Stained Lacquer Finish	1966

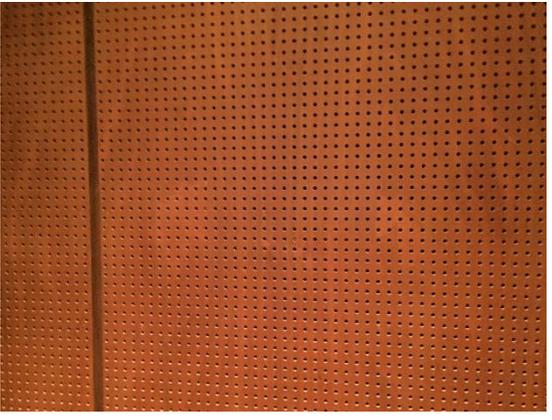
Base	Marble – MO. Cliffdale	Polished	1966	
<p>The rear (south) wall of the auditorium is clad in perforated walnut veneer. Perforation is an acoustical treatment for sound dampening at this location. The wall base is brown Cliffdale marble tiles with a simple rectangular profile. The marble base is cracked in some locations.</p>

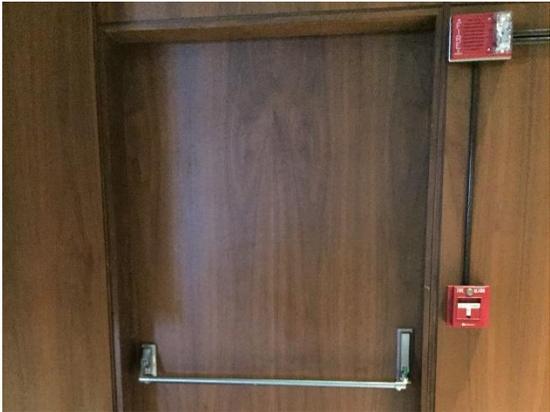
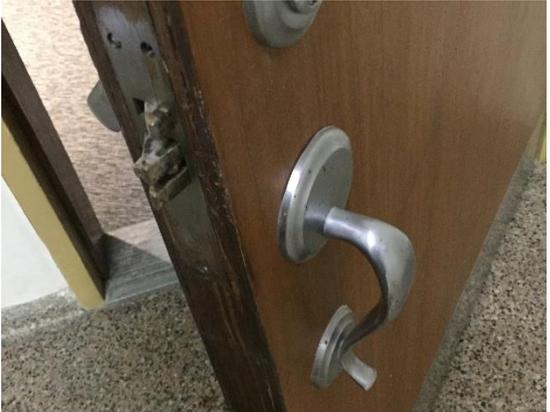
Frame	Steel w/ American Walnut Veneer	Stained Lacquer	1966	
Hardware – Pull and Push Bar	Aluminum	Satin	1966	
Hardware – Hinges	Stainless Steel	Satin	1966	
<p>Hollow metal fire doors are clad in walnut veneer so that they blend in with walnut wall panels. There are two such fire doors, one on either side of the stage area. Each fire door opens directly into a stairwell with access to the basement and first floor. Hardware includes a panic bar and push plate on the auditorium side, a simple pull handle and dead bolt on the stairwell side, and a concealed closer.</p>

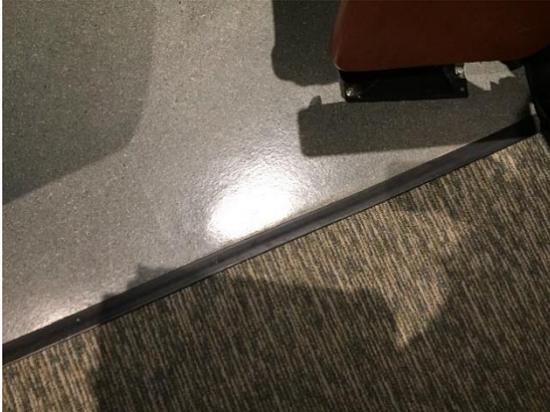
<p>Resilient tile flooring is found at the seating area. This was last replaced during renovations in 2000. Originally, this area had solid field vinyl asbestos tile flooring.</p>

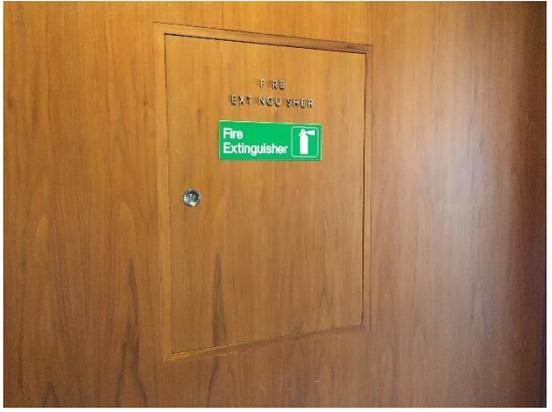
There are four fire extinguisher cabinets - two recessed into the east wall and two into the west. The cabinet door is clad in walnut veneer to match adjacent walls. The wood grain is continuous across the wall panels and doors. Raised metal letters spell out fire extinguisher in all capitals. Some letters have fallen off, and a modern green sign is now adhered to each door face. A simple metal ring pull opens the door.				
Speaker Grille	American Walnut	Stained Lacquer	1966

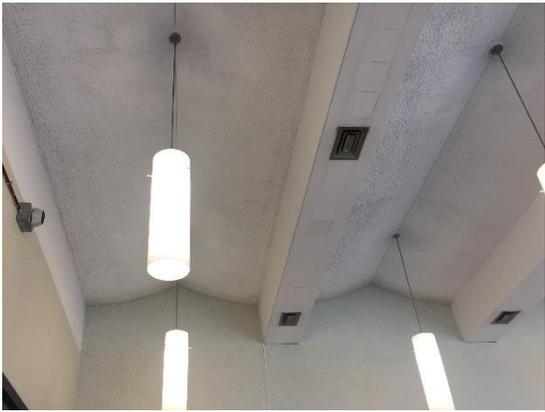
<p>The ceiling over the main dining area is scalloped, expressing the geometry of the exterior roof system in the building interior. Rectangular concrete soffits suspend from the bottom of each concrete curve. Aluminum ductwork runs within each concrete soffit. Original drawings included plans for metal-lath-and-plaster panels in a shallow “V” shape to be attached to the ridge between individual scallops. These panels would have been clad in fissure mineral acoustic tiles. Instead, the concrete ceiling has been treated wholesale with a textured acoustic coating, obscuring the concrete’s original rubbed finish.</p>				
Ceiling	Acoustic Tile	Smooth	2001

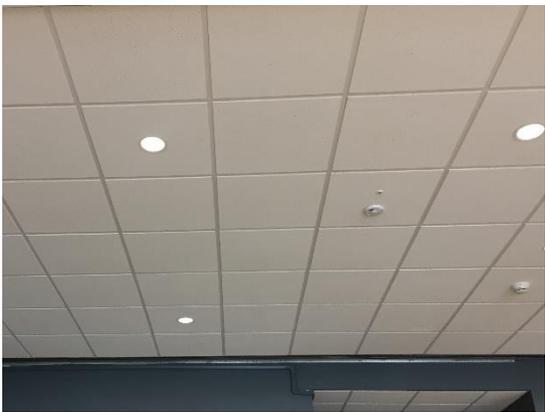
<p>Ceilings over the entries, serving area, and cashier counters are flat and much lower than the scalloped ceiling at the main dining area. These ceilings were originally perforated aluminum acoustic tiles. Current ceilings are smooth mineral fiber acoustic tiles set within an exposed metal grid. This ceiling was likely replaced at the same time as first-floor corridor ceilings.</p>

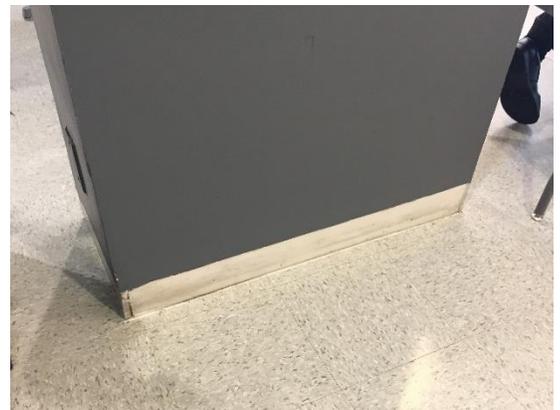
The south wall of the dining area and west wall of the serving area are plastered and painted. All columns throughout the space are also plastered and painted. Originally these surfaces were covered with vinyl fabric.

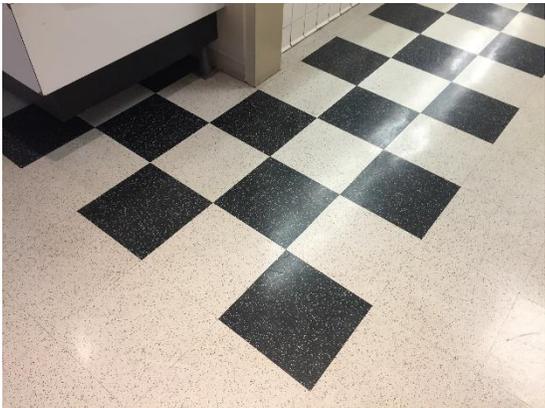
<p>Floors were original vinyl asbestos tile in a repeating grid pattern. They have been replaced with white and black vinyl tiles. The main field of the floor is white vinyl tile with black tiles forming a checkerboard pattern at the perimeter. The existing floor likely dates to the ceiling replacement in 2001.</p>				
Lighting	Solid Brass/ Cast Acrylic	US-26D Dull Chromium/ Surface Polished	1966

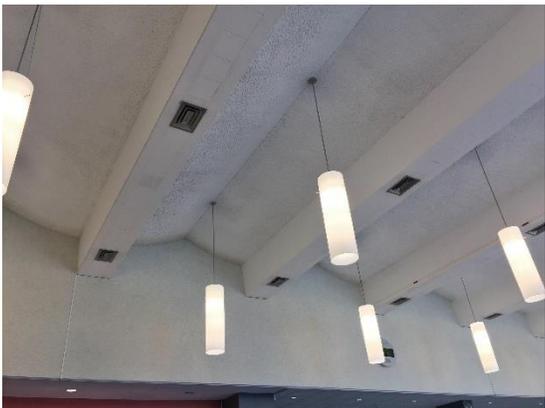
<p>These are the original light fixtures in the main dining area. The fixture body and canopy are solid brass with a dull chromium finish. The cylindrical shade is polished acrylic. The fixtures were recently refurbished.</p>

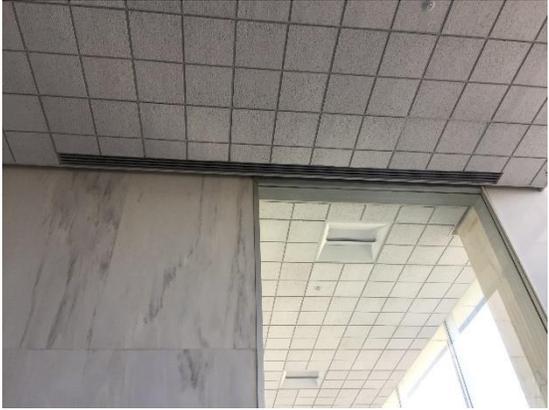
<p>The ceiling in the Red Auditorium Lobby was originally acoustic tile. The existing ceiling dates to the corridor ceiling updates in 2001.</p>				
Wall	Marble – VT. Meadow White	Polished	1966

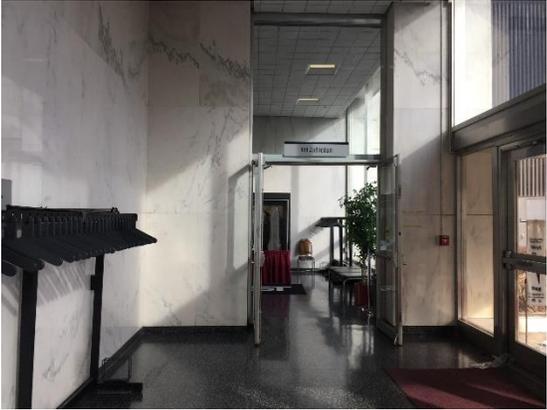
Frame	Anodized Aluminum	Clear Satin Finish/ Clear	1966	
<p>Double-leaf doors lead from the corridor CO-D-01 into the lobby. An aluminum push bar visually divides the single lite at each door. The push bar is attached at either end to the aluminum stiles and does not bisect the single lite. The doors have been retrofitted to be ADA-compliant automatic entrances. Original hardware has been replaced as part of the retrofit. The glass transom extends above the height of the ceiling.</p>				
Radiator Cabinet	Steel	Painted	1966

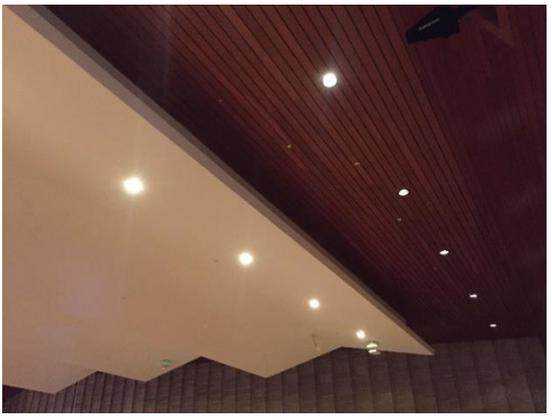
Ceiling	Wood Strip	Perforated	1966	
<p>A perforated wood strip ceiling runs around the perimeter of the space. The wider slats strips are butternut. Thinner strips of walnut are placed behind the gaps in the butternut strips so that they are not visible from the ground. A suspended, stepped plaster ceiling hangs below the slat ceiling above the seating area. The existing plaster ceiling is in its original configuration.</p>				
Ceiling	Wood Plank	Stained Lacquer	2000

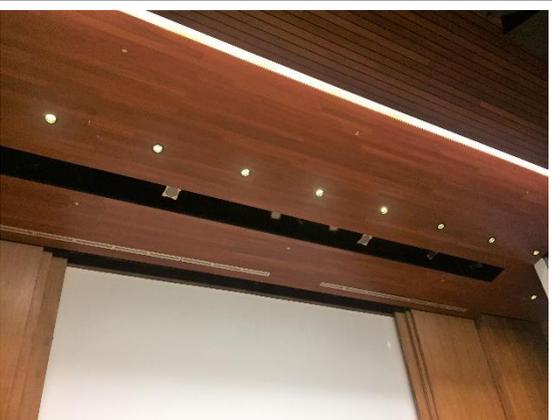
<p>The ceiling above the stage area is flush wood strip without perforations. The spacing of the wood planks do not match original drawings. This ceiling was likely installed during renovations in 2000.</p>				
Wall	Formed Concrete Block	Textured	1966

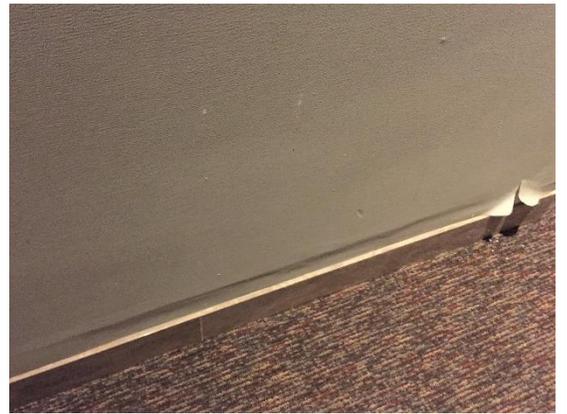
Plaster walls flanking the stage are clad in vinyl fabric. The vinyl covering is pulling away from the plaster wall in areas.

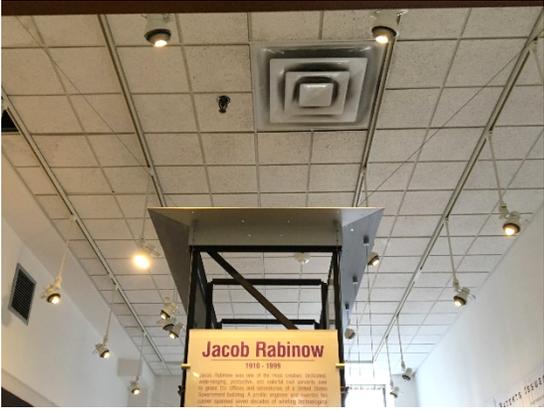
<p>This is not the original ceiling in room E115. It is not known when this ceiling was altered.</p>				
Wall	Plywood w/ American Walnut Veneer	Stained Lacquer	1966

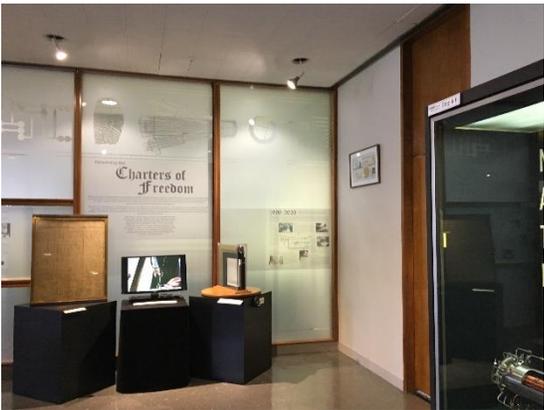
Base	Vinyl	N/A	1966	
<p>The east wall of the museum lobby (E109) is glass panels set within a walnut frame. The glass panels are frosted and etched with symbols and documents relevant to the history of NIST. Glass panels were originally clear.</p>				
Window - Fixed	Anodized Aluminum/ Glass	Clear Satin Finish/ Clear	1966

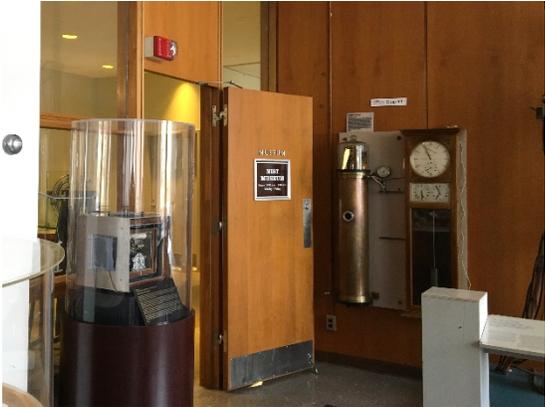
Frame	American Walnut	Stained Lacquer	1966	
Hardware – Knob	Aluminum	Satin	1966	
Hardware – Hinges	Stainless Steel	Satin	1966	
<p>Doors leading into the larger exhibit room are clad in walnut veneer. There is a full height wood transom panel above each door. Original hardware includes stylized modernist butt hinges and aluminum door knobs. Door knobs have been replaced on some doors.</p>

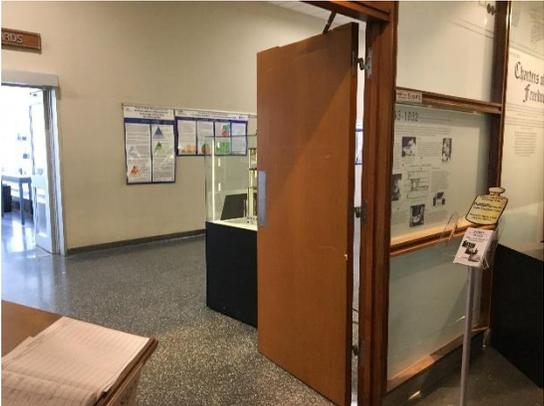
Frame	American Walnut	Stained Lacquer	1966	
Hardware – Knob	Aluminum	Satin	1966	
Hardware – Hinges	Stainless Steel	Satin	1966	
<p>A double-leaf walnut door leads from CO-E-01 into the museum lobby. Original hardware includes stylized modernist butt hinges and aluminum door knobs. Door knobs have been replaced on some doors.</p>

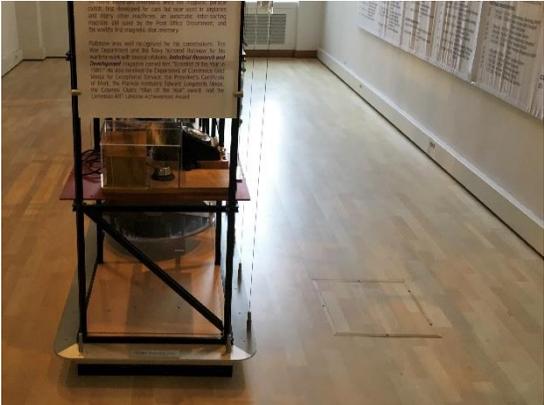
<p>The floor in the smaller exhibit rooms is narrow wood plank. This floor is not original. It is not known when it was installed.</p>

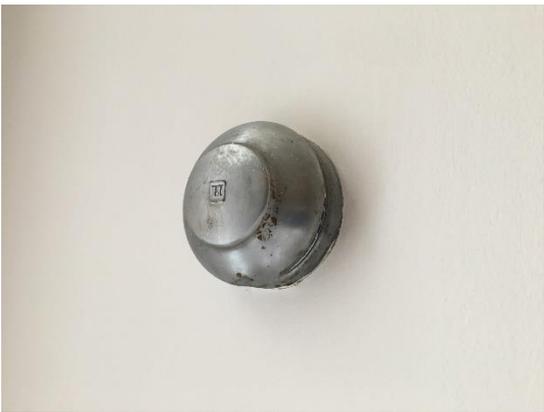
<p>Original thermostats are found in the museum lobby (E109) and main exhibit space (E107). The manufacturer is Honeywell.</p>

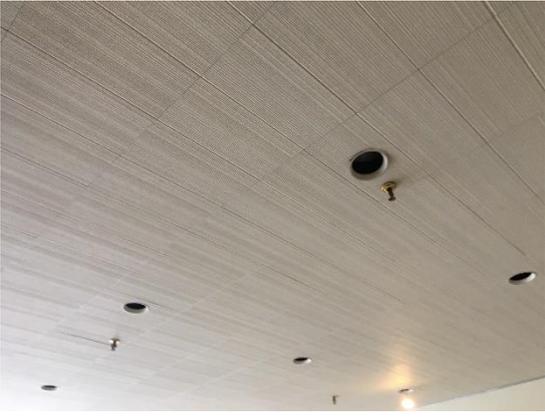
Diffuser	Extruded Aluminum	Clear Satin	1966	
<p>Striated acoustic ceiling tiles are suspended from a concealed grid. Linear diffusers occur at spans of curtain wall along the north wall. This is one of a very few interior spaces that retain their original acoustic ceiling tiles.</p>				
Ceiling	Plaster	Painted	1966

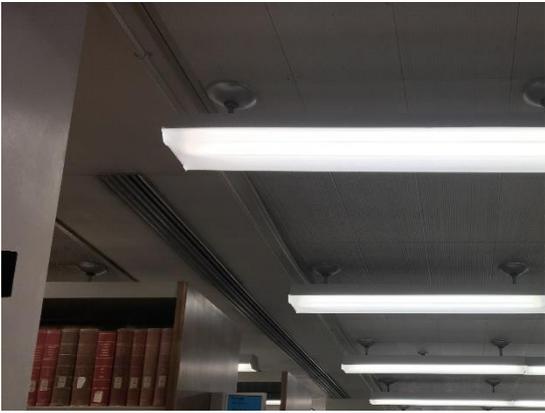
Diffuser	Extruded Aluminum	Clear Satin	1966	
<p>Three linear runs of plaster ceiling occur above the stacks on the first-floor and mezzanine levels. These plaster sections run along east to west in line with the square structural columns. Linear aluminum diffusers are centered within the plaster tacks between columns. Plaster ceilings also occur on the first-floor level above the carrel area in the protruding bay at the west end of the library. Ten rectangular areas of acoustical tiles are spaced evenly along the plaster ceiling.</p>

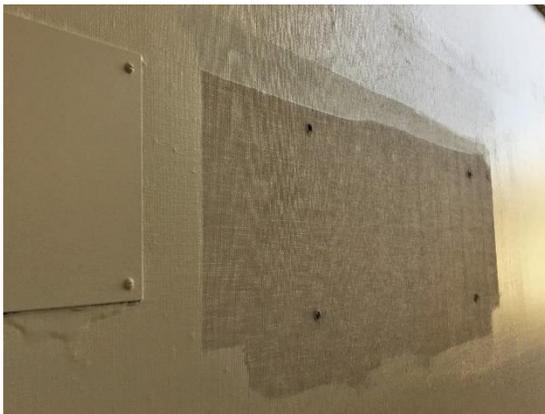
Base	Vinyl	N/A	1966	
<p>Originally all plaster walls were clad in a textured vinyl fabric. In some areas, vinyl fabric has been painted over.</p>				
Flush Metal Partitions	Steel	Baked Enamel	1966

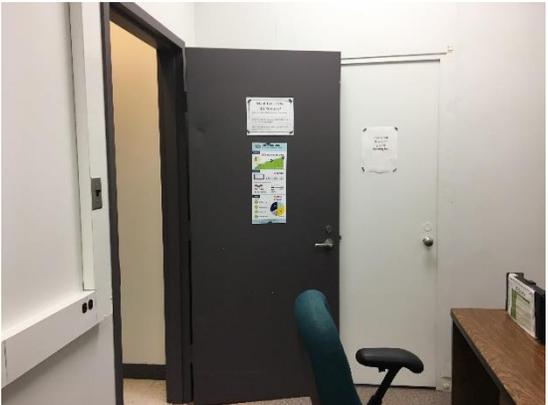
Frame	Steel	Painted	1966	
Hardware	Aluminum	Satin	1966	
<p>This is the typical office door. Original hardware is an aluminum door knob. Lever handles have replaced these at some doors. Some office doors have a single glazed opening above the height of the door knob.</p>

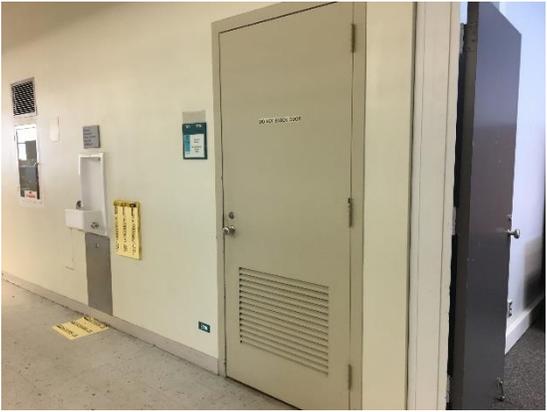
Frame	Steel	Painted	1966	
Hardware	Aluminum	Satin	1966	
<p>Hollow metal doors with louvers occur at electrical, mechanical, and janitor's closets. Original hardware is an aluminum door knob. Lever handles have replaced these at some doors.</p>				
Floor	Vinyl Asbestos Tile	N/A	1966

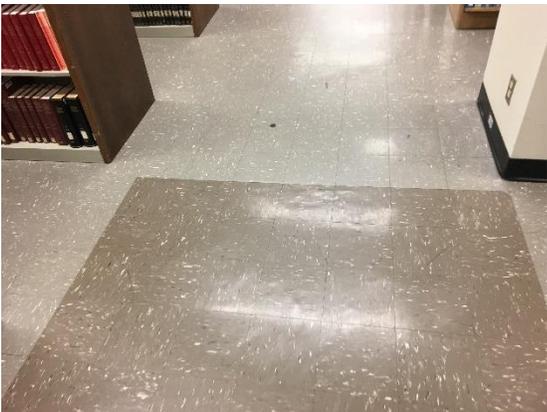
<p>The original flooring is a solid field of vinyl asbestos tile in a light gray color. Patches of replacement tile do not match the original in color or pattern.</p>

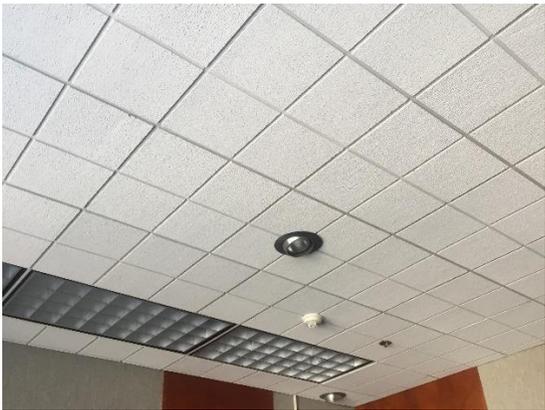
<p>Ceilings in the Directors' suite were originally 12" by 12" prefab mineral plaster acoustic tiles. Ceilings were most recently replaced during updates to the space in the late 1990s.</p>				
Wall	Plaster	Painted	1966

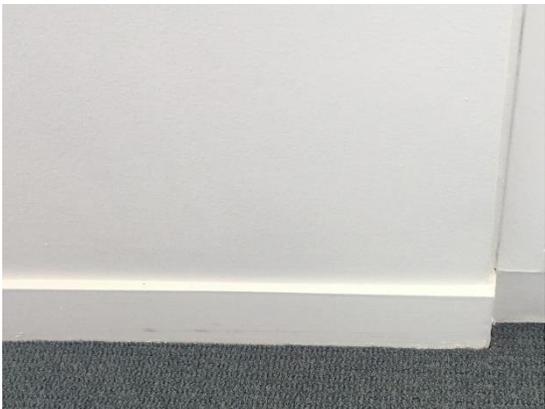
Base	Steel	Baked Enamel	1966	
<p>Exterior walls are plastered and painted. The wall base is steel with simple rectangular profile. The original finish is baked enamel, but bases have been painted.</p>				
Wall	Plaster	Vinyl Fabric	c. 1999

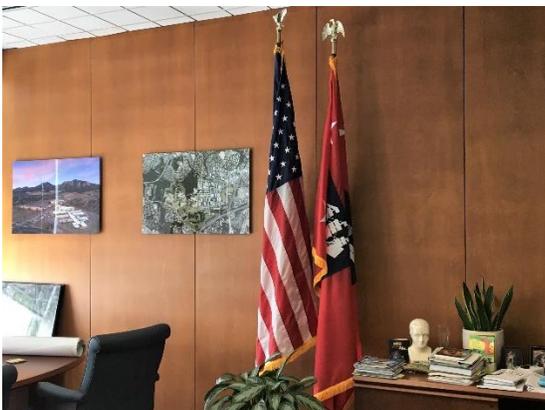
Base	Steel	Baked Enamel	1966	
<p>Certain walls in the Director's office, Executive Director's office, and reception area are clad in walnut paneling. The existing cherry stained finish dates to the late 1990s. The original finish was more natural walnut color, as can be seen on original finish boards in the library archives. The wall base is steel with simple rectangular profile. The original finish is baked enamel, but bases have been painted.</p>

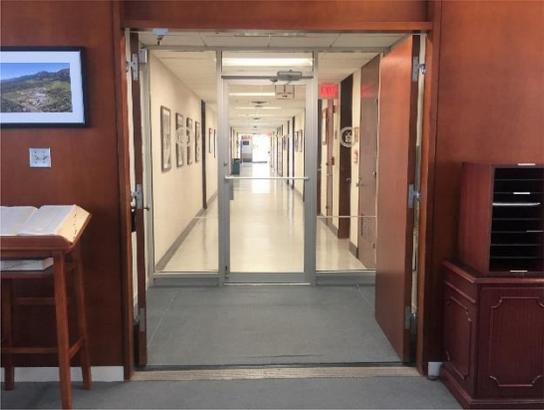
Frame	American Walnut	Stained Lacquer	1966	
Hardware – Knob	Aluminum	Satin	1966	
Hardware – Hinges	Stainless Steel	Satin	1966	
<p>Double-leaf swinging doors lead from the vestibule into the reception area. Doors are clad in walnut veneer to match the walnut paneling. They were also refinished during the late 1990s. Original hardware includes modernist hinges and an aluminum door knob. The face-mounted closer is not original. A louvered walnut transom above the doors originally allowed for ventilation between the reception area and corridor before the construction of the vestibule and the lowering of the corridor ceiling.</p>

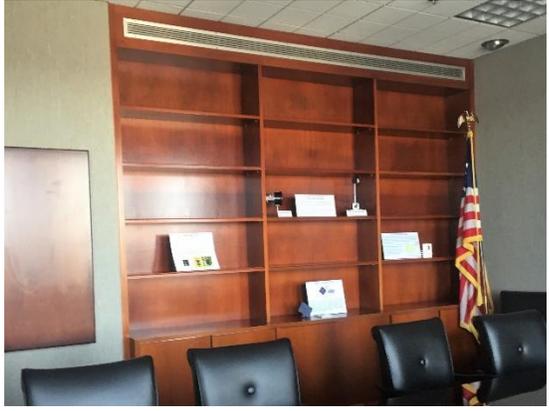
Diffuser	Extruded Aluminum	Clear Satin Finish	1966	
<p>The offices and conference room feature built-in walnut casework. There is an extruded aluminum grille set within the crown trim of the casework. All wood casework and trim in the Director's office suite were refinished in the late 1990s. An aluminum diffuser is mounted within the upper panel of the casework. The original finish was more natural walnut color, as can be seen on original finish boards in the library archives.</p>

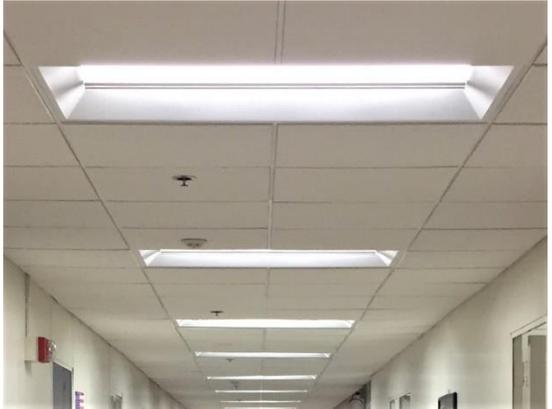
<p>This is the typical ceiling in interior corridors. Acoustic tiles are smooth and set within an exposed grid. The ceiling height has been lowered. Originally it was above the height of louvered transoms above the doors that allowed additional air circulation between the office and corridors. These are now only visible inside the offices.</p>				
Ceiling	Acoustic Tile	Smooth	N/A

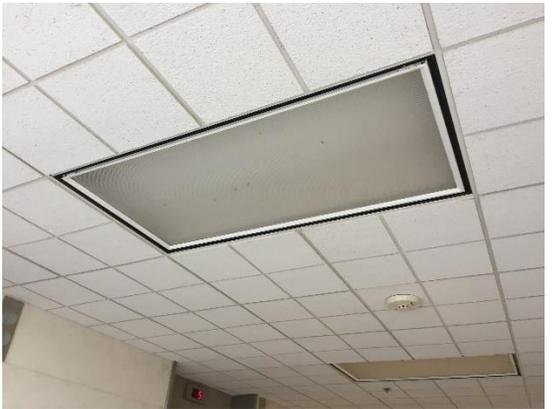
<p>This ceiling type is only found in the sixth-floor corridor. Acoustic tiles are smooth and set within an exposed metal grid. It is not known when these ceilings were installed. The ceiling height has been lowered. Originally it was above the height of louvered transoms above the doors that allowed additional air circulation between the office and corridors. These are now only visible inside the offices.</p>				
Wall	Steel Flush Metal Panel	Vinyl Coating	1966

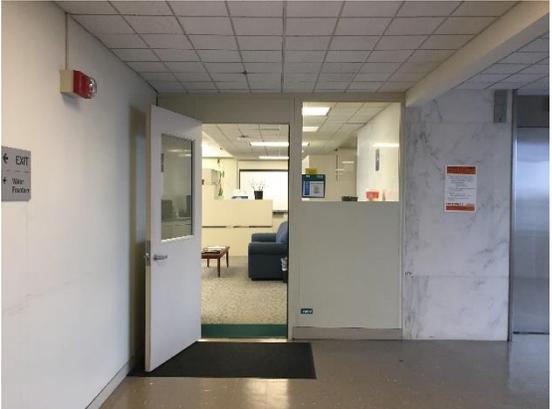
Frame	Steel	Painted	1966	
Hardware	Aluminum	Satin	1966	
<p>This door assembly leads into the large office suite at the east end of the sixth-floor corridor. It is probable that this door assembly originally existed at this location on the second through the tenth floors. It now only exists on the sixth floor. It has been replaced with a centered aluminum-and-glass door with sidelites and transom on all other floors. Original aluminum knobs have been replaced with lever handles.</p>				
Door – Single-Leaf	Steel	Painted	1966

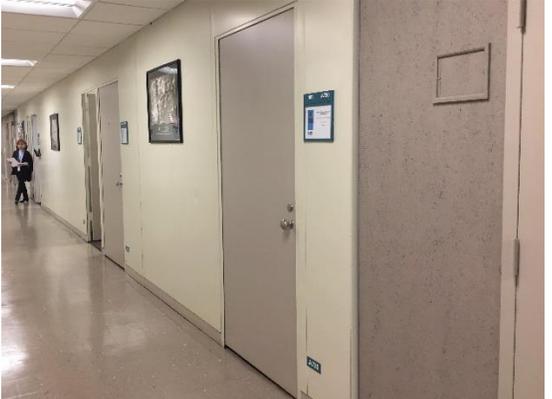
Frame	Steel	Painted	1966	
Hardware	Aluminum	Satin	1966	
<p>Typical office doors are single-leaf with no glazed or louvered openings. Original hardware includes aluminum door knobs, deadbolts, and butt hinges. Some door knobs have been replaced with lever handles. Office doors have a steel louver transom above the height of the suspended corridor ceiling.</p>

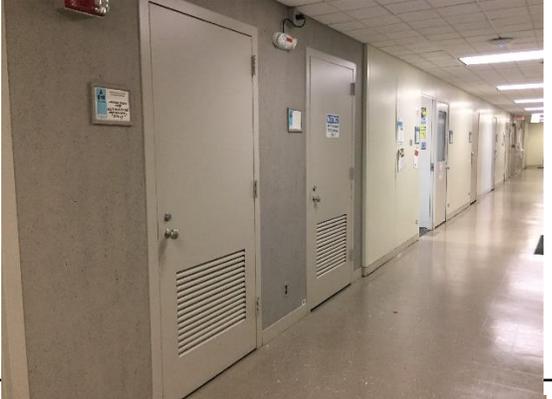
Frame	Steel	Painted	1966	
Hardware	Aluminum	Satin	1966	
<p>Doors to restrooms and janitor and utility closets have steel louvers set below the door's midline. Original hardware includes aluminum door knobs, deadbolts, and butt hinges. Door knobs have been replaced with lever handles on some doors.</p>				
Door – Single-Lite	Steel	Painted	1966

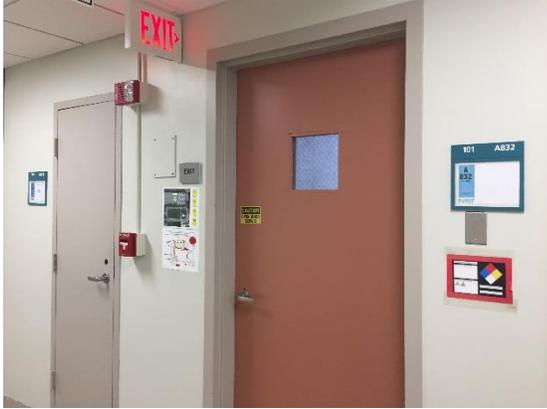
Frame	Steel	Painted	1966	
<p>This is the standard stairwell door. There are two on every upper-floor corridor. Original hardware was likely a stainless-steel door knob, but the door has been retrofitted with a lever handle. Stairwell doors have a single lite of wire glass.</p>				
Door – Double-Leaf	Steel	Painted	1966

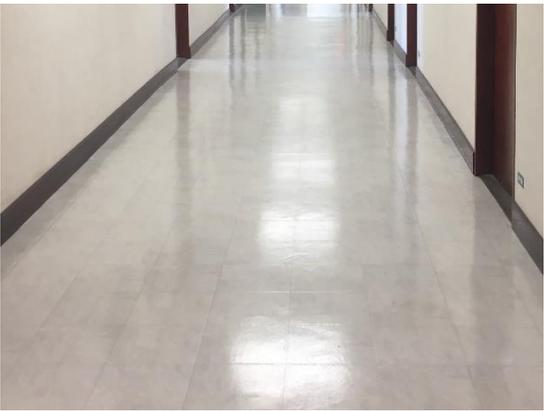
<p>Floors were originally vinyl asbestos tile. Existing floors are vinyl tile with a faux marble pattern. It is not known when these floors were installed. They may date to ceiling modifications in the 2000s.</p>

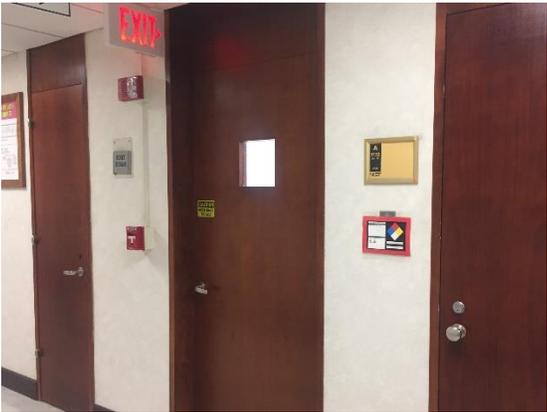
Frame	Walnut	Stained Lacquer	1966	
Hardware	Aluminum	Satin	1966	
<p>Stair doors have a single square lite set with wire glass. The lever handle does not appear to be original. Hinges likely are original.</p>				
Mail Drop	Stainless Steel/ Glass	No. 4 Satin/ Clear	1966

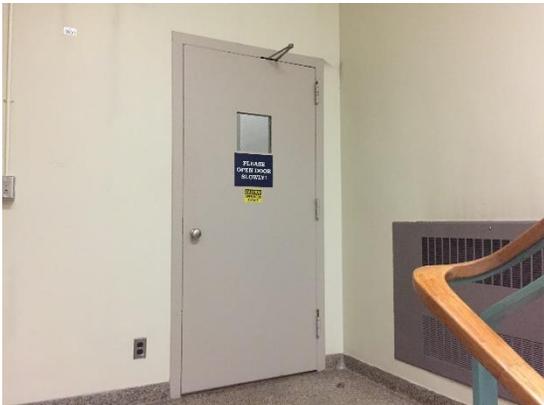
Frame	Steel	Painted	1966	
Hardware	Aluminum	Satin	1966	
<p>The typical stair door is a hollow metal fire door with a single wire-glass lite. The only exception is the 11<sup>th</sup> floor of the office tower, where the stair door is clad in walnut veneer. (See Survey Sheet for eleventh-floor corridor). Original hardware includes aluminum door knobs. Door knobs have been replaced in some locations.</p>

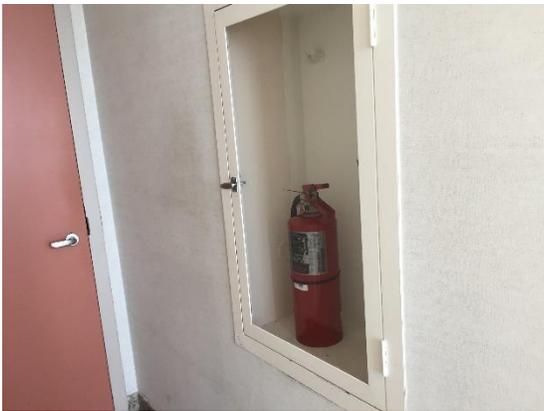
<p>Fire extinguisher cabinets in stairwells are painted steel with wire glass glazing. Some cabinets are missing their glazing entirely.</p>

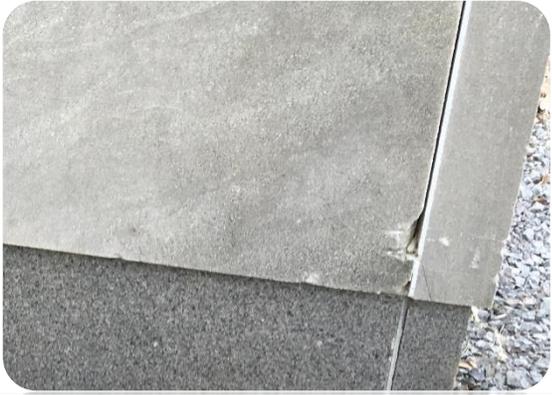
Exterior Masonry			
ELEMENT	CONDITION	RECOMMENDATION	PHOTO
Exterior Masonry	Failed Mortar Joints	Repoint mortar joints 100% with a compatible mortar that matches the original in color and texture.

Priority: High			
Marble Panels	Inappropriate Mortar	When repointing, use a compatible mortar that is soft enough to act as a sacrificial element.

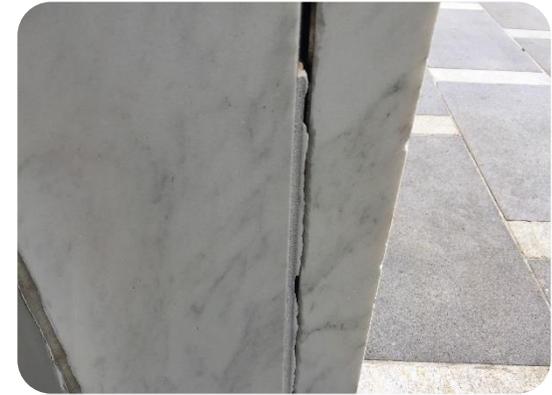
Priority: Low			
Exterior Masonry	Sealant in Masonry-to-Masonry Joints	Remove sealant from masonry-to-masonry joints and repoint with a compatible mortar that matches the original in color and texture.

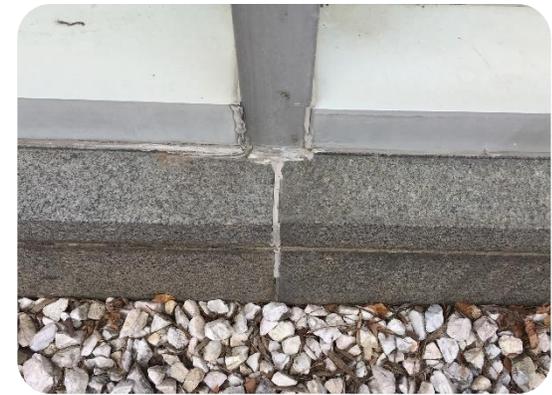
Priority: High			
Exterior Masonry	Sealant in Masonry Crack	Remove sealant from masonry cracks. Repair crack with crack injection mortar or patch.

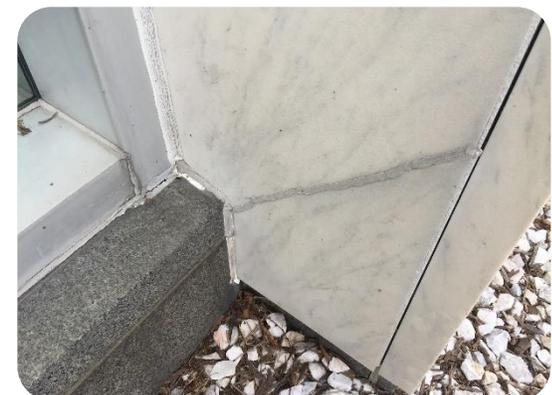
Priority: High
