# NIST Building 101

## Historic Structure Report and Condition Assessment

Final Submission  
March 15, 2020

**John Milner Associates Preservation**

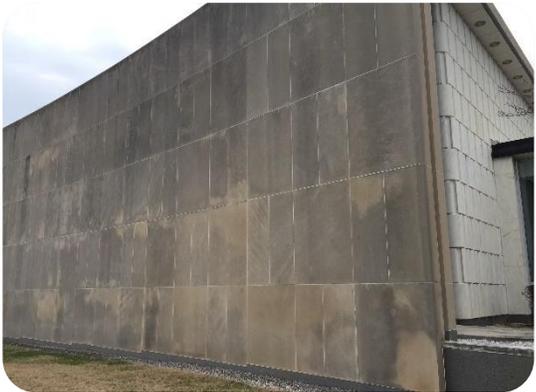
Exterior Masonry			
ELEMENT	CONDITION	RECOMMENDATION	PHOTO
Exterior Masonry	Heavy Soiling	Clean with a biocide and low-pressure wash. More aggressive methods – such as misting and microabrasives – may be necessary if gentler methods do not clean successfully.

Priority: Low			
Exterior Masonry	General Soiling	Clean with a gentle neutral or alkaline detergent and a low-pressure wash.

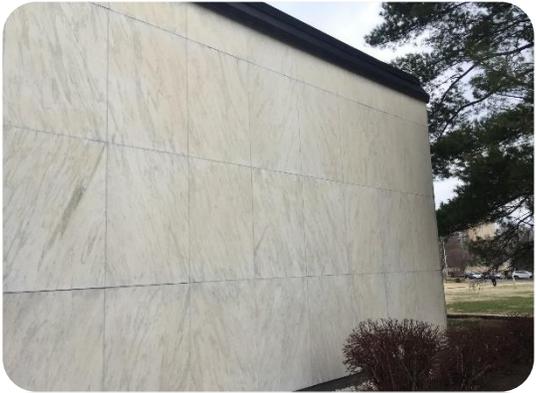
Priority: Low			
Exterior Masonry	Copper Staining	Clean with an alkaline poultice specifically formulated for removing copper stains from masonry.

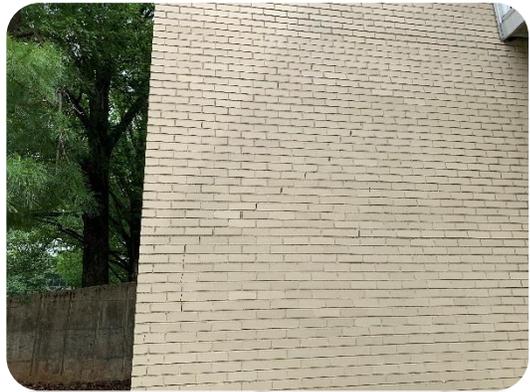
Exterior Masonry			
ELEMENT	CONDITION	RECOMMENDATION	PHOTO
Brick Walls	Step cracking – most likely due to horizontal thermal movement compounded by lack of expansion joints.	Patch brick (or replace) cracks & joints with mortar and monitor.

Priority: Low			
Brick Walls	Step cracking – most likely due to horizontal thermal movement compounded by lack of expansion joints.	Patch brick (or replace) cracks & joints with mortar and monitor.

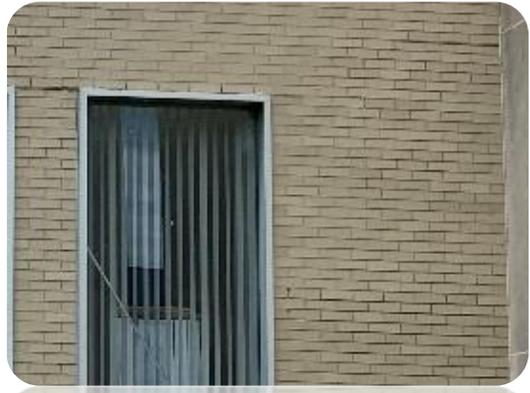
Priority: Low			
Brick Walls	Step cracking – most likely due to horizontal thermal movement compounded by lack of expansion joints.	Patch brick (or replace) cracks & joints with mortar and monitor.

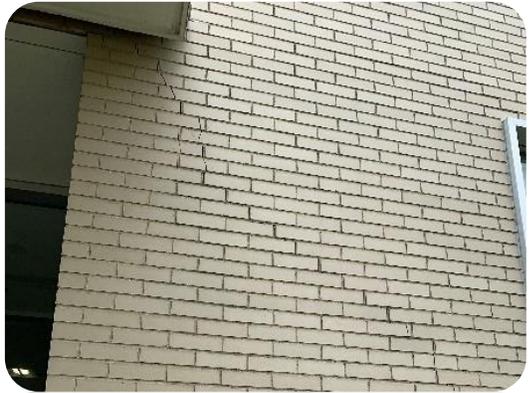
Priority: Low			
Brick Walls	Vertical expansion joint has popped out due to brick wall thermal movement.	Remove old expansion joint material. Install new backer rod and sealant for a soft expansion joint.

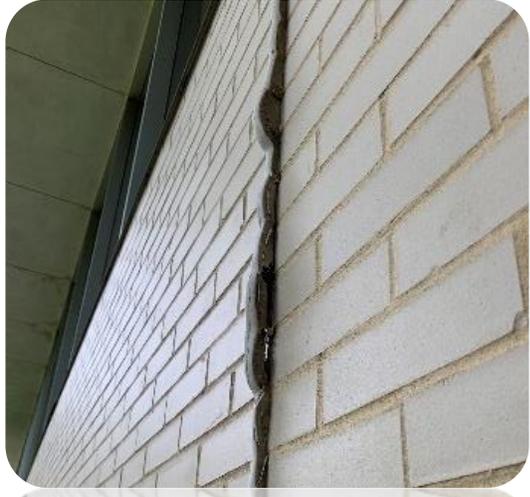
Priority: High

Two expansion joints were found in this retaining wall. The expansion joint material at both locations were hardened. Hard joints are not functional and should be removed. After removing all failed material from the expansion joints, install new backer rod and sealant for a soft joint.

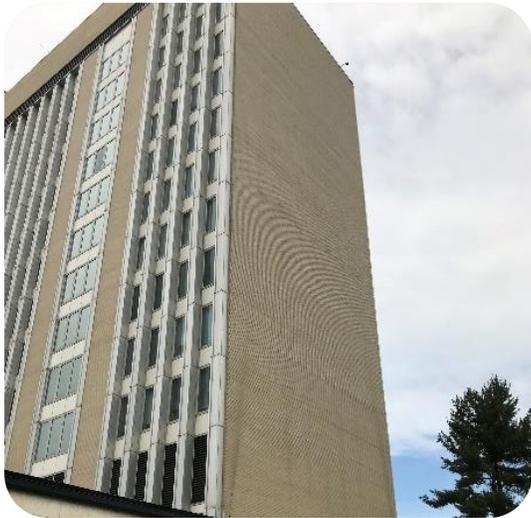
Exterior Masonry			
ELEMENT	CONDITION	RECOMMENDATION	PHOTO
Brick Walls	Brick discoloration and possible horizontal cracking along 13-story façade. Discoloration could be due to shelf angle corrosion or dirt. Possible cracking could be due to lack of horizontal soft joints.	Clean façade, perform closeup visual survey above ground level, remove bricks and evaluate.

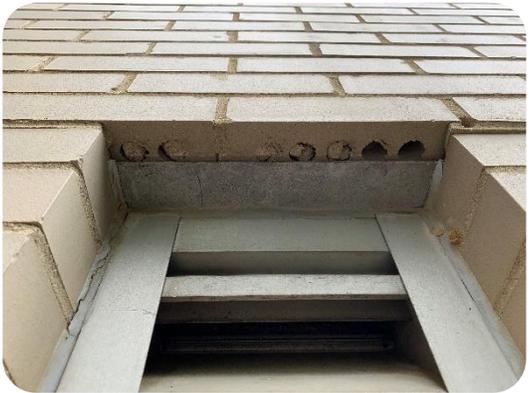
Priority: Medium			
Brick Wall Louver lintels	Brick lintels above louvers are cored. Old mortar is loose and falling off.	Remove failed mortar, Refill with mortar that matches existing.

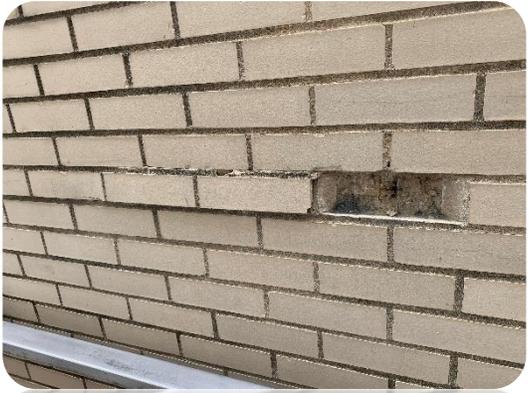
Priority: Low			
Brick Walls	Many bricks have popped out and displaced around the building.	At each location, remove displaced brick pieces, clean joints, and install new brick.

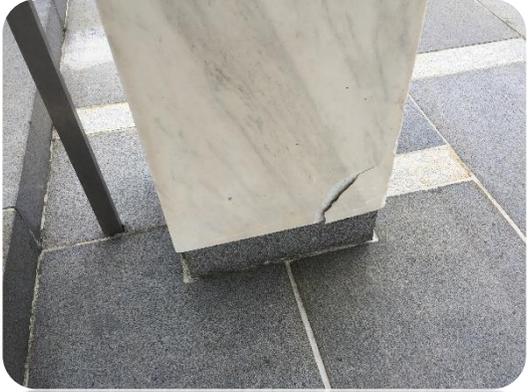
Priority: Low			
Marble Panels	Spall	Repair masonry spall.

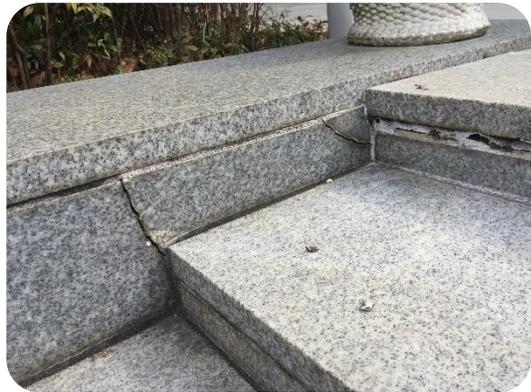
Exterior Masonry			
ELEMENT	CONDITION	RECOMMENDATION	PHOTO
Exterior Masonry	Crack	Repair crack with crack injection grout.

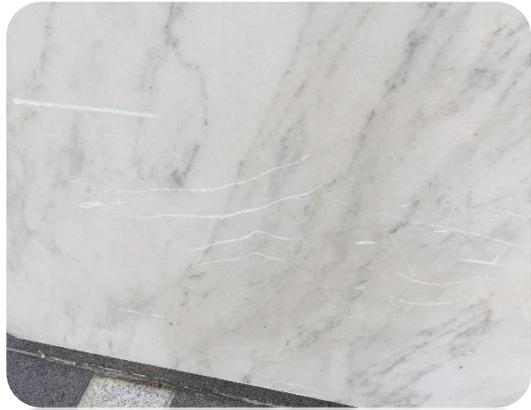
Priority: High			
Exterior Masonry	Scratches	Scratches do not require any repair.

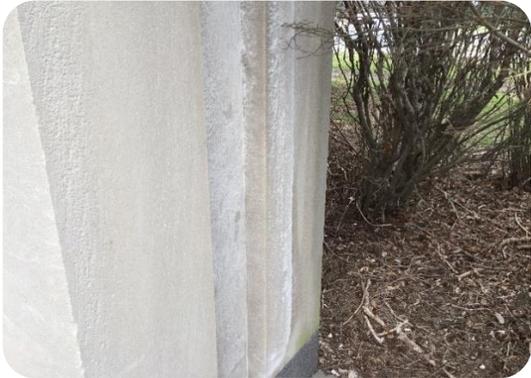
Create work plans designed to limit new damage to stone during maintenance and landscaping activities.	
		Train landscaping/maintenance crews to avoid damaging stone.	
Priority: Low			
Exterior Masonry	Erosion	Correct source of water runoff that is contributing to erosion.

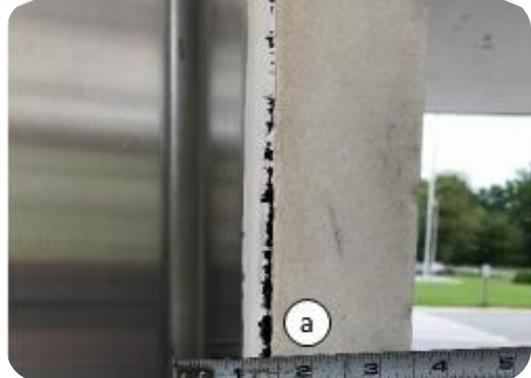
Priority: Medium			
Marble Panels	Displacement	Clean out cavities and provide a positive drainage outlet at marble columns. Repoint with softer mortar.

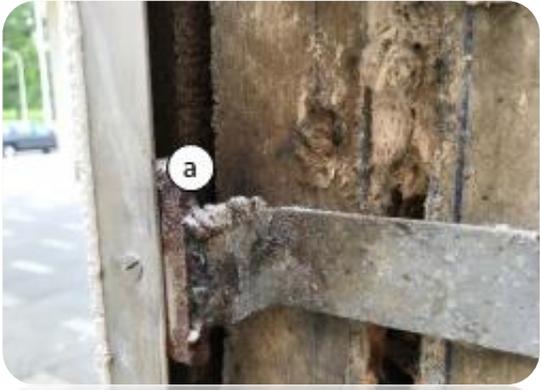
Exterior Masonry			
ELEMENT	CONDITION	RECOMMENDATION	PHOTO
Marble Panels	Corroded Anchors	Replace corroded anchors.

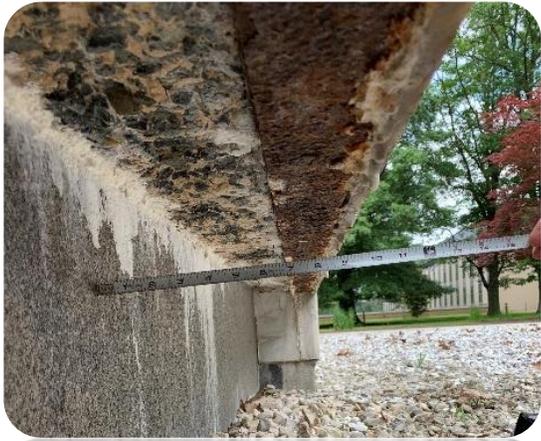
Priority: High			
Marble Panels	Steel angle supports for marble panels along library colonnade base are badly corroded.	Remove all marble panels along this angle and evaluate existing conditions.

Examine extent of corrosion for steel angles.	
		Provide structural repair design including replacing steel angle with stainless steel angle. (Approximately 84FT)	
Priority: High

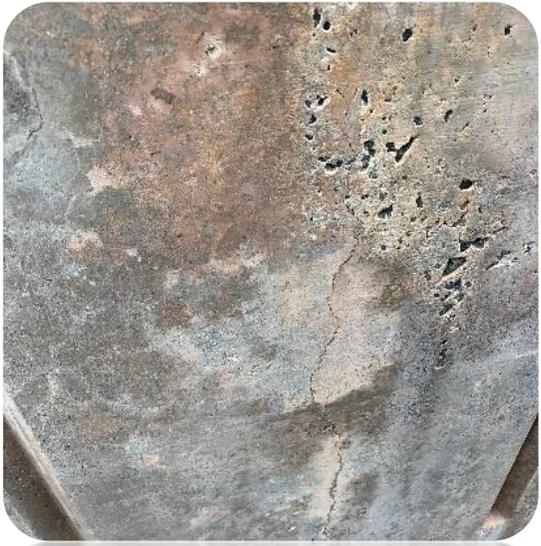
Retaining Walls			
ELEMENT	CONDITION	RECOMMENDATION	PHOTO
Concrete Retaining Wall	Vertical crack on wall. The concrete was sound, and there were no signs of corrosion.	Route and fill crack with mortar (approximately 10FT).

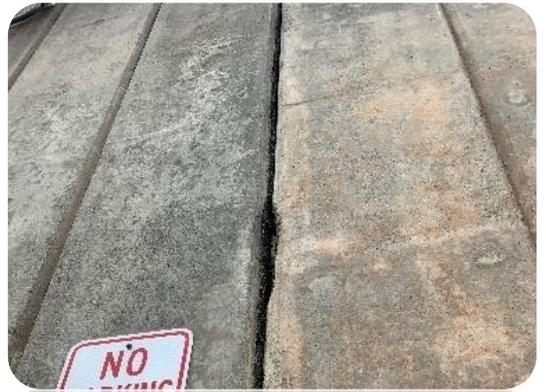
Retaining Walls			
ELEMENT	CONDITION	RECOMMENDATION	PHOTO
Concrete Retaining Wall	Vertical expansion joints have hardened.	Remove old expansion joint material. Install new backer rod and sealant for a soft expansion joint (approximately 50FT).

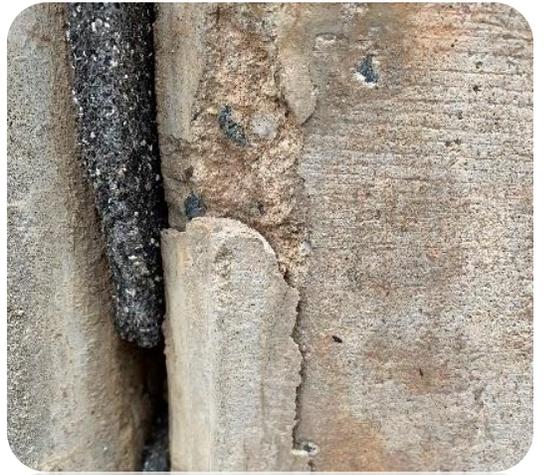
Priority: Medium			
Concrete Retaining Wall	Previous concrete patches are spalling off.	Remove delaminated patch/concrete and patch (approximately 25SF).

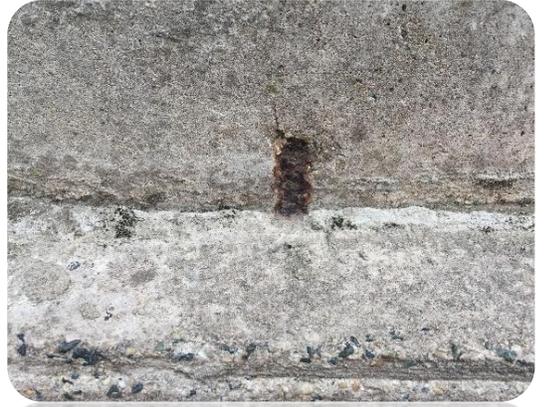
If rebar is visible after removing spalled concrete, expose it by removing at least 3/4 inches of concrete around bar and check for corrosion.	
		If corrosion is present, the condition should be further investigated by an engineer. Otherwise patch with appropriate concrete patching material.	
Priority: Medium			
Concrete Retaining Wall	Exposed Rebar	Remove failed concrete next too and behind exposed rebar.

Remove corrosion and provide a corrosion-resistant coating system.	
		Patch concrete with compatible patching material that matches the original in color and texture.

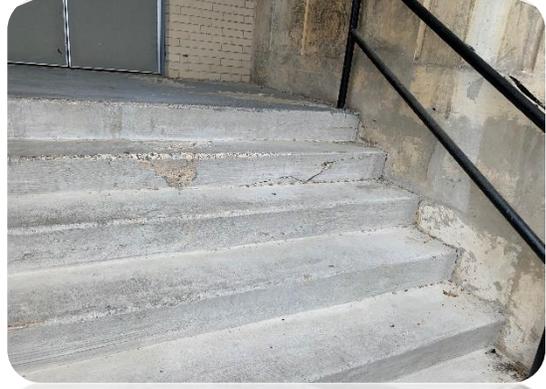
Priority: Medium			
Stairs at Loading Dock	Top step is spalling.	Remove delaminated concrete and patch (approximately 6SF).

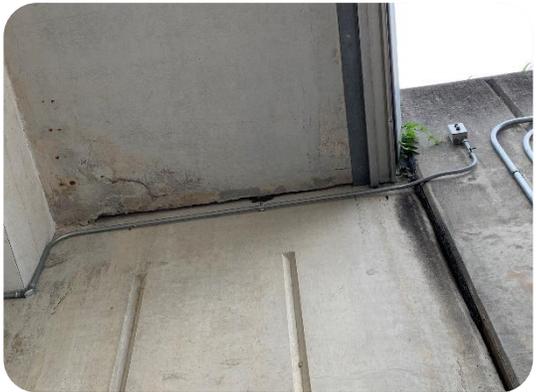
Retaining Walls			
ELEMENT	CONDITION	RECOMMENDATION	PHOTO
Loading Dock	Stucco soffit at loading dock appears to be spalling. Unable to reach the soffit to perform delamination sounding.	Perform delamination sounding. Make a test opening and reevaluate.

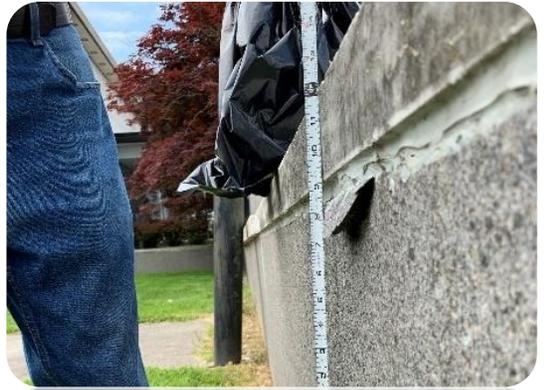
Retaining Walls			
ELEMENT	CONDITION	RECOMMENDATION	PHOTO
Stone Retaining Walls	Granite stone piece is loose.	Remove loose piece and reattach with epoxy.

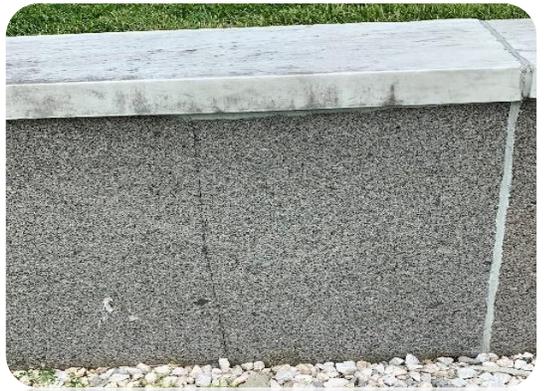
Priority: Low			
Stone Retaining Walls	Granite panel is cracked in half.	Repair or replace granite panel.

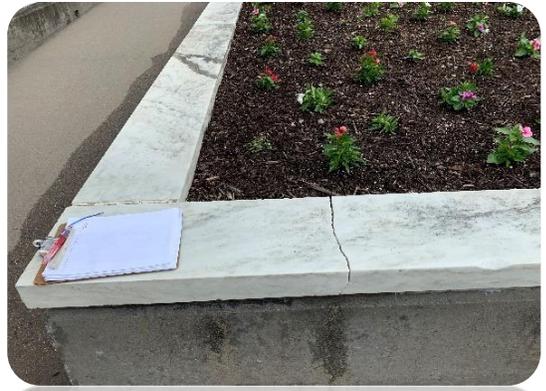
Priority: Low			
Stone Retaining Walls	Marble coping panel is cracked.	Repair or replace marble piece.

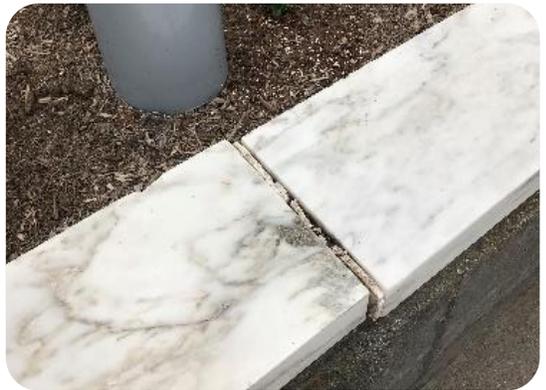
Priority: Low			
Stone Retaining Walls	Open and failed joints.	Repoint mortar joints along entire wall.

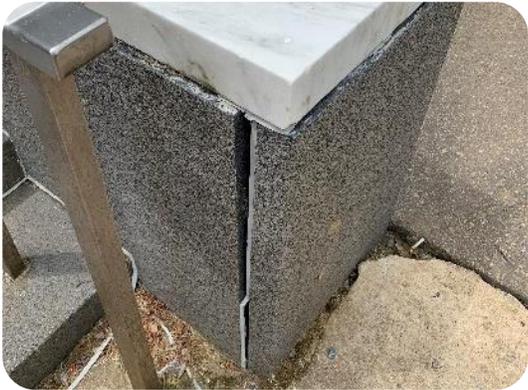
Retaining Walls			
ELEMENT	CONDITION	RECOMMENDATION	PHOTO
Entrance Retaining Walls	Entrance steps sidewall granite mortar joints are open. Some granite panels are displaced.	Removed displaced panels and reset. Repoint mortar joints along entire wall.

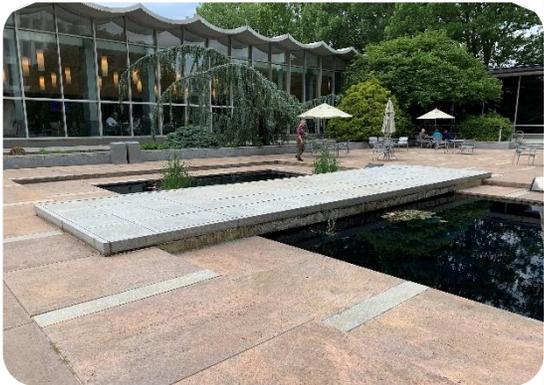
Courtyard Bridge			
ELEMENT	CONDITION	RECOMMENDATION	PHOTO
Concrete Bridge	Concrete bridge at courtyard pool appears to be sagging. Concrete was sounded and no spalling was found.	Install gauge and monitor sagging deflection for one year.

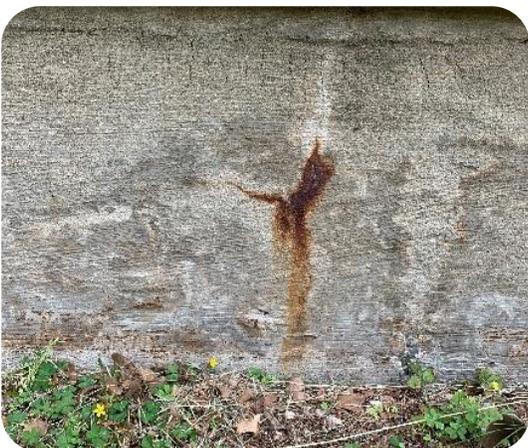
Arcade			
ELEMENT	CONDITION	RECOMMENDATION	PHOTO
Arcade	Minor corrosion.	Remove concrete at corrosion location and reevaluate. Repatch (approximately 1SF).

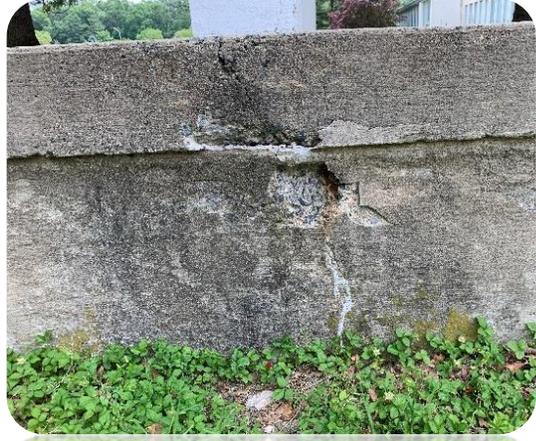
Arcade			
ELEMENT	CONDITION	RECOMMENDATION	PHOTO
Arcade	Concrete spall.	Remove delaminated concrete and patch (approximately 25 SF).

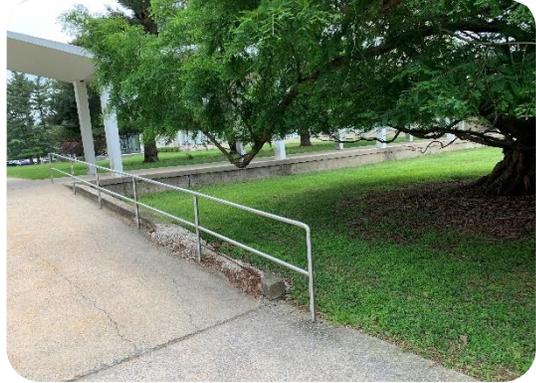
If rebar is visible after removing spalled concrete, expose it by removing at least ¾ inches of concrete around bar and check for corrosion.	
		If corrosion is present, the condition should be further investigated by an engineer. Otherwise patch with appropriate concrete patching material.	
Priority: Medium			
Arcade	Broken concrete curb on both sides.	Demo and replace with new concrete curb (approximately 24CF).

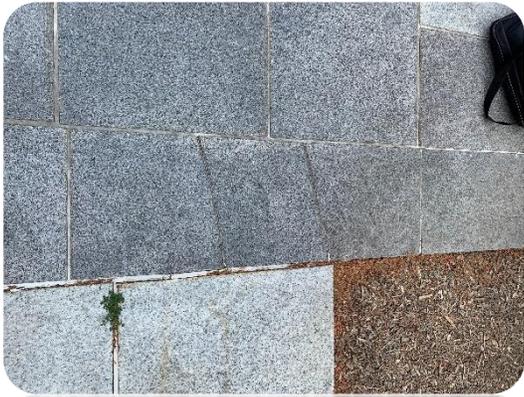
Entrance Terraces - Pavers			
ELEMENT	CONDITION	RECOMMENDATION	PHOTO
Pavers	Granite paver is cracked.	Remove stone, regrade and compact soil, repair or replace stone.

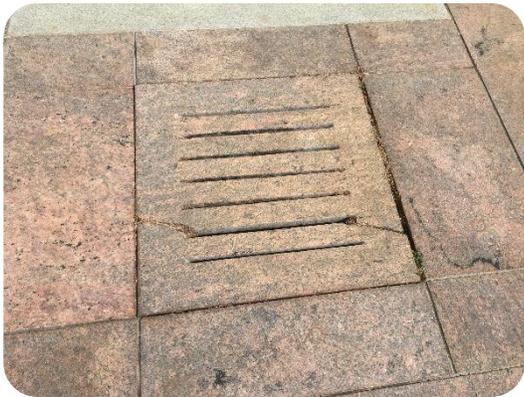
Priority: Low			
Pavers	Crack	Cracks do not require repair.

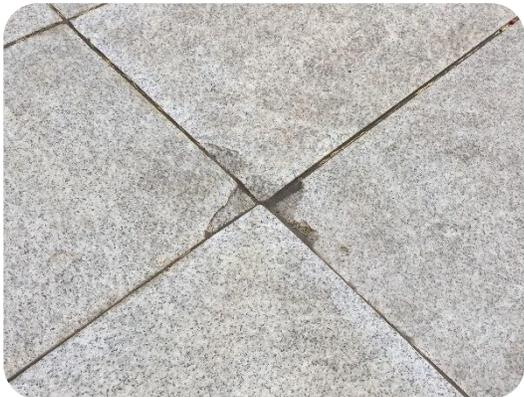
Priority: Low			
Pavers	Spall	Minor spalls do not require repair.

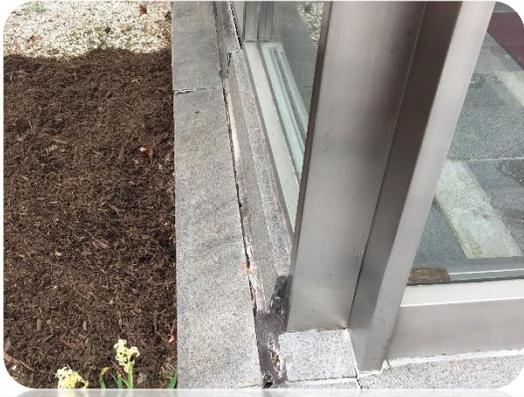
Large spalls should receive a dutchman repair.	
Priority: Low			
Pavers	Displacement	Remove displaced paver, correct for displacement, and reset.

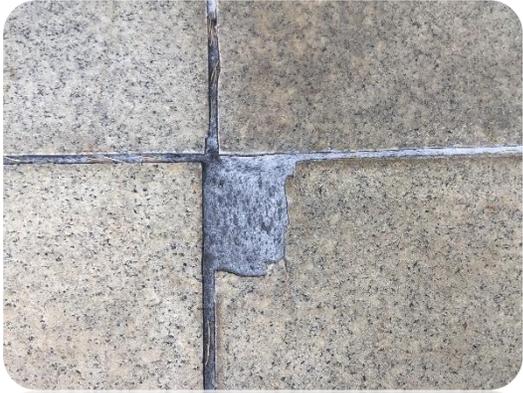
Entrance Terraces - Pavers			
ELEMENT	CONDITION	RECOMMENDATION	PHOTO
Pavers	Sealant in Joints	Remove sealant from joints in granite pavement.

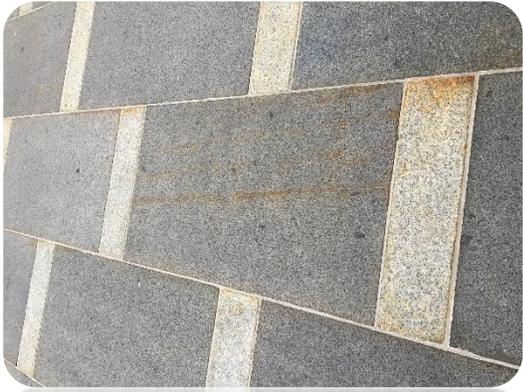
Repoint with a compatible mortar.	
Priority: High			
Pavers	Rust Stains	Clean rust stains with an acidic rust remover.

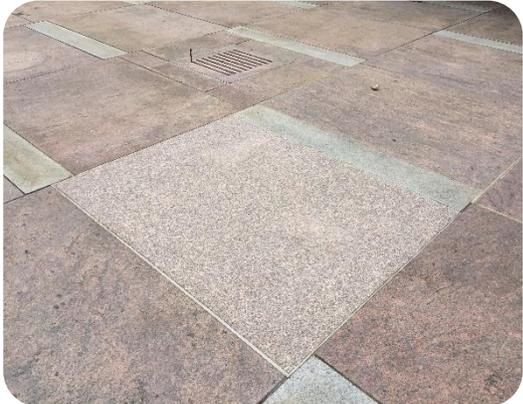
Priority: Low			
Pavers	Inappropriate Replacement	Existing replacements that are a poor match do not require replacement if they are in sound condition.

Replacement is appropriate when more than 50% of a stone is damaged.	
		When necessary, replace damaged stones with new or salvage stone that matches the original in color, texture, size, shape, and profile.	
Priority: Low

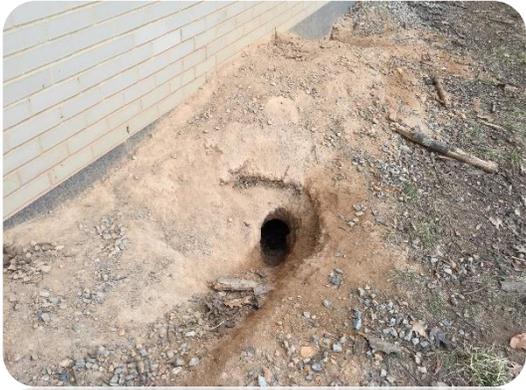
Landscaping and Site Work			
ELEMENT	CONDITION	RECOMMENDATION	PHOTO
Pests	Ground Hog Tunnels	Remove ground hogs. Back fill holes and tunnels.

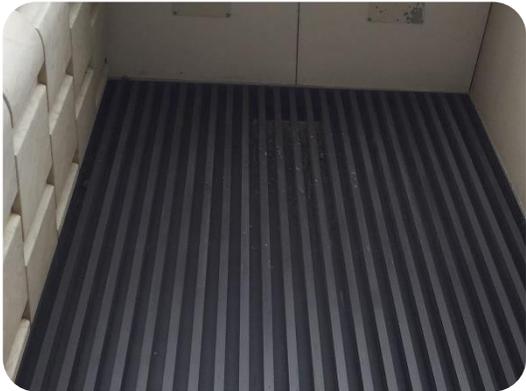
Priority: High			
Pests	Nesting Birds	Explore possible methods of bird proofing to determine a compatible system. A compatible system will successfully deter birds without damaging building elements or detracting significantly from the original design intent. Do not install incompatible systems.

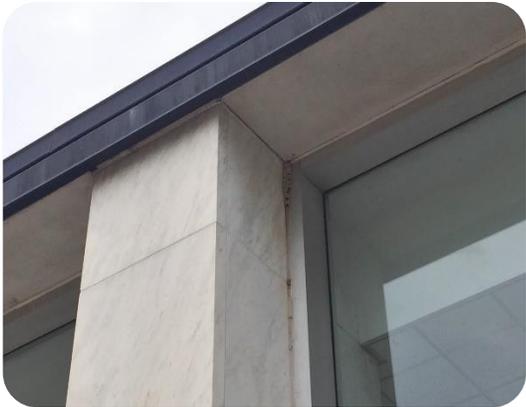
Priority: Low			
Pests	Nesting Insects	Use a low-pressure wash to remove dirt dauber nests as they appear.

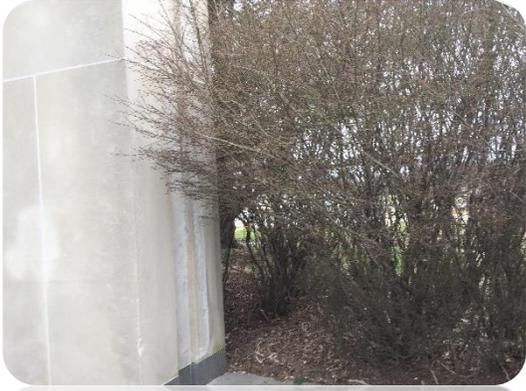
More sensitive means are needed to remove bees and hornets nests.	
Priority: Low			
Landscaping	Landscaping Too Close to Building	Remove or trim landscaping that grows within two feet of the building façade.

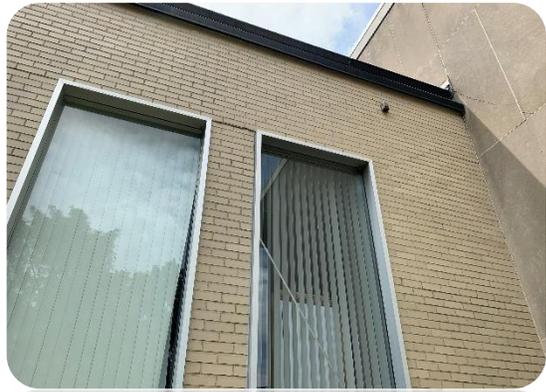
Windows and Doors			
ELEMENT	CONDITION	RECOMMENDATION	PHOTO
Brick Wall Window lintels	Brick cracking above windows. Steel lintes behind bricks possibly corroding, which could be causing the cracks.	Remove bricks and evaluate.

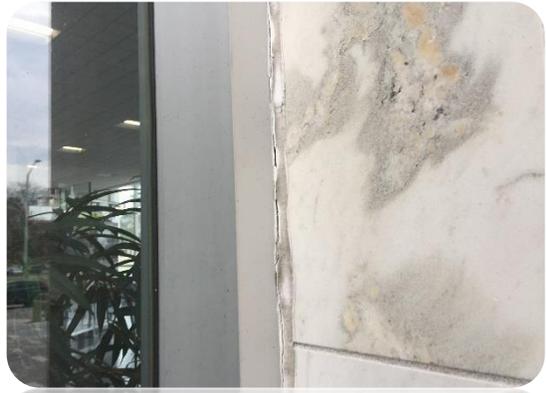
Priority: Medium			
Windows and Doors	Sealant Failure	Remove failed sealant and replace with new.

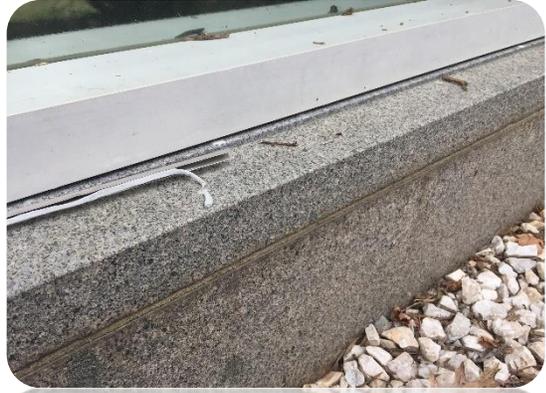
Priority: Medium			
Windows and Doors	Weather-stripping Failure	Remove failed weather-stripping and replace with new.

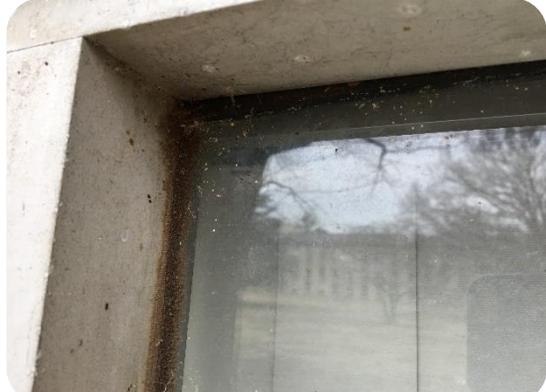
Priority: Medium			
Doors and Windows	Gasket Failure	Replace failed gaskets in kind.

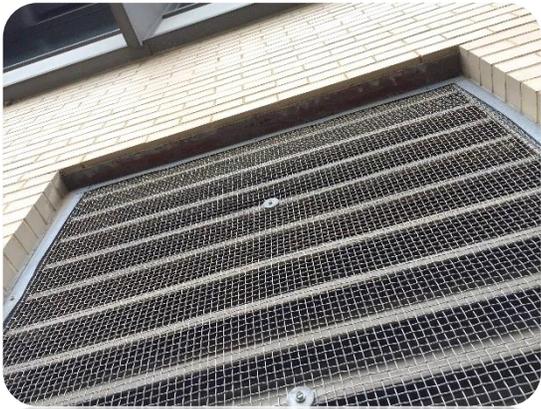
Windows and Doors			
ELEMENT	CONDITION	RECOMMENDATION	PHOTO
Windows and Doors	Corroded Lintel	Remove corrosion.

Prepare surface. Provide a corrosion-resistant coating.	
		Prime and repaint.	
Priority: Medium			
Windows and Doors	Film Failure	Remove failed film at all exterior glazing and replace with new.

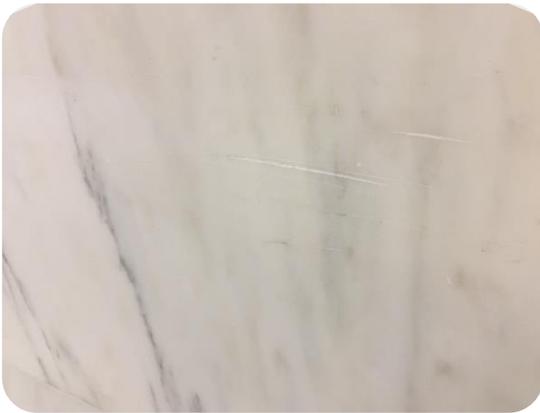
Interior Finishes: Marble, Terrazzo, and Tile			
ELEMENT	CONDITION	RECOMMENDATION	PHOTO
Interior Marble	Nicks and Scratches	Scratches do not require any repair.

Create protocols designed to prevent damage from collisions with carts and maintenance equipment.	
Priority: Low

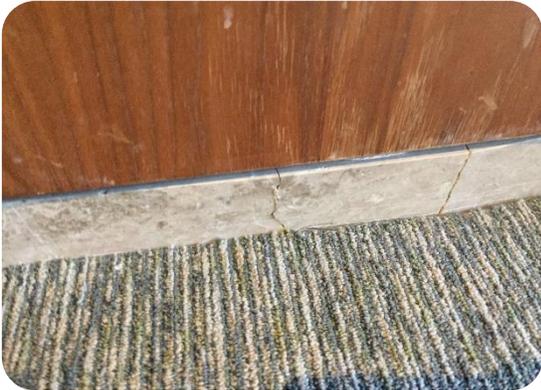
Interior Finishes: Marble, Terrazzo, and Tile			
ELEMENT	CONDITION	RECOMMENDATION	PHOTO
Interior Marble	Crack	Repair crack with crack injection mortar.

Priority: Medium			
Interior Marble	Spall	Minor spalls do not require any repair.

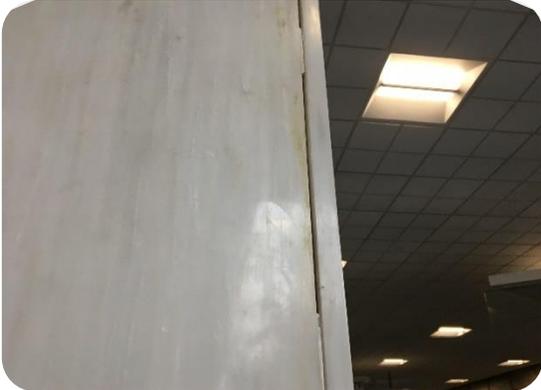
Create protocols designed to prevent damage from collisions with carts and maintenance equipment.	
Priority: Medium			
Interior Marble	Joint Failure	Repoint all interior marble joints with a compatible grout that matches the original in color and texture.

Priority: Medium			
Interior Marble	Displacement	Determine if movement at failed sealant joint is active. Correct source of movement if still active.

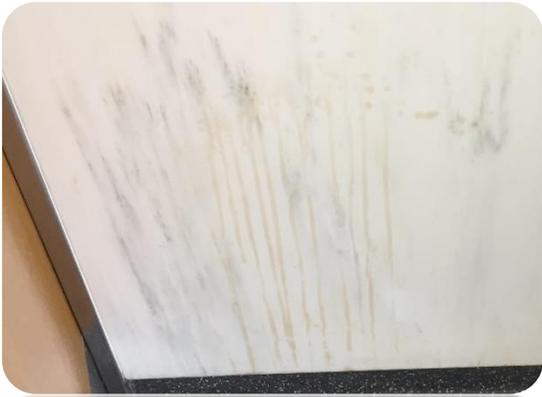
Interior Finishes: Marble, Terrazzo, and Tile			
ELEMENT	CONDITION	RECOMMENDATION	PHOTO
Interior Marble	Soiling	Clean interior marble with mild, non-ionic detergent and water.

Priority: Low			
Interior Marble	Staining	Clean stains that remain after general cleaning with neutral or alkaline latex poultice material.

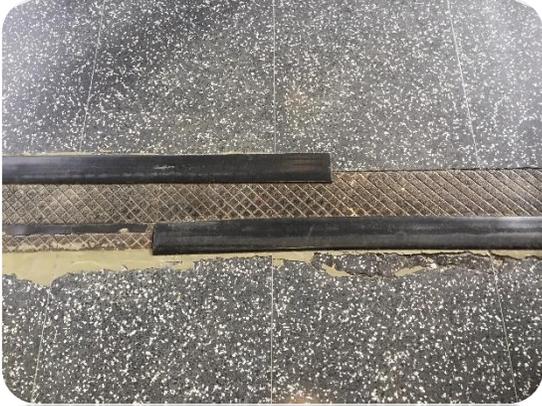
Priority: Low			
Terrazzo	Inappropriate Repair	Remove inappropriate epoxy patch.

Patch with terrazzo patch that matches original in color and texture.	
Priority: Low			
Terrazzo	Spall	Patch with terrazzo patch that matches original in color and texture.

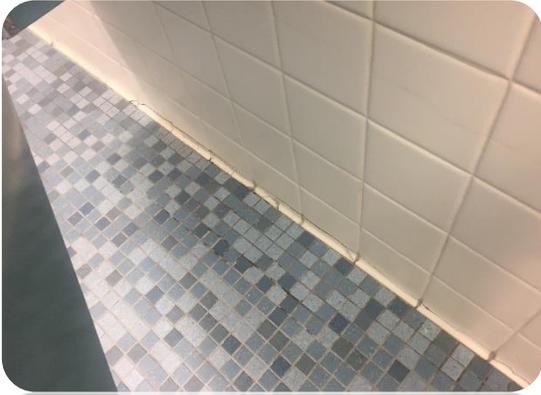
Interior Finishes: Marble, Terrazzo, and Tile			
ELEMENT	CONDITION	RECOMMENDATION	PHOTO
Tile	Crack	Replace cracked tiles in kind.

Priority: Low			
Tile	Spall	Replace spalled tiles in kind.

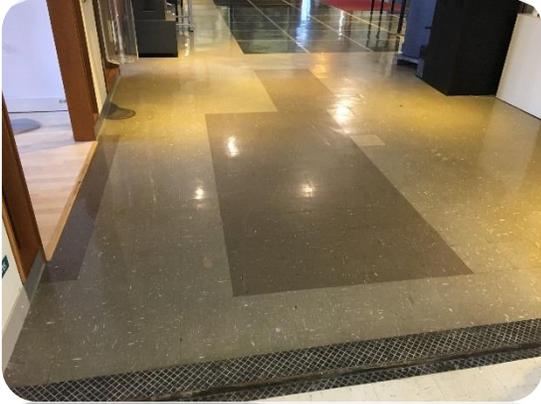
Priority: Low			
Interior Finishes	Inappropriate Replacement	Existing replacements that are a poor match do not require replacement if they are in sound condition.

When necessary, replace damaged stones with new or salvage stone that matches the original in color, texture, size, shape, and profile.	
Priority: Low

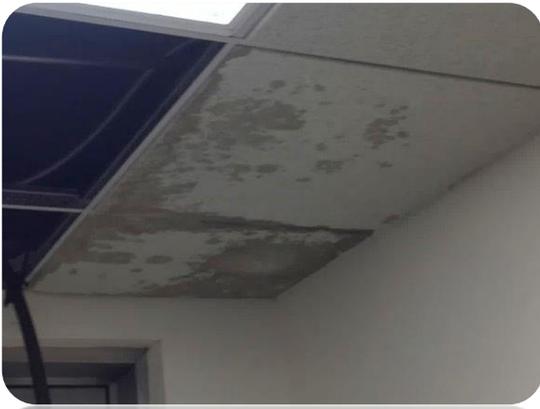
Ceiling Tiles			
ELEMENT	CONDITION	RECOMMENDATION	PHOTO
Ceiling Tiles	Water Damage	Investigate and correct sources of water infiltration or high relative humidity.

After correcting source of water leak, remove damaged ceiling tiles and replace in kind.	
Priority: Medium			
Interior Finishes	Missing Element	Replace missing element in kind.

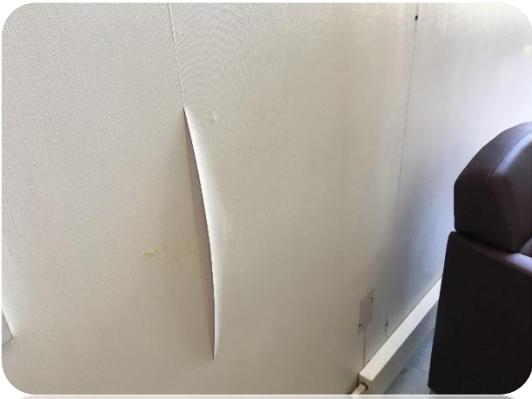
Plaster			
ELEMENT	CONDITION	RECOMMENDATION	PHOTO
Plaster Wall Vinyl Covering	Delamination	Reattach delaminated vinyl wall covering.

Priority: Low

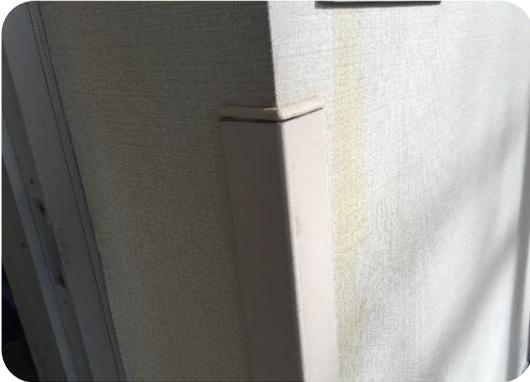
Plaster			
ELEMENT	CONDITION	RECOMMENDATION	PHOTO
Plaster Wall Vinyl Covering	Staining	Clean stained vinyl wall fabric with a mild, non-ionic detergent and water.

Priority: Low			
Plaster	Water Damage	Investigate and correct sources of water infiltration.

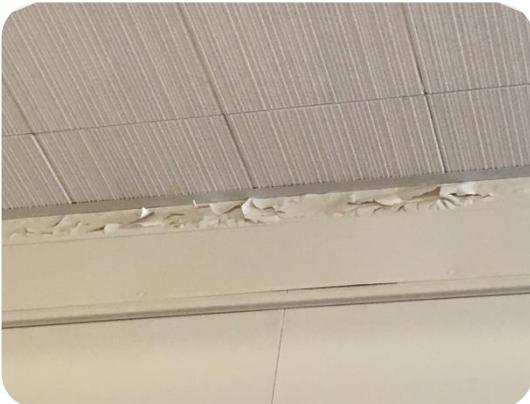
After correcting source of water leak, remove damaged plaster.	
		Patch with new plaster. Sand so that patch is smooth and flush with adjacent plaster. Paint or provide vinyl wall covering to match adjacent wall or ceiling.	
Priority: Medium			
Plaster	Paint Loss	Investigate and correct sources of water infiltration or high relative humidity.

After correcting source of water leak, remove damaged plaster.	
		Patch with new plaster. Sand so that patch is smooth and flush with adjacent plaster. Paint.	
Priority: Medium

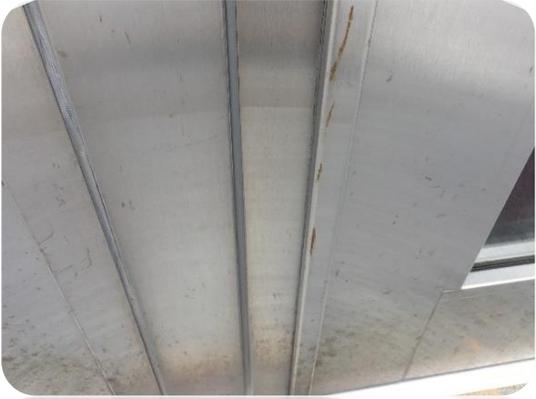
Architectural Metal			
ELEMENT	CONDITION	RECOMMENDATION	PHOTO
Architctural Metals	Corrosion	Remove corrosion and apply protective coating.

When salting exterior pavement, avoid allowing salt to come in contact with ornamental metals. Rinse salts from all surfaces once temperatures are above freezing and rising.	
Priority: Low			
Architctural Metals	Dents and Dings	Minor dents and dings to not require repair.

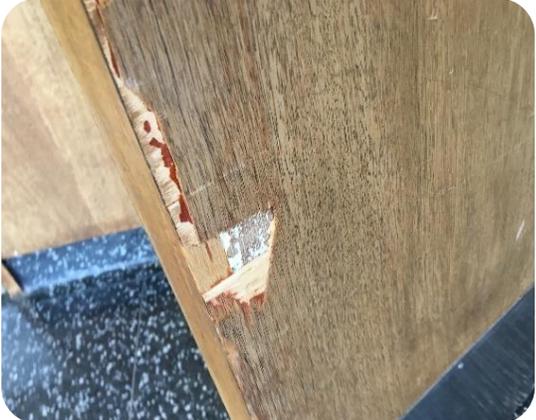
Architectural Woodwork			
ELEMENT	CONDITION	RECOMMENDATION	PHOTO
Doors	Veneer Loss	Provide dutchman repair with walnut veneer that matches the original in color and texture.

Priority: Low

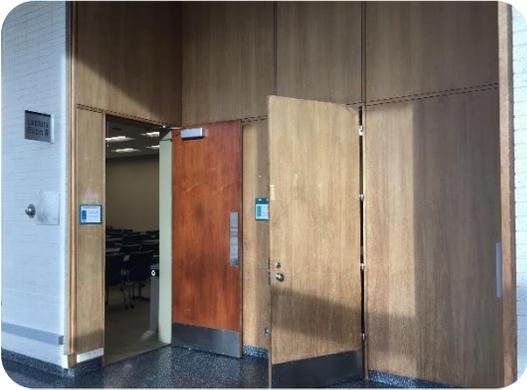
Architectural Woodwork			
ELEMENT	CONDITION	RECOMMENDATION	PHOTO
Paneling	Faded Finish	Using original material boards as a guide, restore original finish.

Priority: Medium			
Paneling	Inappropriate Finish	Using original material boards as a guide, restore original finish.

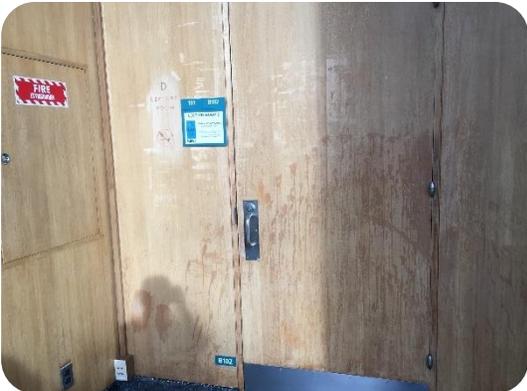
Priority: Medium			
Paneling	Residue	Clean veneer.

Create maintenance protocols that prevent damage to wood veneer from cleaning chemicals and floor refinishing products.	
Priority: Low			
Architectural Woodwork	Nicks and Scratches	Minor nicks and scratches do not require repair.

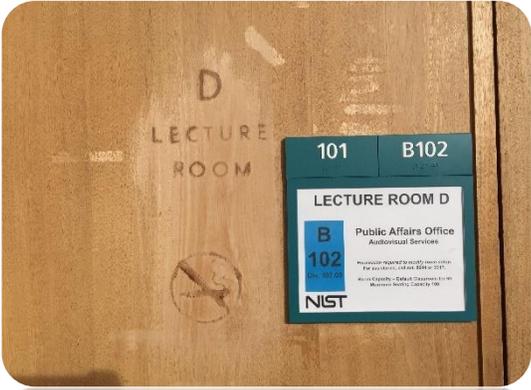
Signage			
ELEMENT	CONDITION	RECOMMENDATION	PHOTO
Historic Signage	Missing	Replicate original signage and reinstall alongside modern signage. Use ghost marks and historic signage that still exist to inform replication.

Priority: Medium			
Historic Signage	Partially Missing	Replicate and reinstall missing elements. Use ghost marks and historic signage that still exist to inform replication.

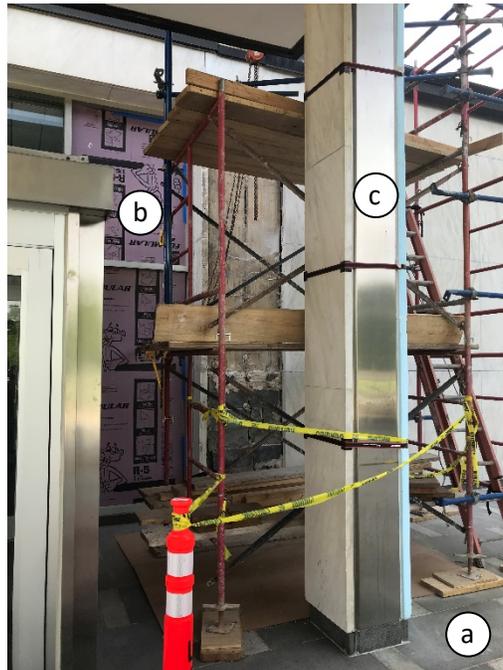
Two opposite faces of the columns are clad in two-inch marble with the other two faces clad in stainless steel. (See Photo 1) There is a short panel of 1 ½ inch thick granite at the base on all four sides. (See Photo 2) The cavity between the granite and the concrete column is filled with mortar. The panels are bedded with ¼ inch white Portland cement mortar and appear to be installed tight to the concrete soffit above. (See Photo 3) The panels appear to have been set on small V-shaped lead shims prior to applying the mortar.

Photo 1 – a. Entrance Column Test Opening. b. Entry Wall Panel Opening. c. Stainless Steel Panels.

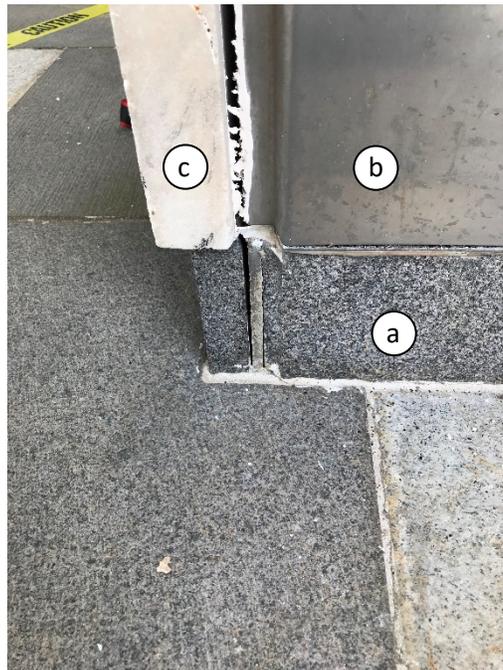
Photo 2 –a. Granite Base. b. Stainless Steel Cover. c. 2 inch Marble Panel.

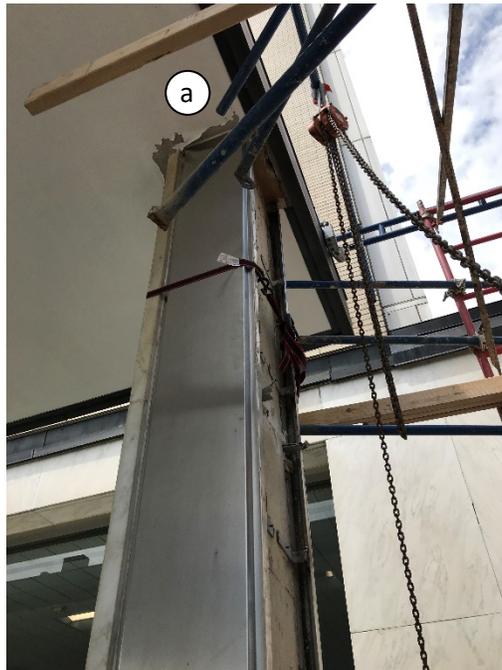
Photo 3 – a. Marble installed tight to underside of soffit.

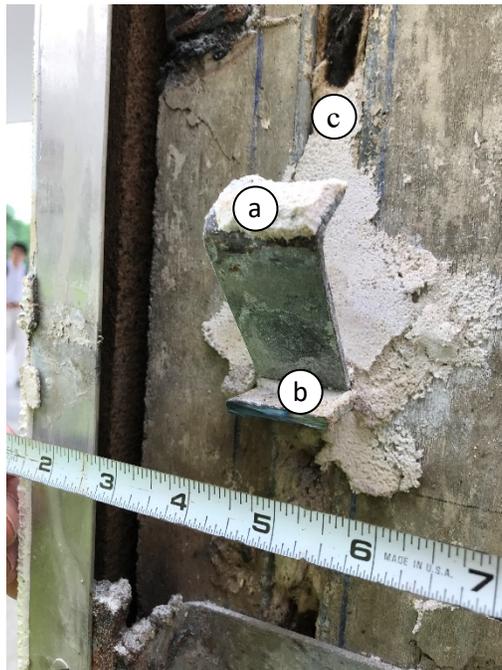
The top of the first course of marble is attached with two 3/16-inch-thick masonry angle ties with the one leg turned down into a kerf at the top of the marble panel and the other in the same continuous dovetail slot cast in the concrete column. At the same location there are two more angle ties with one leg facing upwards to receive the next course of marble panels. (See Photo 4)

Photo 4 – a. Masonry Anchor bent up during removal of stone. b. Masonry Anchor cut during removal. c. Embedded dovetail slot.

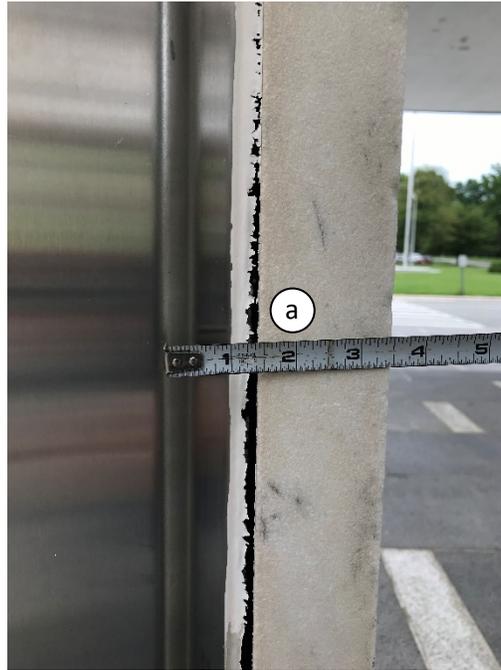
The panels are bowing outwards with the most bowing at the lowest panel. (See Photo 5)

Photo 5 – a. Bowing of Panel.

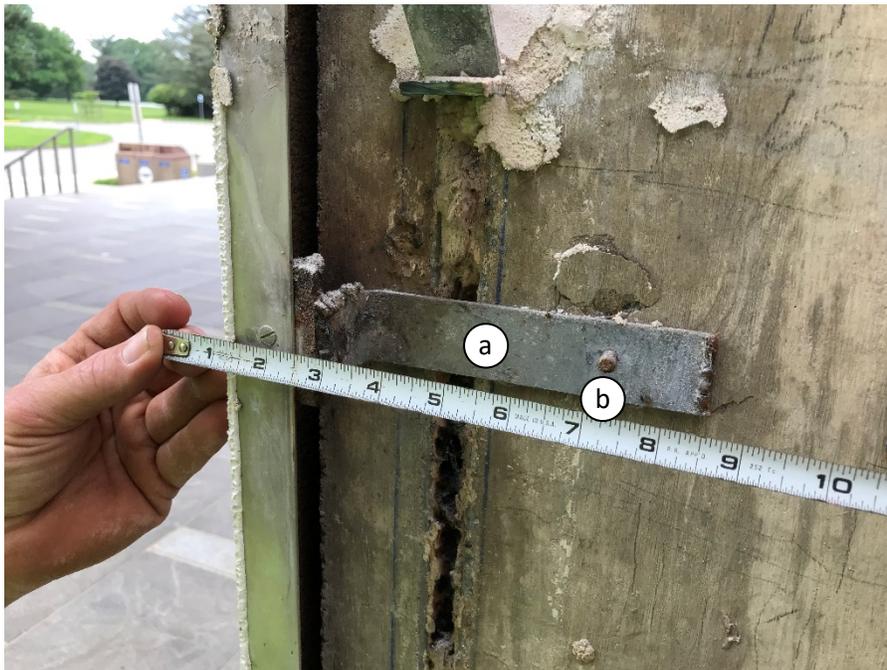
The stainless-steel covers are attached with a welded steel plate attached in turn to a metal strap nailed into the concrete column. The metal strap appears to be galvanized but the metal connection plate is ferrous metal and corroded. (See Photos 6, 7) There is no flashing or weep holes to allow water to escape from the cavity.

Photo 6 – a. Anchor for stainless steel cover. b. Fastener for anchor to concrete.

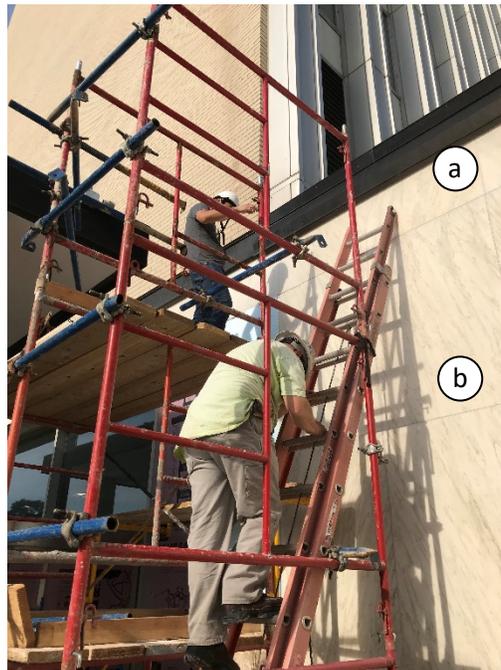
The exterior façade is clad in three courses of 37-inch wide x 55-inch-high panels stacked vertically. (See Photo 8)

Photo 8 – a. Top band of marble panels. b. Three courses of 2-inch marble panels.

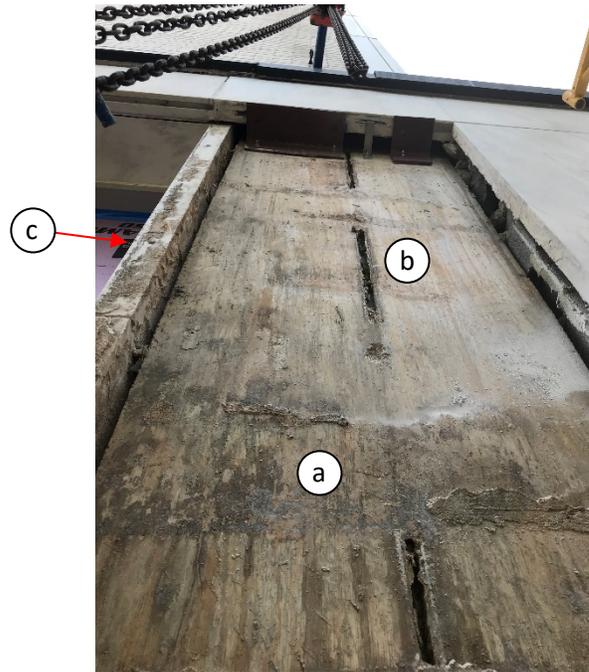
The three 3-inch-thick panels removed near the entrance on the perimeter wall were attached to a concrete column. (See Photo 10) This condition is likely to be the same at all other building perimeter columns but not on the walls between the columns. Between the back of the panel and the face of the concrete column there was a thin infill of concrete block loosely mortared in place.

Photo 10 – a. Perimeter concrete column. b. Embedded dovetail slot. c. Marble return panel.

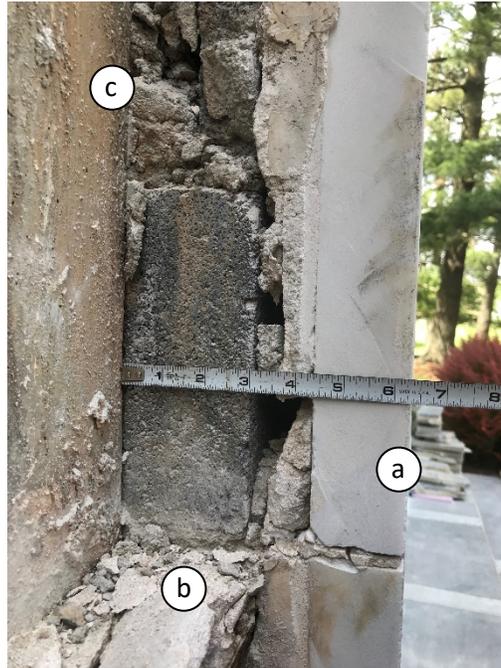
Between the columns the panels are 2-inch-thick with a concrete masonry block backup. This block infill is likely to provide lateral support to the panels at these locations. In order to evaluate the panel to block connection system another panel would have to be removed. (See Photo 11)

Photo 11 – a. 2 inch typical exterior wall panel. b. Masonry packing in front of column. c. Masonry back up to wall panels.

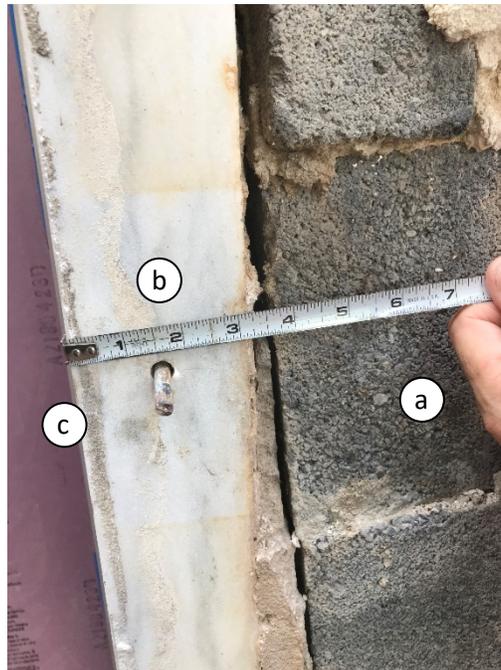
The entrance wall panels were doweled with two pins each side to the short 3-inch-thick, 10-inch-wide return panels at the door (See Photos 12, 13) and to the adjacent 2-inch-thick panels.

Photo 12 – a. Masonry fill in front of column. b. 3 inch return panel. c. S.S. dowel to panel on column face.

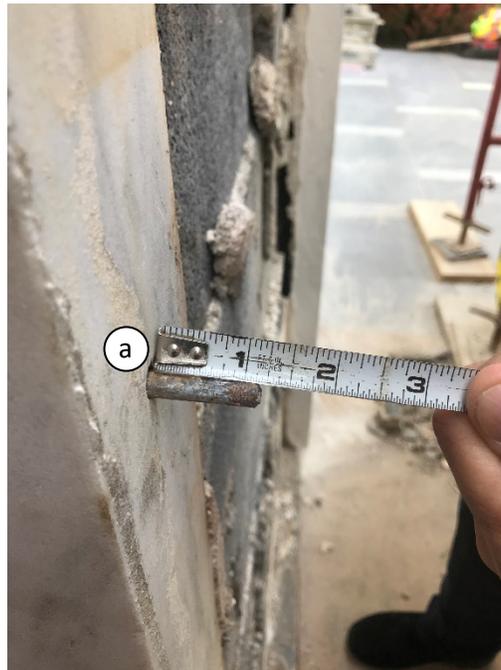
Photo 13 – a. 2 ¾ inch x 5/16 dia. Stainless Steel dowel.
