# NIST Building 101

## Historic Structure Report and Condition Assessment

Final Submission  
March 15, 2020

**John Milner Associates Preservation**

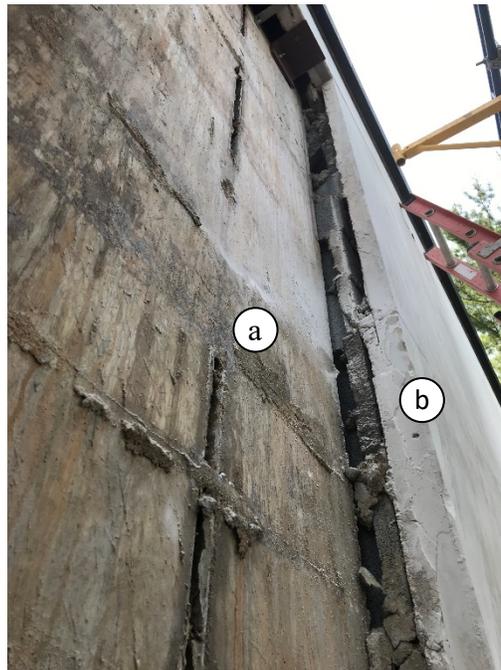
(See Photo 14) They were also attached at the four corners with split tail masonry anchors (See Photo 15), also hooked into kerfs cut in the top and bottom of the stones and fastened to the concrete column. (See Photo 16) The masonry ties at each of the four corners appear to have pulled away from the concrete column by 3/8 inch and, in at least one instance, the fastener had corroded to the extent that it was not connected to the concrete causing the anchor to become loose and ineffective. (See Photo 17) However, other fasteners appear to be in good condition and still attached to the concrete (See Photo 18). Several of the fasteners were corroded but still embedded in the concrete. The split tail anchor attached into the top of the base granite course was also loose and pulled away from the concrete. (See Photos 19, 20) The fasteners appear to be power activated nails shot through the 3/16-inch metal masonry ties and into the concrete. (See Photos 56, 64)

Photo 14 – a. Insert embedded dovetail in column. b. 2 inch wall panel.

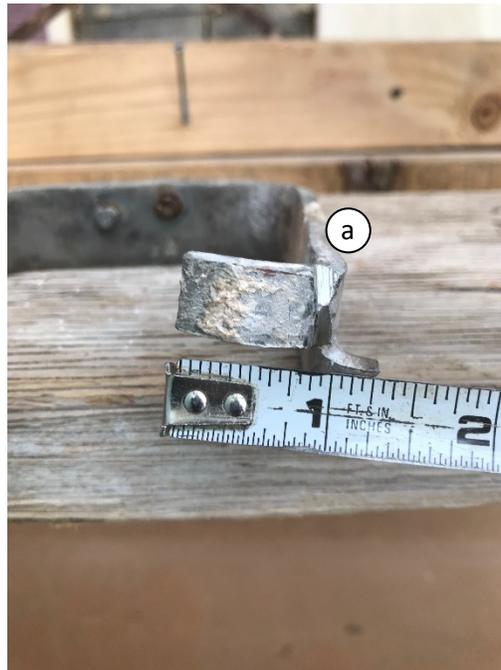
Photo 15 – a. Typical split tail masonry anchor.

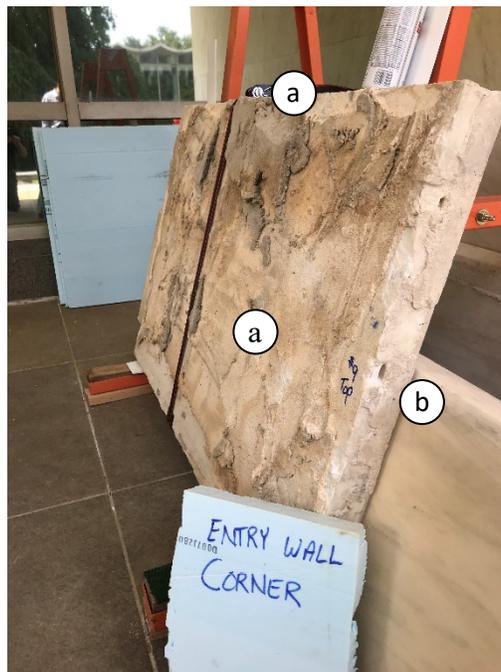
Photo 16 – a. 3 inch thick panel at perimeter column. b. 3 off-center kerfs cut in top and bottom of stone.

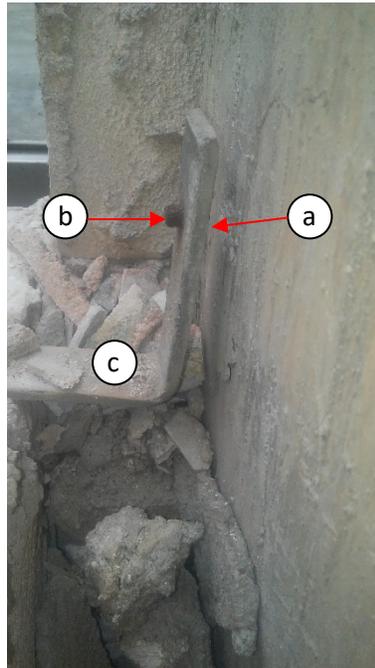
Photo 17 – a. Masonry anchor pulled 3/8" away from concrete. b. Head of fastener but missing piece to concrete. c. Masonry anchor.

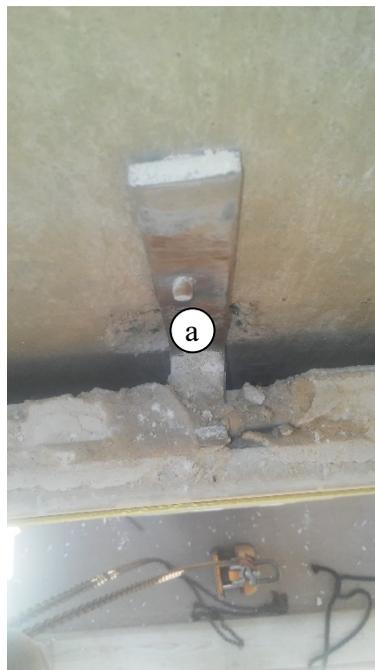
Photo 18 – a. Masonry anchor with fastener in good condition.

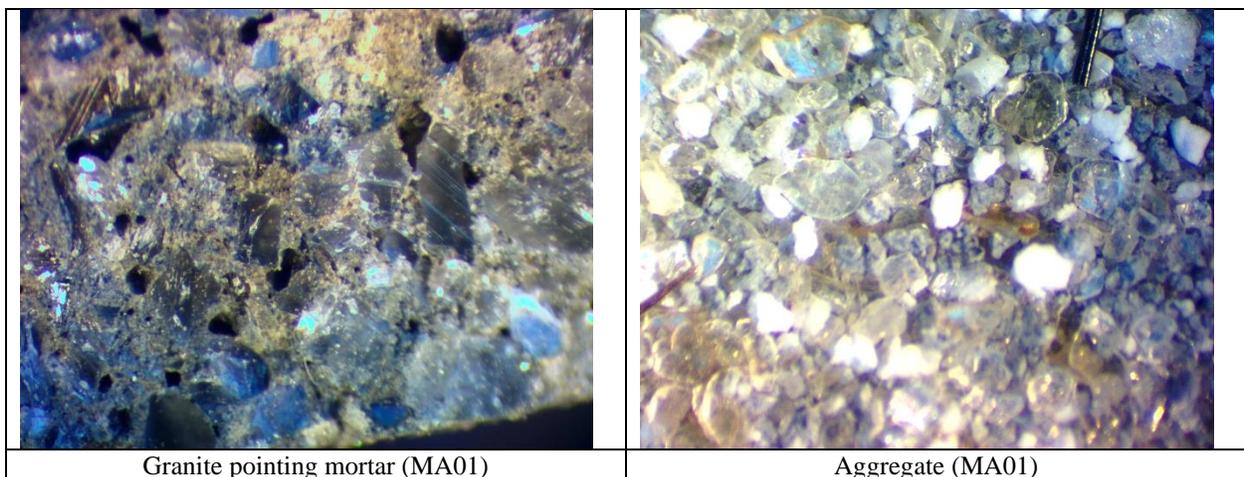
The pointing mortar is hard and brittle. It breaks by hand with some difficulty. This level of brittle hardness suggests the binder consists mostly or entirely of Portland cement with little or no lime present. Original construction specification data confirms this observation. The matte binder for mortar sample MA01 is a dark bluish gray (5PB 4/1). In cross section, the aggregate appears to be relatively fine and homogenous in size and shape. Grains are mostly gray or translucent and colorless, so that they pick up the gray color of the surrounding binder.

The aqueous solution of the powdered mortar sample effervesced violently with the addition of acid, which is typically a characteristic of lime mortars rather than entirely Portland cement mortars. However, visual inspection revealed no lime clumps and construction specifications do not list lime as a component. It is therefore possible that an unknown component of the original mortar and grout compound described in

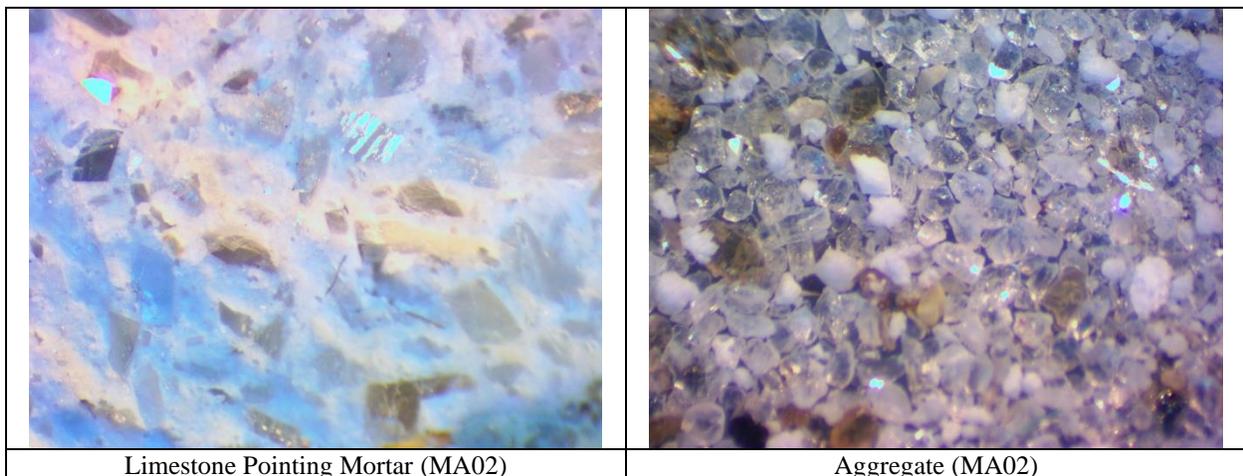
The pointing mortar is hard and brittle. It breaks by hand with some difficulty. This level of brittle hardness suggests the binder consists mostly or entirely of Portland cement with little or no lime present. Original construction specification data confirms this observation. The creamy matte binder for mortar sample MA02 is a yellowish white (5Y 9/0.5), indicating white rather than gray Portland cement was the principal binder. In cross section, the aggregate appears to be relatively fine and homogenous in size and shape. Grains are white, gray, and yellow in color.

The aqueous solution of the powdered mortar sample effervesced violently with the addition of acid, which is typically a characteristic of lime mortars rather than entirely Portland cement mortars. However, visual inspection revealed no lime clumps and construction specifications do not list lime as a component. It is therefore possible that an unknown component of the original mortar and grout compound described in specifications reacts violently with acid. After the initial effervescence, the reaction was relatively slow, taking several days for the binder to fully dissolve.

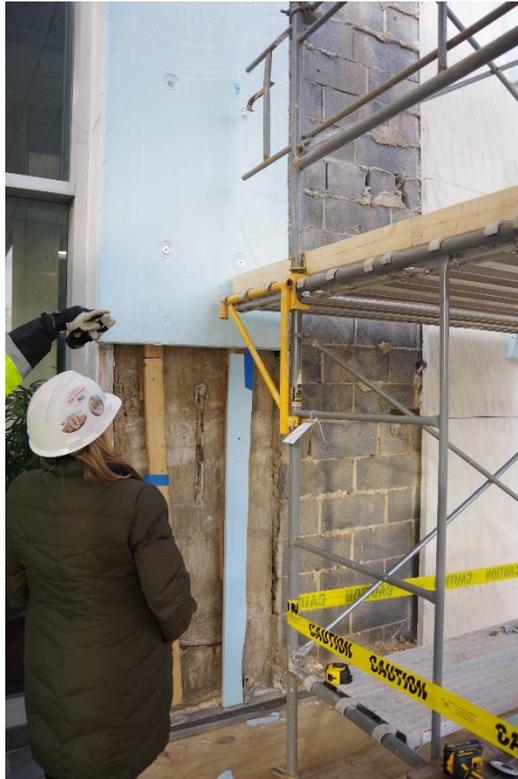
Photo 1 – Overview, Exterior Marble Panels on East Perimeter CMU Wall

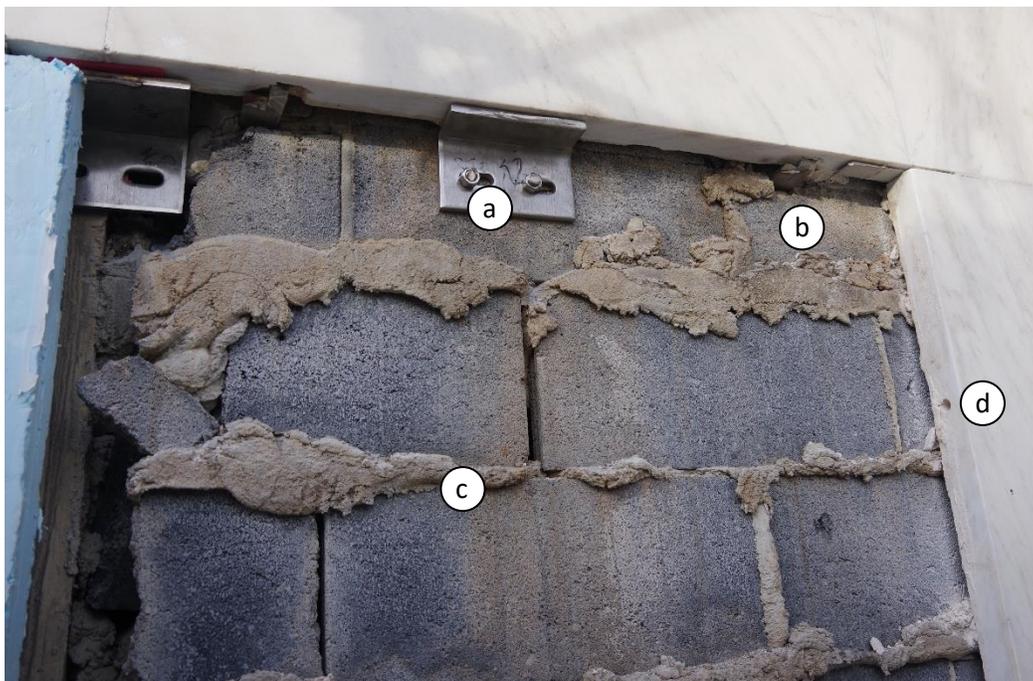
Photo 2 – Top of removal area - a. Stainless steel support angle (new). b. Stainless split tail tie (exist).  
c. CMU backup wall. d. hole for alignment pin in adjacent panel

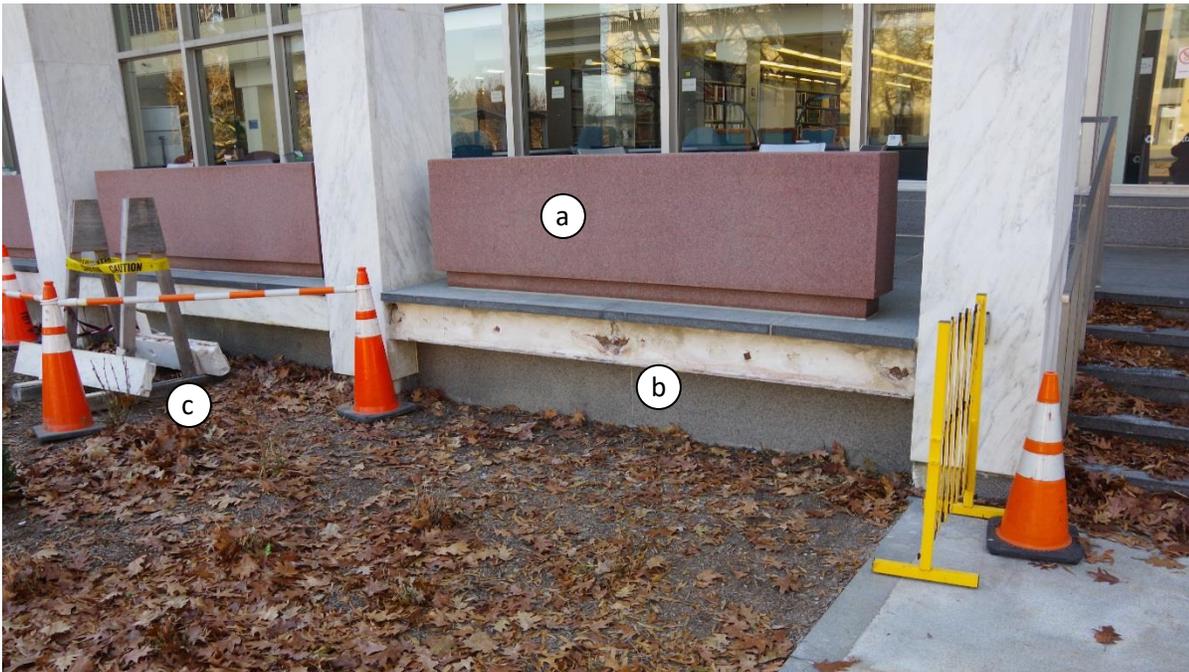
Photo 7 – a. Overview, Marble Panel Supports at Library Patio Fascia. b. Steel angle. c. Removed marble fascia panels.

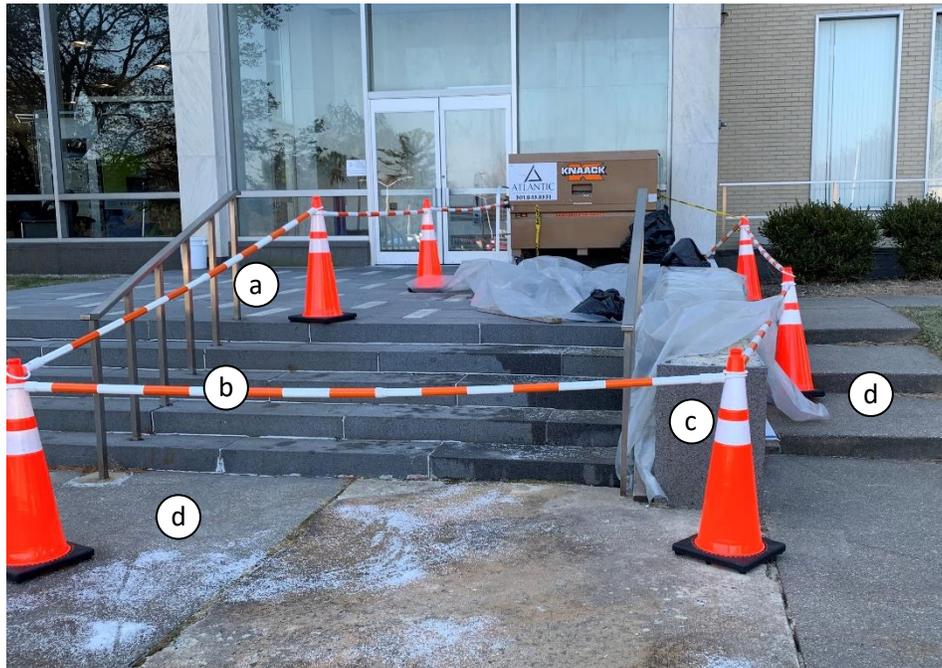
Photo 11 – North entrance plaza overview. a. Granite Pavers. b. Granite Steps. c. Cheek Wall. d. Concrete slabs and steps

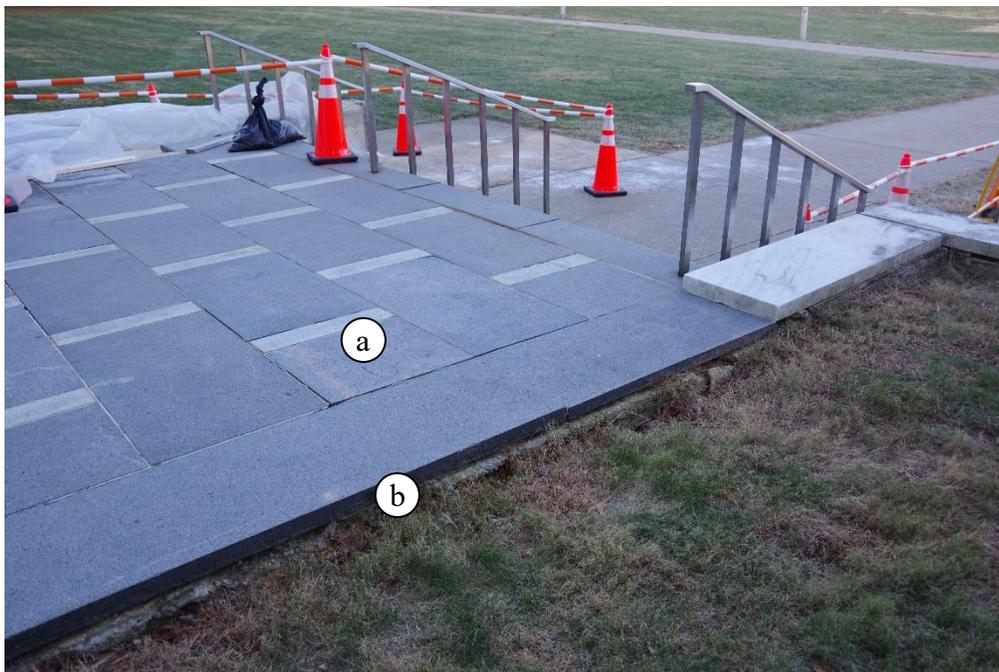
Photo 12 – North entrance plaza. a. Granite Pavers with open joints. b. Edge of paving.

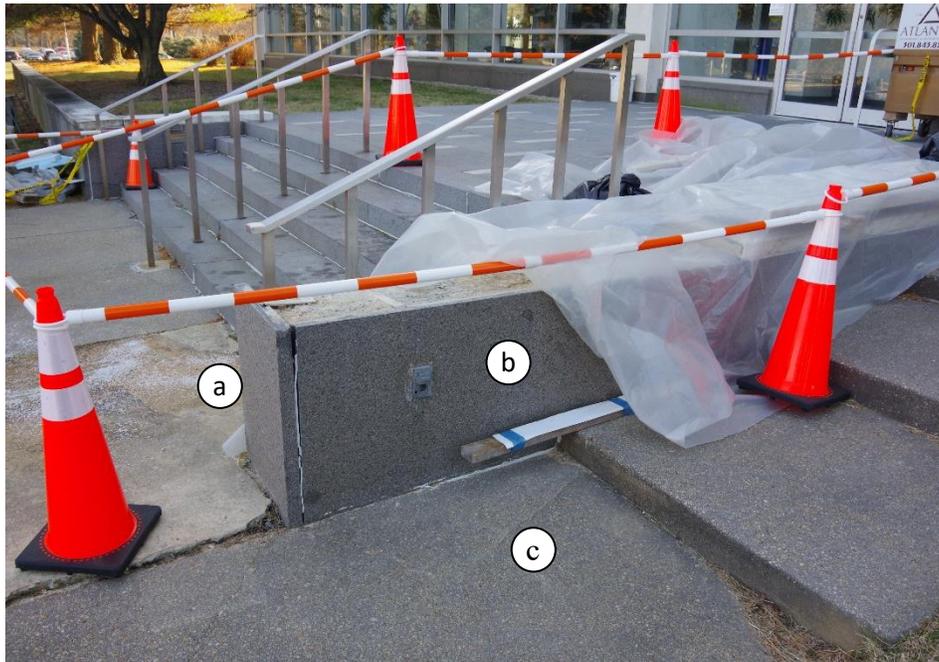
Photo 15 – Cheek wall. a. End stone. b. Side wall stone. c. Adjacent concrete slabs tight to stones.

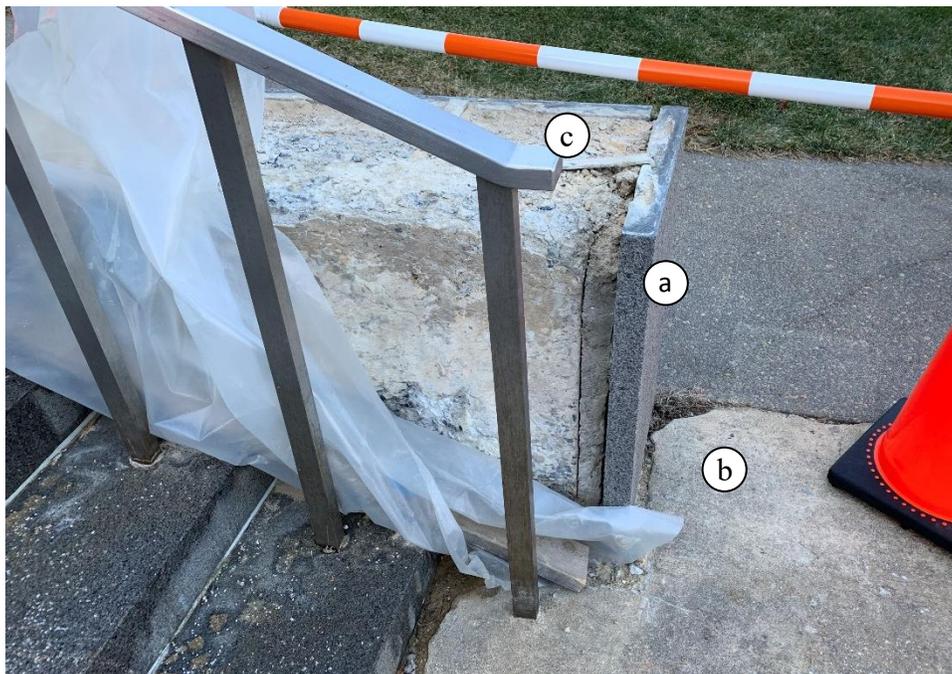
Photo 16 – a. End stone with fully grouted cavity. b. Concrete slab on grade tight to stone. c. Stainless steel strap anchor.

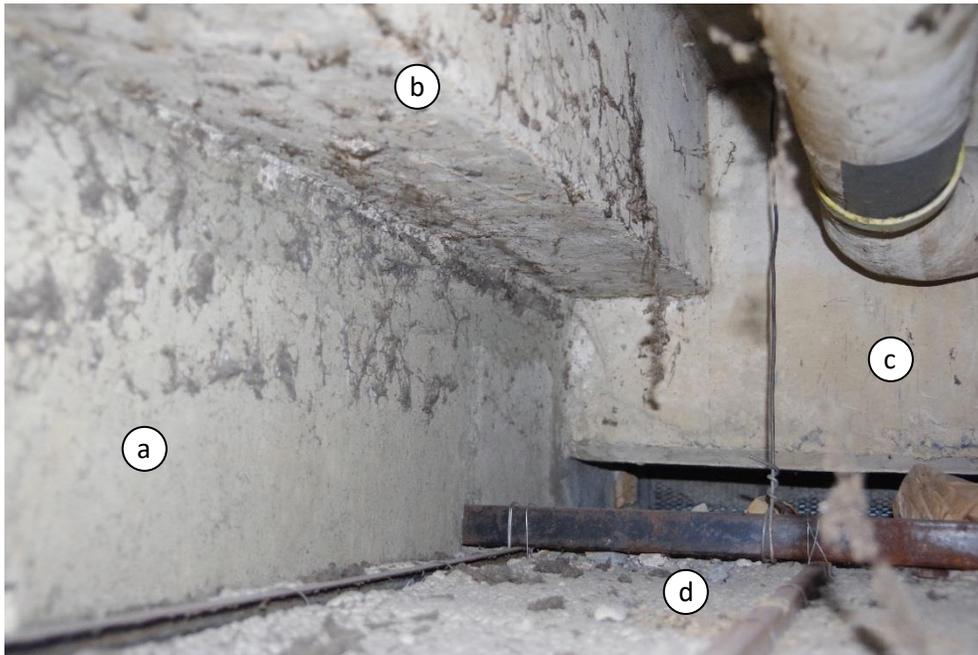
Photo 19 – a. Retaining wall. b. Concrete beam. c. Concrete spandrel beam at front of soffit. d. Plaster soffit with steel channels and wire hangers.

- *Replace plaster soffit within 10 years*

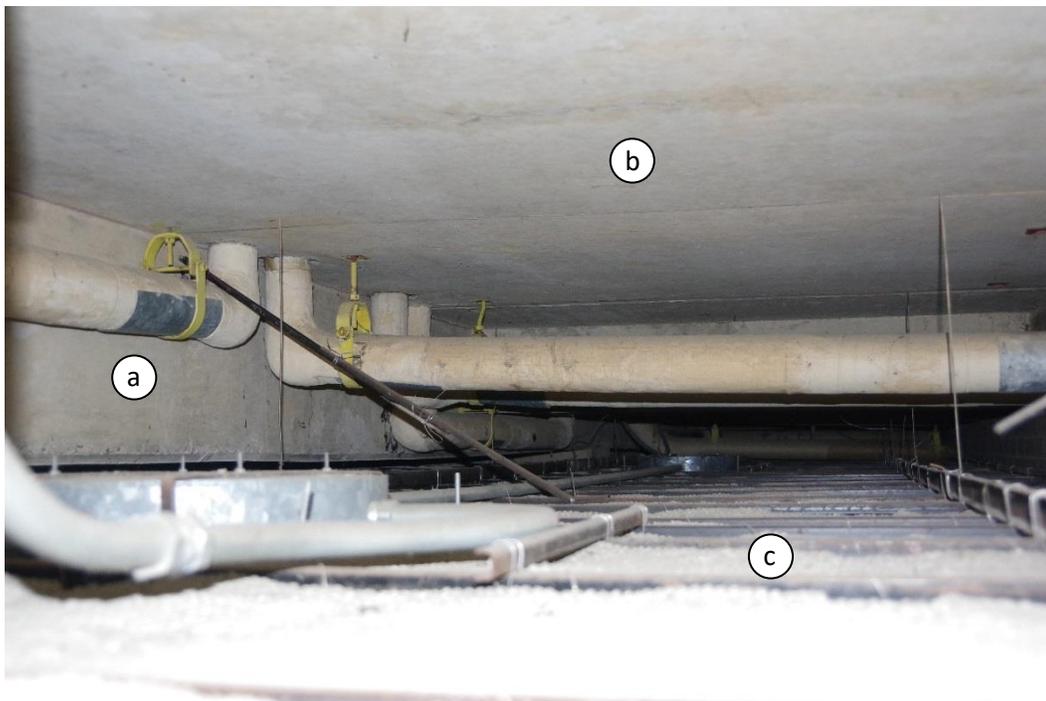
Photo 20 – a. Concrete spandrel beam at front of soffit. b. Concrete slab above. c. Plaster soffit.
