National Institute of Standards and Technology General Purpose Laboratories

Historic Structures Report | 100% Submission Condition Assessment

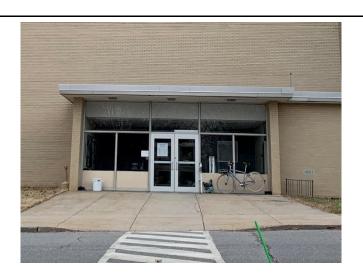
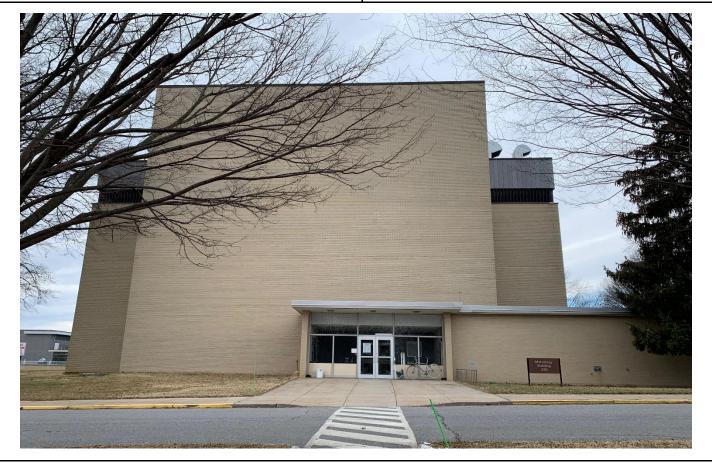
Building 220 – East Elevation

The east elevation is the principal elevation of Building 220, the Metrology Building at NIST. The main formal entrance is located on this elevation with a wide canopy, an aluminum fascia, and aluminum curtain wall demarcating the vestibule. There are no punched openings in the three-story brick façade besides the main entrance on the first floor. Instead, the architectural interest is expressed in the projecting and recessed forms reflecting the interior function. The laboratory core is pushed forward in the center while the supporting corridors and offices are recessed to the left and right. The one-story entrance projects from the main body of the building and wraps around to indicate the service entrance on the north façade.

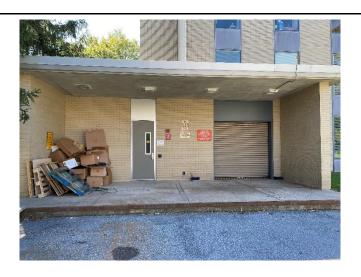
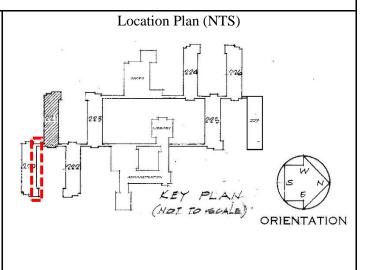
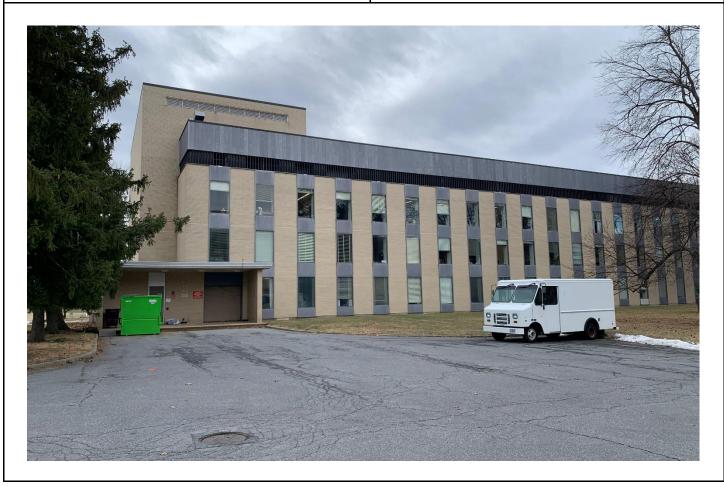
Building 22	0 - North	Elevation
-------------	-----------	-----------

The north elevation of Building 220 is a secondary facade and faces the concourse at Building 221's east elevation and the south elevation of Building 222. The north elevation features a large expanse with regularly alternating beige face brick with insulated aluminum curtain walls with plate glass windows and aluminum spandrel panels. Above, the attic level of the building is defined by heavy horizontal banding consisting of insulated aluminum cladding. At the east end of the elevation is a one-story storage room and loading dock. A secondary exterior entrance indicates the internal stair hall located toward the building's midpoint.

There are no original 1963 doors on the north elevation as all doors and their associated frames and hardware are replacement ones.

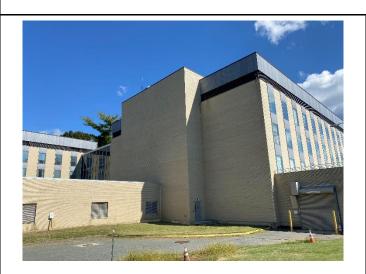
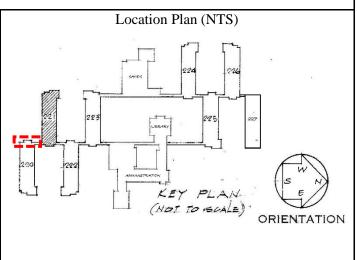
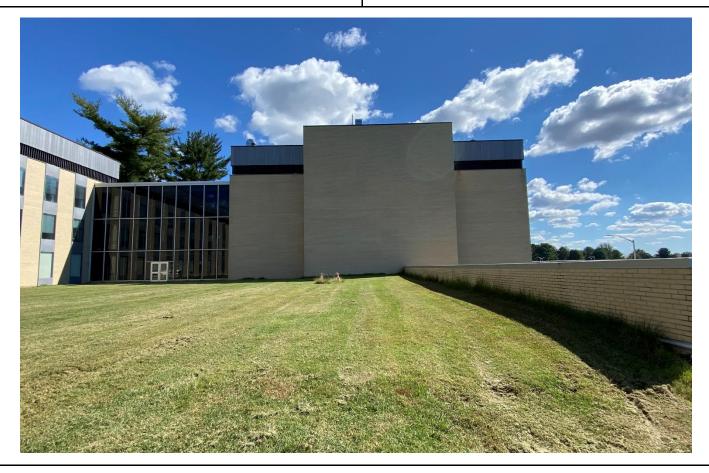
Building 220 – West Elevation

The west elevation is secondary facade of Building 220 and directly abuts the concourse to Building 221. The elevation features beige face brick and is devoid of any openings. Above the first three stories, the attic level is articulated by heavy horizontal banding consisting of insulated aluminum cladding.

There are no original 1963 doors on the west elevation of Building 220.

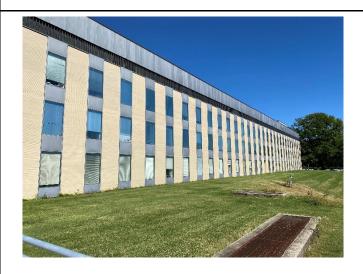
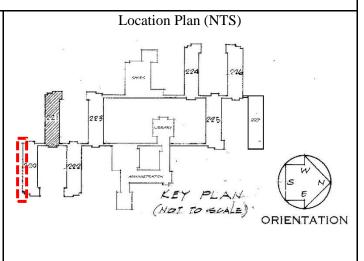
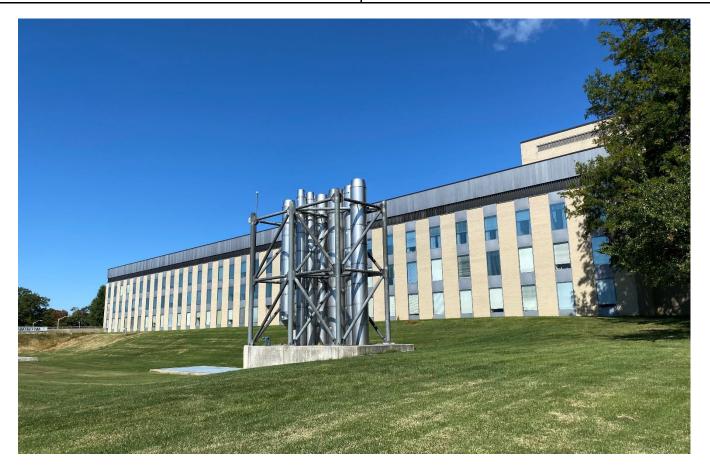
Building 220 – South Elevation

The south elevation of Building 220 is a secondary facade and faces the Center for Nanoscale Science and Technology 216 buildings. The north elevation features a large expanse with regularly alternating beige face brick with insulated aluminum curtain walls with plate glass windows and aluminum spandrel panels. Above, the attic level of the building is defined by heavy horizontal banding consisting of insulated aluminum cladding. A secondary exterior entrance indicates the internal stair hall located toward the building's midpoint.

There are no original 1963 doors on the north elevation as all doors and their associated frames and hardware are replacement ones.

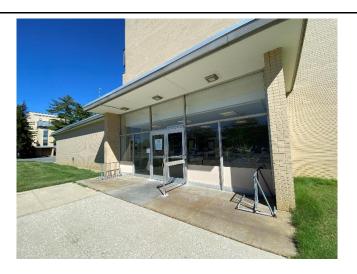
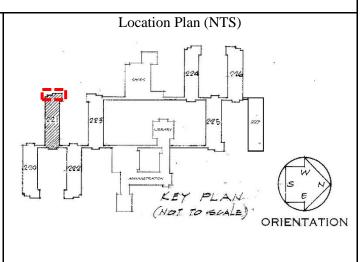
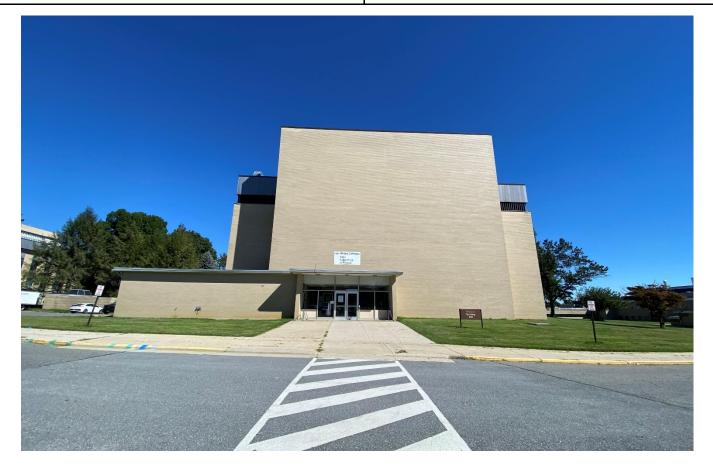
Building 221 – West Elevation

The west elevation is the principal facade of Building 221, the Physics Building, at NIST. The main formal entrance is located on this elevation with a wide canopy, an aluminum fascia, and aluminum curtain wall demarcating the vestibule. There are no punched openings in the four-story brick façade besides the main entrance on the first floor. Instead, the architectural interest is expressed in the projecting and recessed forms reflecting the interior function. The laboratory core is pushed forward in the center while the circulation corridors and office cores are recessed to the left and right. The one-story entrance projects from the main body of the building and wraps around to indicate the service entrance on the north façade. This horizontal element offsets the verticality of the blank brick walls.

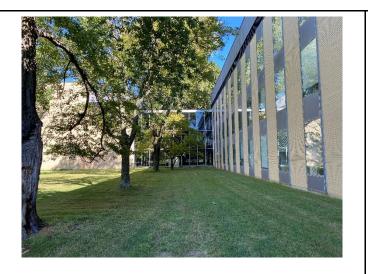
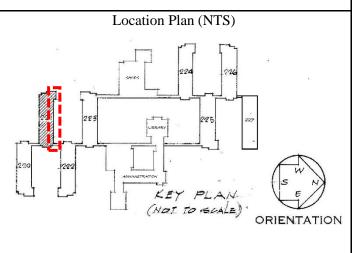
Building 221 – North Elevation

The north elevation of Building 221 is a secondary facade and faces the concourse at Building 223's south elevation. The north elevation features a large expanse with regularly alternating beige face brick with insulated aluminum curtain walls with plate glass windows and aluminum spandrel panels. Above, the attic level of the building is defined by heavy horizontal banding consisting of insulated aluminum cladding. At the west end of the elevation is a one-story storage room and loading dock. A secondary exterior entrance indicates the internal stair hall located toward the building's midpoint.

There are no original 1963 doors on the north elevation as all doors and their associated frames and hardware are replacement ones.

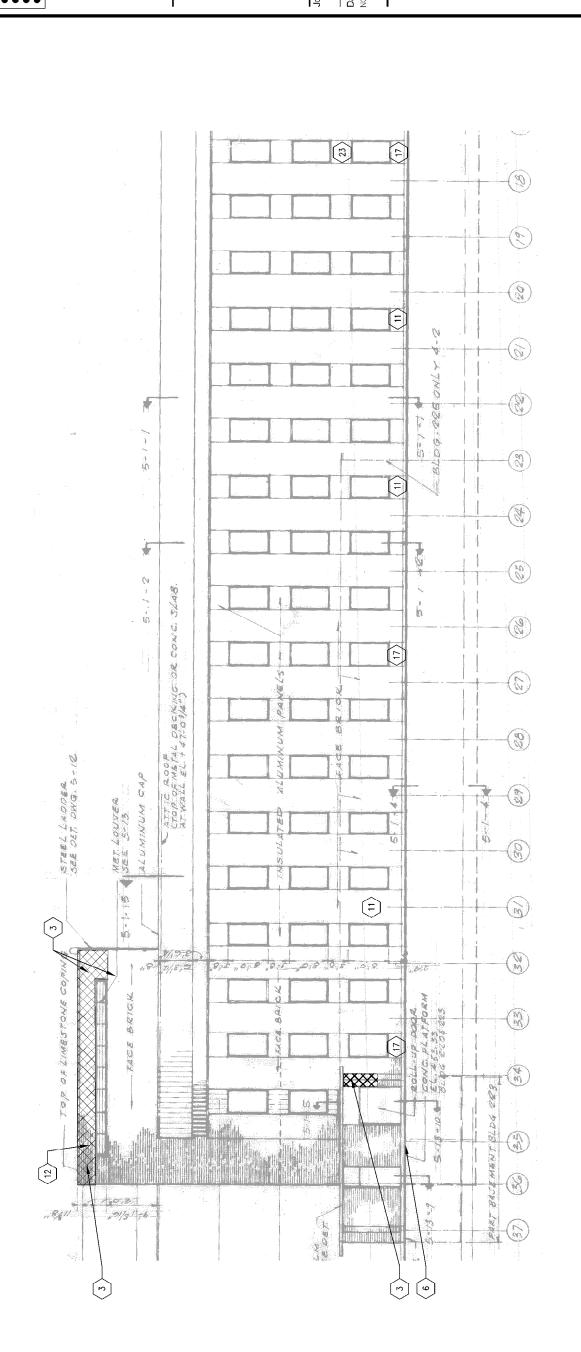
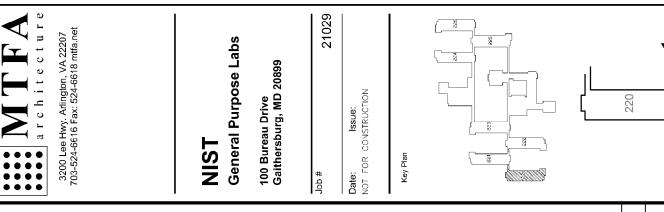
$(\hat{\Xi})$ (8) VERTICAL CRACKS. REPLACE REPAIR WALL AT BROKEN BRICKS.

GRANITE PAVERS AT ENTRANCES EXHIBIT EROSION, RUST STAINING, PREVIOUS REPAIRS AT RAILING. CLEAN AND REPAIR GRANITE.

1 > WHERE HATCHED, REPOINT OPEN JOINTS 100%

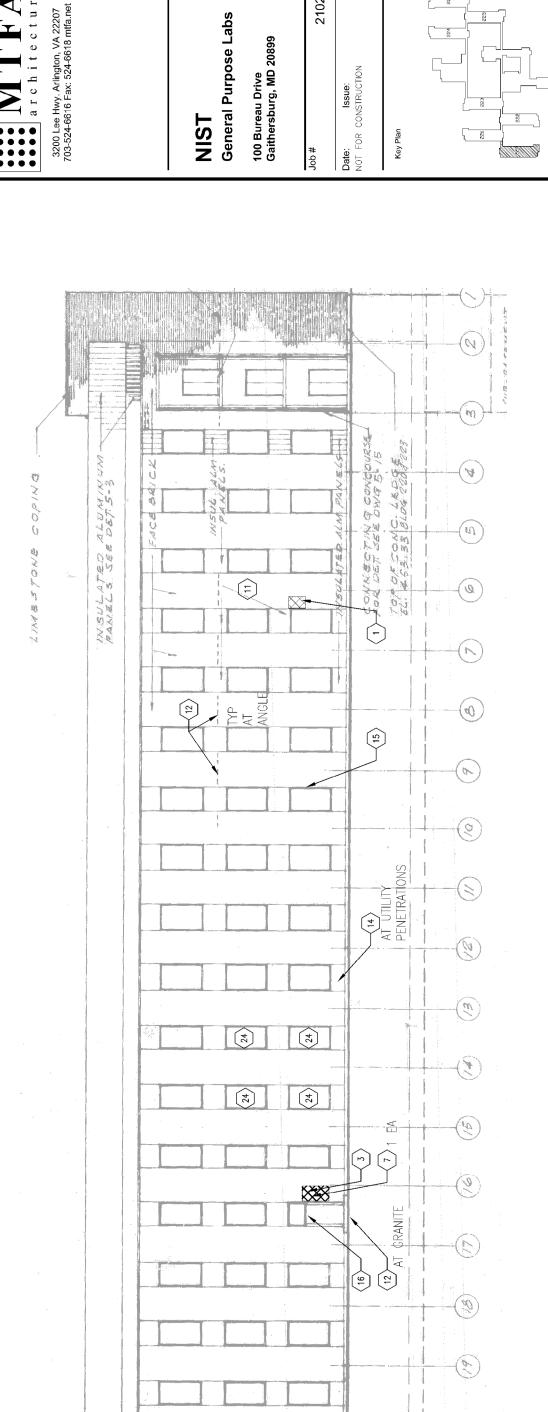
A102

GENERAL NOTES DENTED ALUMINUM. NO REPAIR.

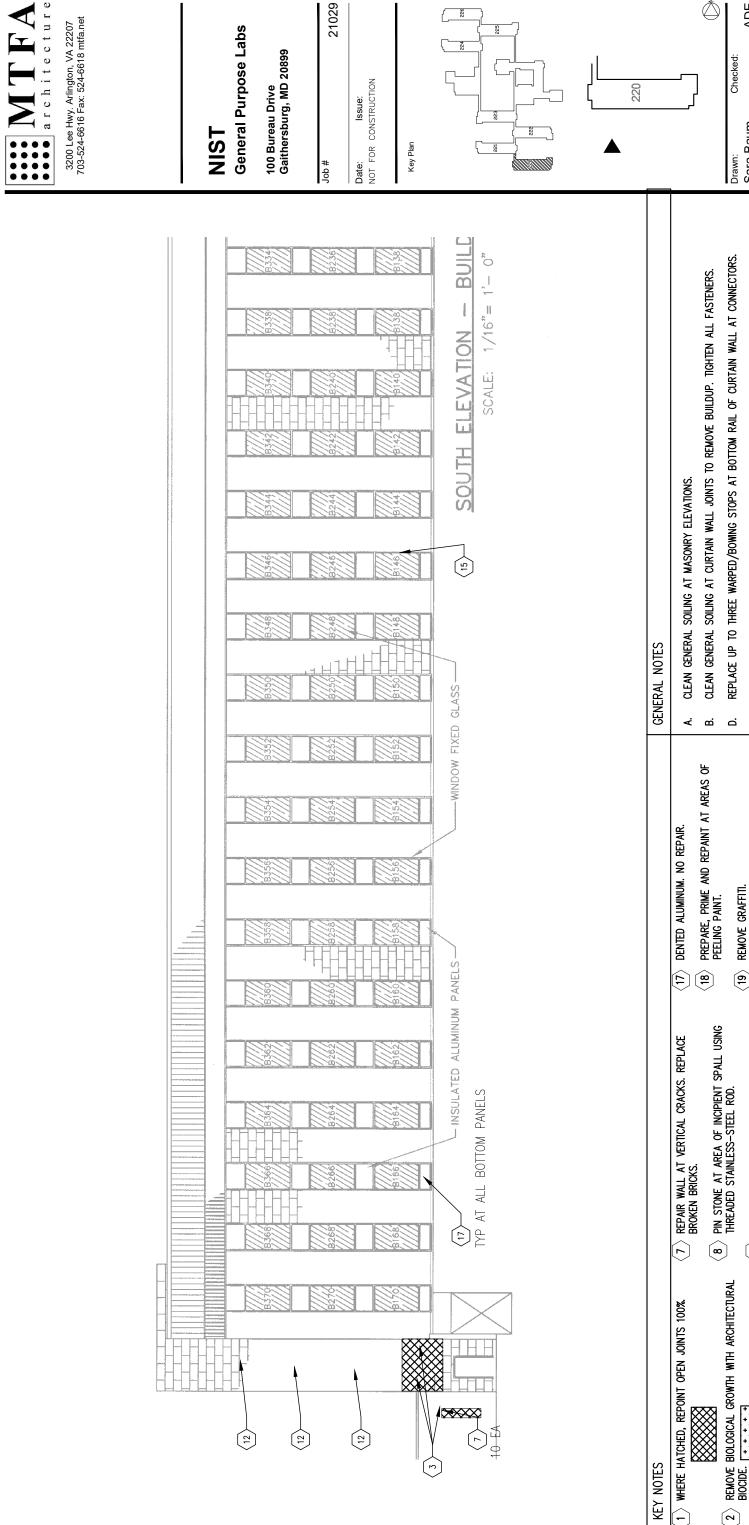
REPLACE UP TO THREE WARPED/BOMING STOPS AT BOTTOM RAIL OF CURTAIN WALL AT CONNECTORS. Ġ

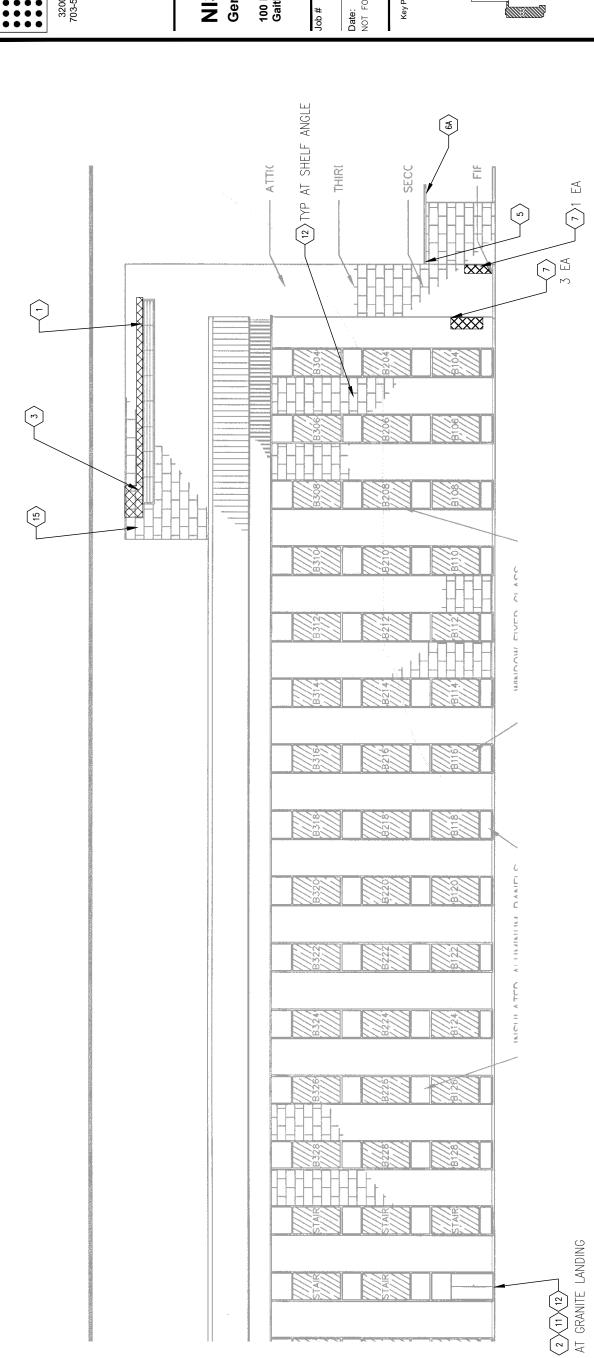
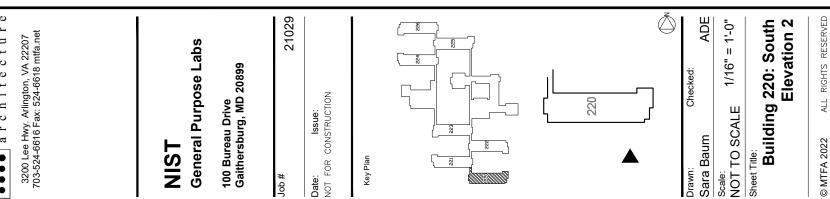
A104

- 1 angle WHERE HATCHED, REPOINT OPEN JOINTS 100%.
- 7
- TRIM LARGE VEGETATION TO BE 2 FEET OFF BUILDING. (Z)
- BRICK STEP CRACKING. (m)
- CRACK IN CONCRETE OR CONCRETE STUCCO.
- (4)
- REPAIR SPALL WITH PATCHING MORTAR THAT MATCHES EXISTING MASONRY IN COLOR, TEXTURE, AND PROFILE. 2
 - 9

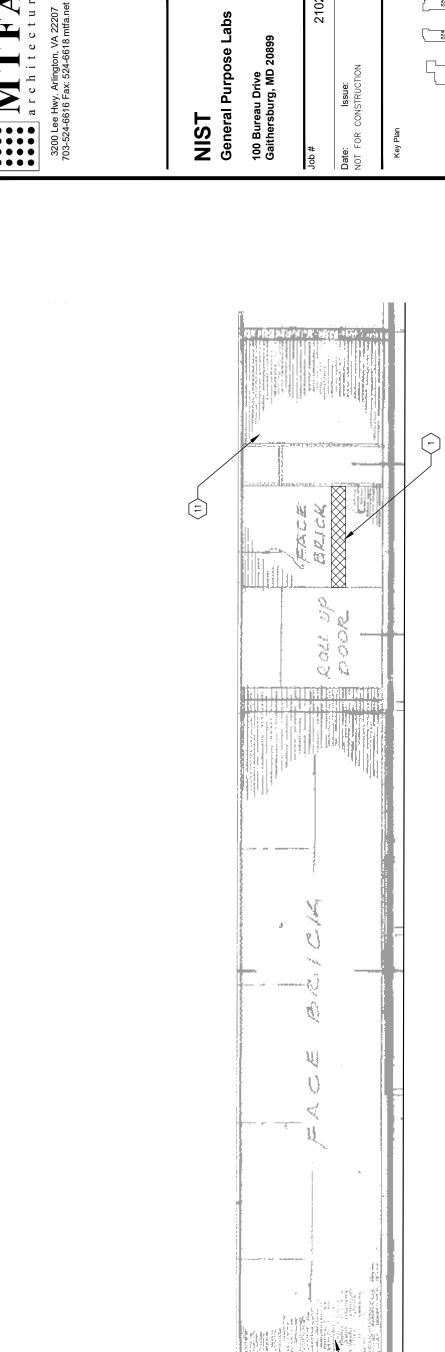
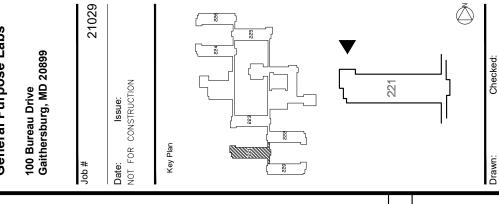
- INVESTIGATE JOINT AT FLOOR PLATE RELIEVING ANGLE WITH A PROBE TO EXPOSE THE ANGLE AND BRICK DETAILING. CORRECT FOR CONCRETE BEAM SHRINKAGE.
- REPLACE SOLAR FILM ON WINDOWS AT ALL GPL.
- GRANITE PAVERS AT ENTRANCES EXHIBIT EROSION, RUST STAINING, PREVIOUS REPAIRS AT RAILING. CLEAN AND REPAIR GRANITE.

1 > WHERE HATCHED, REPOINT OPEN JOINTS 100% KEY NOTES

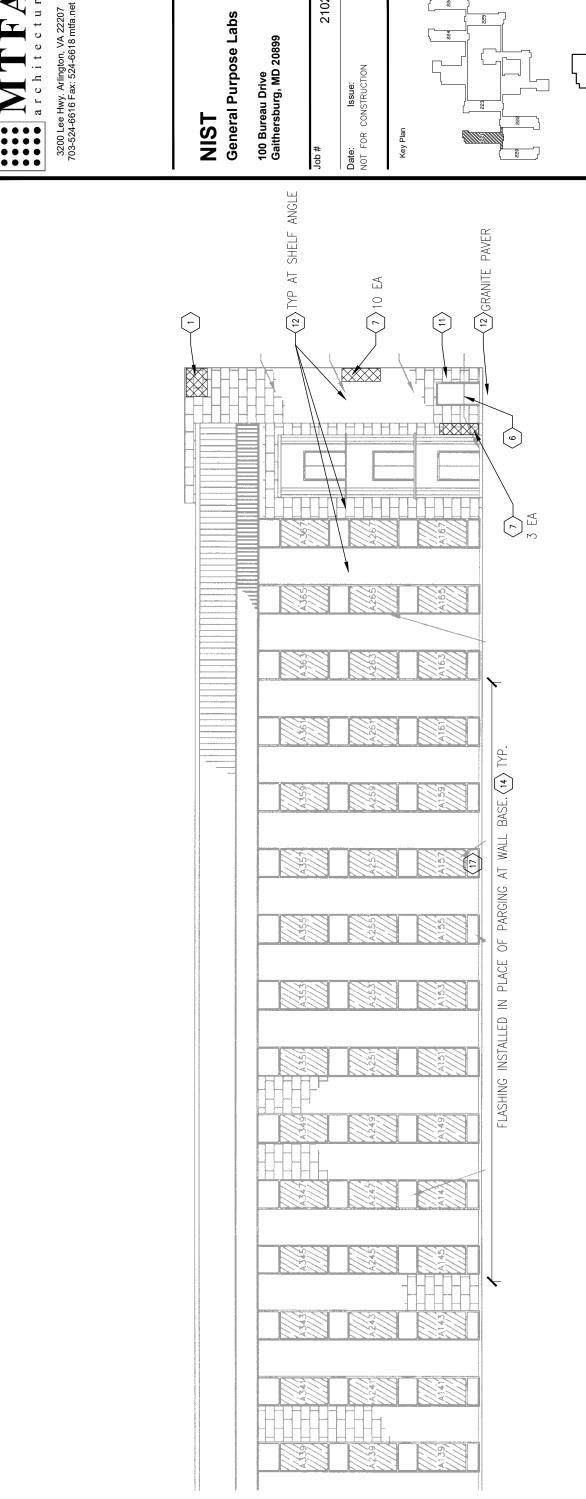
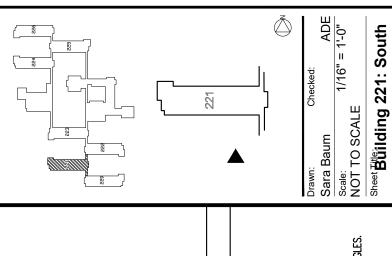
GRANITE PAVERS AT ENTRANCES EXHIBIT EROSION, RUST STAINING, PREVIOUS REPAIRS AT RAILING. CLEAN AND REPAIR GRANITE.

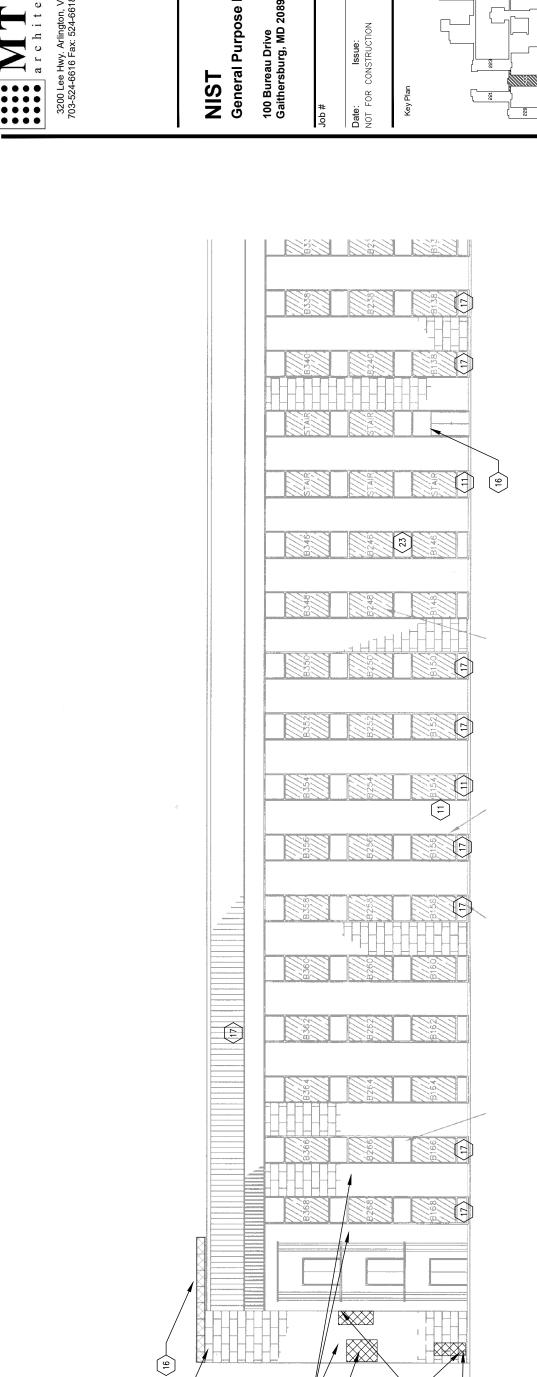
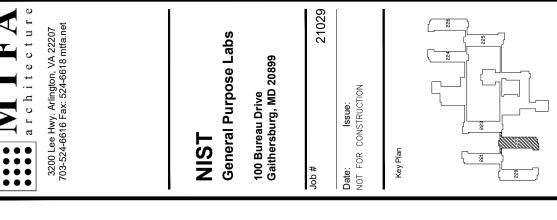
A116

PREPARE, PRIME AND REPAINT AT AREAS OF PEELING PAINT. **®** VERTICAL CRACKS. REPLACE REPAIR WALL AT BROKEN BRICKS. 1 WHERE HATCHED, REPOINT OPEN JOINTS 100%. KEY NOTES

- REDESIGN JOINT COVER AT TOP OF WINDOW CURTAIN WALLS TO PREVENT STAINING.
- INVESTIGATE JOINT AT FLOOR PLATE RELIEVING ANGLE WITH A PROBE TO EXPOSE THE ANGLE AND BRICK DETAILING. CORRECT FOR CONCRETE BEAM SHRINKAGE.
- REPLACE SOLAR FILM ON WINDOWS AT ALL GPL.
- GRANITE PAVERS AT ENTRANCES EXHIBIT EROSION, RUST STAINING, PREVIOUS REPAIRS AT RAILING. CLEAN AND REPAIR GRANITE.

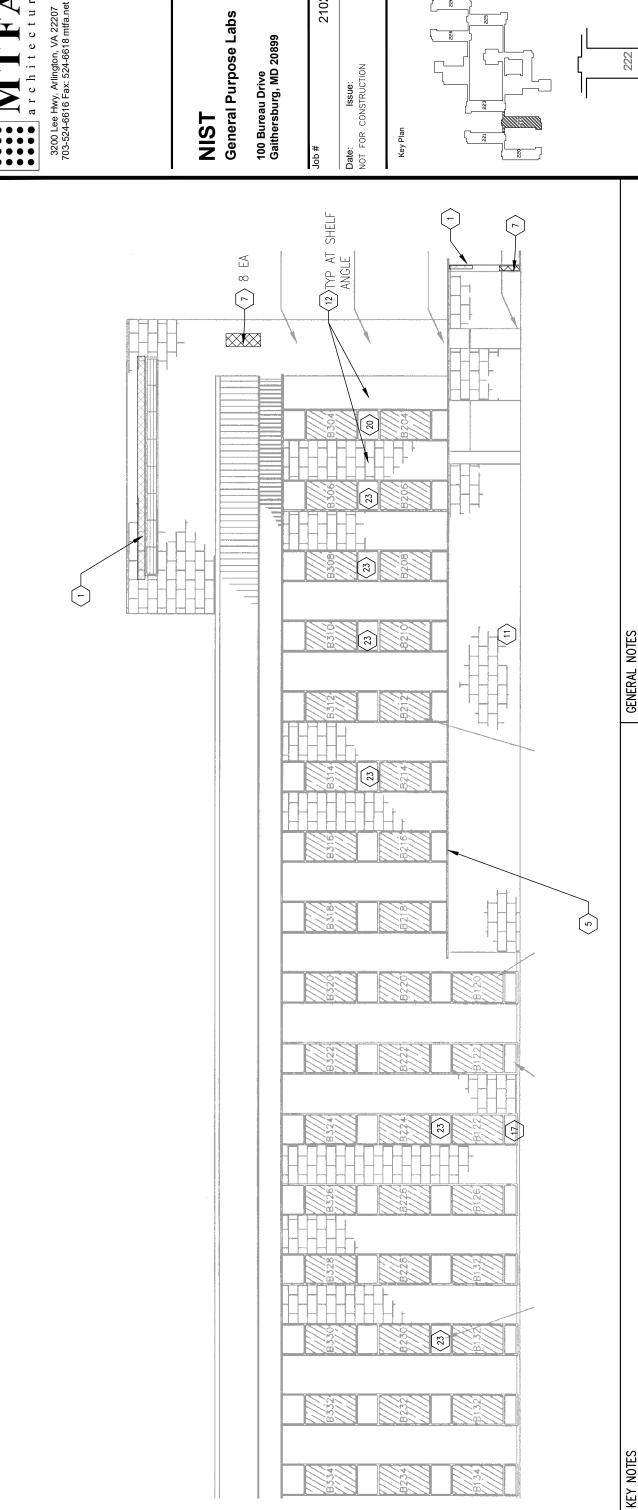
DENTED ALUMINUM. NO REPAIR.

CLEAN GENERAL SOILING AT MASONRY ELEVATIONS. e y

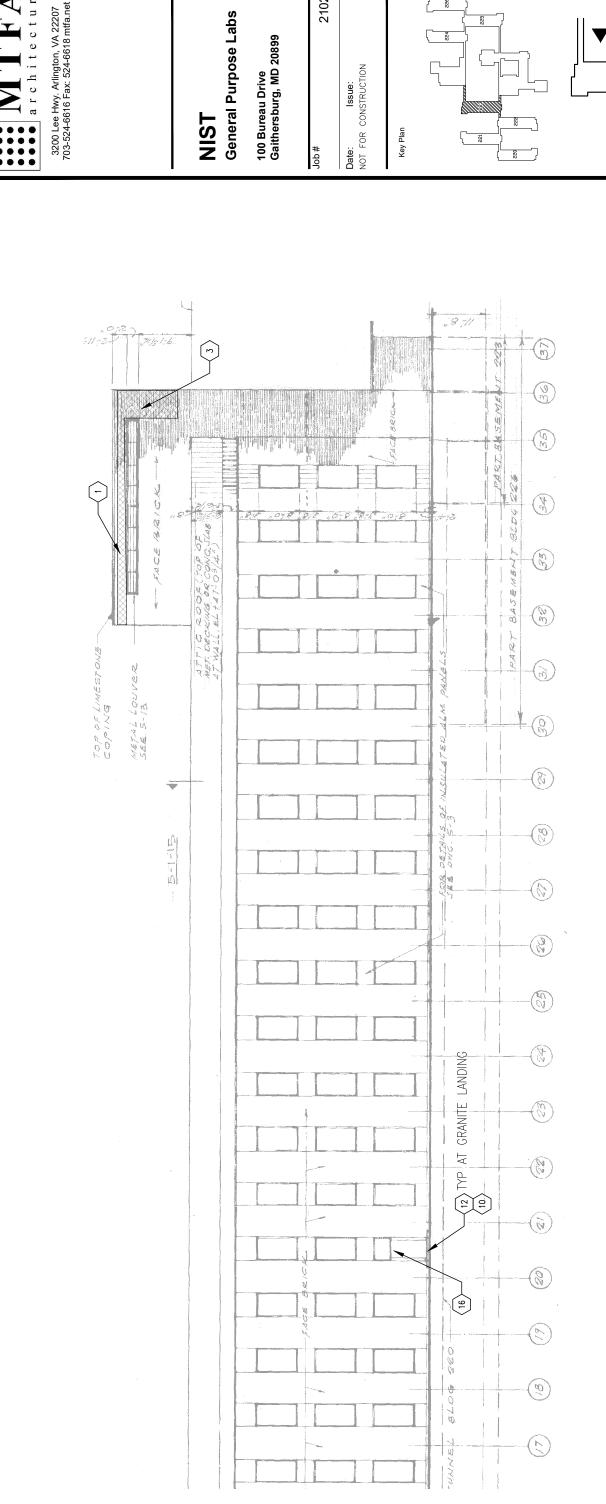
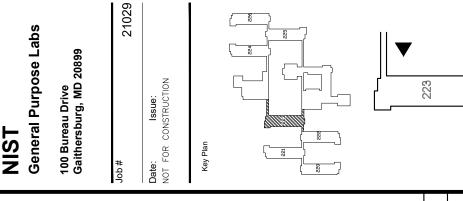
A121

GRANITE PAVERS AT ENTRANCES EXHIBIT EROSION, RUST STAINING, PREVIOUS REPAIRS AT RAILING. CLEAN AND REPAIR GRANITE.

CLEAN GENERAL SOILING AT MASONRY ELEVATIONS. GENERAL NOTES

CLEAN GENERAL SOILING AT CURTAIN WALL JOINTS TO REMOVE BUILDUP. TIGHTEN ALL FASTENERS. -Э

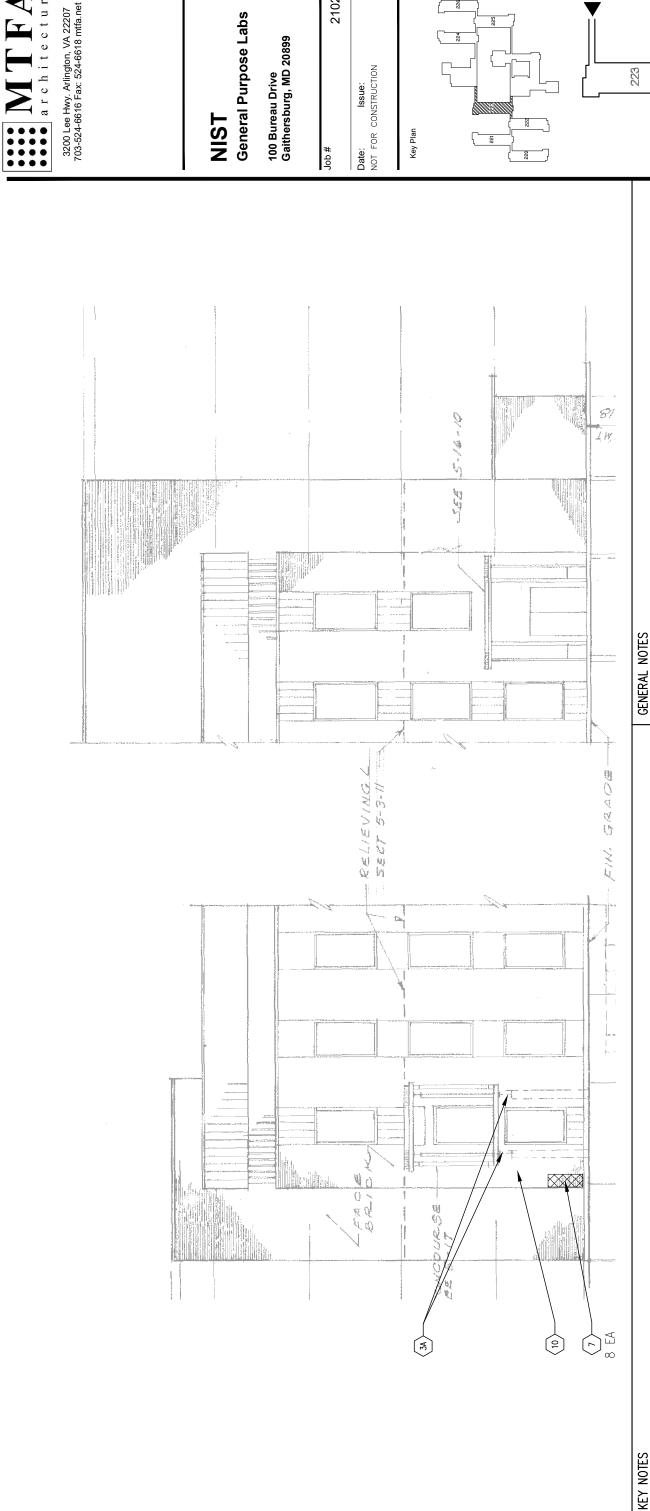
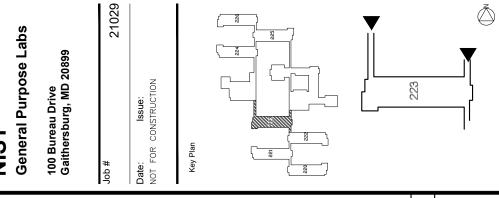
GRANITE PAVERS AT ENTRANCES EXHIBIT EROSION, RUST STAINING, PREVIOUS REPAIRS AT RAILING. CLEAN AND REPAIR GRANITE.

CLEAN GENERAL SOILING AT MASONRY ELEVATIONS. ъ.

PREPARE, PRIME AND REPAINT AT AREAS OF PEELING PAINT.

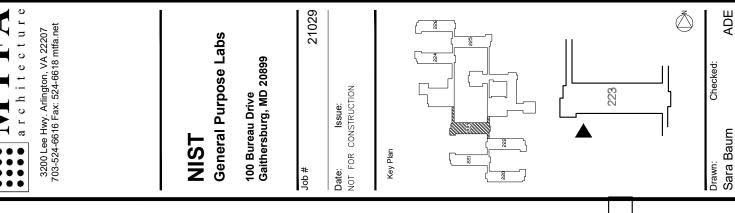
Building 223: South Elevation 1

- REPLACE EXTERIOR SEALANT JOINTS 100% INCLUDING AT ALL OPENINGS, CURTAIN WALLS, AND SHELF ANGLES. ci
 - 5% OF BRICK ELEVATIONS. Ξ
- REPLACE PARGING AT BASE OF WALLS 100%.
- REPAIR TOPPING SLAB AT CONNECTOR ENTRANCE LANDINGS, TYP. ゔ
- REDESIGN JOINT COVER AT TOP OF WINDOW CURTAIN WALLS TO PREVENT STAINING.
- INVESTIGATE JOINT AT FLOOR PLATE RELIEVING ANGLE WITH A PROBE TO EXPOSE THE ANGLE AND BRICK DETAILING. CORRECT FOR CONCRETE BEAM SHRINKAGE.
- REPLACE SOLAR FILM ON WINDOWS AT ALL GPL.
- GRANITE PAVERS AT ENTRANCES EXHIBIT EROSION, RUST STAINING, PREVIOUS REPAIRS AT RAILING. CLEAN AND REPAIR GRANITE.

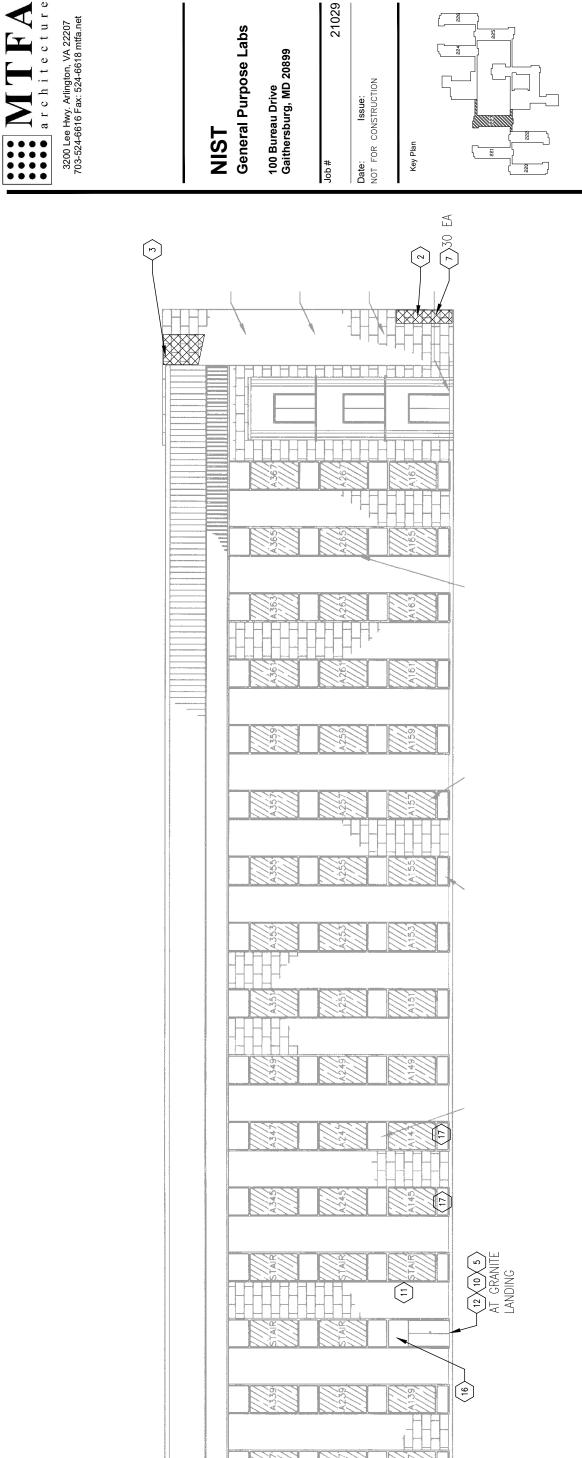
A124

REPLACE UP TO THREE WARPED/BOWING STOPS AT BOTTOM RAIL OF CURTAIN WALL AT CONNECTORS

CLEAN GENERAL SOILING AT MASONRY ELEVATIONS. GENERAL NOTES

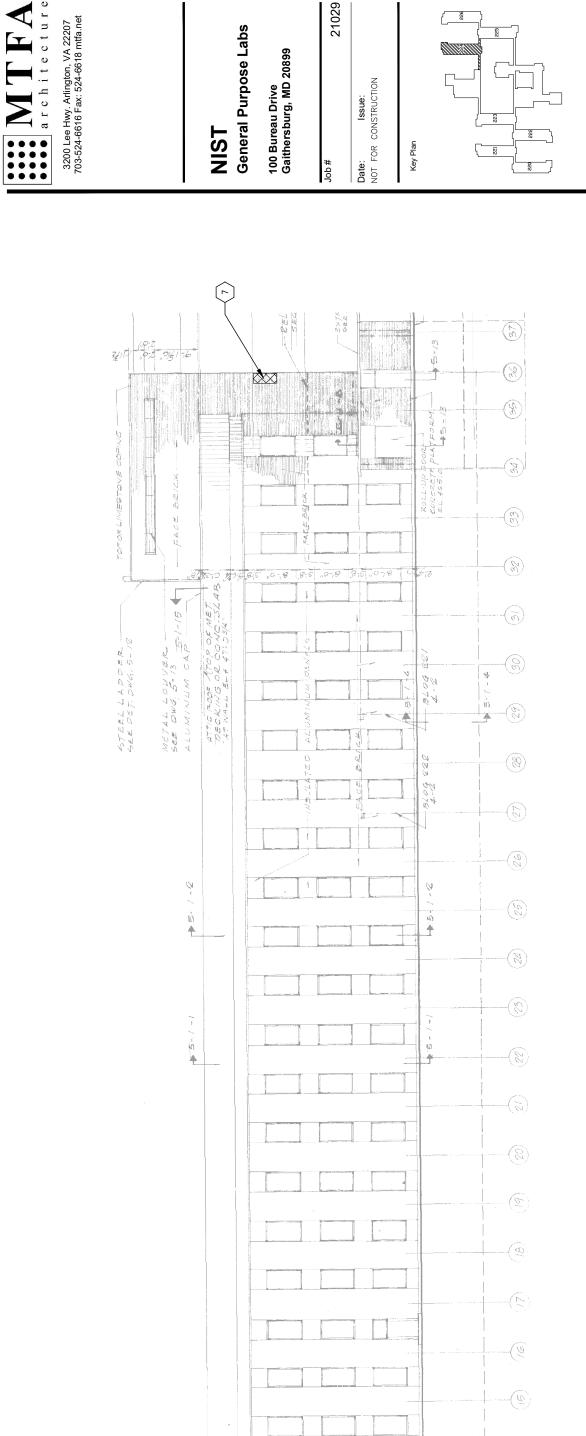
Sheet Title:
Building 224: North Elevation 2 ALL RIGHTS RESERVED © MTFA 2022

DENTED ALUMINUM. NO REPAIR.

VERTICAL CRACKS. REPLACE

EROSION AT CONCRETE. NO REPAIR.

EXTERIOR STAIRCASE DETERIORATION.

CRACK IN CONCRETE OR CONCRETE STUCCO.

BRICK STEP CRACKING.

- CLEAN GENERAL SOILING AT CURTAIN WALL JOINTS TO REMOVE BUILDUP. TIGHTEN ALL FASTENERS. e. A
- REPLACE UP TO THREE WARPED/BOWING STOPS AT BOTTOM RAIL OF CURTAIN WALL AT CONNECTORS. ä
- REPLACE WEATHERSTRIPPING AND GASKETS AT MINDOWS AND CURTAIN WALLS 100%.
- REPLACE STOREFRONT ALUMINUM BASE, TYP.

- REPLACE EXTERIOR SEALANT JOINTS 100% INCLUDING AT ALL OPENINGS, CURTAIN WALLS, AND SHELF ANGLES. ပ
- 5% OF BRICK ELEVATIONS. ェ
- REPLACE PARGING AT BASE OF WALLS 100%. _:
- REPAIR TOPPING SLAB AT CONNECTOR ENTRANCE LANDINGS, TYP. ゔ
- REDESIGN JOINT COVER AT TOP OF WINDOW CURTAIN WALLS TO PREVENT STAINING. Σ.

- INVESTIGATE JOINT AT FLOOR PLATE RELIEVING ANGLE WITH A PROBE TO EXPOSE THE ANGLE AND BRICK DETAILING. CORRECT FOR CONCRETE BEAM SHRINKAGE.
- REPLACE SOLAR FILM ON WINDOWS AT ALL GPL.

REPAIR SPALL WITH STONE DUTCHMAN THAT MATCHES EXISTING IN COLOR, TEXTURE, GRAIN, AND PROFILE.

REPAIR SPALL WITH PATCHING MORTAR THAT MATCHES EXISTING MASONRY IN COLOR, TEXTURE, AND PROFILE.

PREPARE, PRIME, AND REPAINT CORRODED STEEL CLEAN POLISHED METAL TO REMOVE CORROSION.

GRANITE PAVERS AT ENTRANCES EXHIBIT EROSION, RUST STAINING, PREVIOUS REPAIRS AT RAILING. CLEAN AND REPAIR GRANITE.

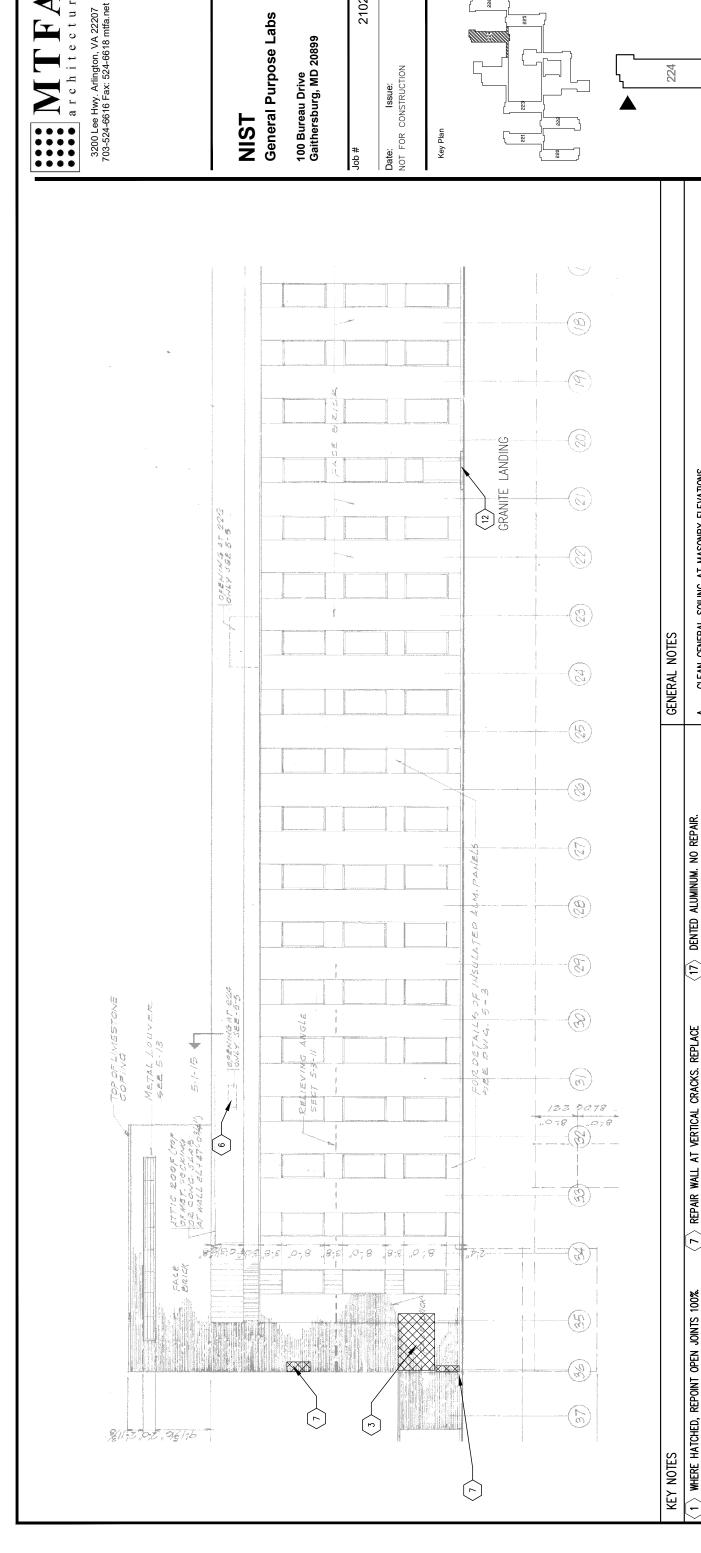
Building 224: South

CRACK IN CONCRETE OR CONCRETE STUCCO.

BRICK STEP CRACKING.

- CLEAN GENERAL SOILING AT CURTAIN WALL JOINTS TO REMOVE BUILDUP. TIGHTEN ALL FASTENERS. A. A.
- REPLACE UP TO THREE WARPED/BOWING STOPS AT BOTTOM RAIL OF CURTAIN WALL AT CONNECTORS.
- REPLACE WEATHERSTRIPPING AND GASKETS AT WINDOWS AND CURTAIN WALLS 100%

- REPLACE STOREFRONT ALUMINUM BASE, TYP.
- REPLACE EXTERIOR SEALANT JOINTS 100% INCLUDING AT ALL OPENINGS, CURTAIN WALLS, AND SHELF ANGLES.
 - 5% OF BRICK ELEVATIONS.
- ゔ

- ä نیا <u>ٺ</u> ഗ് ∺് Prepare, prime and repaint at areas of Peeling Paint. EROSION AT CONCRETE. NO REPAIR. REPLACE ALUMINUM ELEMENT. REPLACE BROKEN GLASS.

PIN STONE AT AREA OF INCIPIENT SPALL USING THREADED STAINLESS—STEEL ROD.

TOOL STONE DEFECT TO ALLOW MASONRY TO DRAIN.

(14) REPLACE FAILED SEALANT.

REPAIR SPALL WITH STONE DUTCHMAN THAT MATCHES EXISTING IN COLOR, TEXTURE, GRAIN, AND PROFILE.

REPAIR SPALL WITH PATCHING MORTAR THAT MATCHES EXISTING MASONRY IN COLOR, TEXTURE, AND PROFILE.

PREPARE, PRIME, AND REPAINT CORRODED STEEL

(10) REMOVE RUST STAIN.

- REMOVE INAPPROPRIATE SILICONE SEALANT. RESTORE WINDOW TO ALLOW PROPER DRAINAGE. **5**4
- EXTERIOR STAIRCASE DETERIORATION

- REPLACE PARGING AT BASE OF WALLS 100%
- REPAIR TOPPING SLAB AT CONNECTOR ENTRANCE LANDINGS, TYP.
- REDESIGN JOINT COVER AT TOP OF WINDOW CURTAIN WALLS TO PREVENT STAINING.
- INVESTIGATE JOINT AT FLOOR PLATE RELIEVING ANGLE WITH A PROBE TO EXPOSE THE ANGLE AND BRICK DETAILING. CORRECT FOR CONCRETE BEAM SHRINKAGE.
- REPLACE SOLAR FILM ON WINDOWS AT ALL GPL.
- GRANITE PAVERS AT ENTRANCES EXHIBIT EROSION, RUST STAINING, PREVIOUS REPAIRS AT RAILING. CLEAN AND REPAIR GRANITE. zi zi

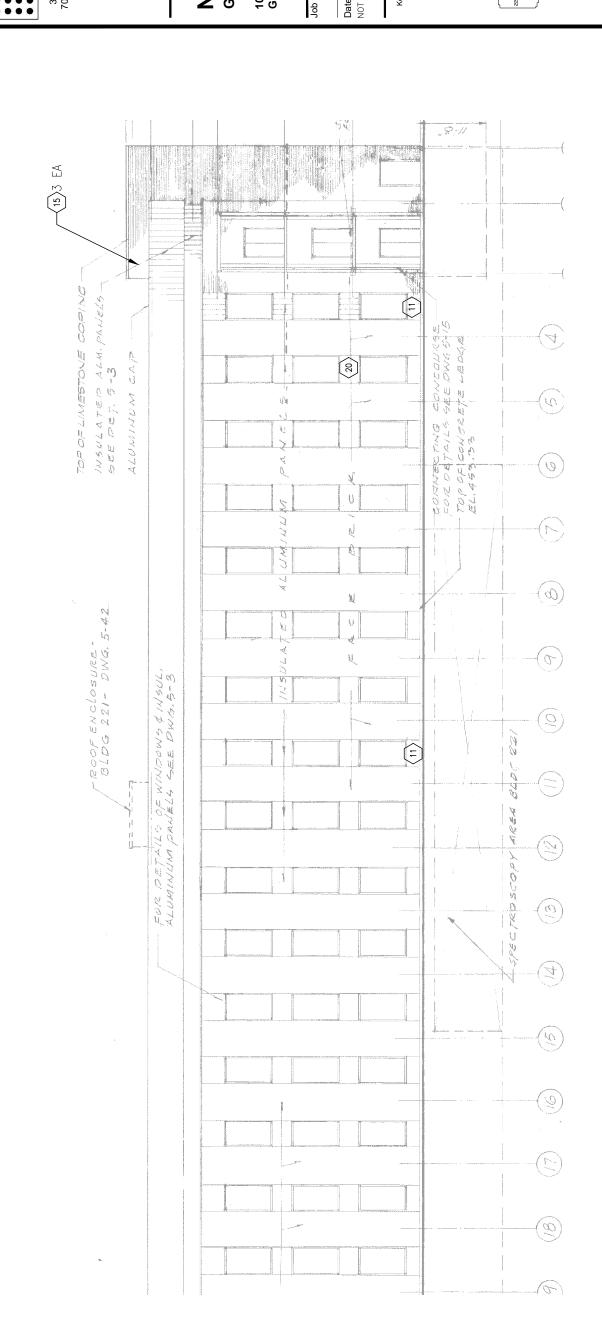
ALL RIGHTS RESERVED **Building 224: South** Elevation 2 1/16" = 1'-0" NOT TO SCALE © MTFA 2022

DENTED ALUMINUM. NO REPAIR.

CRACK IN CONCRETE OR CONCRETE STUCCO

BRICK STEP CRACKING.

REPLACE UP TO THREE WARPED/BOWING STOPS AT BOTTOM RAIL OF CURTAIN WALL AT CONNECTORS. CLEAN GENERAL SOILING AT CURTAIN WALL JOINTS TO REMOVE BUILDUP. TIGHTEN ALL FASTENERS. ei y Ġ

PIN STONE AT AREA OF INCIPIENT SPALL USING THREADED STAINLESS—STEEL ROD.

REPAIR WALL AT BROKEN BRICKS.

- REPLACE WEATHERSTRIPPING AND GASKETS AT WINDOWS AND CURTAIN WALLS 100%. ய்ய

- REPLACE STOREFRONT ALUMINUM BASE, TYP.
- REPLACE EXTERIOR SEALANT JOINTS 100% INCLUDING AT ALL OPENINGS, CURTAIN WALLS, AND SHELF ANGLES. ა Ŧ
 - 5% OF BRICK ELEVATIONS.
- REPLACE PARGING AT BASE OF WALLS 100%. _:
- ゔ
- REPAIR TOPPING SLAB AT CONNECTOR ENTRANCE LANDINGS, TYP.
- REDESIGN JOINT COVER AT TOP OF WINDOW CURTAIN WALLS TO PREVENT STAINING. ᅶ

TOOL STONE DEFECT TO ALLOW MASONRY TO DRAIN.

REPAIR SPALL WITH STONE DUTCHMAN THAT MATCHES EXISTING IN COLOR, TEXTURE, GRAIN, AND PROFILE.

(14) REPLACE FAILED SEALANT.

REPAIR SPALL WITH PATCHING MORTAR THAT MATCHES EXISTING MASONRY IN COLOR, TEXTURE, AND PROFILE.

PREPARE, PRIME, AND REPAINT CORRODED STEEL

GRANITE PAVERS AT ENTRANCES EXHIBIT EROSION, RUST STAINING, PREVIOUS REPAIRS AT RAILING. CLEAN AND REPAIR GRANITE.
