Solder Bump Coupon Testing of Backsheets for Simplified Comprehensive Evaluation

Michael Kempe, Trevor Lockman, and Joshua Morse
2019 NIST/UL Workshop on Photovoltaic Materials Durability
NIST, Gaithersburg, MD 20899

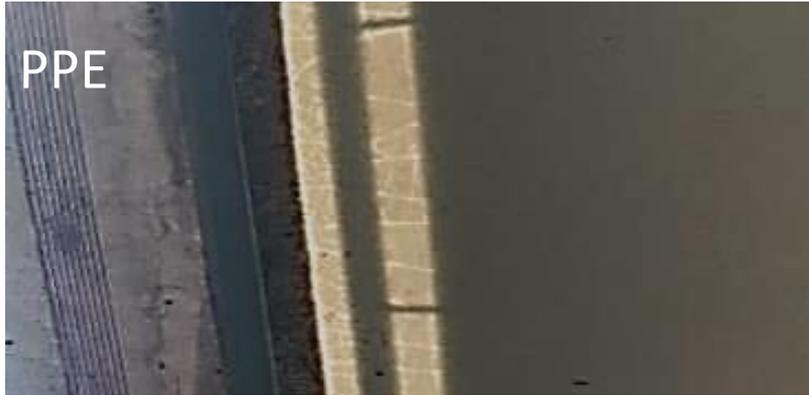
Module Deployed in New Delhi for 4 y (Courtesy of Liang Ji).

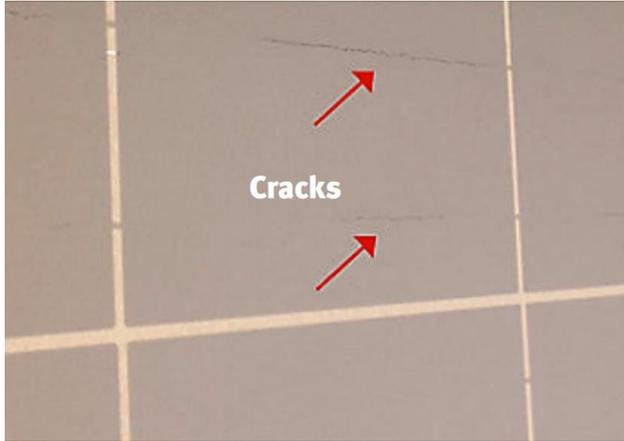
The Polyamide may crack over gaps or between cells

Cracks
between cells
on module
deployed in
Rome for 4 y.

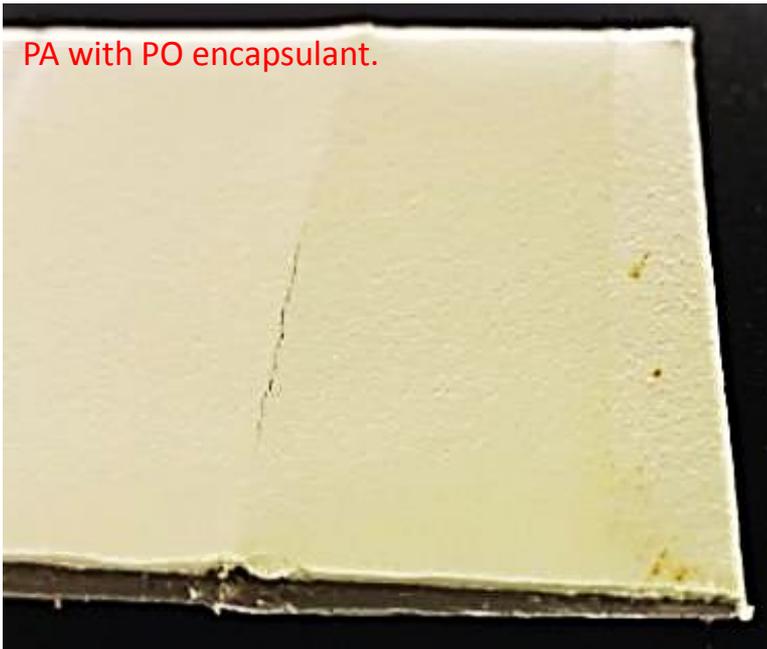
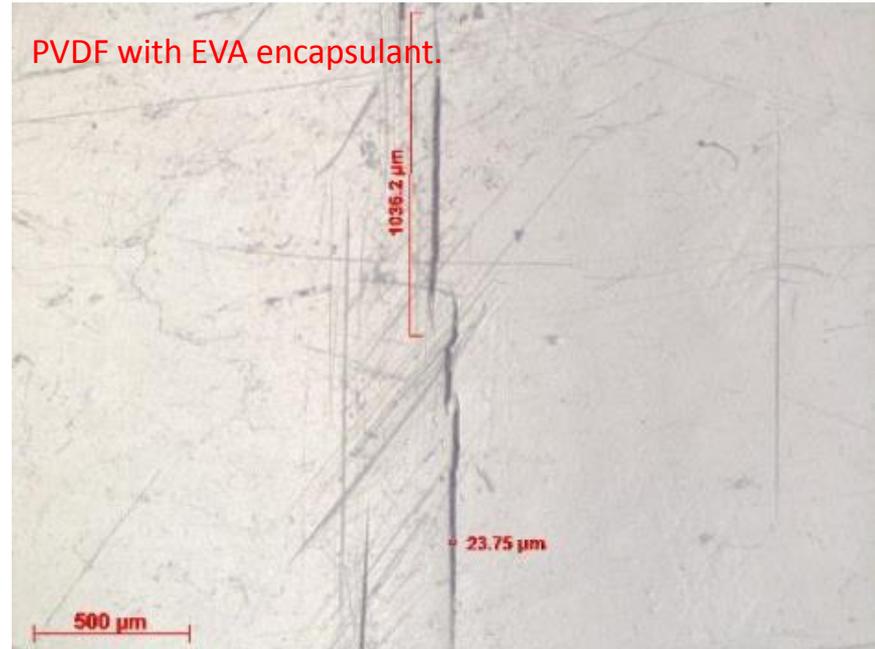
- After 500 h UV and 100 TC.
 - PVDF – Cracks on cell-side exposed samples only.
 - PA – Cracks on air-side exposed samples for both PO and EVA encapsulant.
- After 2500h UV and 500TC
 - PA and PVDF show cracks with exposure to either side
 - PPE shows only surface cracking and some erosion/chalking.

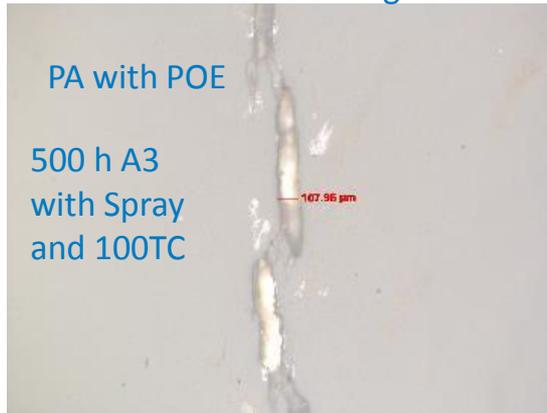
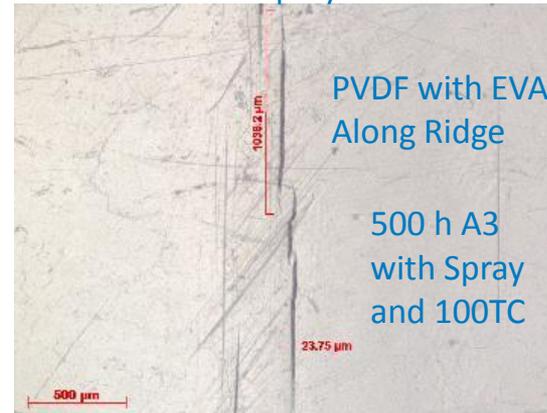
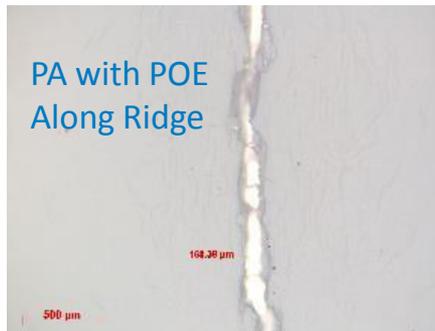
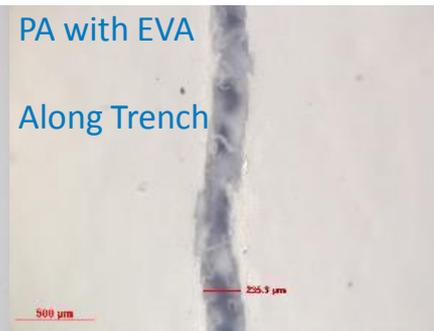
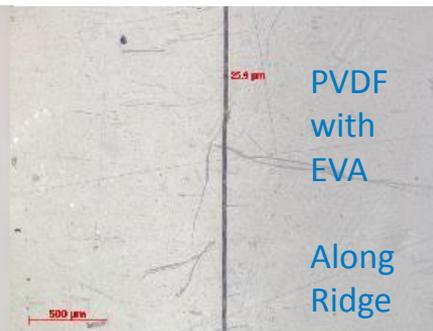
500 h A3 with Spray and 100 TC

After 2000 h/400TC the addition of spray only serves to increase the amount of erosion on the surfaces. The Cracking tendencies are the same as without spray.

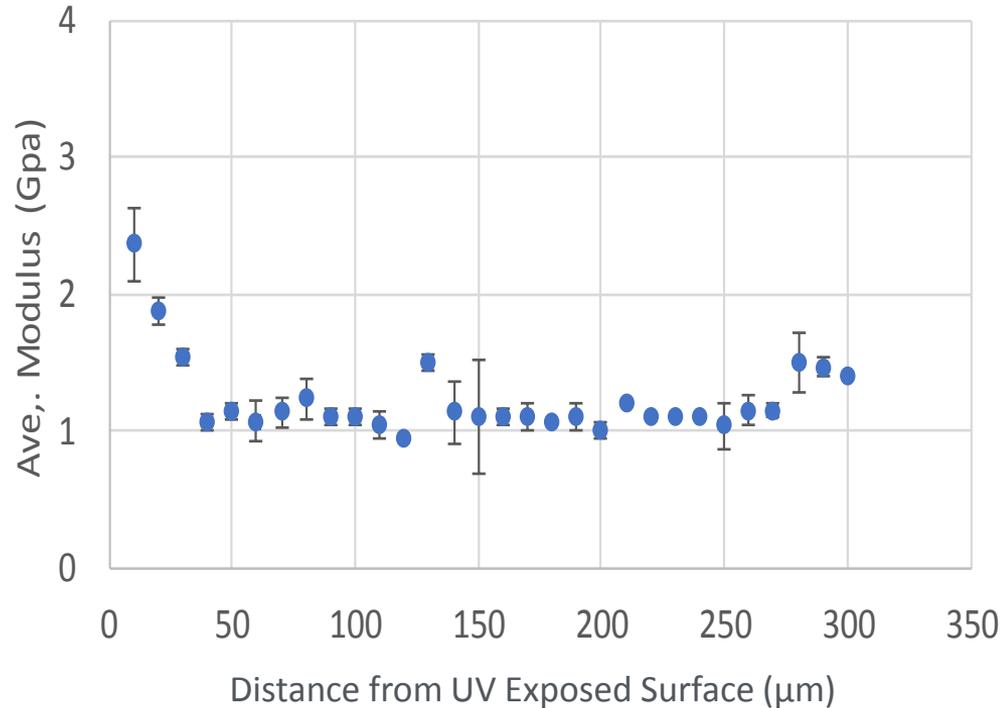
- The UV exposed side creates a region of high modulus in one of the PA outer layers.
- This allows for thermo-mechanical stress to initiate a crack after which the stress concentration at the crack tip in combination with more thermo-mechanical stress will propagate the crack all the way through the backsheet.

4000 h of UV exposure under A3 conditions
(0.8 W/m²/nm @340 nm, CAT 65°C, 20% RH, BPT 90°C)
