# Survey of Mechanical Durability of PV Backsheets

Michael D. Kempe<sup>1</sup>, David C. Miller<sup>1</sup>, Allen Zielnik<sup>2</sup>, Daniel Montiel-Chicharro<sup>3</sup>,  
Jiang Zhu<sup>3</sup>, Ralph Gottschalg<sup>3</sup>

Atlas/NIST November 5, 2017

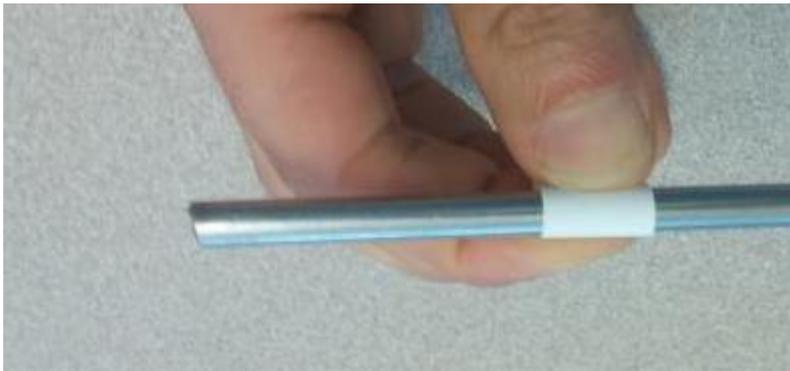
- 1.5×8 cm samples are bent around a 6.35 mm diameter mandrel in both directions.
- Testing is conducted every 250 h till failure or 4000 h.
- Usually the cracks are seen, but sometimes you can only hear the cracks forming.

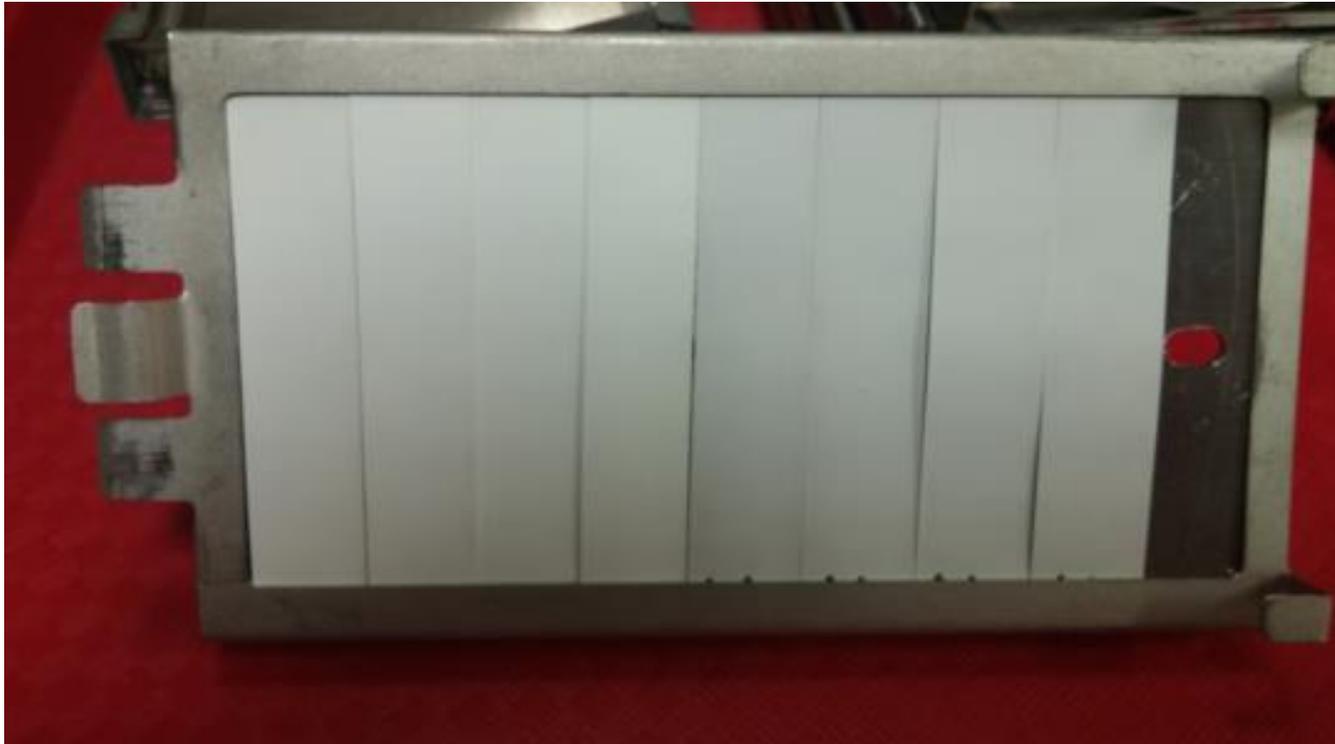
- Bend test samples mounted in an Atlas Ci5000 Weather-Ometer, CAT=65°C, 20% RH, BPT=90°C, Irradiance = 0.8 W/m<sup>2</sup>/nm at 340 nm. This is cycle A3 of the newly proposed IEC 62788-7-2 weathering standard for PV
- For the mandrel specimens, a backing plate was used to minimize the amount of UV light hitting the cell side of the films.
- For tensile test samples, they were similarly mounted but without the backing plate such that reflected light hits the backside of the samples.

Bend test samples  
in sample holder  
for two materials

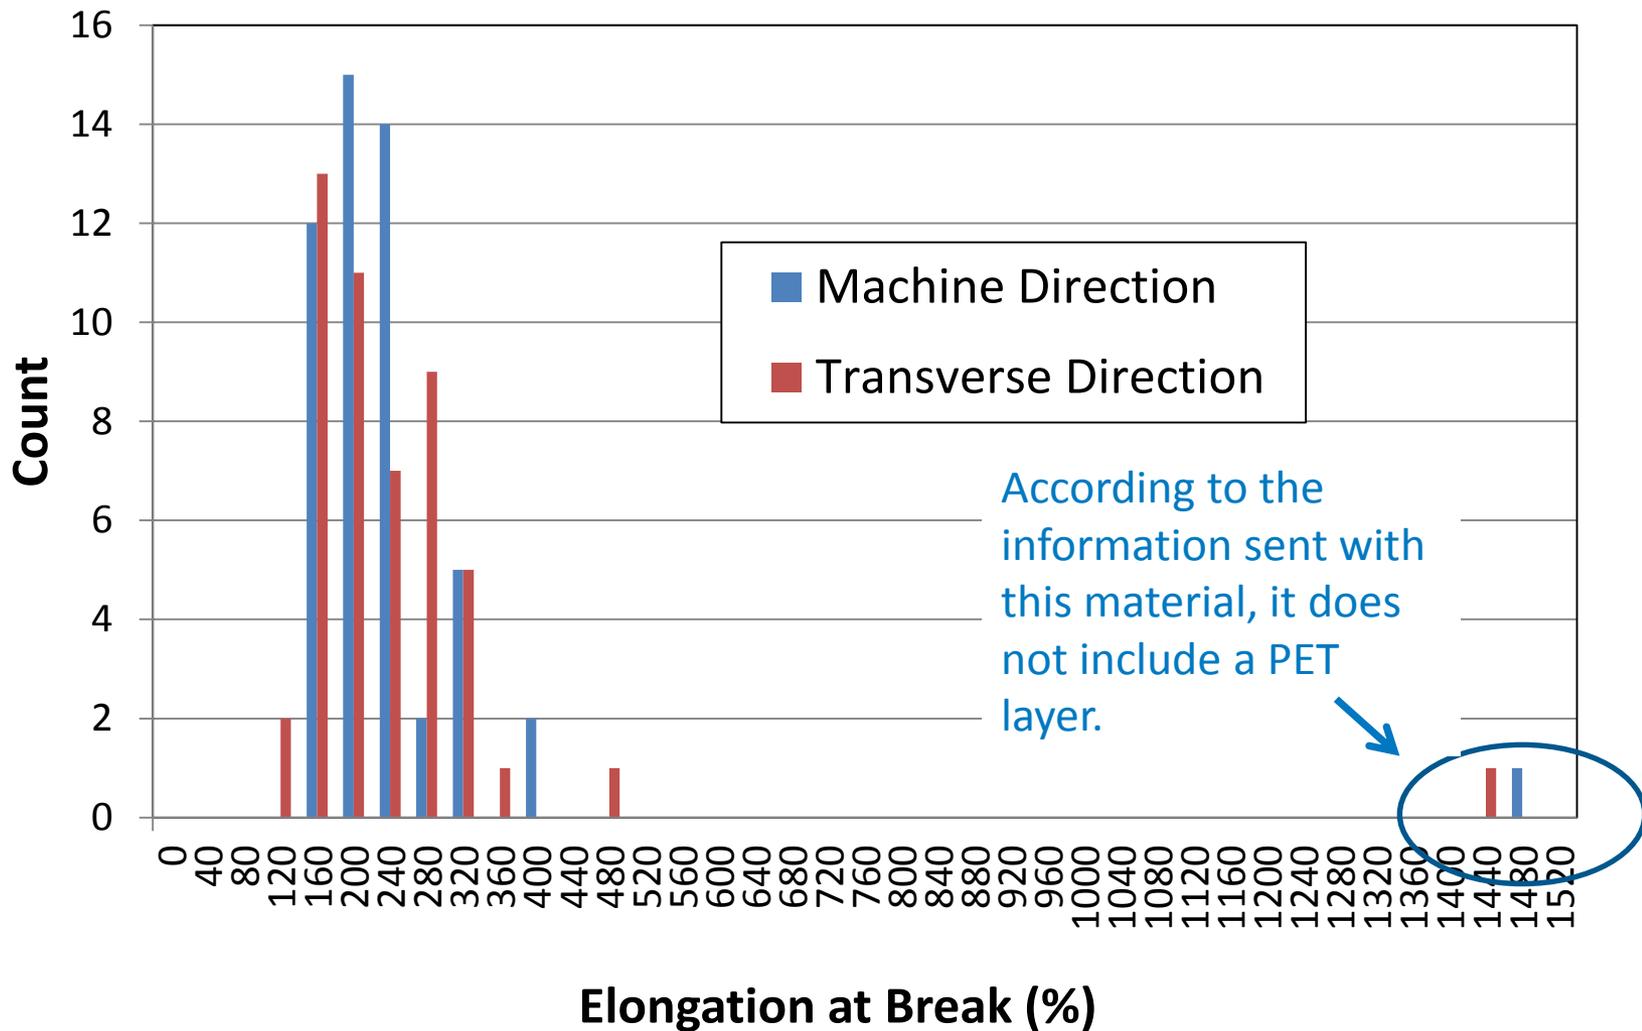
Testing according to IEC 62788-2, section 4.2.4.

Rectangular test samples, 10 mm×80 mm with 50 mm between the grips, pulled at 50 mm/min.

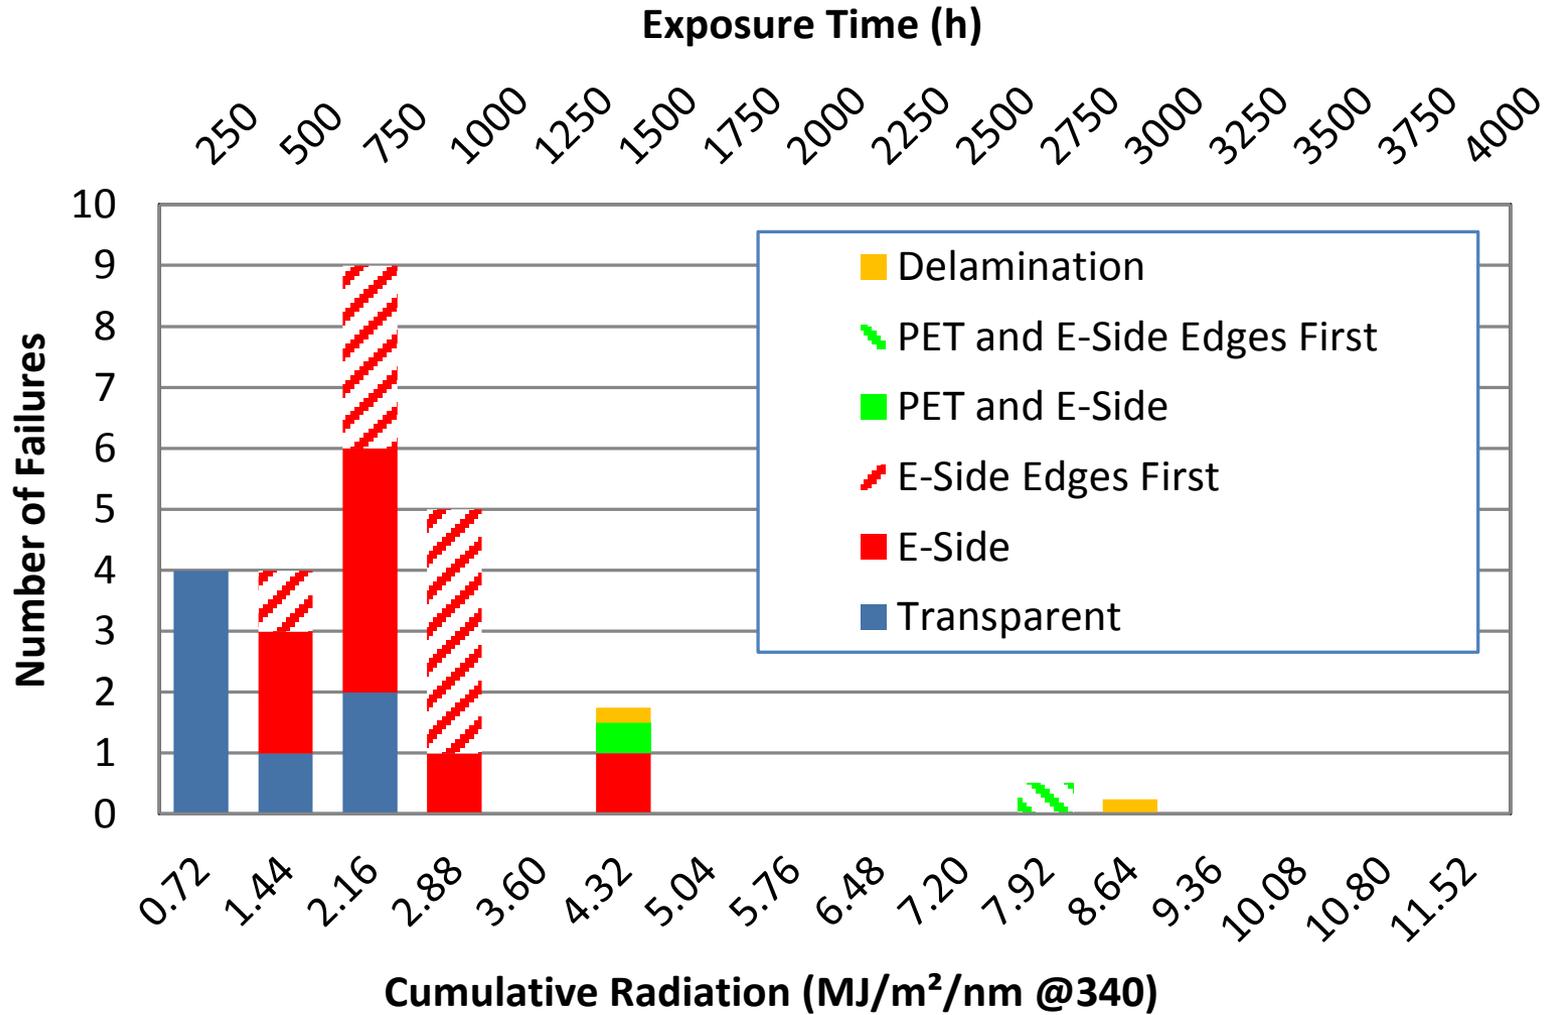
Exposure to 0.8 W/m<sup>2</sup>/nm at 340 nm, CAT=65°C, BPT=90°C, 20% RH.

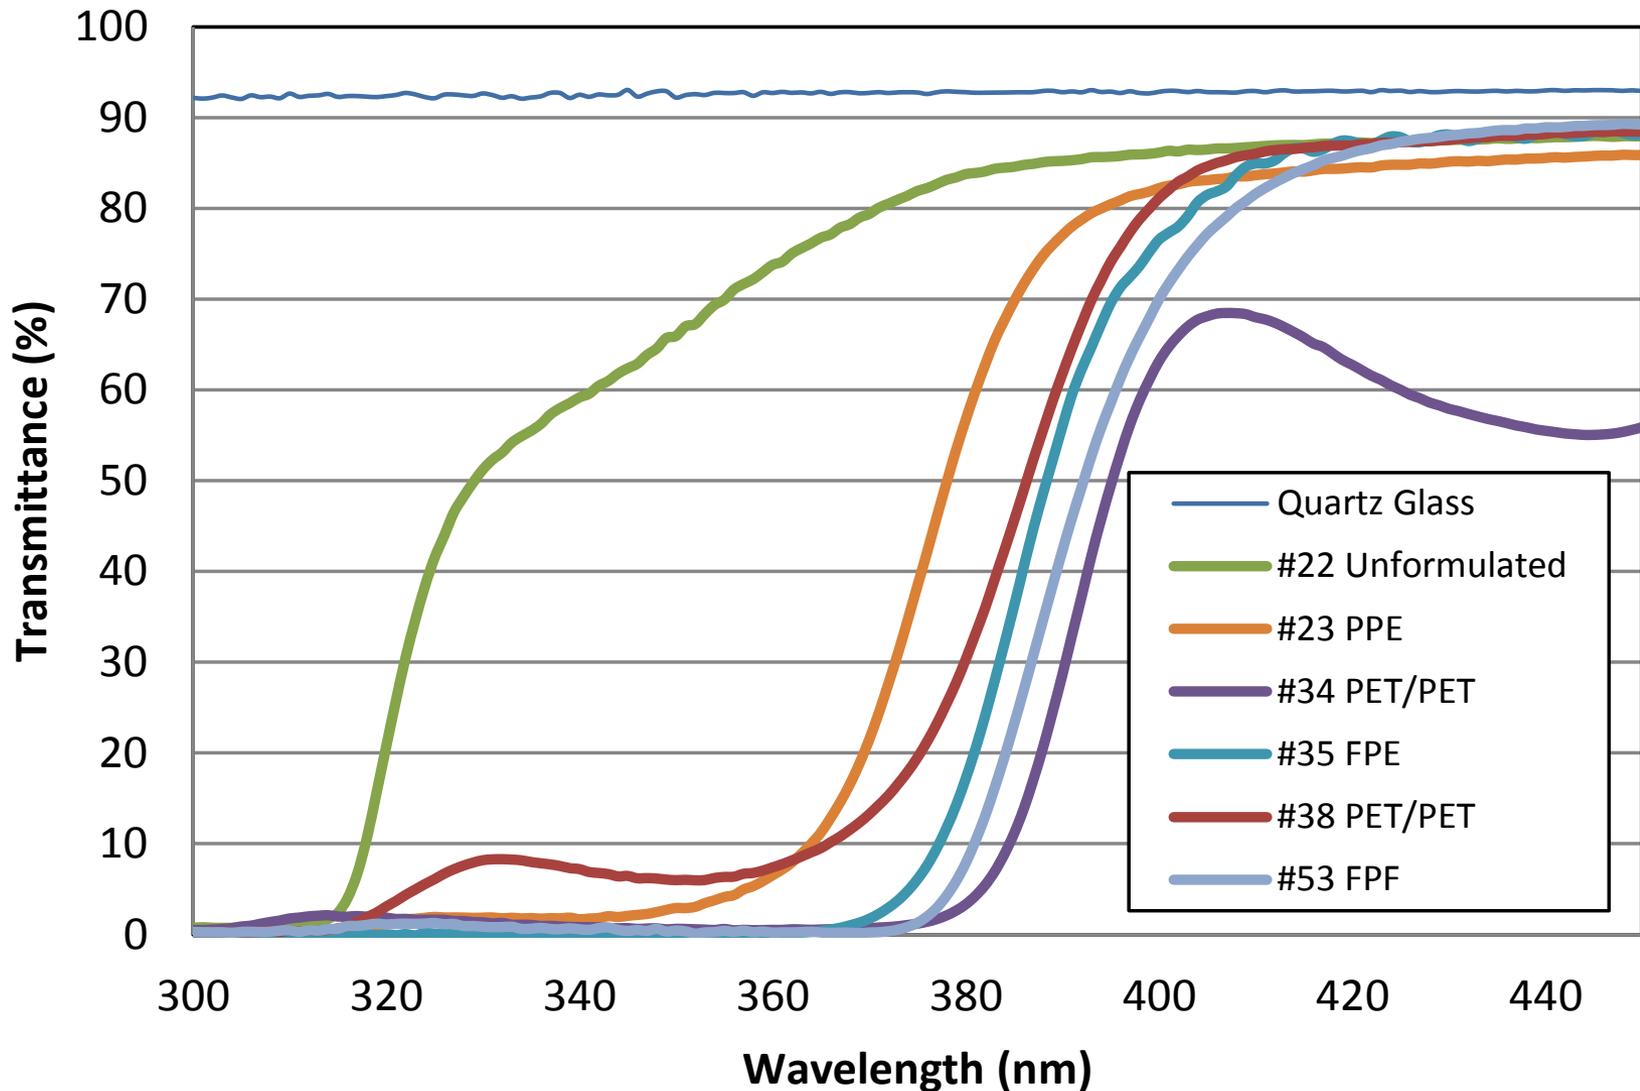
Transmittance spectra of transparent backsheets

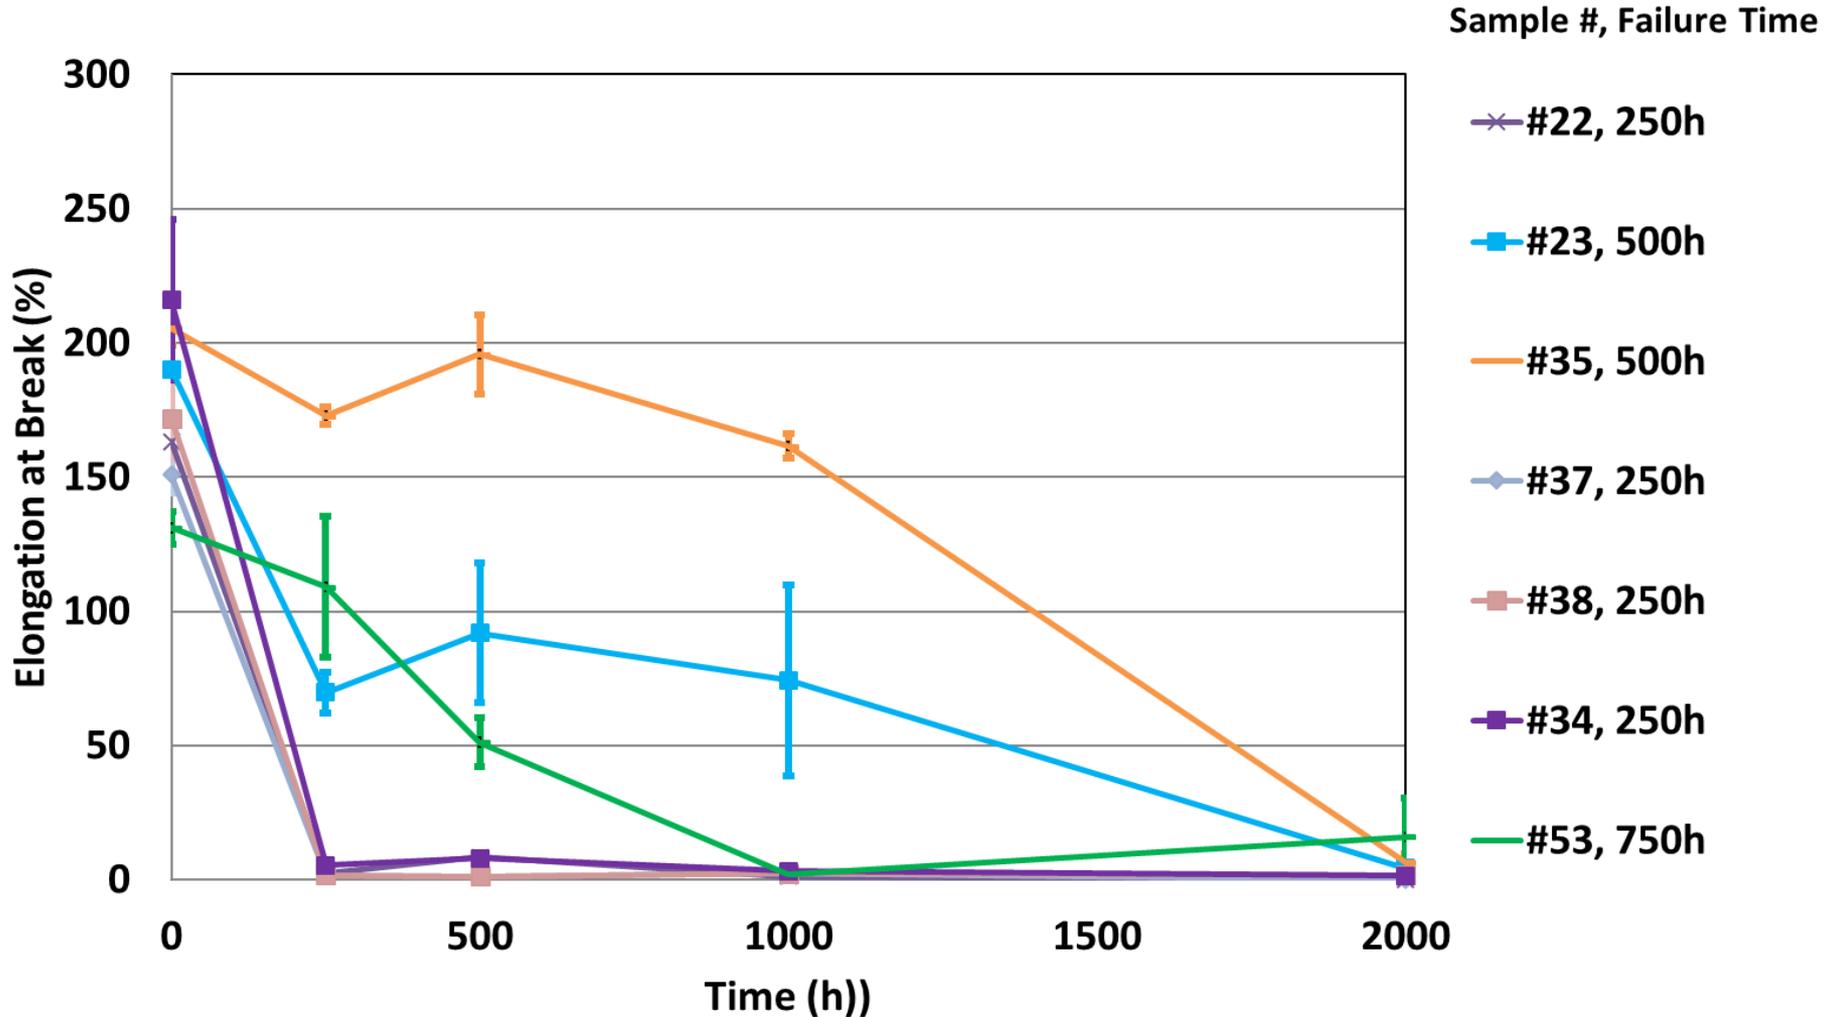
- Even though #35 failed the Bend test after 500 hour, ETB is evaluating the effect on the bulk of the film which allowed it to retain ETB long after cracks were forming in the bend test.

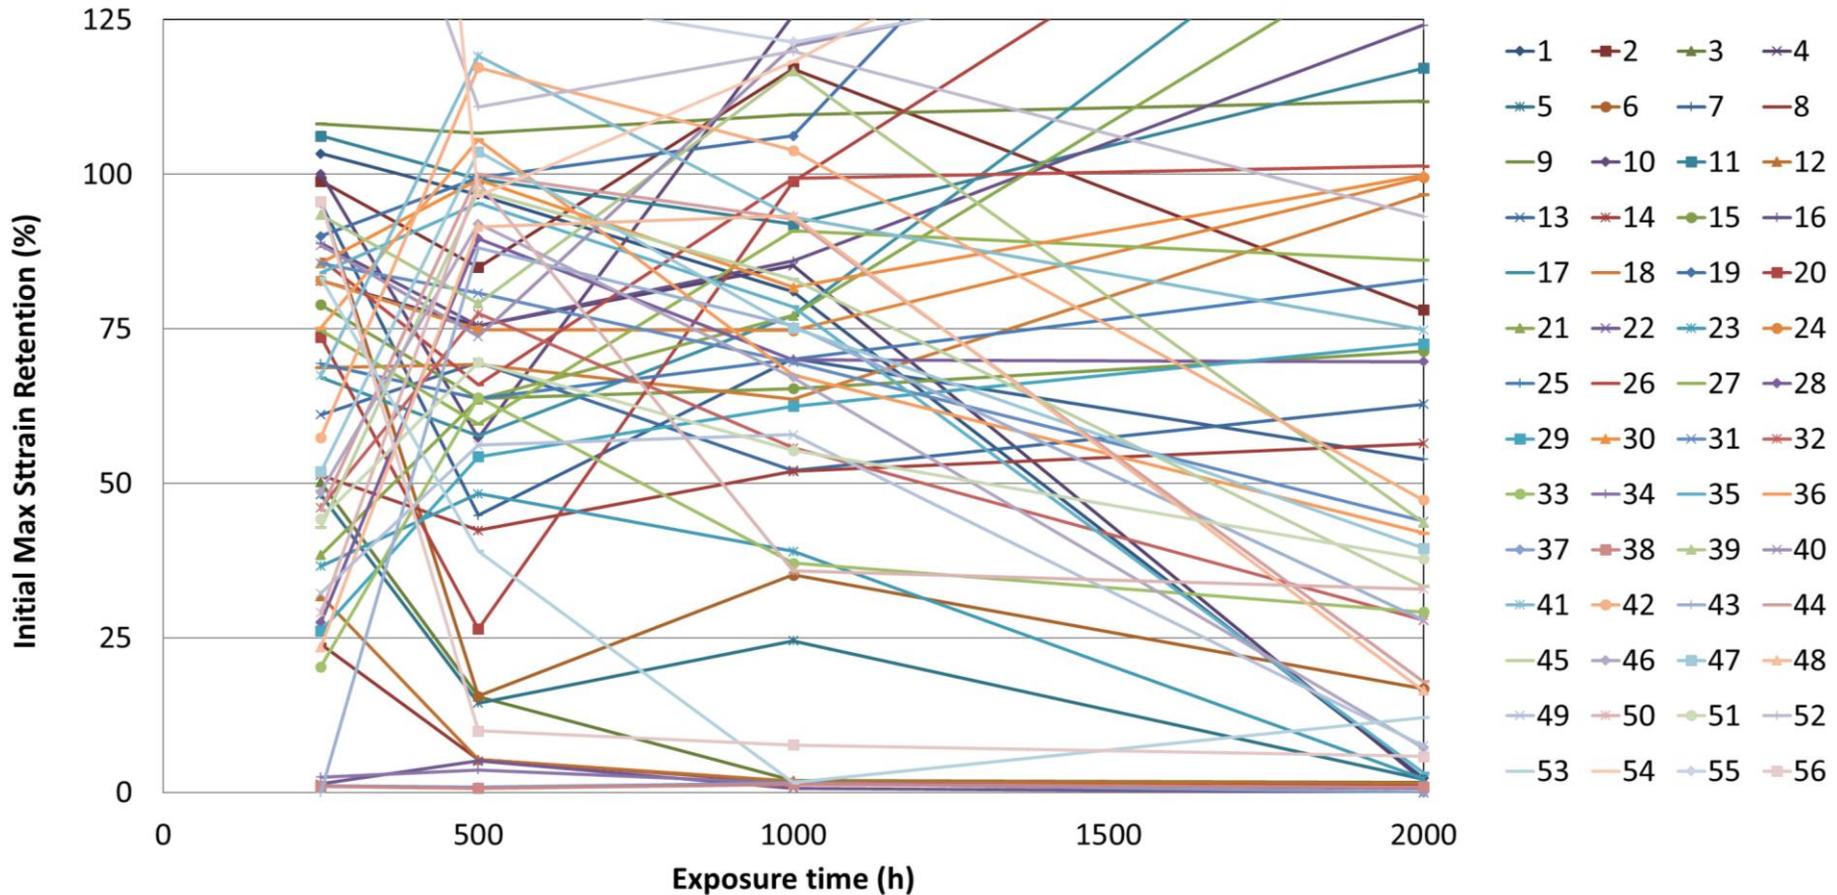
- New IEC 61730 amendment proposes: 50% retention after 2000h while allowing for preconditioning of up to 200 h, and a minimum of 25% ETB. Or at least 25% ETB after 4000 h of exposure.
- Based on the 50% relative retention criteria and 25% absolute ETB at 2000 h, only 26 samples passed. However, it should be noted that we specifically sought out many materials we thought would fail so we are not surprised at this finding.
- This criteria would eliminate sample number 56 which is known to fail in the field.
