Technical Investigation of the May 22, 2011, Tornado in Joplin, MO

December 10, 2012
NCST Advisory
Committee Meeting

Structural Response

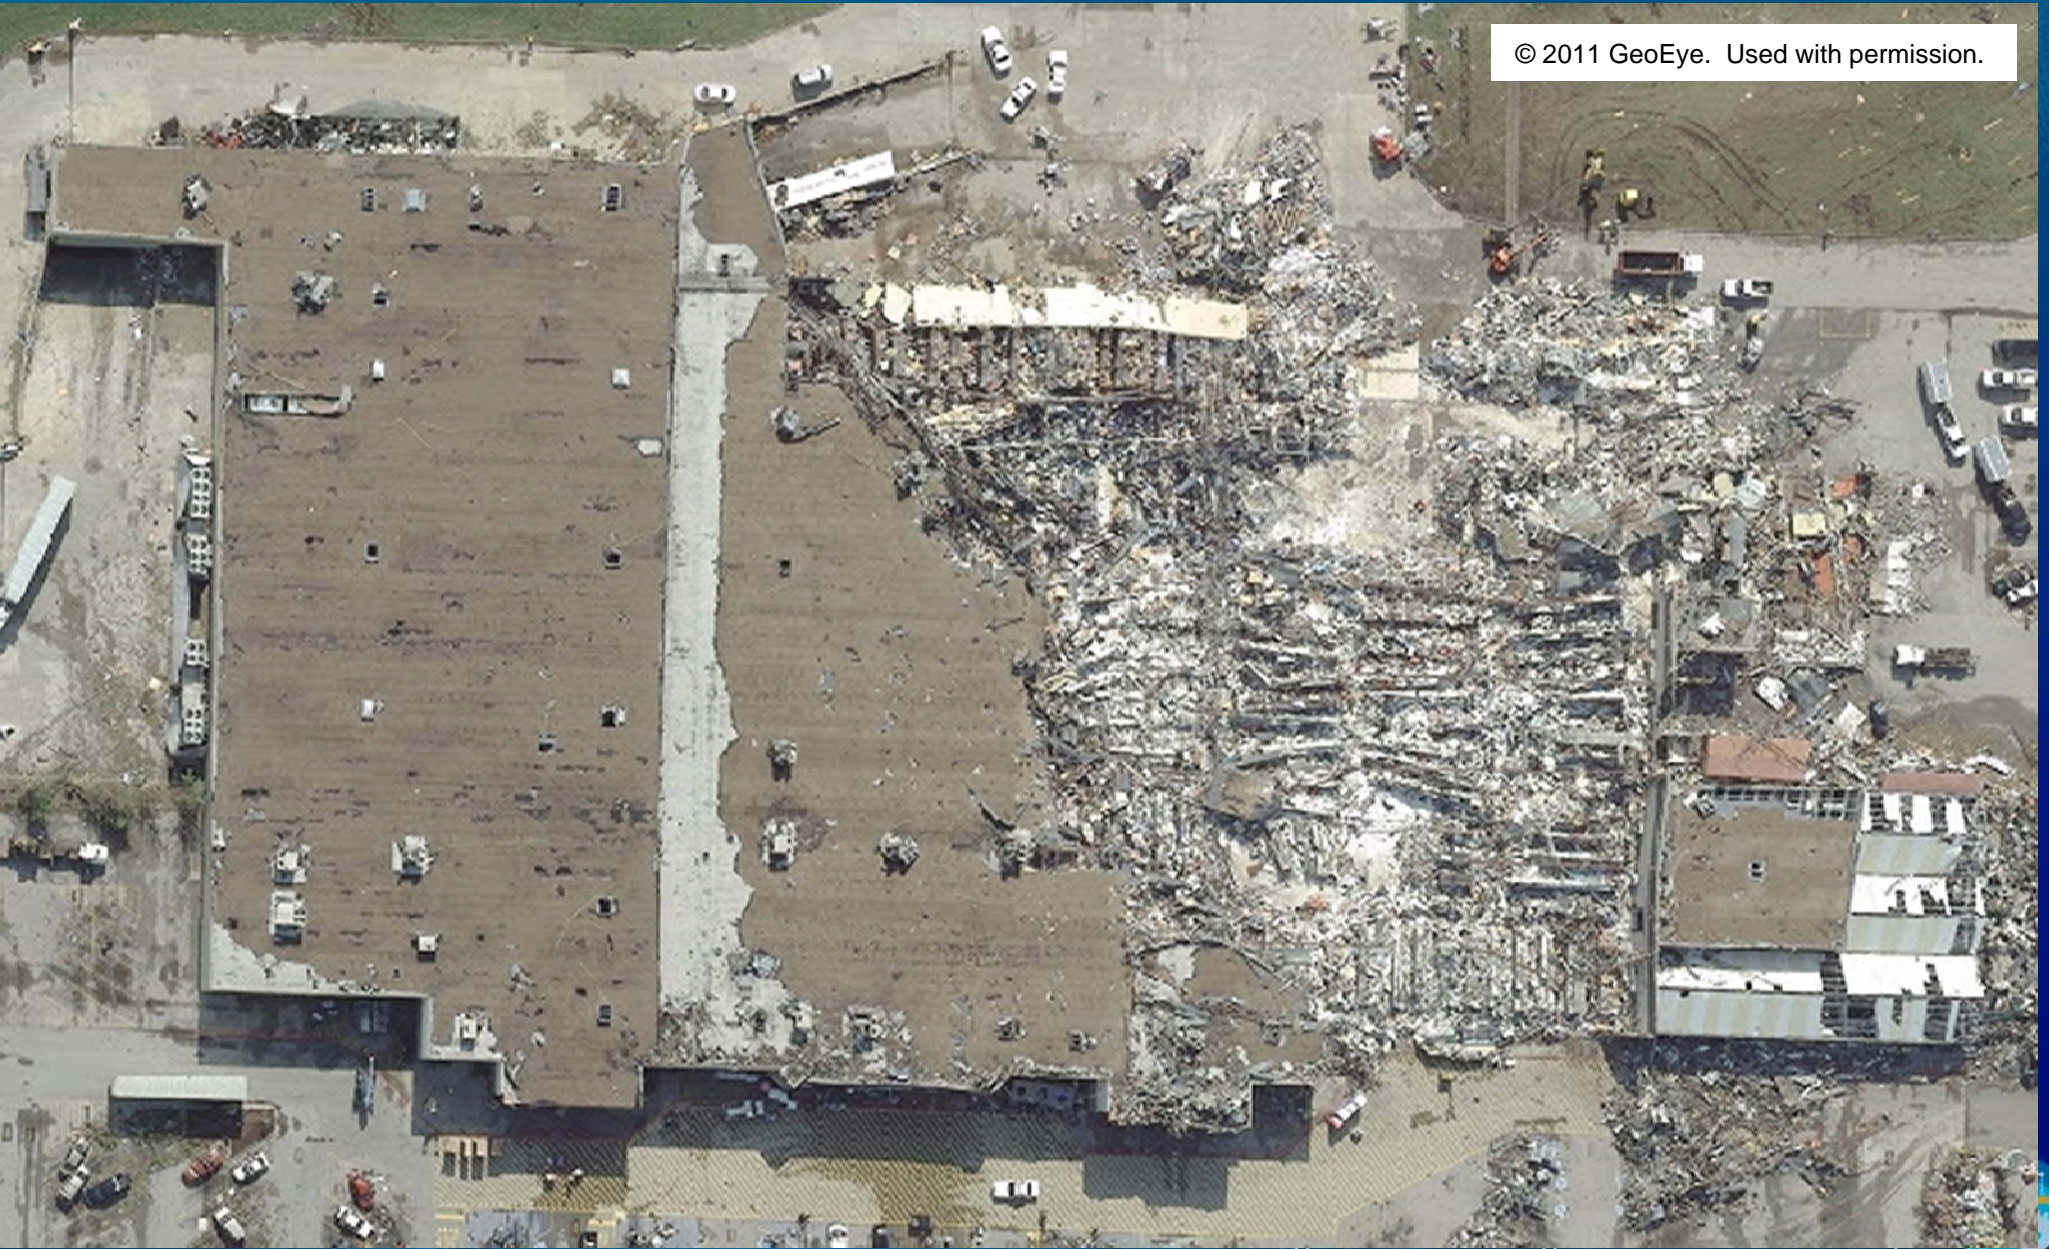
BTS Building, Located at 1501 South Range Line Road (Walmart Supercenter #59)

- Loss of roof decks
- Loss of roof joists
- Most joist girders remained in place, albeit damaged (bent upward)
- All interior columns remained in place
- Sections of perimeter walls collapsed inward

Roof Decks and Joists missing
