NIST Response to the World Trade Center Disaster

**Federal Building and Fire Safety Investigation
of
the World Trade Center Disaster**

November 19, 2008

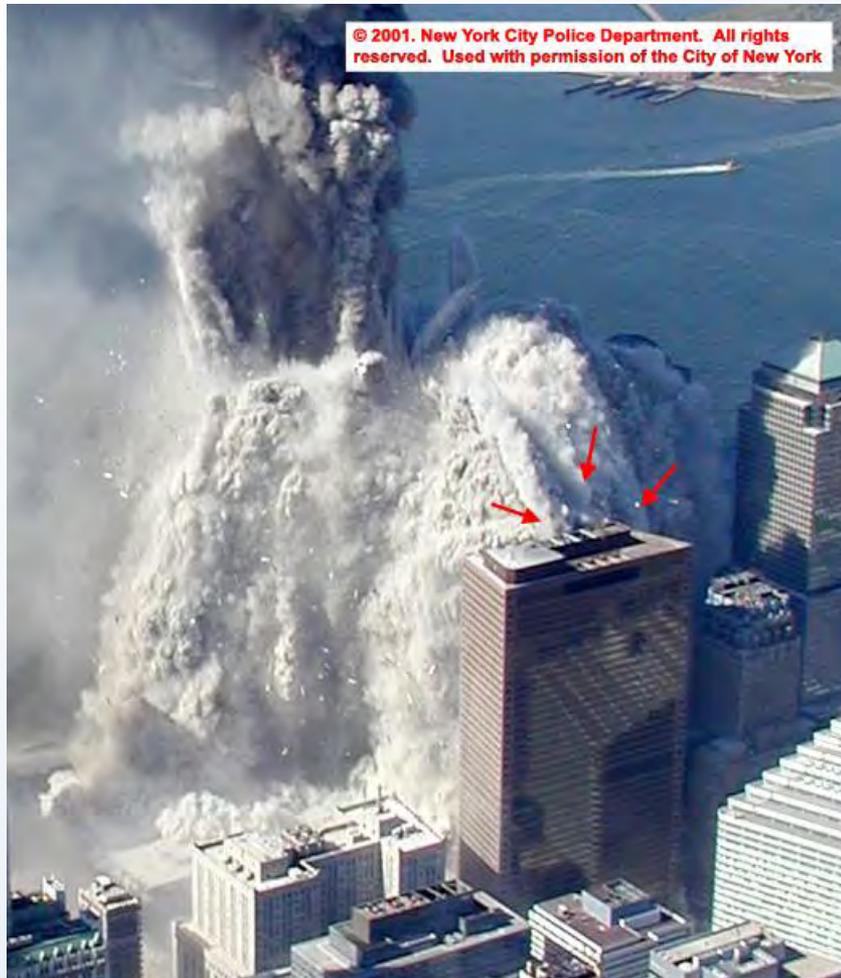
Summary of Probable Collapse Sequence (1)

- Collapse of the WTC Towers.
 - Collapse of WTC 2 did not cause any structural damage or start any fires in WTC 7.
 - Collapse of WTC 1 damaged seven exterior columns on the lower floors of the south and west faces and initiated fires on 10 floors between Floors 7 and 30.
- Aerial photograph shot $14 \text{ s} \pm 0.5 \text{ s}$ after WTC 1 began to collapse.
- Arrows mark arcs formed by debris that seemed to be ejected outwards from the debris cloud

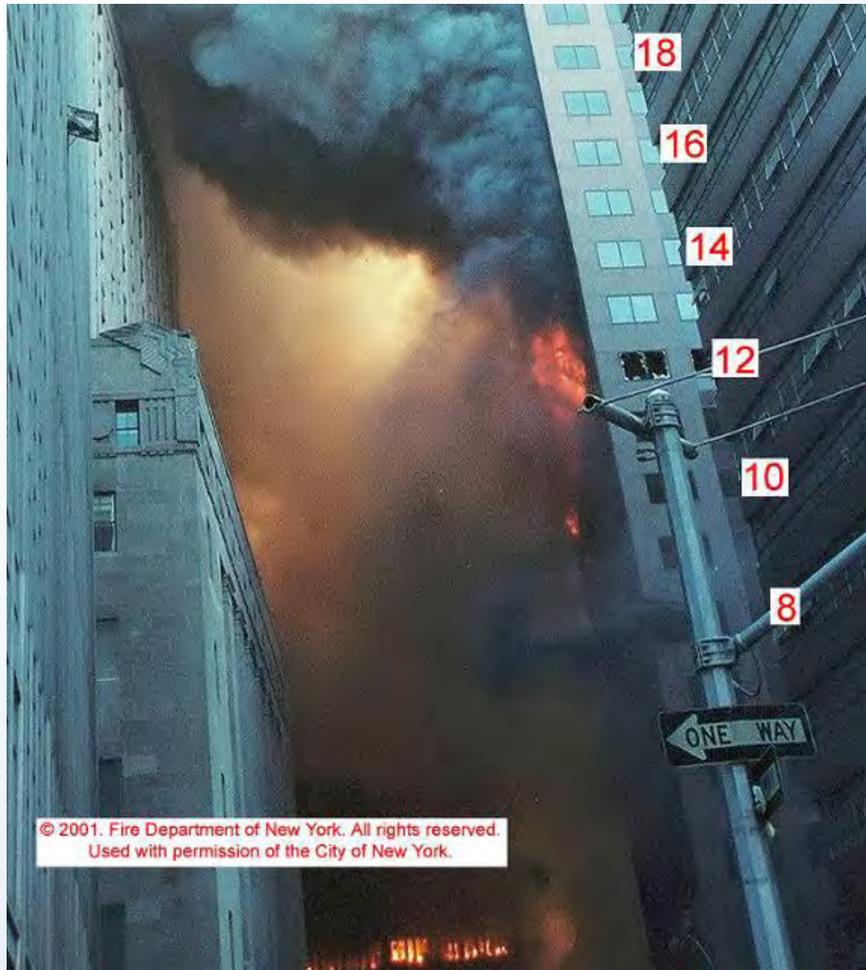
Summary of Probable Collapse Sequence (2)

- Growth and Spread of Fires.
 - Fires on the lower floors (Floors 7 to 9 and 11 to 13) grew and spread since they were not extinguished either by the automatic sprinkler system or by FDNY because water was not available.
 - Fires were generally concentrated on the east and north sides of the northeast region beginning at about 3 p.m. to 4 p.m.
 - The local fires on the upper floors (Floors 19, 22, 29, and 30) were not observed after approximately 1 p.m.
- Cropped photograph showing east edge of the north face and oblique view of east face of WTC 7.
- It was likely taken between 3:20 p.m. and 3:40 p.m.

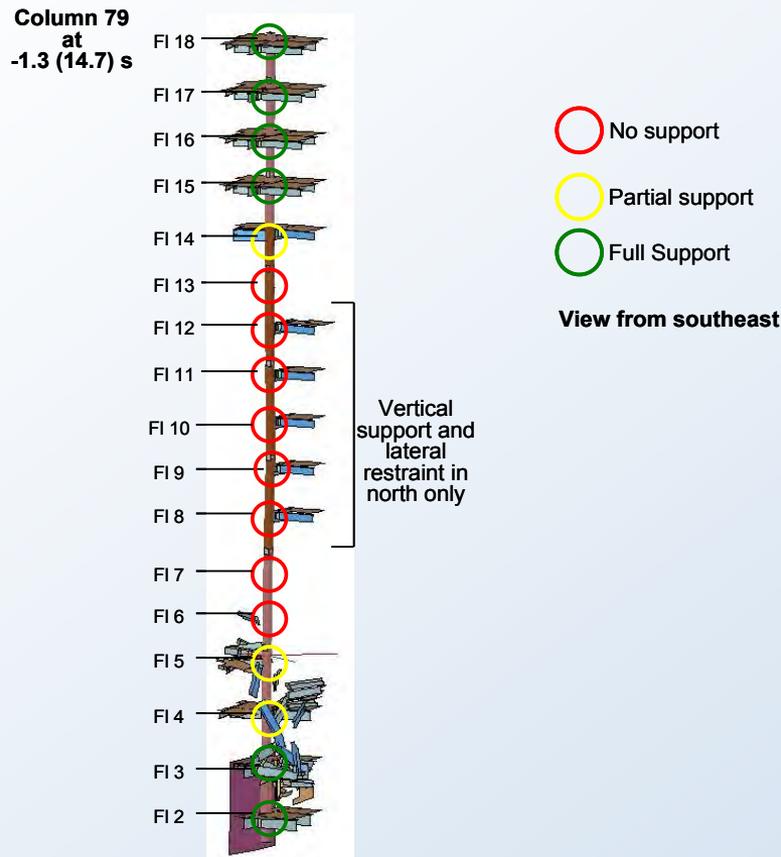
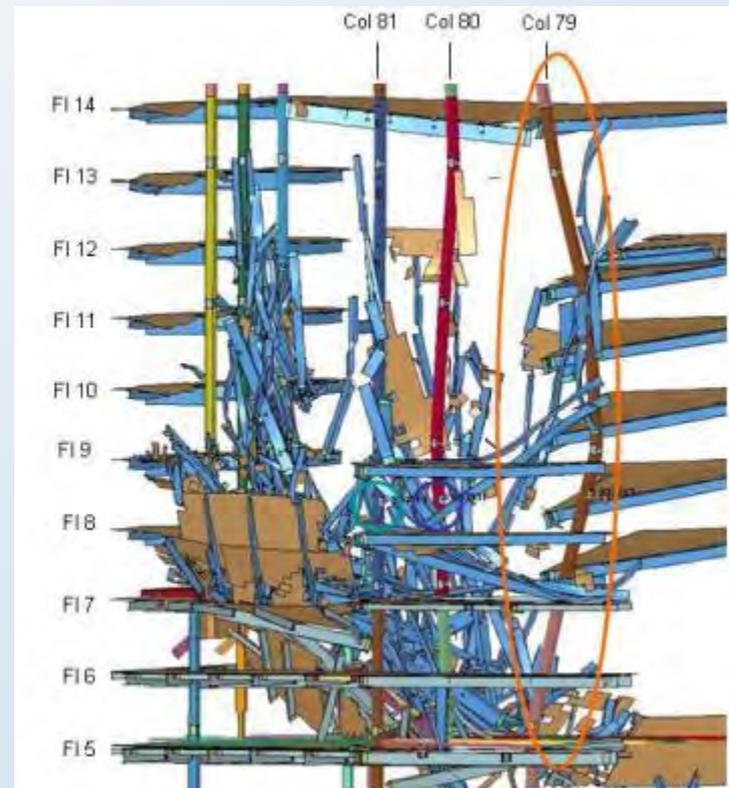
North East Floor System Near Column 79

- Initial Local Failure for Collapse Initiation.
 - Fire-induced thermal expansion of the floor system surrounding Column 79 led to collapse of Floor 13 that triggered a cascade of floor failures.
 - This, in turn, led to loss of lateral support to Column 79 over nine stories, resulting in the buckling failure of Column 79.

Forces from thermal expansion failed the connection at Column 79, then pushed the girder off the seat.

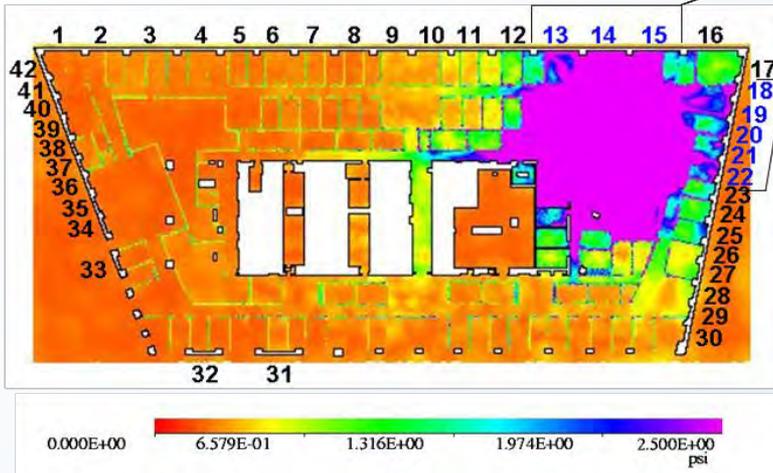
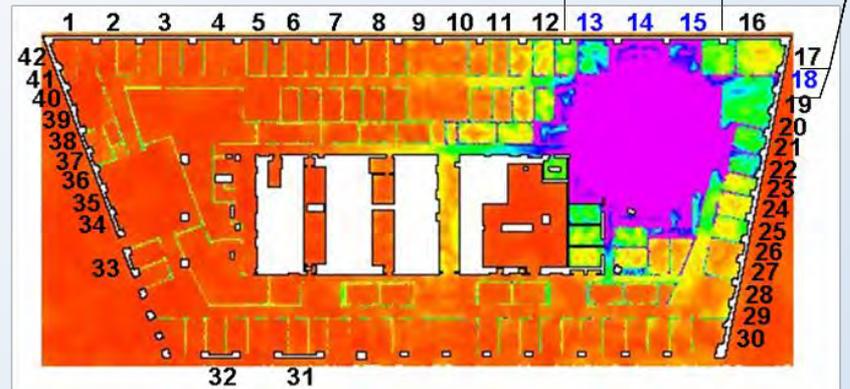
Station numbers in Blue are predicted window failure locations

Peak over pressures for 9 lb shaped charge (left) and 2lb charge (right).

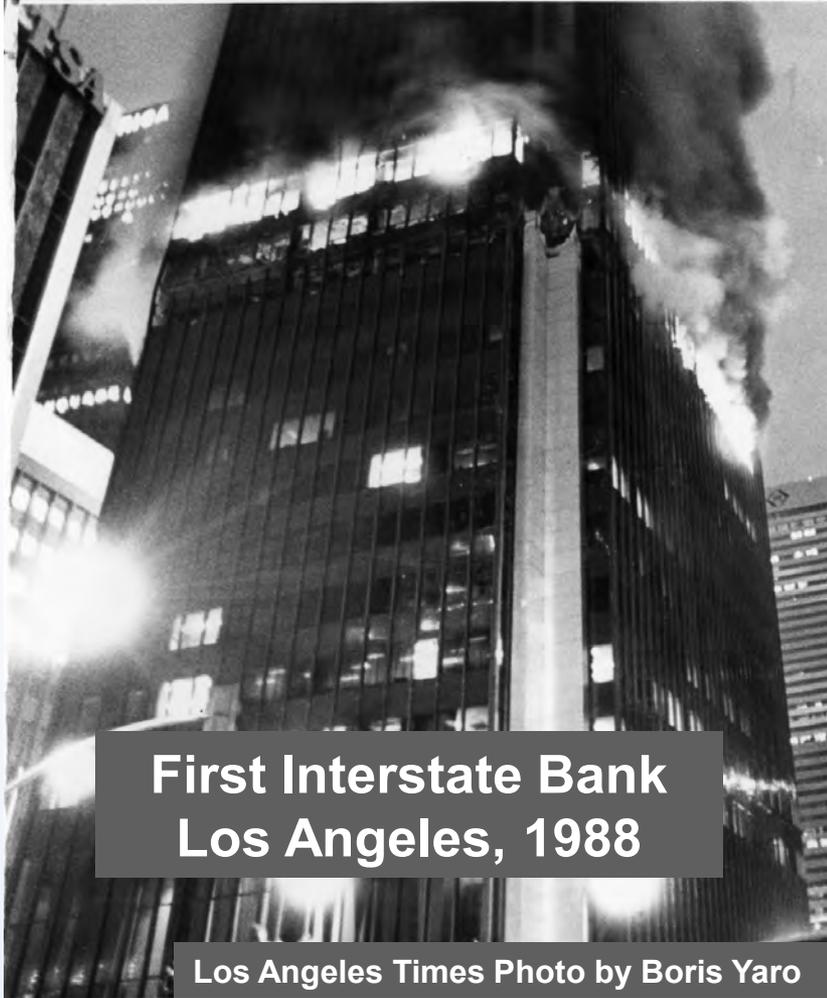
**First Interstate Bank
Los Angeles, 1988**

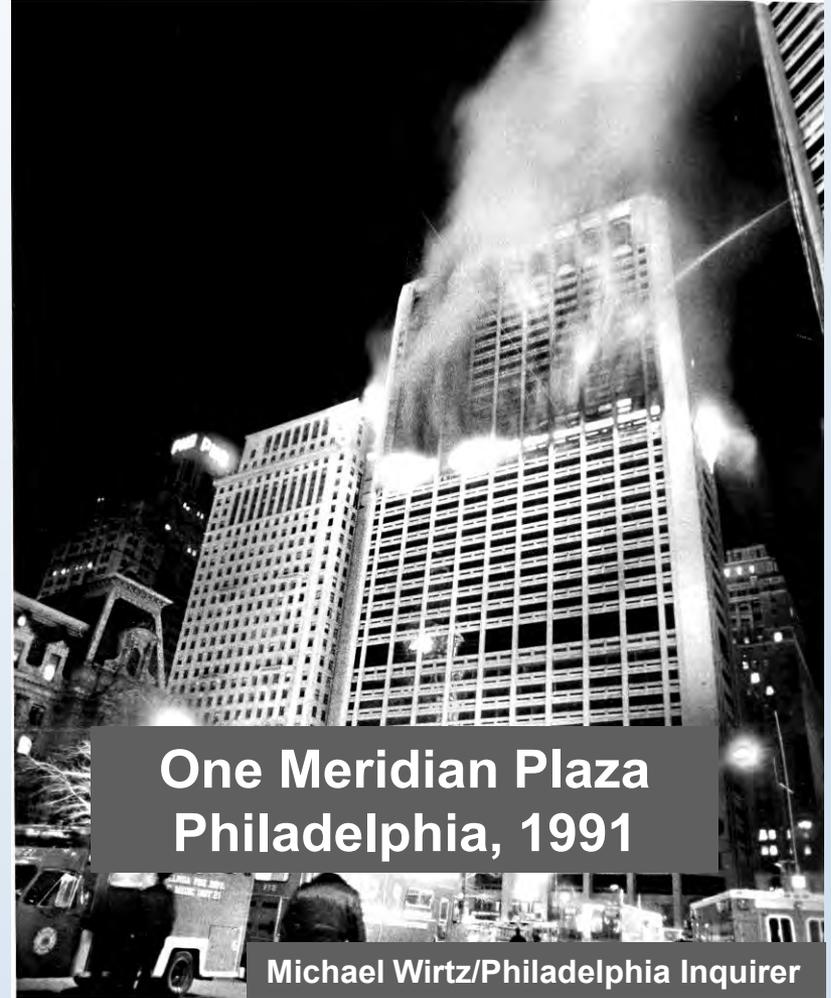
**One Meridian Plaza
Philadelphia, 1991**

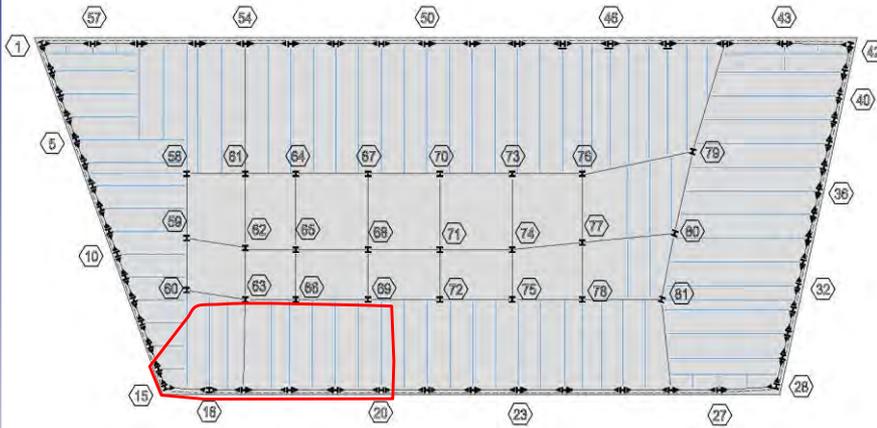
Floor 8

Estimated Debris Impact Damage by Floor
