NIST Response to the World Trade Center Disaster

**Federal Building and Fire Safety Investigation
of
the World Trade Center Disaster**

August 26, 2008

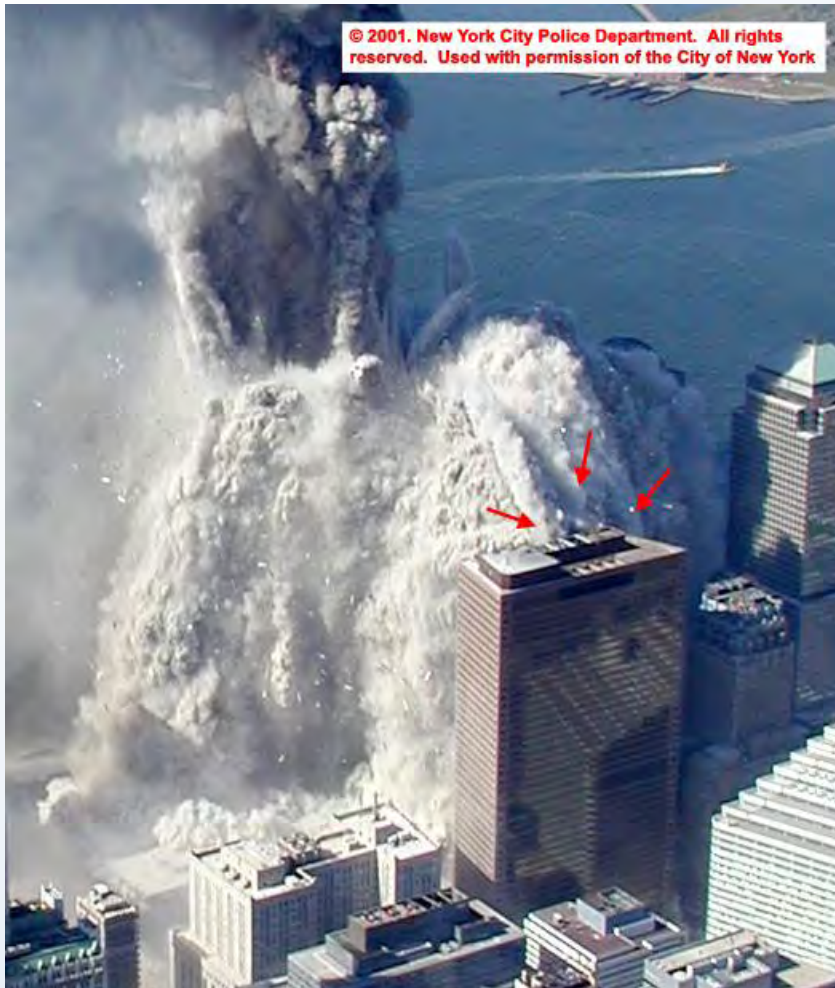
Summary of Probable Collapse Sequence (1)

- Collapse of the WTC Towers.
 - Collapse of WTC 2 did not cause any structural damage or start any fires in WTC 7.
 - Collapse of WTC 1 damaged seven exterior columns on the lower floors of the south and west faces and initiated fires on 10 floors between Floors 7 and 30.

Aerial photograph shot $14 \text{ s} \pm 0.5 \text{ s}$ after WTC 1 began to collapse.

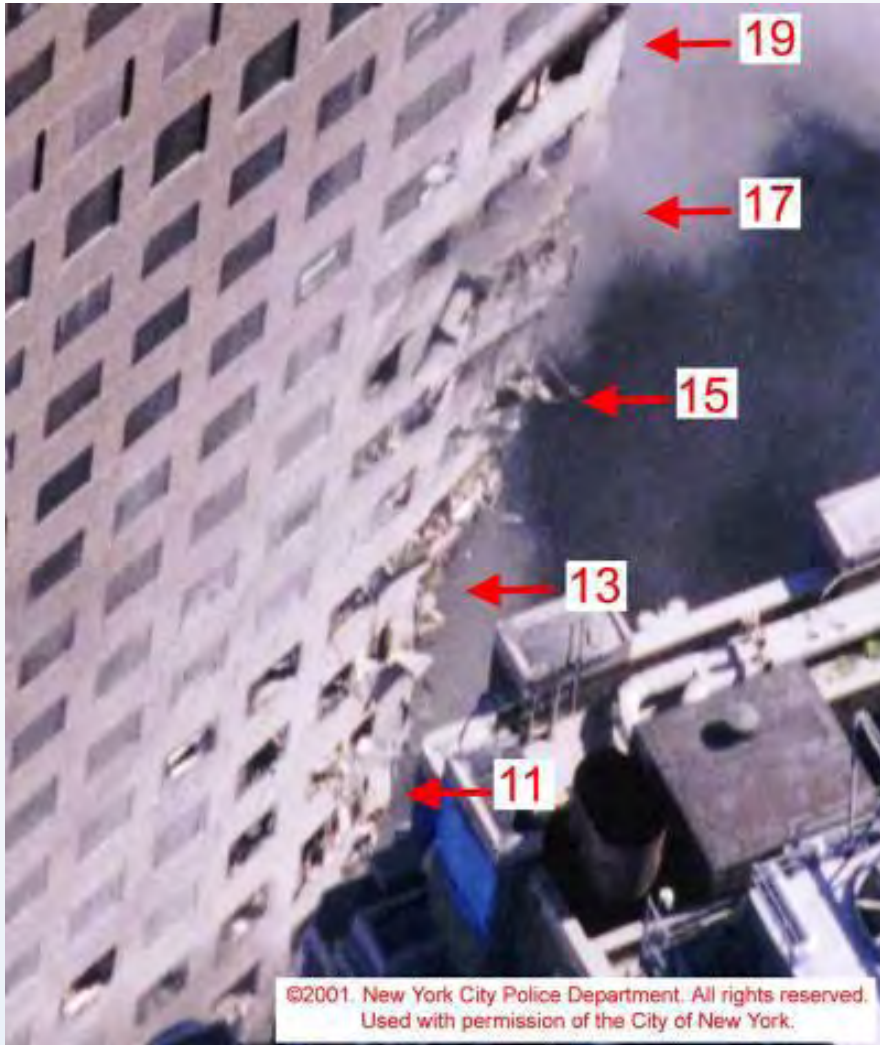
Debris Impact Damage to WTC 7

- Enlargement of a photograph showing part of the west face of WTC 7.
- Arrows and floor numbers have been added for the corresponding rows of windows.

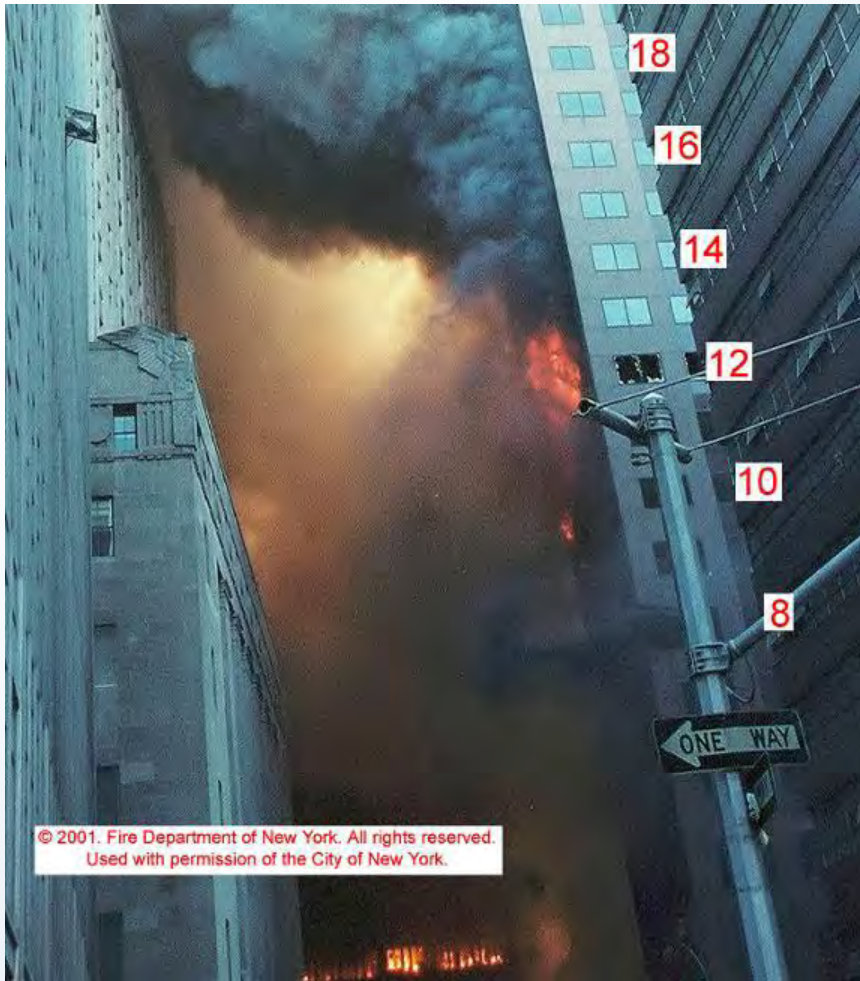
- Photo showing north and east faces.
- Likely taken between 3:20 - 3:40 p.m.

- Growth and Spread of Fires.
 - Fires on Floors 7 to 9 and 11 to 13 grew and spread since they were not extinguished either by the automatic sprinkler system or by FDNY because water was not available.
 - Fires were generally concentrated on the east and north sides beginning at about 3 p.m. to 4 p.m.
 - The local fires on Floors 19, 22, 29, and 30 were not observed after ~ 1 p.m.

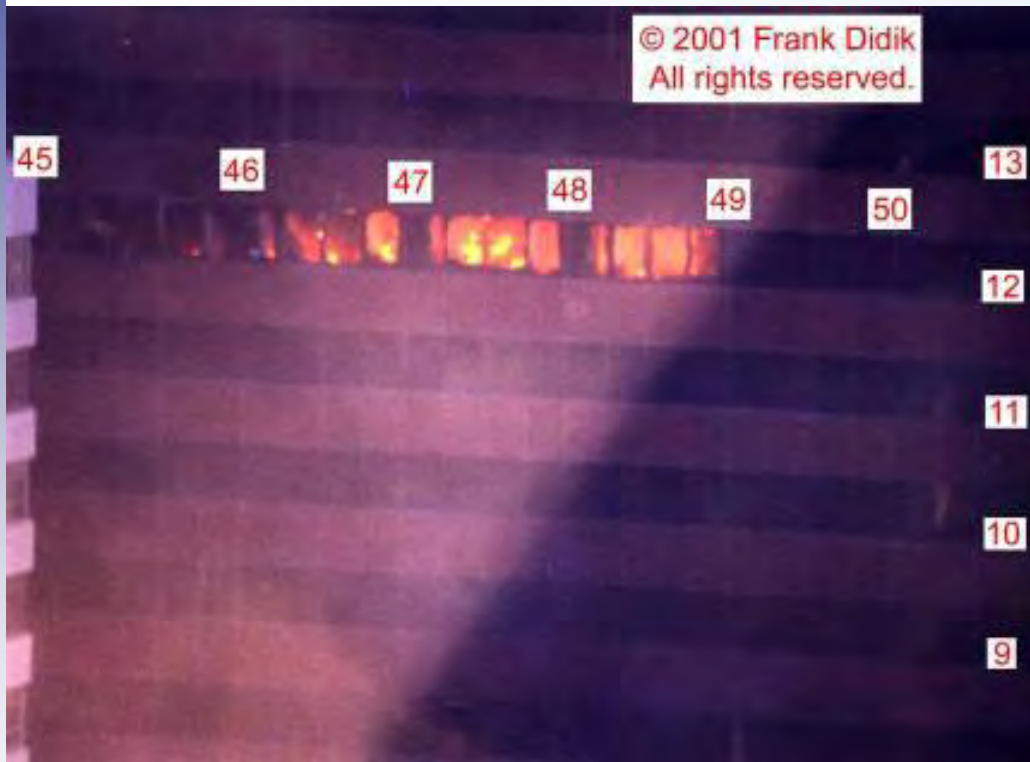
Observed Fires

- Cropped photograph of north face taken between 3:11:15 p.m. and 3:16:51 p.m.

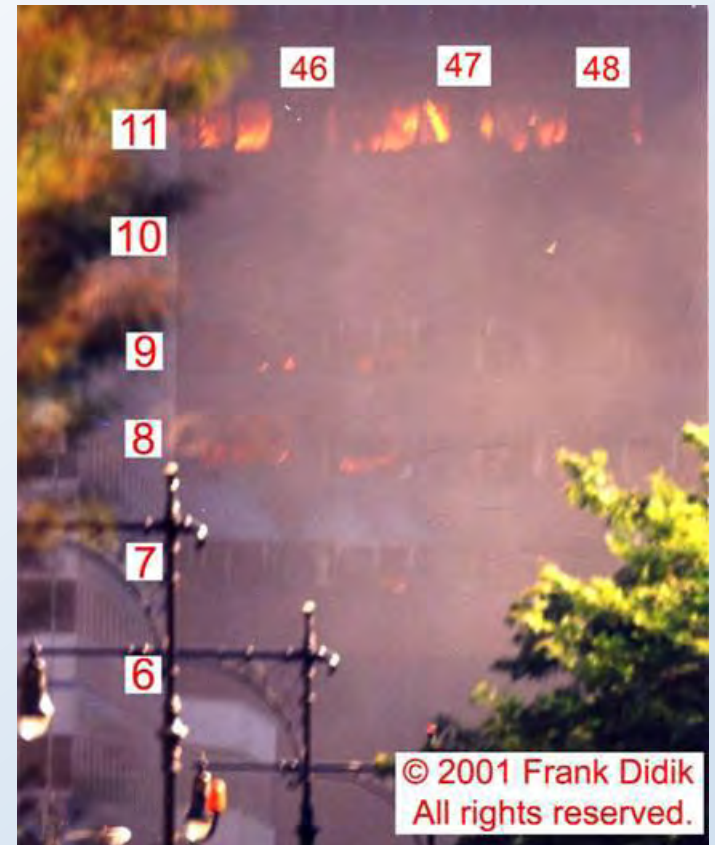
- Cropped photograph showing part of north face at 4:39 p.m. \pm 120 s.

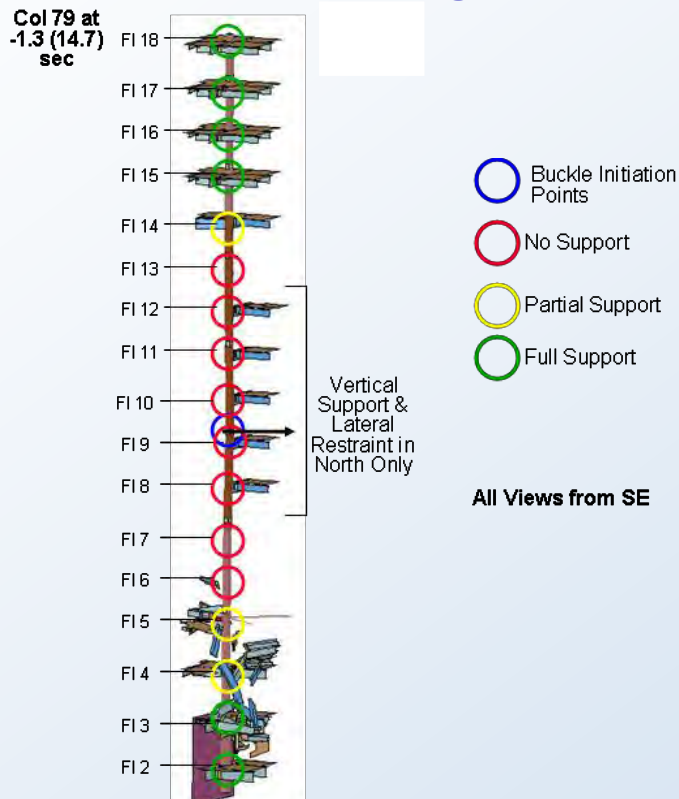
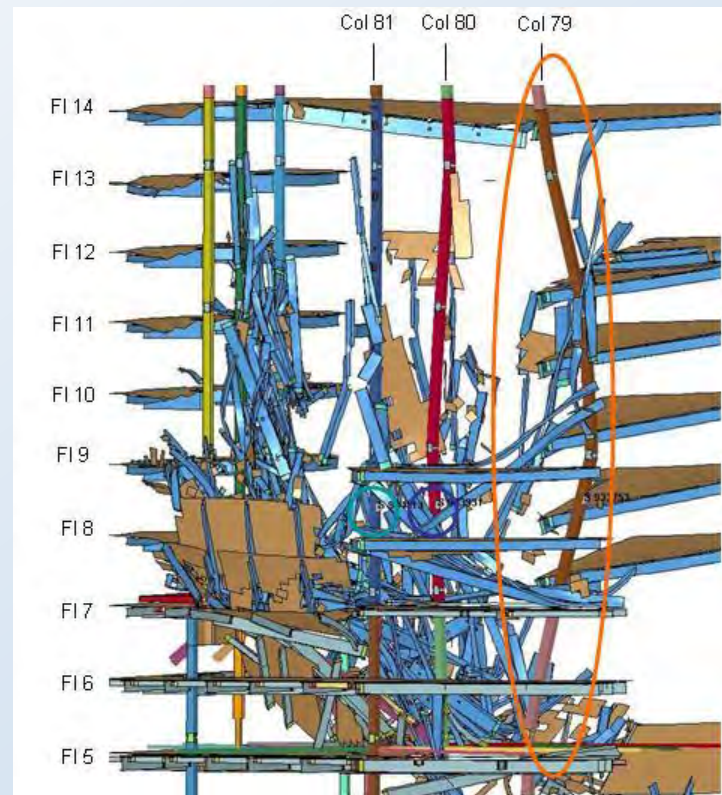
North East Floor System Near Column 79

- Initial Local Failure for Collapse Initiation.
 - Fire-induced thermal expansion of the floor system surrounding Column 79 led to the collapse of Floor 13 and triggered a cascade of floor failures.
 - This, in turn, led to loss of lateral support to Column 79 over nine stories, resulting in the buckling failure of Column 79.

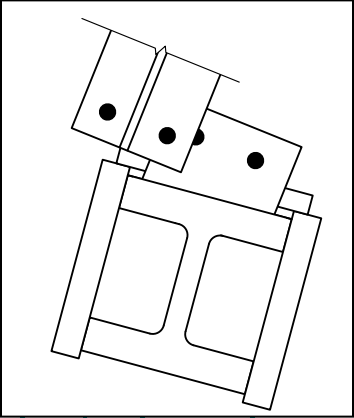
Girder was pushed laterally by thermal expansion of floor beams, due to one-sided framing and lack of shear studs.

Forces from thermal expansion failed the connection at Column 79, then pushed the girder off the seat.

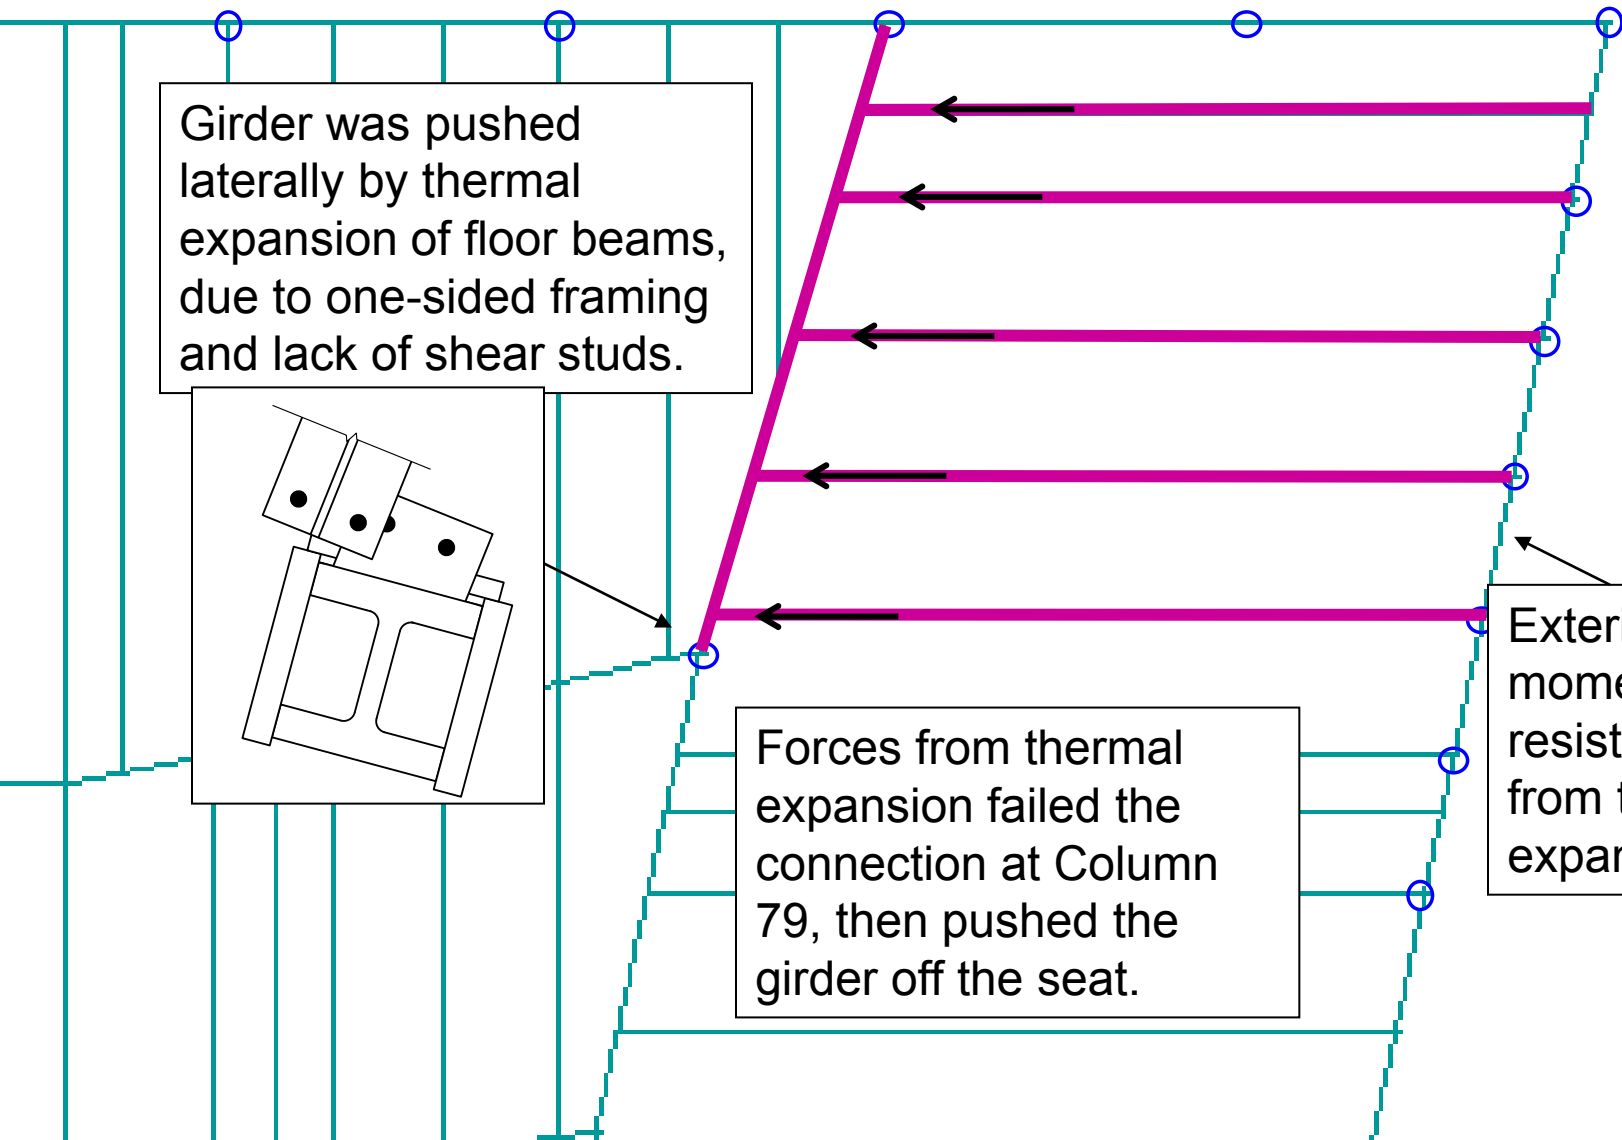
Exterior moment frame resisted forces from thermal expansion.

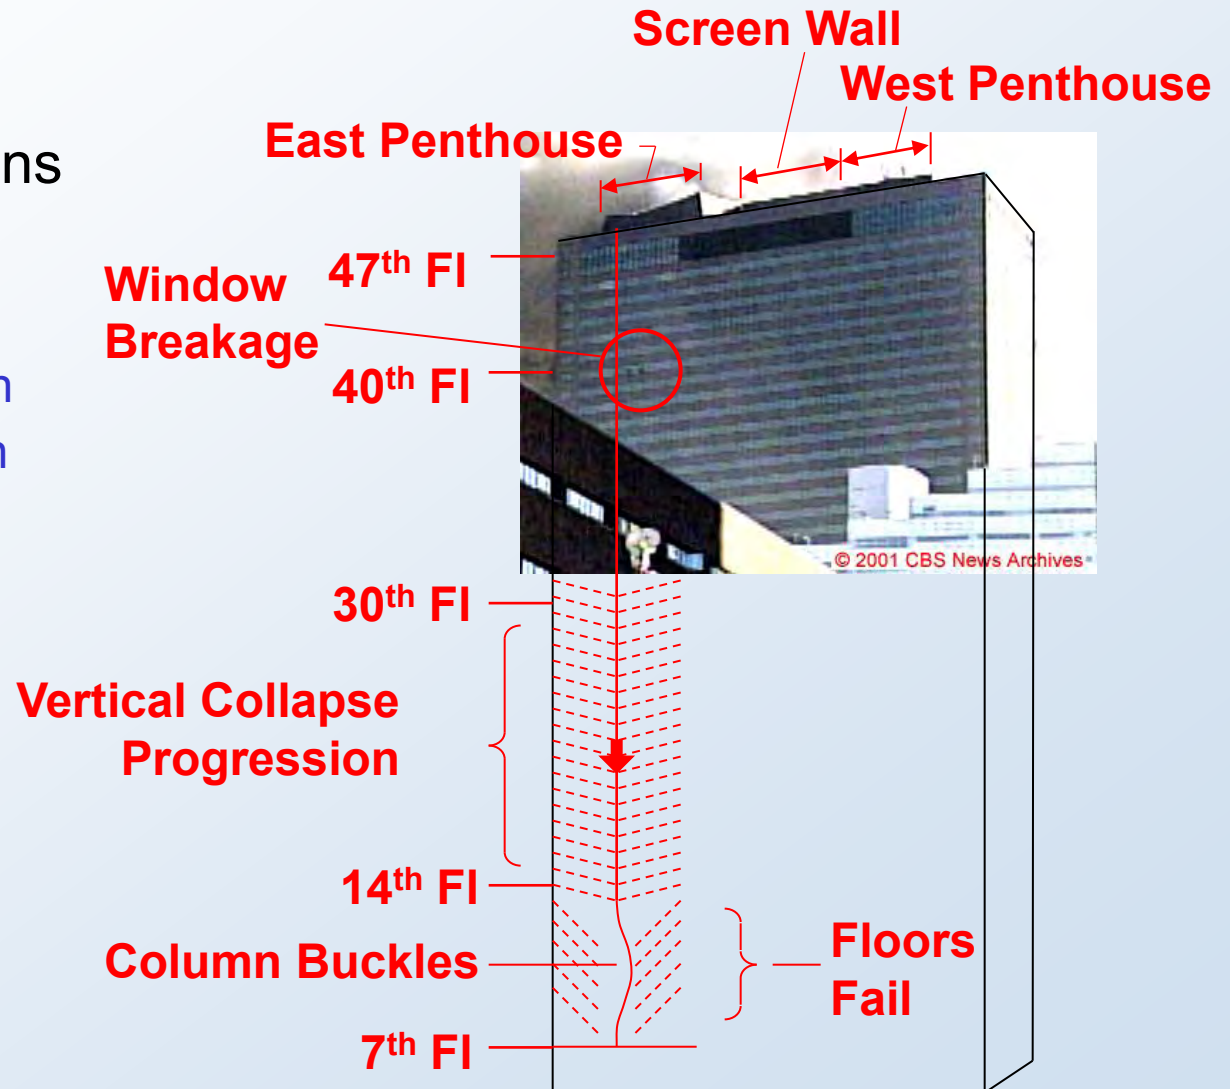
- ❑ East Penthouse Kinks
- ❑ Windows break on East Side of North Face

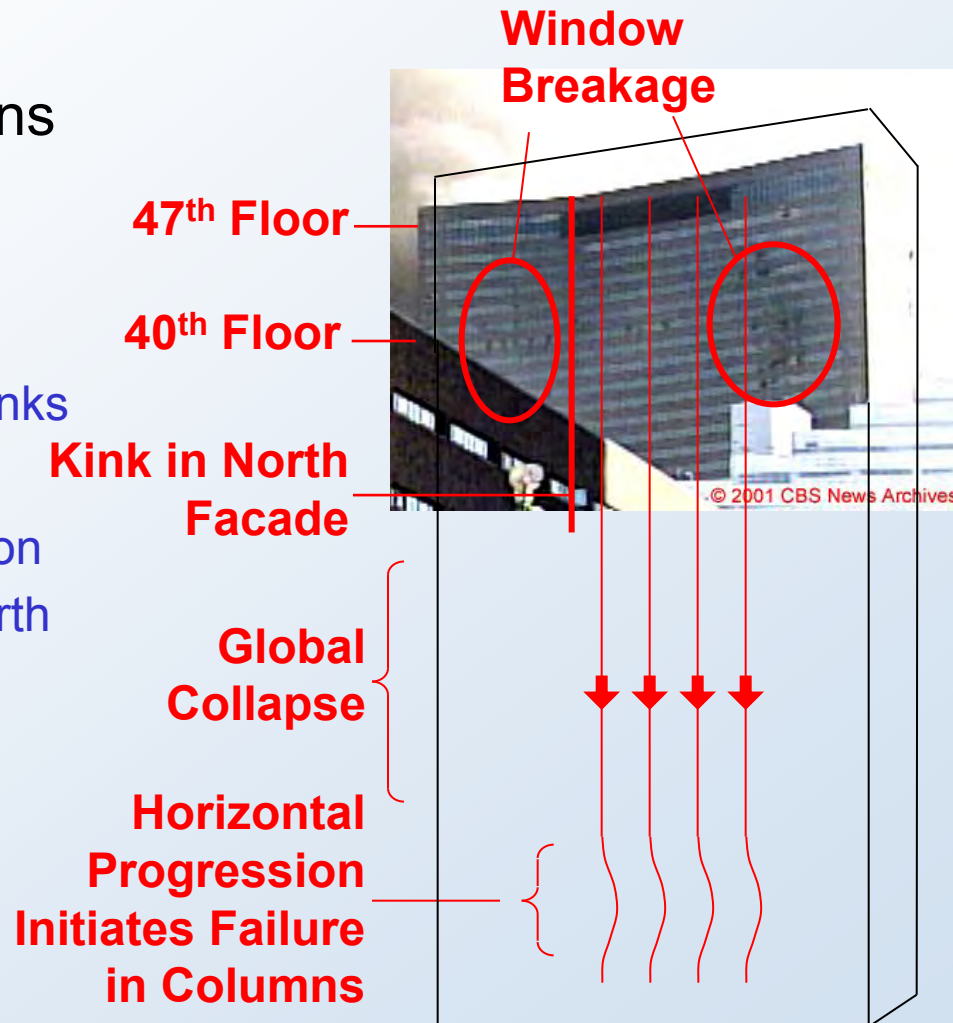
- ❑ Screenwall and West Penthouse Sink
- ❑ North Façade Kinks at Edge of Core
- ❑ Windows break on West Side of North Face

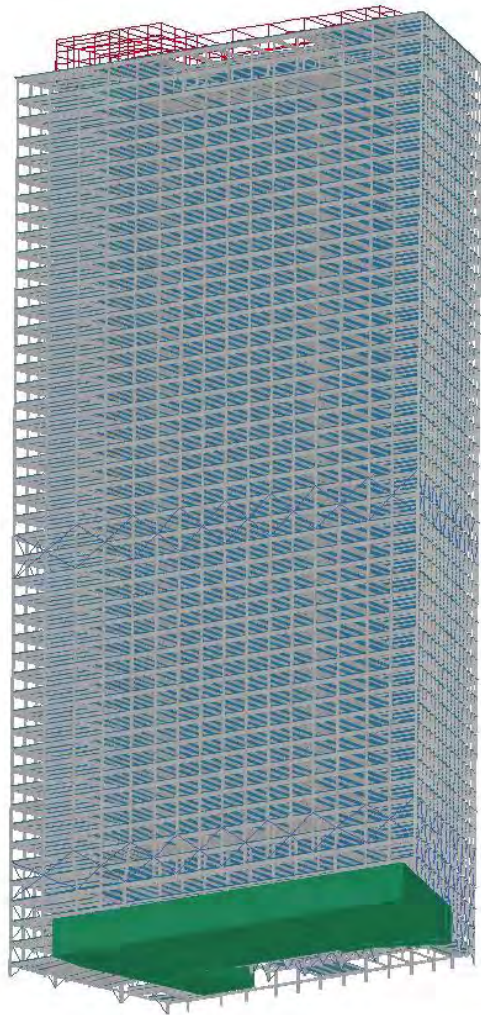
LSDYNA Model of WTC-7
Time = 6.5

WTC 7 Collapse Visualization w/o Damage

View from
Northwest

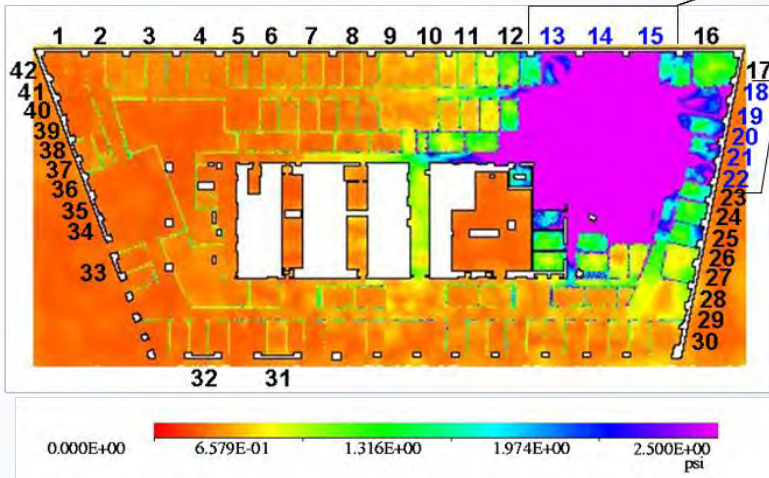
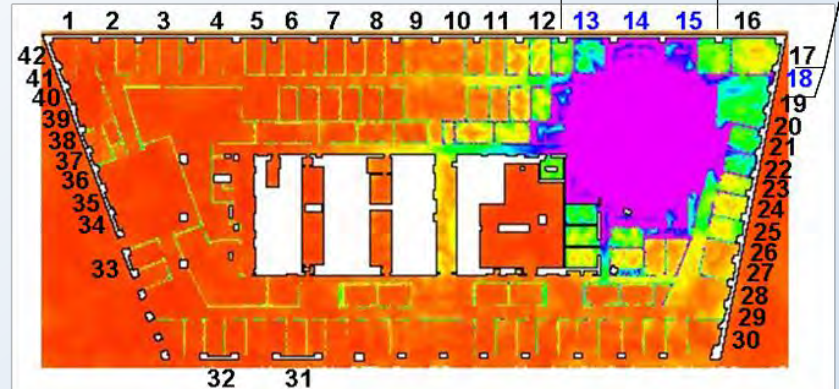
Role of Hypothetical Blast Events (2)

Station numbers in Blue are predicted window failure locations

Peak over pressures for 9 lb shaped charge (left) and 2lb charge (right).

- The minimum explosive charge (lower bound) required to fail a critical column (i.e., Column 79) would have:
 - produced a pressure wave that would have broken windows on the north and east faces of the building near Column 79.

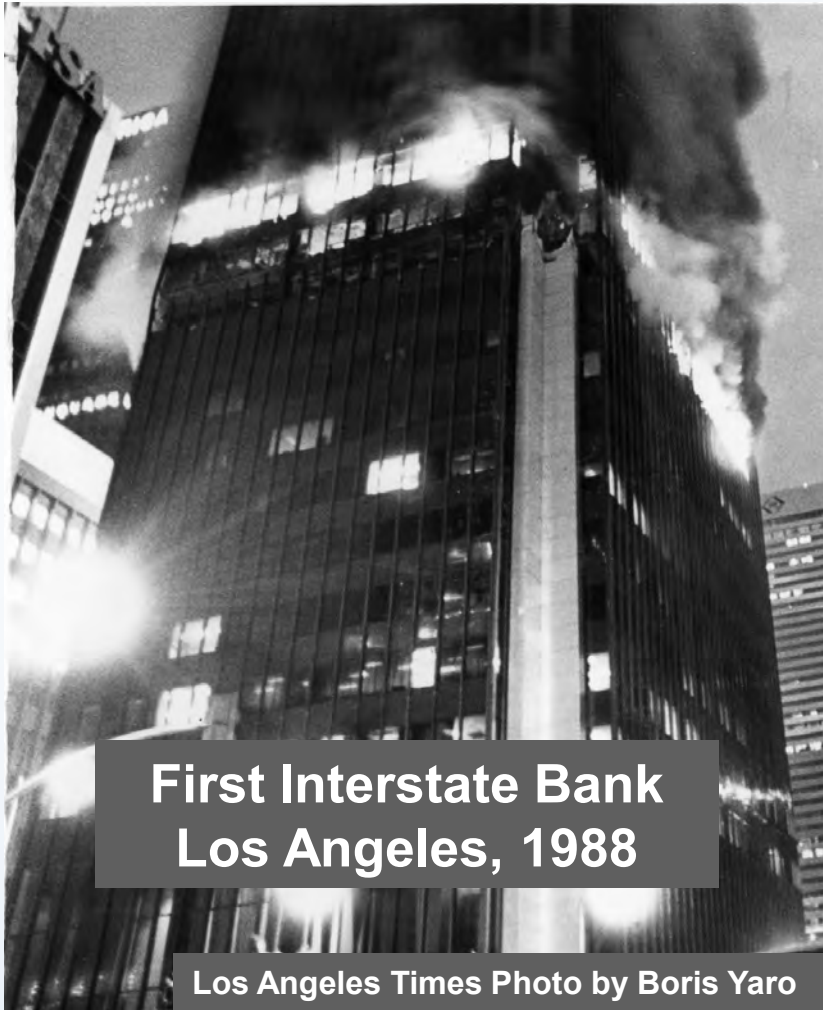
**First Interstate Bank
Los Angeles, 1988**

- Fire scenarios for structural design based on single compartment or single floor fires are not appropriate representations of infrequent fire events. Such events occurred in several tall buildings resulting in unexpected substantial losses.
