Technical Conference on the Federal Building and Fire Safety Investigation of the World Trade Center Disaster

Session VI - Structural Fire Response and Collapse Analysis

Observations for Structural Response Structural and Fire Protection Damage Due to Aircraft Impact

Therese McAllister

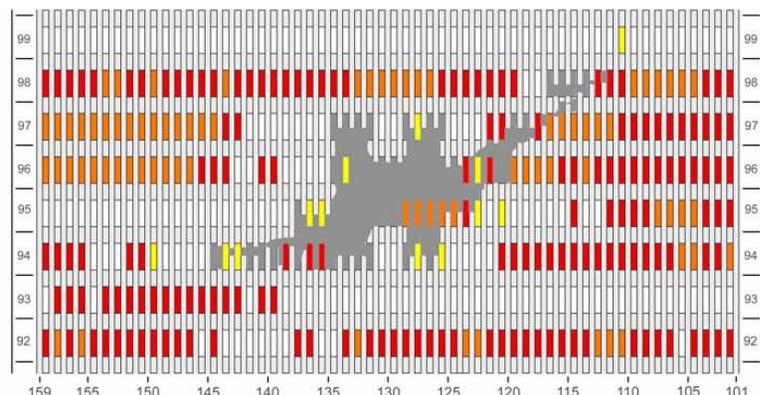
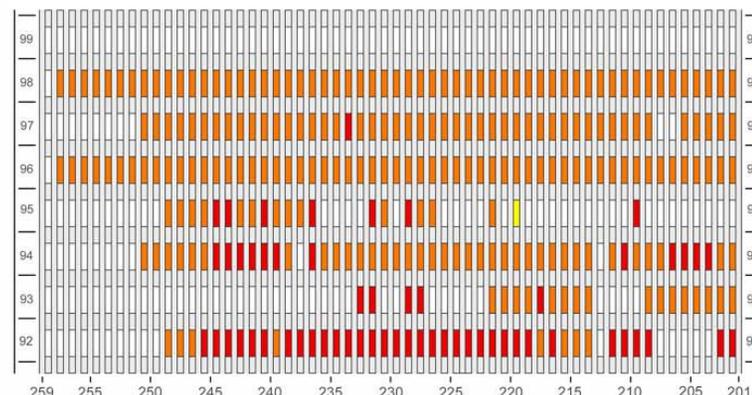
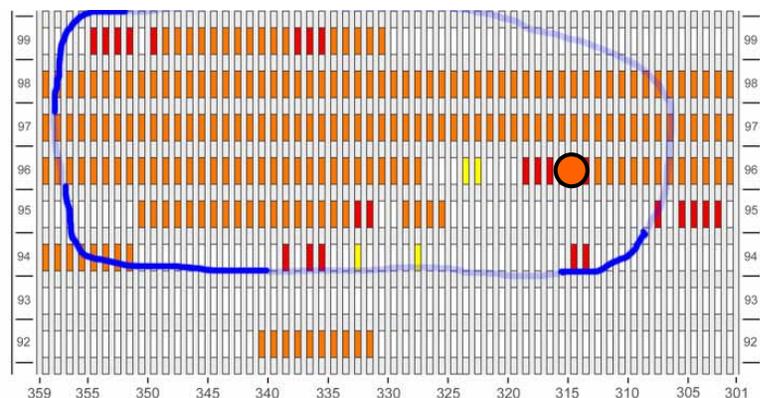
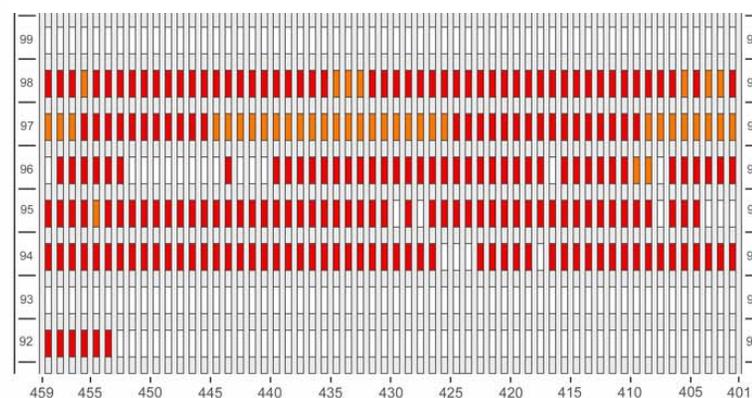
Visual Evidence of Fires in WTC 1, 8:47 a.m. to 10:28 a.m.

Dark blue line indicates extent of inward bowing observed in visual images.
Light blue line is estimated region of inward bowing where visual images were obscured.

- ❑ Inward bowing of south face first seen at 10:23 a.m., 5 min before collapse initiated.
- ❑ Maximum inward bow was 55 in. \pm 6 in. at Floor 97.
- ❑ Extent of fires on all WTC 1 exterior faces was similar.
- ❑ North face did not bow inward.
- ❑ Time to collapse was 102 min.
- ❑ Tilt of upper building section took place near Floor 98. Exterior column buckling progressed rapidly across the adjacent east and west faces.
- ❑ Upper building section tilted to the south with no discernable east or west component in the tilt.
- ❑ Tilt reached 8° before view was obscured by dust clouds.

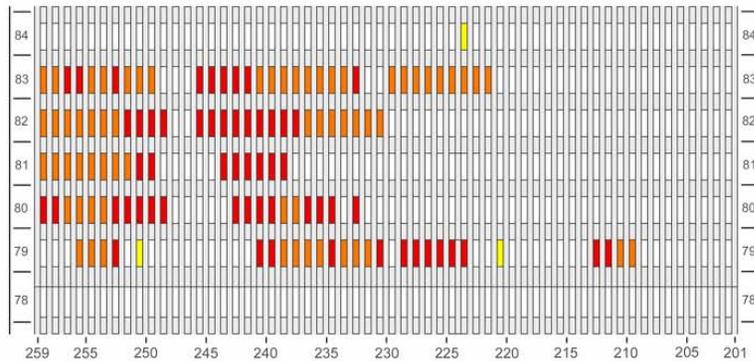
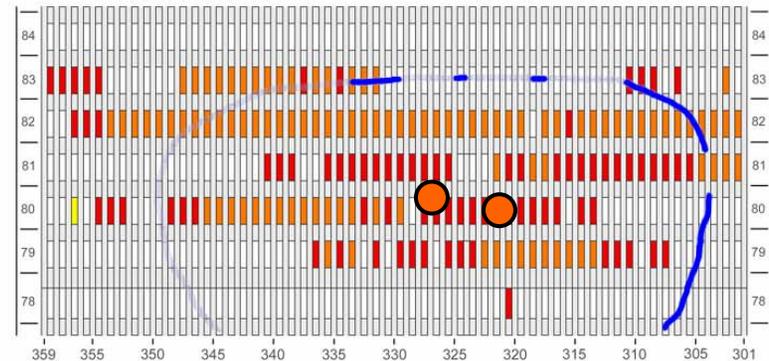
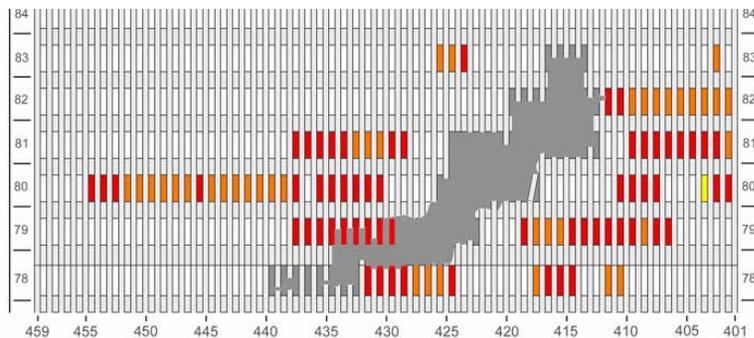
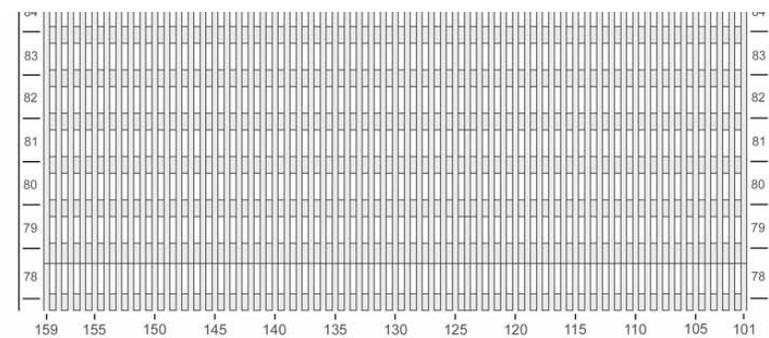
Visual Evidence of Fires in WTC 2, 9:04 a.m. to 9:58 a.m.

Dark blue line indicates extent of inward bowing observed in visual images.
Light blue line is estimated region of inward bowing where visual images were obscured.

- ❑ Draped objects were observed in the windows of the east and north faces which appeared to be hanging floors. The drape increased with time and extended across approximately half of the east face.
- ❑ Maximum inward bow of the east face was 10 in. \pm 1 in. at Floor 80, first seen at 9:21 a.m., 18 min after impact.
- ❑ Maximum inward bowing increased to 20 in. \pm 1 in. at Floor 80, 6 min before collapse initiation.
- ❑ Fires were more extensive on the east side of the tower. No fires or inward bowing of the west wall were observed on the west face.
- ❑ Time to collapse was 56 min.
- ❑ Tilt of upper building section took place near Floor 82. Exterior column buckling progressed rapidly across the adjacent north and south faces.
- ❑ Upper building section tilted 3° to 4° south and 7° to 8° to the east.
- ❑ Tilt to the east reached 20° before view was obscured by dust clouds.

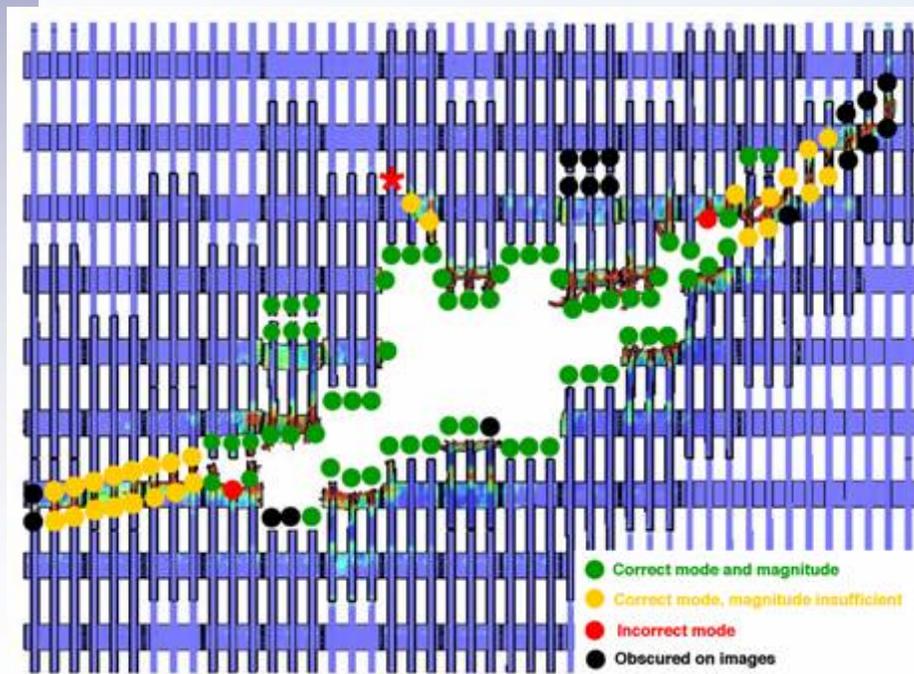
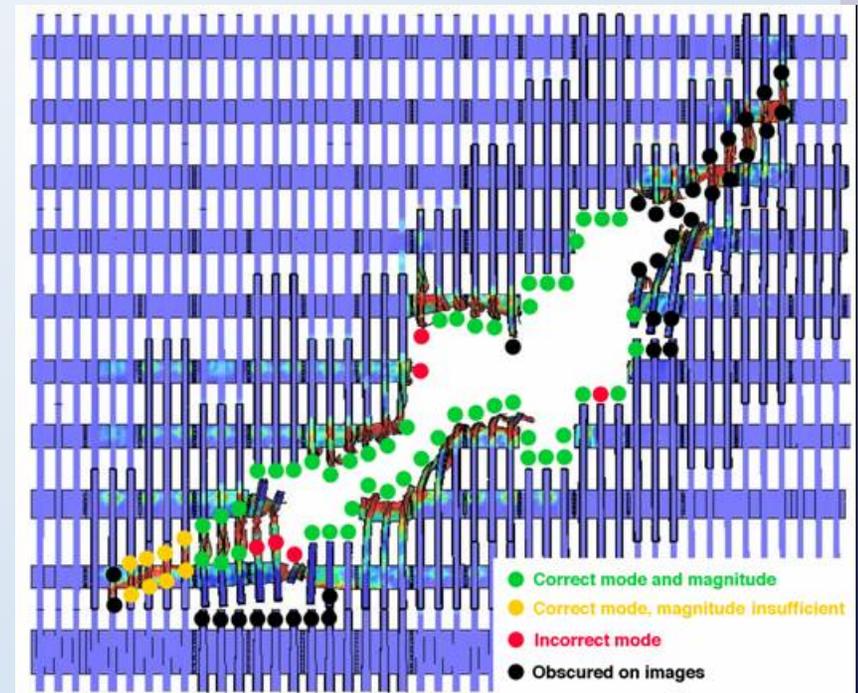
Aircraft Impact Damage for Structural Response Analysis

Damage to exterior columns was determined from photographs.

Damage to core columns, floor systems (slabs, core beams, trusses), and fire protection and partitions was determined from aircraft impact analysis results, which were validated with evidence from photographs and videos.

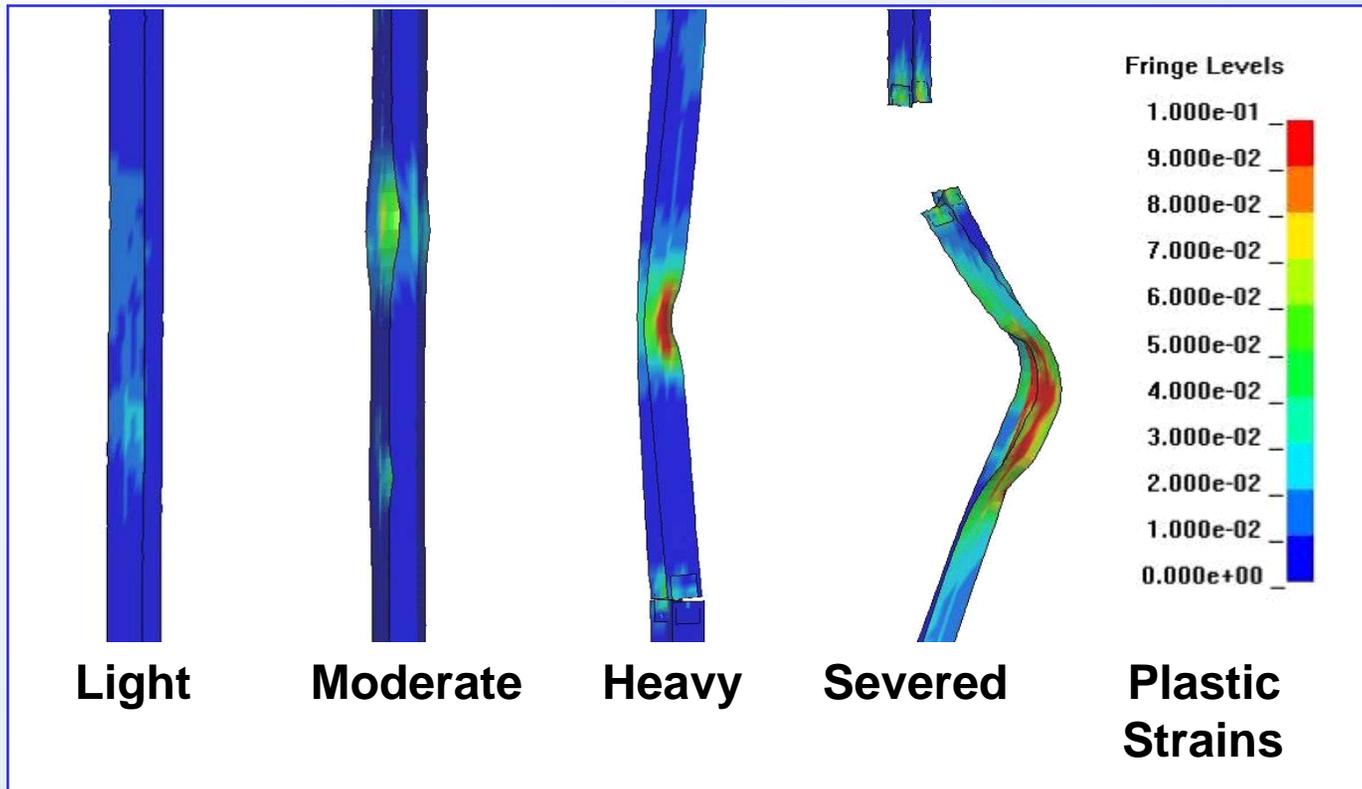
Core Column Damage

WTC 1	WTC 2
Severed	6	10
Heavy	3	1
Moderate	6	6
Light	5	6

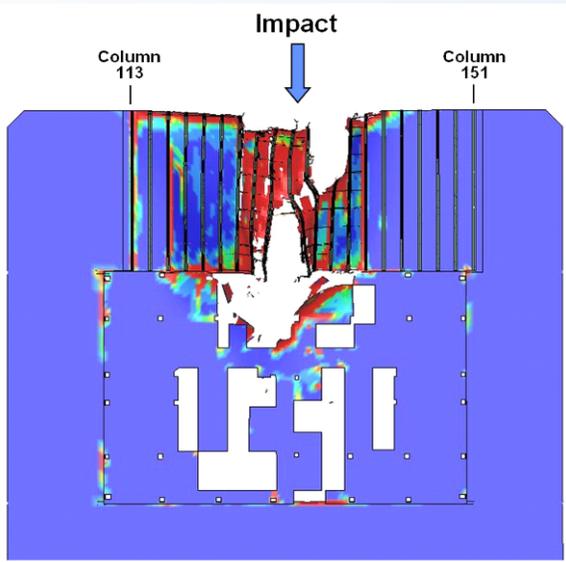
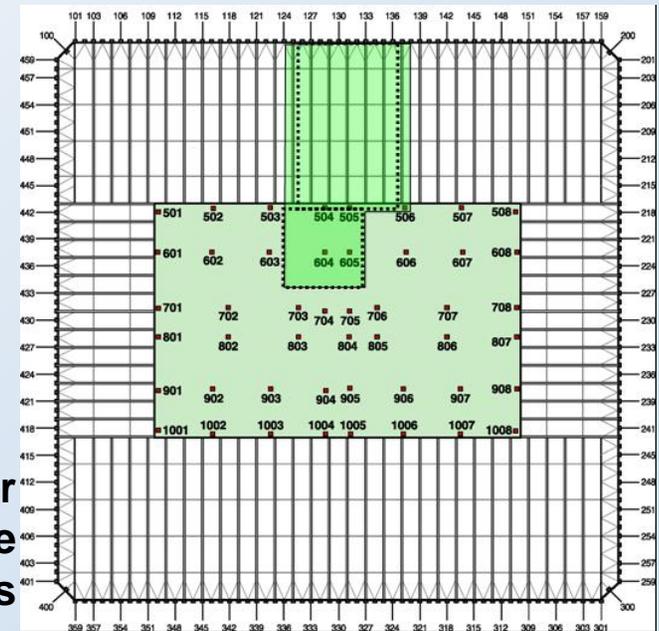
Structural Floor Damage

Severely damaged or missing areas incapable of supporting loads

- ❑ Severed trusses, beams, and connections
- ❑ Concrete damage

Floor slab damage from aircraft impact analysis

Floor slab damage for structural response analysis

Floor areas were removed for both types of damage in structural analyses

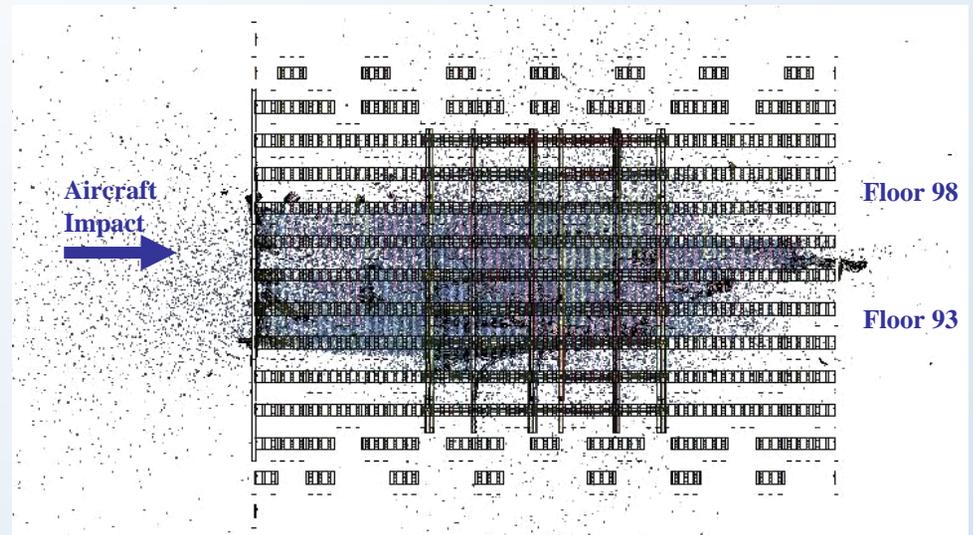
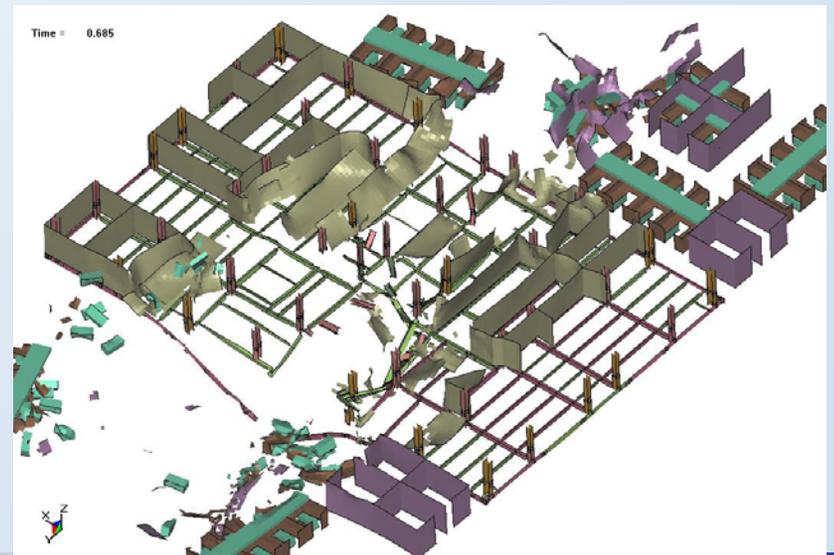
Damage to Passive Fire Protection for Structural Steel

Debris and fuel field traveled across multiple floors and tended to fill floor spaces.

Damage to interior structural framing, partitions, and furnishings was calculated by the aircraft impact analysis.

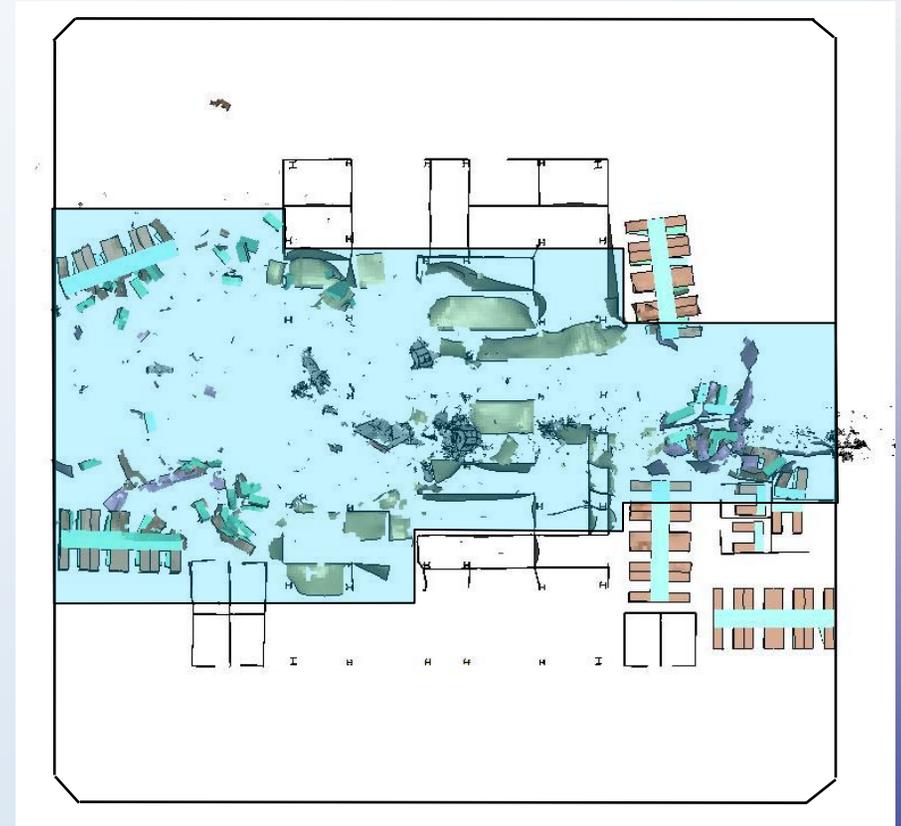
Criteria for Dislodged Passive Fire Protection of Floor Trusses

If the debris impact damaged or destroyed room furnishings (modular office workstations), then the debris field was considered to extend high enough and be strong enough to dislodge the fire protection in the same floor area.

If the debris field did not damage room furnishings, then the fire protection in the same floor area was considered to be intact.

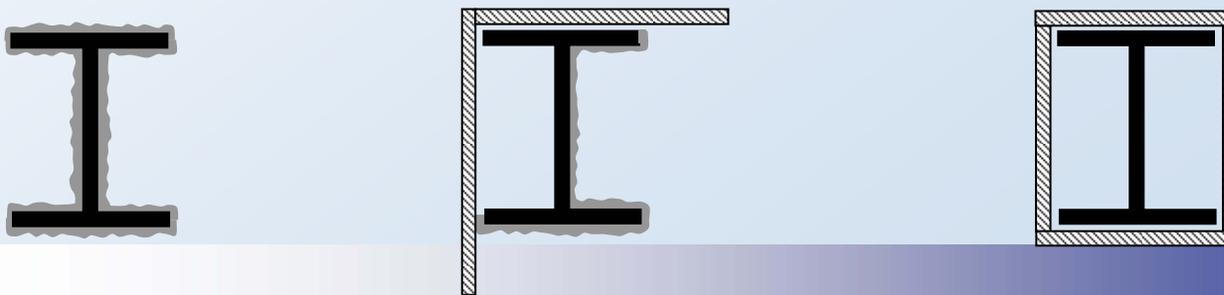
Criteria for Dislodged Passive Fire Protection of Core Columns

If debris impact failed partitions immediately in front of core columns, then the fire protection was assumed to be dislodged over the floor height on core columns behind failed partitions.

If the partitions remained intact, then the fire protection on core columns behind these partitions was assumed to remain intact.

The *representative* strength of building partitions was assumed to be 500 psi based on a survey of data for partition walls and modular workstations; while the *representative* laboratory cohesive and adhesive strengths of fire protection measured by NIST was generally less than 12 psi.

Passive fire protection for core columns included sprayed fire resistive material (SFRM), gypsum wallboard enclosures, or a combination.

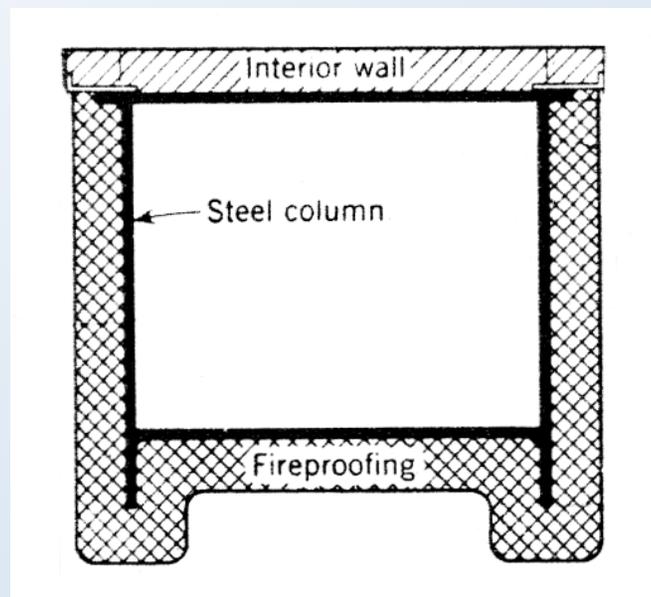
Criteria for Dislodged Passive Fire Protection of Exterior Columns

If debris impact damaged or destroyed room furnishings (modular office workstations) adjacent to the exterior columns, then the fire protection on the inside face of the exterior columns in the same vicinity was assumed to be dislodged over the floor height.

If furnishings remained intact adjacent to the exterior columns, then the fire protection on the inside face of the exterior columns behind the furnishings was assumed to remain intact.

The other three faces of the exterior columns were protected by the windows and/or aluminum cladding and were assumed to have no fire protection damage.

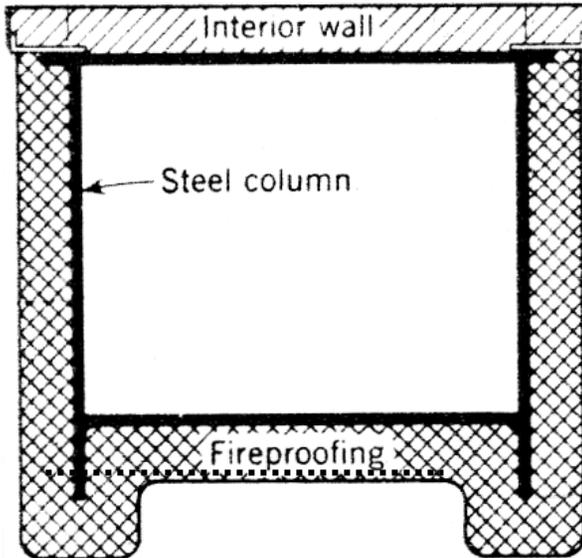
Application of SFRM to External Columns

- By design, uniform thickness
- As applied, region between flange tips fill (for example, see column 246 at right)
- Missing SFRM from outer flange indicate shadowing and exposed red paint

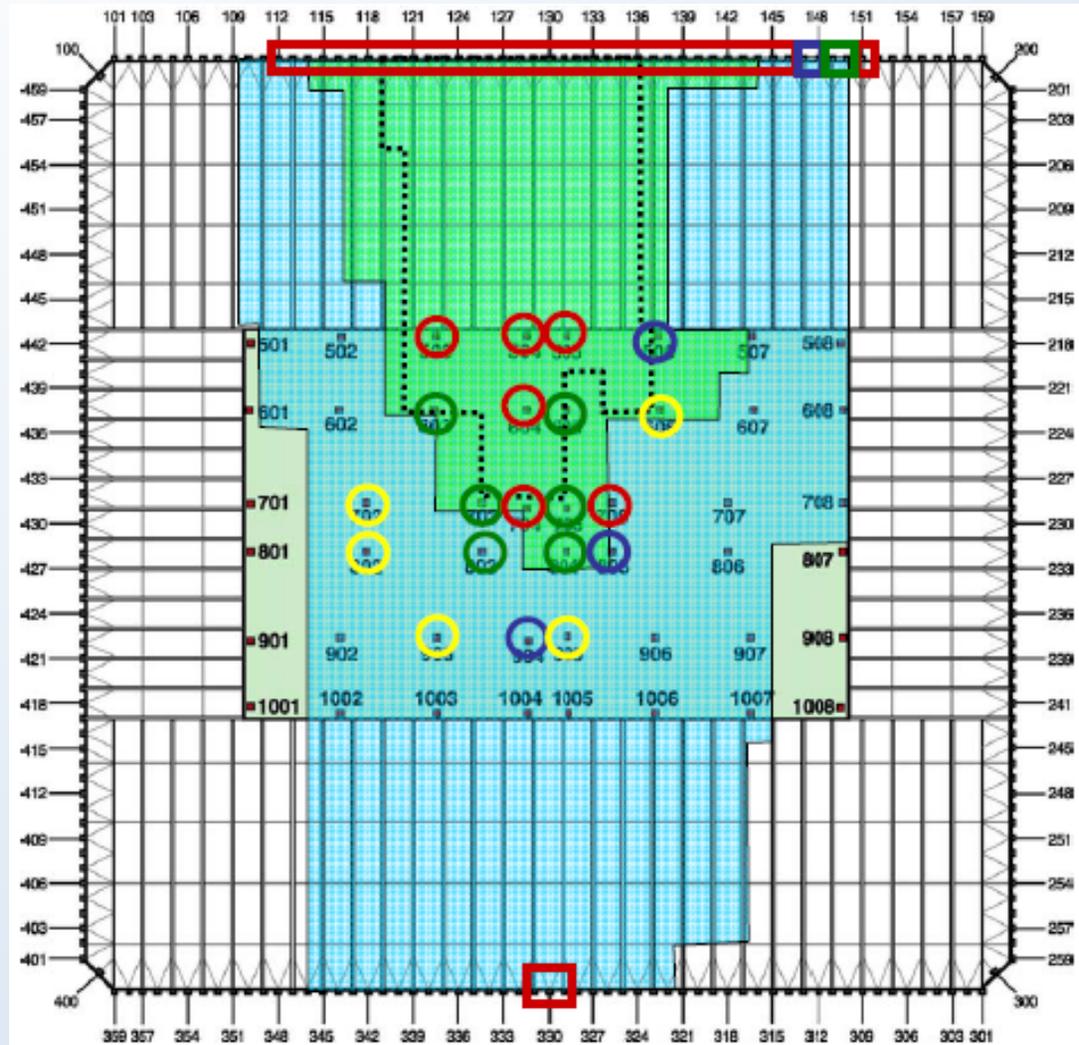
WTC 1 Damage: Composite Summary for Floors 93 to 98

- ❑ In WTC 1, structural systems were damaged and fire protection was dislodged by direct debris impact over Floors 94 to 98, over most of the north floor areas, the core, and central regions of the south floor areas, extending to the south wall.
- ❑ In WTC 2, structural systems were damaged and fire protection was dislodged by direct debris impact over Floors 78 to 83, over the south floor area in front of the core, central and east regions of the core, and most of the east floor areas, extending to the north wall.
- ❑ Fire protection damage estimates were conservative. Possible damage outside area of direct debris impact was not included as a robust criteria to estimate vibration-induced dislodging could not be established.
