Building and Fire Safety: Responding to the World Trade Center Disaster

Chicago Committee on High-Rise Buildings

September 9, 2004

National Institute of Standards and Technology

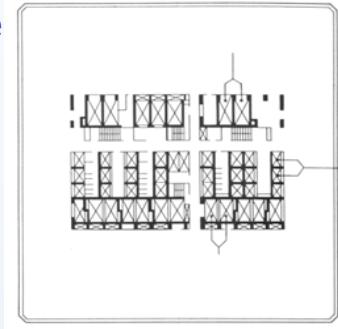
North tower

Point of impact: close to the center and nearly normal to the building

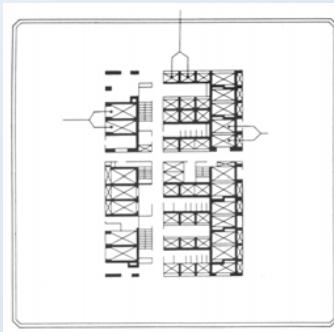
South tower

Point of impact: close to the corner and with an angle

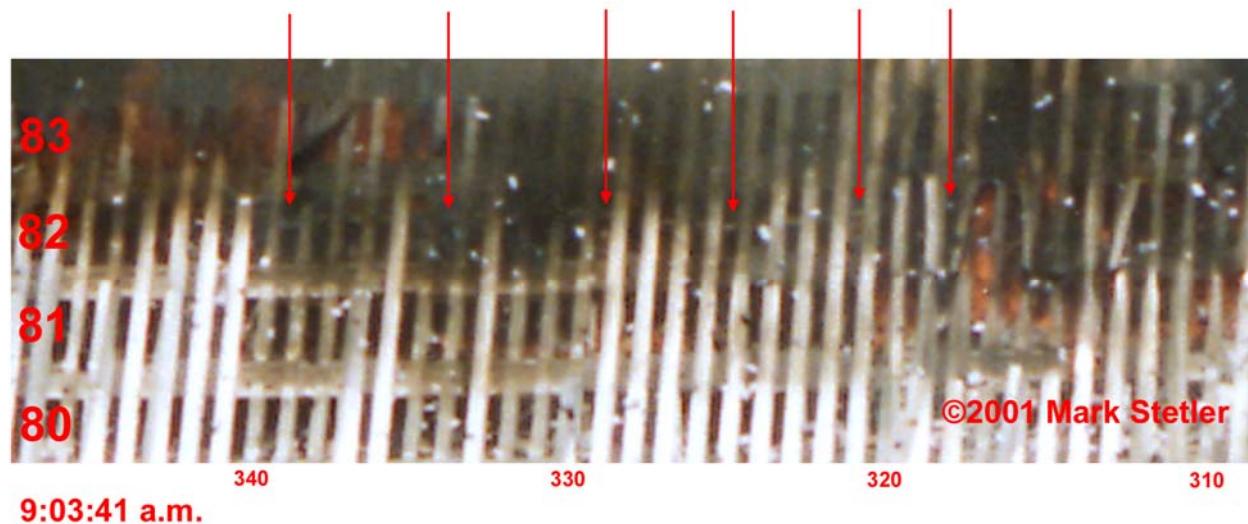
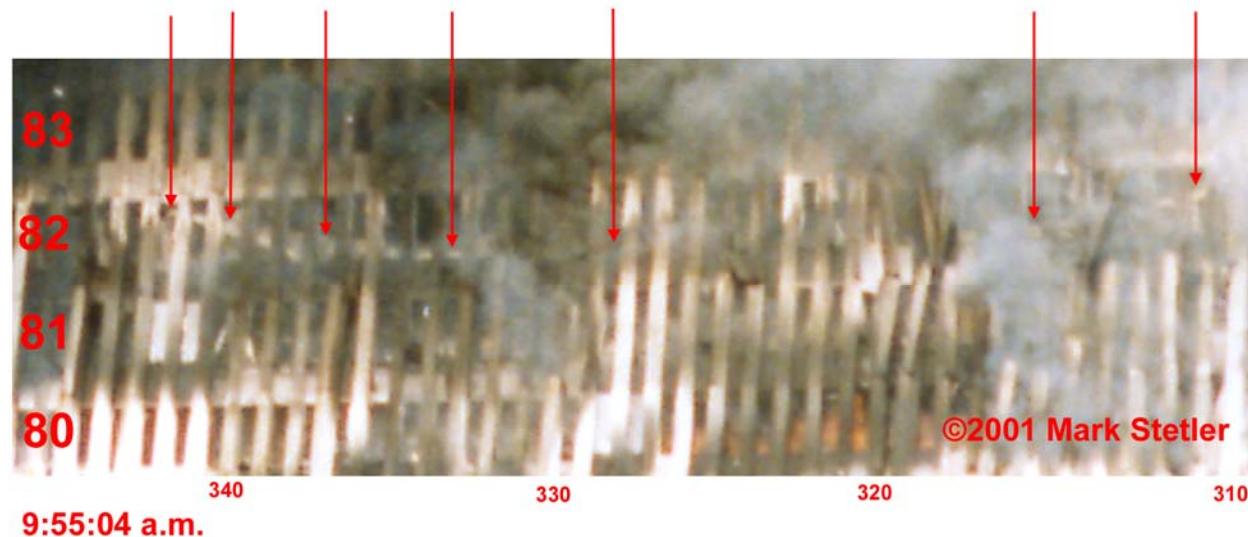
Photographic Evidence of Hanging Floor Slab

East Face of the South Tower. Image shows what appear to be a floor slab from the 83rd floor hanging across window opening over a large fraction number of the 82nd floor.

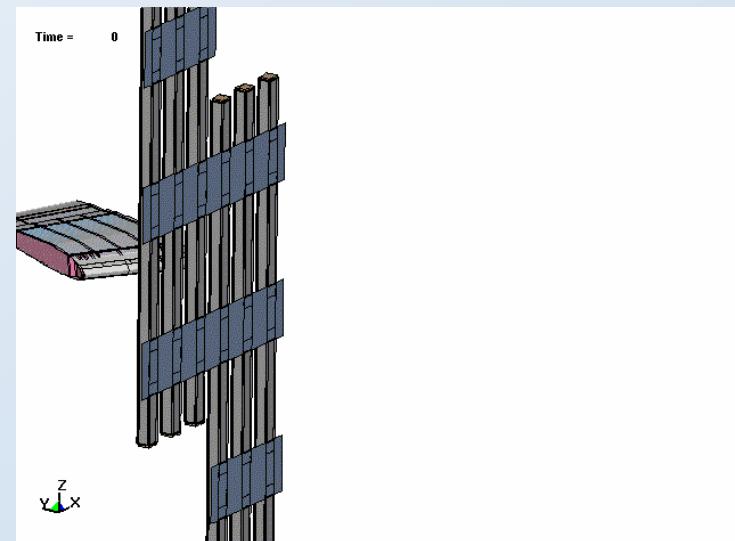
Preliminary Aircraft Impact Damage Analysis

- The impact of the exterior wall by an empty wing segment produces significant damage to the perimeter columns, not necessarily complete failure.
- The impact of a fuel-filled wing section results in extensive damage to the exterior wall panel, including complete failure of the perimeter columns.

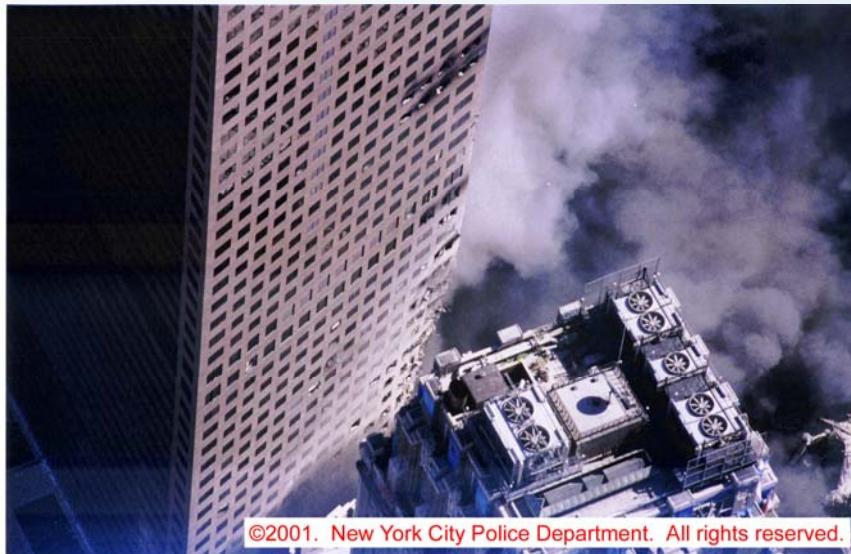
Visual Observations for WTC 7

- *The first exterior sign of structural failure in WTC 7 was the sinking of the east penthouse roof structure into the building.*
- *Witnesses reported structural damage to WTC 7 on its south face and southwest corner from WTC 1 debris.*

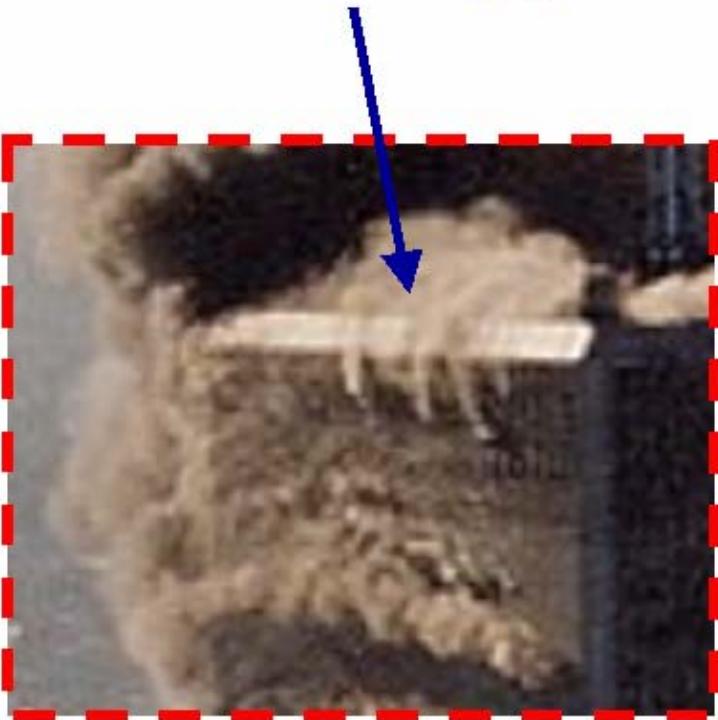
North Face – WTC 1

Smoke Exits NW Interior
Ventilation Zone Supply Inlet
