**Federal Building and Fire Safety Investigation
of the World Trade Center Disaster**

**Project 6: WTC 7 Structural Fire Response
and Collapse Analysis**

June 22, 2004

**Building and Fire Research Laboratory
National Institute of Standards and Technology
U.S. Department of Commerce**

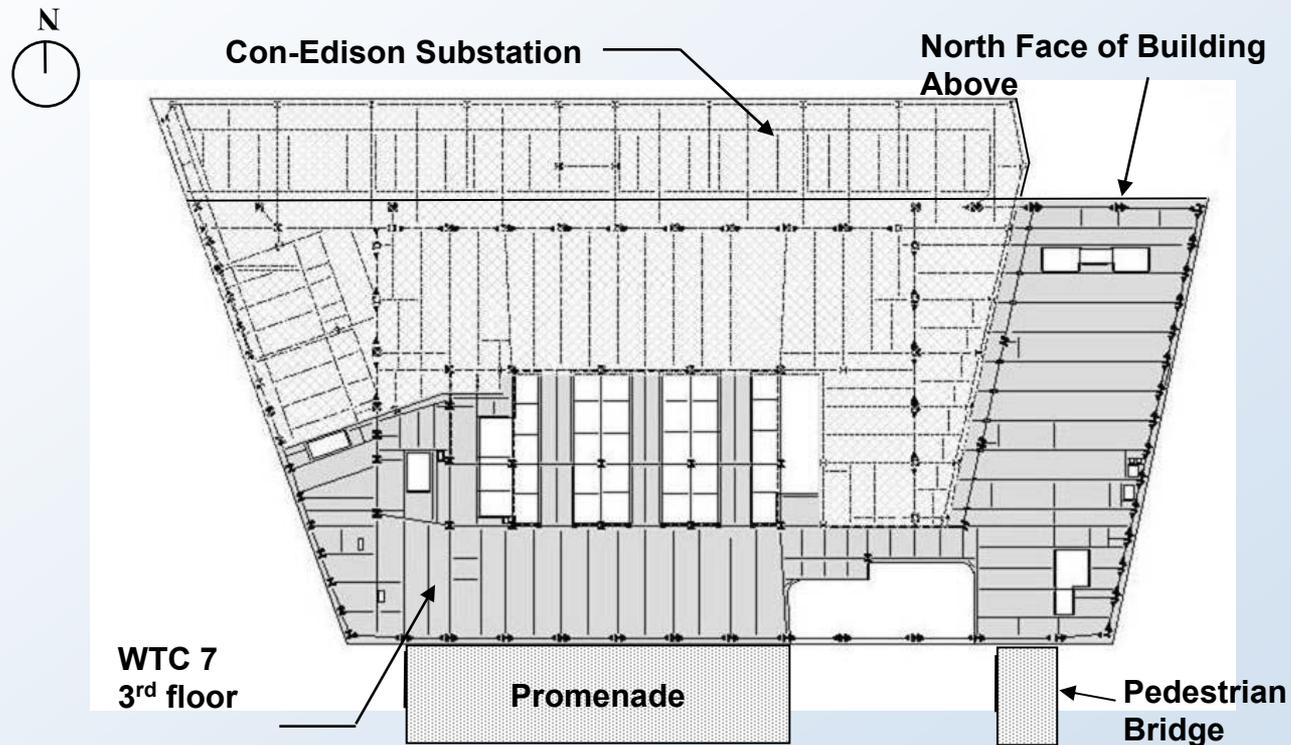
WTC 7 and Con Edison Substation

Below 7th floor, braced frame constructed over Con Ed substation

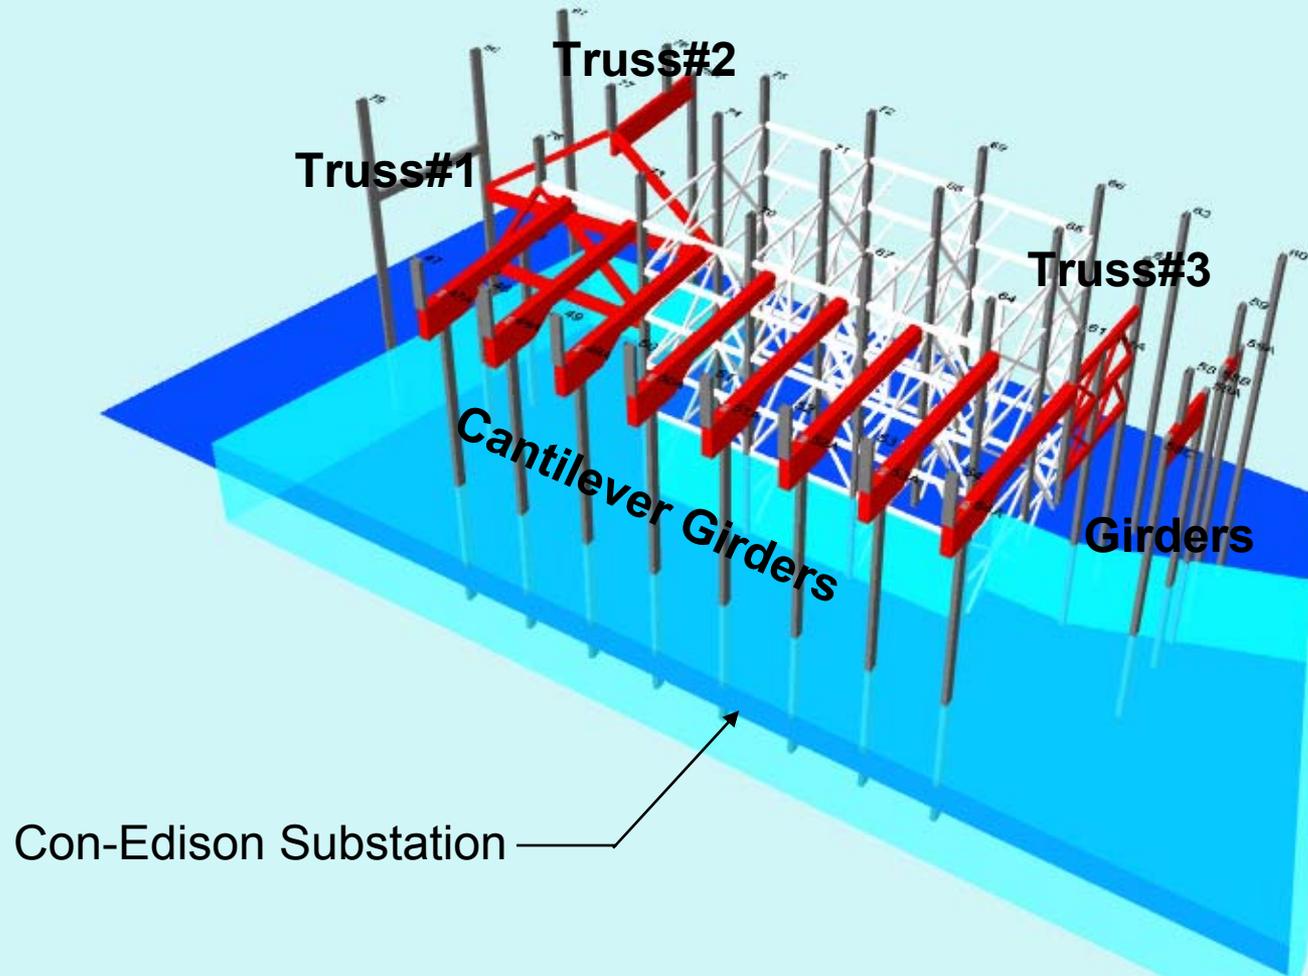
Transfer System Between Floors 5 and 7

- ❑ A vertical failure would pile debris on the east side of the building, damaging or severing transfer girders and trusses between floors 5 and 7.
- ❑ This secondary damage has been postulated to cause a horizontal progression of failure in the core columns at or near floors 5 and 7.

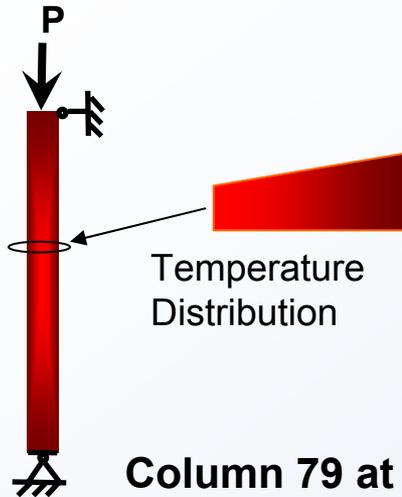
Column 79 at Floors 5-7

- ❑ Columns 79, 80, and 81 supported large tributary areas for floor spans of approximately 50 ft. Failure of column 79, 80, or 81 would likely result in failure at the floor-column connections and would progress vertically up to the east penthouse.

Possible Modes of Column Failure:

- Squashing (Yielding) of Column
- Cover Plate Weld Failure
- Failure of Column Splice

NIST continues to evaluate the factors that could have caused column 79, 80, or 81 to fail

- Massive size of columns 79, 80, and 81 appears to require severe fires and/or damaged fireproofing to initiate thermally-related failures

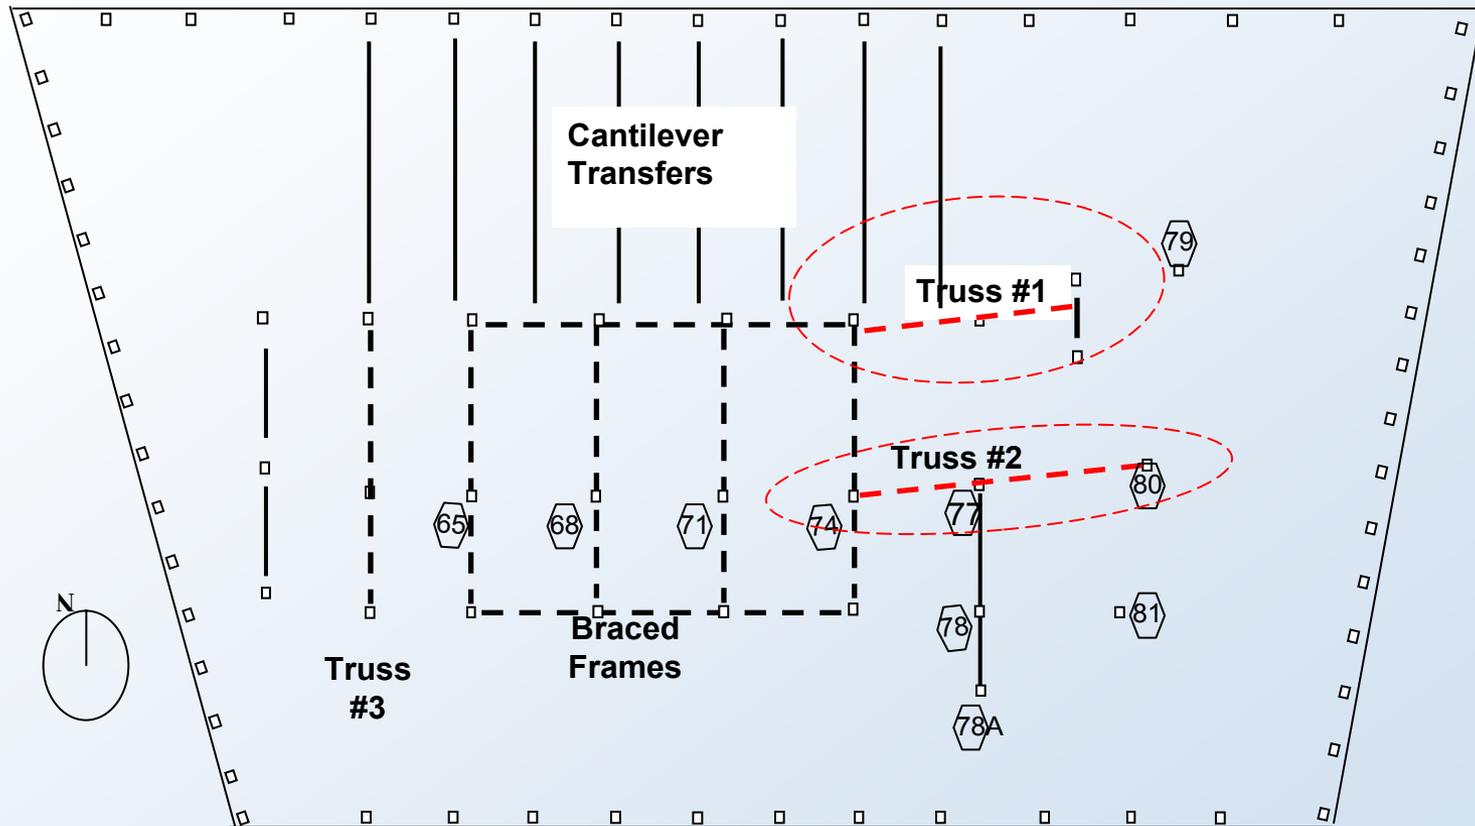
Truss #1 and Truss #2 Locations

- Damage to components adjacent to truss #2 from debris impact
- Damage to fireproofing from normal activities prior to event or debris damage
- Unusual fuel loads (fuel lines, high density of building contents)
