NIST's Findings On The World Trade Center Fire and Collapse

**NFPA World Safety Conference & Exposition
Las Vegas, NV**

June 8, 2005

**Building and Fire Research Laboratory
National Institute of Standards and Technology**

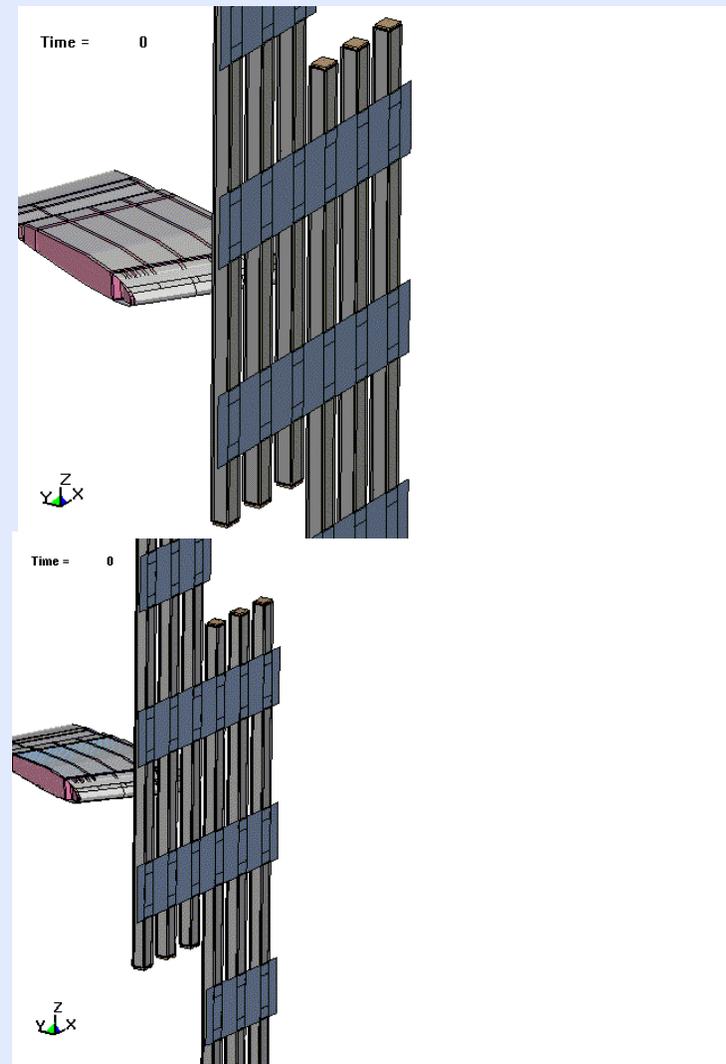
Preliminary Aircraft Impact Damage Analysis

- The impact of the exterior wall by an empty wing segment produces significant damage to the perimeter columns, not necessarily complete failure.
- The impact of a fuel-filled wing section results in extensive damage to the exterior wall panel, including complete failure of the perimeter columns.

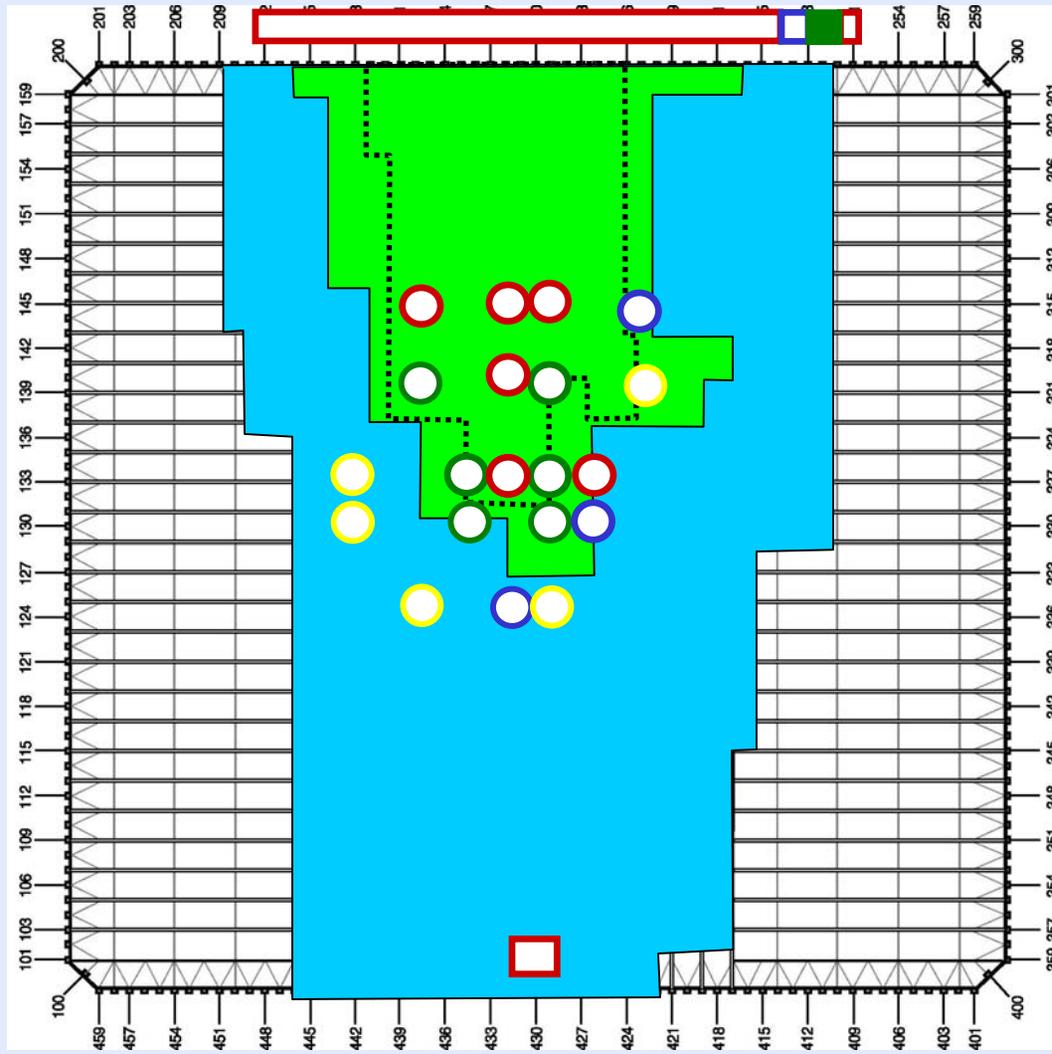
WTC 1 Damage: Composite Summary for Floors 93 to 98

Severe Floor Damage

Floor system structural damage

Column Damage

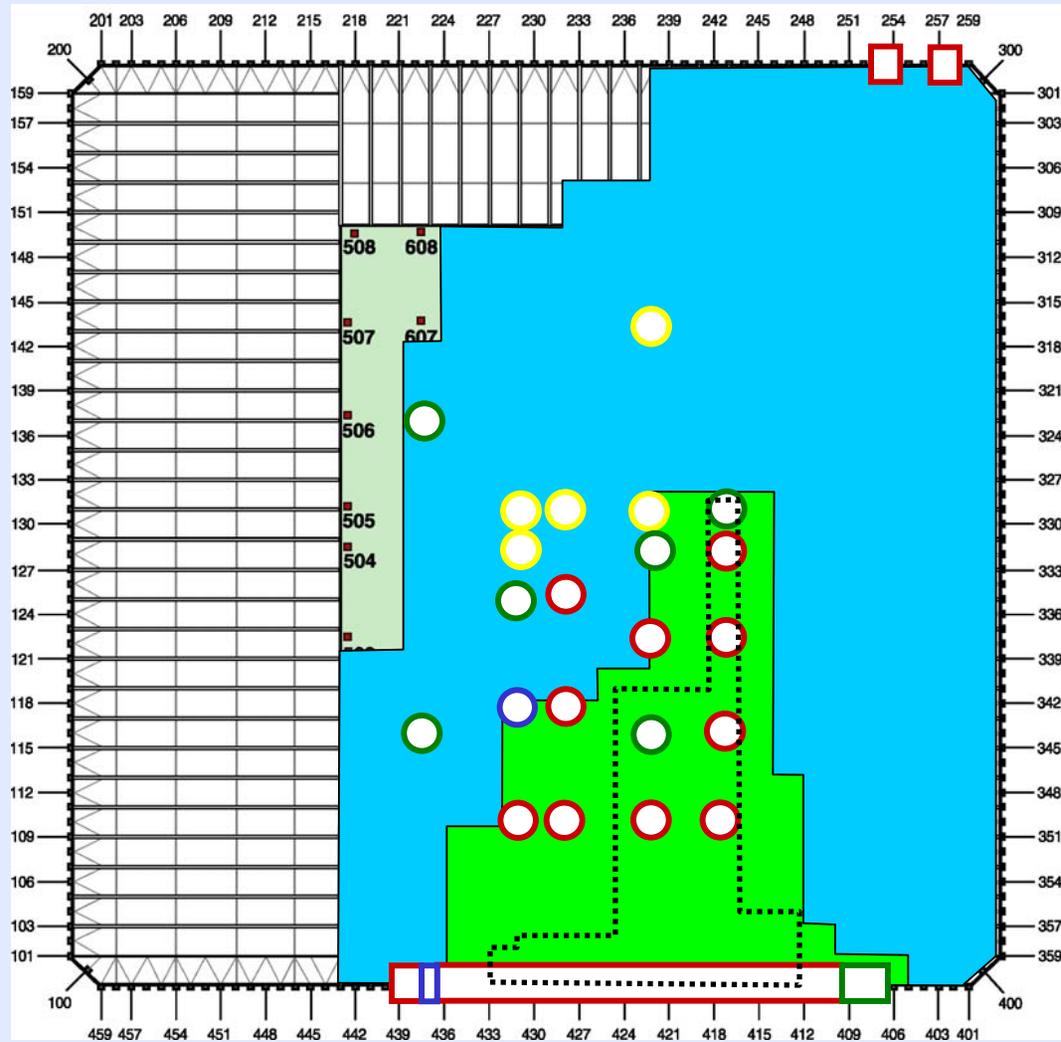
WTC 2 Damage: Composite Summary for Floors 78 to 83

Floor Damage

- Fireproofing and partitions
- Floor system structural damage
- Floor system removed

Column Damage

- Severed
- Heavy Damage
- Moderate Damage
- Light Damage

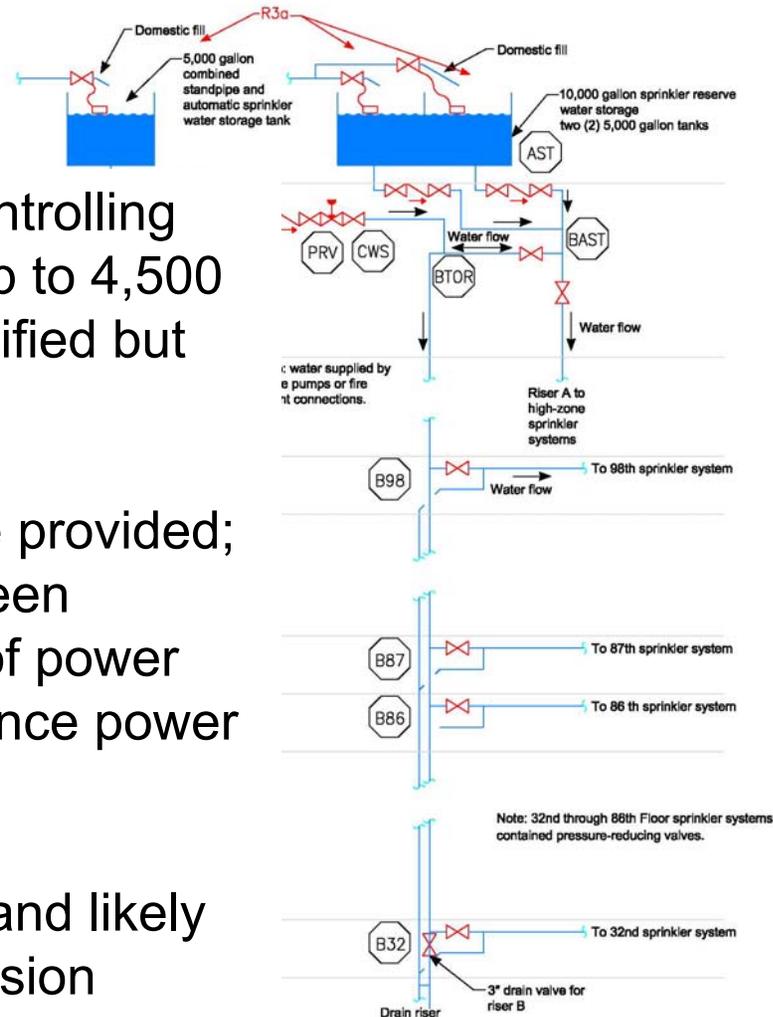
Sprinkler and Standpipe Systems (2)

- Sprinkler systems capable of controlling typical fire with coverage area up to 4,500 ft², three times design area specified but less than 15 % of single floor.
- Primary and backup power were provided; system operability could have been affected by lack of redundancy of power lines to emergency fire pumps once power was lost.
- Due to magnitude of initial fires and likely aircraft impact damage, suppression systems in WTC towers could not have been expected to control the fires.

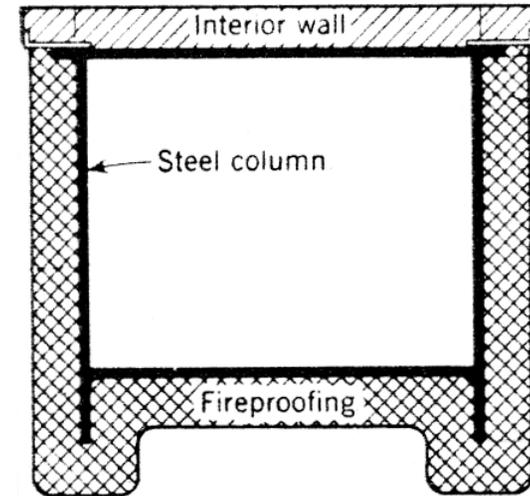
SFRM used in Towers

<u>Structural Component</u>	<u>Member size</u>	<u>Location</u>	<u>Material</u>	<u>Thickness, inches</u>
Floor Trusses	All	All	Cafco DC/F	1/2
Interior columns	< 14WF228	All	Cafco DC/F	2-3/16
	≥ 14WF228	All	Cafco DC/F	1-3/16
Exterior Columns	"heavy"	Ext. Faces	Cafco DC/F	1-3/16
		Int. Faces	Vermiculite Aggregate	7/8
Spandrel Beams	All	Ext. Face	Cafco DC/F	1/2
	All	Int. Face	Vermiculite Aggregate	1/2

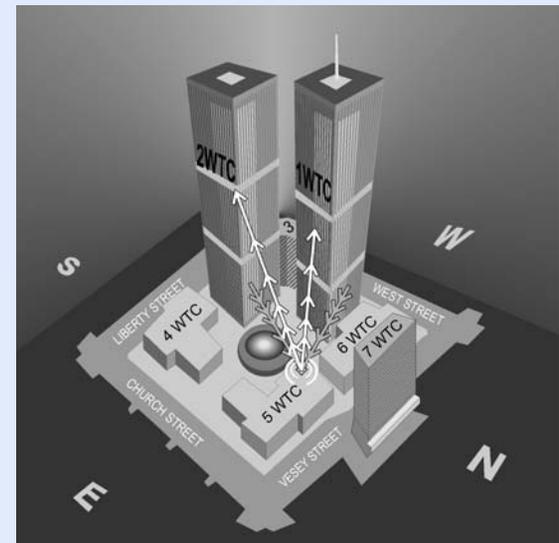
Schematic of WTC Radio Repeater System

- FDNY, NYPD & PAPD all experienced difficulties with radio communications.
- Each department was aware of shortfalls associated with their radio communications systems as they related to operations in high-rise buildings.
- Two basic issues with radio communications:
 - Normal function of the radio equipment in high-rise environments. (Radio signal attenuation in steel and concrete buildings).
 - The volume of radio traffic

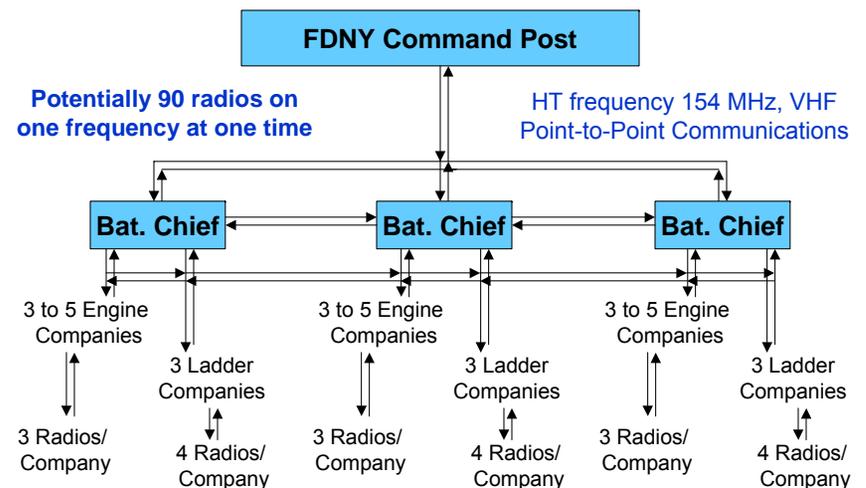
Example: Handie-Talkie Radio System Structure

Only one radio transmission at a time
